PROJECT MEMORANDUM
SCE WEST OF DEVERS UPGRADE PROJECT

To: John Forsythe, Project Manager, CPUC
From: Vida Strong, Aspen Project Manager
Date: June 25, 2020
Subject: Monitoring Report #117: June 15 to June 21, 2020

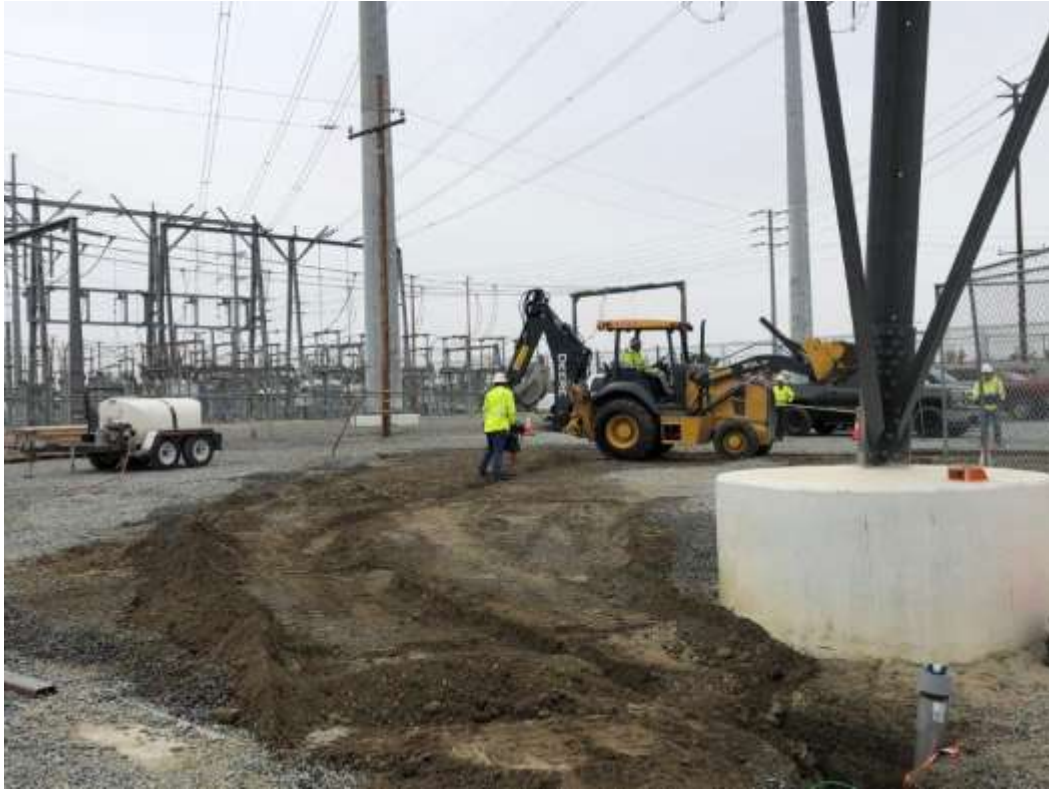
Photo 1 – Conduit installation activities at Construction Area 1X26, Segment 1 (June 19, 2020) (Photo courtesy of SCE).

2. Work activities associated with Segment 1 included installing conduit at Construction Area 1X26 (see Photo 1) and BMP maintenance at Construction Areas 1X10 through 1X18.

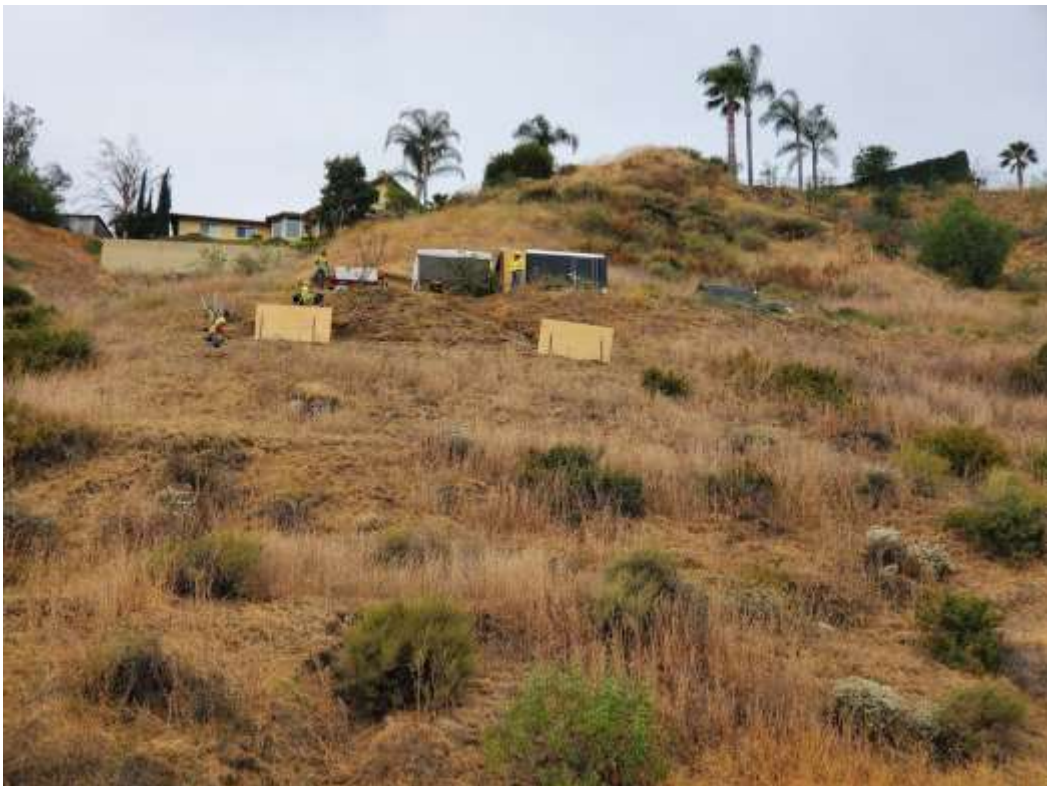
Photo 2 – Foundation removal at Construction Area 2N32, Segment 2 (June 16, 2020).

3. Work activities associated with Segment 2 included: Foundation wreck-out activities at Construction Area 2N32 (see Photo 2); grading and v-ditch preparation at Construction Area 2N18; BMP installation at Construction Area TWA-2-VistaSub-MPR-37; access road maintenance between Construction Areas 2N17 and 2N20; and hydroseed watering at Construction Area 2N32.

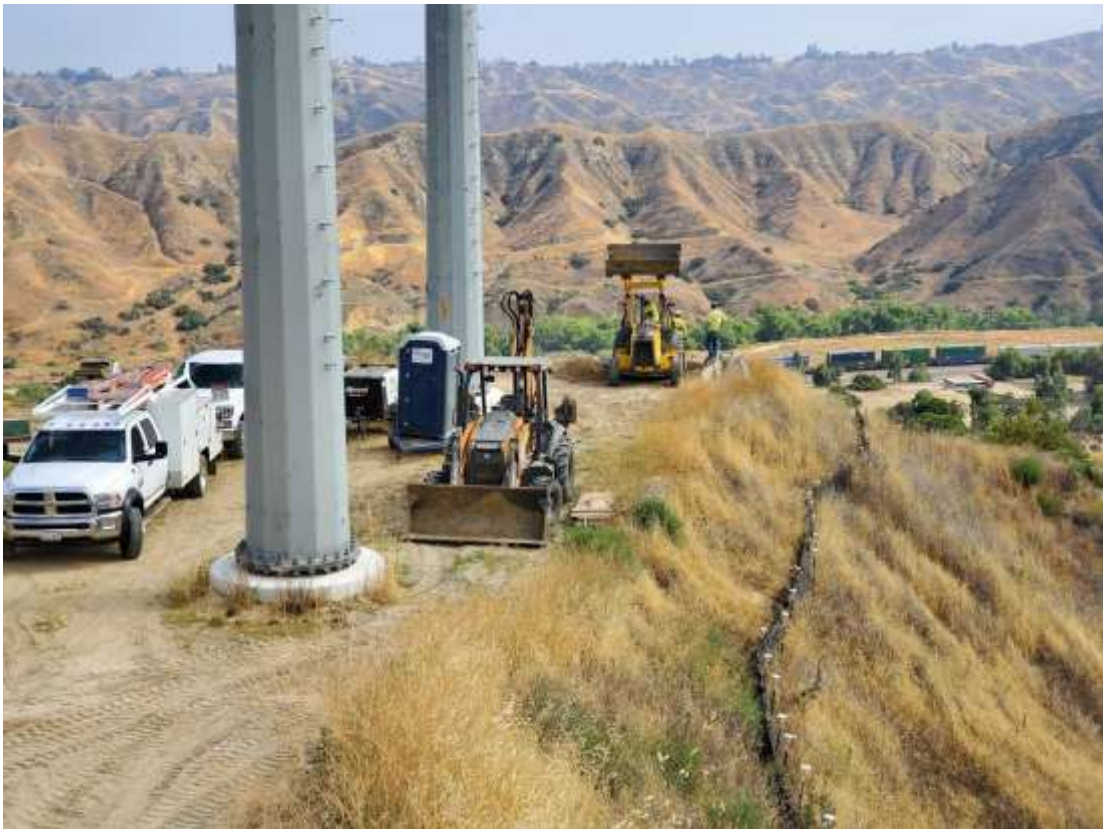
Photo 3 – MAC drain installation at Construction Area 3X35, Segment 3 (June 16, 2020).

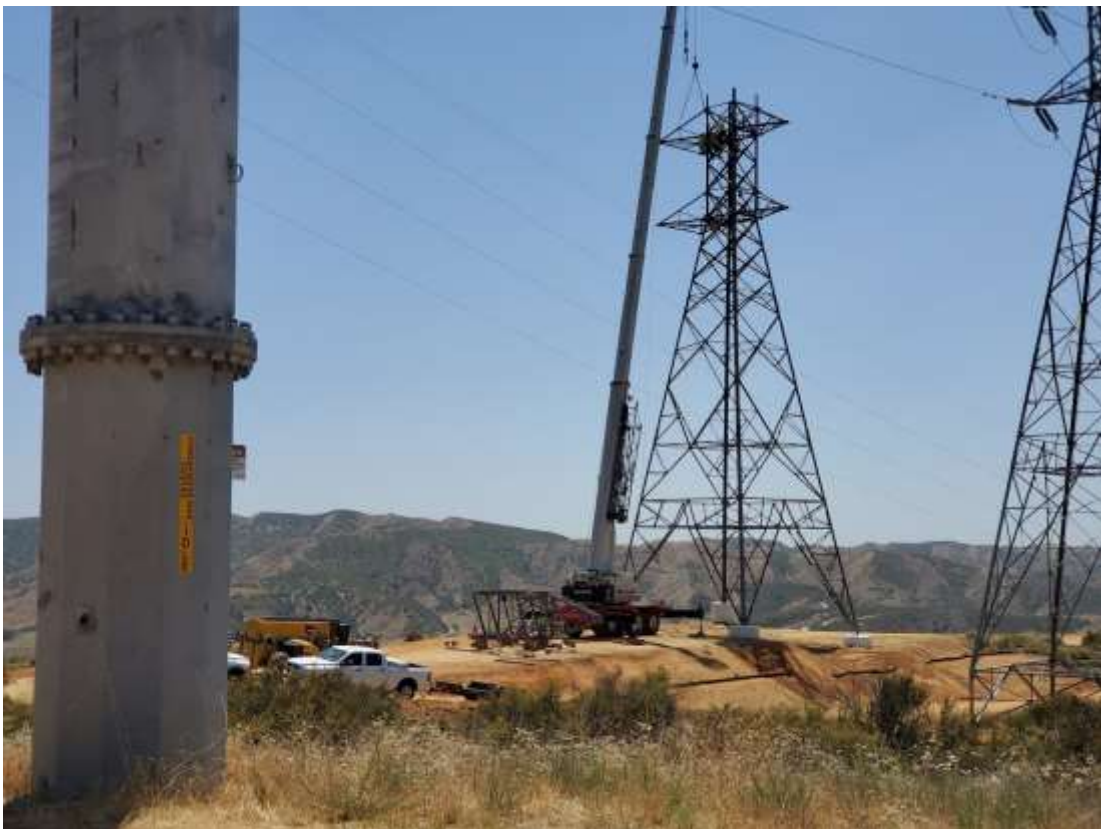
Photo 4 – Tower assembly at Construction Area 4X56, Segment 4 (June 15, 2020).

5. Work associated with Segment 4 (including Construction Areas 4X12 and 4X13 within Morongo Lands as reported by SCE) included: Foundation wreck-out activities at Construction Areas 4X41, 4X45, 4X46, and 4X48; tower assembly at Construction Area 4X56 (see Photo 4); mowing in preparation for wire stringing at Construction Area 4X23; wire stringing activities (helicopter and ground) at Construction Areas 4X01 through 4X29 and 4X55 (see Photo 5); OPGW block installation at Construction Areas 4X17 through 4X19, 4X21, 4X22, and 4X24; installing counterpoise at Construction Area 4X55; installation of climbing discouragers at Construction Areas 4X23 through 4X31, 4X35, 4X36, and 4X43; utilizing Construction Areas 4X29 and 4X35 as a Helicopter Landing Zones; BMP maintenance at Construction Areas 4X27, 4X36, 4X51, and 4X54; and hydroseed watering at Construction Areas 4N59, 4N62, and 4N63.

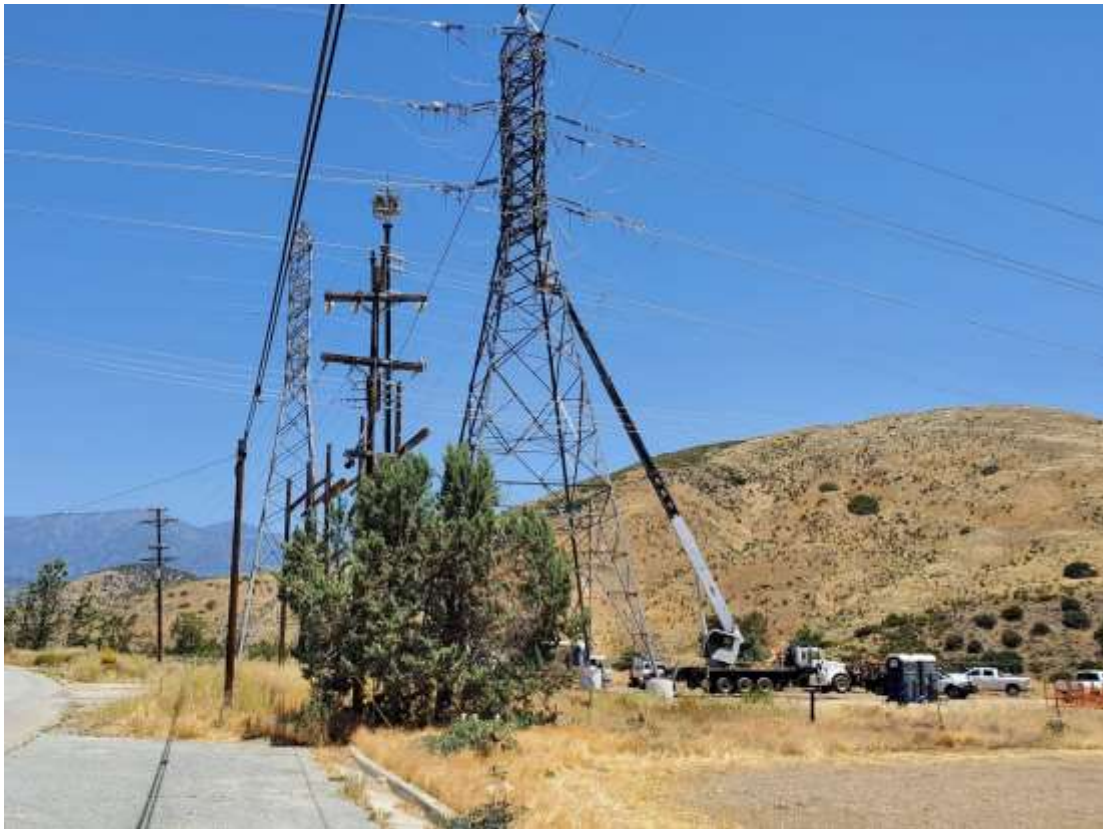
Photo 5 – Wire stringing activities at Construction Area 4X01, Segment 4 (June 15, 2020).

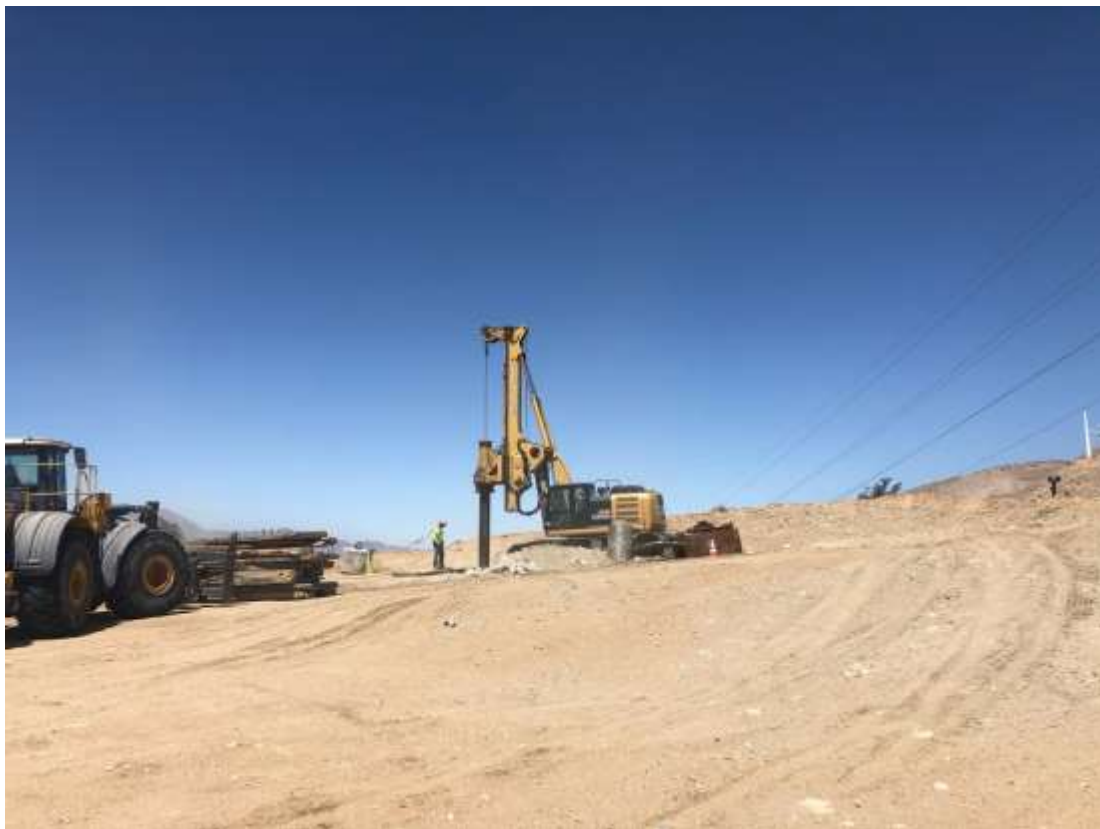
Photo 6 – Foundation activities at Construction Area 6N28, Segment 6 (June 18, 2020).

7. Work associated with Segment 6 (non-BLM lands) included: Tower and foundation wreck-out at Construction Areas 6X09-6X10 and M65-T2; foundation activities at Construction Areas 6N28, 6N29, 6N30 (see Photo 6), and 6N31; foundation clean-up activities at Construction Areas 6N28, 6S28-S, 6N29, 6N30, 6N31, 6S31, 6S32, and 6N34 through 6S38; foundation patching at Construction Area 6N35; tower assembly at Construction Areas 6X09-6X10, 6N15 through 6N23, 6N25, and 6N32; installing spacers at Construction Areas 6S41 through 6X48; and BMP maintenance at Construction Areas 6X08 through 6X48.
