PROJECT MEMORANDUM
SCE WEST OF DEVERS UPGRADE PROJECT

To: John Forsythe, Project Manager, CPUC
From: Vida Strong, Aspen Project Manager
Date: May 13, 2021
Subject: Monitoring Report #160: May 03 to May 09, 2021

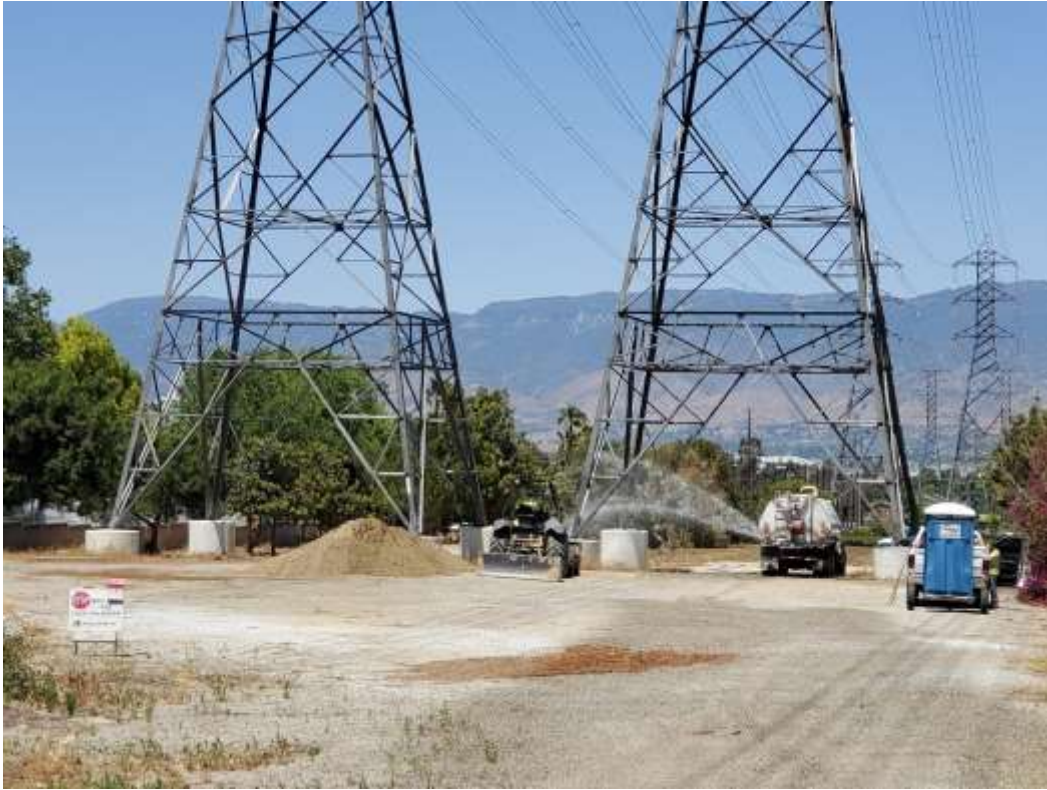
Photo 1 – Site restoration activities at Construction Area 1X08, Segment 1 (May 3, 2021).

2. Work activities associated with Segment 1 included: Site restoration, foundation compaction, vegetation clearing, soil import, and access road maintenance at Construction Areas 1X03 through 1X11 (see Photo 1) and 1X26; construction entrance rock removal at entrances to Construction Areas 1X10, 1X15 through 1X21, and 1X26; and fiber testing at Construction Area 1X26.

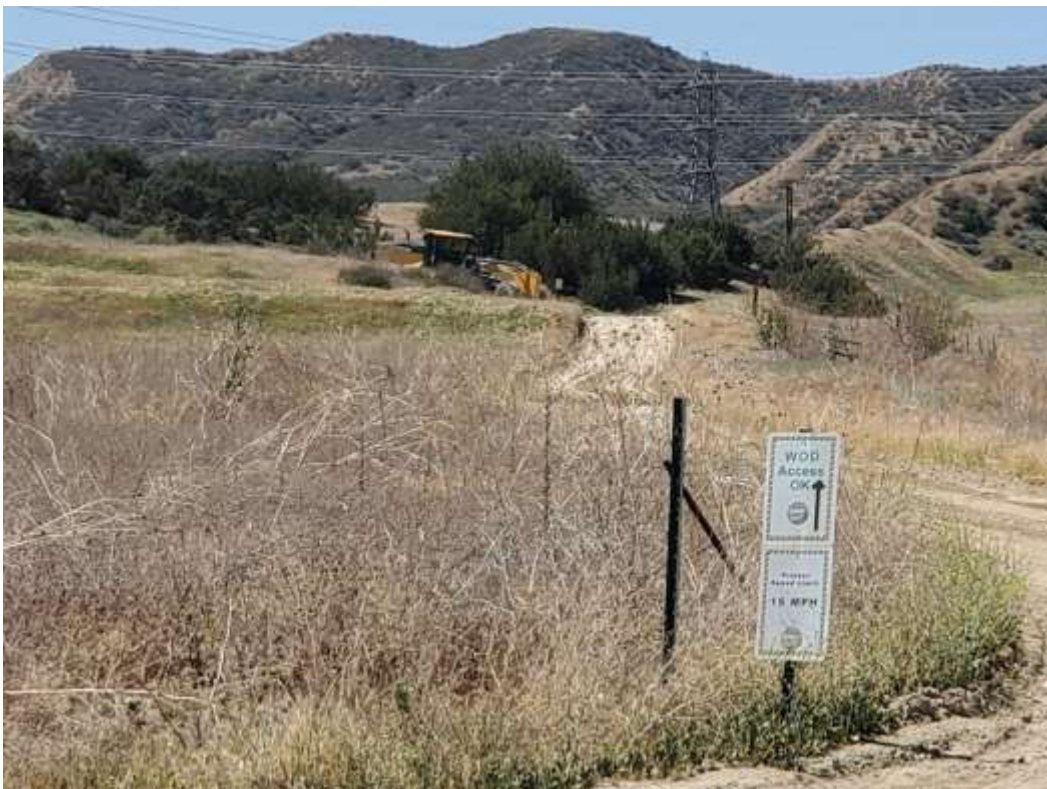
Photo 2 – Maintenance on the access road to Construction Area 3X06, Segment 3 (May 3, 2021).

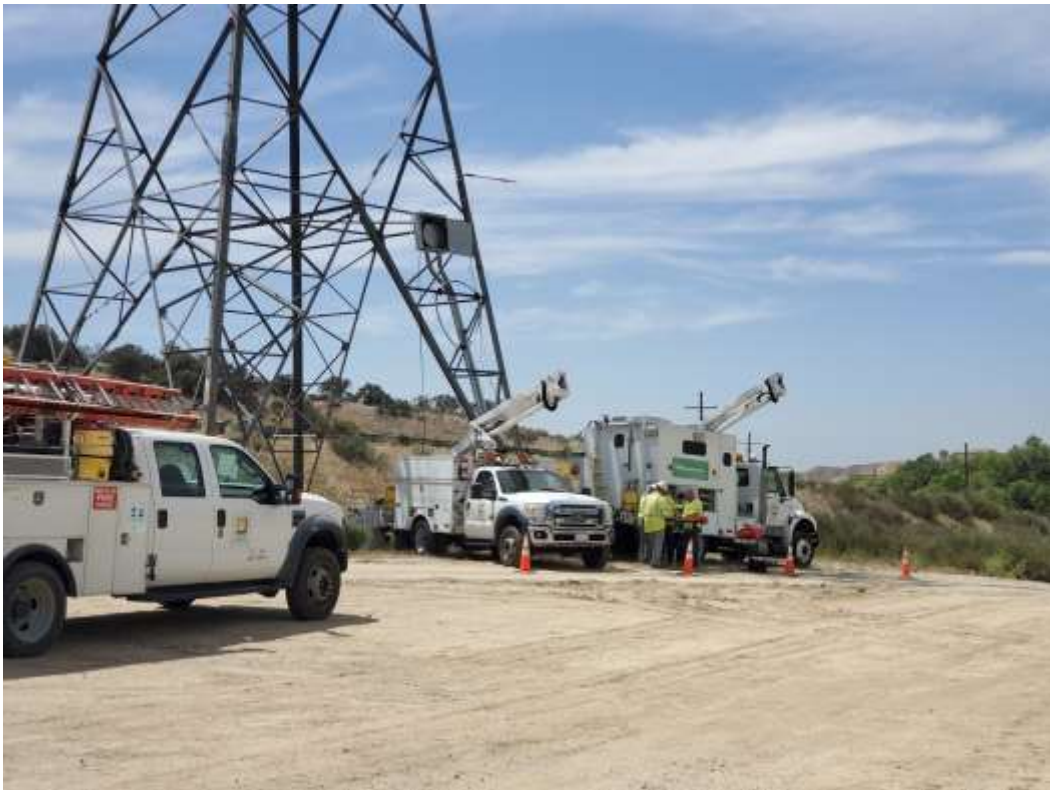
Photo 3 – Fiber optic testing at Construction Area 3N01, Segment 3 (May 5, 2021).

3. Work activities associated with Segment 2 included weed removal at Construction Areas 2N06 and 2N07.
4. Work activities associated with Segment 3 included: Tower shearing and foundation wreck-out at Construction Areas 3X32, 3X33, 3X35, 3X37, 3X61, and 3X65; tower pad recontouring at Construction Area 3S02; MAC drain installation at Construction Area 3S02; access road maintenance between Construction Areas 3N01 through 3X06-07 (see Photo 2) and 3X14; stockpile removal at Construction Area 3X06; BMP maintenance at Construction Area WSS-3X06-07; hydroseed watering at Construction Areas 3N03, 3N04, and 3X10; wire punch-list activities at Construction Area 3X06; and fiber testing and splicing at Construction Area 3N01 (see Photo 3).

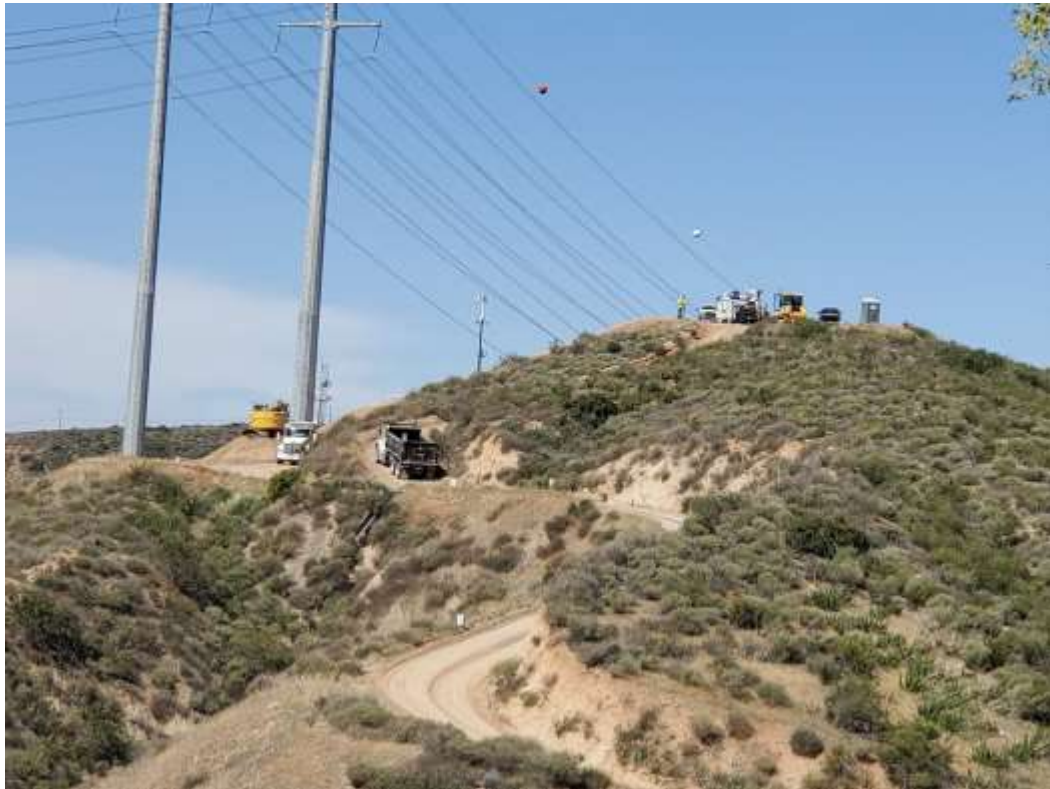
Photo 4 – Tower pad recontouring and soil export at Construction Area 4X03, Segment 4 (May 5, 2021).

1. There was one SCE self-reported and no CPUC issued incidents during the monitoring period. On May 6, the paleontological monitor observed a significant amount of grading activity at Construction Area 4X03 on Segment 4 without the presence of a Paleontological Monitor present that was determined to occur over 5 days. The extent of unmonitored grading was photographed, measured, and thoroughly documented; no resources were identified. SCE issued a Level 1 Incident and provided that due to changes in Project personnel the full extent of the grading required was not realized in the context of the need for a Paleontological Monitor at the location. The environmental team met with construction crews to clarify monitoring needs moving forward in relation to this location and its paleontological sensitivity. A Paleontological Monitor was assigned to monitor at the site for the remainder of grading activities at Construction Area 4X03.

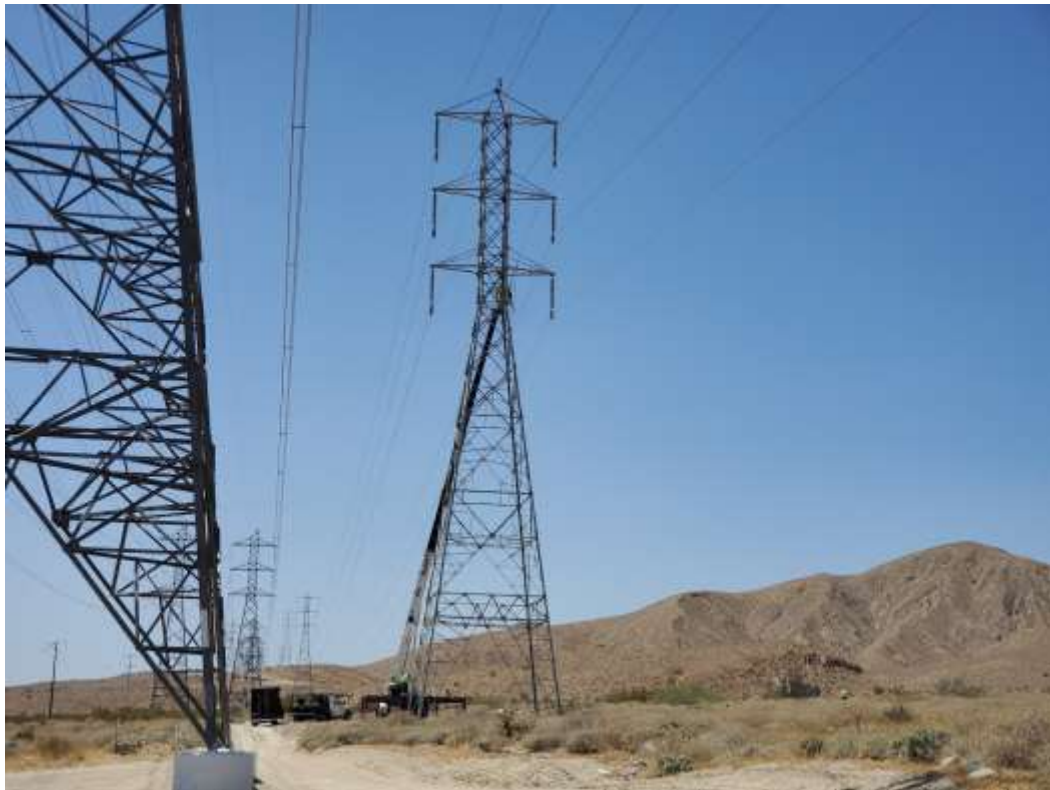
Photo 5 – Wire wreck-out activities at Construction Area 5X04, Segment 5 (May 6, 2021).

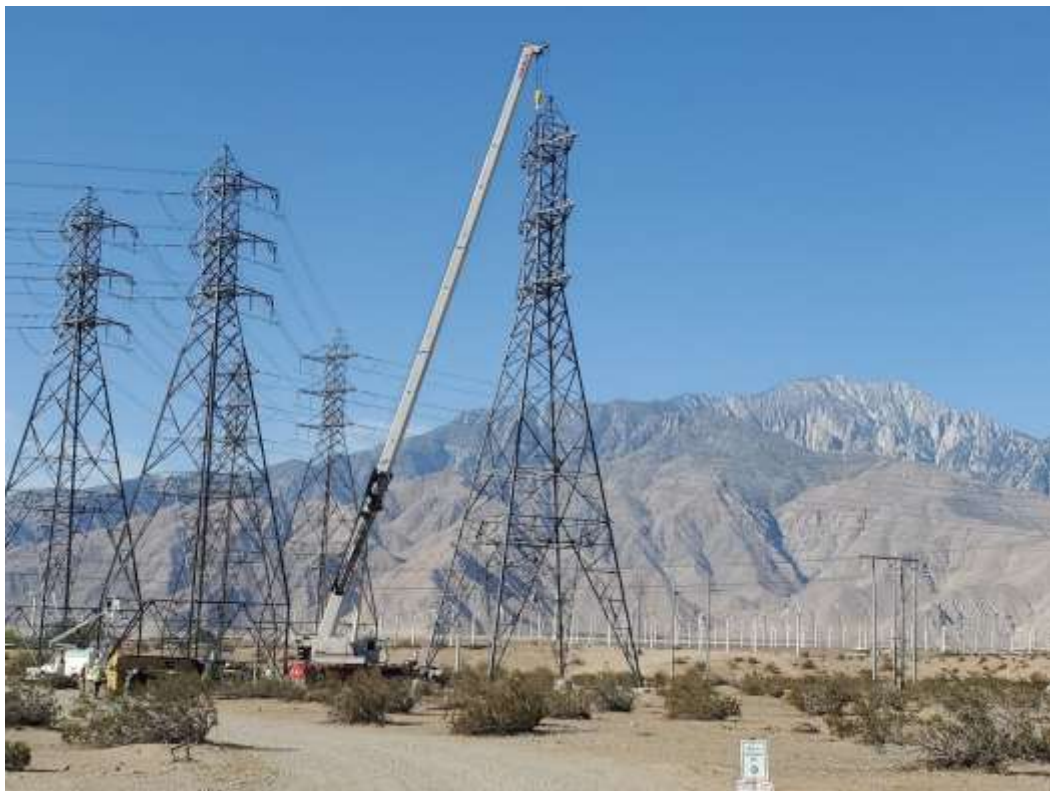
Photo 6 – Tower wreck-out activities at Construction Area 6X09-6X10, Segment 6 (May 5, 2021).

Construction Areas 6X09 (see Photo 6) through 6X11, 6N15, M0-T4, M1-T2, and M61-T1; shoofly tower base removal at Construction Area 6X09-6X10; vegetation removal and grading activities at Construction Areas 6N34 and 6X42; fiber installation at Construction Area 6X09-6X10; and BMP maintenance at Construction Areas 6S30A, 6S31, and 6S31A.
