PROJECT MEMORANDUM
SCE WEST OF DEVERS UPGRADE PROJECT

To: John Forsythe, Project Manager, CPUC
From: Vida Strong, Aspen Project Manager
Date: September 23, 2021
Subject: Monitoring Report #179: September 13 to 19, 2021

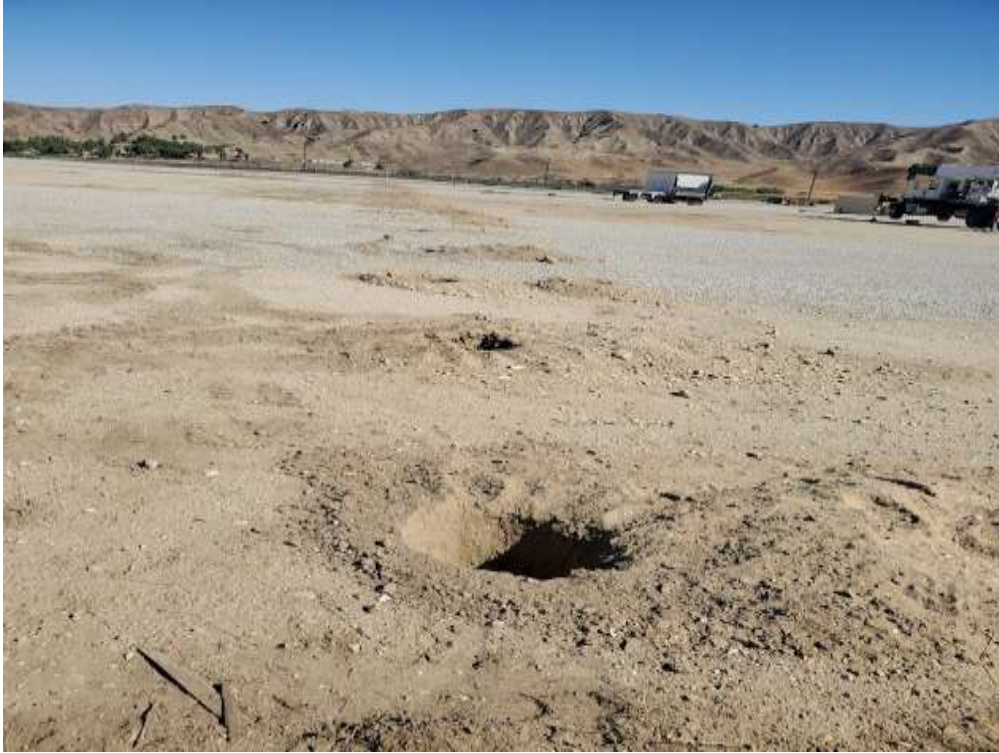
1. There was one SCE self-reported, one CPUC-issued incident, and no observations during the monitoring period. On September 15, the CPUC EM observed 60 steep-walled excavated holes within the Poultry MY that were open and uncovered (see Photo 1). The EM notified the FCR of the observation who arrived onsite and inspected all open holes for any entrapped wildlife. None were found. It was confirmed that the holes were excavated the previous day without the knowledge of the FCR and no biological monitors were onsite to inspect the open holes at the end of the day. The CPUC EM was informed that SCE would issue a Level 1 incident and that the contractor was made aware of the issue and all open holes were provided ramps for wildlife to escape and would be filled the next day. The CPUC EM also issued a Level 1 incident report as the MMCRP WIL-1b states, "Holes and trenches shall be secured to prevent wildlife entry and entrapment. Holes and trenches shall be back-filled, securely covered, or fenced". Furthermore, "at the end of each workday, a biological monitor shall ensure that excavations have been secured or provided with appropriate means for wildlife escape".

Photo 1 – Line of open steep-walled holes for fencing at the Poultry MY (September 15, 2021).

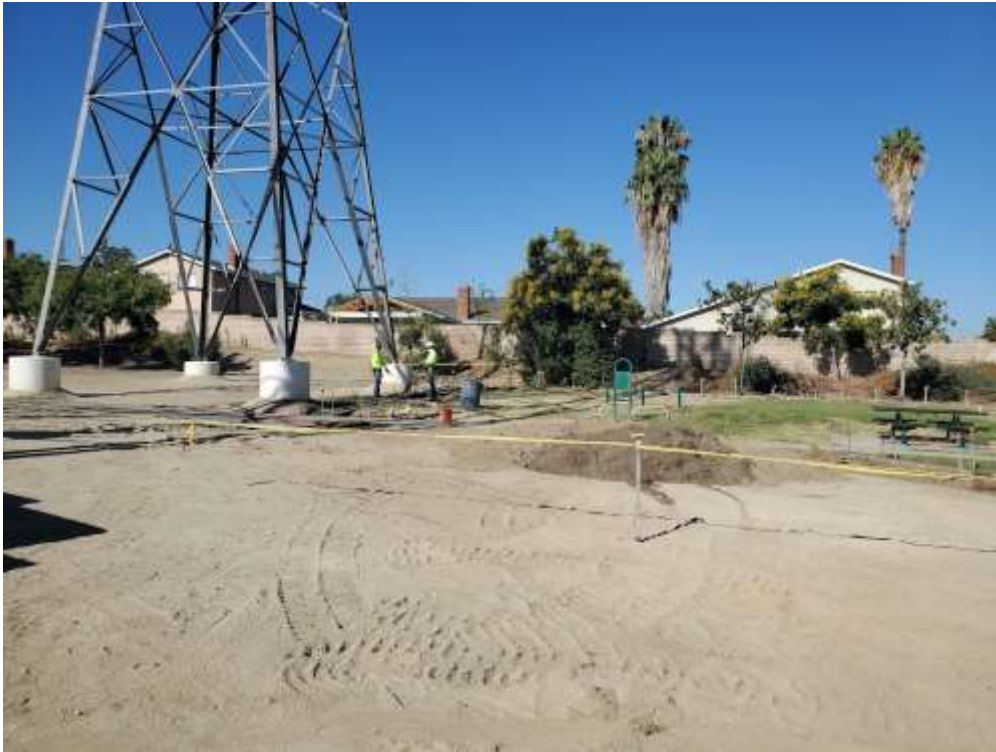
2. Work associated with Segment 1 included concrete repair and clean-up activities at Construction Areas 1X03 through 1X06 (see Photo 2), 1X24, and 1X25.

Photo 2 – Concrete repair activities at Construction Area 1X05, Segment 1 (September 15, 2021).

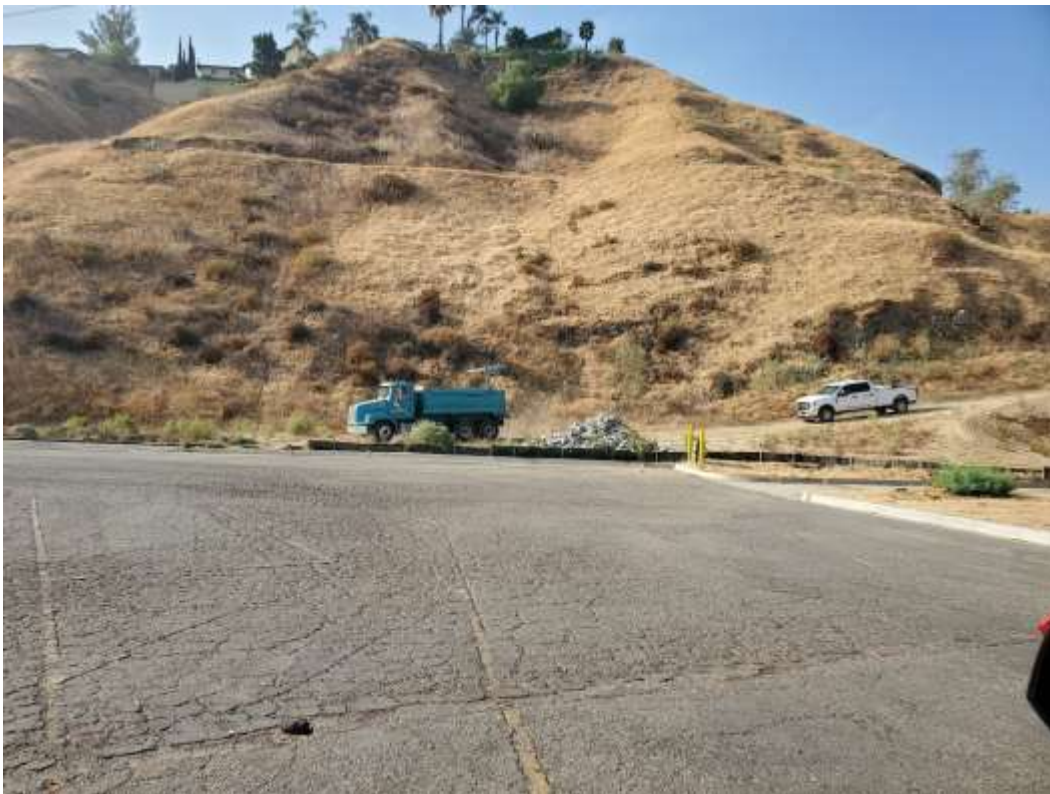
3. Work associated with Segment 2 included hydroseed watering at Construction Areas 2X28 through 2N30, 2N32, and 2N35, and rock delivery and erosion repair activities at Construction Areas 2N25 and 2N32 (see Photo 3).

Photo 3 – Rock delivery at Construction Area 2N32, Segment 2 (September 17, 2021).

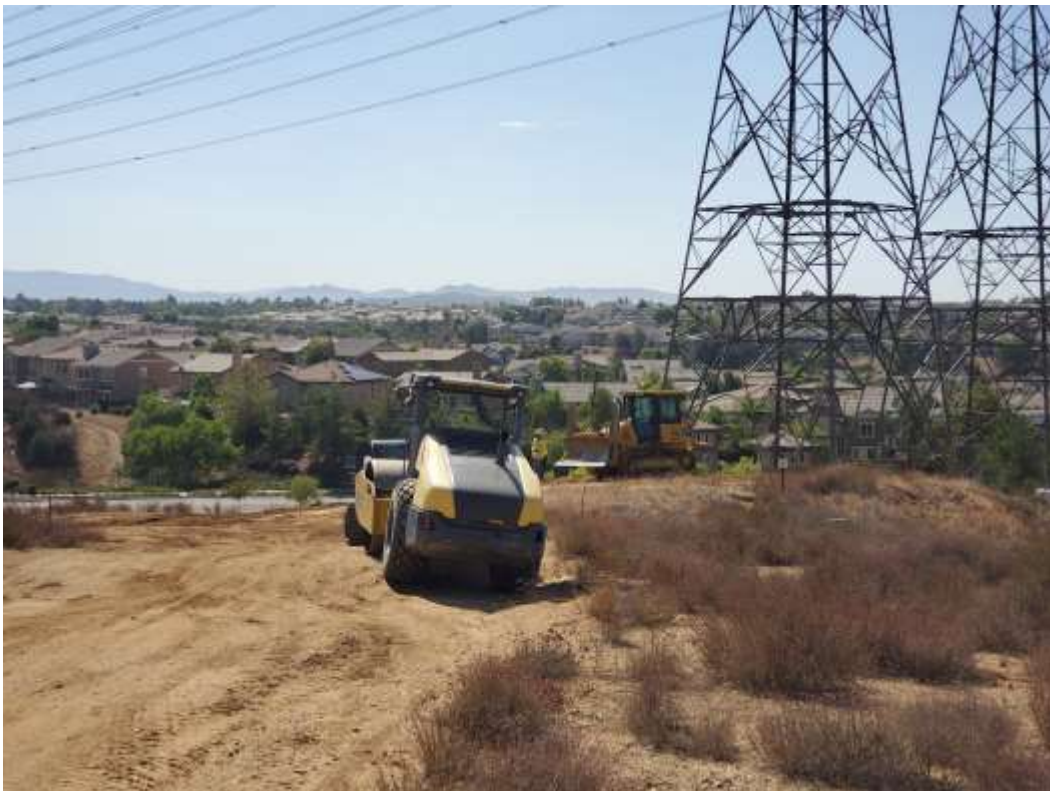
5. Work associated with Segment 4 included: Site restoration and foundation compaction at Construction Areas 4X50 through 4X55 (see Photo 4) and restoration watering and maintenance at Construction Areas 4N59 through 4N63.

Photo 4 – Site restoration activities at Construction Area 4X53, Segment 4 (September 17, 2021).

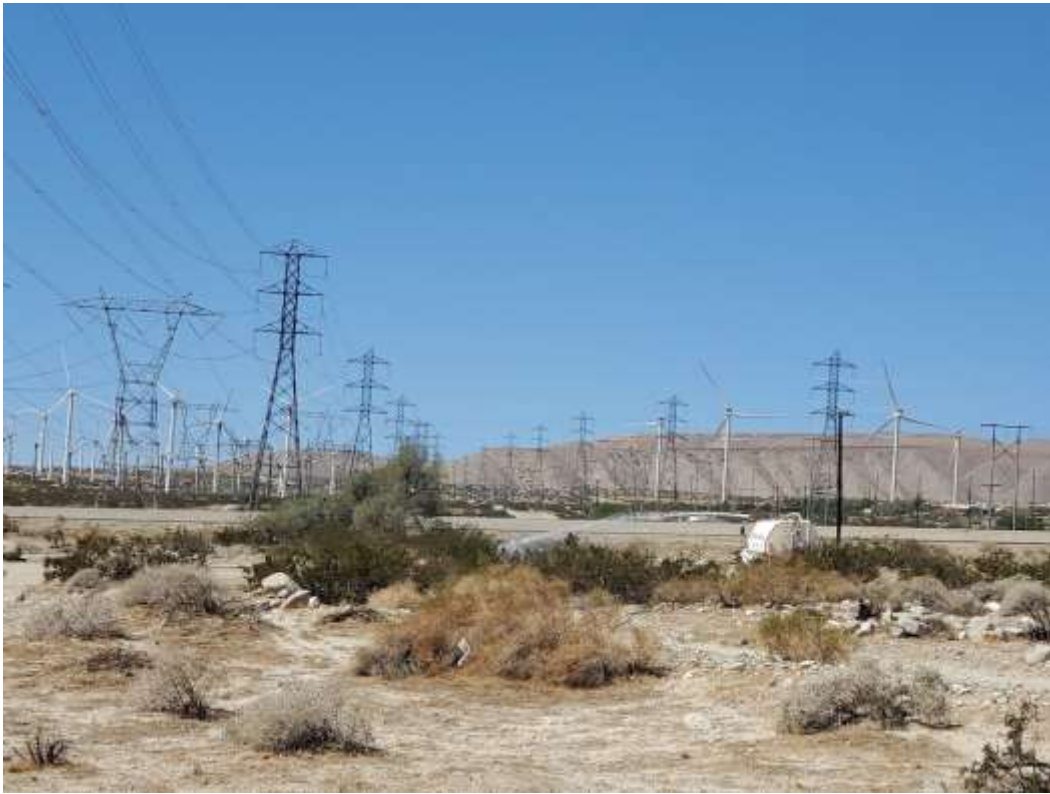
Photo 5 – Hydroseed watering at Construction Area 6N15, Segment 6 (September 15, 2021).
