<p><b>California Public Utilities Commission</b>  <b><i>Mitigation Monitoring, Compliance, and Reporting Program</i></b></p>
	<p><b>Cleveland National Forest Power Line Replacement Projects</b></p> <p><b>Compliance Status Report: 001</b></p> <p><b>October 2, 2016</b></p>

This compliance status report covers construction activities from September 23 through October 2, 2016.

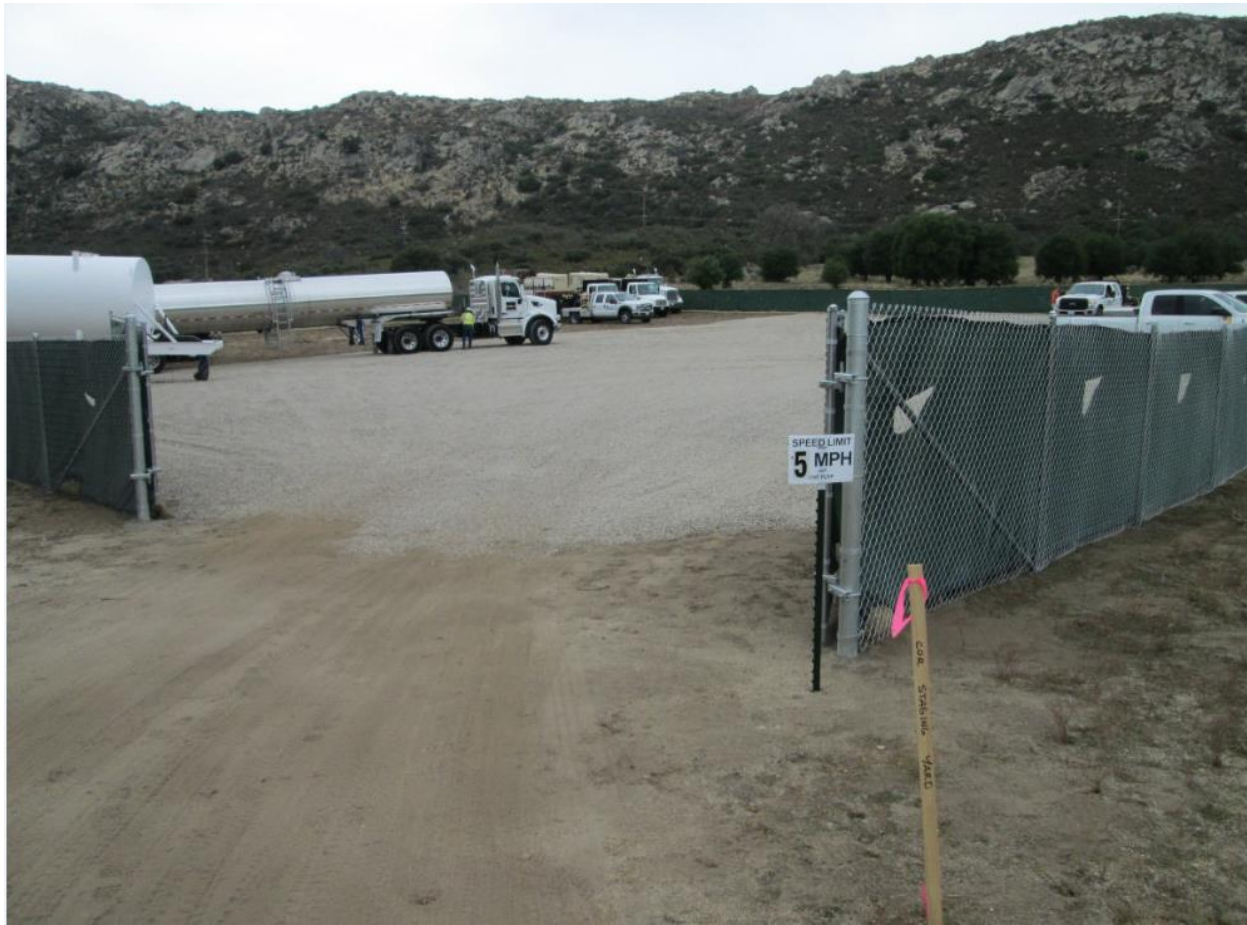
**Photo 1:** Establishment of the Kitchen Creek Staging Yard included delineating work limits and ESAs, laying gravel foundation, installing a perimeter fence and placing opaque screening material (APM VIS-2). Speed limits were posted at the entrance of the yard, which were less than 15 mph in accordance with APM AIR-03 and MM BIO-24.

Construction activities at the Kitchen Creek Staging Yard consisted of delineating work limits and marking Environmentally Sensitive Areas (ESAs) for avoidance in accordance with MM BIO-1, installing a perimeter fence, delivering and spreading gravel base within the staging yard, mobilizing portable restroom facilities, and mobilizing an elevated water storage unit for implementation of dust and fire prevention measures (See Photo 1— Attachment A). The perimeter fence, which was erected within the designated work limits, was observed to have green, opaque screening material to minimize visual impacts to close-range residential areas in accordance with APM VIS-02. Storm Water Pollution Prevention Plan (SWPPP) Best Management Practices (BMPs) were observed being installed at the staging yard in accordance with APM HYD-05, MM BIO-7, and MM HYD-1 and included installation of straw wattles/fiber rolls around the perimeter of the fence, installation of a rumble plate (designed to reduce sediment track-out onto the paved roadway) at the entrance of the staging yard access road, and keeping the rumble plate clear of sediment (crews sweeping) (See Photo 2— Attachment A). Once work vehicles were able to mobilize at the staging yard, drip pans were observed underneath vehicles and portable restroom facilities were observed staged over catchment units to minimize potential for soil contamination in accordance with the SWPPP. A fire box containing necessary fire-fighting tools was observed at the staging yard in accordance with the Construction Fire Prevention/Protection Plan (CFPPP) (MM FF-1).

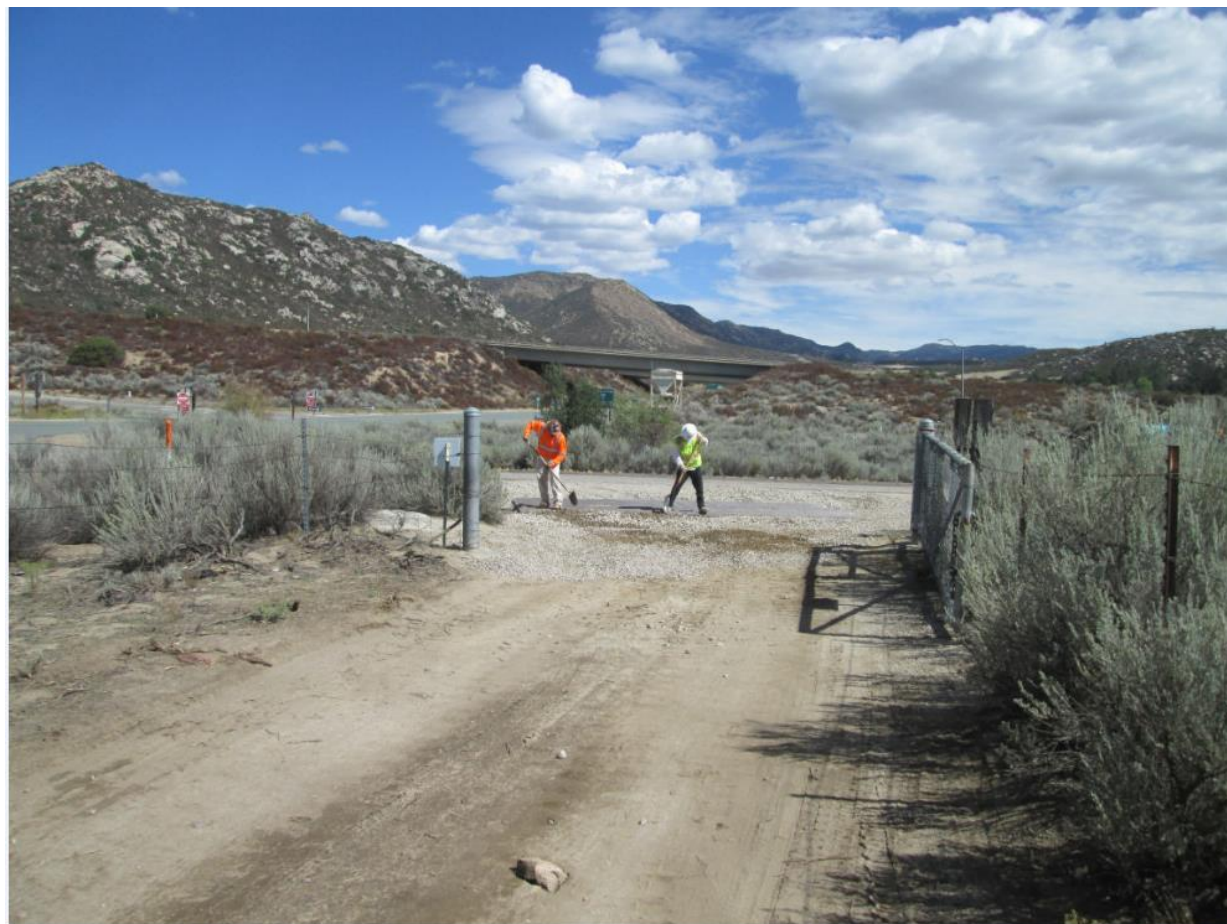
**Photo 2:** Crews were observed cleaning the rumble plates of sediment and debris at the entrance of the Kitchen Creek Staging Yard in accordance with the SWPPP (APM HYD-05, MM BIO-7, MM HYD-1) and ensuring pavement on was free of track out (APM-AIR-04).

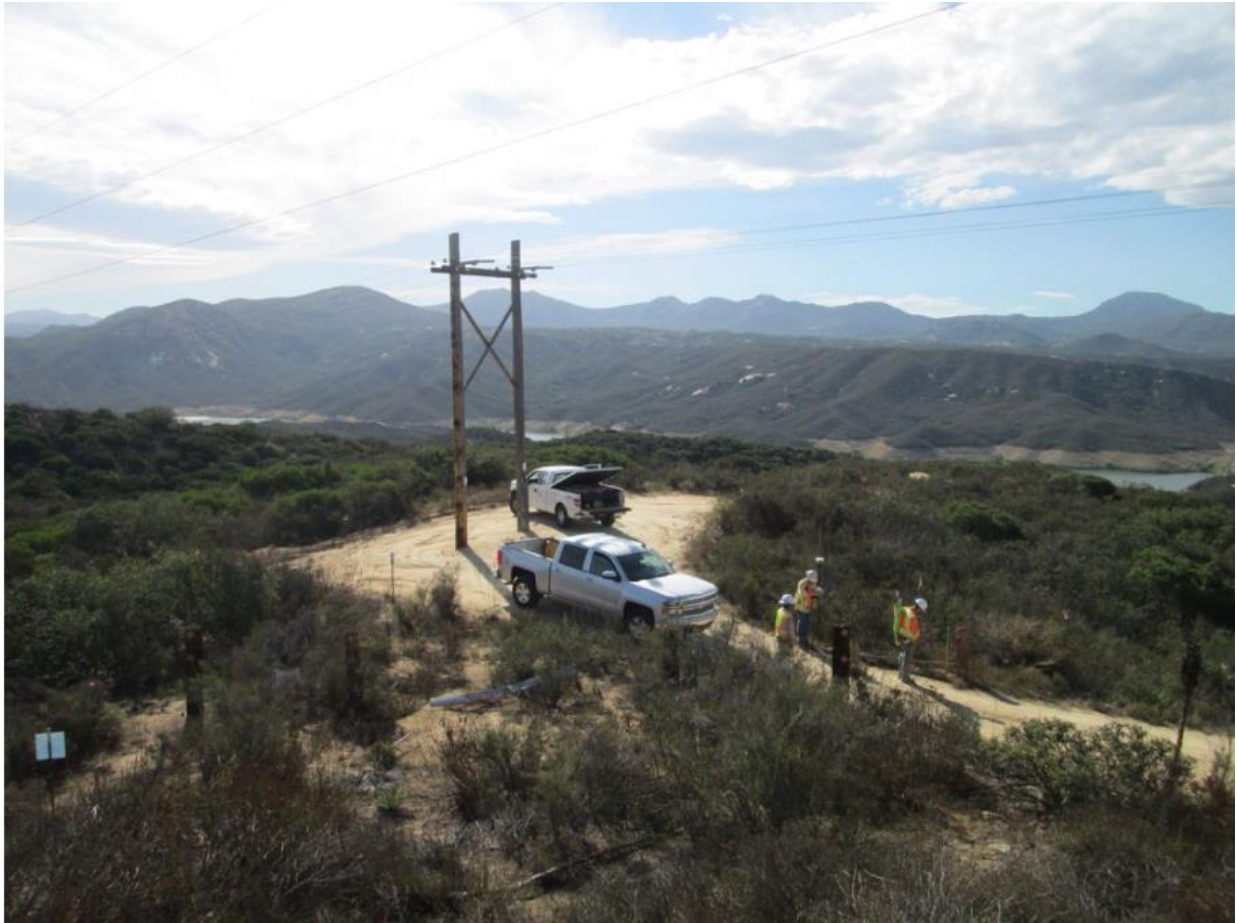
**Photo 3:** Prior to any work occurring at pole sites, resource crews were observed surveying and staking approved work spaces in the field (TL 625B, above) in accordance with MM BIO-1.

Limited activities occurred along TL 625B this reporting period and included staking approved work areas (See Photo 3— Attachment A) in accordance with MM BIO-1, clearing sites, installing SWPPP BMPs and pole preparation work. During mobilization of equipment used for pole preparation work, crews were observed staying within existing access roads and staging notification/cautionary signage in accordance with APM TRANS-02 (See Photo 4—Attachment A). Vehicles were observed limiting idling in accordance with APM AIR-01.

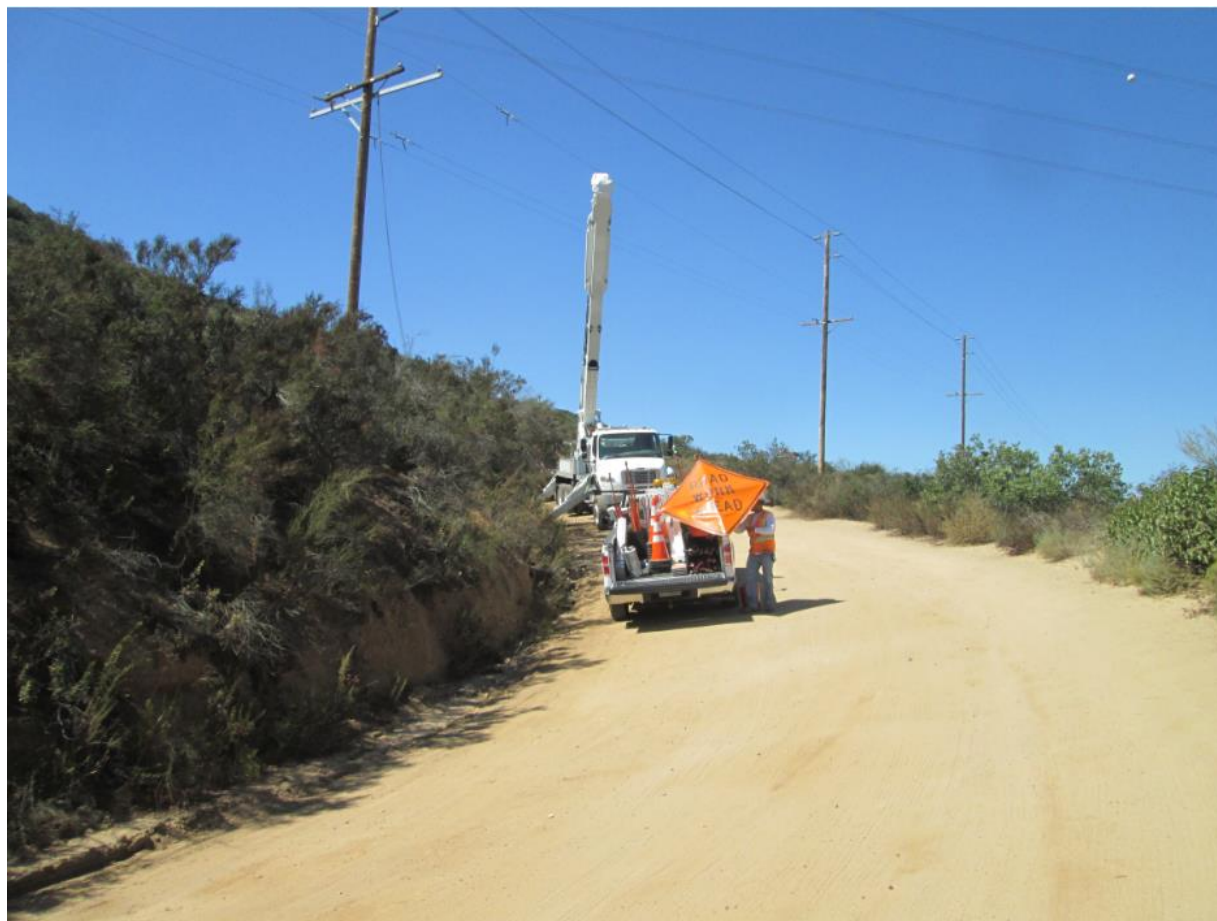
**Photo 4:** During pole preparation activities within TL 625B access roads, crews were observed using traffic signage to maintain a safe transportation corridor during construction in accordance with APM-TRANS-02.

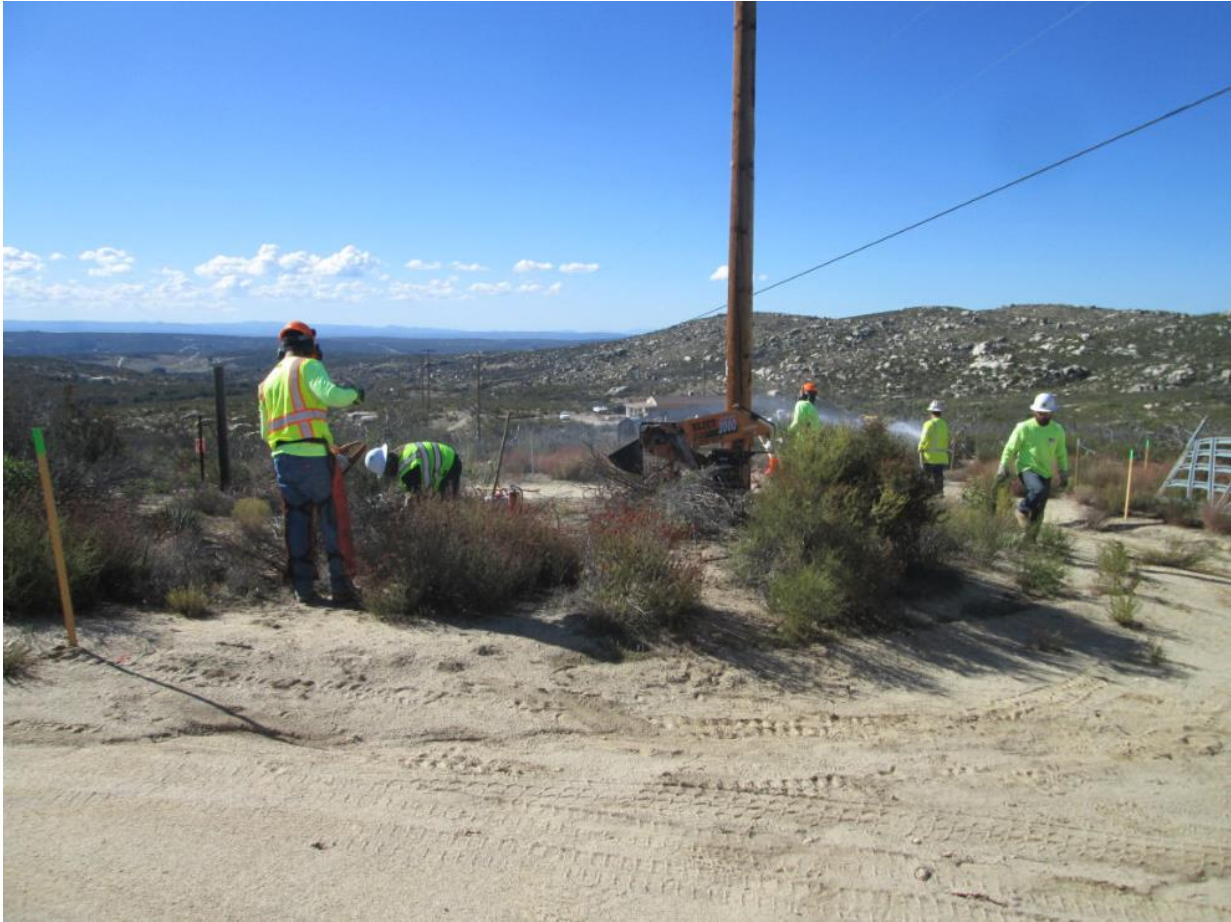
**Photo 5:** Crews were observed clearing brush and vegetation (manually and by using a chipper) around approved work sites (TL 629E, above) prior to SWPPP BMP installation. Areas were watered down and fire tools were staged adjacent to work areas in accordance with the CFPPP (MM FF-1).

For work spaces that required brush and vegetation clearing, which involved manual removal and on-site chipping equipment, biological monitors were observed present during initial ground disturbing and vegetation-removal activities in undeveloped areas in accordance with MM BIO-3 and ensuring work was confined to/occurred in delineated areas in accordance with MM BIO-1. Cultural resources monitors were also observed during these activities to ensure protective measures were adhered to in specific locations in accordance with APM CUL-04, MM CUL-1 and MM CUL-3. Signs marking ESAs were observed and crews were observed avoiding these areas. Crews were observed staging fire tools adjacent to work areas and areas were wetted via a mobile water buffalo and hose in accordance with the CFPPP (MM FF-1)

(See Photo 5—Attachment A). Also, vehicles adjacent to work spaces were also observed containing fire tools and being checked by fire personnel in accordance with the CFPPP and were observed staying on existing access roads (roads approved per NTP-1 and roads prohibited for SDG&E use were observed marked in the field). Plant salvage was observed in accordance with the Habitat Restoration Plan (HRP) (MM BIO-4) and the Special Status Plant Salvage and Relocation Plan (SSPSRP) (MM BIO-15). Upon completion of clearing and plant salvage activities, SWPPP BMPs, such as straw wattles were observed installed (APM HYD-05 and MM BIO-7) within approved work limits (See Photo 6—Attachment A).

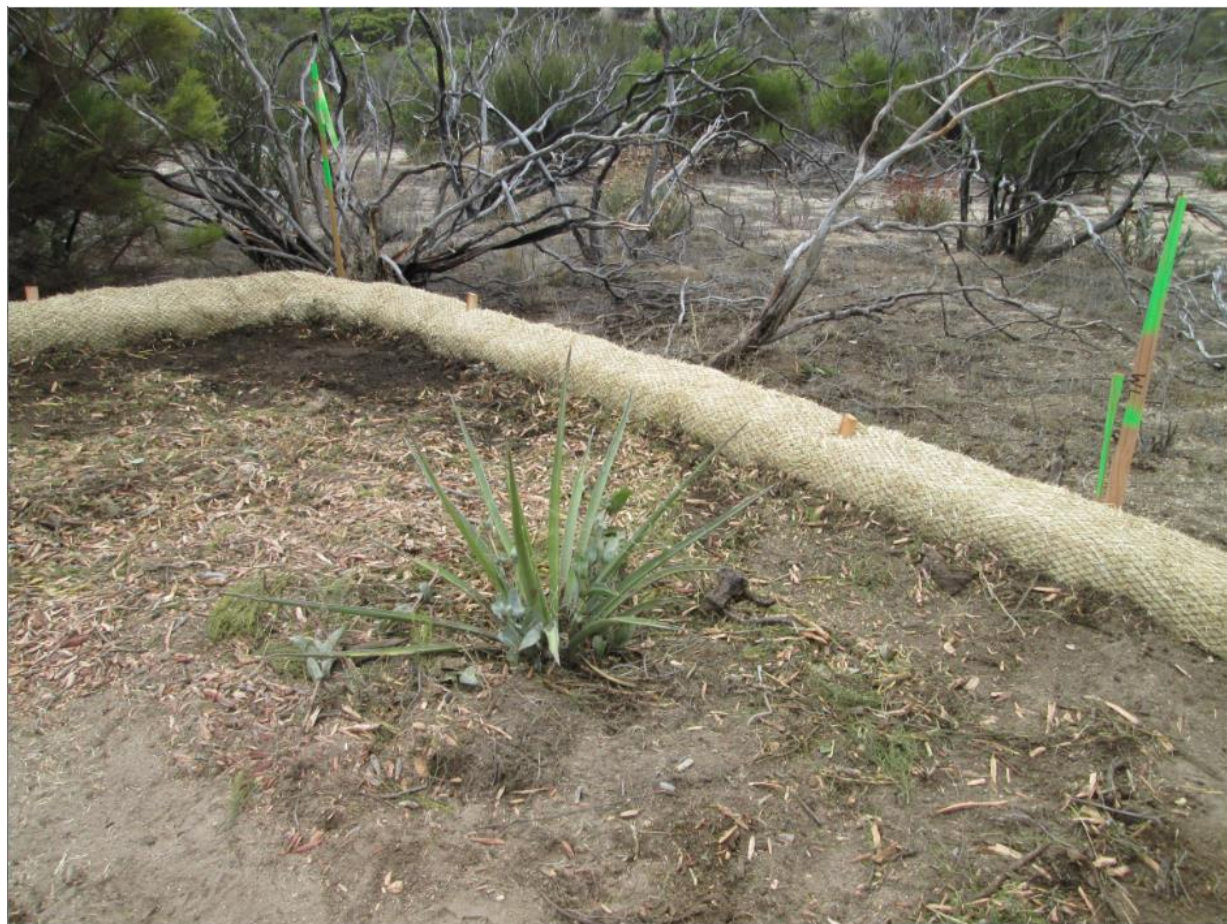
**Photo 6:** Crews were observed avoiding plants designated for salvage as described in the HRP and SSPSRP (MM BIO- 4, MM BIO-15). Salvaged plants were observed being transported to an off-site nursery until the restoration phase for the segment. Fiber rolls were placed around work sites as approved in the SWPPP (APM HYD-05, MM BIO-7, MM HYD-1).

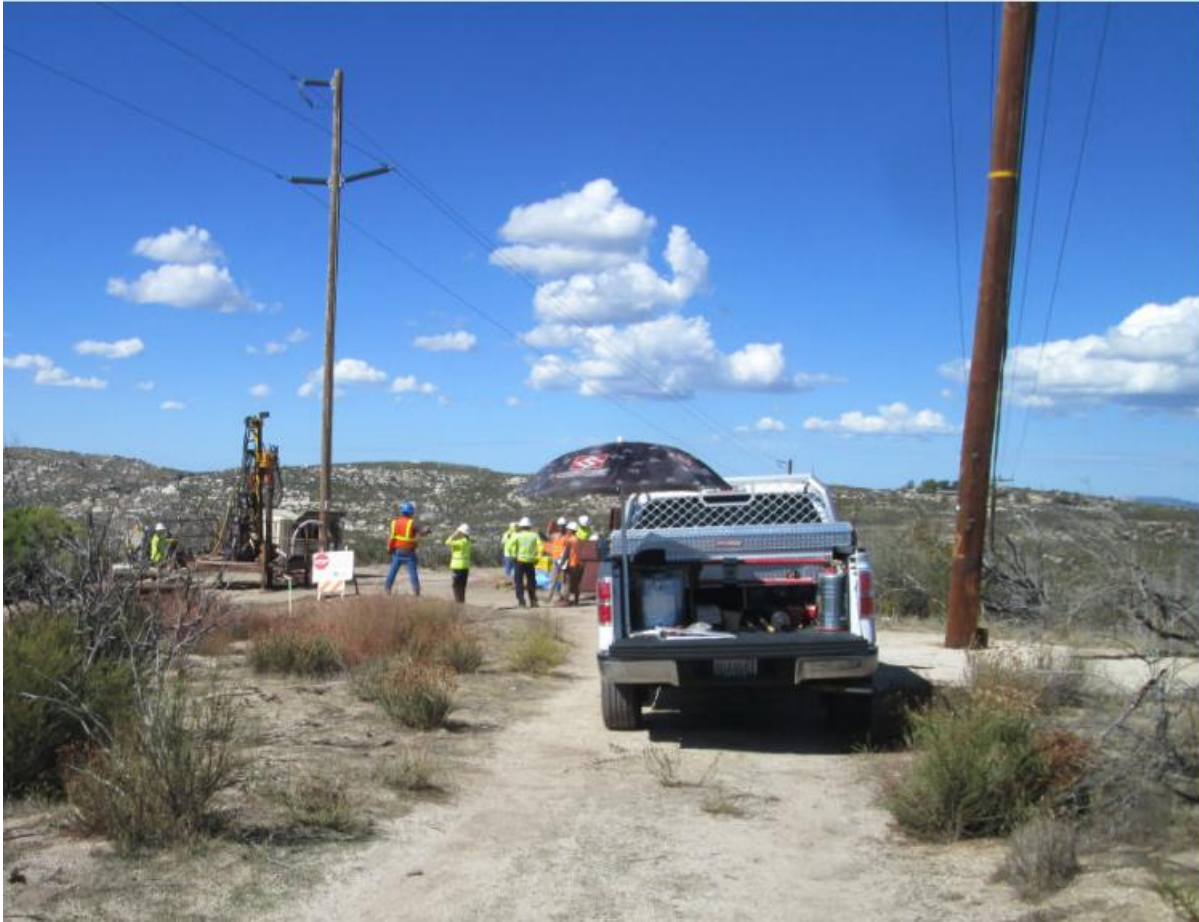
**Photo 7:** Subsequent to surveying, clearing, and BMP installation, equipment used for steel pole micro pile foundations was mobilized on site. At the work sites, vehicles were observed carrying required fire equipment (5-gallon backpack pump, shovel, Pulaski, and fire extinguisher) and a fire box containing fire equipment was observed staged adjacent to the immediate work areas in accordance with the CFPPP.

Once SWPPP BMPs had been installed, crews were observed mobilizing equipment used for steel pole micro pile foundations within work limits. Similar to the Kitchen Creek Staging Yard, a fire box was observed staged adjacent to these work areas and vehicles were observed containing required fire equipment in accordance with the CFPPP (MM FF-1) (See Photo 7—Attachment A).
