<p>California Public Utilities Commission <i>Mitigation Monitoring, Compliance, and Reporting Program</i></p>
	<p>Cleveland National Forest Power Line Replacement Projects</p> <p>Compliance Status Report: 029</p> <p>October 29, 2017</p>

This compliance status report covers construction activities from October 16 through October 29, 2017.

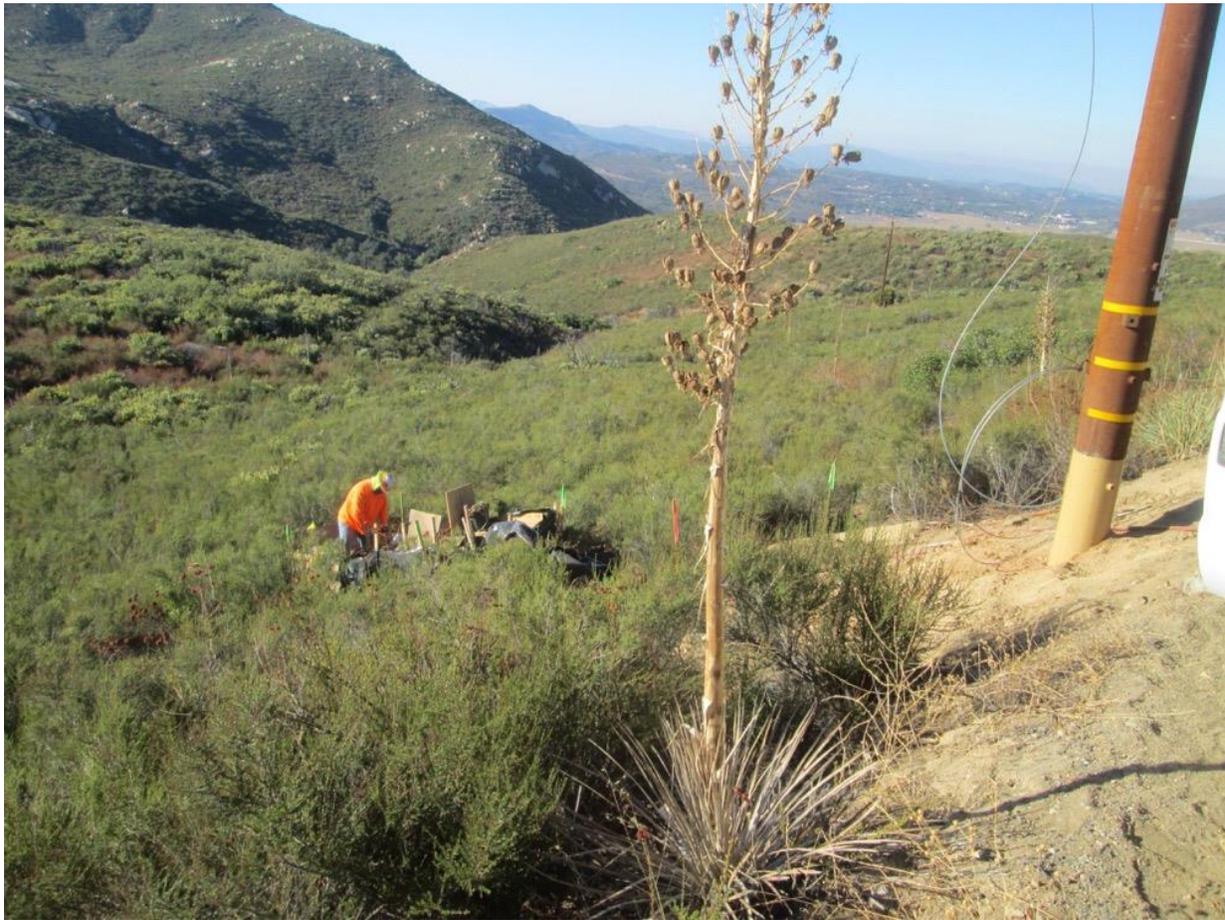
Photo 1: Anchor hole digging was observed at P172687. Work and access occurred within the delineated limits of disturbance in accordance with MM BIO-1 (C 78).

During construction activities, crews were observed adhering to delineated work limits and working within existing access roads in accordance with MM BIO-1 (See Photo 1 – Attachment A). In accordance with MM BIO-3 and MM BIO-22, biological monitors were observed conducting full time monitoring of initial ground-disturbing activities as well as vegetation clearing and trimming, which were occurring along TL 682 and C 78. To prevent wildlife entrapment along C 78, completed pole holes were observed securely covered in accordance with MM BIO-23. On October 26, the onsite lead biological monitor informed the CPUC ECM that the covering for a pole hole had been removed, possibly by a member of the public at a previously drilled hole. The CPUC ECM confirmed that the hole would be inspected for wildlife and re-covered in accordance with MM BIO-23. CPUC ECMs observed construction crews using trash bags to contain and collect trash at worksites in accordance with MM BIO-26 and BIO-33.

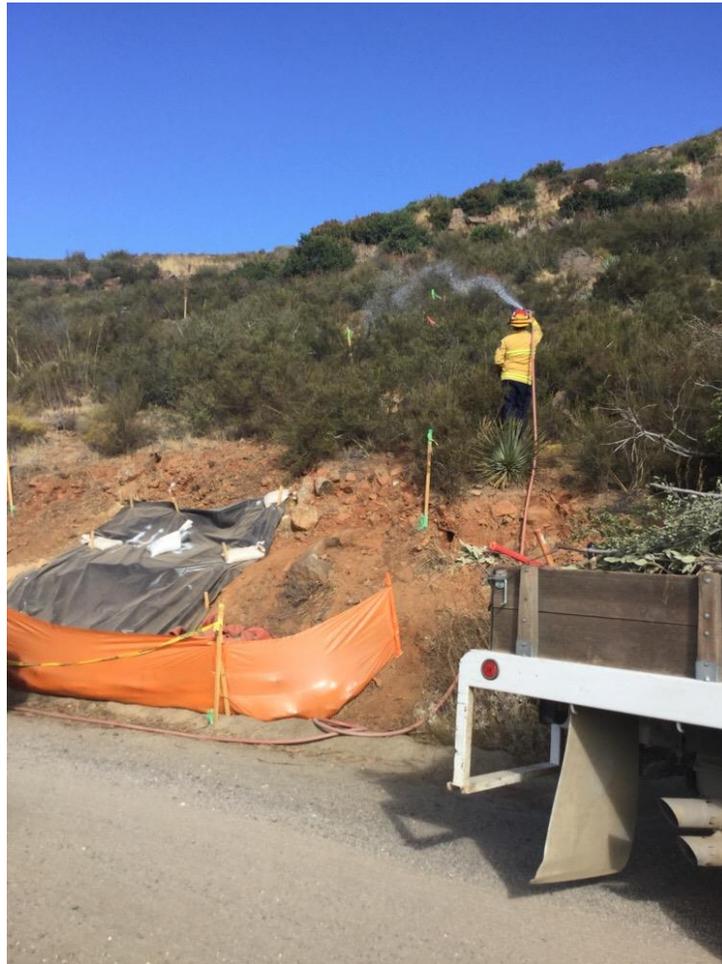
Photo 2: Fire patrol personnel were observed watering the vegetation before work began at P257743 in accordance with the CFPPP (C78).

During construction activities along all rights-of-way, construction fire patrols were observed inspecting sites for compliance with the Construction Fire Prevention/Protection Plan (CFPPP) (MM FF-1). Crews were observed staging the required fire tools and equipment based on the Project Activity Level (on Cleveland National Forest (CNF) land)/Fire Potential Index (off CNF land) and the construction activity being performed as allowed in the Fire Prevention Matrices CFPPP (MM FF-1 and APM HAZ-01). During vegetation clearing along C78, a water truck was used to water before clearing activities for fire safety in accordance with the CFPPP (See Photo 2 – Attachment A). Work activities were limited or cancelled during Red Flag Warnings and on several other days with extreme fire danger during this reporting period.

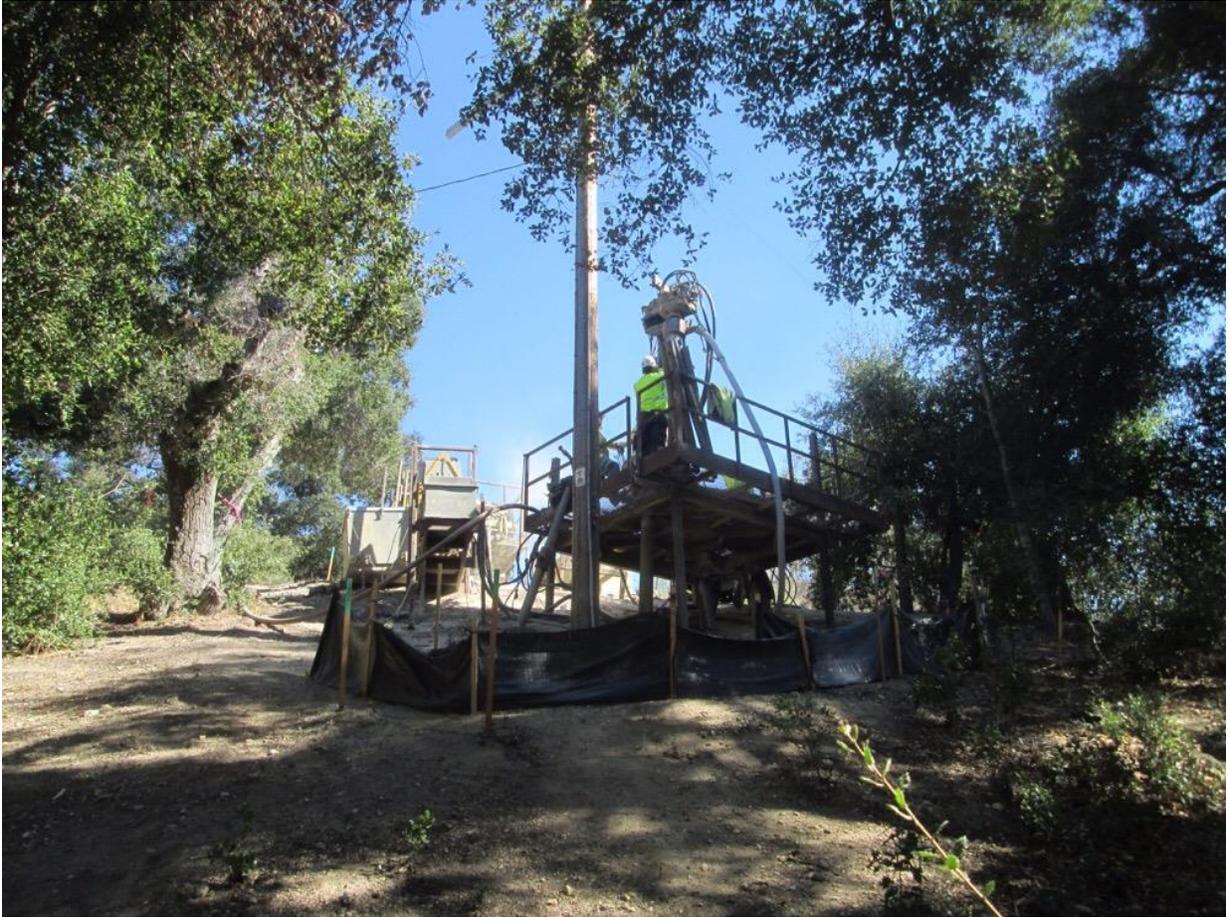
Photo 3: A silt fence was observed around the downslope side of the micropile drilling workspace at Z118123 in accordance with the SWPPP (TL 682).

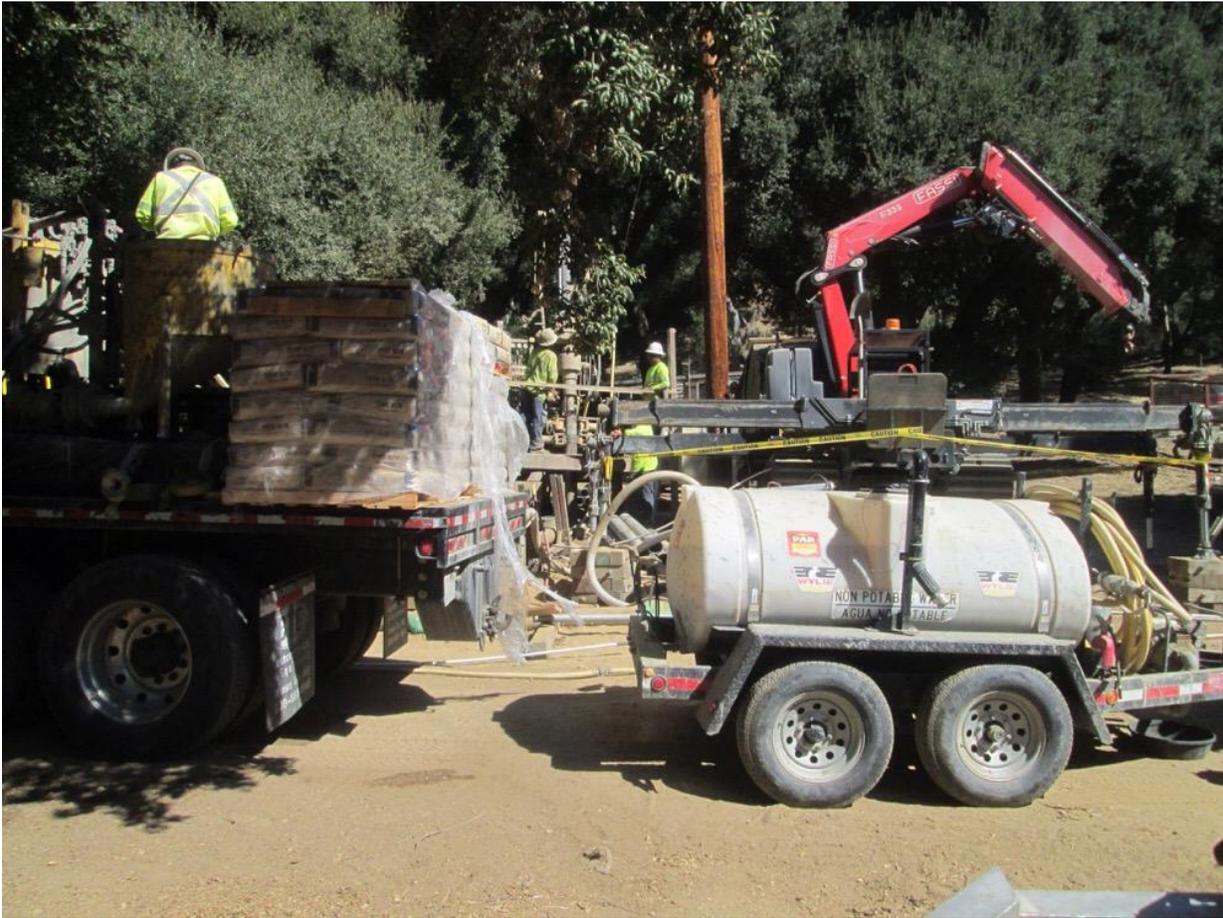
Photo 4: During grouting activities at Z118122, a water buffalo was used to capture and contain concrete wash water in accordance with APM-HYD-01 (TL 682).

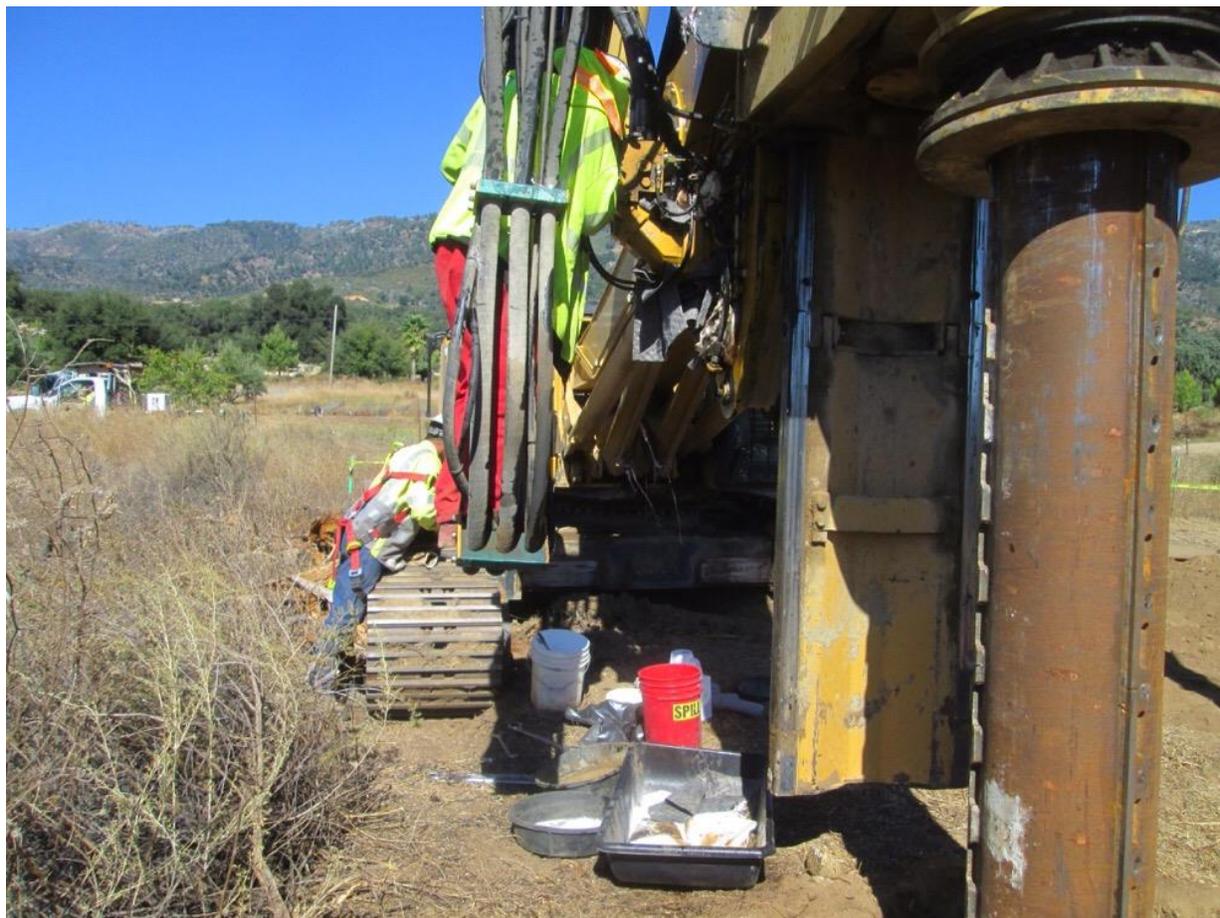
Photo 5: During direct bury pole hole drilling at Z118049, the crew stopped drilling to respond to an equipment leak in accordance with the Spill Response and Notification Plan (MM-PHS-2) (TL 682).

Site-specific erosion and sediment control BMPs continued to be observed along the project rights-of-way in accordance with the project SWPPP (MM HYD-1, APM HYD-09, and MM BIO-7). BMPs designed to prevent off-site erosion and sedimentation included the use of fiber rolls, silt fencing, and prowattle. Silt fence was observed to be installed at micropile drilling workspaces in accordance with the SWPPP (See Photo 3 – Attachment A). CPUC ECMs observed the capture and containment of concrete wash water during grouting activities along TL 682 in accordance with APM HYD-01 (See Photo 4 – Attachment A). ECMs observed crews cleaning spills and maintaining equipment leaks in accordance with the Spill Response and Notification Plan (MM PHS-2) (See Photo 5 – Attachment A).

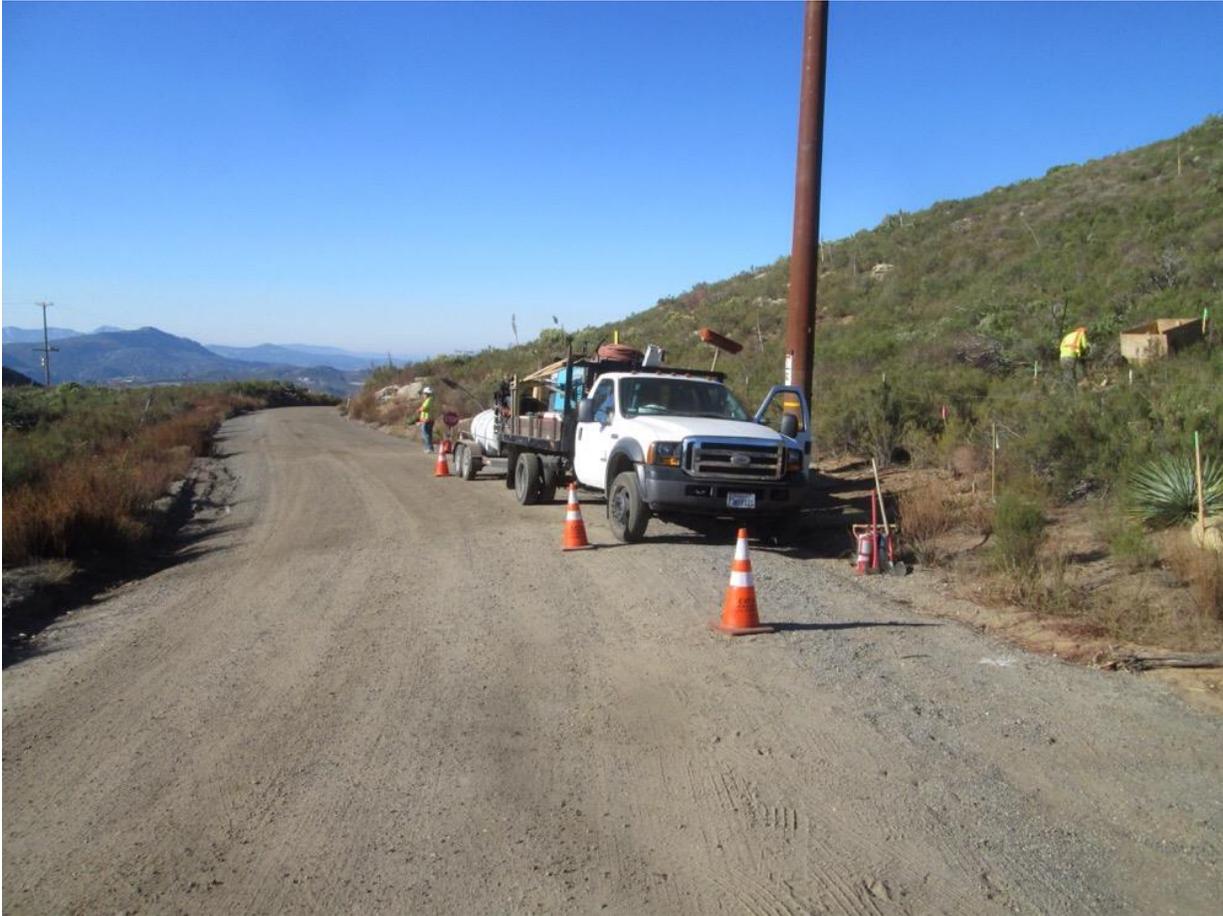
Photo 6: During anchor hole drilling at P172692, a traffic control flagperson and cones were stationed to direct traffic around equipment staged on Viejas Grande Road in accordance with APM-TRANS-02 (C 78).

operations along TL 682 in accordance with APM TRANS-02. During pole setting activities along C 78 and helicopter external load operations along TL 682, traffic control notification signs, cones, and flag persons were observed being utilized to temporarily stop traffic. Signage, cones, and flag person were also utilized along C 78 to direct traffic around construction vehicles and equipment staged on Viejas Grade Road during anchor drilling (See Photo 6 – Attachment A).
