California Public Utilities Commission <i>Mitigation Monitoring, Compliance, and Reporting Program</i>
	Cleveland National Forest Power Line Replacement Projects Compliance Status Report: 032 December 10, 2017

This compliance status report covers construction activities from November 27 through December 10, 2017.

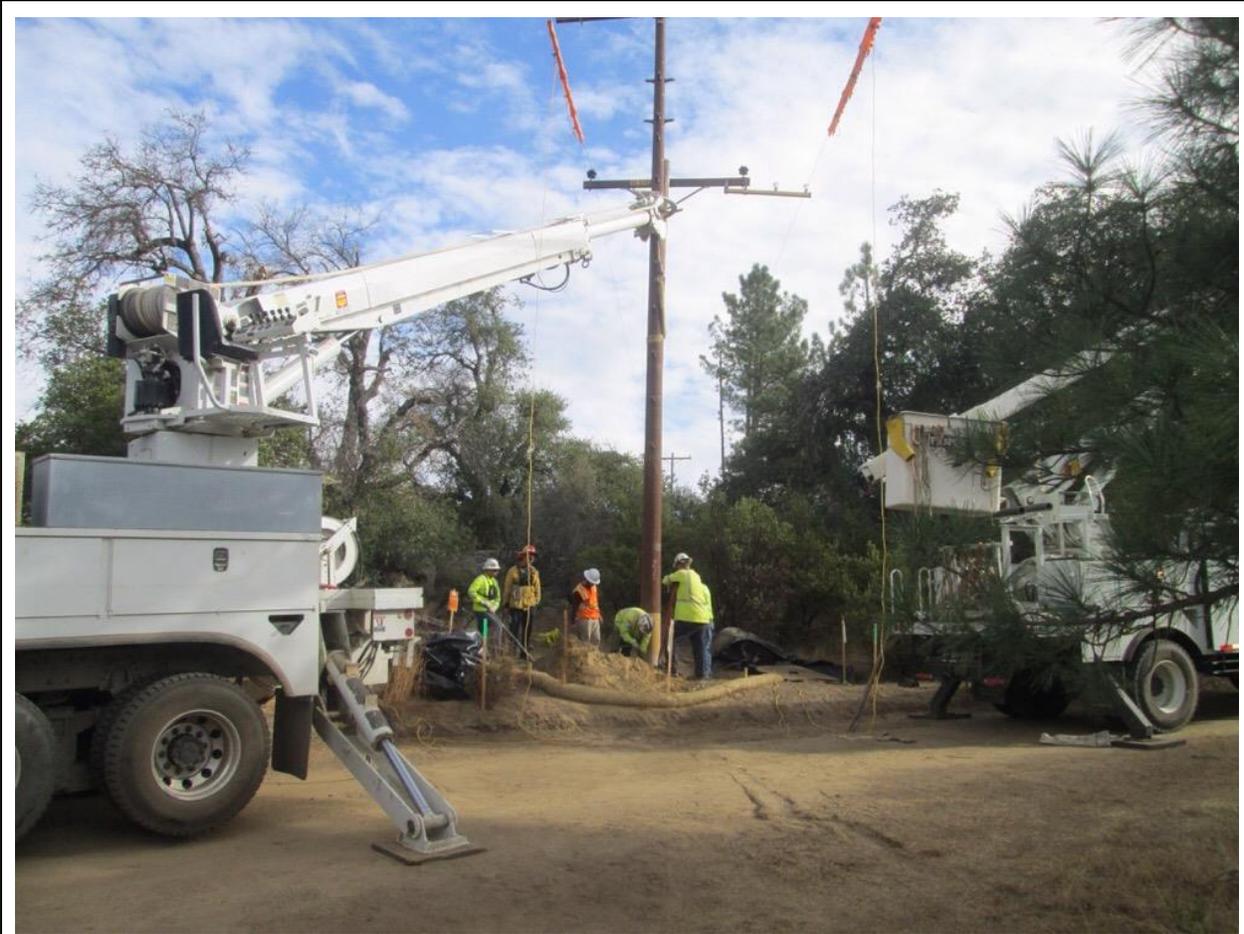
Photo 1: A construction crew observed setting a direct bury steel pole (C 442). Fiber rolls were present and functional in accordance with the project's Erosion Control Plan, SWPPP (MM HYD-1, MM BIO-7) and APM HYD-09.

During this reporting period, construction activities observed by Dudek third party ECMs included setting direct bury steel poles (See Photo 1 – Attachment A), trenching and installing ground rods (See

control BMPs included the use of fiber rolls, silt fencing, and prowattle at pole replacement sites and staging yards (See Photo 1 – Attachment A). Tracking control BMPs designed to prevent offsite dirt and mud tracking onto public roadways included the use of rock aprons at entrances to project access roads and staging yards.

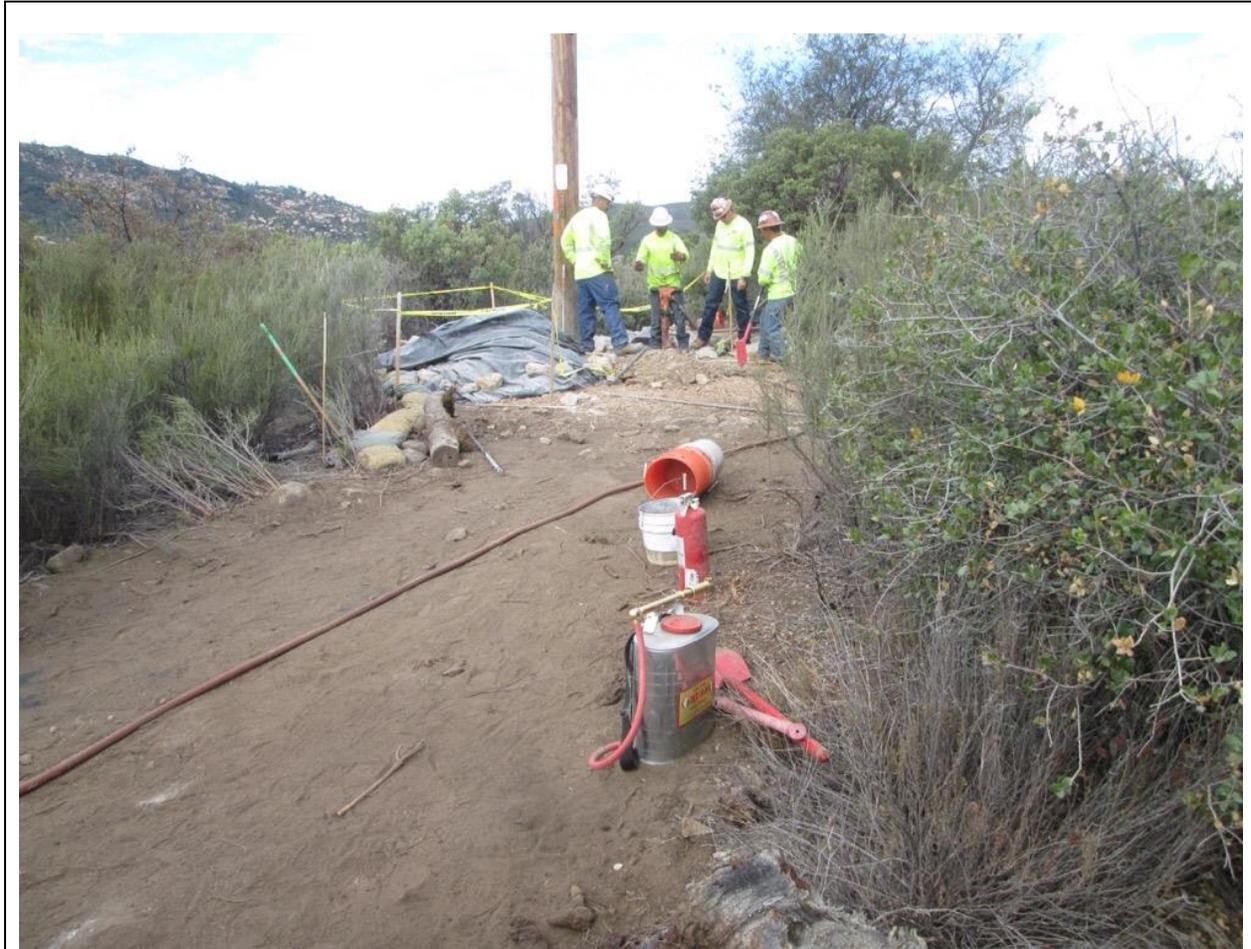
Photo 2: A construction crew observed trenching and installing ground rods at Pole P177017 (C442). The crew was observed staging the required 5-gallon backpack pump, round point shovel, Pulaski, and 2A10BC fire extinguisher, along with 100 gallons of water and pump hose (not pictured) in accordance with the Fire Prevention Matrix (off CNF land), CFPPP (MM FF-1 and APM HAZ-01), and APM HAZ-04.

Photo 2 – Attachment A), drilling pole holes (See Photo 3 – Attachment A), trimming vegetation and grading/repairing existing access roads (See Photo 4 – Attachment A), and preparing poles and drilling equipment for helicopter transport at Corte Madera Staging Yard. Along TL 682, crews were observed drilling pole holes (See Photo 5 – Attachment A), trenching and installing ground rods, digging anchor holes, conducting wire stringing activities, mobilizing equipment for helicopter transport at Love Valley Staging Yard, and drilling for micropiles. Along TL 629E, construction crews were observed splicing a 69 kV underground transmission line near Crestwood Substation and the underground crossing of Old Highway 80 (See Photo 6 – Attachment A).

During construction activities along all rights-of-way, construction fire patrols were observed inspecting sites for compliance with the Construction Fire Prevention/Protection Plan (CFPPP) (MM FF-1). Construction crews were observed staging the required fire tools and equipment based on the Project Activity Level (on CNF land)/Fire Potential Index (off CNF land) and the construction activity being performed as allowed in the Fire Prevention Matrices CFPPP (MM FF-1 and APM HAZ-01) (See Photo 2 – Attachment A). In addition, a set of fire tools (5 gallon backpack pump, round point shovel, Pulaski, and 2A10BC fire extinguisher) and 100 gallons of water with a pump and hose was observed on site for activities that required it. This includes access road grading near Pole P176969 (C 442) and trenching for ground rod installation at Pole P177017 (C 442) and Poles Z118011 and Z118015 (TL 682).

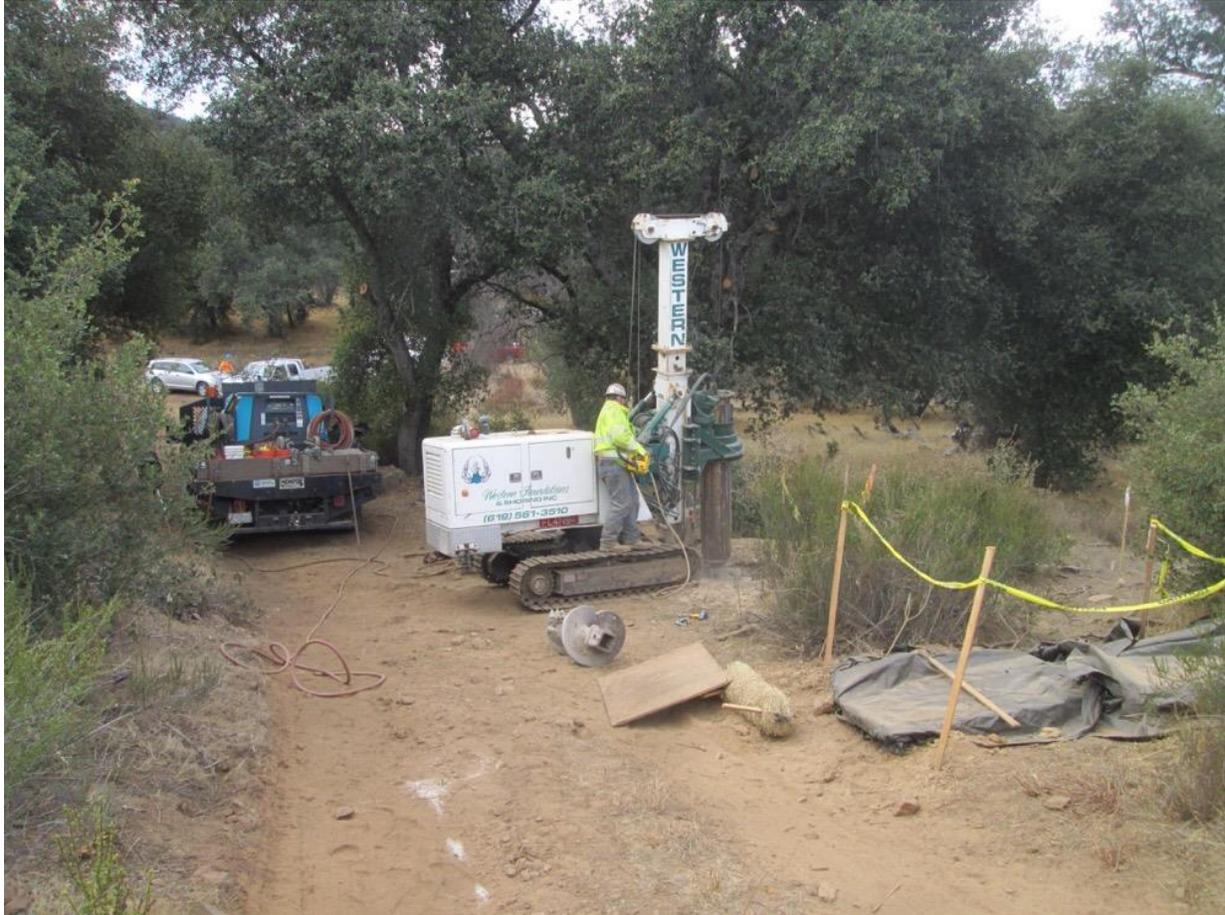
Photo 3: During pole hole drilling at Pole P258121 (C 442), crews remained within the delineated work limits in accordance with MM BIO-1.

During construction activities, crews were observed working within delineated work limits and remaining on existing access roads in accordance with MM BIO-1 (See Photo 3 – Attachment A). In accordance with MM BIO-3 and MM BIO-22, biological monitors were observed conducting full time monitoring of initial ground-disturbing activities as well as vegetation clearing. To prevent wildlife entrapment, completed pole holes were observed securely covered in accordance with MM BIO-23. Crews were observed using trash bags to contain and collect trash at worksites in accordance with MM BIO-26.

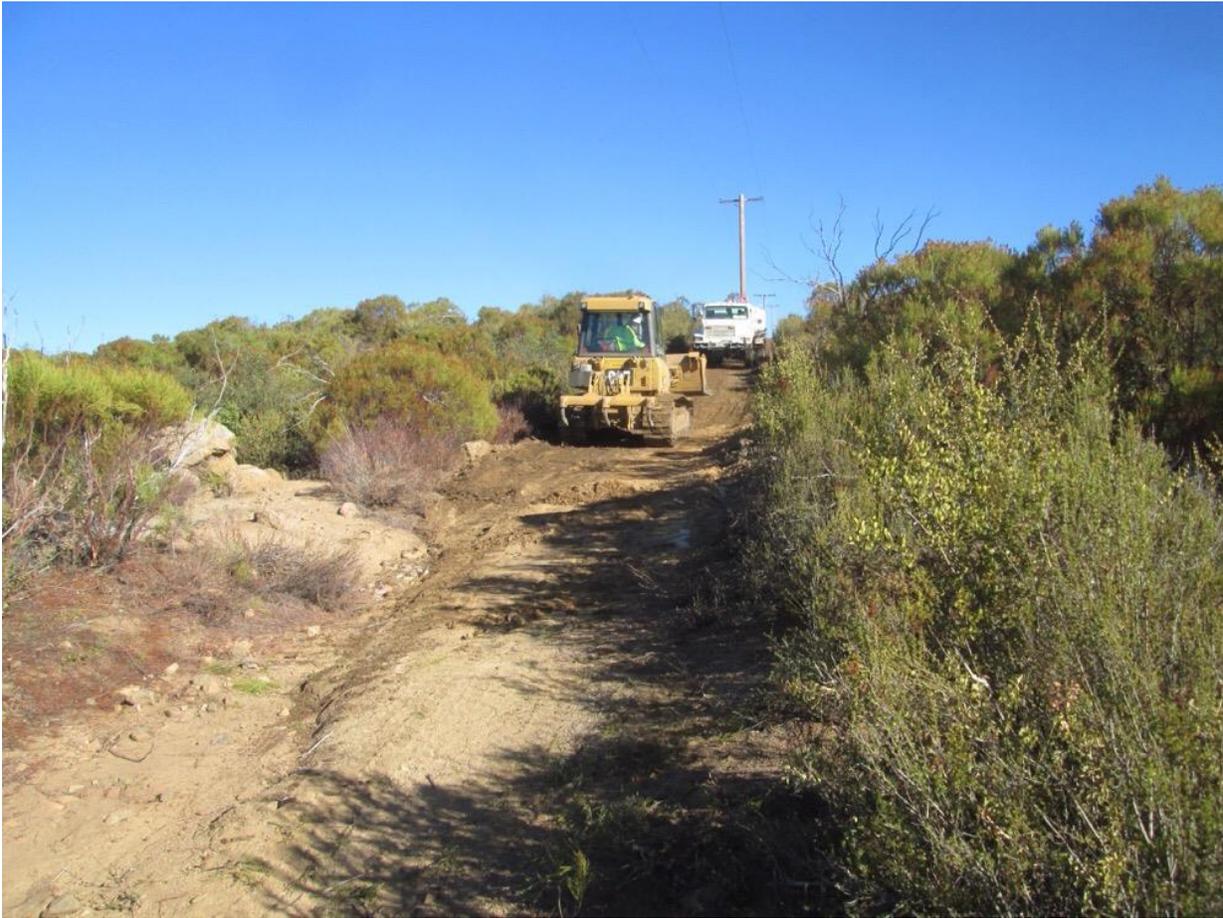
Photo 4: During the grading and maintenance of an existing access road between Poles P176961 to P176964 (C 442), a water tender was used to prevent dust emissions in accordance with APM AIR-02.

During this reporting period, CPUC ECMs observed implementation of dust control measures including the application of water on access roads and in work areas in accordance with APM AIR-02 (See Photo 4 – Attachment A), and project personnel maintaining posted speeds of 15 miles per hour on unpaved roads in accordance with APM AIR-03 and MM BIO-24.

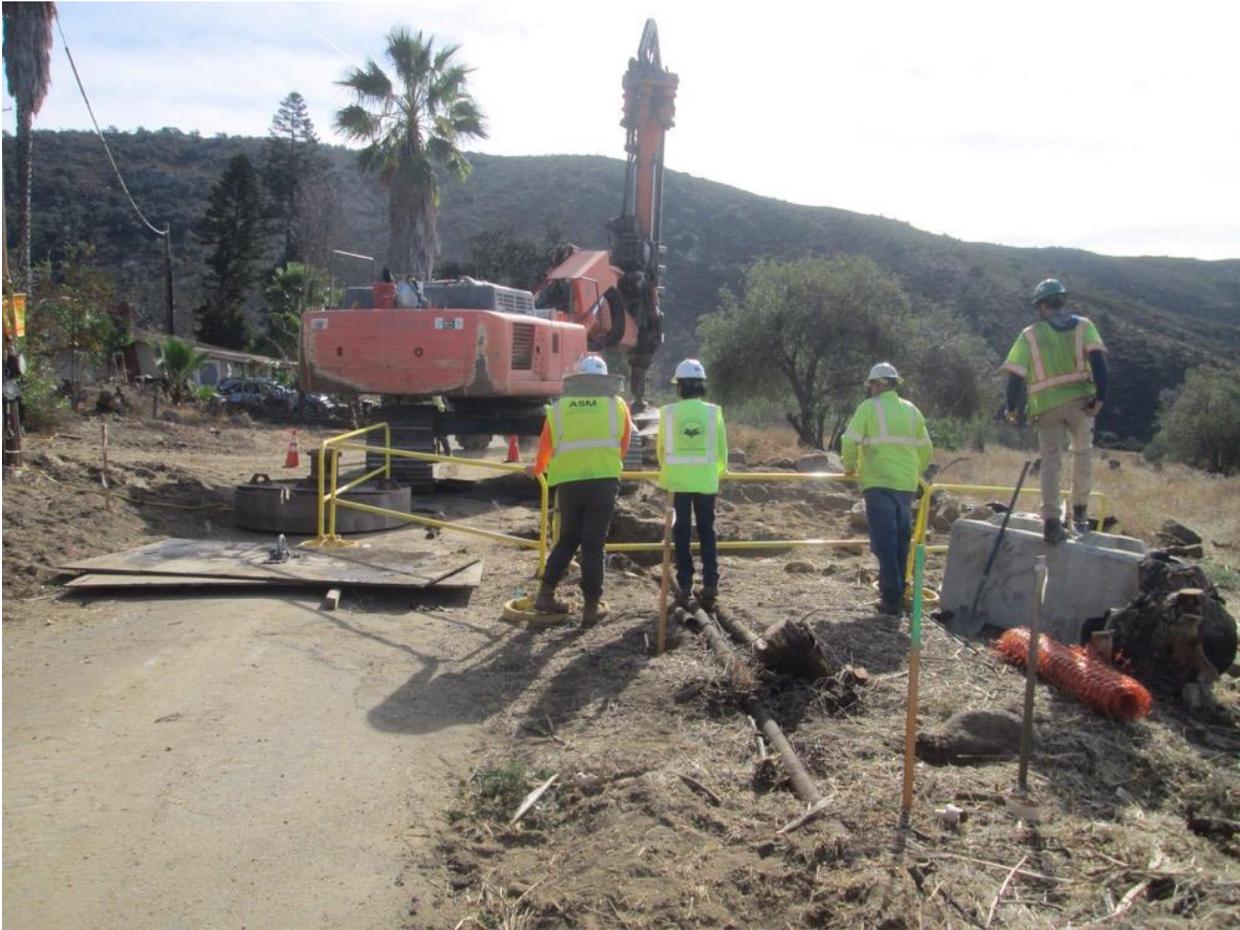
Photo 5: During pole hole drilling at Pole Z118011 (TL 682), Archaeological and Native American Monitors were observed inspecting excavated soil in accordance with MM CUL-1. A Biological Monitor was also present (not pictured) in accordance with MM BIO-3 and MM BIO-22.

Cultural resource monitors, including Archaeological and Native American monitors, were observed monitoring ground disturbing activities, such as trenching associated with ground rod installation, and inspecting excavated soils for potential sensitive cultural resources along TL 682 in accordance with the Historic Properties Management Plan (HPMP), MM CUL-1, MM CUL-3, and APM CUL-04 (See Photo 5 – Attachment A). In addition, a Paleontological Monitor was observed monitoring pole hole drilling activities along C 442 in accordance with APM CUL-08. Cultural resources ESAs were fenced off along TL 682 and C 442 to prevent unauthorized access into areas with previously recorded cultural resources.

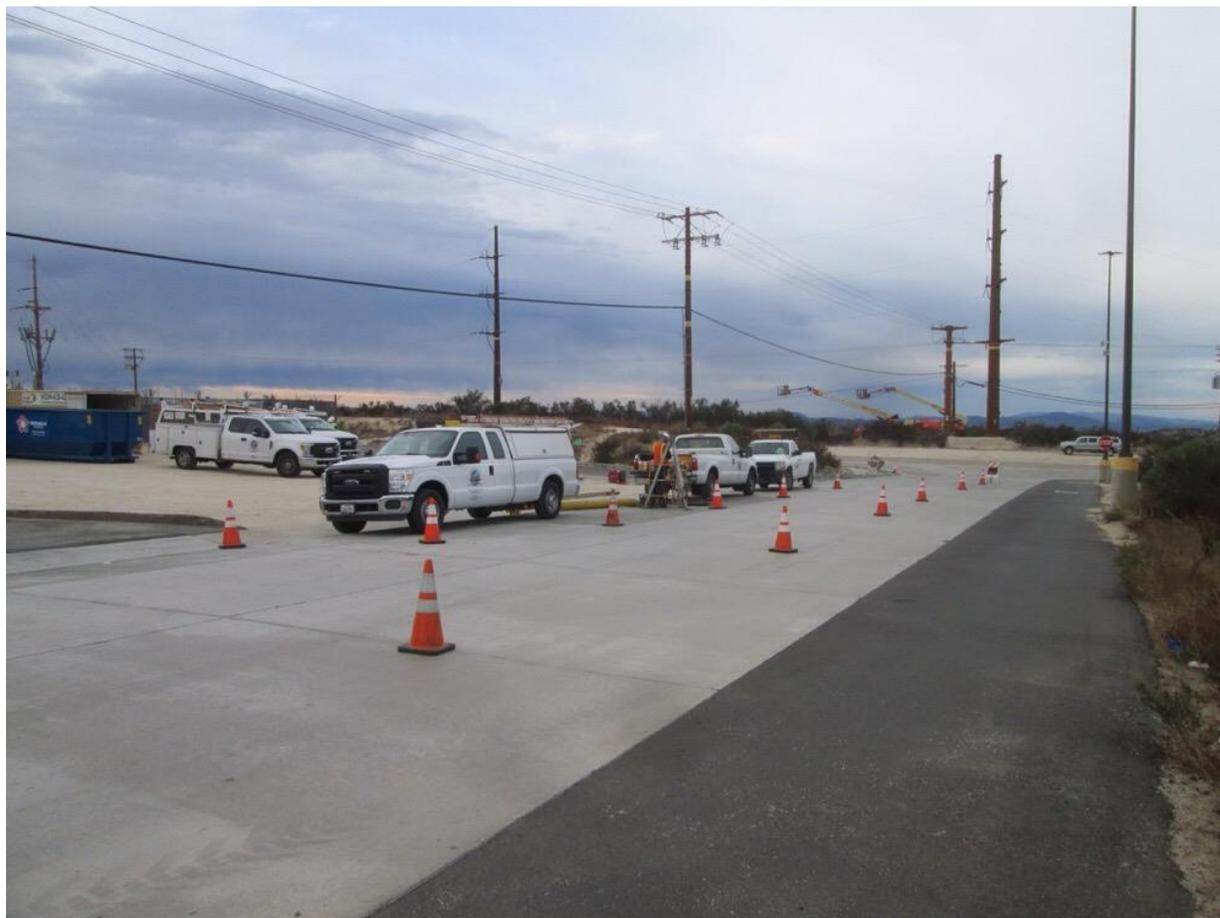
Photo 6: During splicing of the underground transmission line near Crestwood Substation (TL 629E), cones and traffic control flaggers were used in accordance with APM TRANS-02.

In accordance with APM TRANS-02, implementation of traffic control measures continued to be observed during this reporting period. Traffic control measures such as the placement of signage and cones as well as the use of flag persons were observed during wire stringing activities across Highway 79 and during work occurring adjacent to Highway 76 (TL 682), along Corte Madera Road to prevent congestion on the one-lane road (C 442), and near Crestwood Substation along Old Highway 80 (TL 629E) (See Photo 6 – Attachment A).
