<p>California Public Utilities Commission <i>Mitigation Monitoring, Compliance, and Reporting Program</i></p>
	<p>Cleveland National Forest Power Line Replacement Projects</p> <p>Compliance Status Report: 043</p> <p>May 13, 2018</p>

This compliance status report covers construction activities from April 30, 2018 through May 13, 2018.

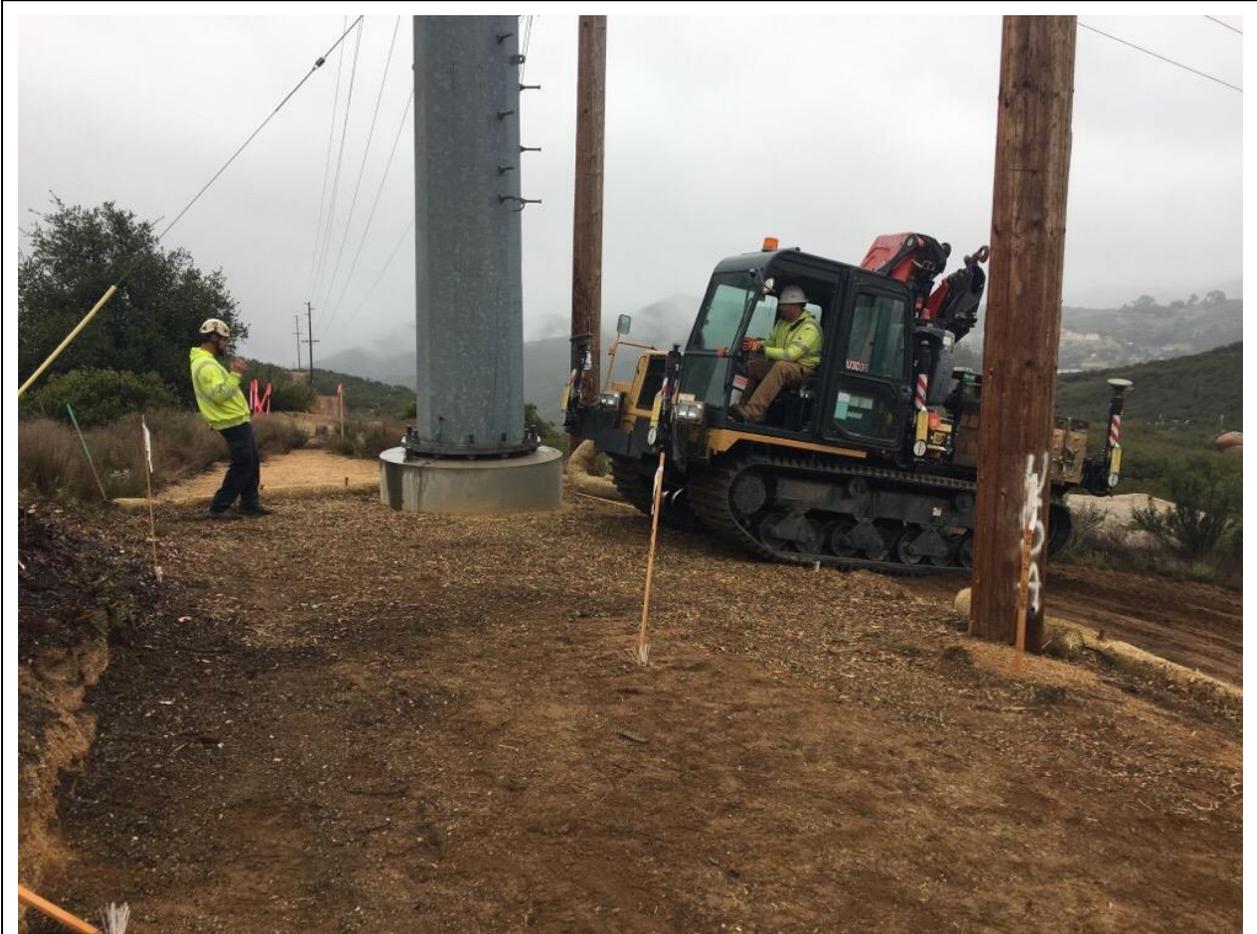
Photo 1: Crews position a crane atop pole site Z105008 (TL6957) in order to set up a drilling platform and associated equipment to drill micropile foundations. Biologists were observed on site working with crews as they set up within the work limits, in accordance with MM BIO-1 and MM BIO-22. Straw wattles moved for equipment mobilization were observed reinstalled in accordance with the SWPPP (MM HYD-1).

During construction activities, crews were observed adhering to delineated work limits and working within existing access roads in accordance with MM BIO-1 (See Photo 1 – Attachment A). SDG&E biological monitors were observed conducting full-time monitoring of initial ground-disturbing activities and vegetation clearing (See Photo 2 – Attachment A) (MM BIO-3 and MM BIO-22). Construction crews were observed collecting trash and disposing of it in covered dumpsters (MM BIO-26). During inspections of pole work areas, access roads, and staging and fly yards, monitors observed protective environmentally sensitive area (ESA) signage for protected butterfly species and habitat (MM BIO-14, MM BIO-16), active nest buffers (MM BIO-28), and protective fencing such as the exclusionary fencing around the perimeter of the Warner Substation Staging Yard for Stephen’s Kangaroo Rat (MM BIO-31) (See Photo 3—Attachment A). Avian biologists were observed surveying for nesting birds ahead of scheduled work activities along TL 682 and TL 6957 (Avian Protection Plan/Nesting Bird Management Plan and MM BIO-28).

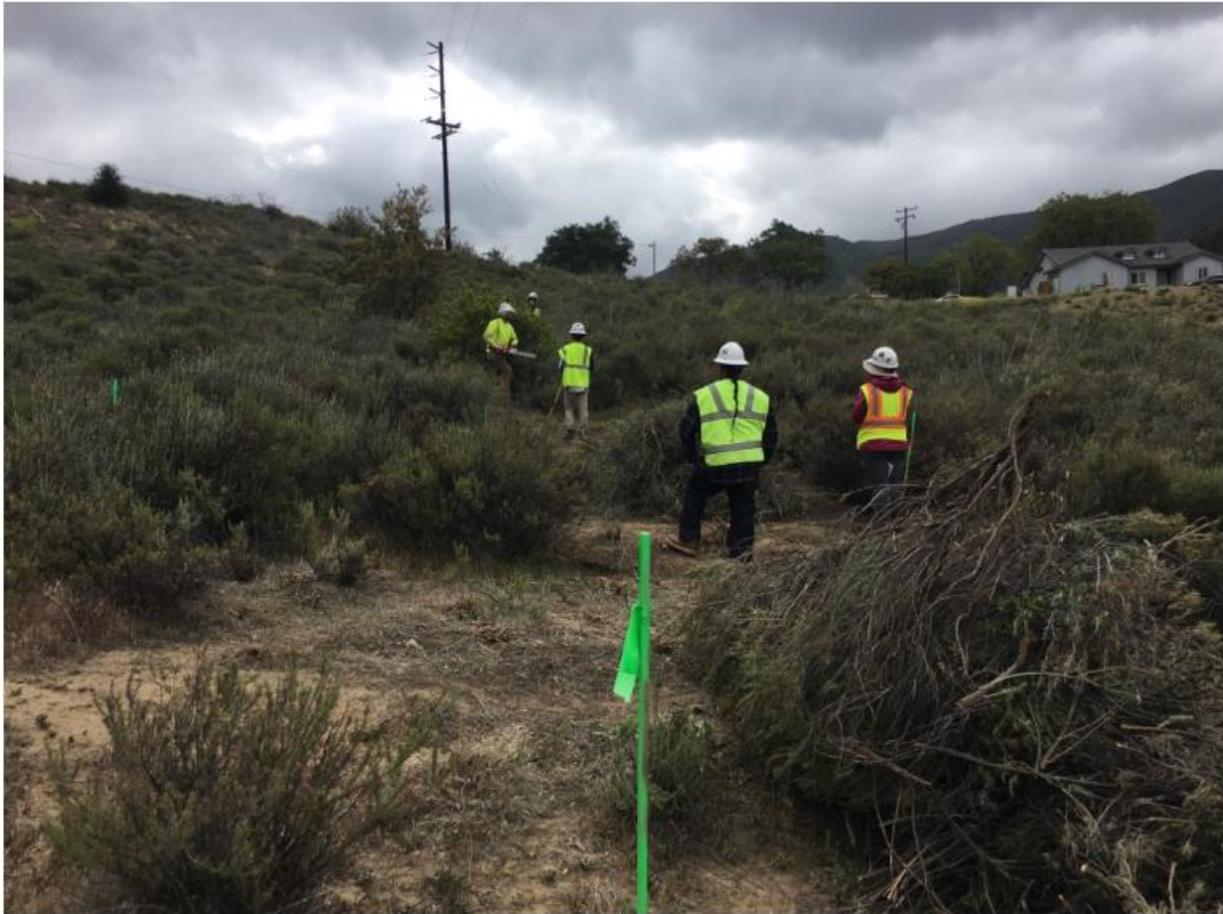
Photo 2: Monitors for cultural and biological resources were observed present during vegetation clearing activities at Pole Z118078 (TL 682) in conformance with the HPMP, MM CUL-01, MM BIO-3 and MM BIO-22. Crews were observed adhering to clearly staked work limits in accordance with MM BIO-1.

Cultural resource monitors, including Archaeological and Native American Monitors, were observed monitoring ground disturbing activities (See Photo 2—Attachment A) and inspecting excavated soils for potential sensitive cultural resources in accordance with the Historic Properties Management Plan (HPMP), MM CUL-1, MM CUL-3, and APM CUL-04. In addition, cultural resources ESAs were roped and signed to prevent unauthorized access into areas with previously recorded cultural resources.

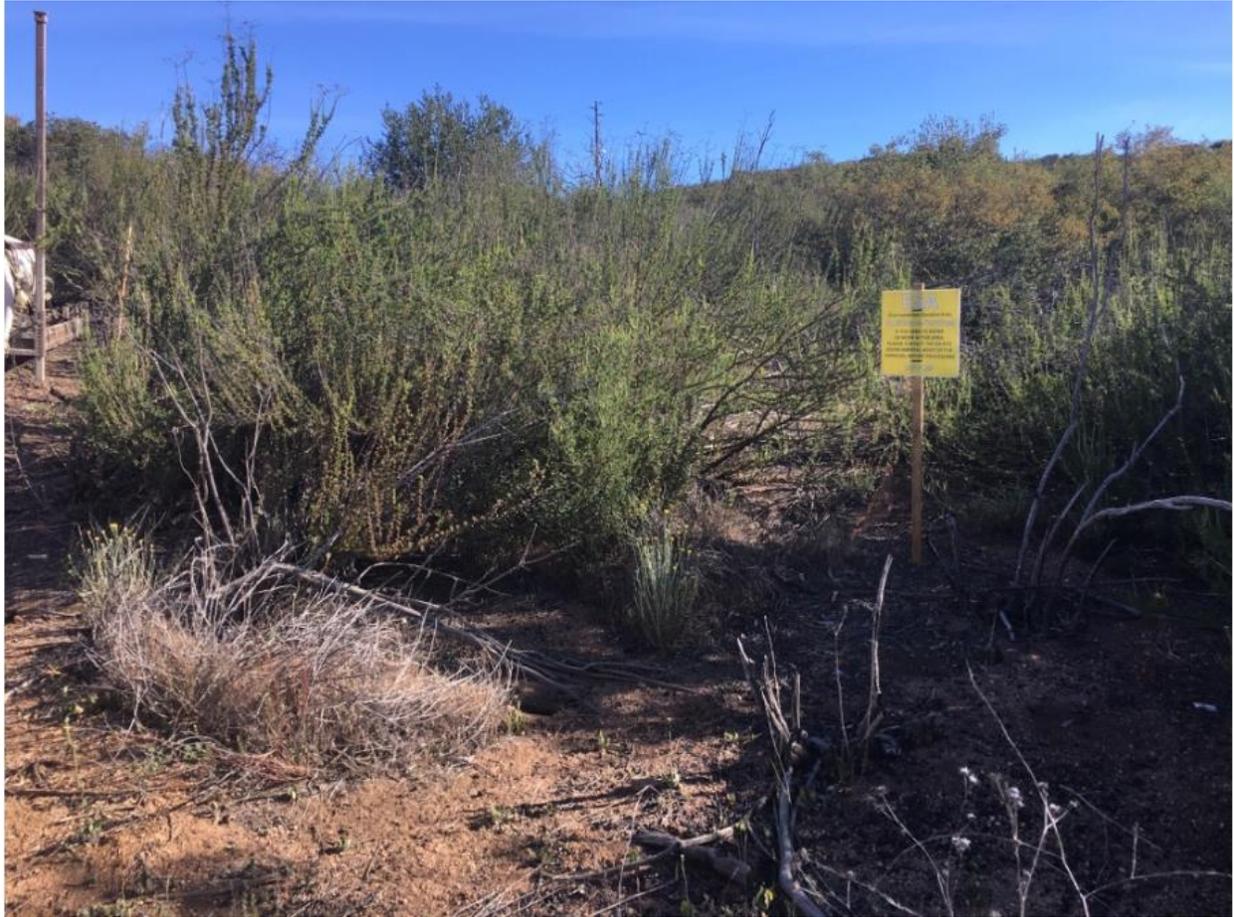
Photo 3: An ESA sign is posted at Pole Z105010 in efforts to minimize impacts to special status host species plants to Quino Checkerspot Butterfly and Hermes Copper Butterfly, in accordance with MM BIO-14 and MM BIO-16.

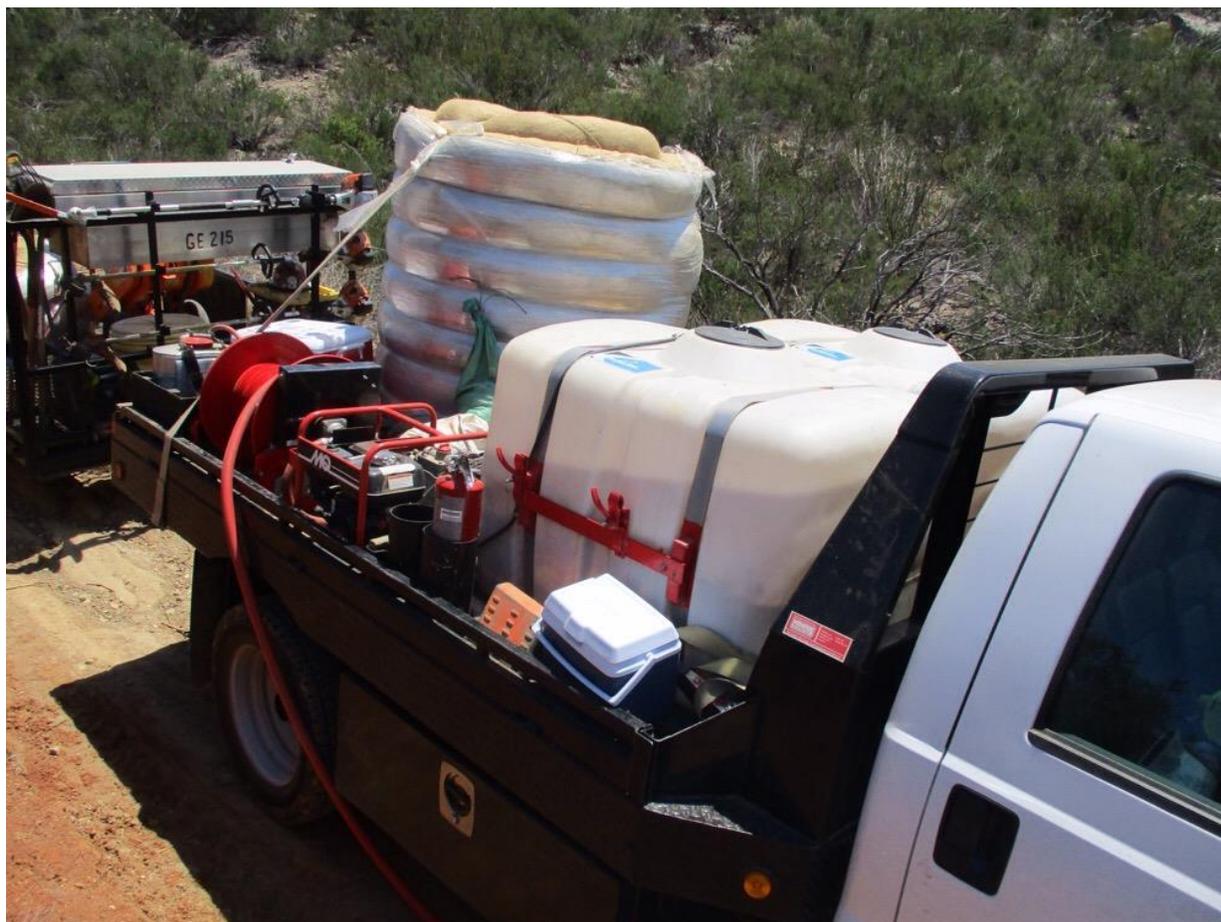
Photo 4: In addition to a 5 gallon backpack pump, round point shovel, Pulaski, and 2A10BC fire extinguisher, the vegetation clearing crew at Z571449 (TL6957) was equipped with 100 gallons of water with a pump and hose (as required for chipping) and a crew member was observed wetting down the area during chipping in accordance with the CFPPP fire prevention matrix (on CNF land).

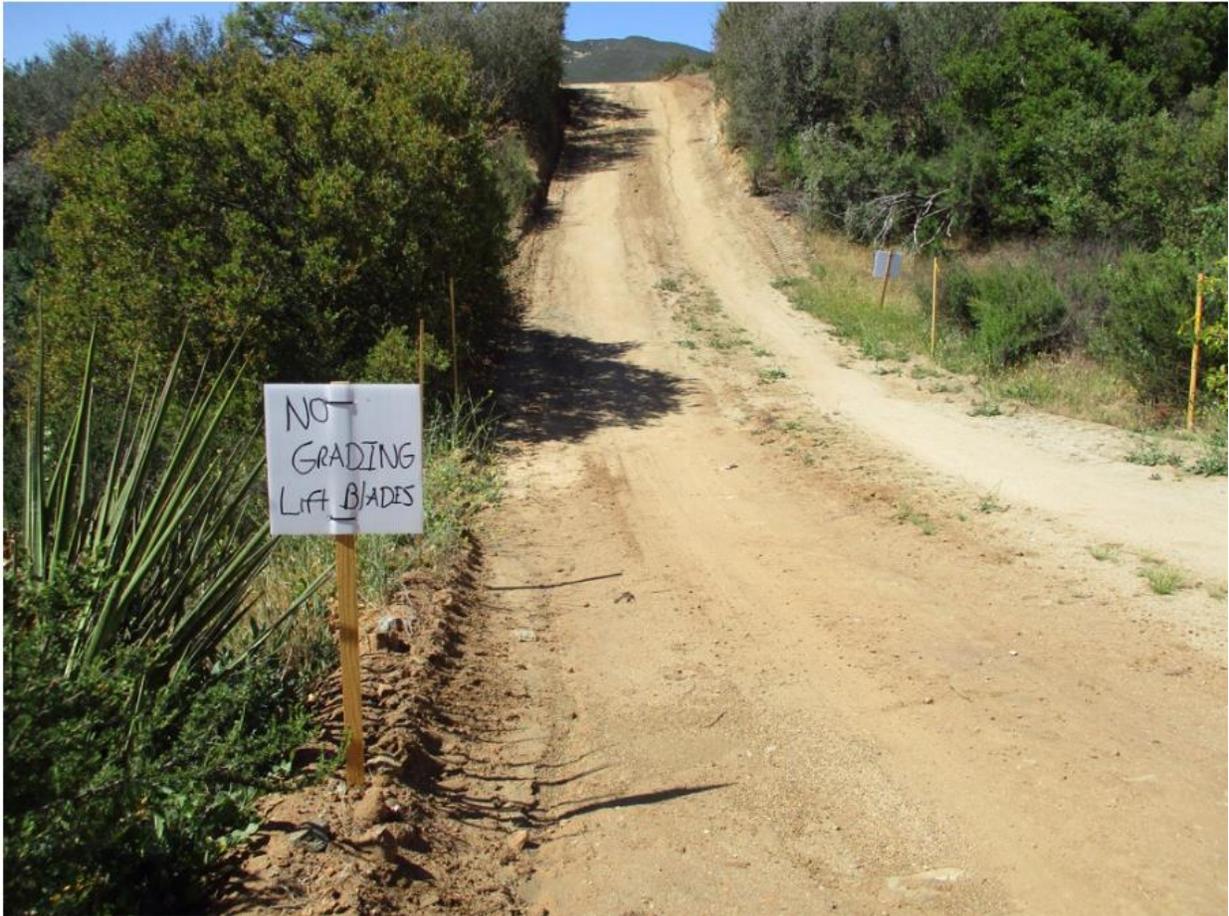
Photo 5: To prevent work from occurring within a jurisdictional drainage in accordance with APM-HYD-06, 'no grading, lift blades' signage was posted at a crossing along the access road near Z571438 (TL 6957).

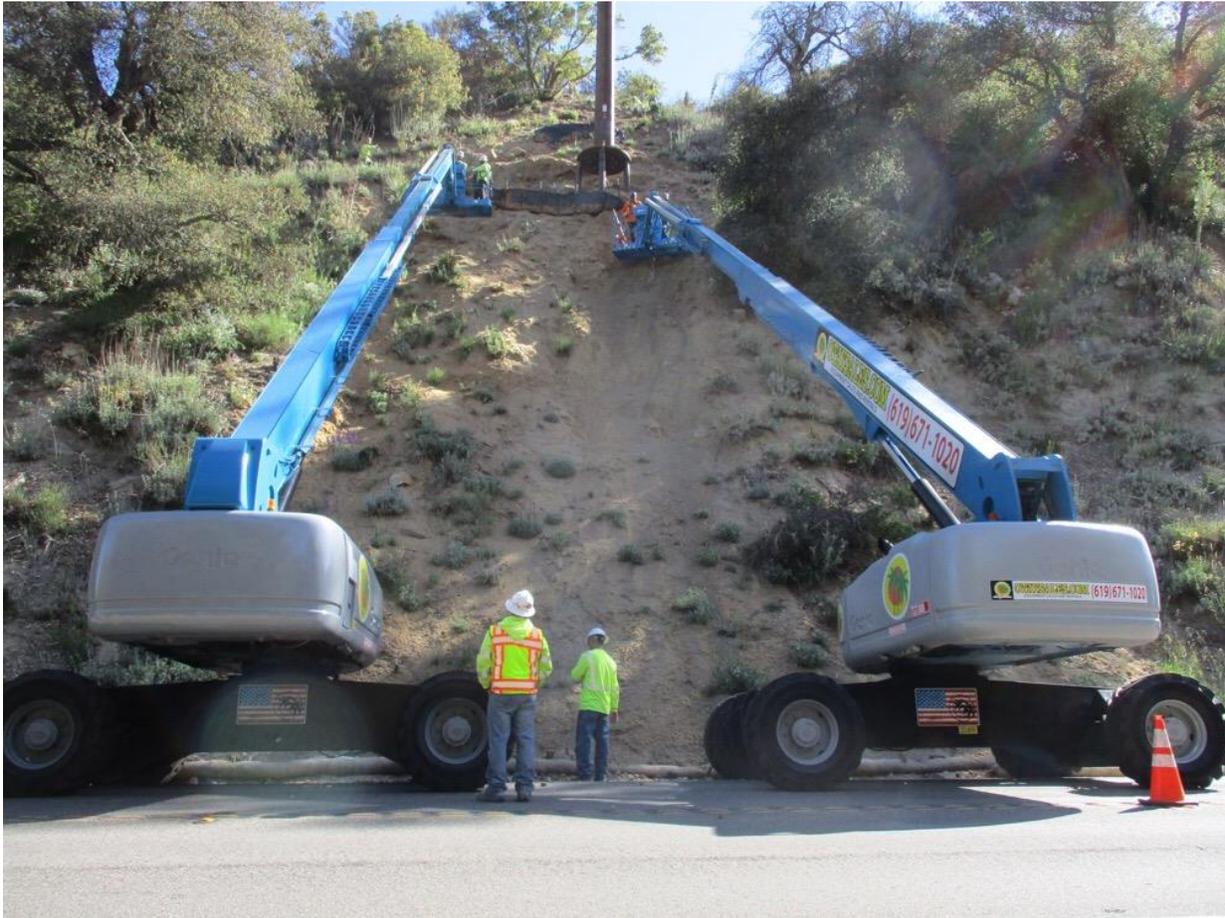
Photo 6: A crew installing fiber rolls and preparing to apply hydro-mulch on the steep slope at Z118138 (TL6957) to prevent erosion, in accordance with the Erosion Control Plan and SWPPP.

Monitors continued to observe installation and maintenance of site-specific erosion and sediment control BMPs at pole site, staging areas, and access roads in accordance with the project Storm Water Pollution Prevention Plan (SWPPP), MM HYD-1, MM BIO-7, and APM HYD-09. Sediment control BMPs including fiber rolls, silt fencing, and prowattle were overall observed in good condition. Signage indicating 'no grading, lift blades' was observed along existing access roads traversing jurisdictional drainages to protect these areas (APM HYD-06) (See Photo 5—Attachment A). Crews were observed preparing to apply hydro-mulch to work areas in accordance with the Erosion Control Plan (MM HYD-1) and the Habitat Restoration Plan (MM BIO-4) (See Photo 6 – Attachment A).
