California Public Utilities Commission <i>Mitigation Monitoring, Compliance, and Reporting</i> <i>Program</i>
	Cleveland National Forest Power Line Replacement Projects
	Compliance Status Report: 052 September 16, 2018

This compliance status report covers construction activities from September 3, 2018 through September 16, 2018.

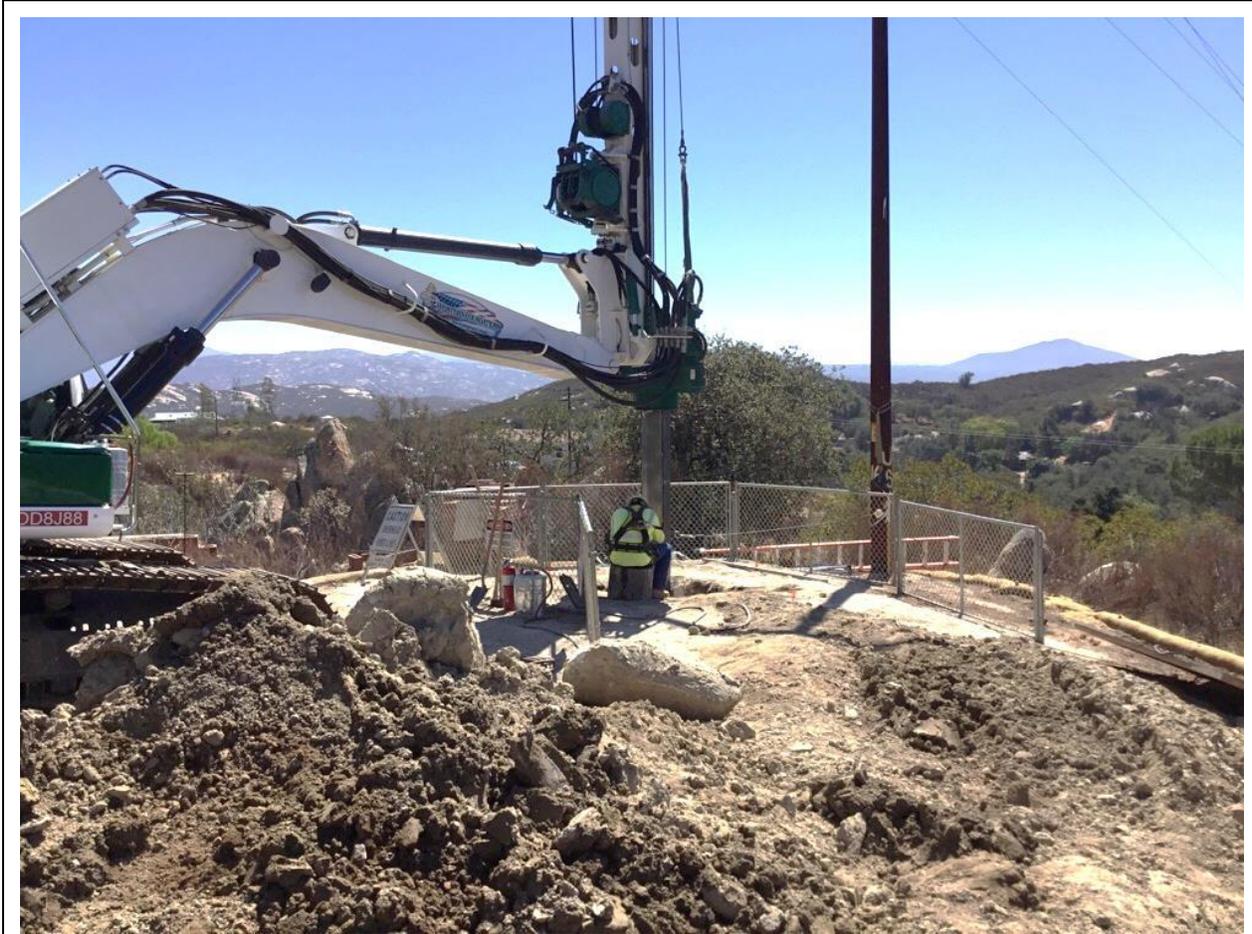
Photo 1: CPUC ECMs observed a crew drilling at Z293658 along TL 6957.

Dudek third party ECMs observed crews drilling foundations as well as installing poles, anchors, and grounds along TL 629C, 682, 6957, and C157 (See Photo 1 – Attachment A). ECMs also observed helicopter external load operations, pole removal, and pole framing and setting along TL 682 and 6957. Crews were observed clearing vegetation and installing erosion and sediment control best management practices (BMPs) along TL 629C and 682, applying hydromulch along TL 682 (See Photo 2 – Attachment A), and maintaining access roads along TL 6957.

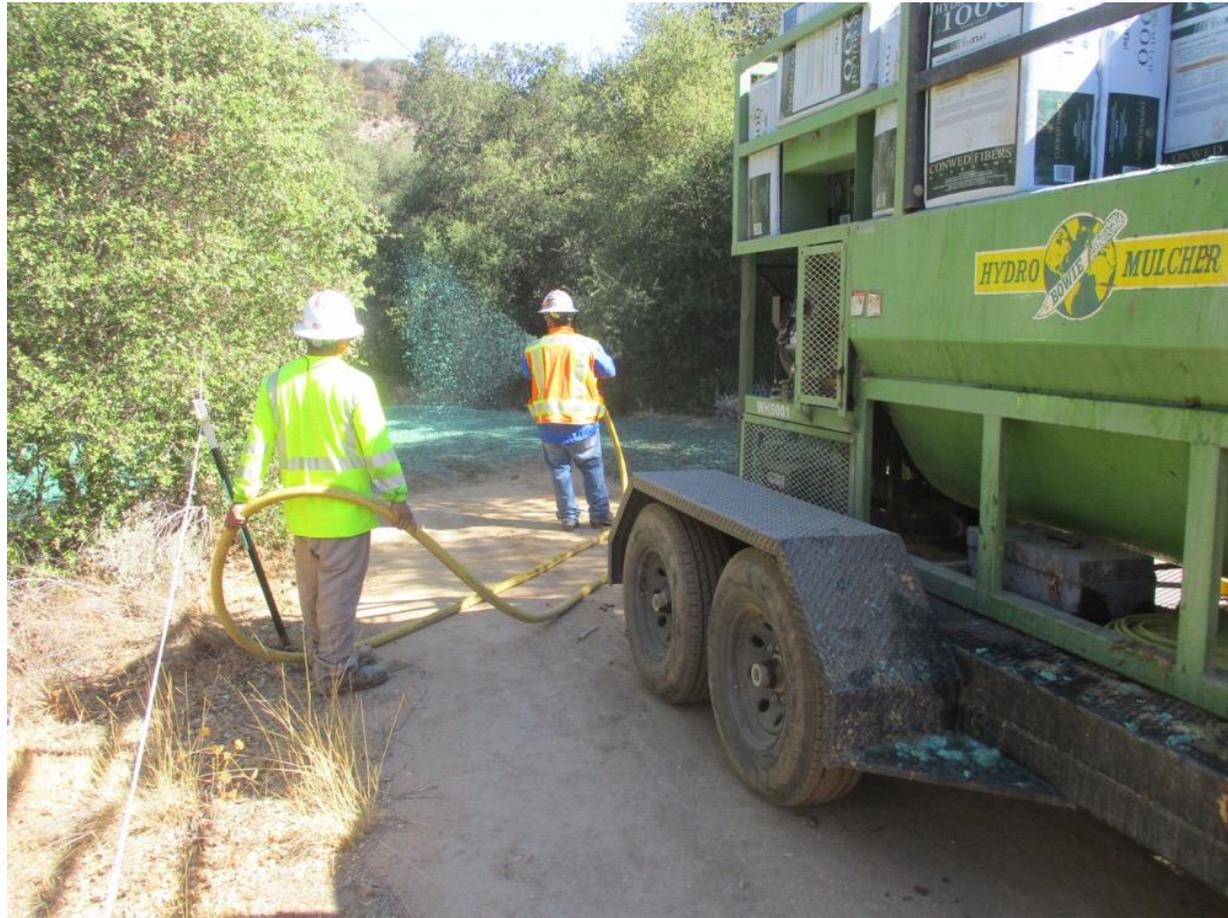
Photo 2: A crew is observed applying hydromulch at Z118153 (TL 682), in accordance with the Erosion Control Plan and SWPPP.

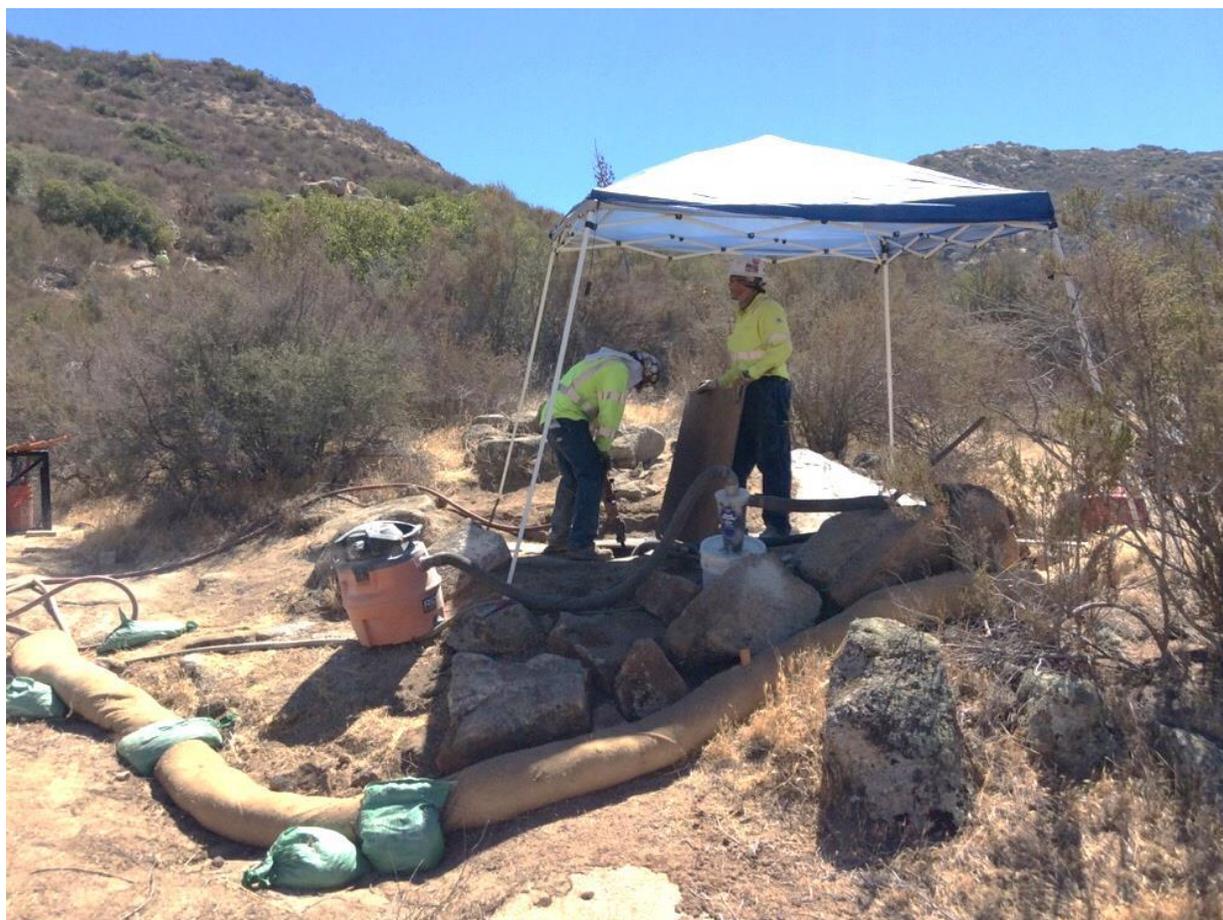
Photo 3: The hand digging crew at Pole P258090 (C 157) was observed using a containment system to capture dust emissions from rock jackhammering, in accordance with APM AIR-05.

During this reporting period, CPUC ECMs observed implementation of dust control measures including the application of water on access roads and in work areas, in accordance with APM AIR-02. ECMs observed use of helicopters to water remote work areas along TL 6957. Containment systems were used to limit dust emissions during jackhammering, in accordance with APM AIR-05 (See Photo 3 – Attachment A).

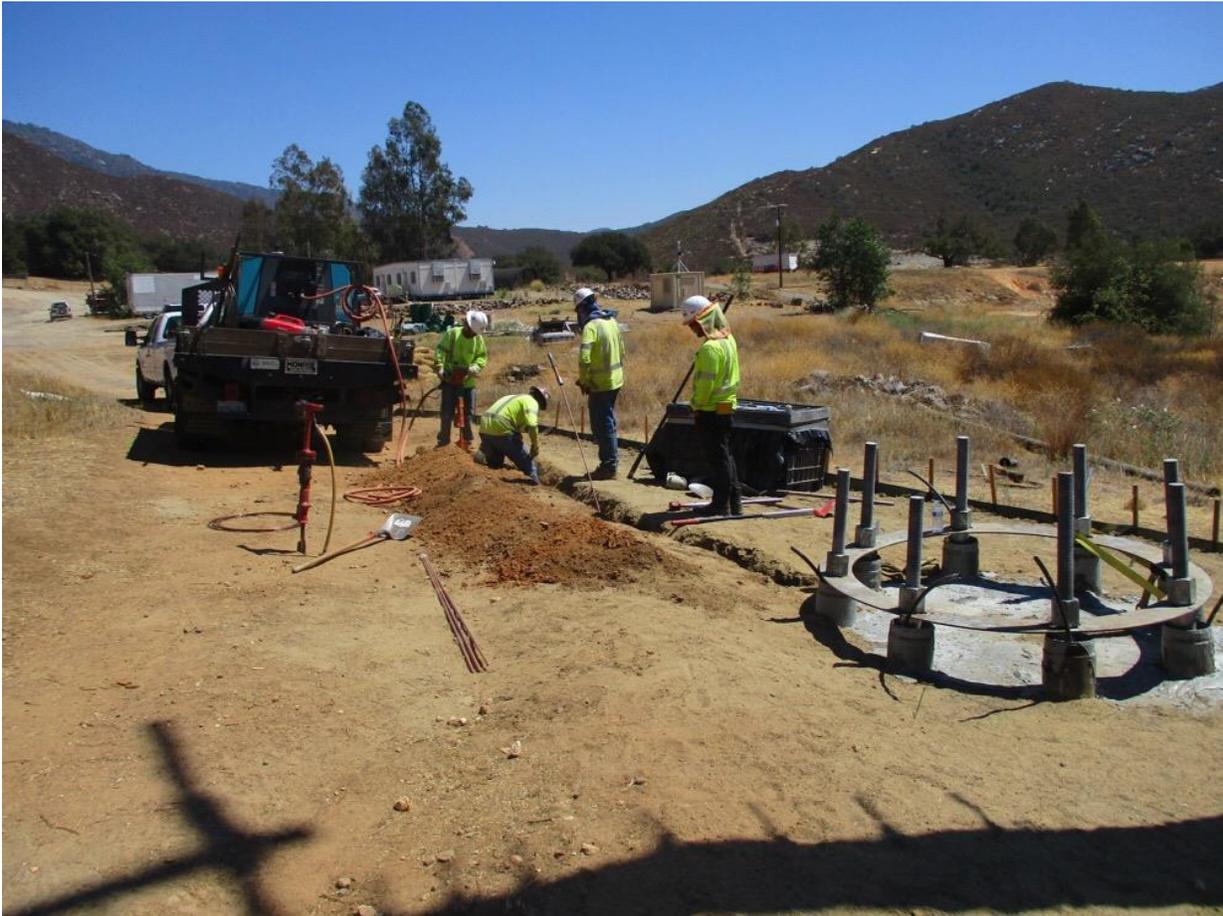
Photo 4: During grounding installation at Z118080 (TL 682), an archaeological monitor was observed inspecting the trench and excavated soils for cultural resources in accordance with MM CUL-1 and APM CUL-04.

Cultural resource monitors, including Archaeological and Native American Monitors, were observed monitoring ground disturbing activities and ESAs were marked to prevent unauthorized access into areas with previously recorded cultural resources, in accordance with the Historic Properties Management Plan (HPMP), MM CUL-1, MM CUL-3, APM CUL-04, and APM CUL-05 (See Photo 4 – Attachment A).

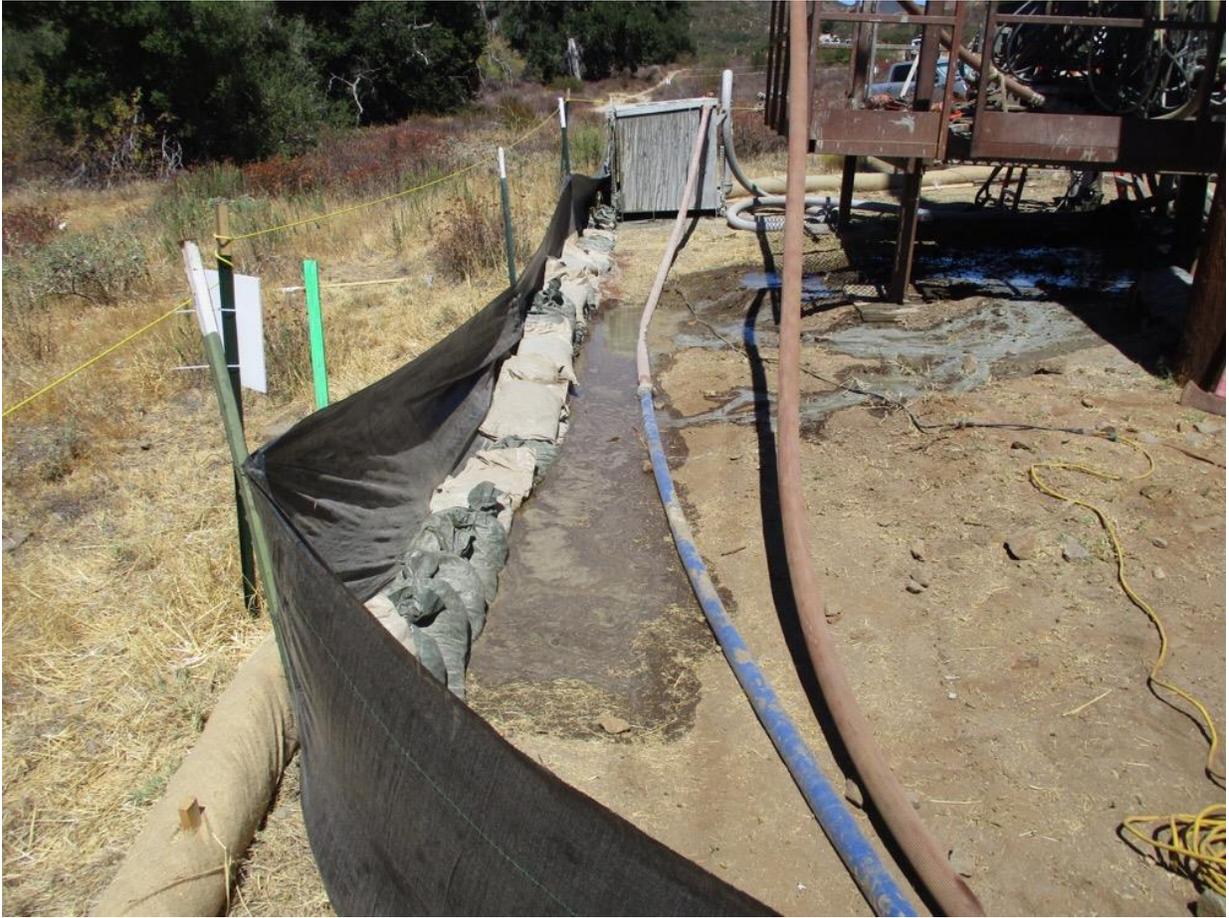
Photo 5: During micropile drilling at Z40517 (TL 629C), silt fencing and a gravel bag berm were installed along the downslope side of the work area to contain groundwater from being expelled from the drill hole, in accordance with the Erosion Control Plan and SWPPP.

To prevent leaks and spills from being discharged into the soil in accordance with the Spill Response and Notification Plan (MM PHS-2), crews implemented spill prevention BMPs, including the use of secondary containment beneath hazardous materials and fuel tanks, double walled fuel tanks, drip pans beneath staged equipment and sanitary facilities, and spill kits. CPUC ECMs continued to observe installation and maintenance of site-specific erosion and sediment control BMPs, including fiber rolls, silt fence, netting, prowattle, and hydromulch along the project rights-of-way in accordance with the project's Erosion Control Plan (ECP) and Storm Water Pollution Prevention Plan (SWPPP) (APM HYD-09, MM HYD-1, MM BIO-7) (See Photo 5 – Attachment A).

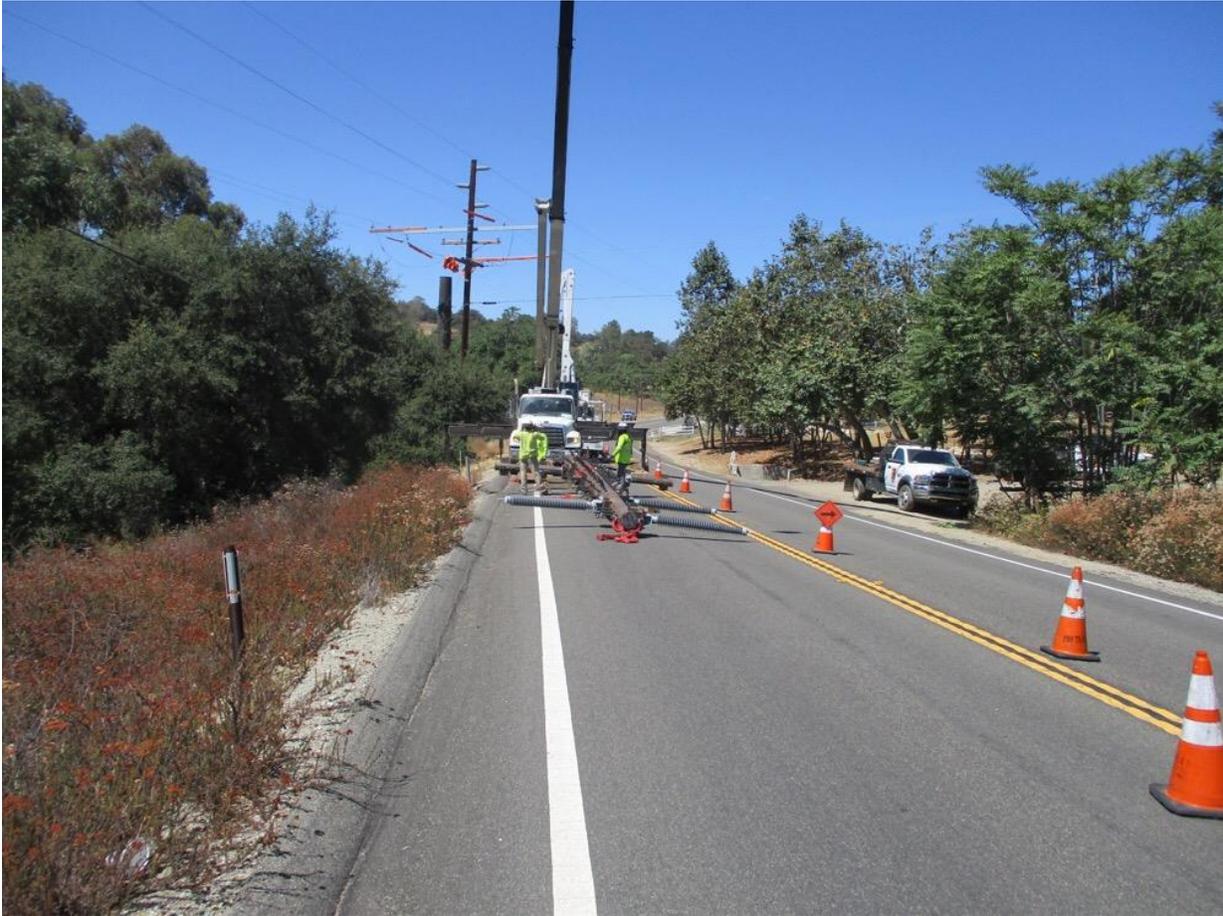
Photo 6: During pole framing and installation at Z112236, crews implemented a lane closure along Highway 76 in accordance with APM TRANS-02.

In accordance with APM TRANS-02, traffic control measures, including the placement of signage and cones as well as the use of flag persons were observed along Highway 76 and Lyons Valley Road (See Photo 6 – Attachment A).
