California Public Utilities Commission <i>Mitigation Monitoring, Compliance, and Reporting</i> <i>Program</i>
	Cleveland National Forest Power Line Replacement Projects Compliance Status Report: 058 December 9, 2018

This compliance status report covers construction activities from November 26, 2018 through December 9, 2018.

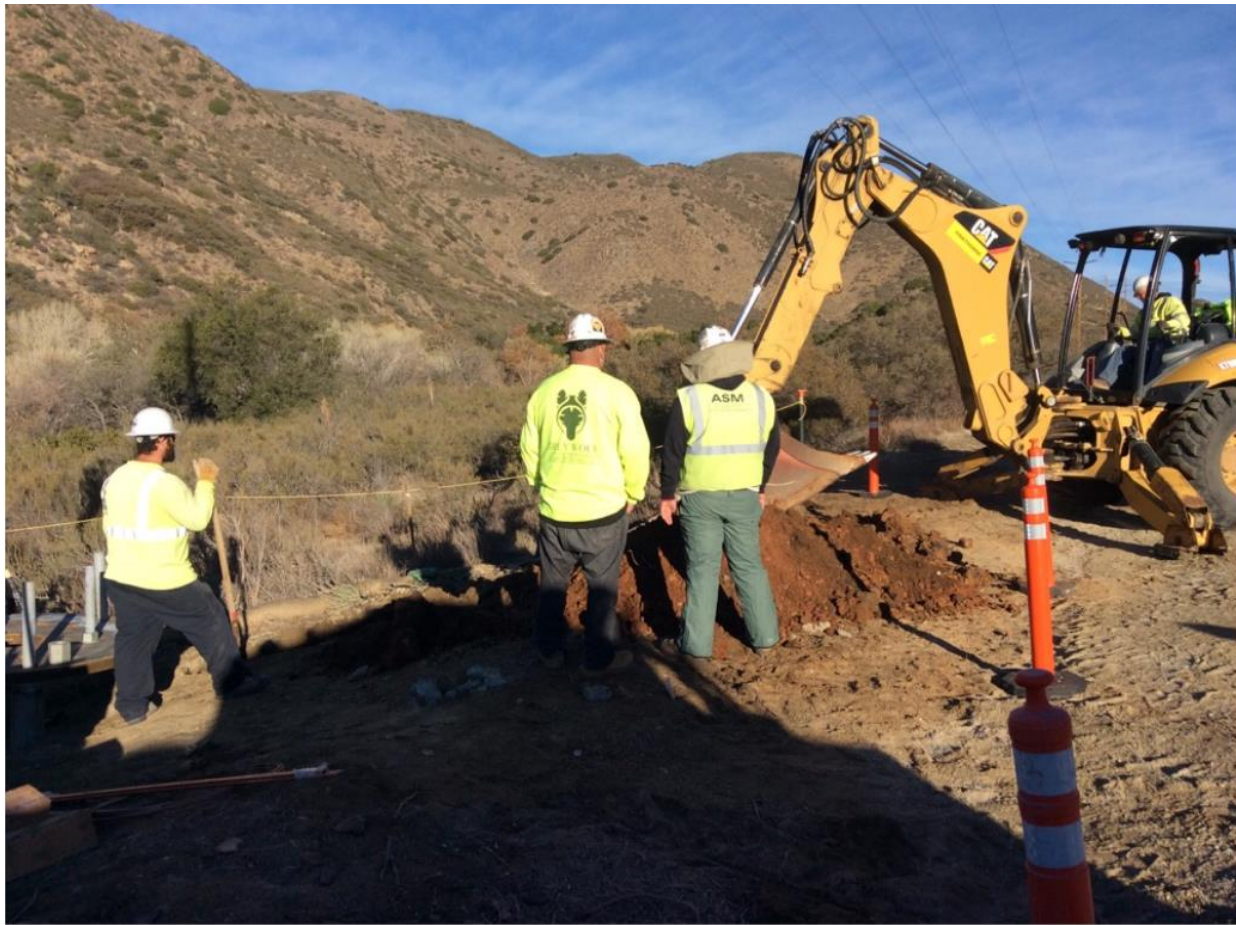
Photo 1: Archaeological and Cultural Monitors were present during ground rod trenching at Pole Z40515 (TL629C) in accordance with the HPMP, APM CUL-04, and MM CUL-1. In addition, crew members were observed adhering to ESA fencing in accordance with the HPMP and APM CUL-03.

Cultural resource monitors, including Archaeological and Native American Monitors, were observed monitoring ground disturbing activities, and Environmentally Sensitive Areas (ESAs) were marked to prevent unauthorized access into areas with previously recorded cultural resources in accordance with the Historic Properties Management Plan (HPMP), MM CUL-1, MM CUL-3, APM CUL-04, and APM CUL-05 (See Photo 1—Attachment A). On November 27, the CPUC followed up with SDG&E regarding

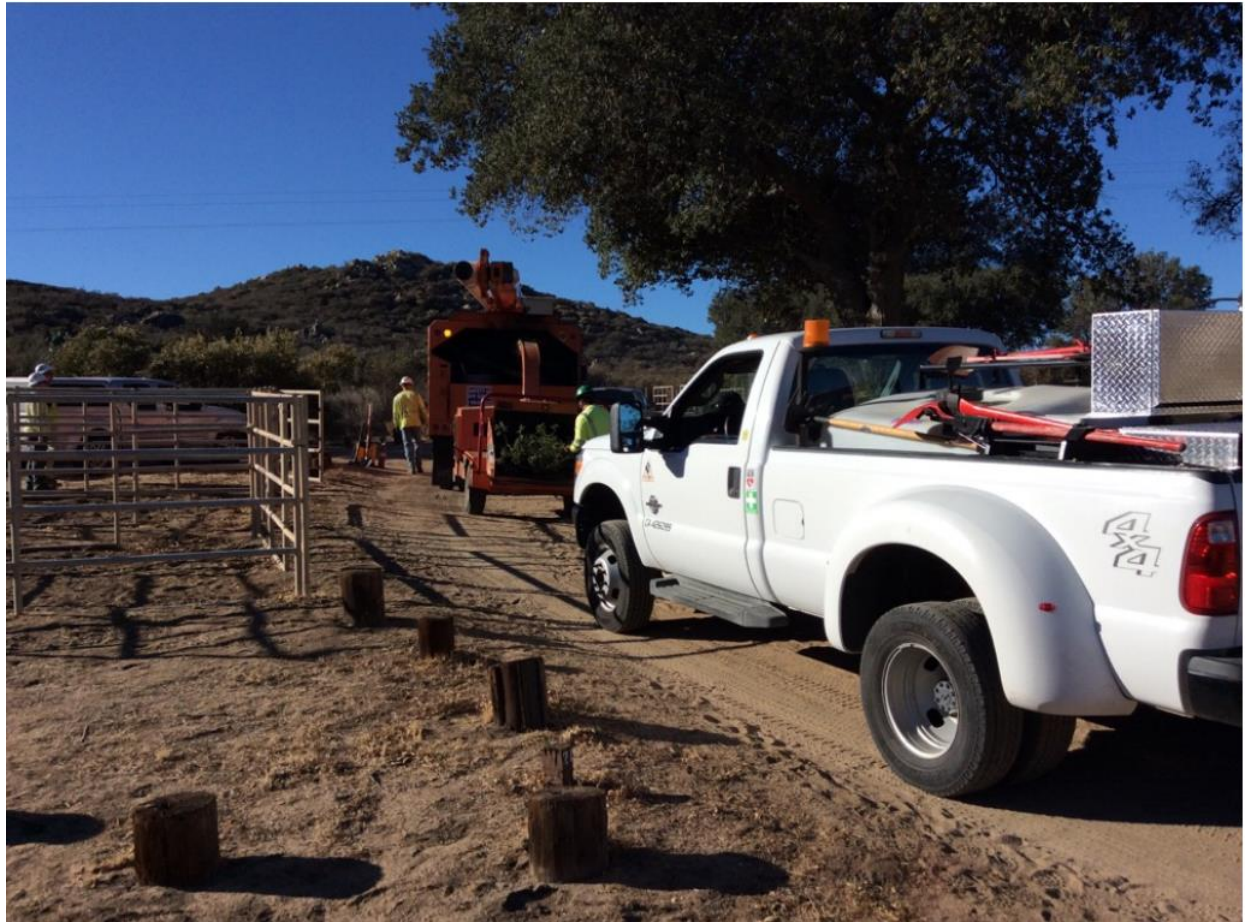
Photo 2: A Fire Patrol remained with the UTS tree trimming crew along the Access Road between Poles Z100048-Z100049 (TL 629C) to ensure the crew was equipped with at least 100 gallons of water with pump and hose during chipping, as required by the CFPPP Fire Matrix (MM FF-1) for the day's fire conditions (PAL D on CNF land).

In accordance with the Construction Fire Prevention/Protection Plan (CFPPP) (MM FF-1), dedicated fire patrols were observed inspecting areas of active construction along the project alignments to ensure fire compliance and safety, and crews were observed staging complete sets of fire tools (i.e. 5 gallon backpack pump, round point shovel, Pulaski, and 2A10BC fire extinguisher) within 50 feet of work activities. Project activities were observed complying with activity-specific CFPPP fire prevention matrix stipulations for work on and off the CNF based on the day's stated fire conditions (See Photo 2—Attachment A).

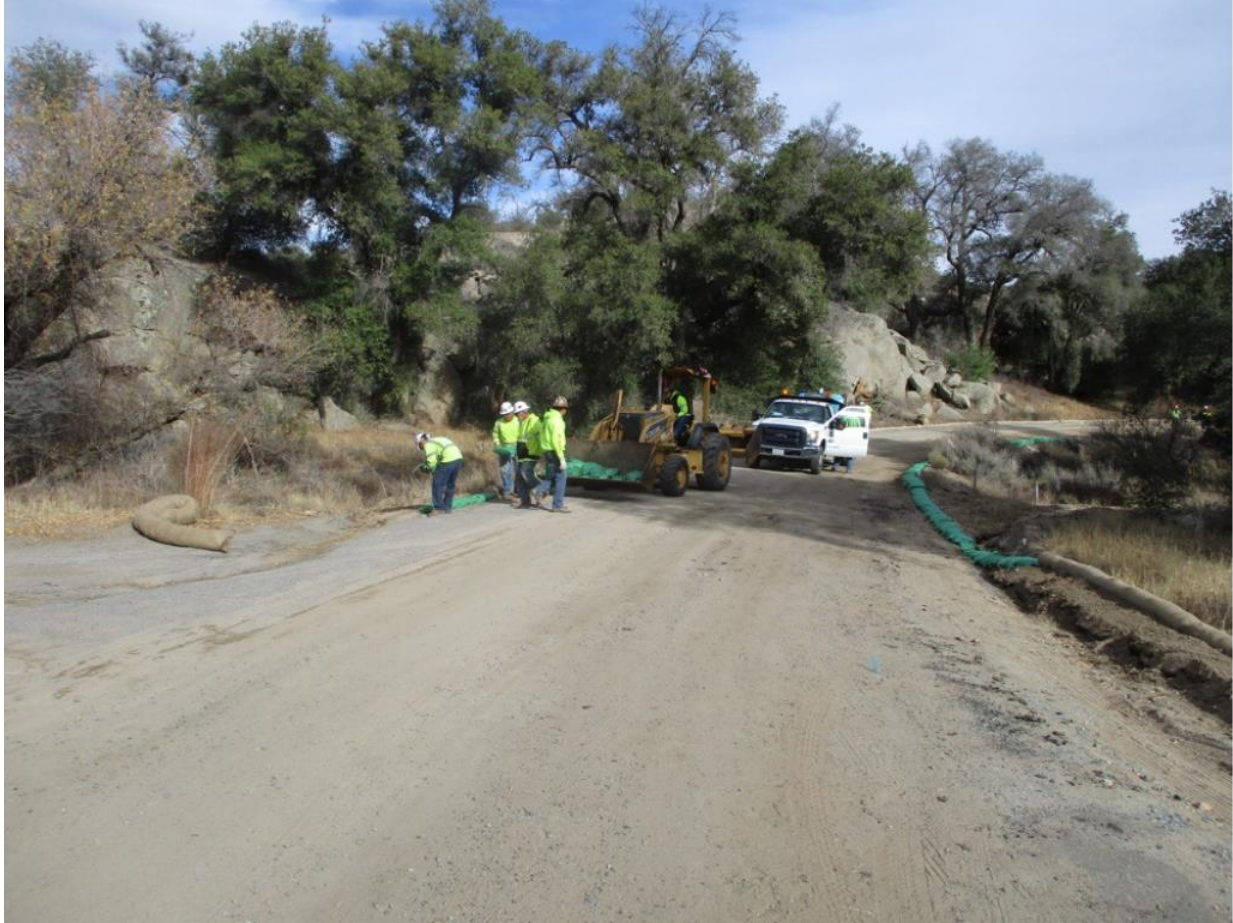
Photo 3: Crews were observed trenching for the installation of silt fence, installing fiber rolls, and installing gravel bag berms along a drainage swale/area of higher velocity flow along Morena Stokes Valley Road in accordance with the ECP, SWPPP (MM HYD-1, MM BIO-7) and APM-HYD-09.

In accordance with the project Erosion Control Plan (ECP) and Storm Water Pollution Prevention Plan (SWPPP) (MM HYD-1, MM BIO-7) and APM HYD-09, site-specific sediment and erosion control BMPs were observed being implemented along project alignments. Fiber rolls and silt fencing were observed being maintained along rights-of-way and at staging yards and new fiber rolls, fencing, and gravel bags were observed installed along C449 (See Photo 3—Attachment A). Soil stockpiles were observed covered to prevent erosion. During micropile grouting operations, concrete waste was managed and excess concrete was not discharged onto the ground in accordance with APM HYD-01 (See Photo 4—Attachment A).

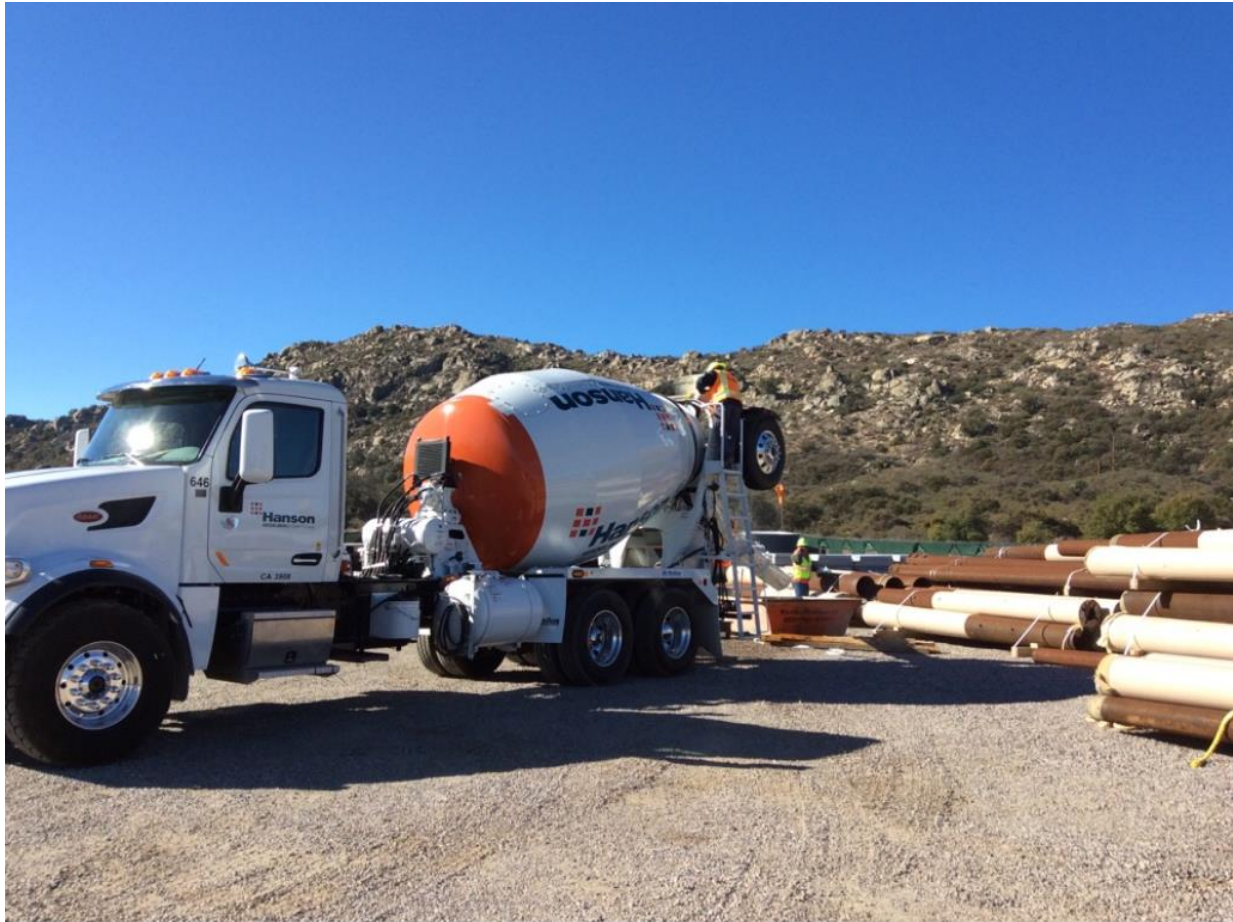
Photo 4: In accordance with APM HYD-01, concrete washout was observed to be taking place at a designated concrete washout station at Kitchen Creek Staging Yard.

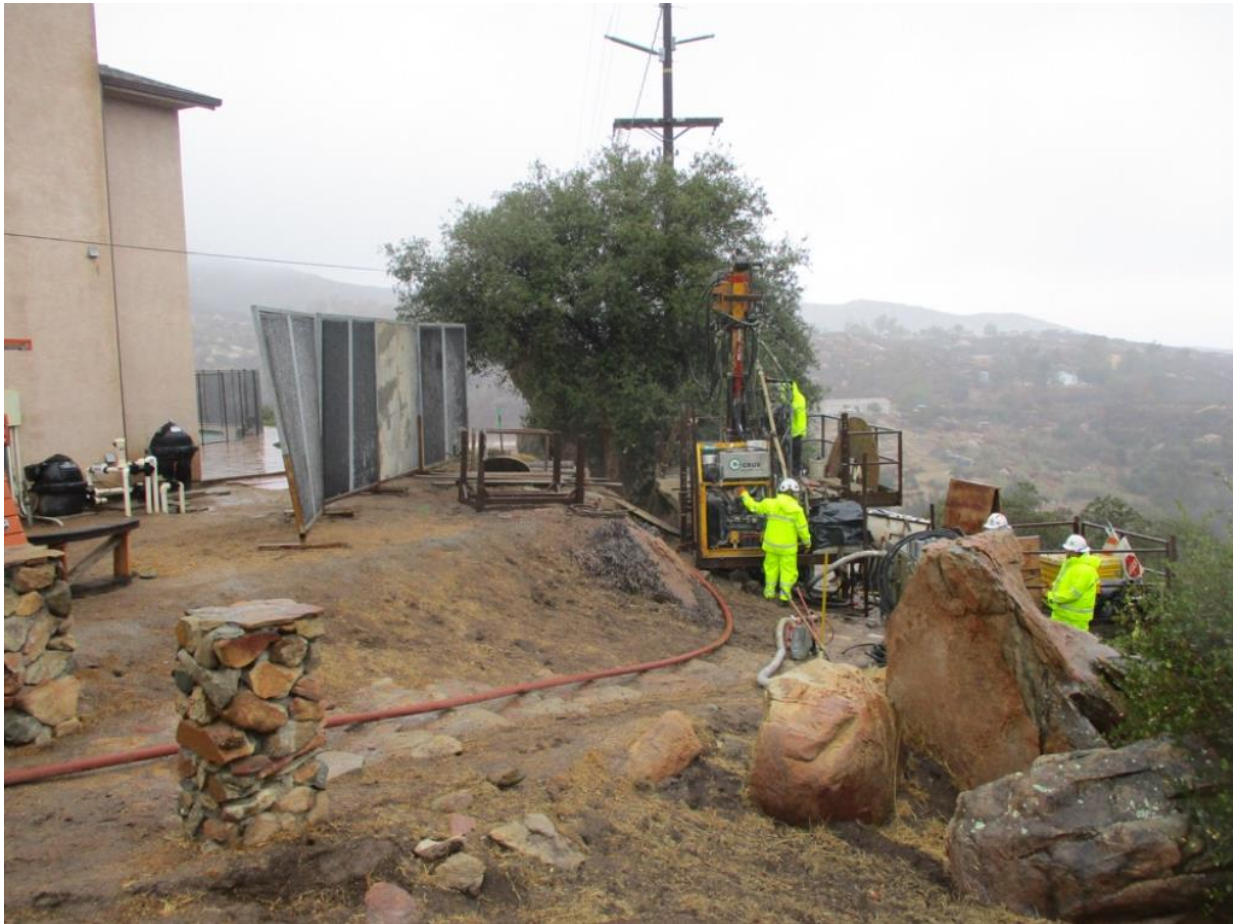
Photo 5: A noise barrier was observed being utilized at Z571469 (TL 6957) in accordance with MM NOI-1 and equipment was observed positioned as far away from the house as possible in accordance with APM NOI-02.

In accordance with APM NOI-02 stationary equipment was observed to be positioned in a way that would maximize its distance from residences and noise barriers were installed in accordance with MM NOI-1 (See Photo 5—Attachment A).

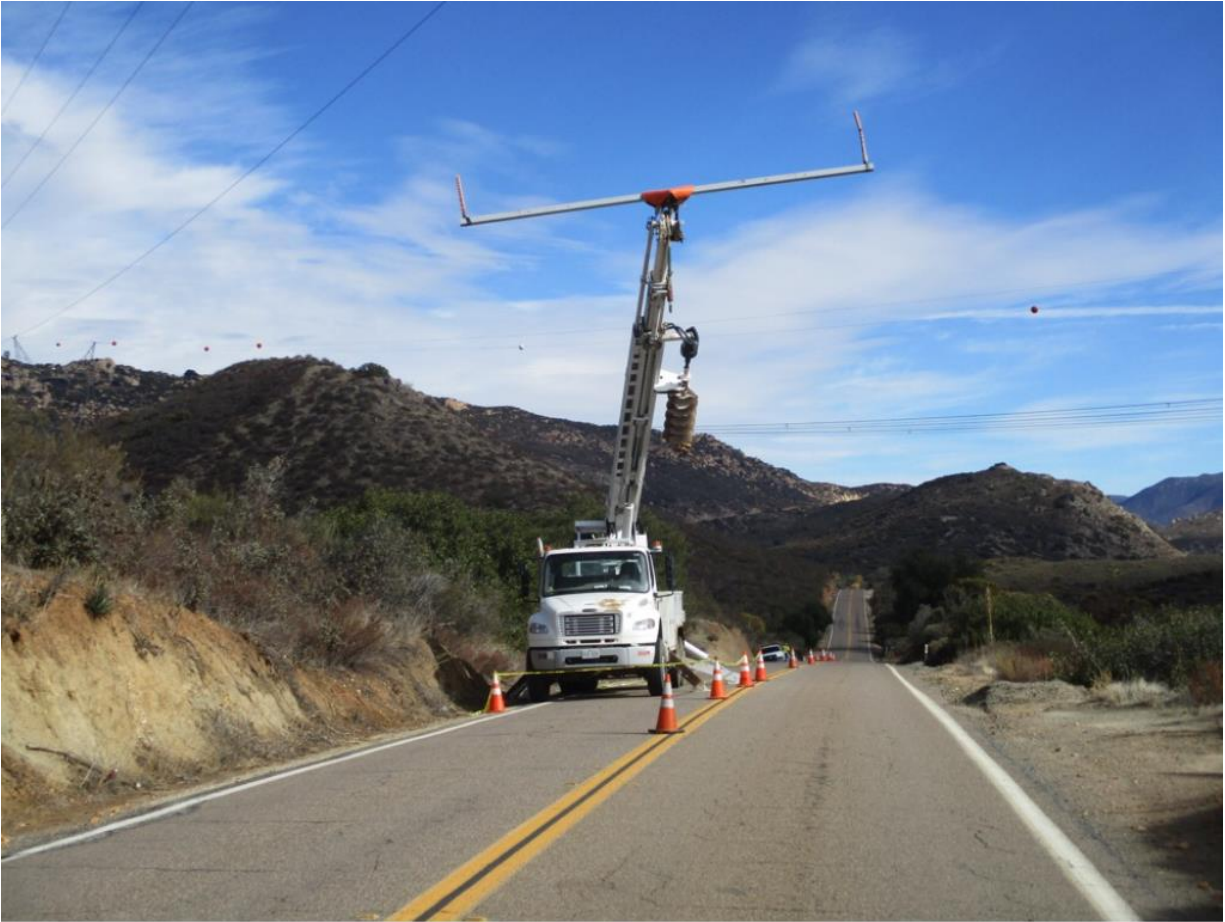
Photo 6: In accordance with APM TRANS-02, Pro Traffic flaggers closed one lane of Lyons Valley Road to allow the staging of a PAR guard structure during fiber optic stringing between Z571432 and Z571451 (TL 6957).

Traffic control measures were observed being implemented along Lyons Valley Road (TL 6957) and Old Highway 80 (TL 629C) in accordance with APM TRANS-02. Signage and cones were used for shoulder closers (See Photo 6 – Attachment A), and flaggers were utilized to temporarily hold traffic when needed, or when helicopter operations crossed or occurred next to public roadways.
