California Public Utilities Commission <i>Mitigation Monitoring, Compliance, and Reporting</i> <i>Program</i>
	Cleveland National Forest Power Line Replacement Projects Compliance Status Report: 100 July 26, 2020

This compliance status report covers construction activities from July 13 through July 26, 2020.

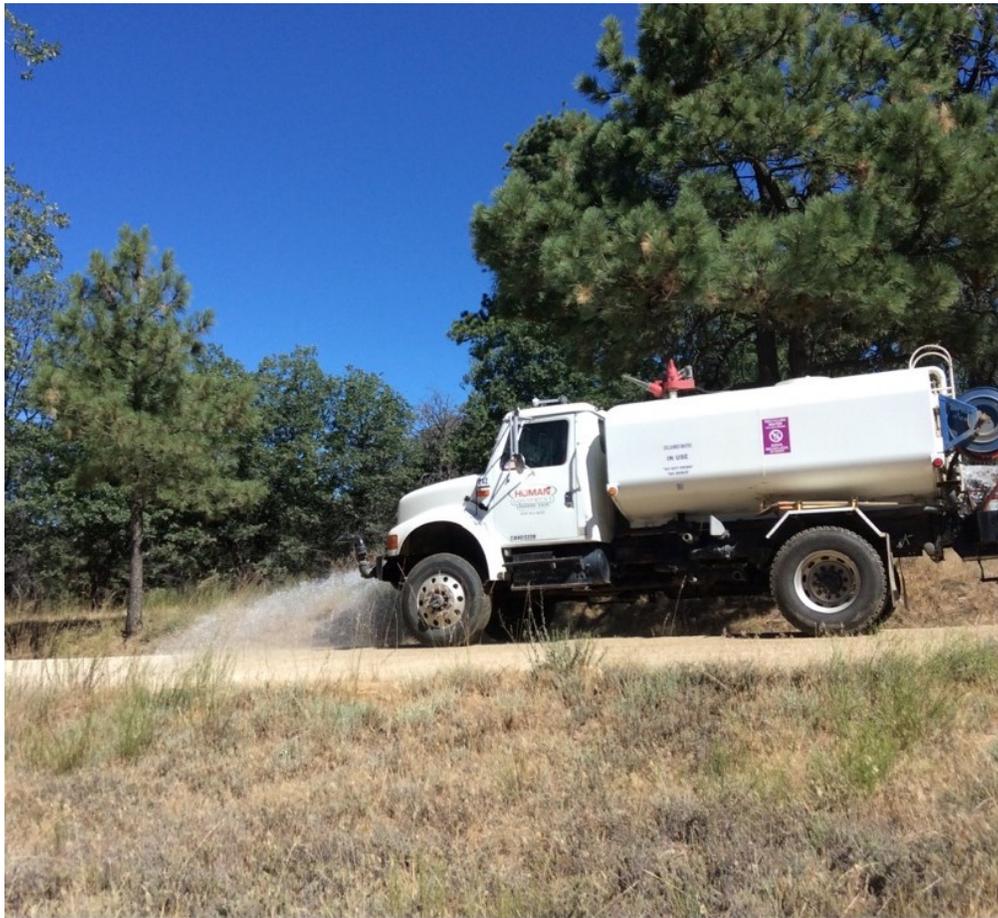
Photo 1: A water tender was observed applying water on Los Huecos Road (C 440 Phase II) to minimize dust emissions throughout the day in accordance with APM AIR-02.

To prevent fugitive dust emissions during project activities, crews were observed applying water to prevent fugitive dust along unpaved access roads and in work areas in accordance with APM AIR-02 (see Photo 1 – Attachment A). Haul trucks used for dirt export were observed utilizing load covers to prevent dust emissions in accordance with APM AIR-02, and construction personnel were observed maintaining posted speeds of 15 miles per hour on unpaved access roads in accordance with APM AIR-03 and MM BIO-24. Construction crews were observed removing track-out from paved access roads in accordance with APM AIR-05.

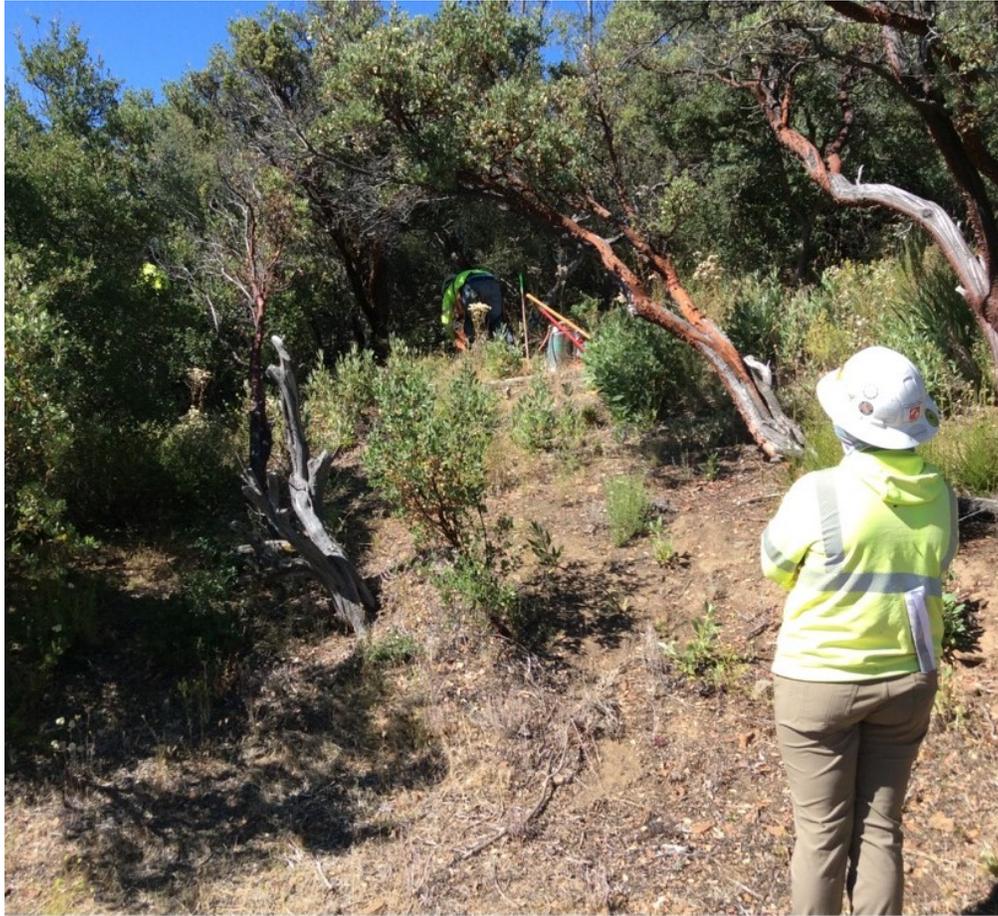
Photo 2: A Biological Monitor was observed monitoring vegetation removal at the anchor site at P874922 (C 79B) in accordance with MM BIO-3.

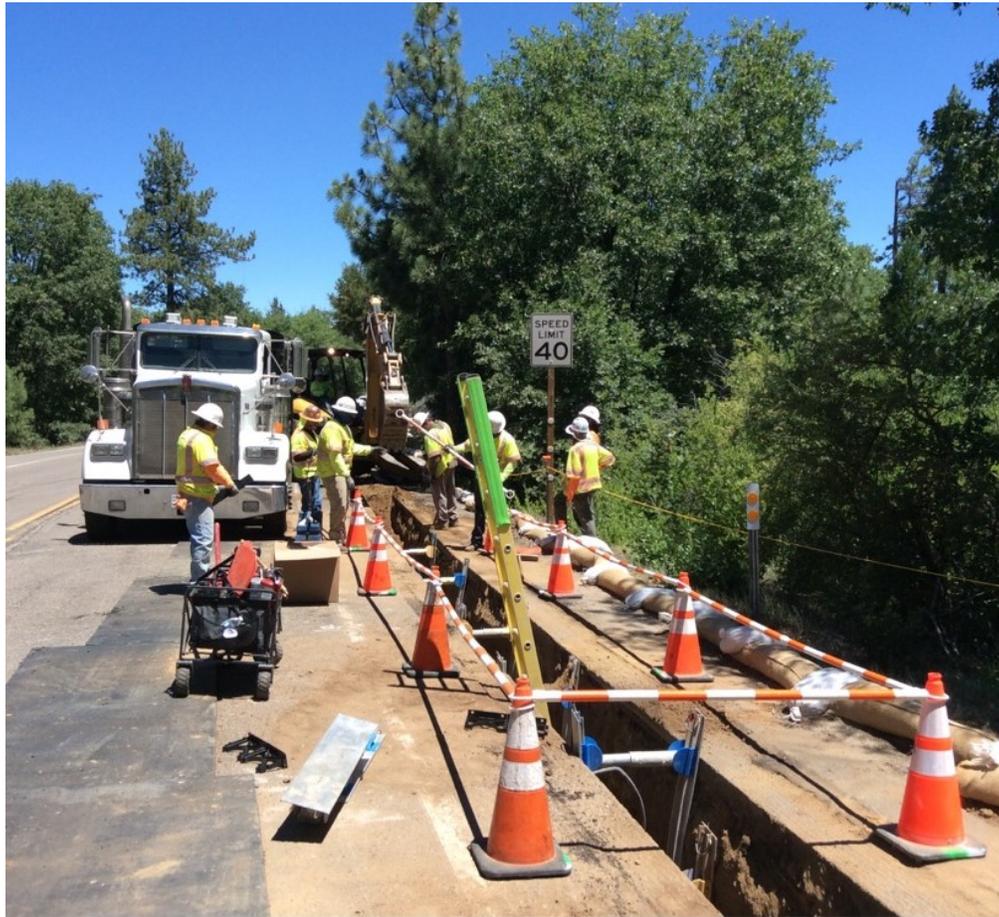
Photo 3: A crew was observed excavating a trench on Sunrise Highway along C 440 Phase II. Archaeological and Cultural Monitors were observed monitoring the activity, and an adjacent Cultural ESA was clearly delineated and avoided by crews in accordance with the HPMP (MM CUL-1), APM CUL-03, APM CUL-04, and MM CUL-1.

CPUC ECMs observed cultural resource monitors, including archaeological and Native American monitors, monitoring construction activities that occurred within or adjacent to identified archaeological or cultural resource site boundaries in accordance with the Historic Properties Management Plan (HPMP), MM CUL-1, MM CUL-3, and APM CUL-04 (see Photo 3 – Attachment A). Cultural ESAs were marked

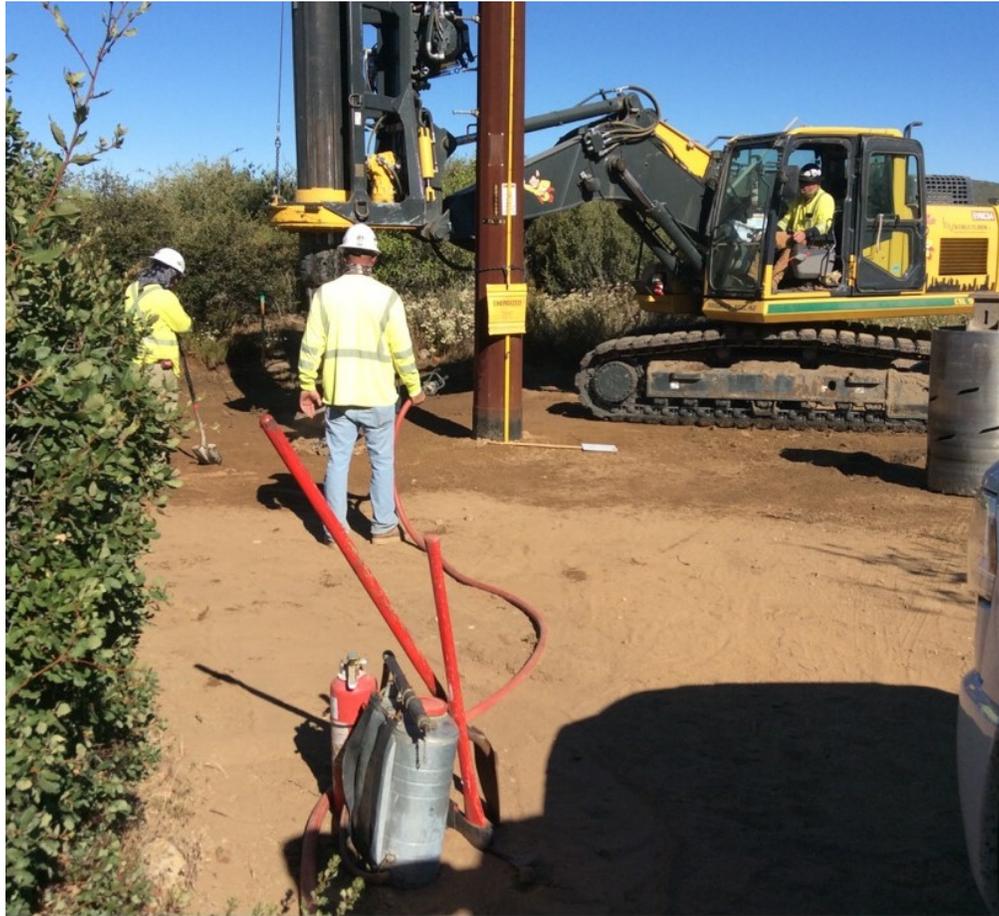
Photo 4: A crew was observed drilling a direct bury pole hole at P258505 (C 79B). A Dedicated Fire Patrol, at least 150 gallons of water with pump and hose, and a full set of fire tools were observed on site in accordance with the CFPPP Fire Prevention Matrix (MM FF-1) for foundation drilling on USFS land with a PAL Ev.

In accordance with the Construction Fire Prevention/Protection Plan (CFPPP) (MM FF-1), San Diego Gas & Electric (SDG&E) and their construction contractors were observed communicating Fire Potential Index (FPI) and Project Activity Levels (PALs) to work crews at daily tailboard meetings, during which daily fire requirements and restrictions for work on private land and on National Forest System (NFS) land were discussed. All project-related vehicles and equipment were observed carrying the required set of fire tools (each set containing a 5-gallon backpack pump, round point shovel, Pulaski, and 2A10BC fire extinguisher). Construction crews were observed staging a set of fire tools within 50 feet of work activities as required by APM HAZ-04 and other tools as required by the CFPPP (see Photo 4 – Attachment A). Fire boxes were observed at staging yards and stocked with the required firefighting tools.

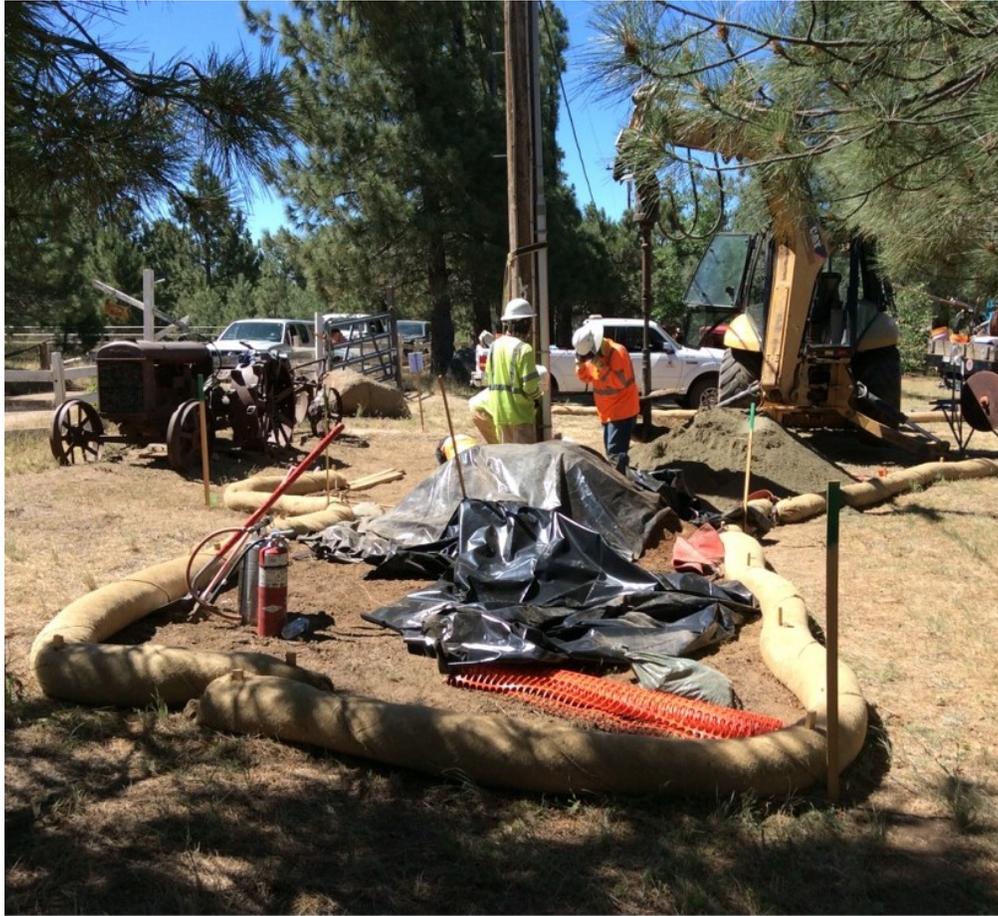
Photo 5: A crew was observed digging a direct bury pole hole at P45115 (C 440 Phase II). Erosion control BMPs at the site were observed in good condition in accordance with the ECP (MM HYD-1) and SWPPP (MM HYD-1, MM BIO-7).

To prevent impacts to hydrology and water quality, site-specific sediment and erosion control BMPs were observed being implemented and maintained along project alignments in accordance with the project Erosion Control Plan (ECP), Stormwater Pollution Prevention Plan (SWPPP; MM HYD-1 and MM BIO-7), and APM HYD-09 (see Photo 5 – Attachment A).

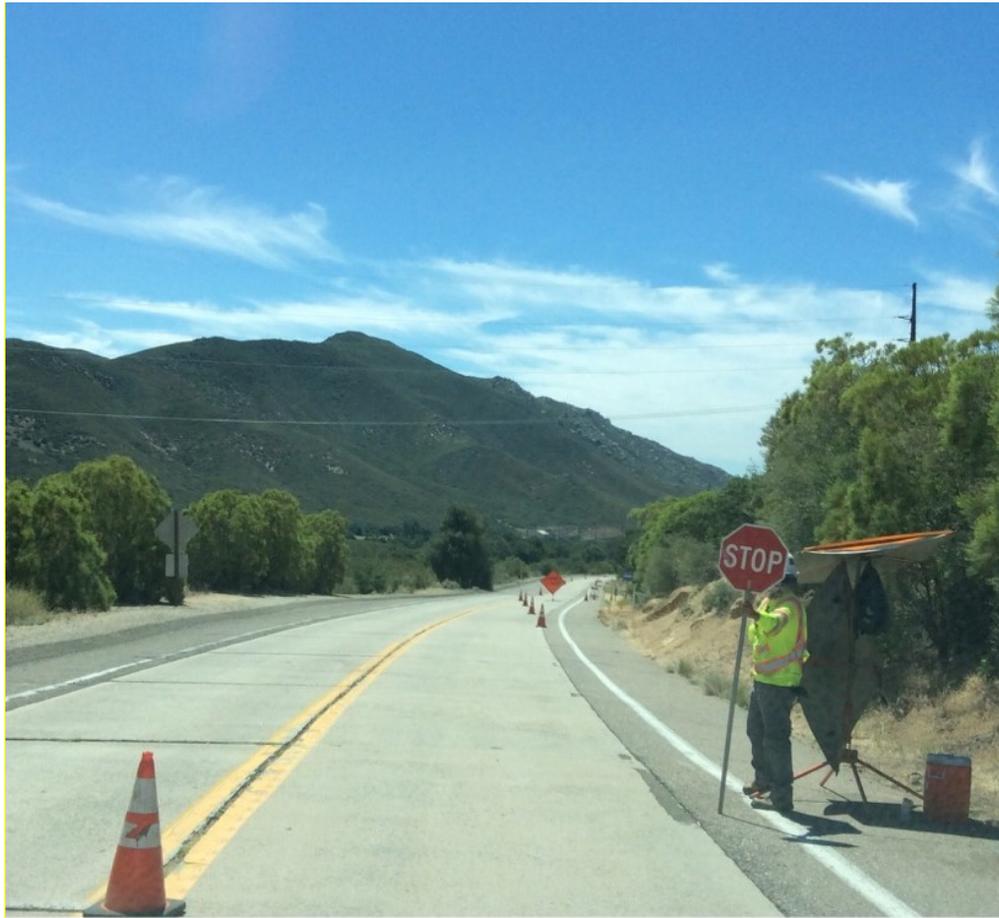
Photo 6: Signage, cones, flagpersons, and a clearly marked pilot vehicle were used to direct one-way traffic around the work area on Old Highway 80 (TL 629A) in accordance with the Traffic Control Plan (TCP; APM TRANS-05) and APM TRANS-02.

Traffic control measures were observed being implemented in accordance with APM TRANS-01 through APM TRANS-05 during this reporting period (see Photo 6 – Attachment A).
