<p>California Public Utilities Commission <i>Mitigation Monitoring, Compliance, and Reporting Program</i></p>
	<p>Cleveland National Forest Power Line Replacement Projects</p> <p>Compliance Status Report: 102</p> <p>August 23, 2020</p>

This compliance status report covers construction activities from August 10 through August 23, 2020.

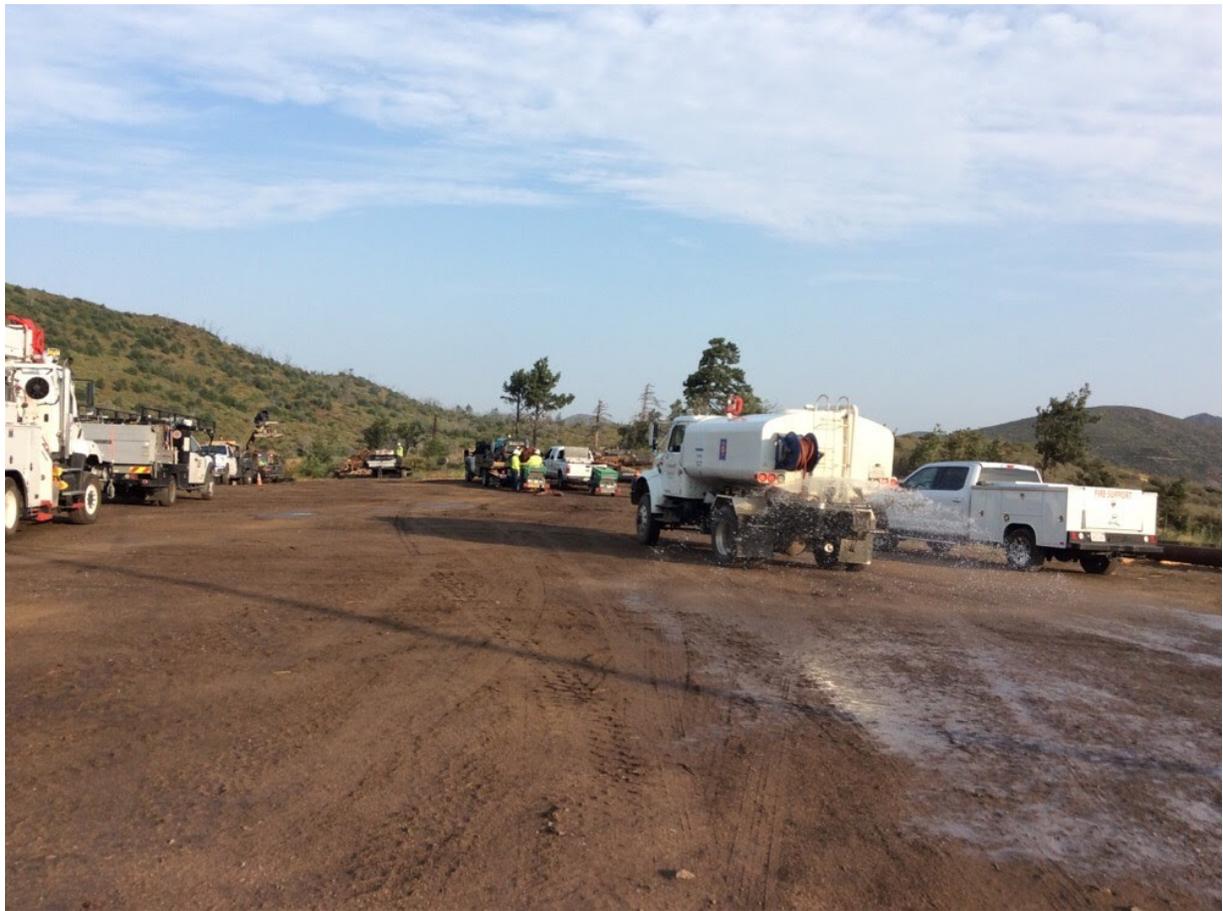
Photo 1: A water tender was observed applying water to the surface at Shrine Camp Staging Yard (C 440) before and during helicopter activities to minimize dust emissions from rotor wash in accordance with APM AIR-02 and the Aviation Safety Plan (MM PHS-5).

To prevent fugitive dust emissions during project activities, crews were observed applying water along unpaved access roads and in work areas in accordance with APM AIR-02 and during helicopter operations in accordance with the Aviation Safety Plan (MM PHS-5) (see Photo 1 – Attachment A). Haul trucks used for dirt export were observed utilizing load covers to prevent dust emissions in accordance with APM AIR-02, and construction personnel were observed maintaining posted speeds of 15 miles per hour on unpaved access roads in accordance with APM AIR-03 and MM BIO-24.

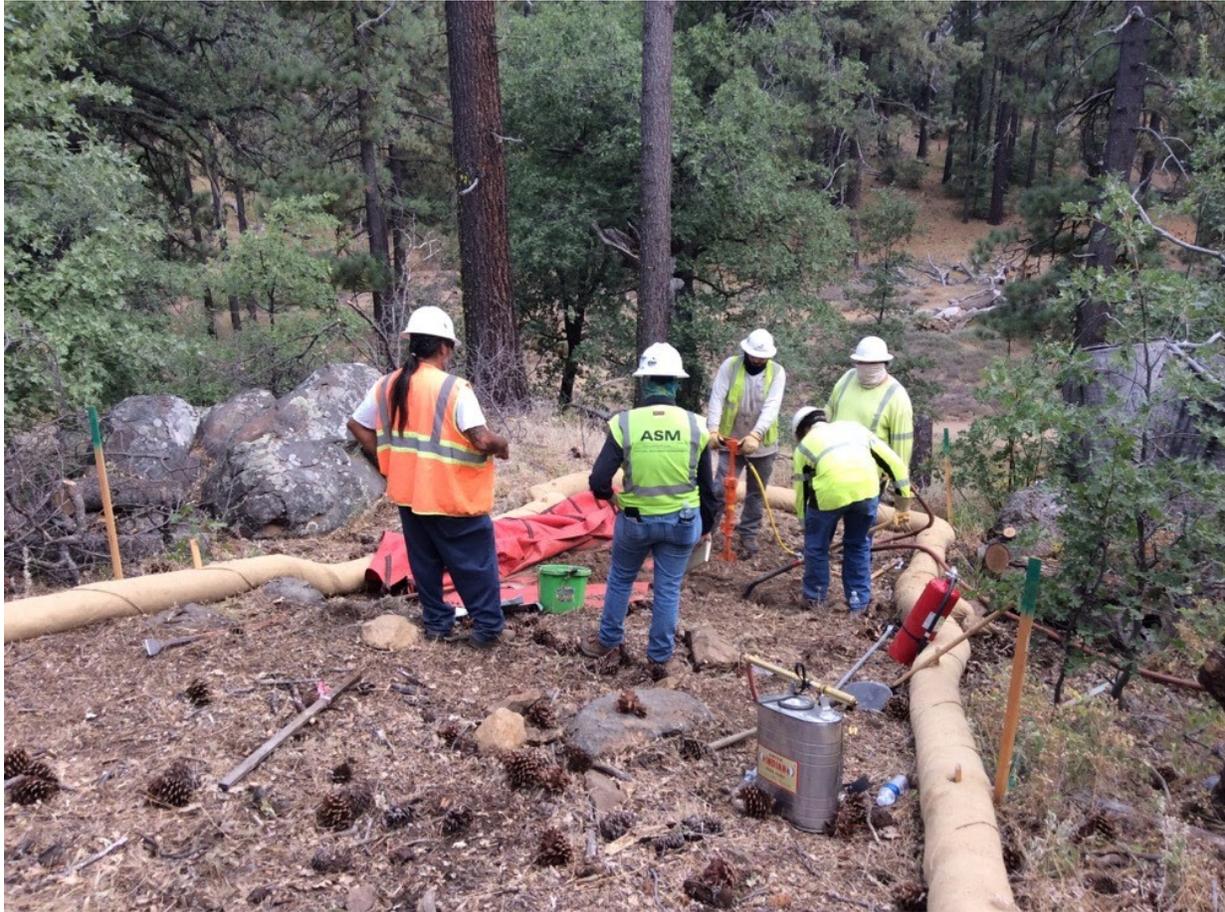
Photo 2: A crew was observed digging an anchor excavation on C 440 within clearly delineated work limits in accordance with MM BIO-1. Additionally, Archaeological and Cultural Monitors were present in accordance with the HPMP (MM CUL-1) and APM CUL-04.

Approved workspaces were observed delineated with staking and flagging, and work crews were observed adhering to work space limits and staying on approved access roads in accordance with MM BIO-1 (see Photos 2 and 3 – Attachment A). Workers were observed having completed the Worker Environmental Awareness Program (WEAP), as shown by project hard hat stickers in accordance with MM BIO-2. Biological monitors were observed conducting full-time monitoring of initial ground-disturbing activities, such as vegetation removal, in accordance with MM BIO-3, and monitoring all other construction activities to ensure compliance with mitigation measures, applicant proposed measures, and permit conditions in accordance with MM BIO-22. In accordance with MM BIO-14 and MM BIO-16, Environmentally Sensitive Area (ESA) signs and flagging were observed installed around areas with special-status species, and ESAs were observed being avoided by crews. Excavations were observed covered to prevent wildlife entrapment in accordance with MM BIO-23, and crews were observed containing trash at work areas in accordance with MM BIO-26. Avian biologists were observed conducting nesting bird surveys and were present to monitor bird nests during construction activities in accordance with the Avian Protection Plan/Nesting Bird Management Plan (APP/NBMP) and MM BIO-28, and ESA signage was observed to protect roosting bat species along C 440 in accordance with MM BIO-30 (see Photo 3 – Attachment A).

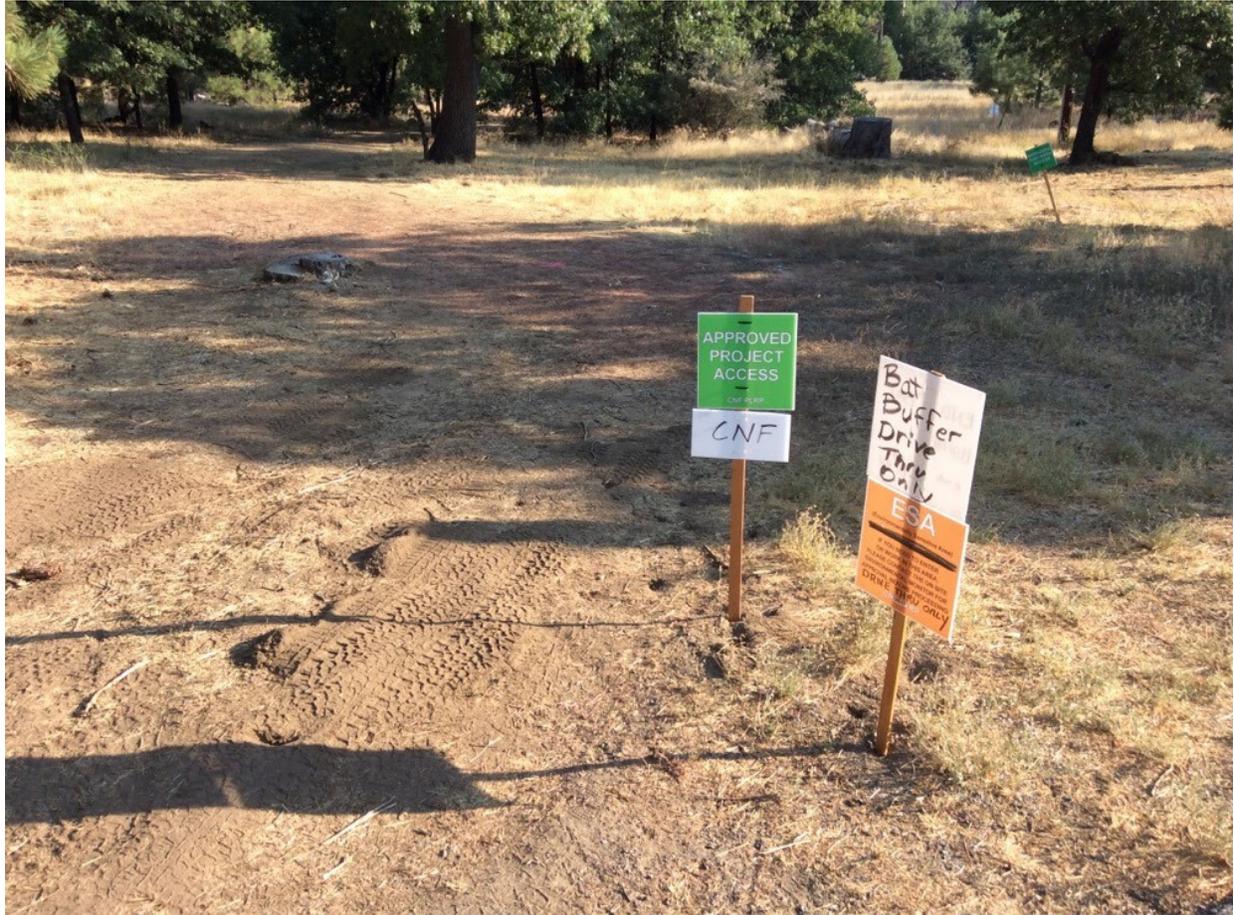
Photo 3: Signage was observed clearly marking the access road to P40178 (C 440) in accordance with MM BIO-1. Additionally, a drive-thru only bat buffer was also marked with signage as a general bat protection measure in accordance with MM BIO-30.

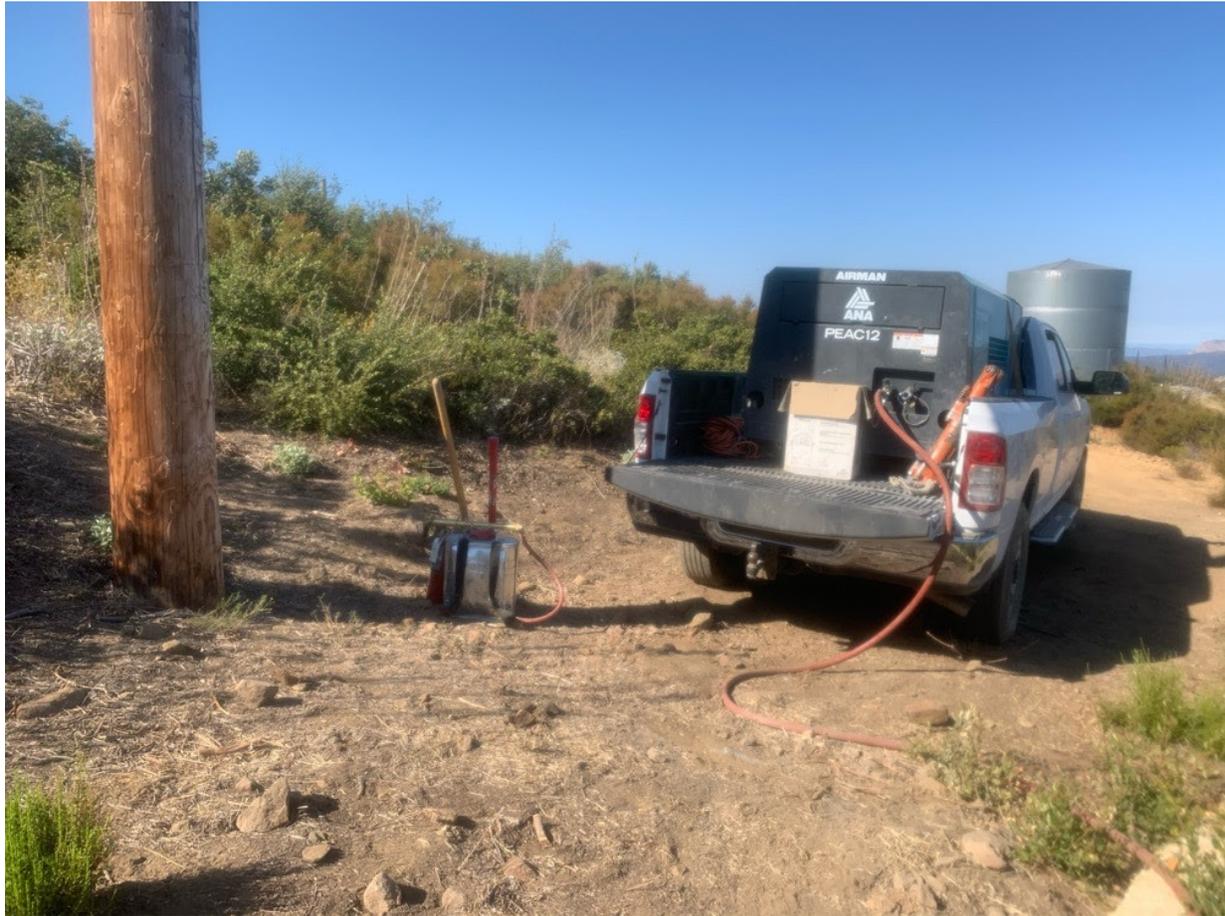
Photo 4: A running air compressor at Pole P258572 (C 79B) had at least 5 feet of clearance from combustible material on all sides and a full set of fire tools (5-gallon backpack pump, round point shovel, Pulaski, and 2A10BC fire extinguisher) within 50 feet in accordance with the CFPPP Fire Prevention Matrix for combustion engine use off USFS land with an Elevated FPI.

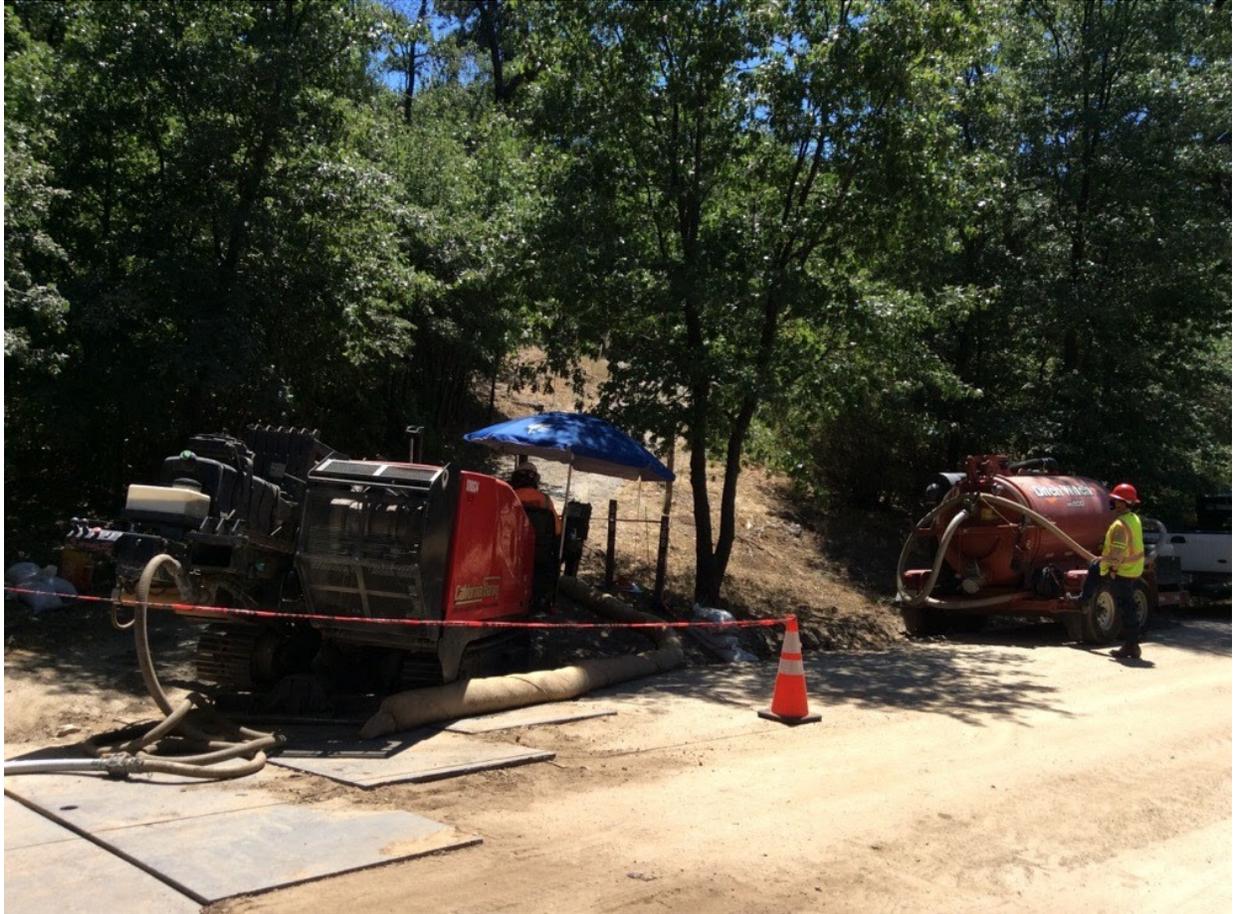
Photo 5: Site-specific erosion control BMPs were used under the directional drill on Los Huecos Road (C 440) to contain drill mud that may result from the activity in accordance with the SWPPP and APM HYD-09.

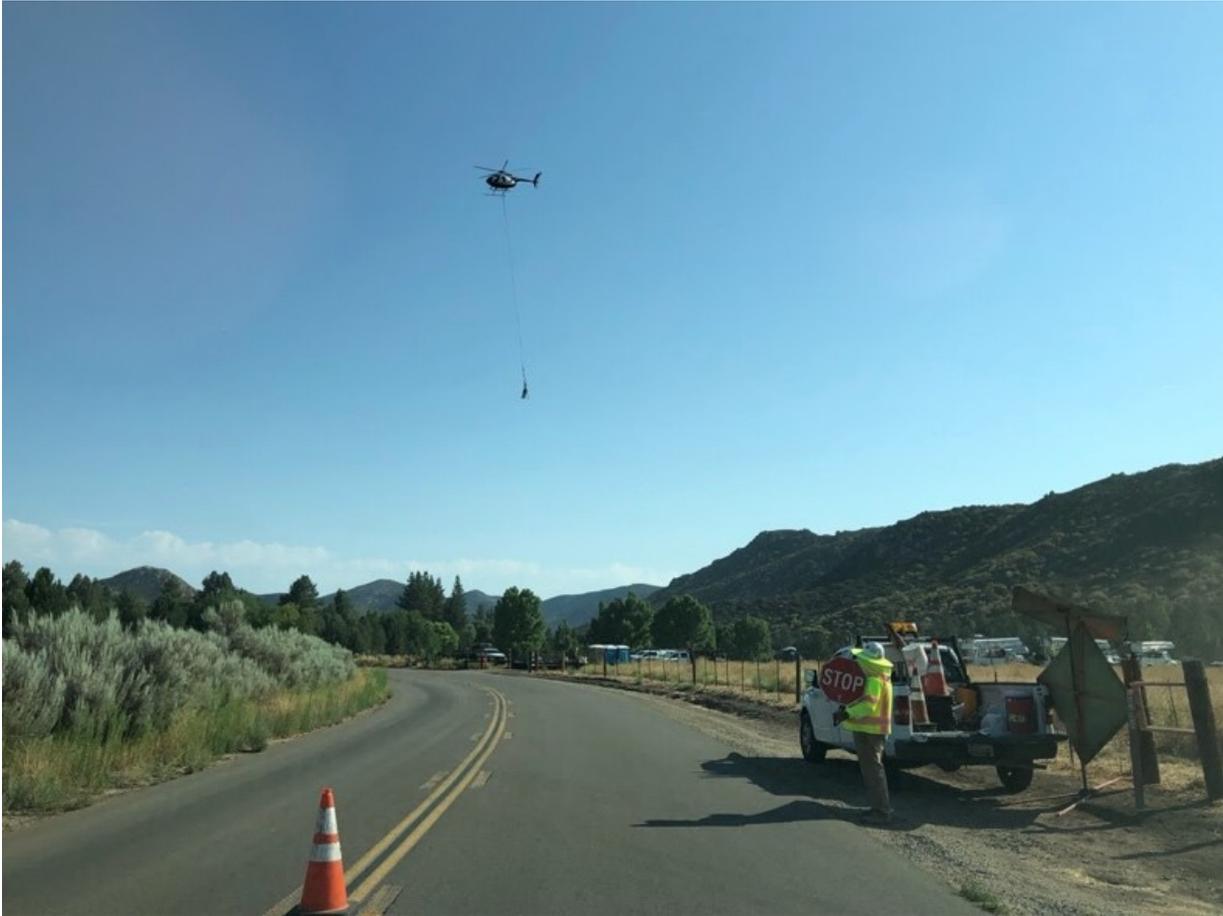
Photo 6: Cones, signage, and flagpersons were used to regulate traffic along Pine Creek Road (TL 629A) while helicopter external load operations in accordance with the Traffic Control Plan (APM TRANS-05), APM TRANS-02, and the Aviation Safety Plan.

Traffic control measures were observed being implemented in accordance with APM TRANS-01 through APM TRANS-05 during this reporting period (see Photo 6 – Attachment A).
