California Public Utilities Commission <i>Mitigation Monitoring, Compliance, and Reporting</i> <i>Program</i>
	Cleveland National Forest Power Line Replacement Projects Compliance Status Report: 104 September 20, 2020

This compliance status report covers construction activities from September 7 through September 20, 2020.

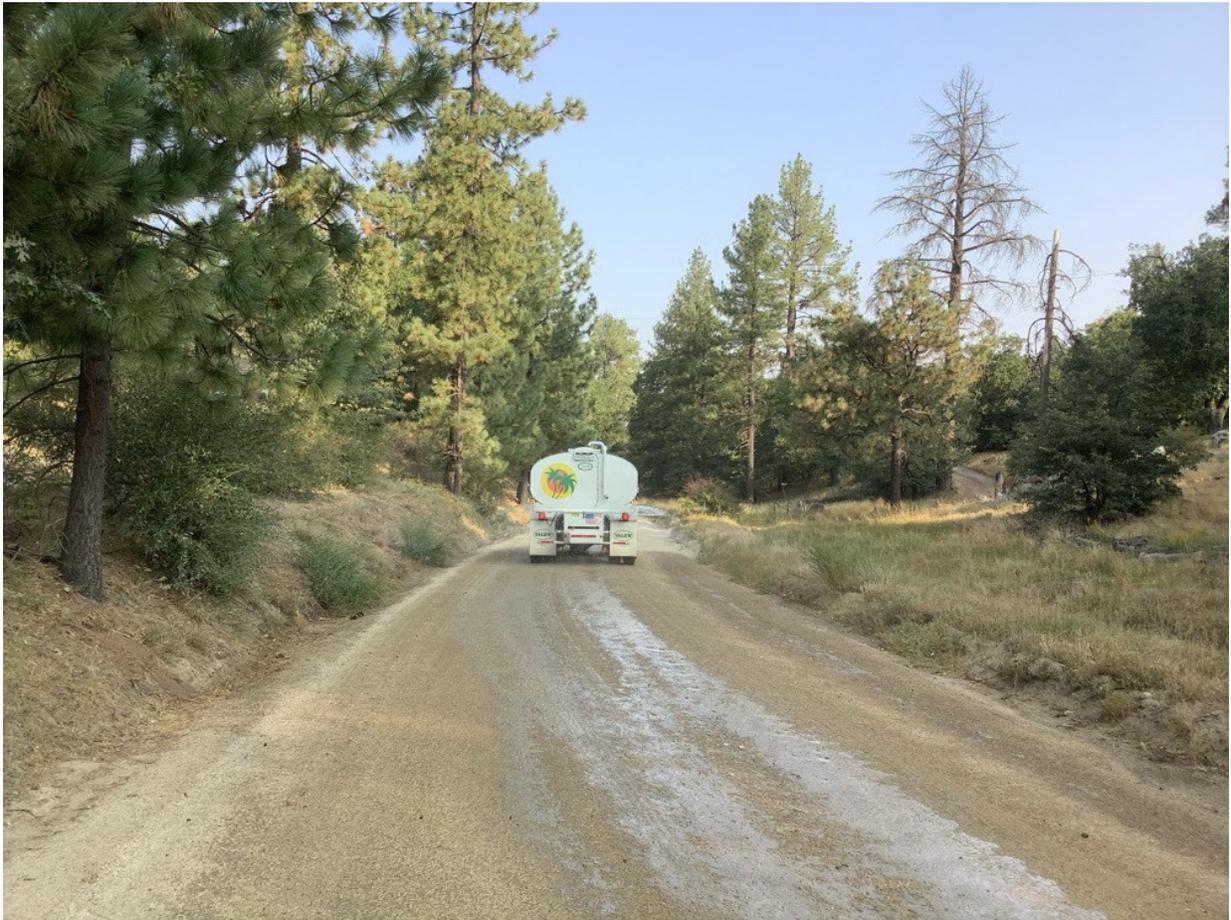
Photo 1: A water tender was observed applying water to the surface on Los Huecos Road (C 440) to minimize dust emissions from Project vehicular traffic in accordance with APM AIR-02.

To prevent fugitive dust emissions during project activities, crews were observed applying water along unpaved access roads and in work areas in accordance with APM AIR-02 (see Photo 1 – Attachment A) and during helicopter operations in accordance with the Aviation Safety Plan (MM PHS-5). Haul trucks used for dirt export were observed utilizing load covers to prevent dust emissions in accordance with APM AIR-02, and construction personnel were observed maintaining posted speeds of 15 miles per hour on unpaved access roads in accordance with APM AIR-03 and MM BIO-24.

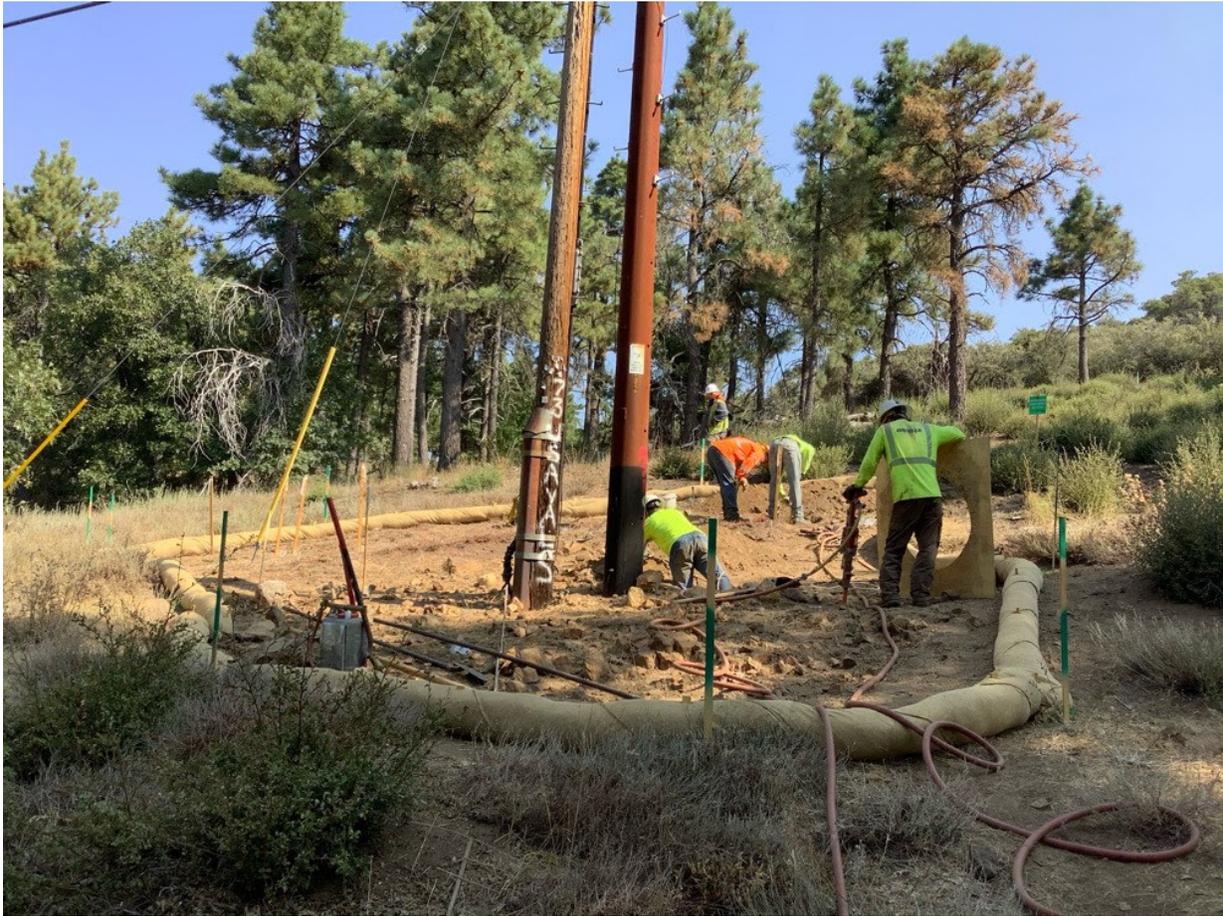
Photo 2: A crew was observed digging pole and anchor excavations at Pole P40370 (C 440). Crew members and materials were observed remaining within clearly delineated work limits in accordance with MM BIO-1.

Approved workspaces were observed delineated with staking and flagging, and work crews were observed adhering to work space limits and staying on approved access roads in accordance with MM BIO-1 (see Photo 2 – Attachment A). Workers were observed having completed the Worker Environmental Awareness Program (WEAP), as shown by project hard hat stickers in accordance with MM BIO-2. Biological monitors were observed conducting full-time monitoring of initial ground-disturbing activities, such as vegetation removal, in accordance with MM BIO-3 (see Photo 3 – Attachment A), and monitoring all other construction activities to ensure compliance with mitigation measures, applicant proposed measures, and permit conditions in accordance with MM BIO-22. In accordance with MM BIO-14 and MM BIO-16, Environmentally Sensitive Area (ESA) signs and flagging were observed installed around areas with special-status species, and ESAs were observed being avoided by crews. Excavations were observed covered to prevent wildlife entrapment in accordance with MM BIO-23, and crews were observed containing trash at work areas in accordance with MM BIO-26. During this reporting period, a CPUC ECM worked with a Biological Monitor to ensure that partially uncovered pole holes on Phase II of C 440 were properly covered in a timely manner.

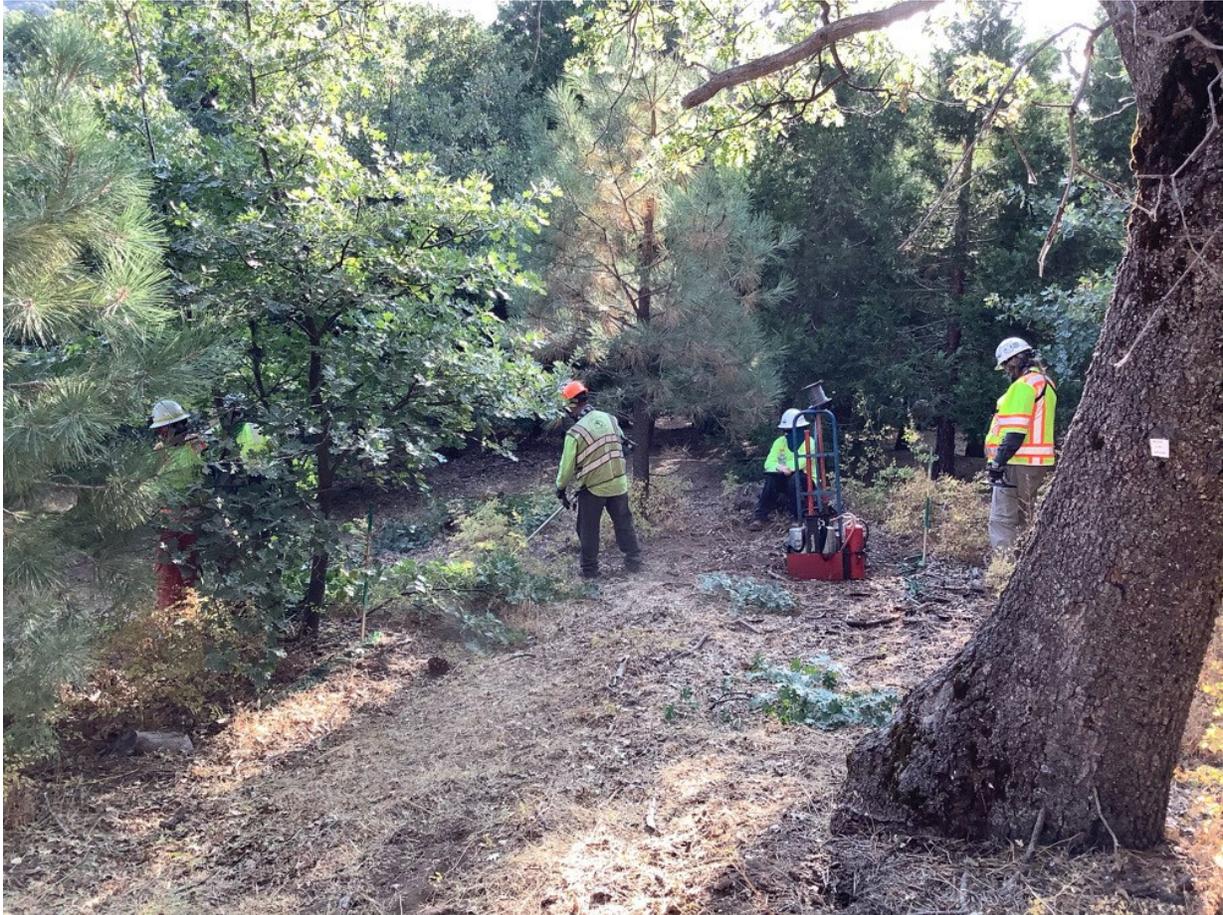
Photo 3: A Biological Monitor was observed monitoring vegetation removal at Pole P260424 (C 440) in accordance with MM BIO-3. In addition, the crew was observed using only battery-operated tools, a full set of fire tools was observed within 50 feet of the activity, and a Dedicated Fire Patrol was present in accordance with the CFPPP Fire Prevention Matrix for vegetation removal on USFS land with a PAL Ev (MM FF-1).

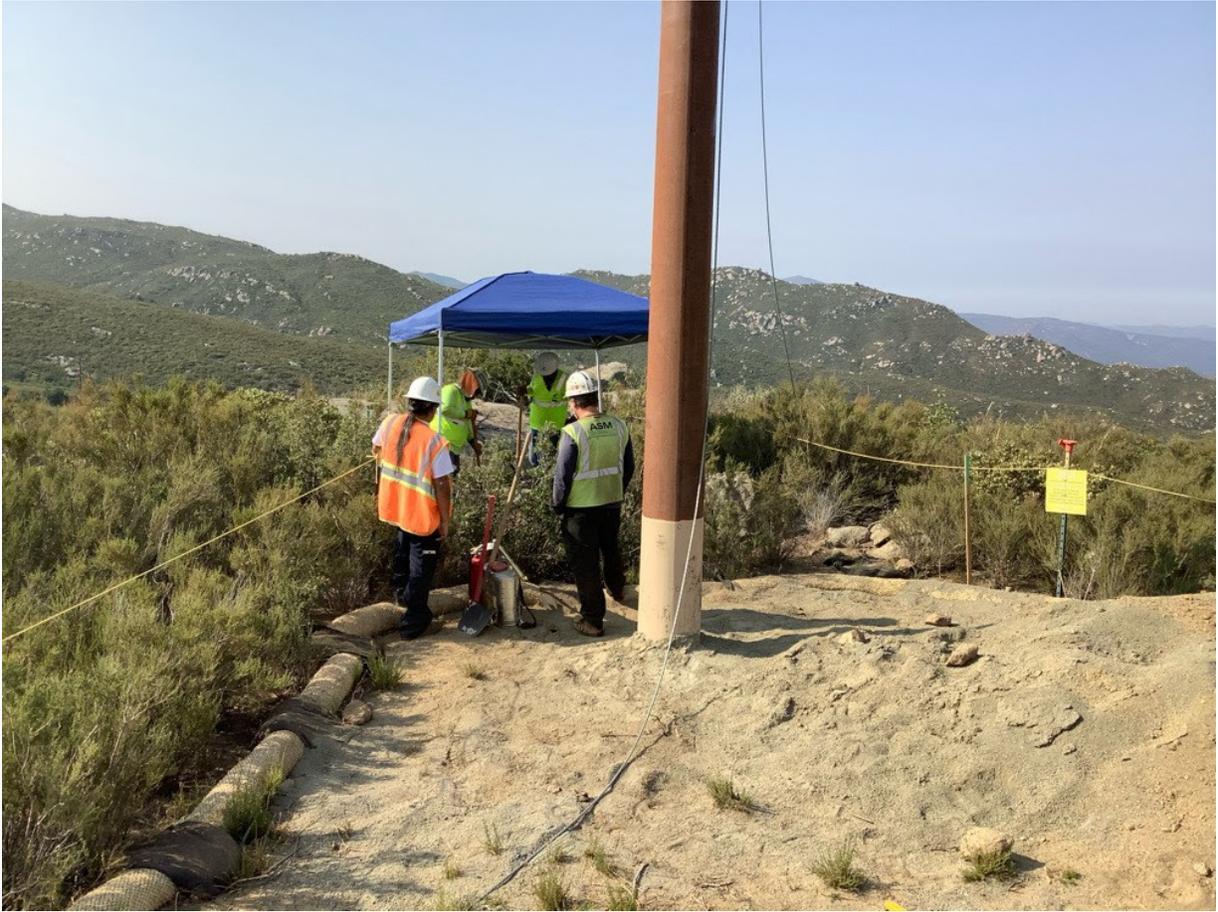
Photo 4: Archaeological and Cultural Monitors were observed monitoring anchor excavation at a site on C 79 B in accordance with the HPMP, APM CUL-04, and MM CUL-1. Additionally, the crew was observed respecting a clearly marked ESA surrounding the site in accordance with the HPMP and APM CUL-03.

CPUC ECMs observed cultural resource monitors, including archaeological and Native American monitors, monitoring construction activities that occurred within or adjacent to identified archaeological or cultural resource site boundaries in accordance with the Historic Properties Management Plan (HPMP), MM CUL-1, MM CUL-3, and APM CUL-04. Cultural ESAs were marked to prevent construction access to areas with cultural and/or historical resources in accordance with the HPMP, and work crews were observed respecting cultural ESA boundaries (see Photo 4 – Attachment A).

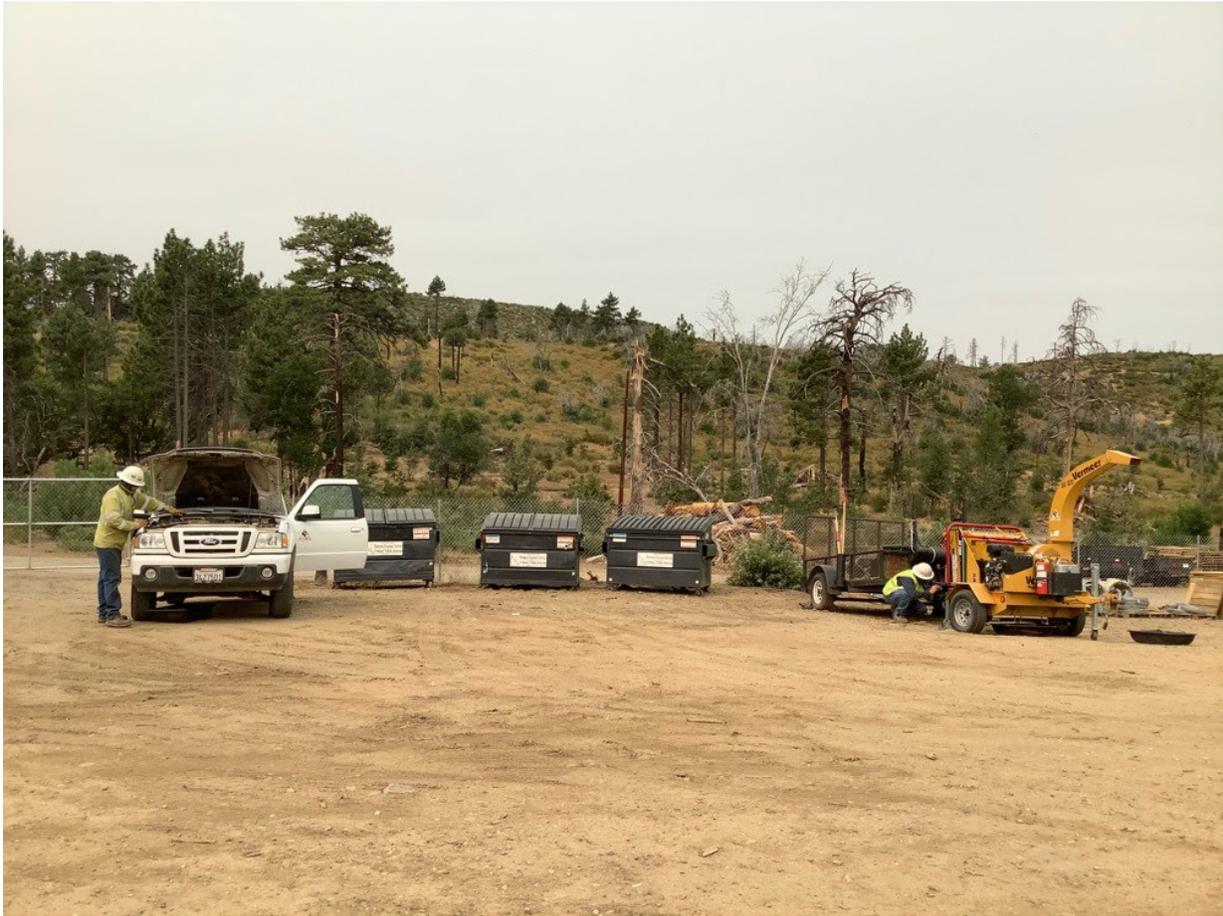
Photo 5: A crew was observed conducting vehicle and equipment maintenance at Shrine Camp Staging Yard (C 440). Drip pans were observed under vehicles and equipment during maintenance to prevent leaks or spills from being discharged onto the ground in accordance with the SRNP and MM PHS-2.

To prevent leaks and spills from being discharged into the soil in accordance with the Spill Response and Notification Plan (SRNP) and MM PHS-2, construction crews were observed implementing spill prevention BMPs, such as using drip pans under staged equipment and beneath equipment during mechanical work and refueling (see Photo 5 – Attachment A), staging spill kits at work sites, using double-walled fuel tanks or implementing secondary containment beneath staged fuel tanks, and cleaning up spills and disposing of contaminated soils in the designated and properly labeled hazardous waste barrels.

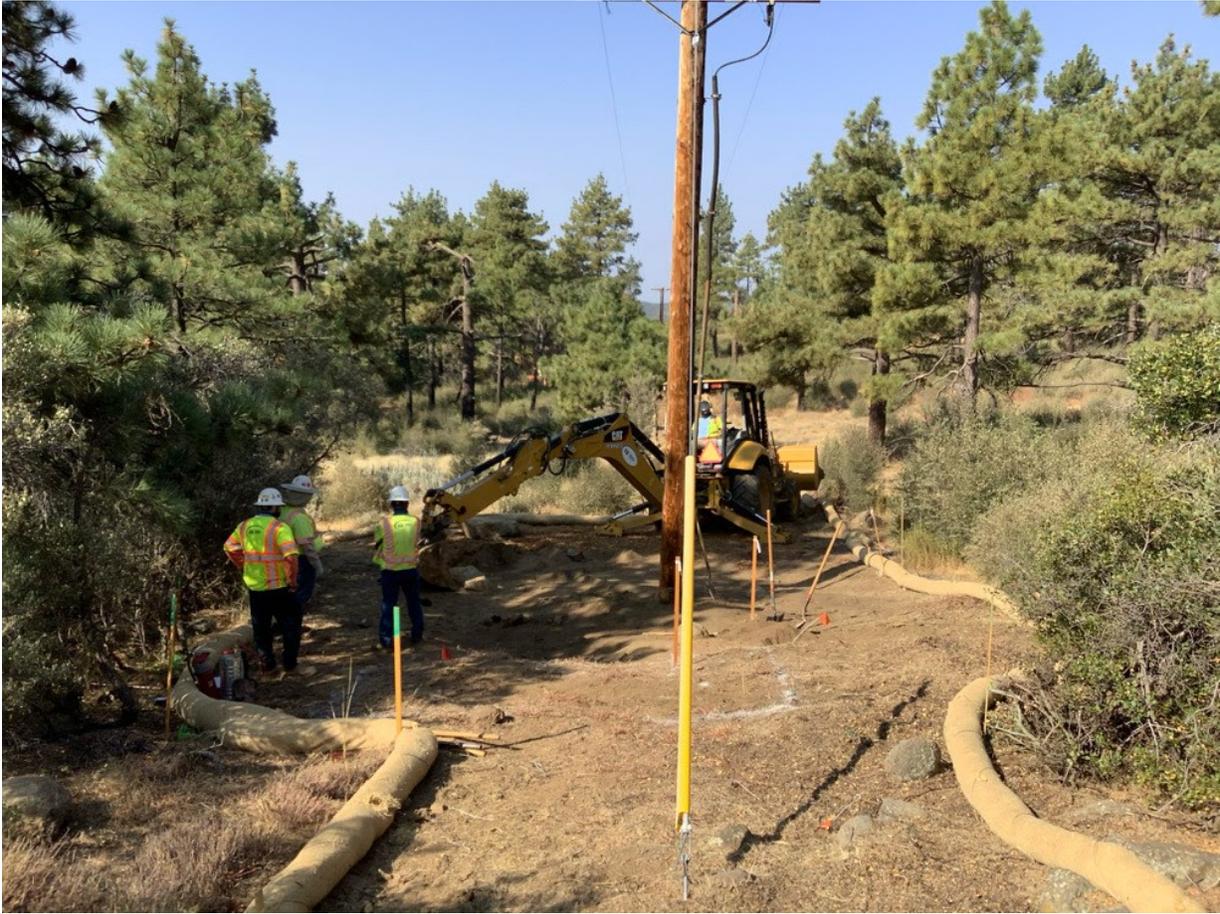
Photo 6: A crew was observed excavating a trench for a retaining wall near Pole P40143 (C 440). Site-specific erosion control BMPs were observed in good condition in accordance with the ECP, SWPPP (MM HYD-1 and MM BIO-7), and APM HYD-09.

To prevent impacts to hydrology and water quality, site-specific sediment and erosion control BMPs were observed being implemented and maintained along project alignments in accordance with the project Erosion Control Plan (ECP), Stormwater Pollution Prevention Plan (SWPPP; MM HYD-1 and MM BIO-7), and APM HYD-09 (see Photo 6 – Attachment A). Other BMPs in the SWPPP, such as hydromulch application, concrete waste containment, and street sweeping, were also observed along the alignments. Hydrological resources were flagged for avoidance, and work activities occurred outside of hydrological resources in accordance with APM HYD-06. During this reporting period, a CPUC ECM communicated with a Biological Monitor to ensure that a site where sediment was observed topping fiber rolls on Phase II of C 440 was addressed in accordance with the timing requirements in mitigation.
