<p>California Public Utilities Commission <i>Mitigation Monitoring, Compliance, and Reporting</i> <i>Program</i></p>
	<p>Cleveland National Forest Power Line Replacement Projects</p> <p>Compliance Status Report: 105</p> <p>October 4, 2020</p>

This compliance status report covers construction activities from September 21 through October 4, 2020.

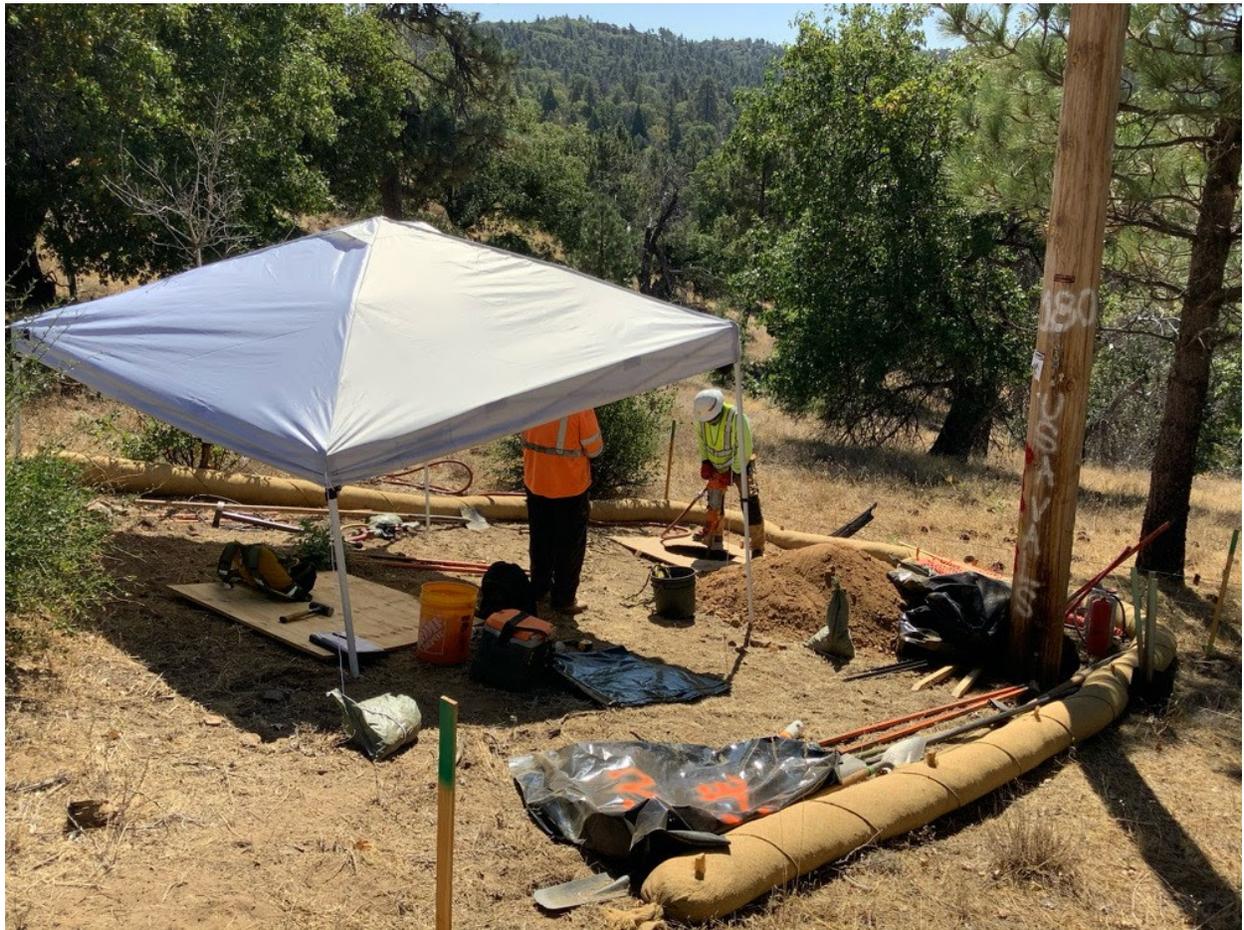
Photo 1: A crew was observed digging a direct bury pole hole at Pole P40320 (C 440) within clearly delineated work limits in accordance with MM BIO-1.

Approved workspaces were observed delineated with staking and flagging, and work crews were observed adhering to work space limits and staying on approved access roads in accordance with MM BIO-1 (see Photo 1 – Attachment A). Workers were observed having completed the Worker Environmental Awareness Program (WEAP), as shown by project hard hat stickers in accordance with MM BIO-2. Biological monitors were observed conducting full-time monitoring of initial ground-disturbing activities, such as vegetation removal, in accordance with MM BIO-3, and monitoring all other construction activities to ensure compliance with mitigation measures, applicant proposed measures, and permit conditions in accordance with MM BIO-22. In accordance with MM BIO-14 and MM BIO-16, Environmentally Sensitive Area (ESA) signs and flagging were observed installed around areas with special-status species, and ESAs were observed being avoided by crews. Excavations were observed covered to prevent wildlife entrapment in accordance with MM BIO-23, and crews were observed containing trash at work areas in accordance with MM BIO-26.

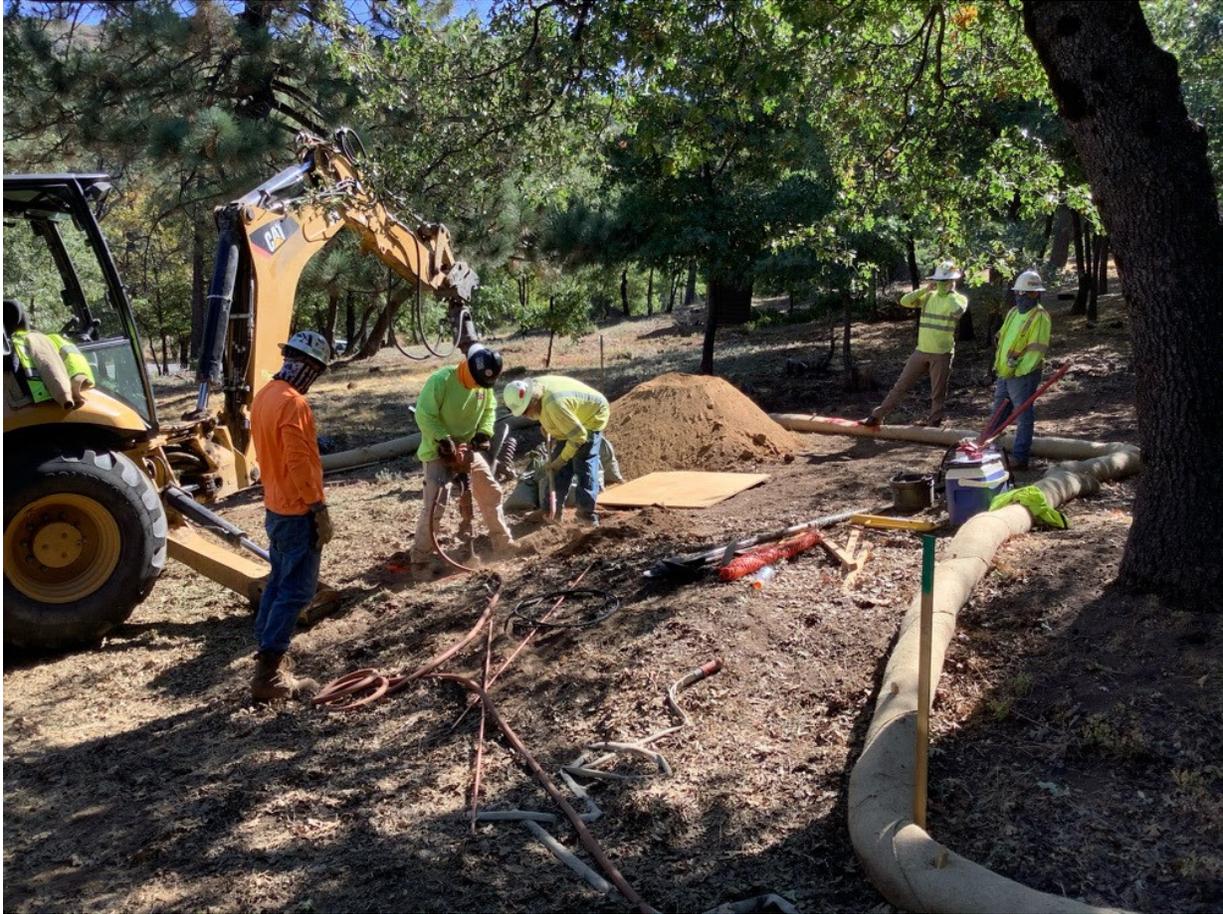
Photo 2: Archaeological and Cultural Monitors were observed monitoring ground rod trenching at a site on C 440 in accordance with the HPMP, APM CUL-04, MM CUL-1, and MM CUL-3. Work limits were observed staked in accordance with MM BIO-1 and SWPPP BMPs were established in accordance with the ECP and SWPPP (MM HYD-1).

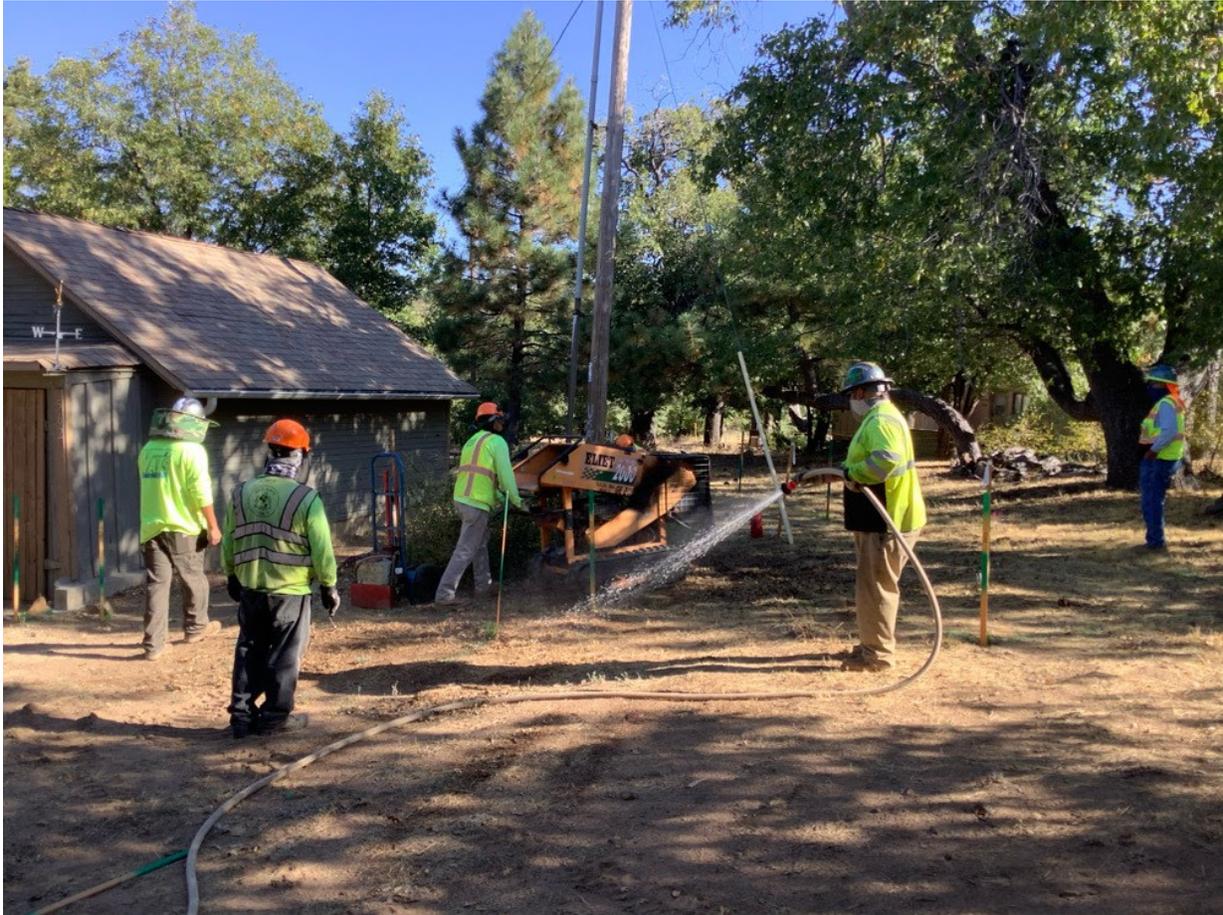
Photo 3: A crew was observed chipping vegetation at Pole P40208 (C 440). A full set of fire tools was observed within 50 feet of the activity, at least 150 gallons of water was observed on site, and a Dedicated Fire Patrol was observed wetting down the area in accordance with the CFPPP Fire Prevention Matrix for chipping on USFS land with a PAL Ev.

5-gallon backpack pump, round point shovel, Pulaski, and 2A10BC fire extinguisher) within 50 feet of work activities as required by APM HAZ-04 and implementing other fire prevention measures as required by the CFPPP (see Photo 3 – Attachment A), and appropriate Fire Patrols were observed on site during activities that required their presence (see Photo 4 – Attachment A). Fire boxes were observed at staging yards and stocked with the required firefighting tools.

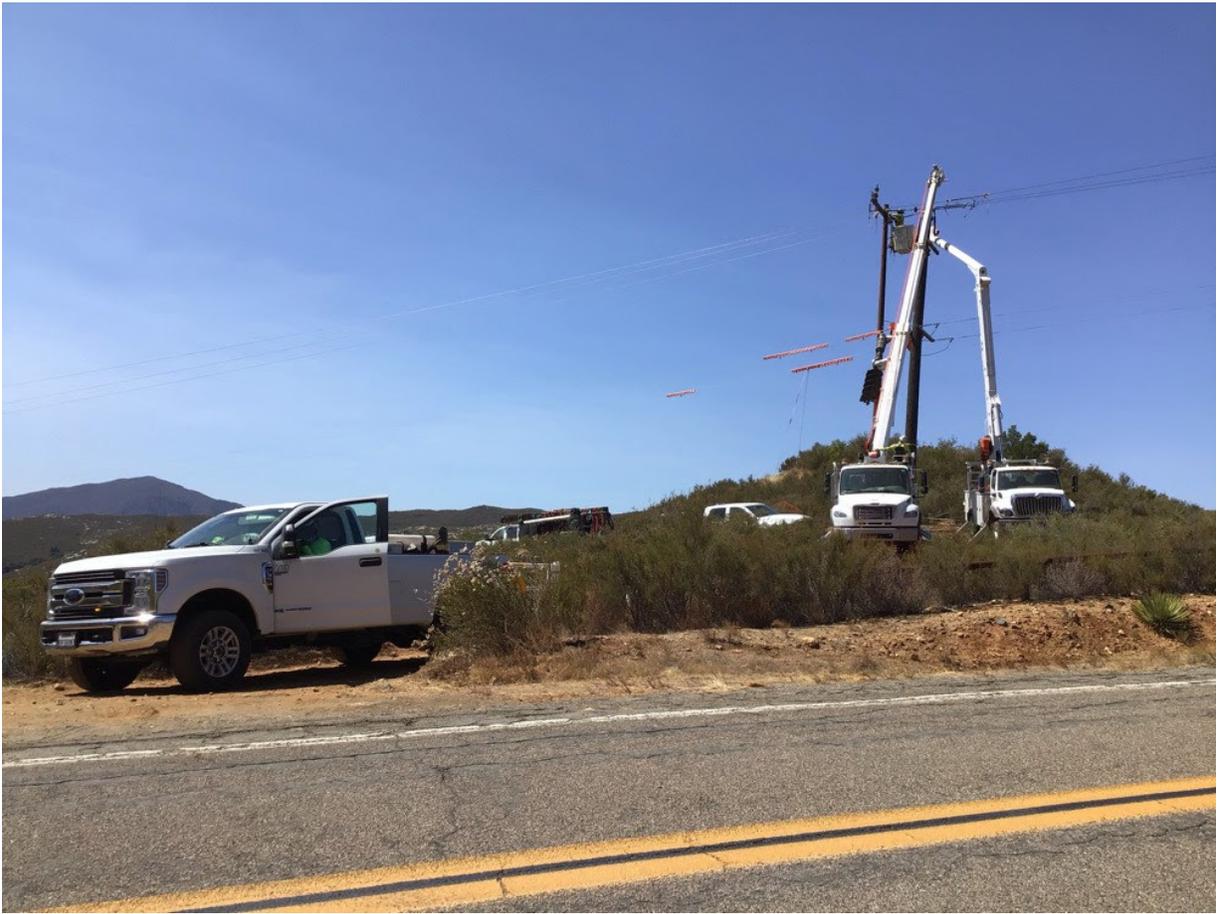
Photo 4: During overhead line work at Pole P258522 (C 79B), a Dedicated Fire Patrol was present and equipped with at least 150 gallons of water with pump and hose in accordance with the CFPPP Fire Prevention Matrix for conductor work with de-energized lines on USFS land with a PAL Ev.

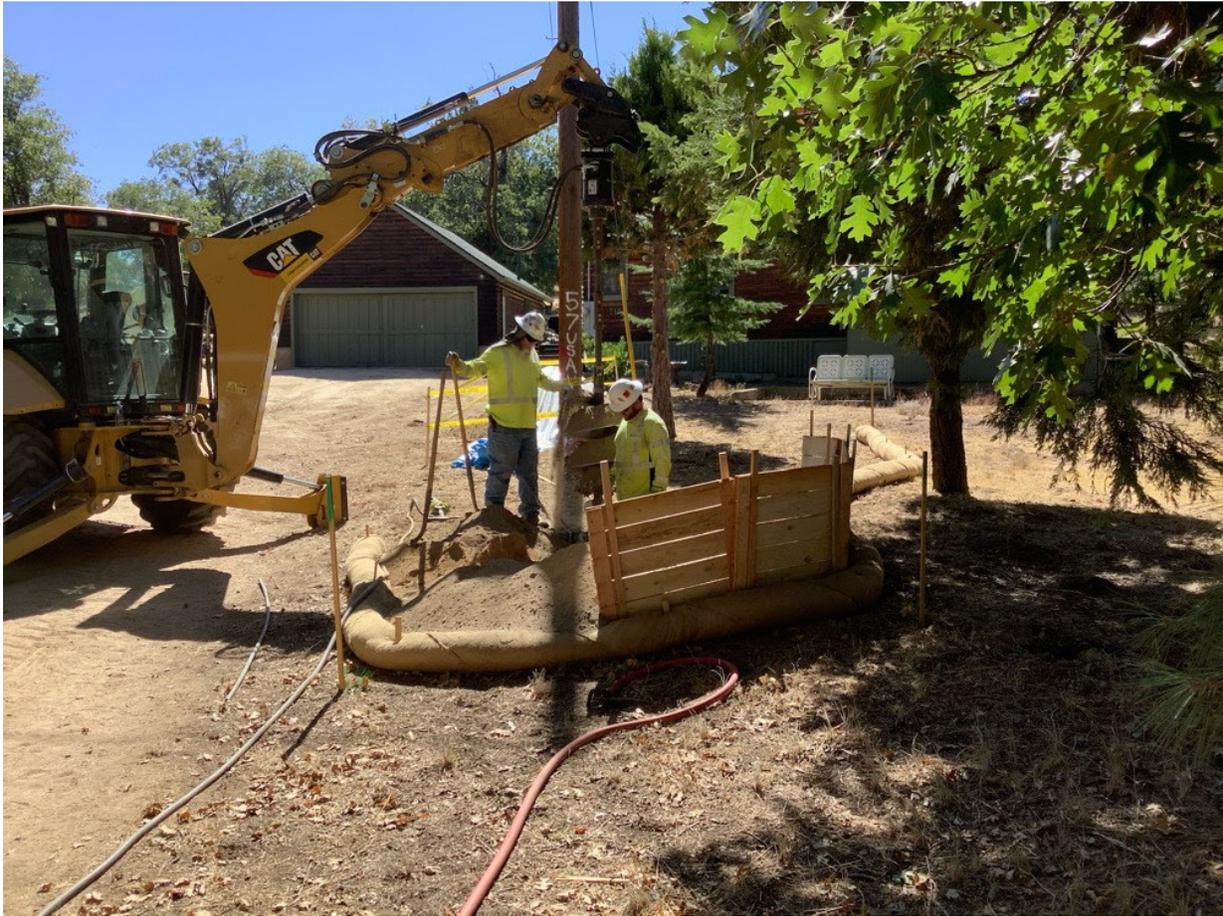
Photo 5: Site-specific sediment control BMPs were observed during anchor excavation at Pole P40383 (C 440) in accordance with the ECP and SWPPP (MM HYD-1), and APM HYD-09.

To prevent impacts to hydrology and water quality, site-specific sediment and erosion control BMPs were observed being implemented and maintained along project alignments in accordance with the project Erosion Control Plan (ECP), Stormwater Pollution Prevention Plan (SWPPP; MM HYD-1 and MM BIO-7), and APM HYD-09 (see Photo 5 – Attachment A). Other BMPs in the SWPPP, such as hydromulch application, concrete waste containment, and street sweeping, were also observed along the alignments. Hydrological resources were flagged for avoidance, and work activities occurred outside of hydrological resources in accordance with APM HYD-06.

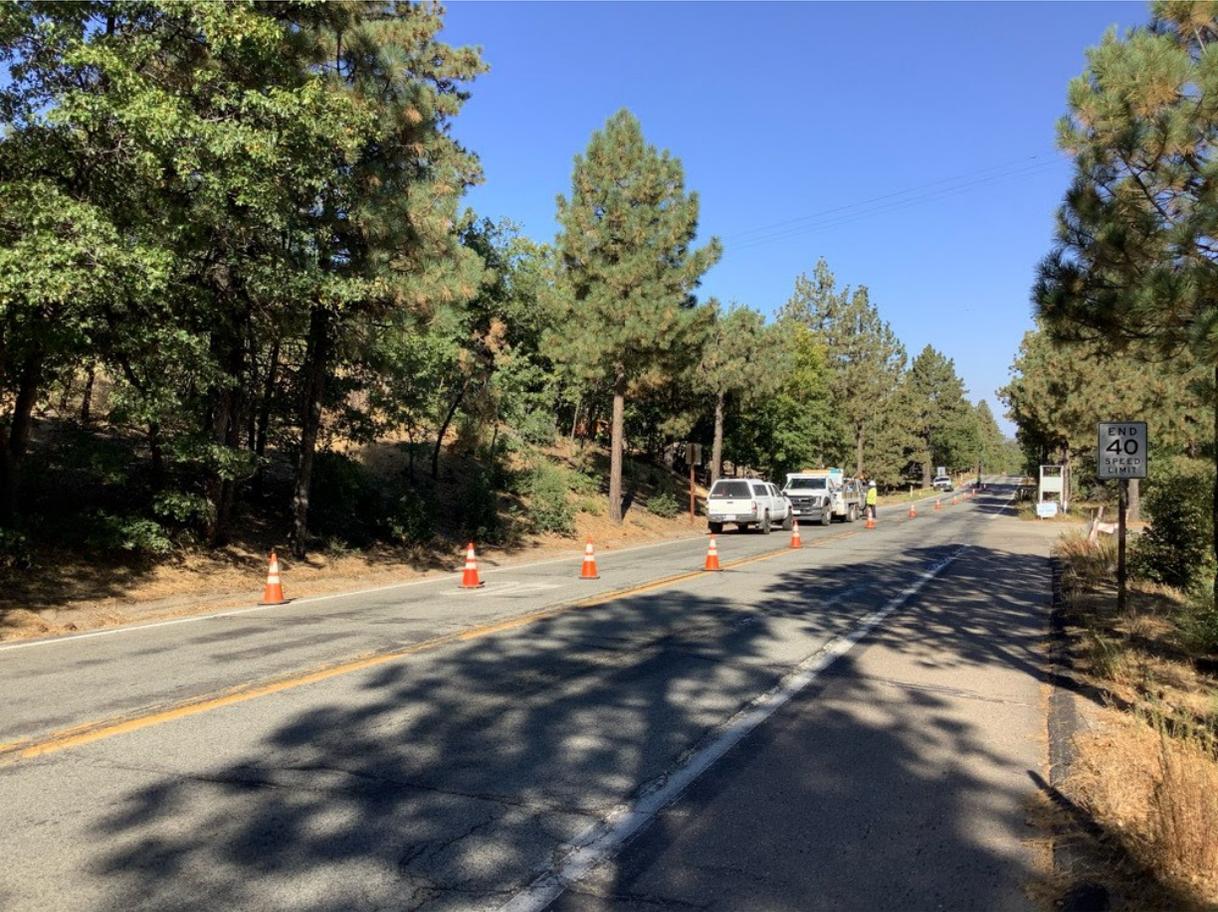
Photo 6: Cones, signage, and flagpersons were used to direct one-way traffic on Sunrise Highway around the work area (C 440) in accordance with the Traffic Control Plan and APM TRANS-02.

Traffic control measures were observed being implemented in accordance with APM TRANS-01 through APM TRANS-05 during this reporting period (see Photo 6 – Attachment A).
