California Public Utilities Commission Mitigation Monitoring, Compliance, and Reporting Program

**Cleveland National Forest Power Line Replacement Projects**

**Compliance Status Report: 108**

November 15, 2020

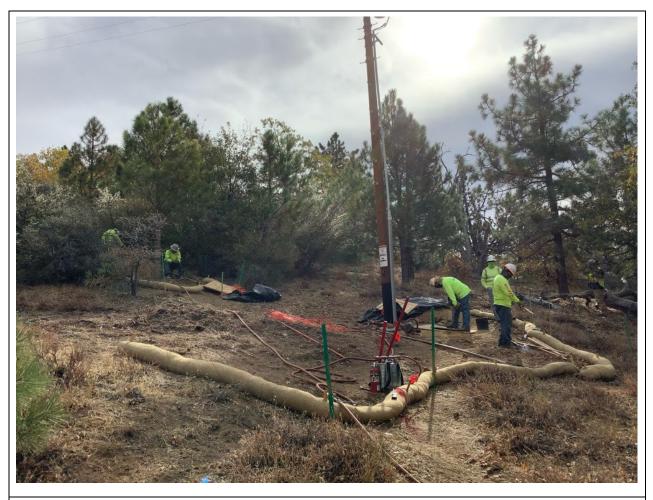
**Photo 1:** During pole and anchor excavation at Pole P40478 (C 440), crews were observed remaining within clearly delineated work limits in accordance with MM BIO-1.

Approved workspaces were observed delineated with staking and flagging, and work crews were observed adhering to work space limits and staying on approved access roads in accordance with MM BIO-1 (see Photo 1 – Attachment A). Workers were observed having completed the Worker Environmental Awareness Program (WEAP), as shown by project hard hat stickers in accordance with MM BIO-2. Biological monitors were observed conducting full-time monitoring of initial ground-disturbing activities, such as vegetation removal, in accordance with MM BIO-3, and monitoring all other construction activities to ensure compliance with mitigation measures, applicant proposed measures, and permit conditions in accordance with MM BIO-22. In accordance with MM BIO-14 and MM BIO-16, Environmentally Sensitive Area (ESA) signs and flagging were observed installed around areas with special-status species, and ESAs were observed being avoided by crews. Excavations were observed containing trash at work areas in accordance with MM BIO-26. During this reporting period, a CPUC ECM worked with an on-site Biological Monitor to ensure that project-related food trash was addressed in a timely manner.

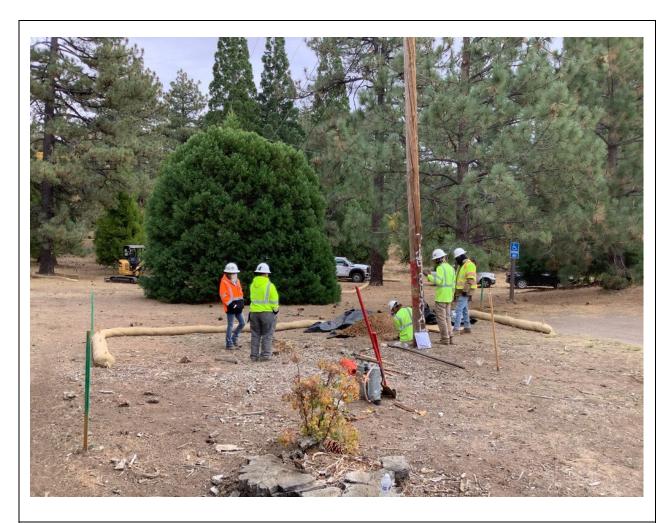
**Photo 2:** Archaeological and Cultural Monitors were observed monitoring pole hole excavation at a site on C 440 in accordance with the HPMP, MM CUL-1, MM CUL-3, and APM CUL-04.

CPUC ECMs observed cultural resource monitors, including archaeological and Native American monitors, monitoring construction activities that occurred within or adjacent to identified archaeological or cultural resource site boundaries in accordance with the Historic Properties Management Plan (HPMP), MM CUL-1, MM CUL-3, and APM CUL-04 (see Photo 2 – Attachment A). Cultural ESAs were marked to prevent construction access to areas with cultural and/or historical resources in accordance with the HPMP, and work crews were observed respecting cultural ESA boundaries.

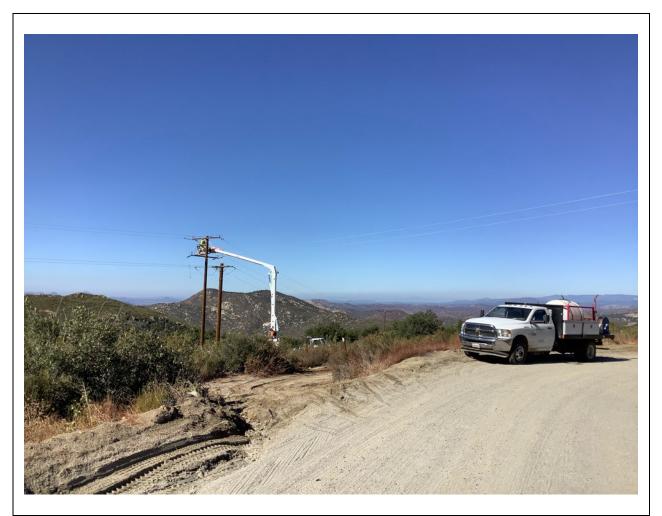
**Photo 3:** A Designated Fire Patrol was present during overhead work at Pole P258558 (C 79B) in accordance with the CFPPP for conductor work with energized lines off NFS land with a Normal FPI.

Index (FPI) and Project Activity Levels (PALs) to work crews at daily tailboard meetings, during which daily fire requirements and restrictions for work on private land and on National Forest System (NFS) land were discussed. All project-related vehicles and equipment were equipped with a full set of fire tools (each set containing a 5-gallon backpack pump, round point shovel, Pulaski, and 2A10BC fire extinguisher). Construction crews were observed staging a set of fire tools within 50 feet of work activities as required by APM HAZ-04 and implementing other fire prevention measures as required by the CFPPP, and appropriate Fire Patrols were observed on site during activities that required their presence (see Photo 3 -Attachment A). Fire boxes were observed at staging yards and stocked with the required firefighting tools.

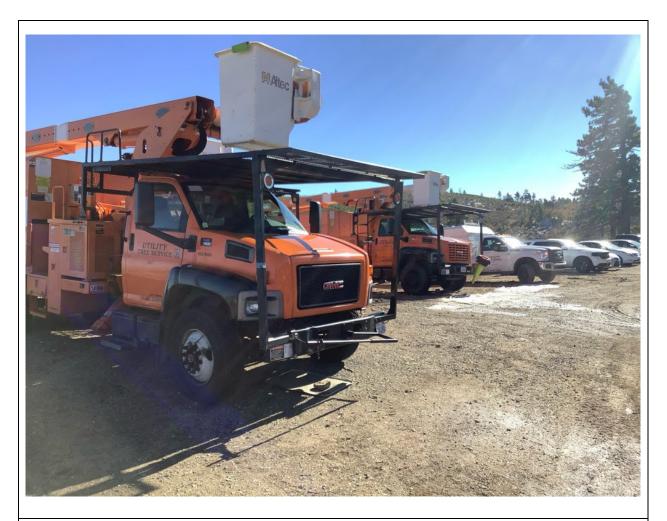
**Photo 4:** Drip pans were observed under staged equipment at Shrine Camp Staging Yard (C 440) to prevent leaks or spills from being discharged onto the ground in accordance with the SRNP and MM PHS-2.

To prevent leaks and spills from being discharged into the soil in accordance with the Spill Response and Notification Plan (SRNP) and MM PHS-2, construction crews were observed implementing spill prevention BMPs, such as using drip pans under staged equipment (see Photo 4 – Attachment A) and beneath equipment during mechanical work and refueling, staging spill kits at work sites, using double-walled fuel tanks or implementing secondary containment beneath staged fuel tanks, and cleaning up spills and disposing of contaminated soils in the designated and properly labeled hazardous waste barrels.

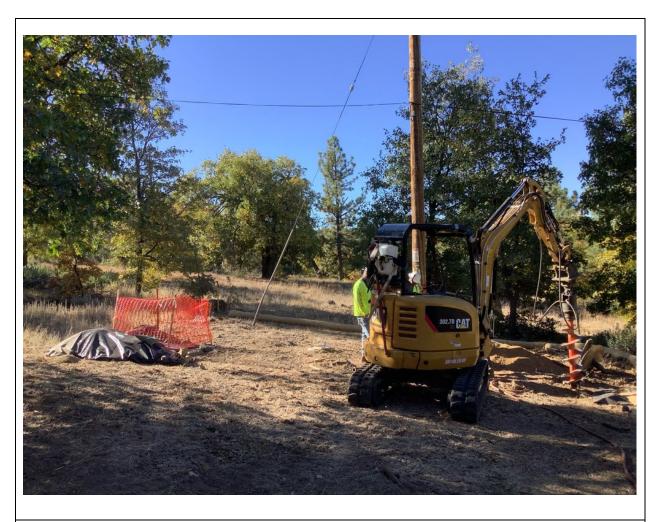
**Photo 5:** A crew was observed drilling a pole hole at Pole P40470 (C 440). An anchor excavation at the site was observed to be covered to prevent wildlife entrapment in accordance with MM BIO-23, and the associated spoils stockpile was observed to be covered in accordance with the ECP, SWPPP, and APM HYD-09.

To prevent impacts to hydrology and water quality, site-specific sediment and erosion control BMPs were observed being implemented and maintained along project alignments in accordance with the project Erosion Control Plan (ECP), Stormwater Pollution Prevention Plan (SWPPP; MM HYD-1 and MM BIO-7), and APM HYD-09 (see Photo 5 – Attachment A). Other BMPs in the SWPPP, such as hydromulch application, concrete waste containment, street sweeping, and access road entrance stabilization were also observed along the alignments. Hydrological resources were flagged for avoidance, and work activities occurred outside of hydrological resources in accordance with APM HYD-06. During this reporting period, a CPUC ECM worked with a Biological Monitor to ensure that a damaged spoils stockpile cover on C 440 was repaired in a timely manner.

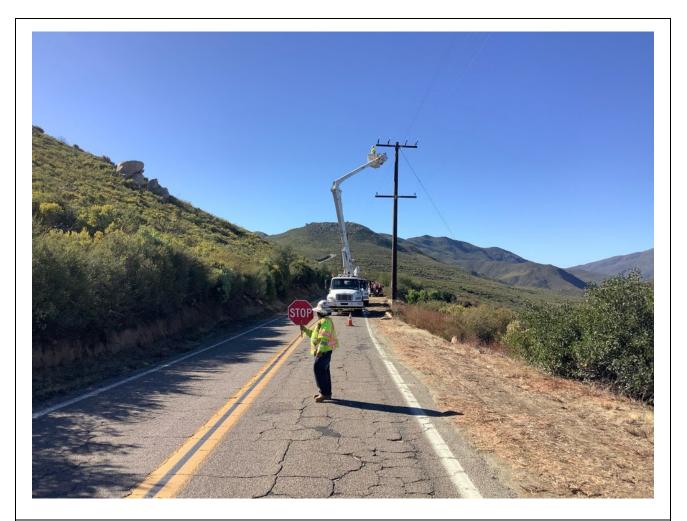
**Photo 6:** Cones, signage, and flagpersons were used to direct one-way traffic on Boulder Creek Road during construction activities at Pole P258511 (C 79B) in accordance with APM TRANS-02.

Traffic control measures were observed being implemented in accordance with APM TRANS-01 through APM TRANS-05 during this reporting period (see Photo 6 – Attachment A).
