California Public Utilities Commission <i>Mitigation Monitoring, Compliance, and Reporting</i> <i>Program</i>
	Cleveland National Forest Power Line Replacement Projects Compliance Status Report: 112 January 10, 2021

This compliance status report covers construction activities from December 28, 2020 through January 10, 2021.

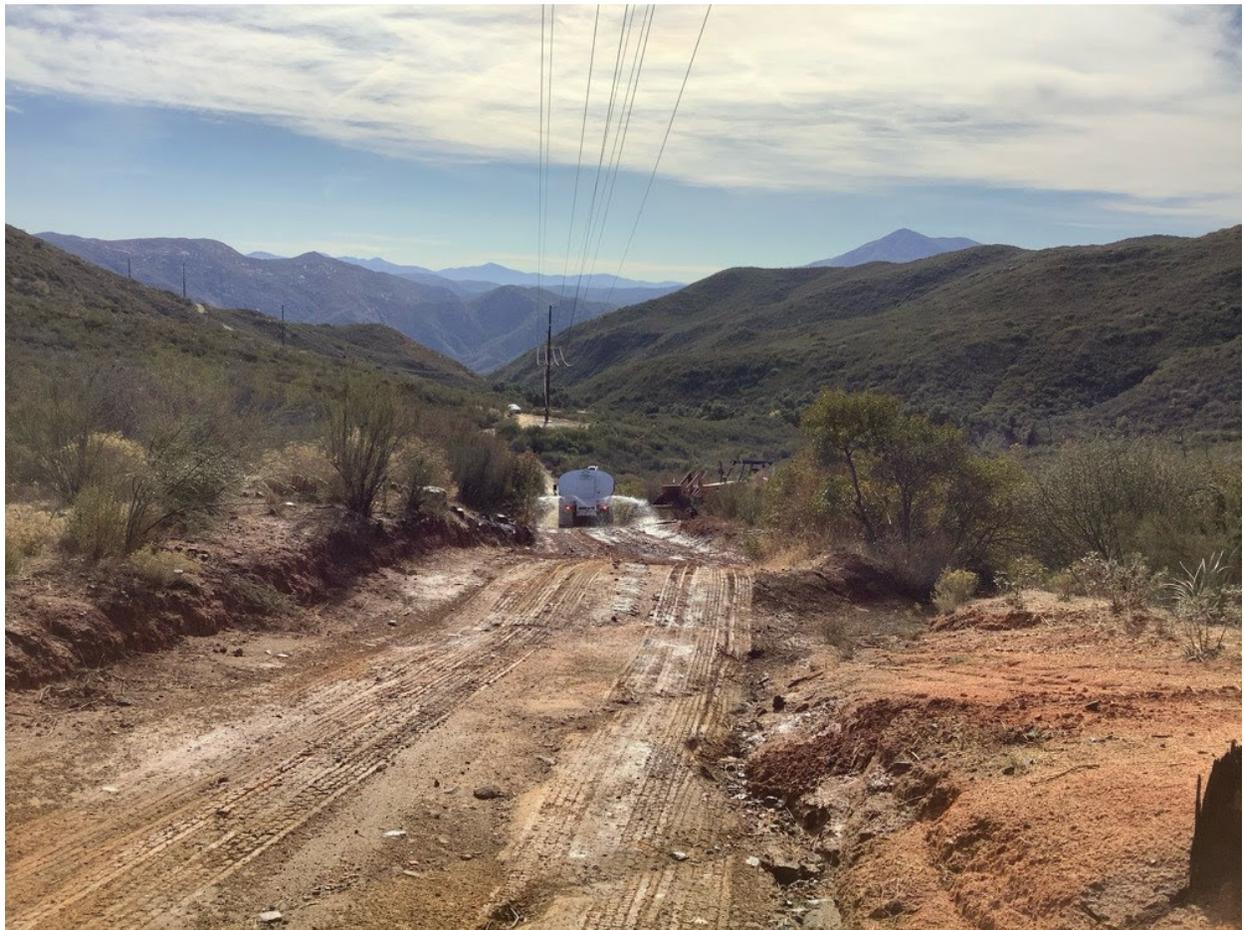
Photo 1: During access road maintenance along TL 6923, a water tender was observed applying water to the road to minimize dust emissions in accordance with APM AIR-02.

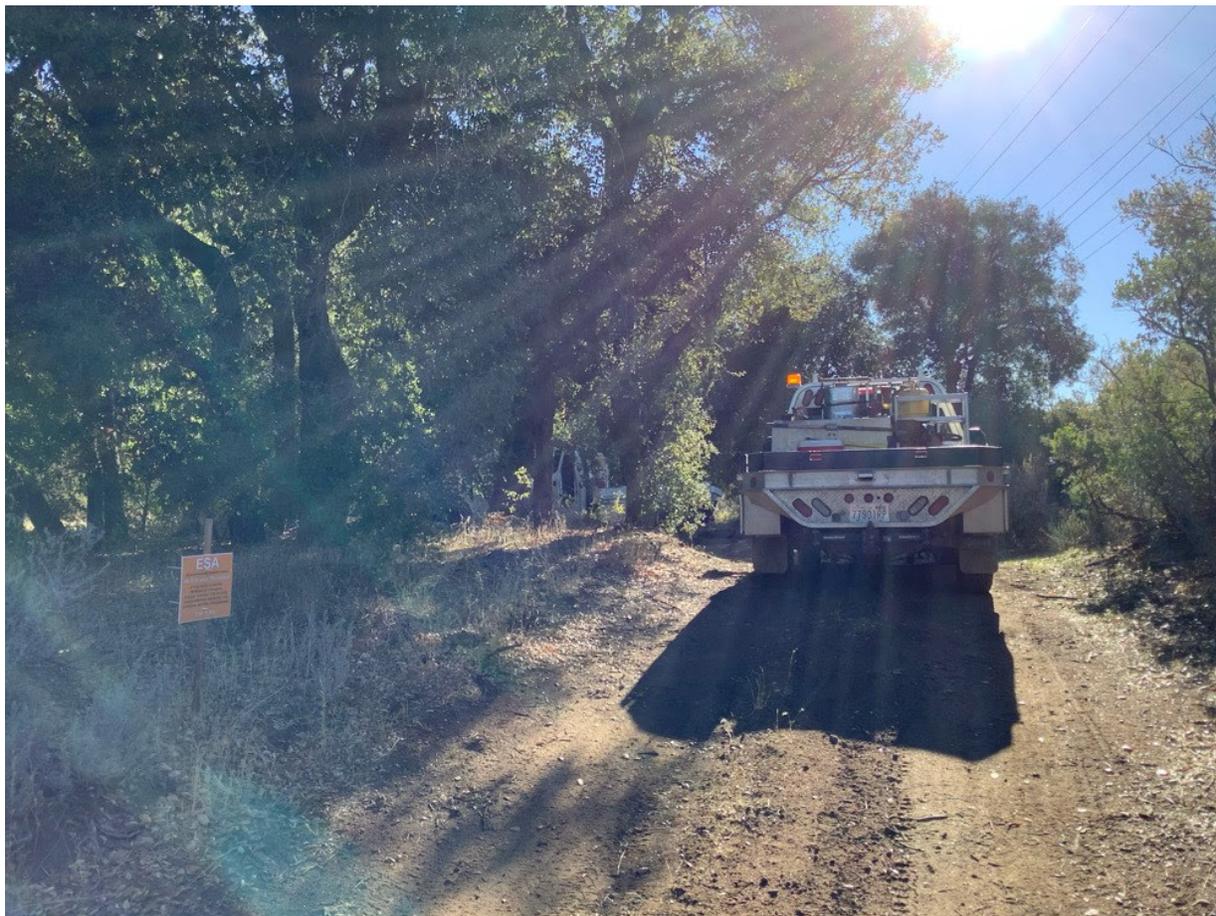
Photo 2: During gate repair activities near Pole Z40402 (TL 629A), project vehicles were observed on approved access roads in accordance with MM BIO-1. Additionally, signage was observed marking a special-status species ESA, which was observed being avoided by crews in accordance with MM BIO-14 and MM BIO-16.

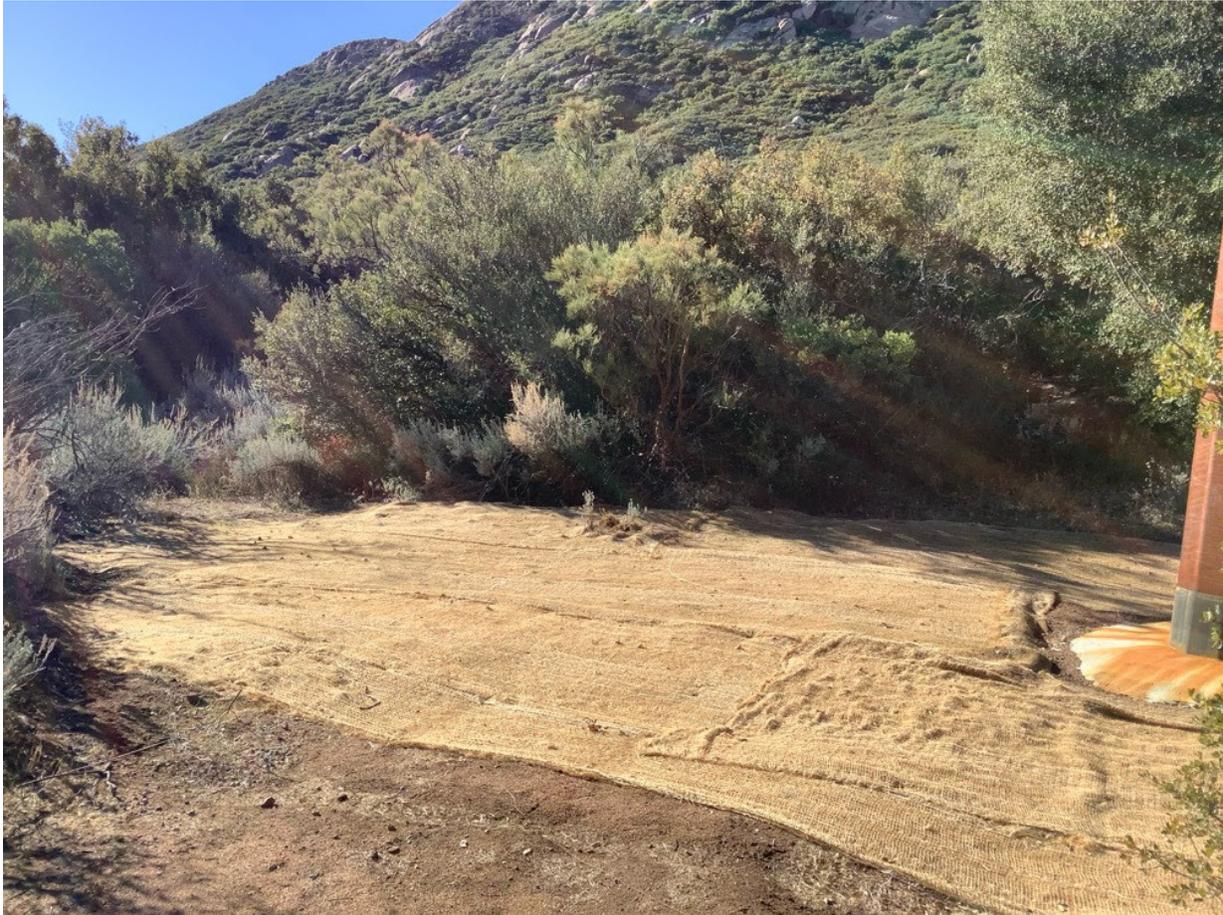
Photo 3: Jute netting at a restoration area, Pole Z40402 (TL 629A), was observed in good condition in accordance with MM BIO-4 and the HRP.

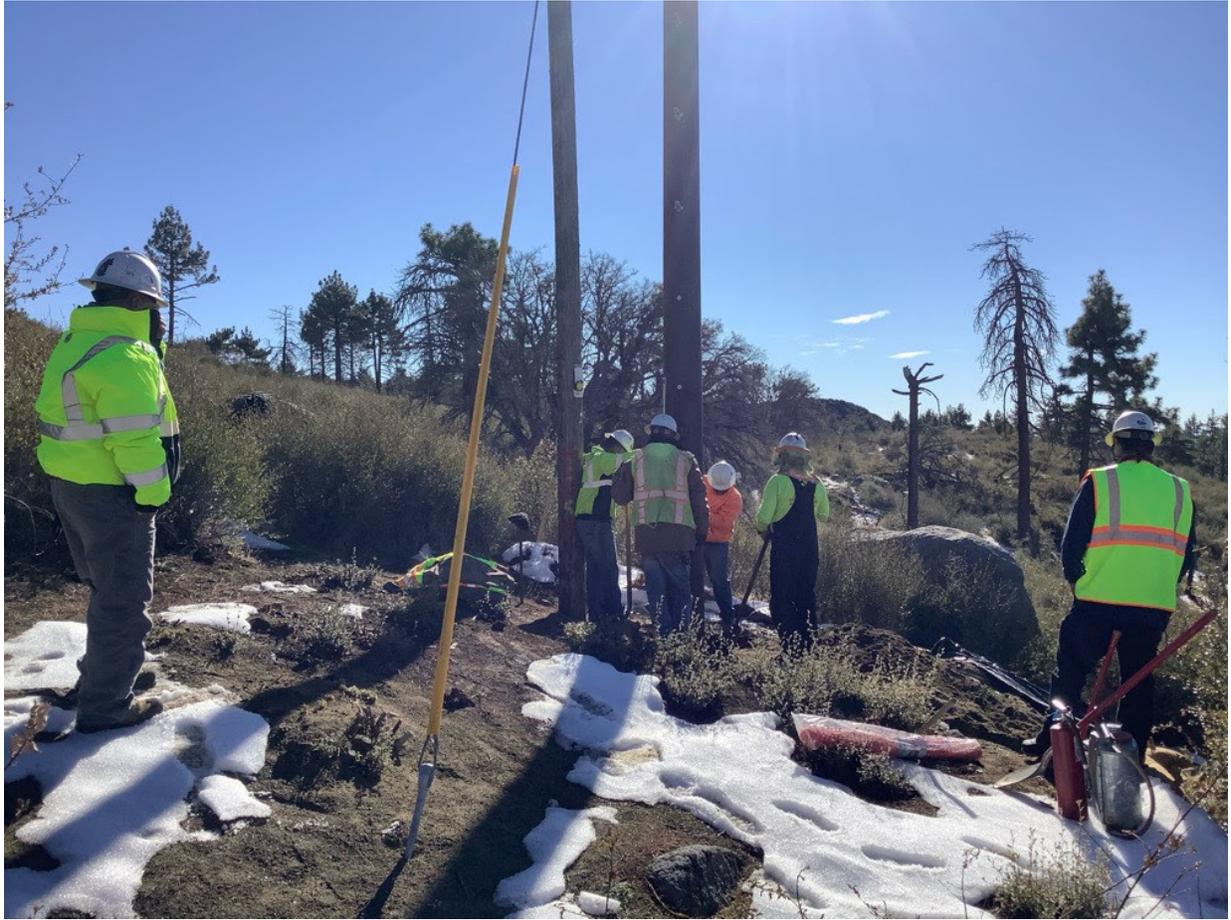
Photo 4: During preparations for pole removal along C 440, Archaeological and Cultural Monitors were observed monitoring digging activities in accordance with the HPMP, APM CUL-04, MM CUL-1, and MM CUL-3.

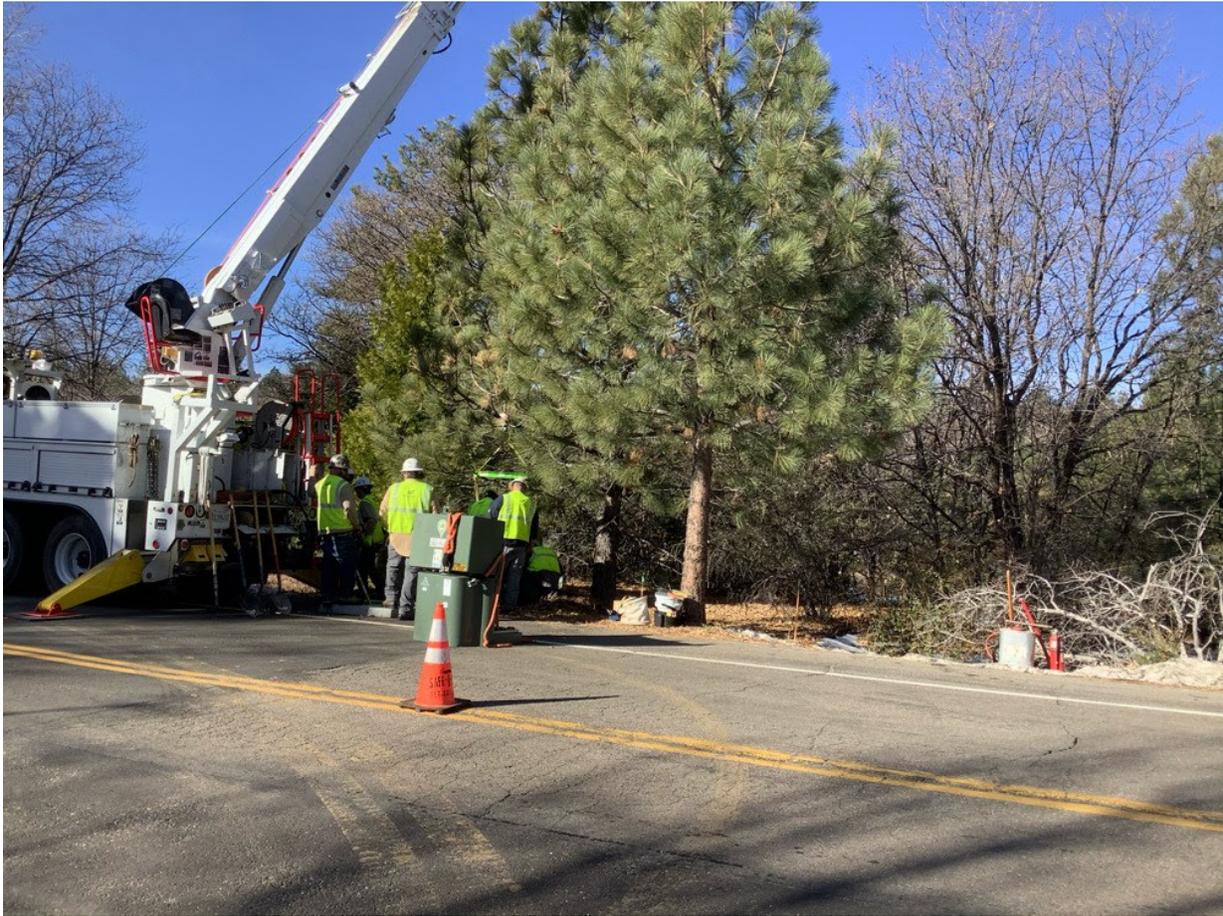
Photo 5: A full set of fire tools was observed within 50 feet of transformer replacement on C 440 in accordance with the CFPPP.

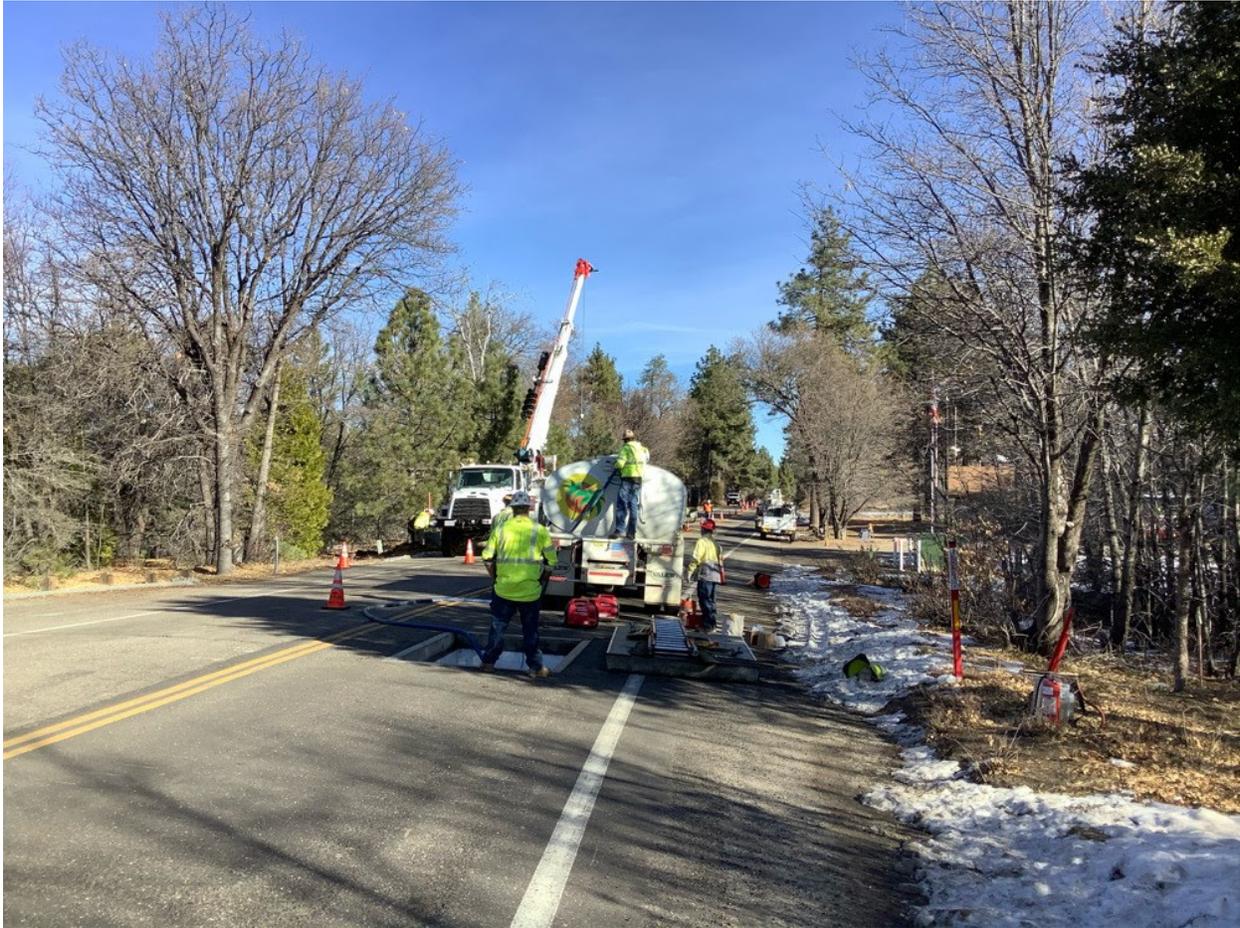
Photo 6: During dewatering activities on C 440, groundwater was pumped into a truck-mounted storage tank and transported to an authorized discharge location in accordance with APM HYD-08.
