<p><b>California Public Utilities Commission</b> <b><i>Mitigation Monitoring, Compliance, and Reporting</i></b> <b><i>Program</i></b></p>
	<p><b>Cleveland National Forest Power Line Replacement</b> <b>Projects</b></p> <p><b>Compliance Status Report: 113</b></p> <p><b>January 24, 2021</b></p>

This compliance status report covers construction activities from January 11 through January 24, 2021.

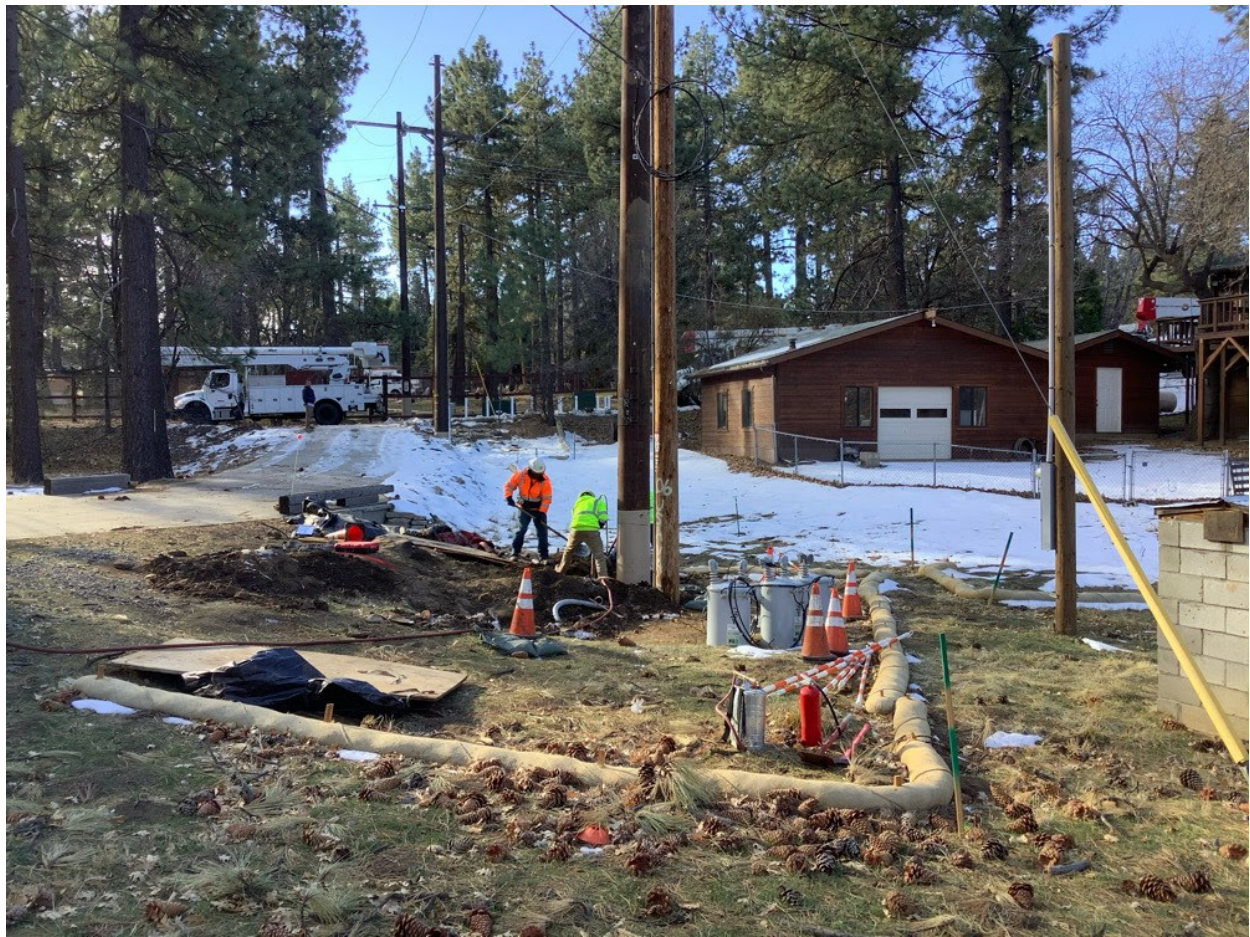
**Photo 1:** During backfill operations at Pole P40196 (C 440), the crew was observed remaining within clearly delineated work limits in accordance with MM BIO-1.

Approved workspaces were observed delineated with staking and flagging, and work crews were observed adhering to work space limits and staying on approved access roads in accordance with MM BIO-1 (see Photo 1 – Attachment A). Workers were observed having completed the Worker Environmental Awareness Program (WEAP), as shown by project hard hat stickers in accordance with MM BIO-2. Biological monitors were observed conducting full-time monitoring of initial ground-disturbing activities, such as vegetation removal, in accordance with MM BIO-3, and monitoring all other construction activities to ensure compliance with mitigation measures, applicant proposed measures, and permit conditions in accordance with MM BIO-22 (see Photo 2 – Attachment A). In accordance with MM BIO-14 and MM BIO-16, Environmentally Sensitive Area signs and flagging were observed installed around areas with special-status species, and ESAs were observed being avoided by crews. Excavations were observed covered to prevent wildlife entrapment in accordance with MM BIO-23, and crews were observed containing trash at work areas in accordance with MM BIO-26. During this reporting period, a CPUC ECM worked with an on-site Biological Monitor to ensure that a gap observed in a pole hole covering was addressed in a timely manner.

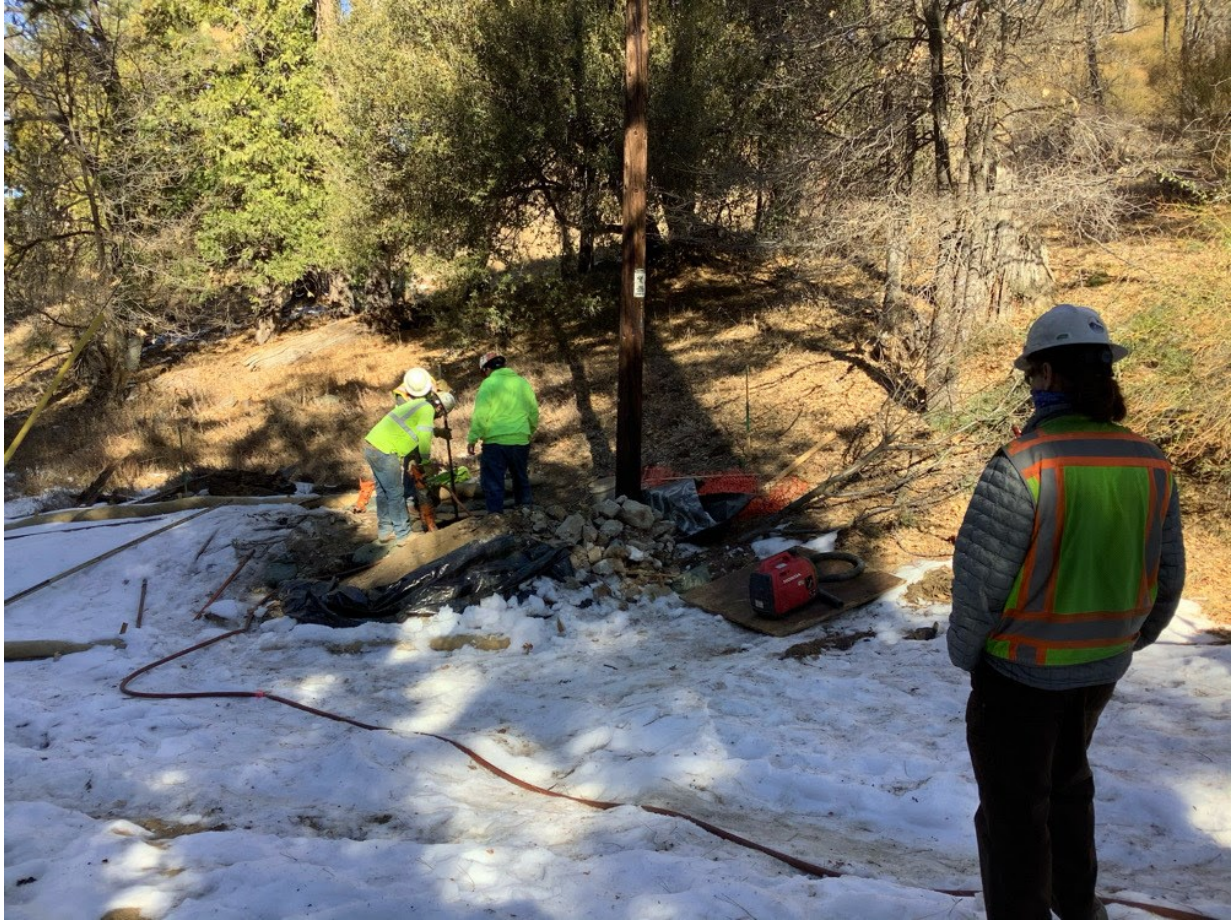
**Photo 2:** A Biological Monitor was observed monitoring pole hole digging at Pole P40217 (C 440) to ensure compliance with mitigation measures, applicant proposed measures, and permit conditions in accordance with MM BIO-22.

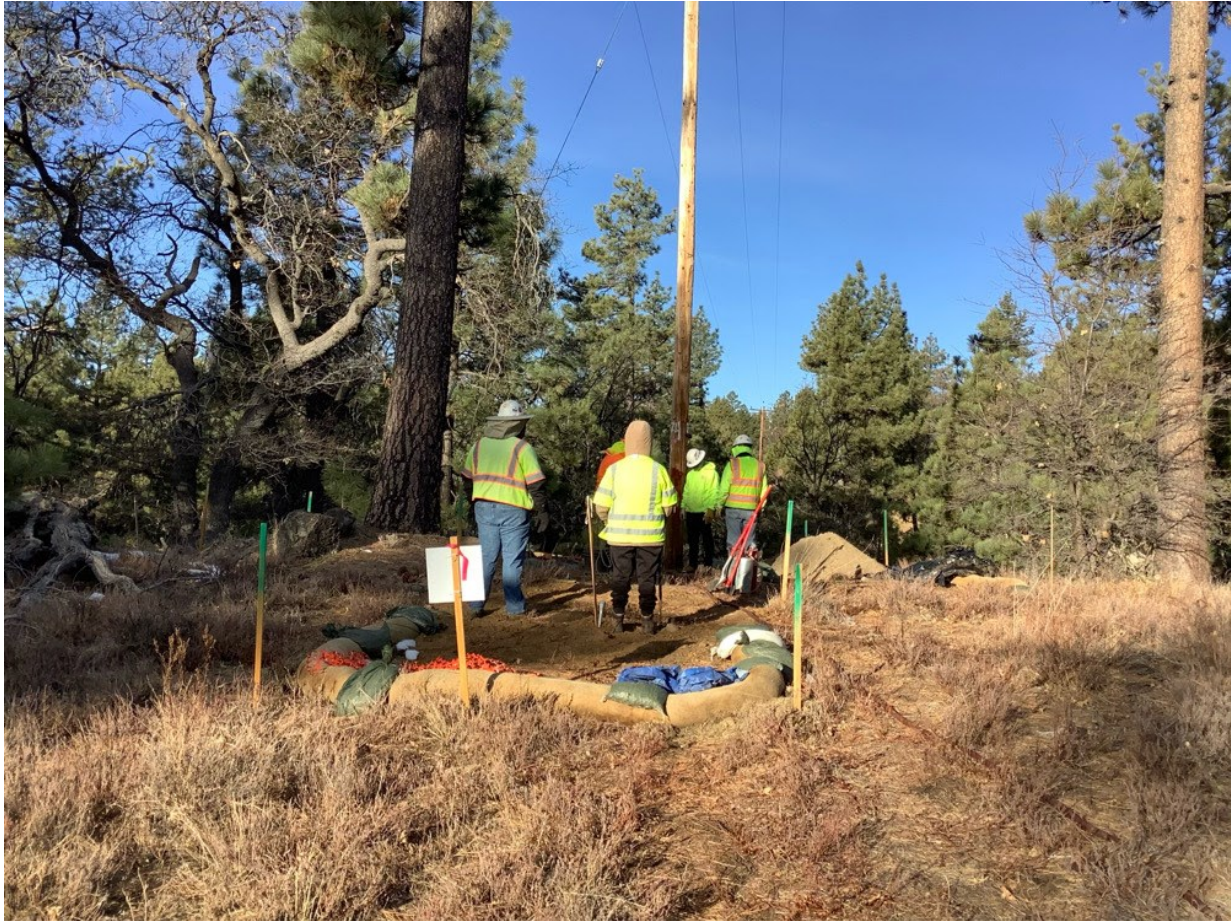
**Photo 3:** Archaeological and Cultural Monitors were observed monitoring pole hole digging along C 440 in accordance with the HPMP (MM CUL-1), MM CUL-3, and APM CUL-04.

CPUC ECMs observed cultural resource monitors, including archaeological and Native American monitors, monitoring construction activities that occurred within or adjacent to identified archaeological or cultural resource site boundaries in accordance with the Historic Properties Management Plan (HPMP), MM CUL-1, MM CUL-3, and APM CUL-04 (see Photo 3 – Attachment A). Cultural ESAs were marked to prevent construction access to areas with cultural and/or historical resources in accordance with the HPMP, and work crews were observed respecting cultural ESA boundaries.

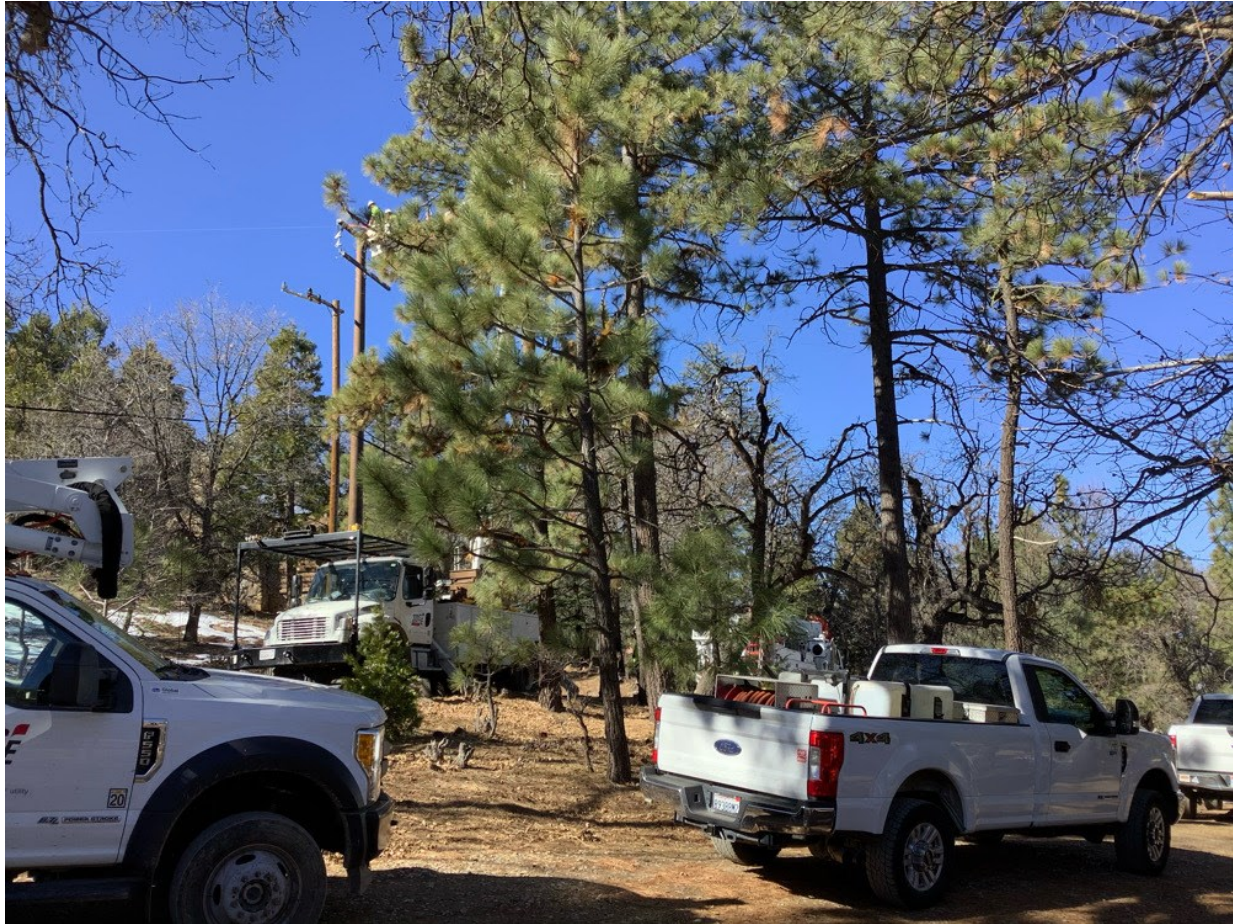
**Photo 4:** During conductor transfer at Pole P40427 (C 440), a Dedicated Fire Patrol was present and equipped with at least 150 gallons of water with pump and hose in accordance with the CFPPP for conductor work with energized lines on NFS land with a PAL C.

In accordance with the Construction Fire Prevention/Protection Plan (CFPPP) (MM FF-1), San Diego Gas & Electric (SDG&E) and their construction contractors were observed communicating Fire Potential Index (FPI) and Project Activity Levels (PALs) to work crews at daily tailboard meetings, during which daily fire requirements and restrictions for work on private land and on National Forest System (NFS) land were discussed. All project-related vehicles and equipment were equipped with a full set of fire tools (each set containing a 5-gallon backpack pump, round point shovel, Pulaski, and 2A10BC fire extinguisher). Construction crews were observed staging a set of fire tools within 50 feet of work activities as required by APM HAZ-04 and implementing other fire prevention measures as required by the CFPPP, and appropriate Fire Patrols were observed on site during activities that required their presence (see Photo

4 – Attachment A). Fire boxes were observed at staging yards and stocked with the required firefighting tools.

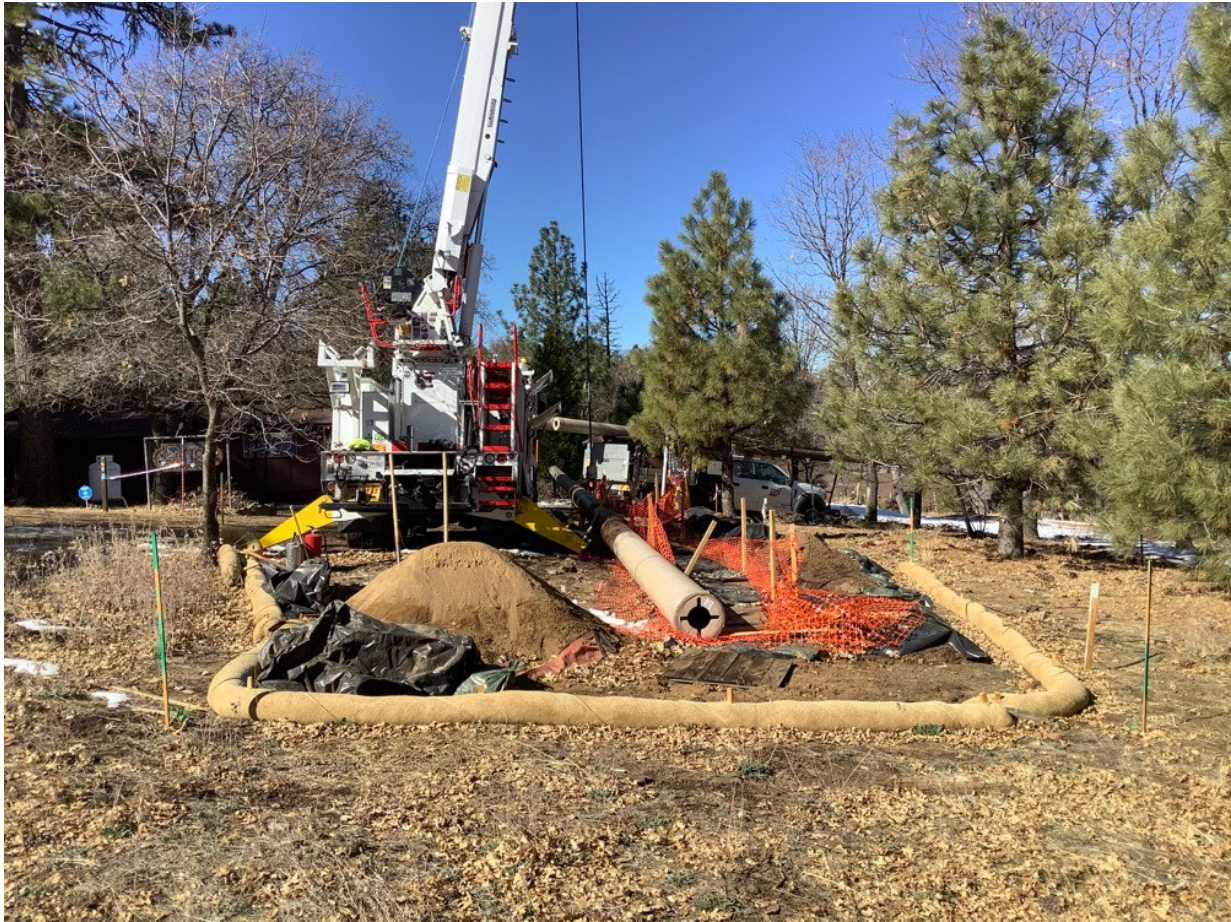
**Photo 5:** A crew was observed framing and preparing to set Pole P260350 (C 440). Erosion control BMPs at the site were observed in good condition in accordance with the ECP, SWPPP (MM HYD-1 and MM BIO-7), and APM HYD-09.

To prevent impacts to hydrology and water quality, site-specific sediment and erosion control BMPs were observed being implemented and maintained along project alignments in accordance with the project Erosion Control Plan (ECP), Stormwater Pollution Prevention Plan (SWPPP; MM HYD-1 and MM BIO-7), and APM HYD-09 (see Photo 5 – Attachment A). Other BMPs in the SWPPP, such as hydromulch application, concrete waste containment, street sweeping, and access road entrance stabilization were also observed along the alignments. Hydrological resources were flagged for avoidance, and work activities occurred outside of hydrological resources in accordance with APM HYD-06.

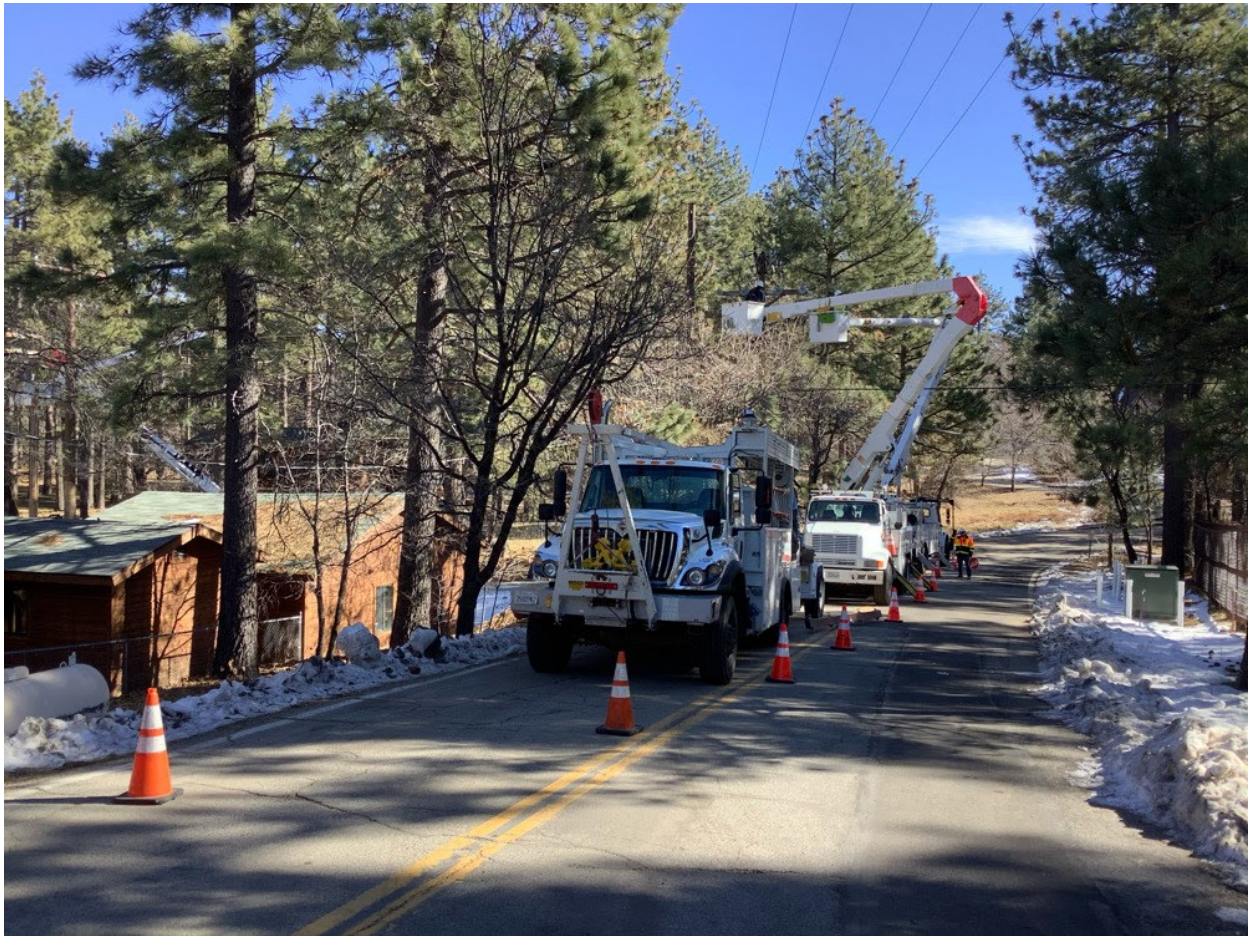
**Photo 6:** A crew was observed conducting overhead work at Pole P40196 (C 440). Cones, signage, and flagpersons were used to direct one-way traffic safely around the work area in accordance with the TCP and APM TRANS-02.

Traffic control measures were observed being implemented in accordance with APM TRANS-01 through APM TRANS-05 during this reporting period (see Photo 6 – Attachment A).
