California Public Utilities Commission <i>Mitigation Monitoring, Compliance, and Reporting</i> <i>Program</i>
	Cleveland National Forest Power Line Replacement Projects Compliance Status Report: 114 February 28, 2021

This compliance status report covers construction activities from January 25 through February 28, 2021.

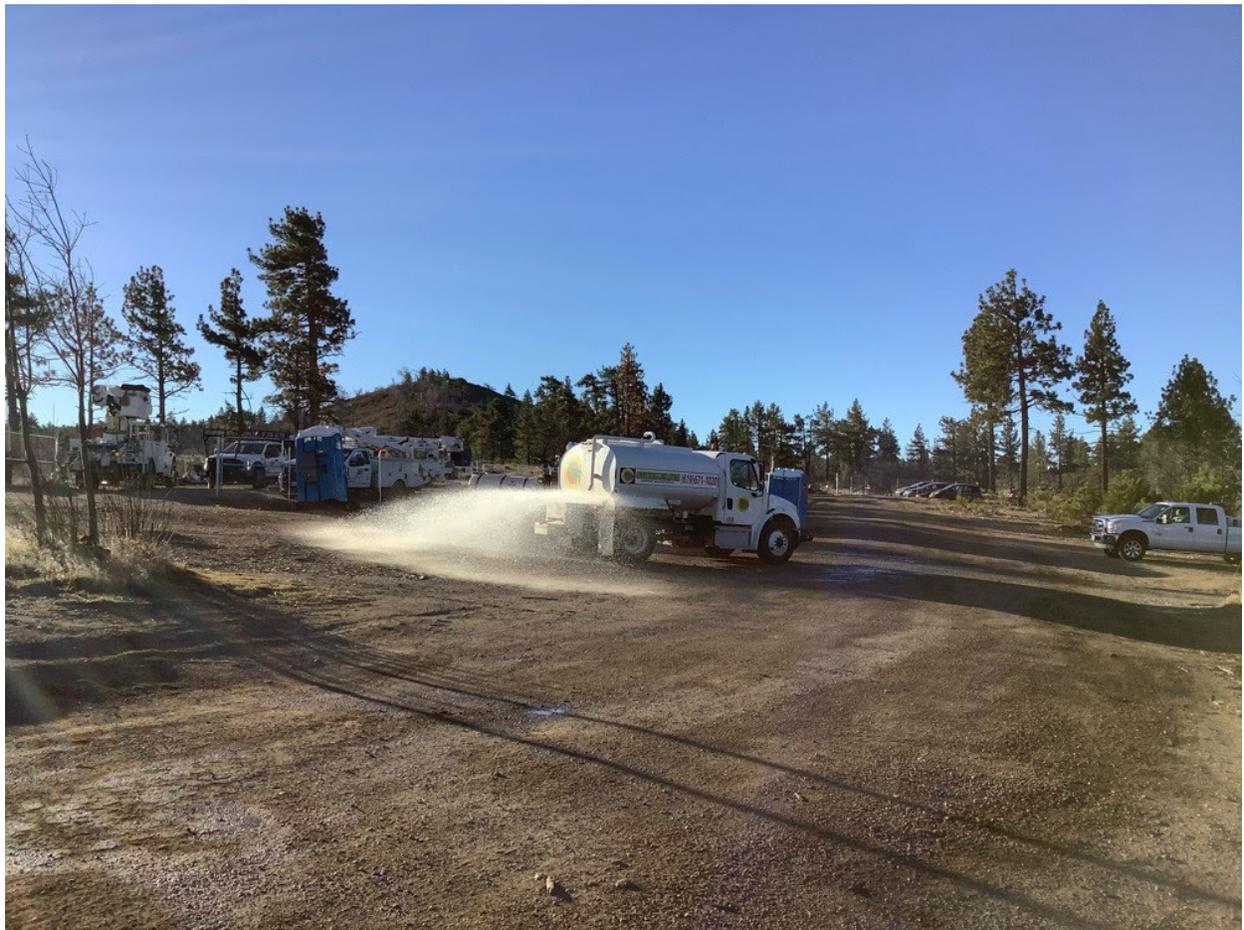
Photo 1: A water tender was observed applying water to the surface at Shrine Camp Staging Yard (C 440) throughout the day to minimize dust emissions in accordance with APM AIR-02.

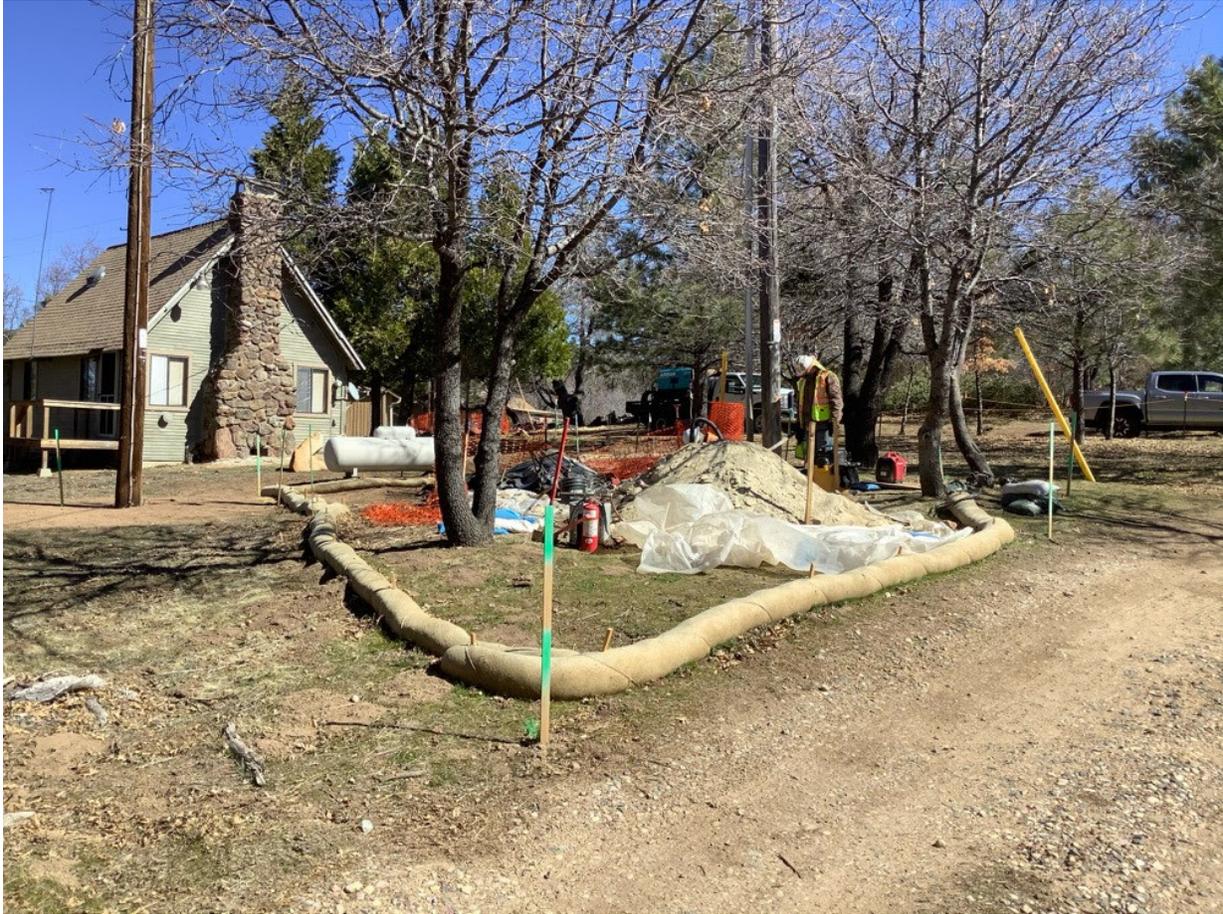
Approved workspaces were observed delineated with staking and flagging, and work crews were observed adhering to work space limits and staying on approved access roads in accordance with MM BIO-1 (see Photo 2 – Attachment A). Workers were observed having completed the Worker Environmental Awareness Program (WEAP), as shown by project hard hat stickers in accordance with MM BIO-2. Biological monitors were observed conducting full-time monitoring of initial ground-disturbing activities, such as vegetation removal, in accordance with MM BIO-3, and monitoring all other construction activities to ensure compliance with mitigation measures, applicant proposed measures, and permit conditions in accordance with MM BIO-22. In accordance with MM BIO-14 and MM BIO-16, Environmentally Sensitive Area signs and flagging were observed installed around areas with special-status species, and ESAs were observed being avoided by crews. Excavations were observed covered to prevent wildlife entrapment in accordance with MM BIO-23, and crews were observed containing trash at work areas in accordance with MM BIO-26 (see Photo 3 – Attachment A).

Photo 2: During direct bury pole excavation at Pole P40206 (C 440), crew members and equipment were observed remaining within clearly delineated work limits in accordance with MM BIO-1.

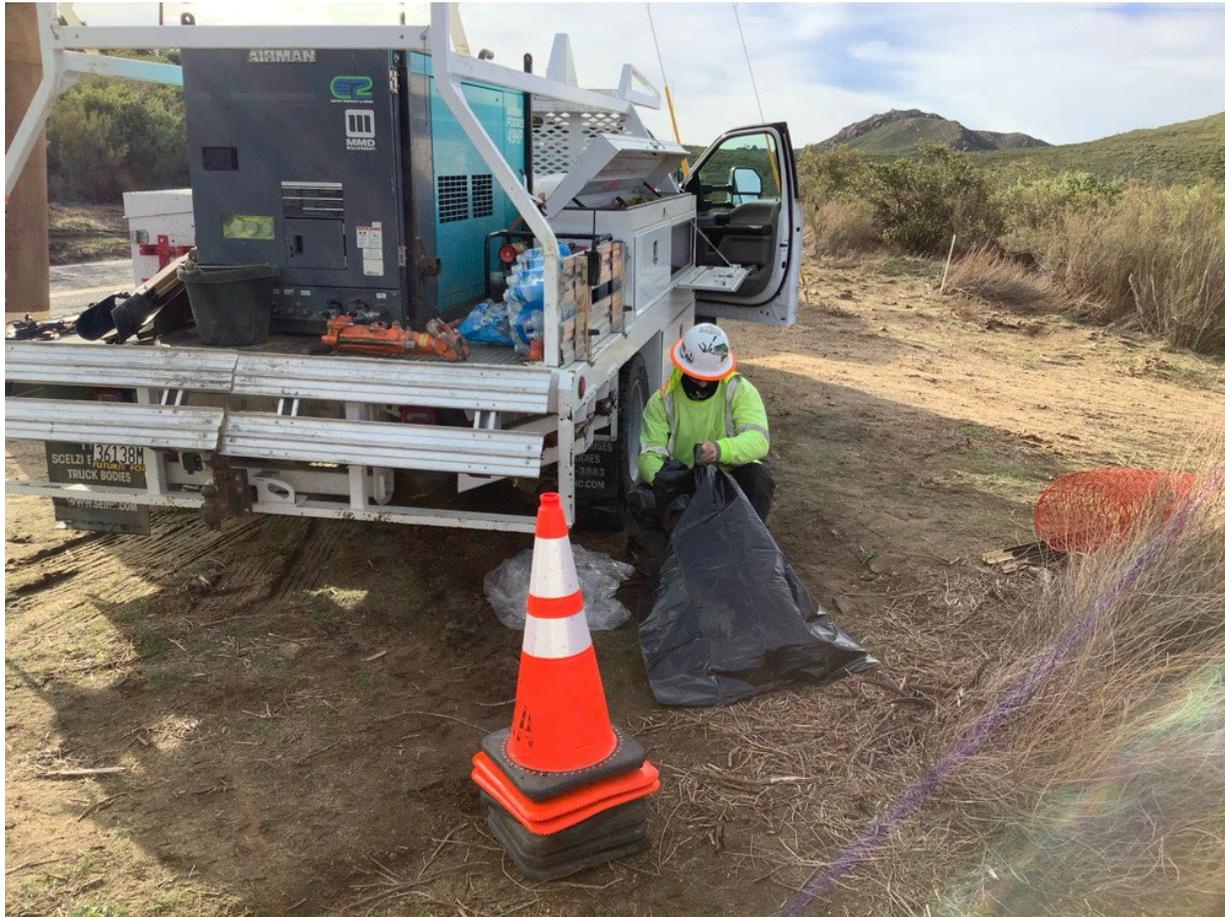
Photo 3: A crew member was observed disposing of trash in a bag at Pole P258500 (C 79B) in accordance with MM BIO-26.

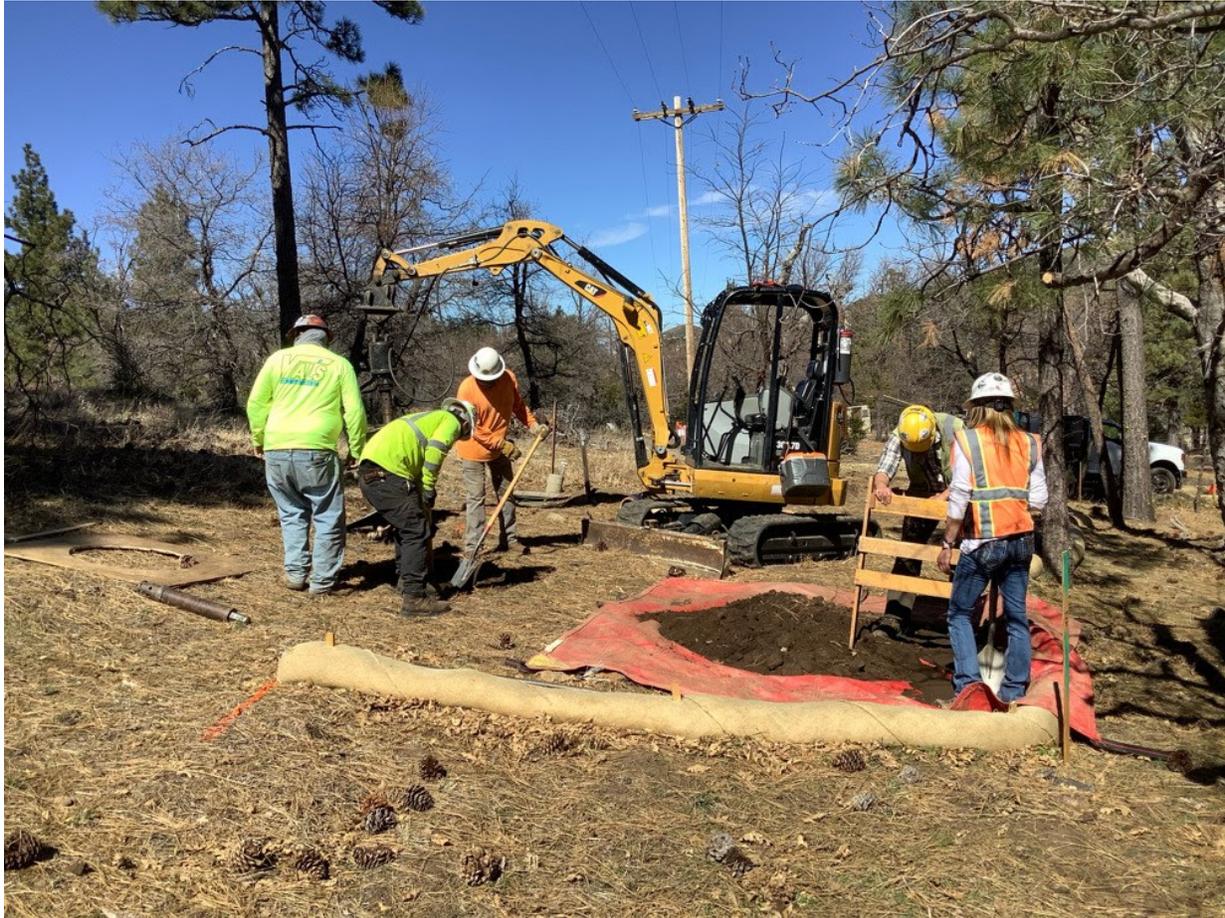
CPUC ECMs observed cultural resource monitors, including archaeological and Native American monitors, monitoring construction activities that occurred within or adjacent to identified archaeological or cultural resource site boundaries in accordance with the Historic Properties Management Plan (HPMP), MM CUL-1, MM CUL-3, and APM CUL-04 (see Photo 4 – Attachment A). Cultural ESAs were marked to prevent construction access to areas with cultural and/or historical resources in accordance with the HPMP, and work crews were observed respecting cultural ESA boundaries.

Photo 4: Archaeological and Cultural Monitors were observed monitoring pole excavation and screening spoils for cultural resources at a site on C 440 in accordance with the HPMP (MM CUL-1), MM CUL-3, and APM CUL-04.

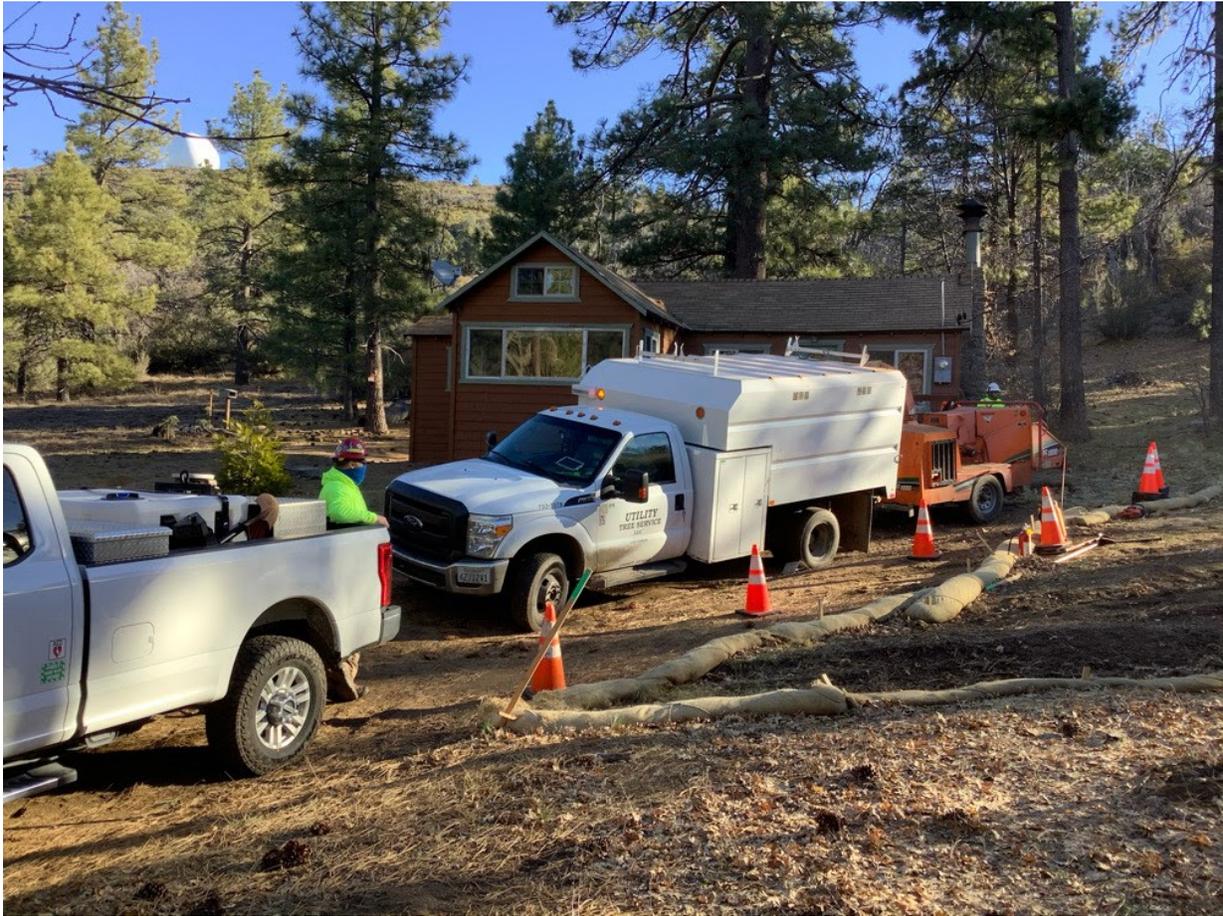
In accordance with the Construction Fire Prevention/Protection Plan (CFPPP) (MM FF-1), San Diego Gas & Electric (SDG&E) and their construction contractors were observed communicating Fire Potential Index (FPI) and Project Activity Levels (PALs) to work crews at daily tailboard meetings, during which daily fire requirements and restrictions for work on private land and on National Forest System (NFS) land were discussed. All project-related vehicles and equipment were equipped with a full set of fire tools (each set containing a 5-gallon backpack pump, round point shovel, Pulaski, and 2A10BC fire extinguisher). Construction crews were observed staging a set of fire tools within 50 feet of work activities as required by APM HAZ-04 and implementing other fire prevention measures as required by the CFPPP, and appropriate Fire Patrols were observed on site during activities that required their presence (see Photo

Photo 5: During chipping at Pole P40359 (C 440), a Fire Patrol was present and equipped with at least 100 gallons of water with pump and hose in accordance with the CFPPP for chipping on NFS land with a PAL C.

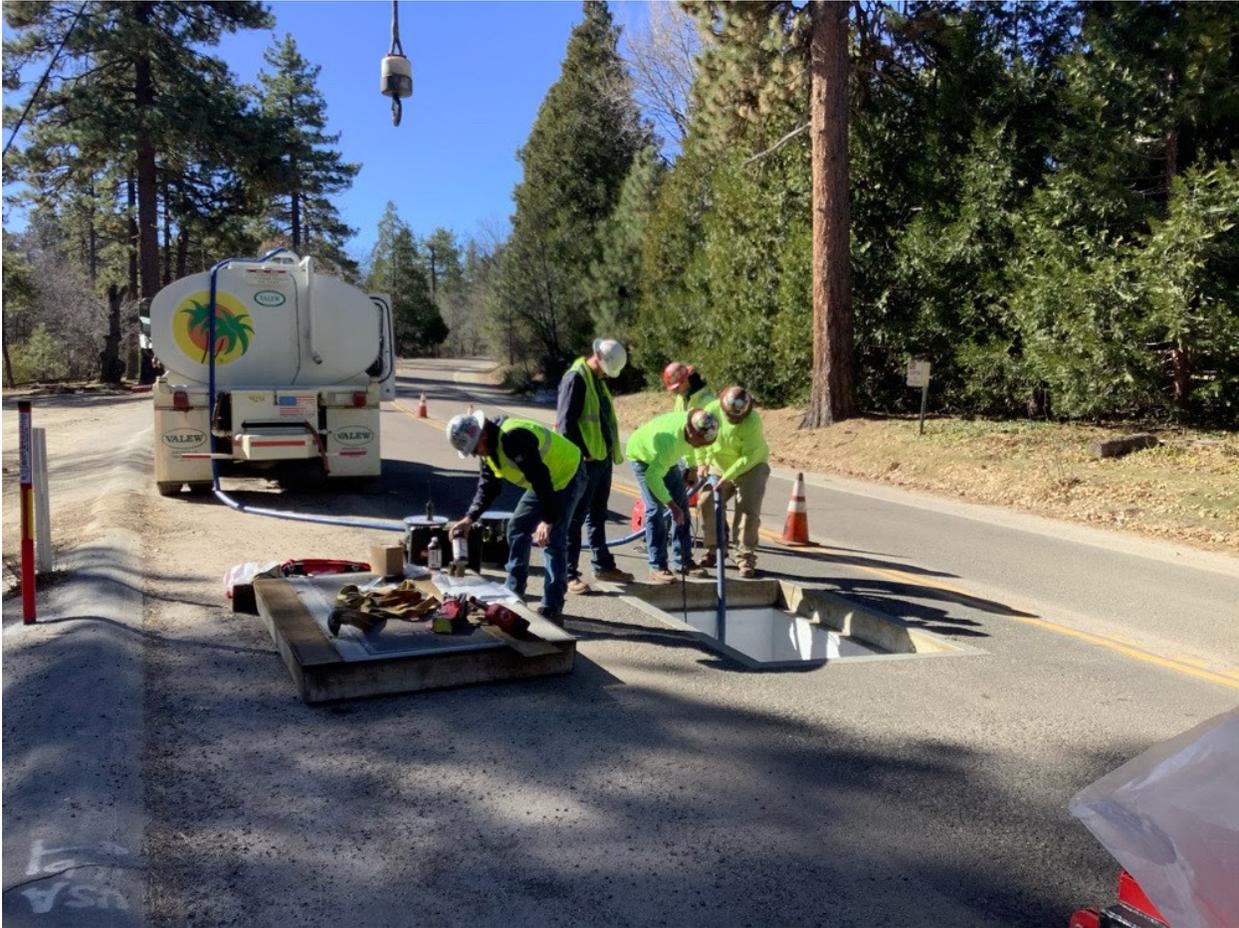
To prevent impacts to hydrology and water quality, site-specific sediment and erosion control BMPs were observed being implemented and maintained along project alignments in accordance with the project Erosion Control Plan (ECP), Stormwater Pollution Prevention Plan (SWPPP; MM HYD-1 and MM BIO-7), and APM HYD-09. Other BMPs in the SWPPP, such as hydromulch application, concrete waste containment, street sweeping, and access road entrance stabilization were also observed along the alignments. Hydrological resources were flagged for avoidance, and work activities occurred outside of hydrological resources in accordance with APM HYD-06. When dewatering was required, dewatering systems such as truck-mounted storage tanks were used to dispose of groundwater in accordance with APM HYD-08 (see Photo 6 – Attachment A).

Photo 6: During dewatering at a hand hole along Sunrise Highway (C 440), water was pumped into a truck-mounted storage tank for dispersal in accordance with APM HYD-08.
