California Public Utilities Commission <i>Mitigation Monitoring, Compliance, and Reporting Program</i>
	Cleveland National Forest Power Line Replacement Projects Compliance Status Report: 061 January 27, 2019

SUMMARY

This compliance status report covers construction activities from January 14, 2018 through January 27, 2019.

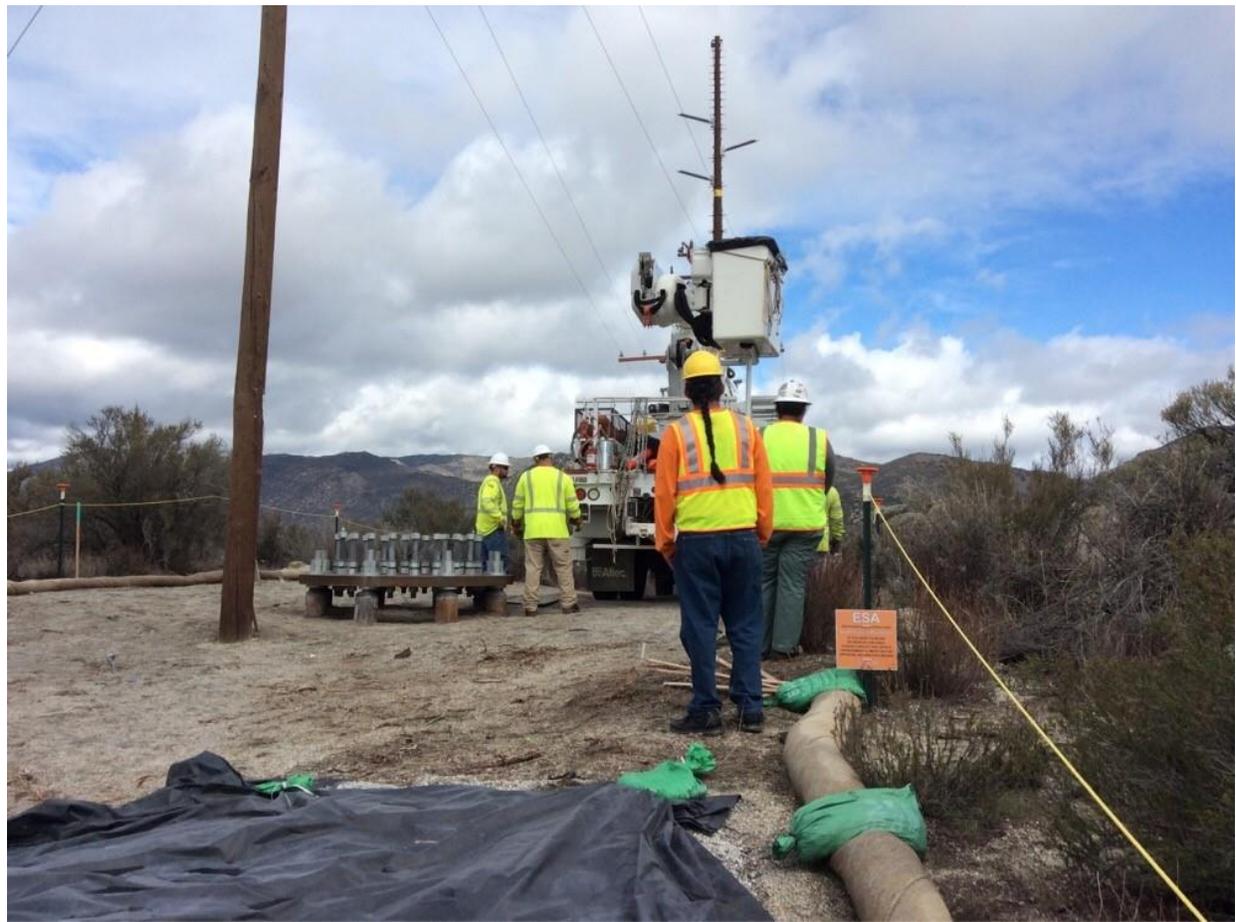
Photo 1: A construction crew observed setting up a bucket truck in order to spread wire at Pole Z100051 (TL 629C). Archeological and Native American monitors were on-site monitoring the activity, and ensuring that no disturbance occurred to an adjacent cultural ESA in accordance with the HPMP, MM CUL-1, and APM CUL-04.

During this reporting period at TL 629C, CPUC ECMs observed construction crews spreading wire (see Attachment A – Photo 1) and setting poles (see Attachment A – Photo 2), conducting overhead work, conducting wire stringing operations, clipping sagging, and dead ending 12 kV and 69 kV lines, and conducting helicopter operations. At TL 6957, crews were observed staging equipment at staging yards, and conducting overhead work and helicopter operations. At TL 6958, crews were observed clearing vegetation and installing erosion and sediment control Best Management Practices (BMPs) (see Attachment A – Photo 3), installing Arroyo Toad exclusionary fencing (see Attachment A – Photo 4), and setting up and drilling for micropile foundation construction (see Attachment A – Photo 5). At TL 629E, crews were observed conducting punch-list work to close out construction of the line, such as removing all construction debris and construction sediment control BMPs, grading water bars in access roads (see Attachment A – Photo 6), and re-contouring a work space.

Cultural resource monitors, including Archaeological and Native American Monitors, were observed monitoring project activities occurring within the vicinity of known cultural resources in accordance with the Historic Properties Management Plan (HPMP), MM CUL-1, MM CUL-3, and APM CUL-04 (see Attachment A – Photo 1). Environmentally Sensitive Area (ESA) fences, used to prevent unauthorized access and or construction activities in areas containing known cultural resources, were observed in working order in accordance with the Historic Properties Management Plan (HPMP), MM CUL-1, and APM CUL-05 (see Attachment A – Photo 1).

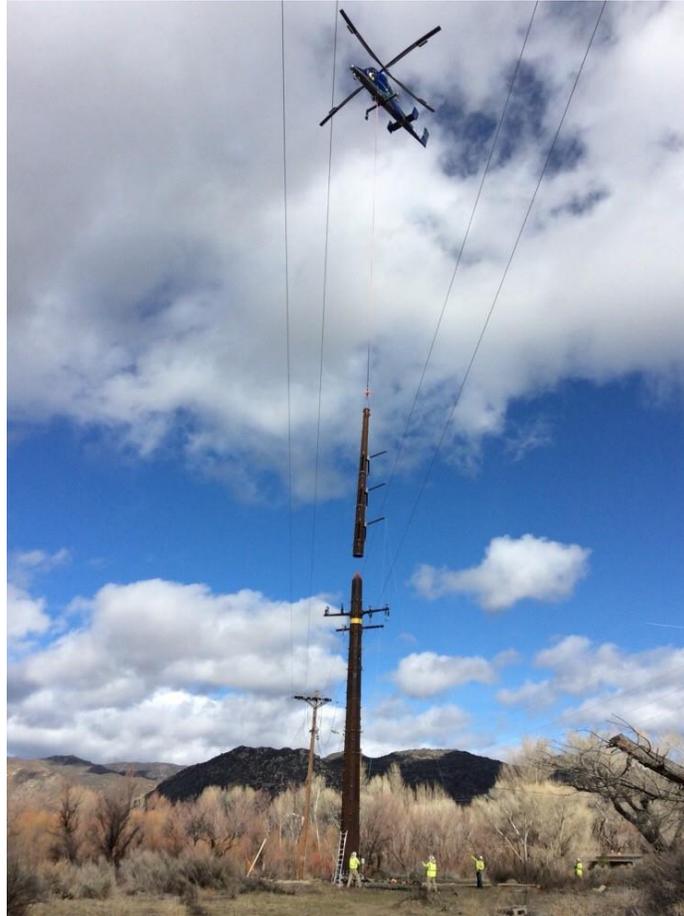
Photo 2: A construction crew observed utilizing helicopter external load operations to set a new steel pole at Pole Z100056 (TL 629C).

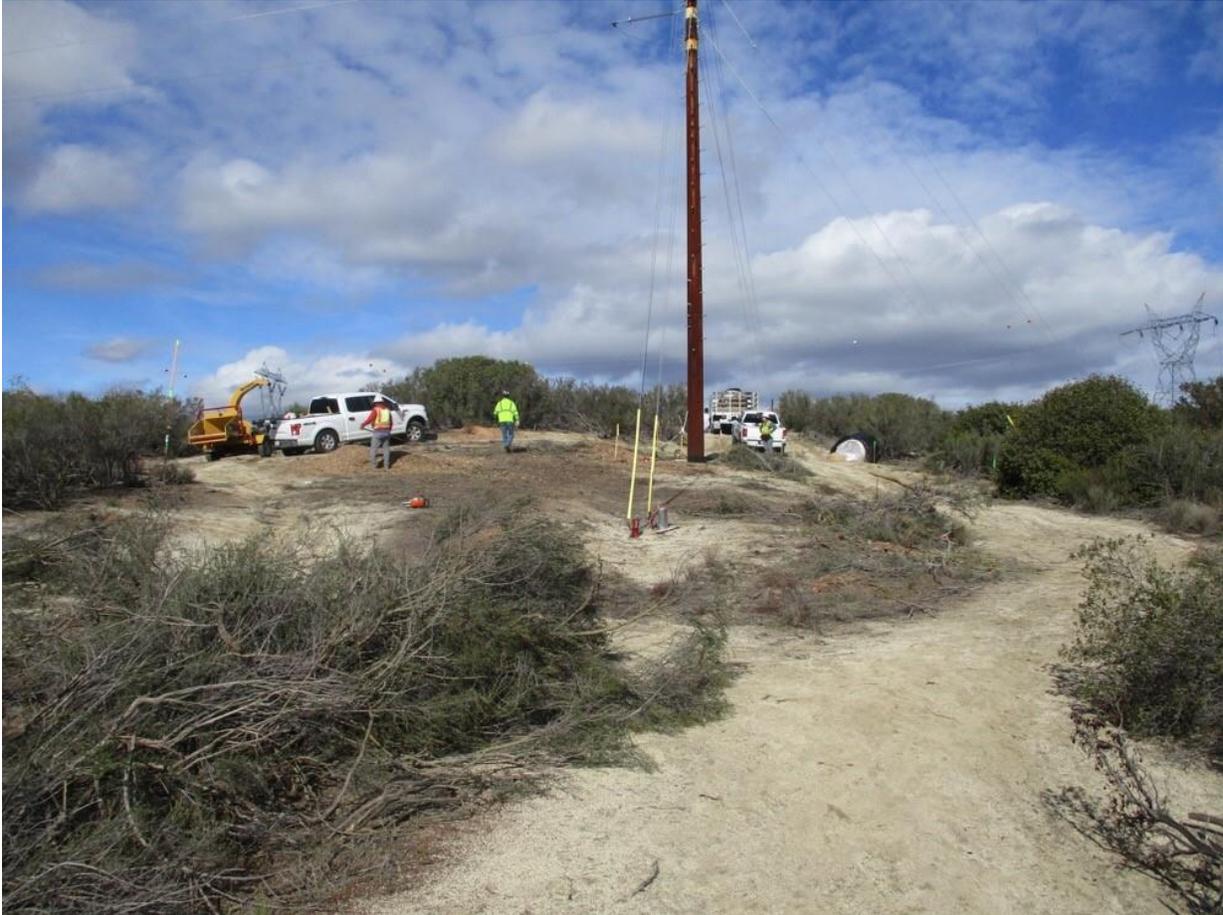
Photo 3: During vegetation clearing at Pole Z41019 (TL 6958), the crew was observed clearing within the approved work space in accordance with MM BIO-1, and a biological monitor was present in accordance with MM BIO-3.

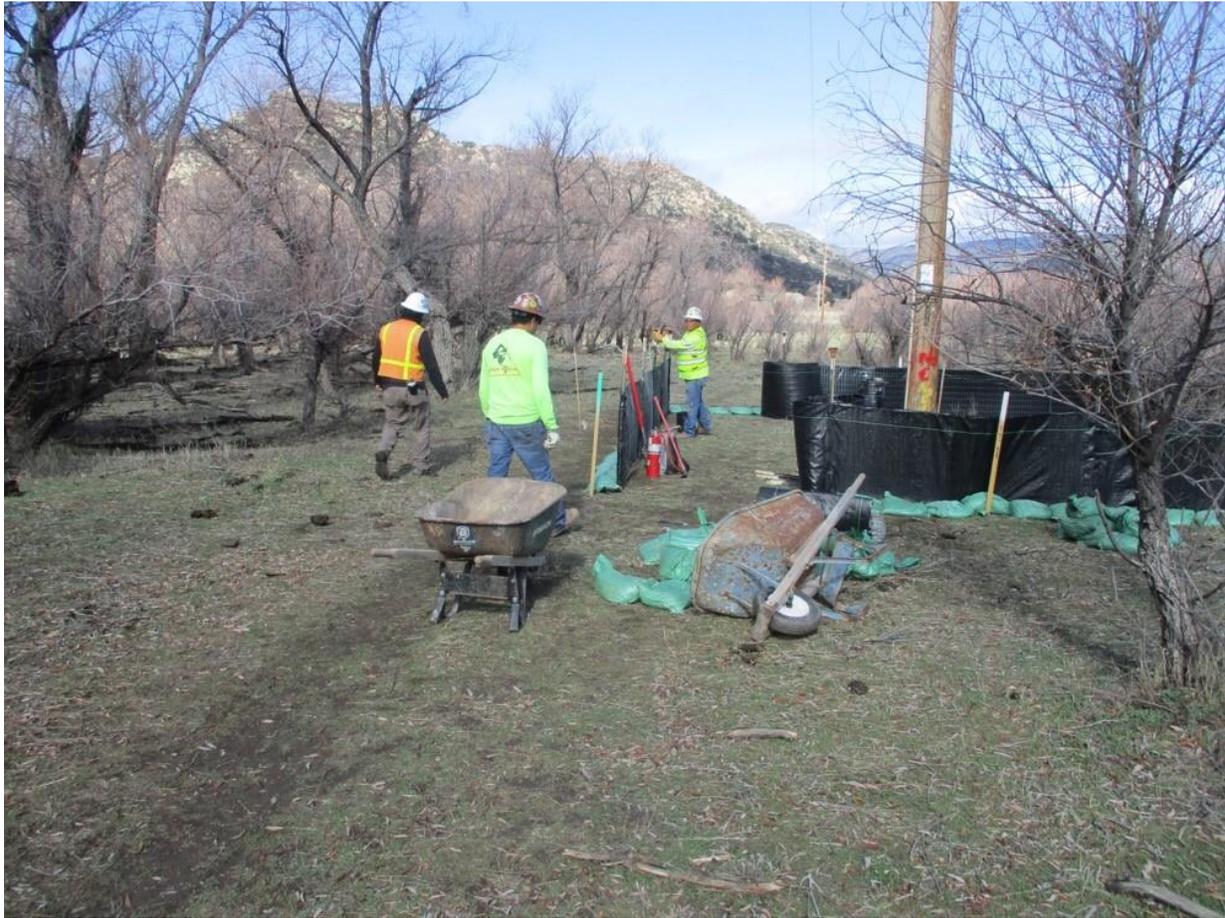
Photo 4: The authorized Arroyo Toad biologist observed overseeing the installation of Arroyo Toad exclusionary fence at Pole Z40981 in accordance with the SAA avoidance and minimization measures.

Approved workspaces were delineated with staking and flagging, and work crews were observed respecting the work space limits in accordance with MM BIO-1. Workers were observed having completed the Worker Environmental Awareness Program (WEAP), as shown by project hard hat stickers in accordance with MM BIO-2. Biological monitors were observed present on site for vegetation clearing work in accordance with MM BIO-3 (see Attachment A – Photo 3). Along TL 629E, sediment control BMPs and other construction-related debris, such as work limit and engineering stakes, were removed and work spaces were re-contoured, where necessary, in accordance with the Habitat Restoration Plan and MM BIO-4. Environmentally Sensitive Area (ESA) signage and flagging was in place to prevent impacts to sensitive plant and animal species, such as special status and/or butterfly host plant populations along rights-of-way in accordance with MM BIO-14 and MM BIO-16. An avian biologist was observed conducting pre-construction nesting raptor surveys along TL 6958, and monitoring a nesting Golden Eagle (*Aquila chrysaetos*) pair near TL 629C in accordance with the Avian Protection Plan/Nesting Bird Monitoring Plan (APP/NBMP) and MM BIO-28. To prevent wildlife entrapment, trenches and direct-bury pole holes were securely covered in accordance with MM BIO-23. To prevent littering, construction crews used trash bags which were removed from sites daily in accordance with MM BIO-26. The Arroyo Toad (*Anaxyrus californicus*) authorized biologist was observed overseeing the installation of Arroyo Toad exclusionary fencing at Pole Z40980 and Pole Z40981 (TL 629C) in accordance with the Streambed Alteration Agreement avoidance and minimization measures (see Attachment A – Photo 4).

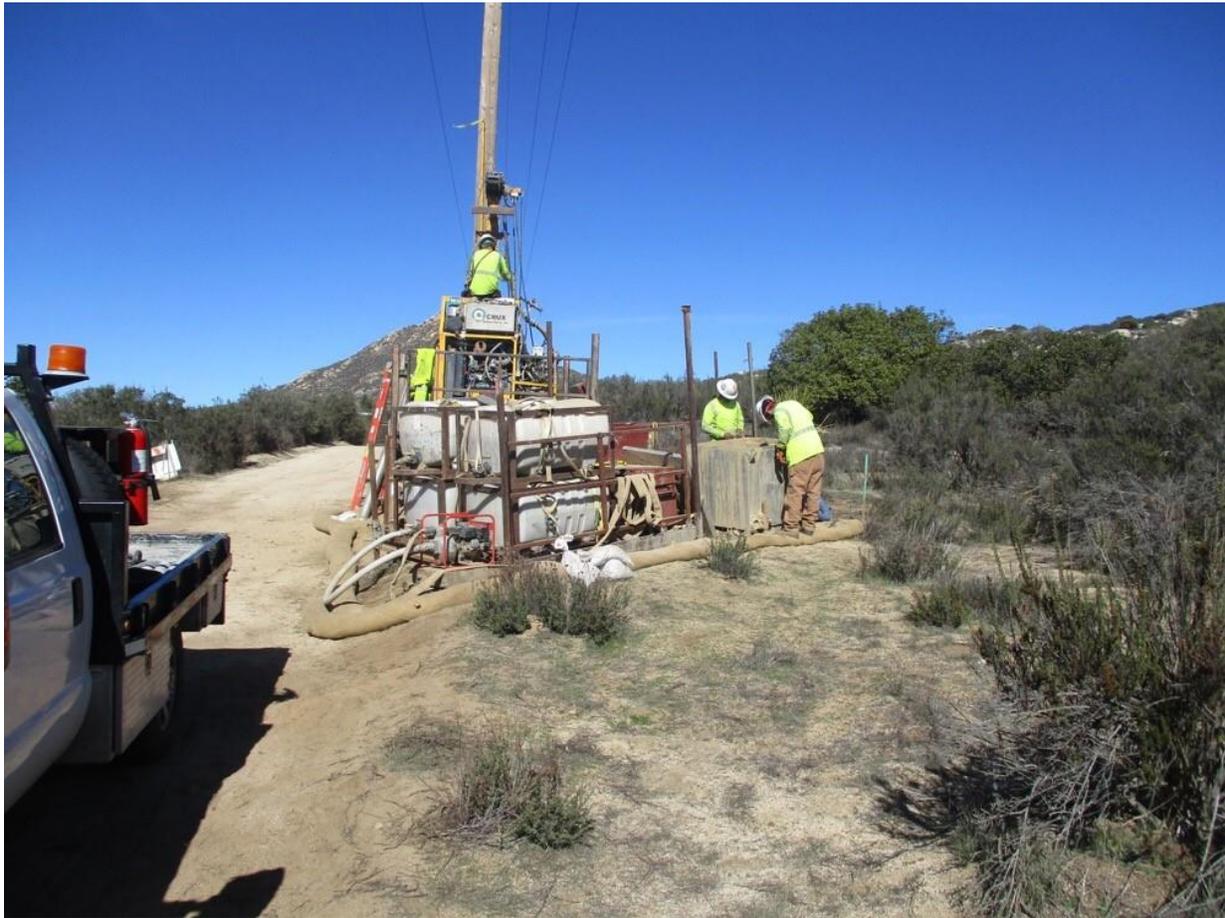
Photo 5: During micropile foundation hole drilling at Pole Z41007, the construction crew was observed cleaning out the cuttings containment box, which is used to trap drill cuttings and control dust emissions in accordance with APM AIR-05.

To prevent fugitive dust emissions during project activities, construction crews were observed watering within staging yards and work areas, and along unpaved access roads as needed to prevent fugitive dust in accordance with APM AIR-02. Watering occurred in areas where helicopter operations were being conducted to prevent dust from rotor downwash in accordance with the Aviation Safety Plan (ASP) and MM PHS-5. Anti-dirt tracking control BMPs, such as rattle plates and rock aprons, were maintained at staging yard entrances, and trackout on public roads was removed in accordance with APM AIR-05. In addition, micropile drilling crews were observed utilizing cuttings containment boxes to control fugitive dust in accordance with APM AIR-05 (see Attachment A – Photo 5).

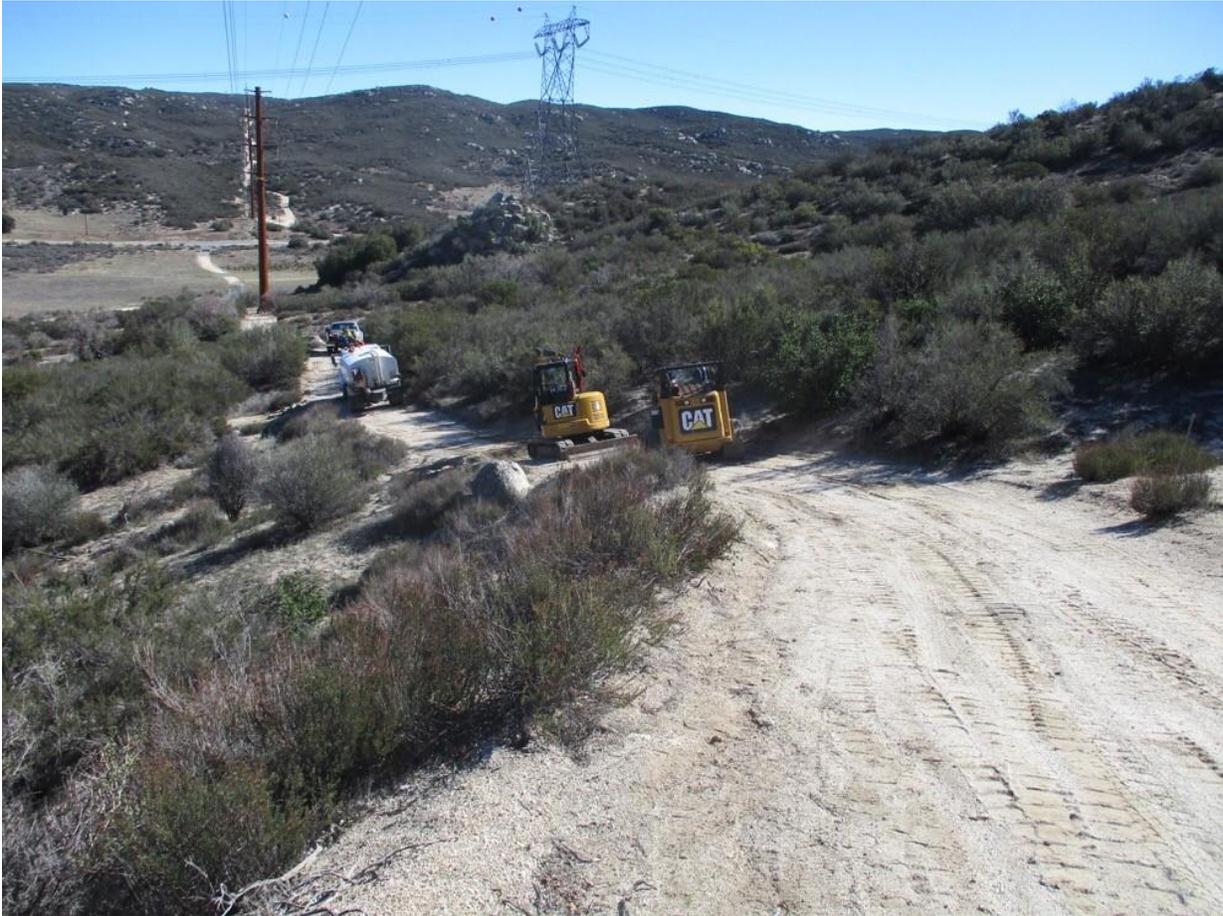
Photo 6: A construction crew observed conducting maintenance grading of water bars along the access road near Pole Z44170 (TL 629E) in accordance with the ECP and SWPPP. In accordance with the CFPPP for today's stated fire conditions (PAL C), a water truck provided the requisite water for fire safety (150 gallons with pump and hose), and a full set of fire tools (i.e. 5 gallon backpack pump, round point shovel, Pulaski, and 2A10BC fire extinguisher) was observed within 50 feet of the activity.
