California Public Utilities Commission <i>Mitigation Monitoring, Compliance, and Reporting</i> <i>Program</i>
	Cleveland National Forest Power Line Replacement Projects Compliance Status Report: 062 February 10, 2019

This compliance status report covers construction activities from January 28, 2019 through February 10, 2019.

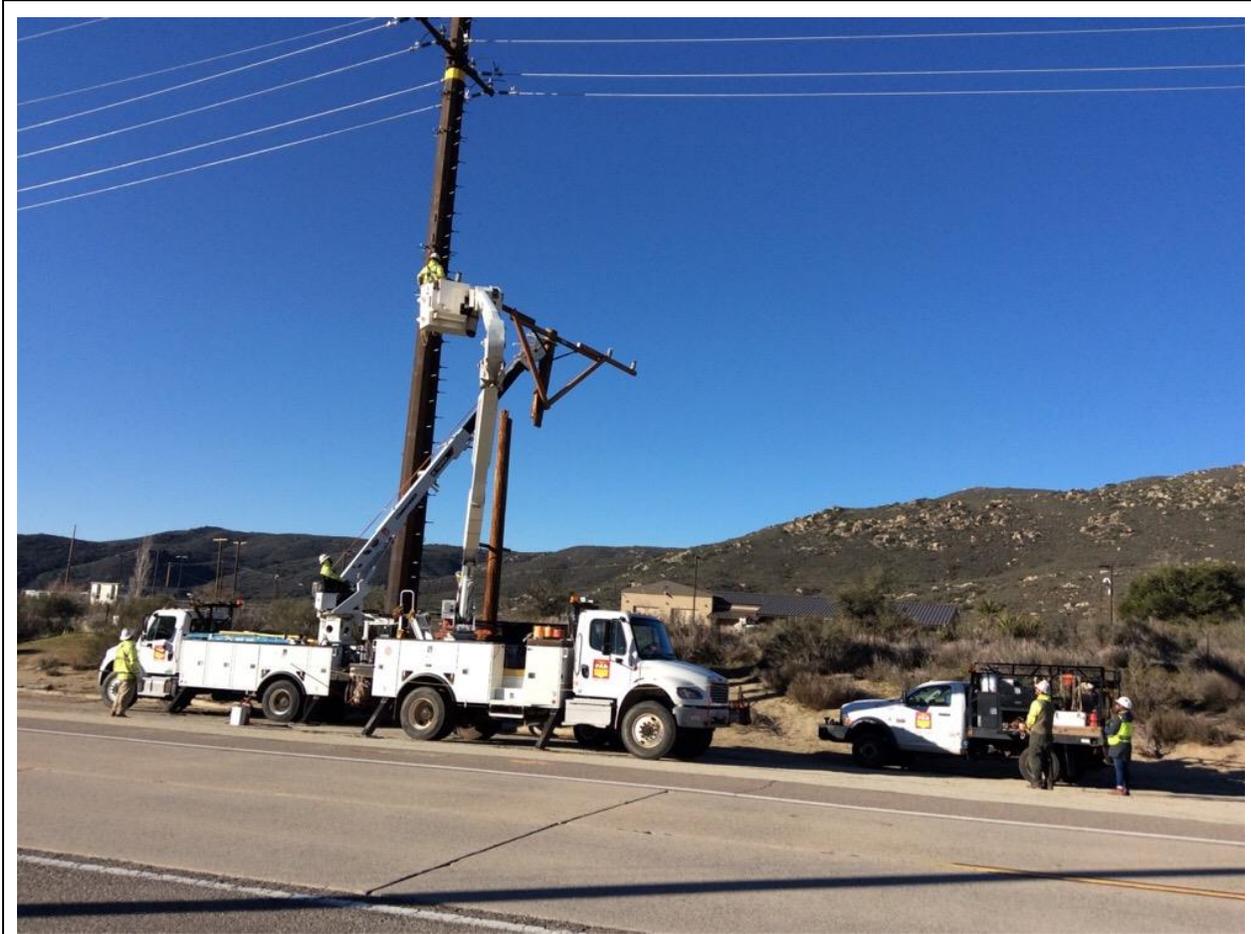
Photo 1: A construction crew observed removing the old wooden pole at Z40525 (TL 629C).

During this reporting period at TL 629C, CPUC ECMs observed construction crews mobilizing drill equipment, removing old poles (see Photo 1 – Attachment A), conducting overhead work, setting pole bases, tying secondary wire to underground boxes, and installing and maintaining sediment control best management practices (BMPs). At TL 6957 and TL 682, crews were observed stringing wire and performing helicopter operations. Crews were also observed installing ground rods along TL 682. At TL 6958, crews were observed mobilizing drill equipment, removing and chipping vegetation, installing erosion and sediment control BMPs, drilling micropile and direct bury foundations (see Photo 2 – Attachment A), hand digging, installing ground rods and anchors, and grouting and proof testing micropile foundations. At TL 629E, crews were observed performing road maintenance activities and removing sediment and erosion control Best Management Practices (BMPs) and work space stakes at completed work areas. Crews were observed pouring concrete, installing boxes, and trenching for the underground distribution line along C 449 (see Photo 3 – Attachment A).

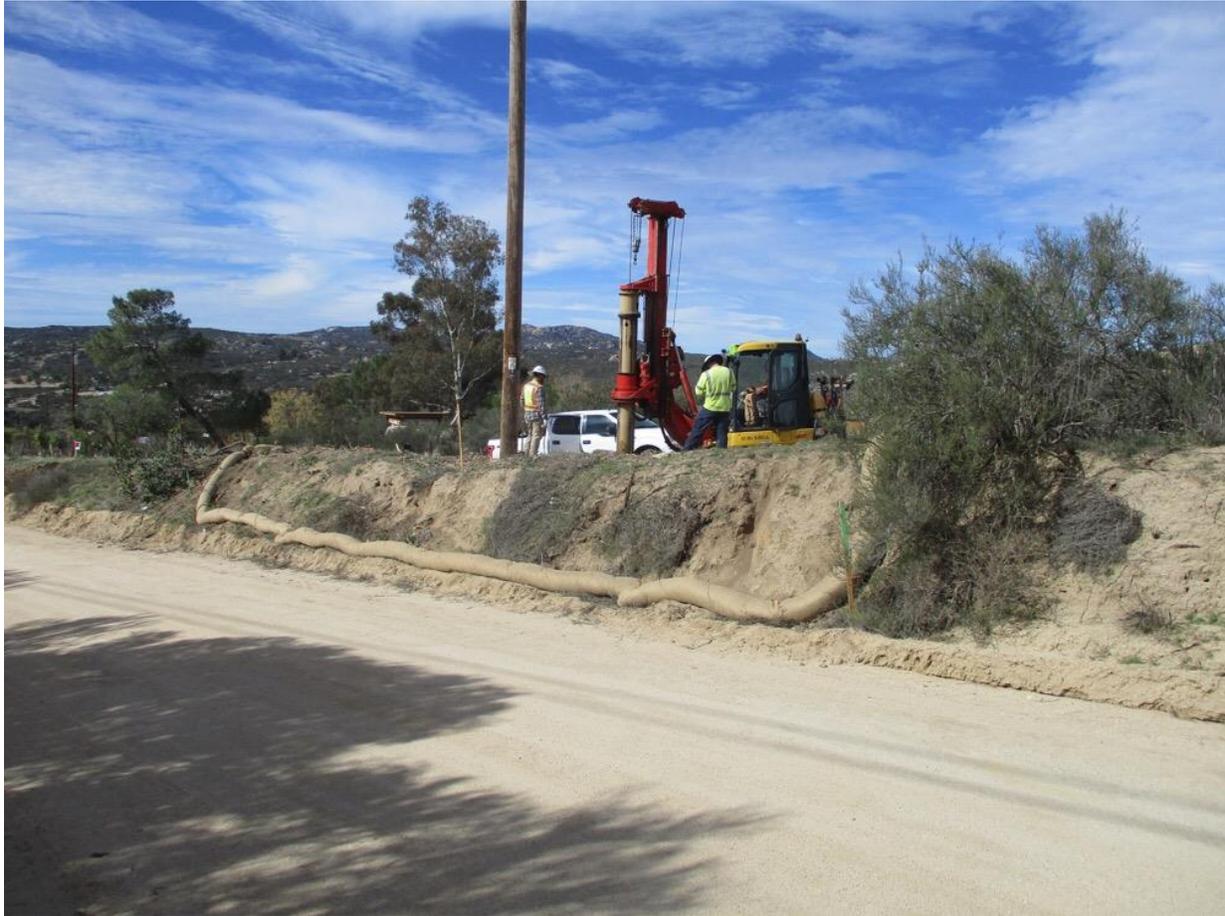
Photo 2: A construction crew observed drilling direct bury pole hole at Z40999 (TL 6958). Fiber rolls used for erosion and sediment control were observed to be in good condition, in accordance with the Erosion Control Plan and SWPPP.

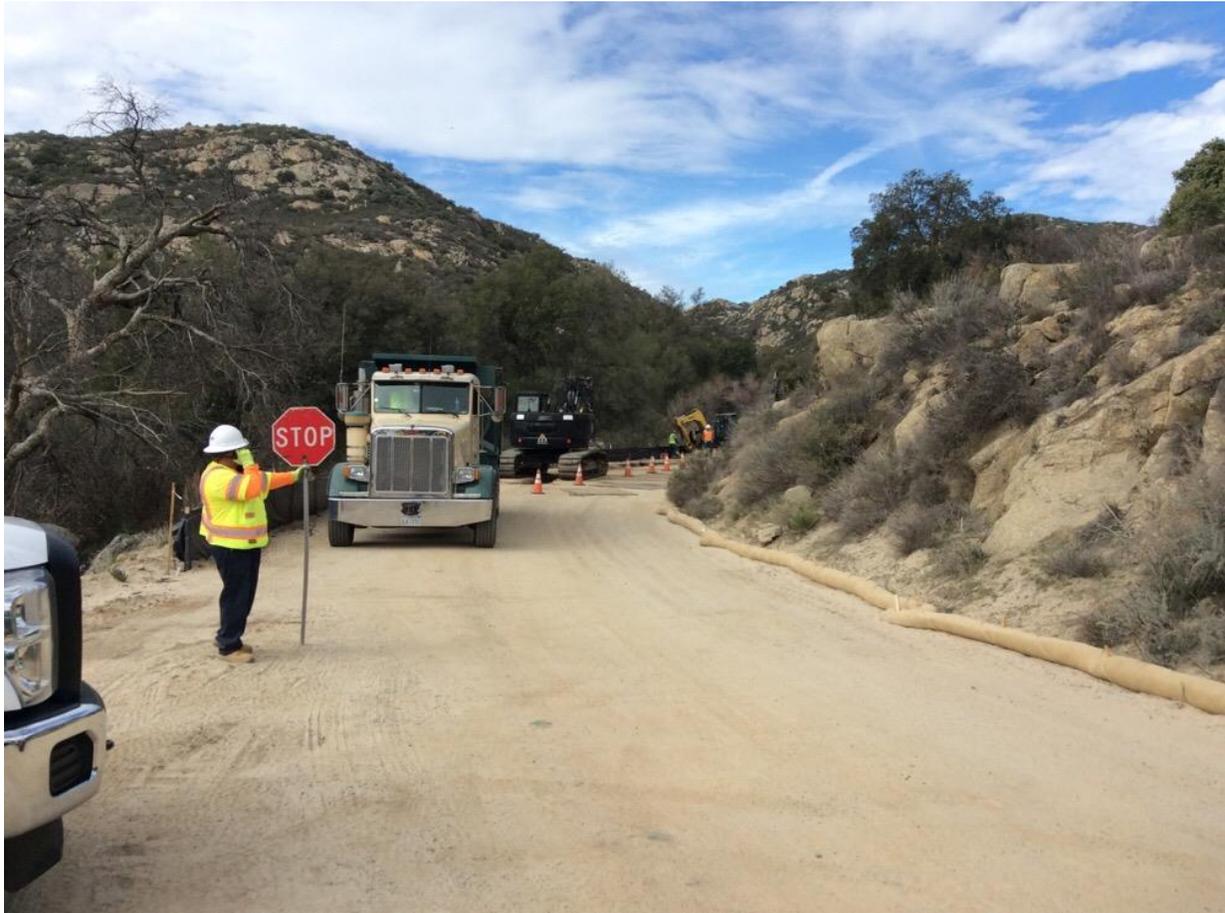
Photo 3: A construction crew was observed trenching for the underground distribution line along Morena Stokes Road (C 449). Traffic was regulated along the road to maintain a safe travel lane for motorists in accordance with APM TRANS-02.

Traffic control measures were observed being implemented along Old Highway 80 and Morena Stokes Road, in accordance with APM TRANS-02 (see Photo 3 – Attachment A). Signage and cones were used for shoulder closers and flaggers were utilized to temporarily hold traffic when needed, or when helicopter operations crossed or occurred next to public roadways.

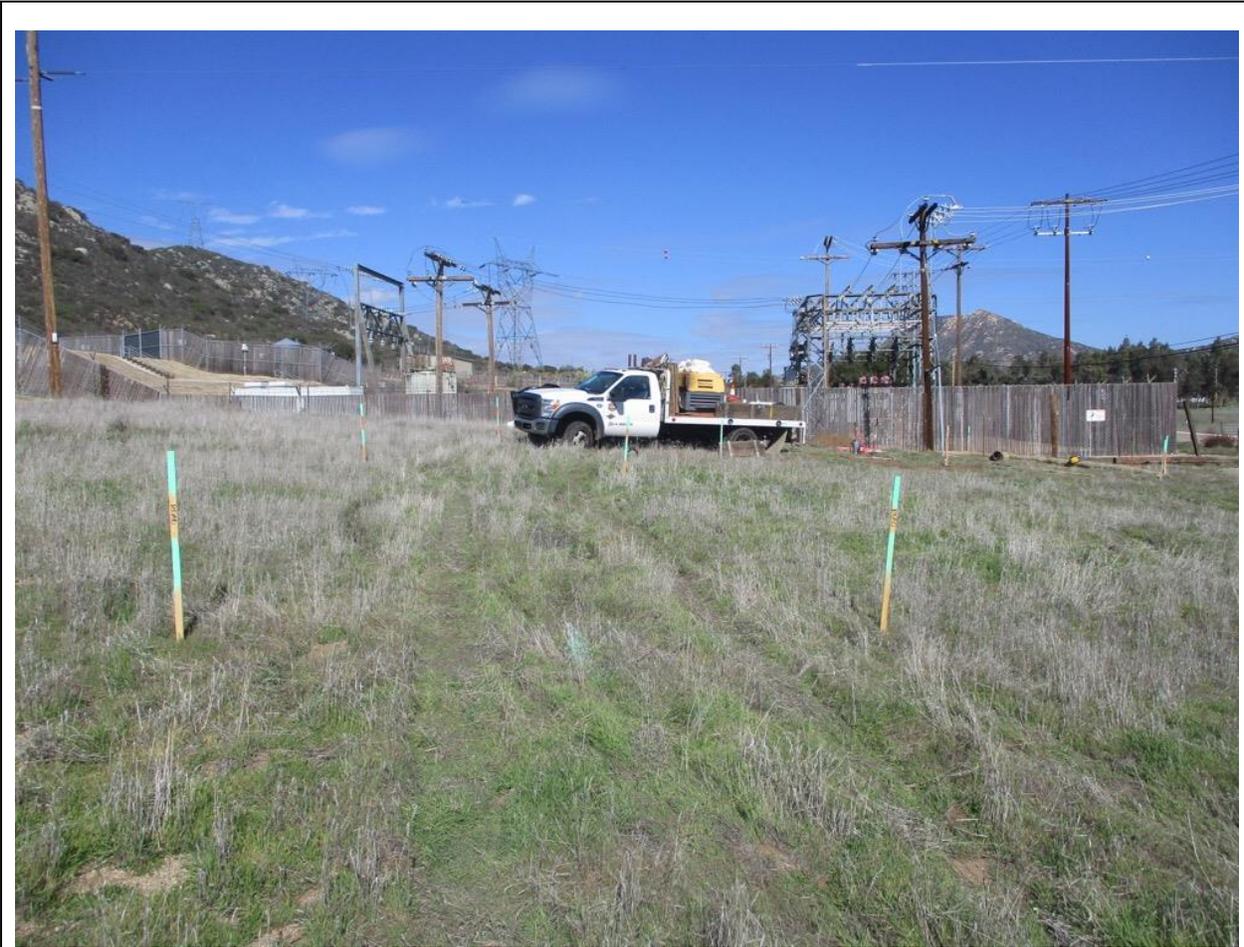
Photo 4: A construction crew was observed accessing the work site at Z43043 (TL 6958) for hand digging a pole anchor hole using the approved and delineated access route in accordance with MM BIO-1.

Approved workspaces and access routes were delineated with staking and flagging, and work crews were observed respecting the work space limits in accordance with MM BIO-1 (see Photo 4 – Attachment A). Biological monitors were observed present on site for vegetation clearing work in accordance with MM BIO-3. The arroyo toad (*Anaxyrus californicus*) Authorized Biologist helped design screened cut-outs in the down-slope sections of arroyo toad fencing at the Buckman Springs Fly Yard for water to flow through while still providing protection for arroyo toad (see Photo 5 – Attachment A). An avian biologist was observed monitoring a nesting golden eagle (*Aquila chrysaetos*) pair near TL 629C in accordance with the Avian Protection Plan/Nesting Bird Monitoring Plan (APP/NBMP) and MM BIO-28. To prevent wildlife entrapment, trenches and direct-bury pole holes were securely covered in accordance with MM BIO-23. Construction crews used trash bags, which were removed from sites daily, to prevent littering and CPUC ECMs observed crew members picking up litter within the staging areas in accordance with MM BIO-26.

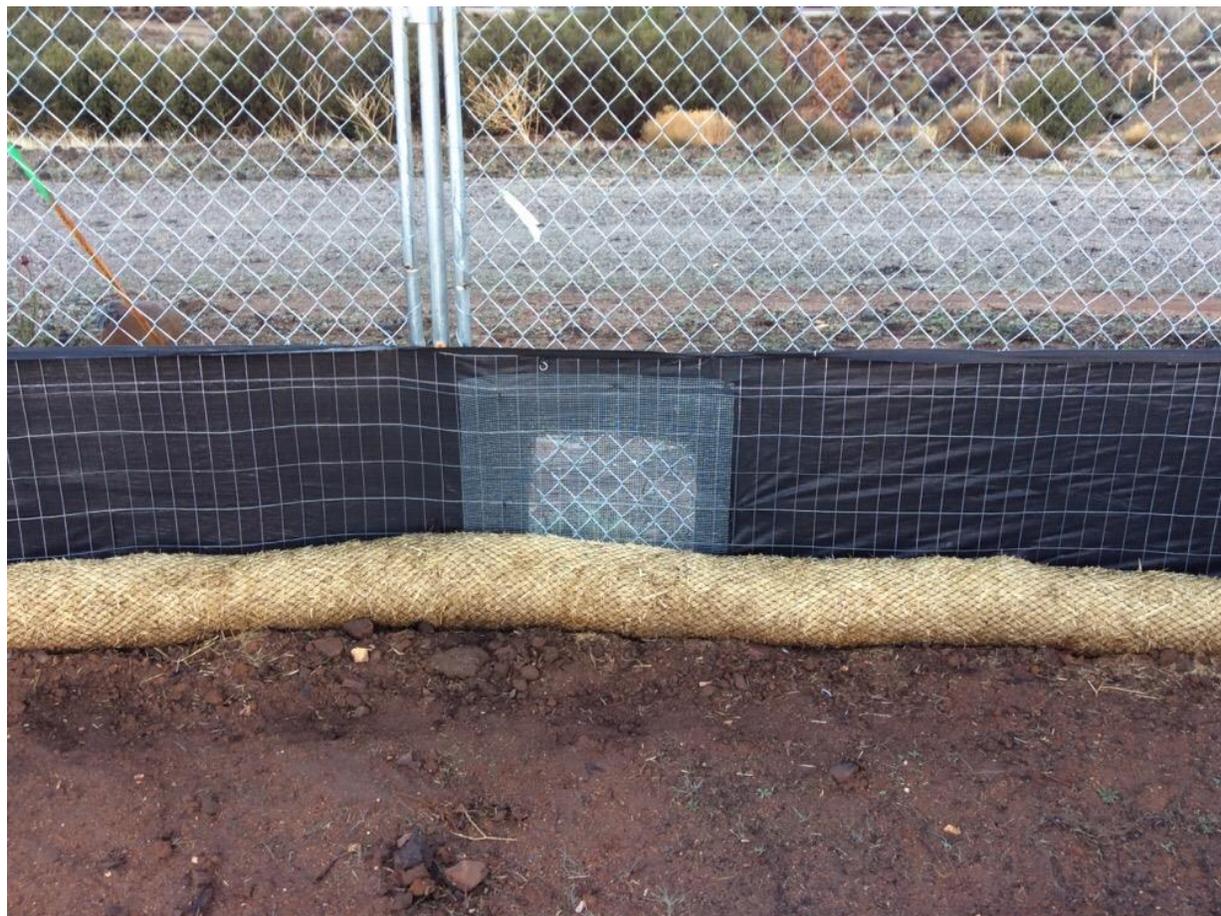
Photo 5: The Arroyo Toad Authorized Biologist approved screened cut-outs along the down-slope sections of the arroyo toad fencing at the Buckman Springs Fly Yard to allow water flow-through and maintain protections for arroyo toad.

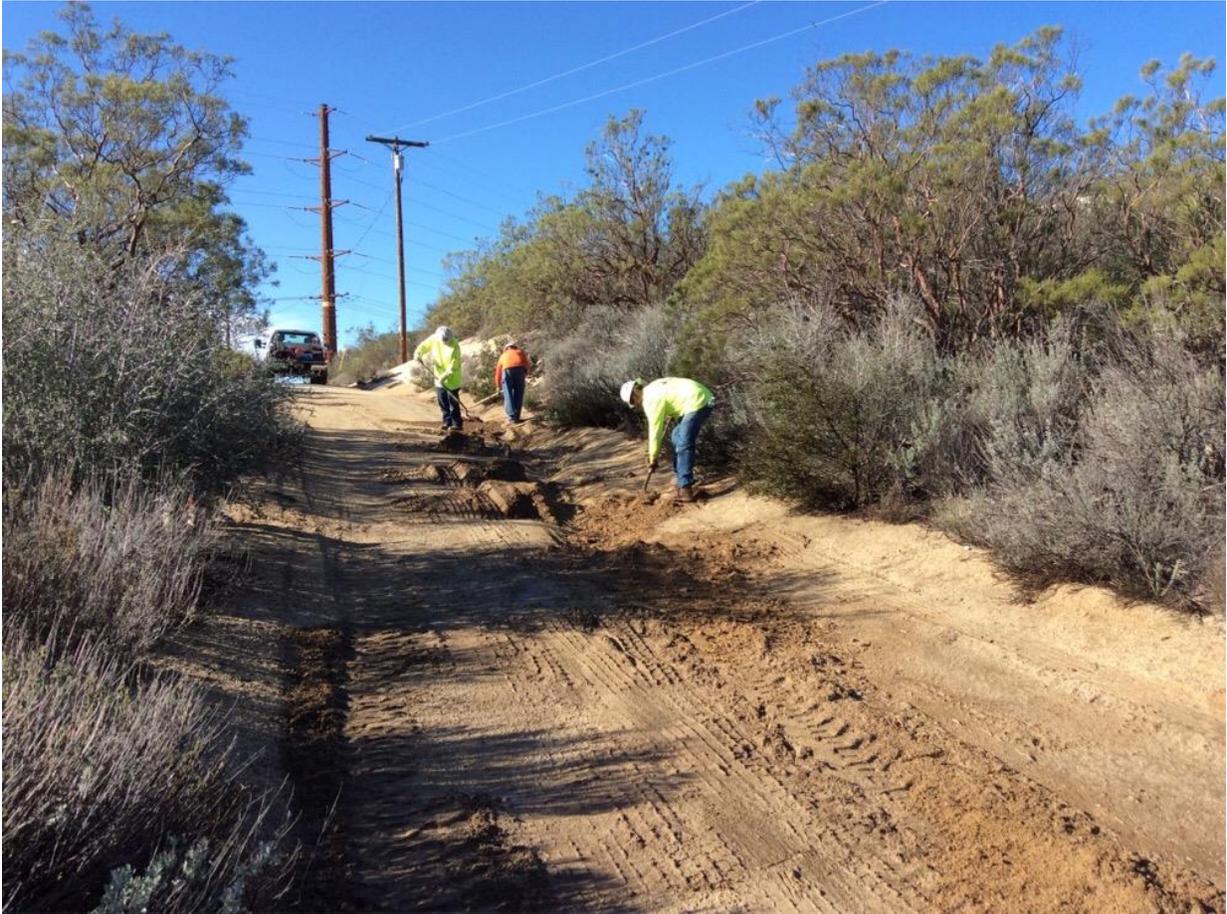
Photo 6: A construction crew was observed performing road maintenance with hand tools to protect cultural resources along TL 629E.

Cultural resource monitors, including Archaeological and Native American Monitors, were observed monitoring project activities occurring within the vicinity of known cultural resource sites in accordance with the Historic Properties Management Plan (HPMP), MM CUL-1, MM CUL-3, and APM CUL-04. Environmentally Sensitive Area (ESA) fences, used to prevent unauthorized access and or construction activities in areas containing known cultural resources, were observed in working order in accordance with the Historic Properties Management Plan (HPMP), MM CUL-1, and APM CUL-05. Road maintenance was performed using only hand tools within the boundaries of known cultural resource sites (see Photo 6 – Attachment A).
