<p><b>California Public Utilities Commission</b> <b><i>Mitigation Monitoring, Compliance, and Reporting Program</i></b></p>
	<p><b>Cleveland National Forest Power Line Replacement Projects</b></p> <p><b>Compliance Status Report: 069</b></p> <p><b>May 19, 2019</b></p>

This compliance status report covers construction activities from May 6, 2019 through May 19, 2019.

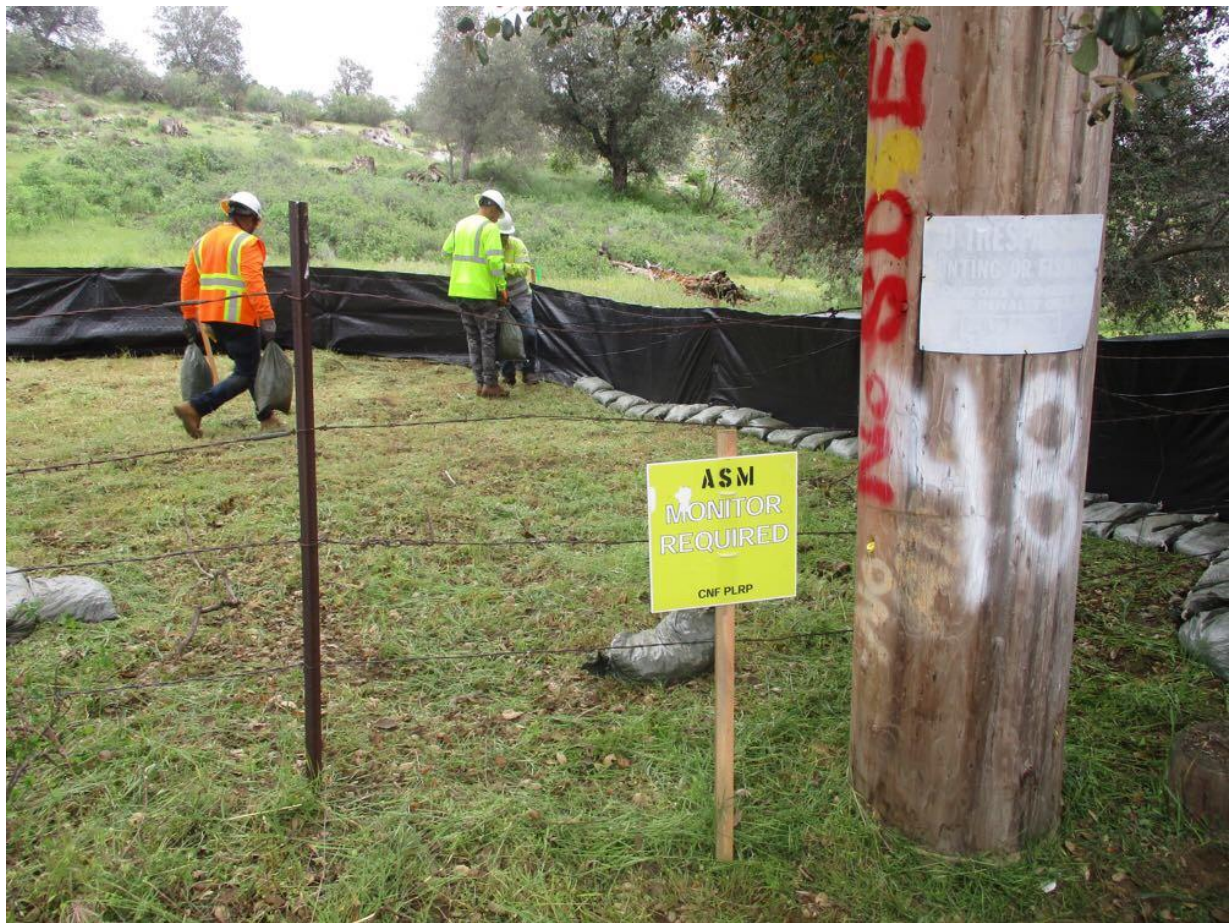
**Photo 1:** A construction crew observed installing a silt fence at a pole site at TL 629A in accordance with the Erosion Control Plan and SWPPP. Securing the silt fence was performed by placing gravel bags on the ground flap to avoid ground disturbance at the site. Archeological and Native American monitors were present on site during the work, and ESA signage was present in accordance with Attachment A of the HPMP.

MM CUL-1, MM CUL-3, and APM CUL-04, including trenching activities along C449, installation of SWPPP BMPs (see Photo 1 – Attachment A), hydro-mulching within TL 629C (see Photo 6 – Attachment A), and vegetation removal along TL 629A. Cultural resource ESAs were also observed to be in place in accordance with the HPMP and MM CUL-1.

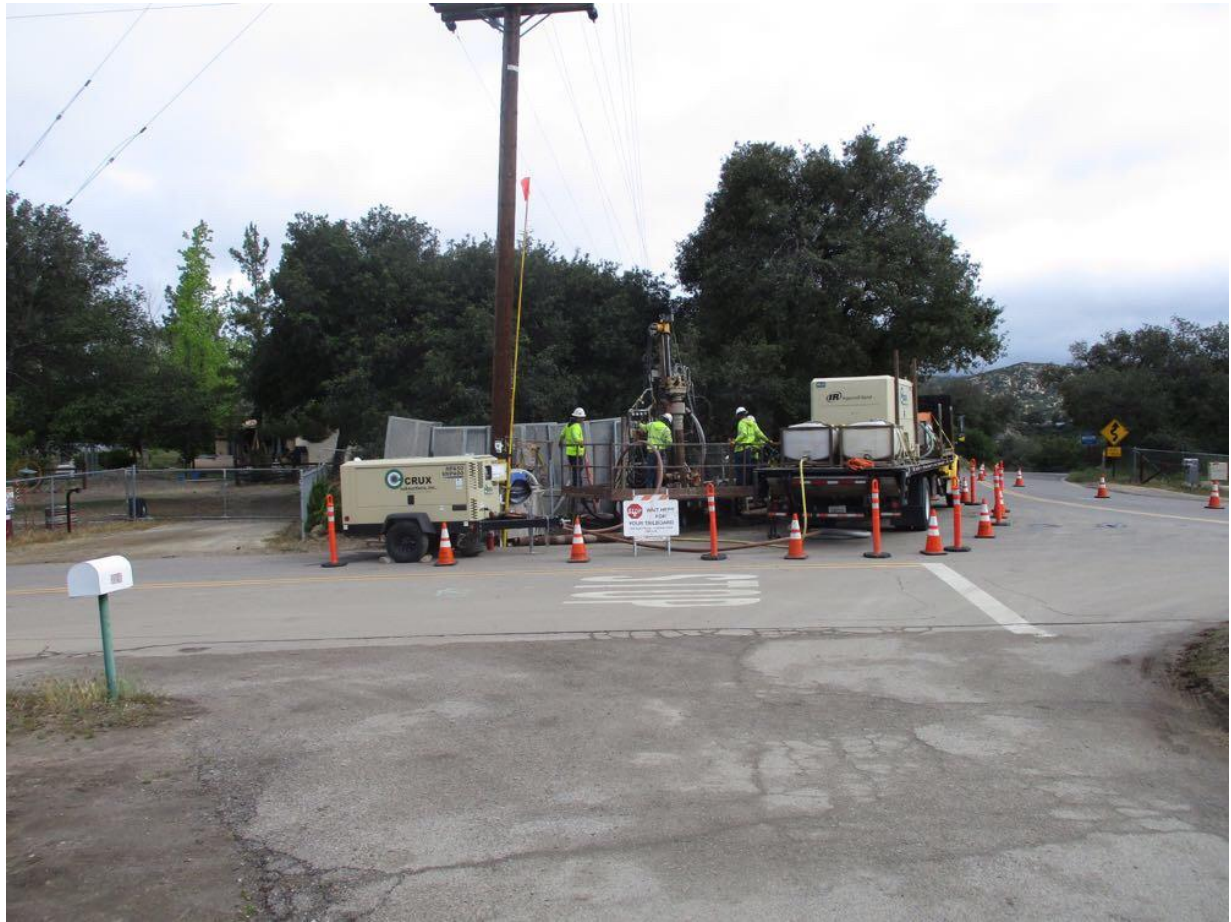
**Photo 2:** During micropile drilling at Pole Z273069 (TL 629A), a noise barrier was erected to minimize disturbance to adjacent residents in accordance with MM NOI-1.

During this reporting period, micropile drilling took place in proximity to private residences in TL 629A. Although the noise levels were reported below the 8-hour Leq of 75 dBA threshold, portable noise barriers were utilized to minimize noise (MM NOI-1) (see Photo 2 – Attachment A).

In accordance with APM VIS-02, construction sites were kept as clean and inconspicuous as possible, and opaque screening was utilized in the portable noise barriers temporarily installed during microphile drilling activities (see Photo 2 – Attachment A).

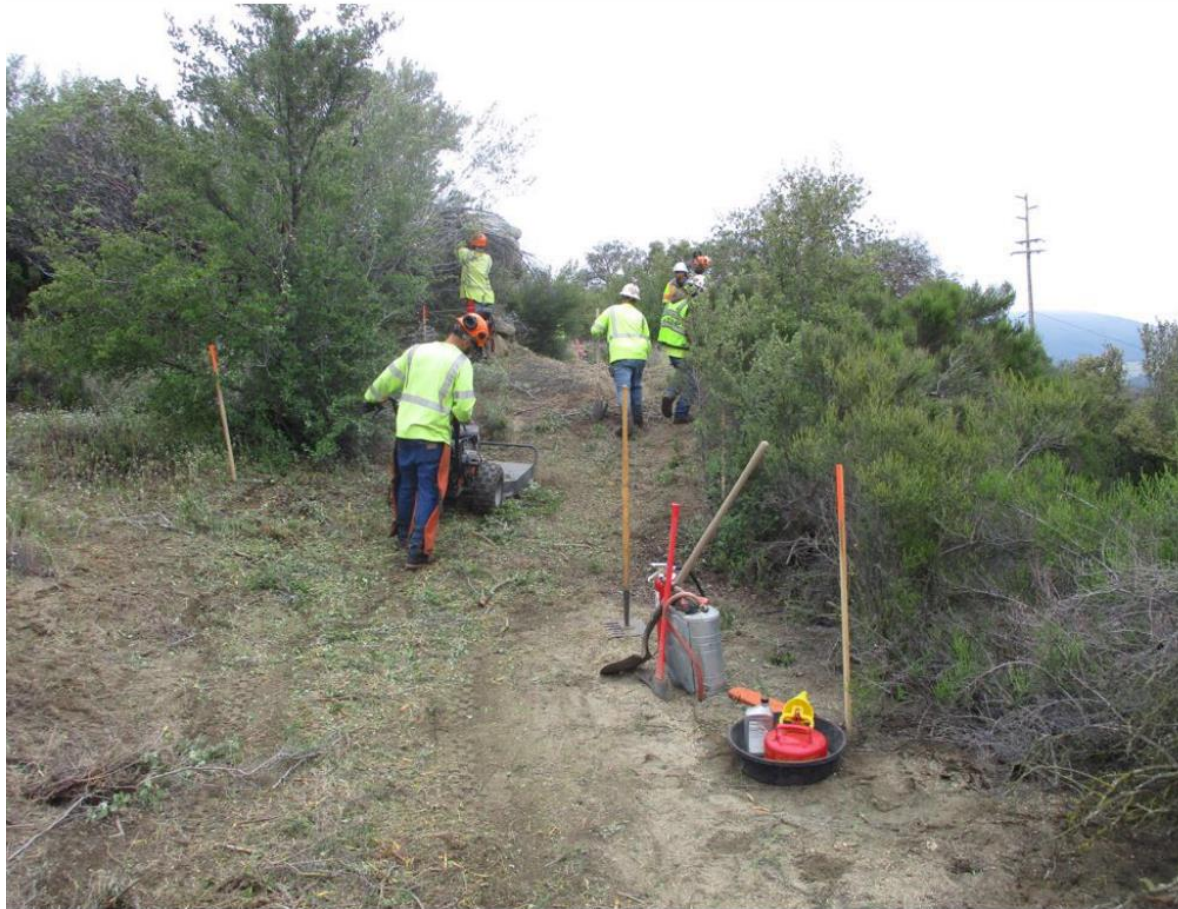
**Photo 3:** A crew was observed clearing vegetation along access to P258376 (TL 629A). A set of fire tools was staged within 50 feet of clearing work in accordance with the CFPPP, and fuel was staged in a drip pan in accordance with the SRNP.

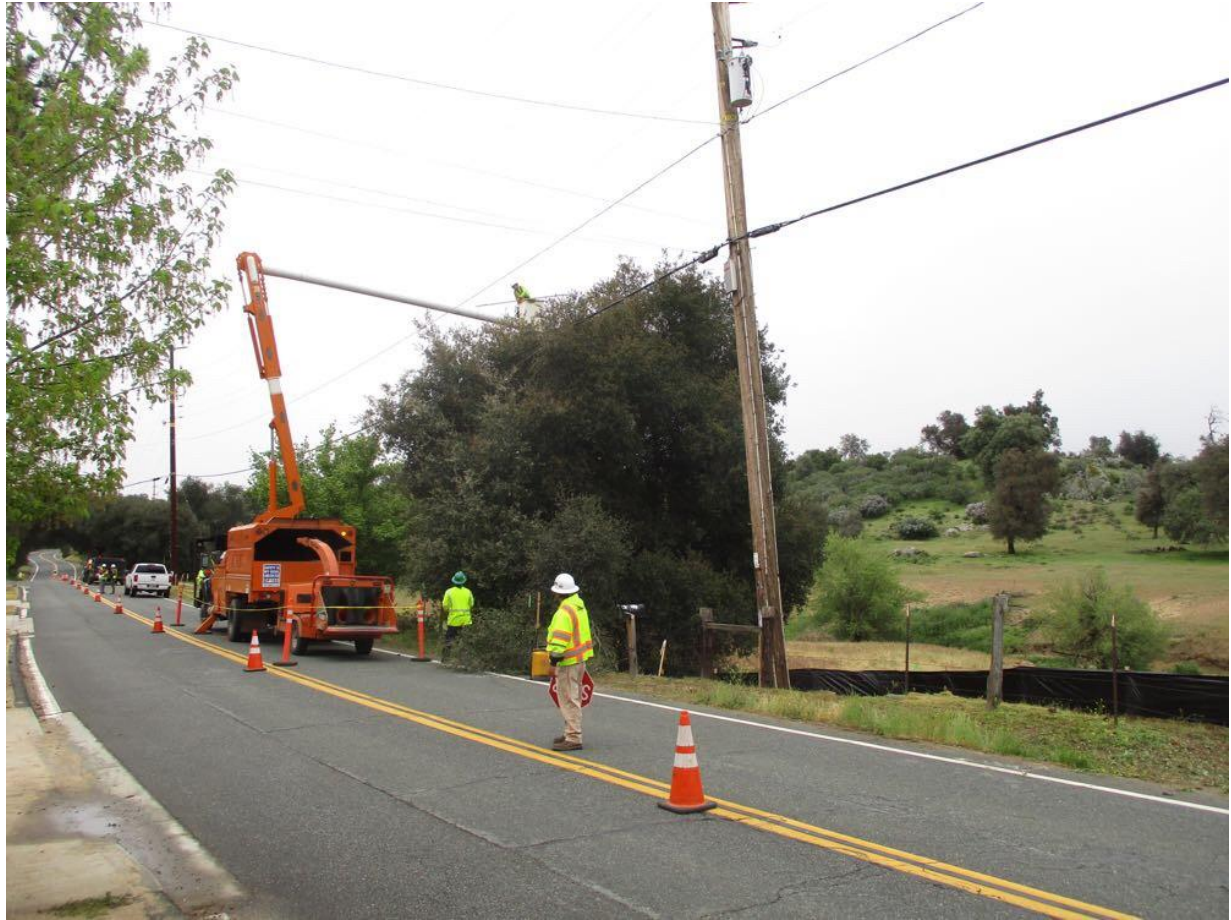
**Photo 4:** Oak trimming activities by a construction crew were observed near Pole Z173041 (TL 629A). Traffic personnel were observed conducting traffic control along Viejas Blvd (within 0.5 miles of the Descanso Elementary School) until approximately 0935h, at which point traffic control and construction activities dependent on the lane closure ceased. The cones and flaggers were not demobilized until 30 minutes after school was in session in accordance with the Traffic Control Plan.

Traffic control measures were observed being implemented in accordance with APM TRANS-02 during this reporting period. Traffic flaggers were observed directing one-way traffic along Viejas Boulevard on TL 629A while construction crews trimmed oak trees to provide clearance for work along the line (see Photo 4 – Attachment A). ECMs observed the completion of these construction activities within a half-mile radius of Descanso Elementary School at approximately 0935h. The cones and flaggers were not demobilized until 30 minutes after school was in session in accordance with the Traffic Control Plan (TCP) (APM TRANS-05).

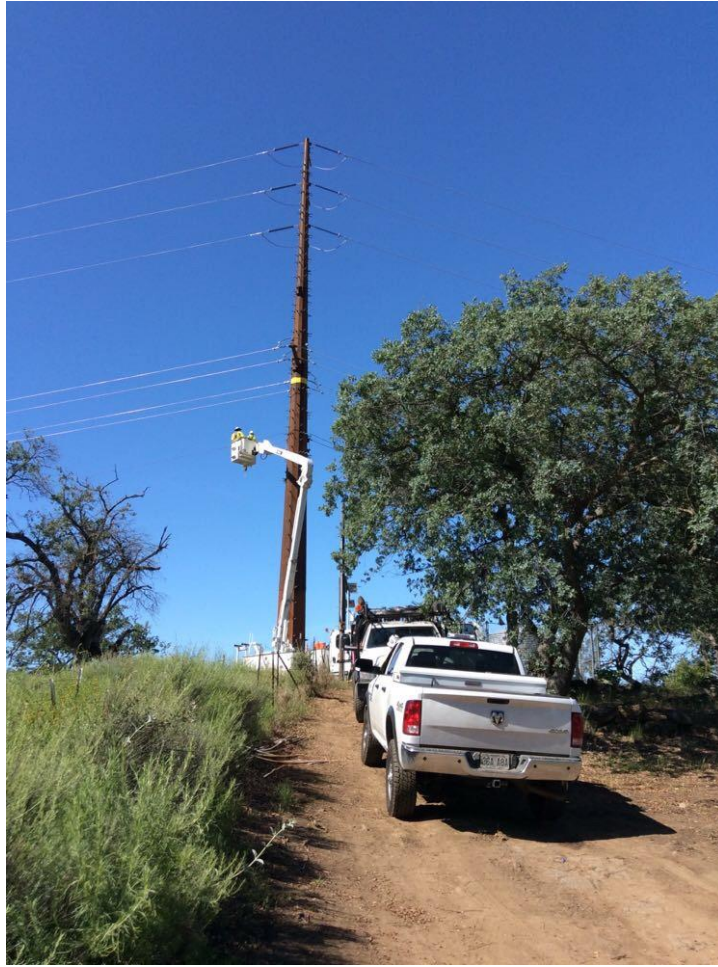
**Photo 5:** A construction crew was observed conducting dead-end activities (overhead work) on a line at Pole Z118027 (TL 682). The crew was observed performing work within the access road and only in approved work limits in accordance with MM BIO-1.

Approved workspaces were observed delineated with staking and flagging, and work crews were observed adhering to work space limits and staying on approved access roads in accordance with MM BIO-1 (see Photo 5 – Attachment A). Workers were observed having completed the Worker Environmental Awareness Program (WEAP), as shown by project hard hat stickers in accordance with MM BIO-2, and biological monitors were observed conducting full-time monitoring of initial ground-disturbing activities on TL 629A while vegetation clearing and SWPPP BMP installation took place to ready workspaces in accordance with MM BIO-3. The application of hydromulch to completed construction areas was observed in several locations along TL 629C in accordance with MM BIO-4 and the Habitat Restoration Plan (see Photo 6 – Attachment A). To prevent wildlife entrapment, following excavation or trenching activities, trenches and excavations were securely covered or backfilled in accordance with MM BIO-23 along C449 and TL 629A. A crew was observed containing food-related trash in secured trash bags and cans in work spaces along TL 629A while performing micropile drilling in accordance with MM BIO-26. ECMs observed construction crews avoiding Environmentally Sensitive Area (ESA) signage and flagging such as those for active nests along TL 629A. Approved avian biologists were observed monitoring active these nests and surveying, ahead of construction crews in accordance with the Avian Protection Plan/Nesting Bird Management Plan (APP/NBMP) and MM BIO-28.

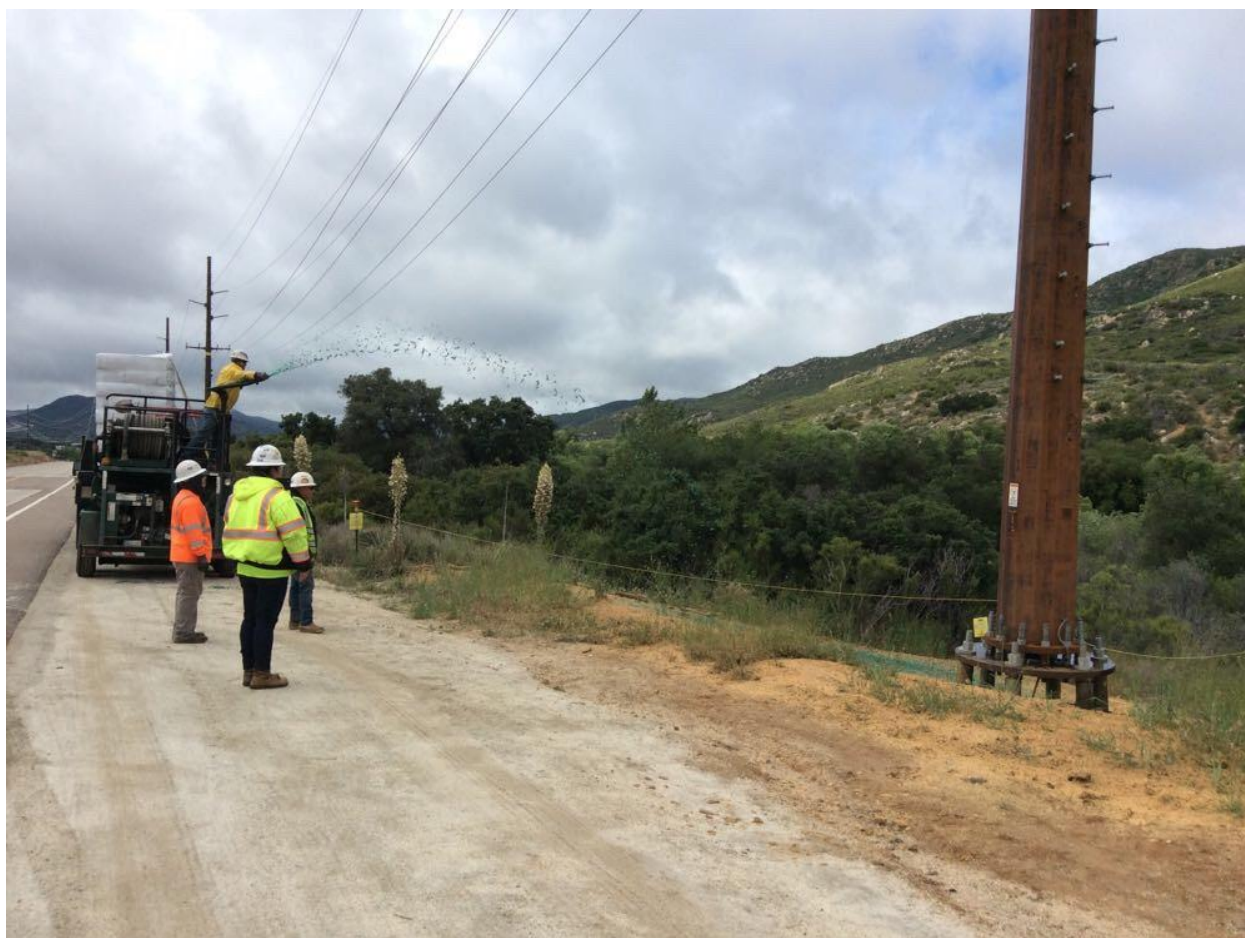
**Photo 6:** Application of hydro-mulch for restoring the native habitat was observed at Pole Z40512 (TL 629C) in accordance with MM BIO-4. An archaeological monitor was also observed monitoring the activities in accordance with the HPMP, APM CUL-04, and MM CUL-1.
