California Public Utilities Commission <i>Mitigation Monitoring, Compliance, and Reporting</i> <i>Program</i>
	Cleveland National Forest Power Line Replacement Projects Compliance Status Report: 070 June 2, 2019

This compliance status report covers construction activities from May 20, 2019 through June 2, 2019.

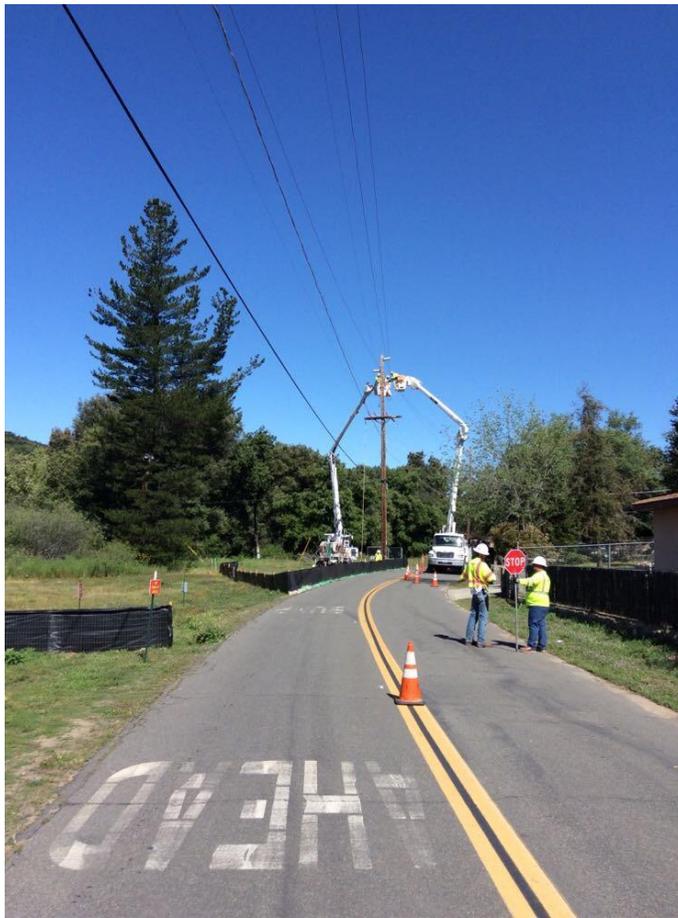
Photo 1: A construction crew was observed spreading wire at Pole Z172804 (TL 629A). Flagmen and signs were used to regulate traffic and maintain a safe transportation corridor in accordance APM TRANS-02. Exclusionary fencing for arroyo toad was observed to be secure and in good condition in accordance with APM BIO-3.

Traffic control measures were observed being implemented along TL 629A. Traffic flaggers were observed directing one-way traffic during overhead wire spreading along River Drive to maintain a safe travel corridor for motorists in accordance with APM TRANS-02 (see Photo 1 – Attachment A). Similarly, one-way traffic was directed by traffic flaggers during tree trimming activities in accordance with the Traffic Control Plan (TCP) (APM TRANS-05) (see Photo 3 – Attachment A).

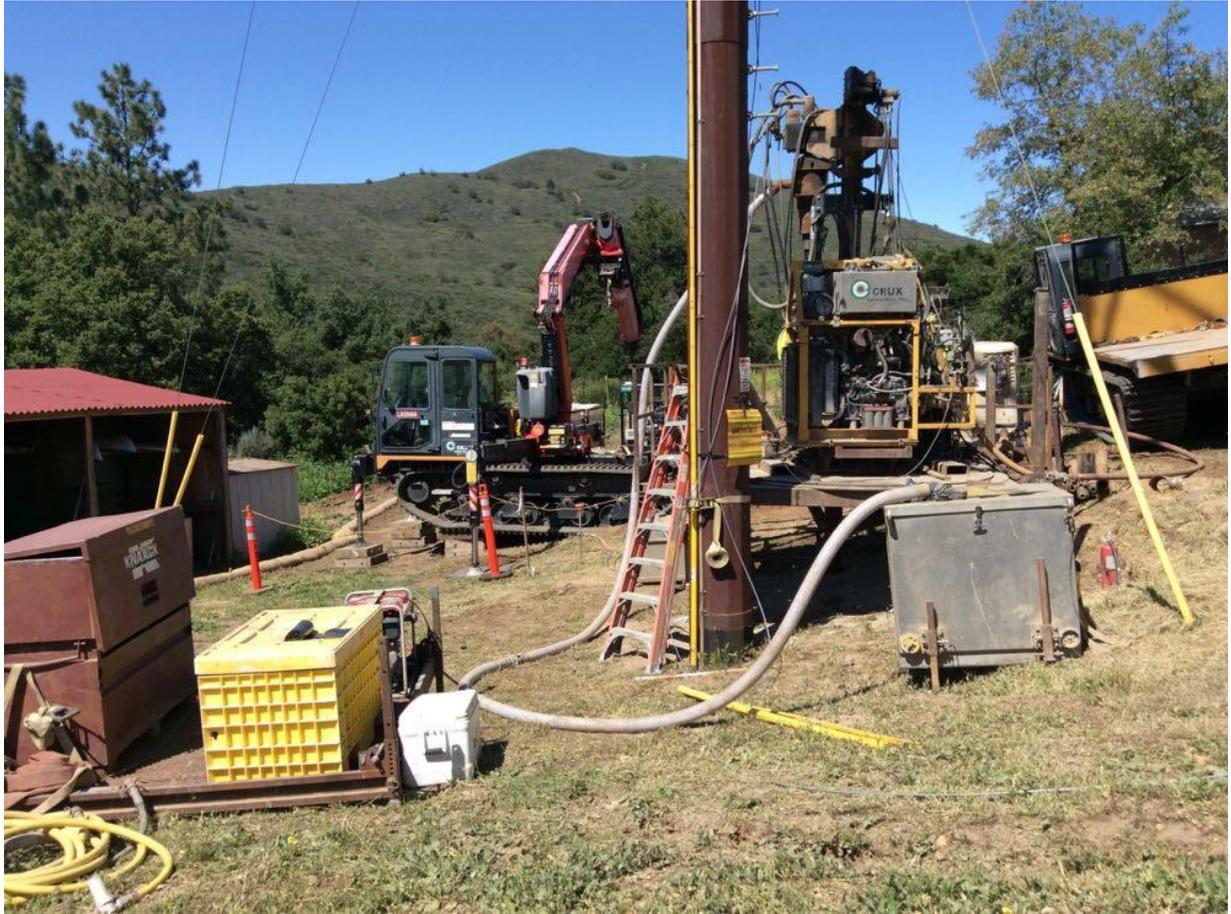
Photo 2: A containment box was used to trap drill cuttings during micropile drilling in order to reduce dust emissions at Z173104 (TL 629A) in accordance with APM AIR-05. Fuel for the micropile equipment was observed stored within a double-walled cell to prevent the release of hazardous materials onto the ground in accordance with MM PHS-2.

To prevent fugitive dust emissions during project activities in accordance with APM AIR-05, a crew was observed using a containment box to trap drill cutting from micropile drilling along TL 629A (see Photo 2 – Attachment A). Additionally, project personnel were observed maintaining the posted speed limit of 15 miles per hour on unpaved roads in accordance with APM AIR-03 and MM BIO-24.

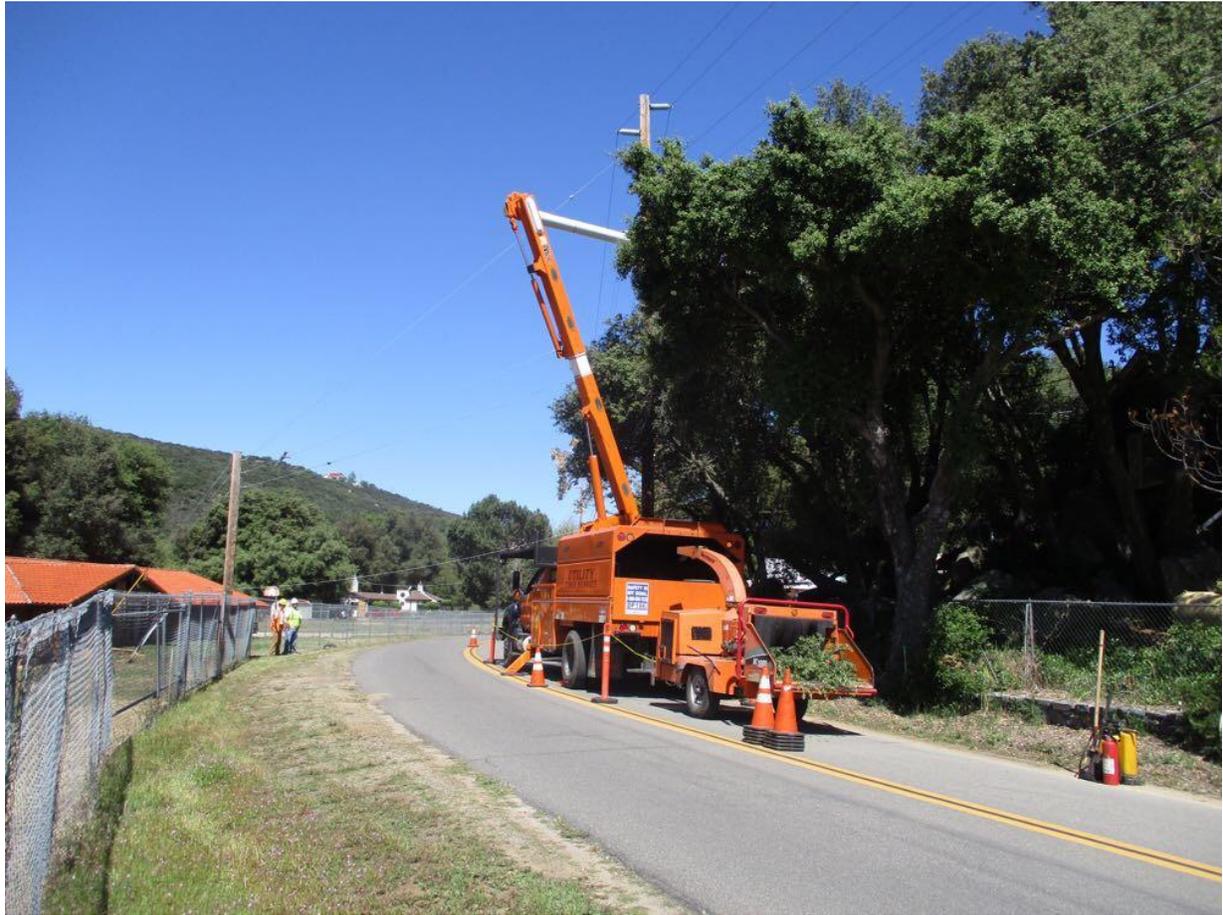
Photo 3: During tree trimming at Pole Z172807 (TL 629A), archaeological and cultural monitors were observed on site in accordance with the HPMP, MM CUL-1, and APM CUL-04. Construction personnel conducted a lane closure and traffic flaggers directed one-way traffic when necessary in accordance with the Traffic Control Plan (APM TRANS-05). A complete set of fire tools was staged on site (5-gallon backpack pump, round point shovel, Pulaski, and 2A10BC fire extinguisher) in accordance with the CFPPP (MM FF-1).

In accordance with the Construction Fire Protection/Prevention Plan (CFPPP) (MM FF-1), all project-related vehicles and equipment were observed carrying the required set of fire tools (including a 5 gallon backpack pump, round point shovel, Pulaski, and 2A10BC fire extinguisher) and these tools were observed within 50 feet of work activities (see Photo 3 – Attachment A).

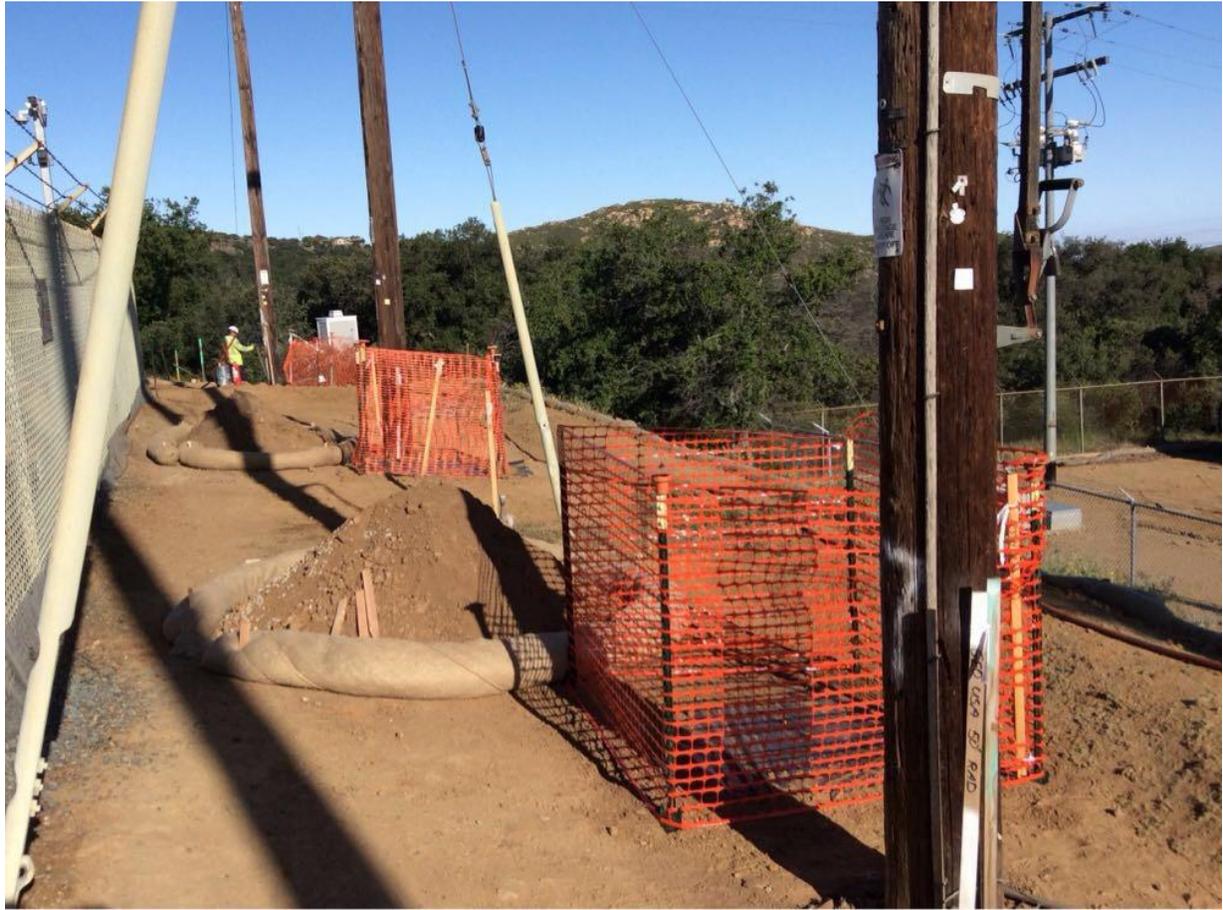
Photo 4: Spoils from pole excavations occurring along TL 629A were stabilized with fiber rolls in accordance with the Erosion Control Plan and SWPPP (MM HYD-1, MM BIO-7) and excavations were securely covered in accordance with MM BIO-23.

To prevent impacts to hydrology and water quality, site-specific sediment and erosion control BMPs were observed being implemented and maintained along project alignments in accordance with the project Erosion Control Plan (ECP) and SWPPP (MM HYD-1, MM BIO-7) and APM HYD-09. Fiber rolls and silt fencing were observed being used as perimeter controls at drilling and pole replacement sites (see Photo 1 and 2 – Attachment A). Groundwater encountered during micropile drilling along TL 629A was observed discharged to land via filter bags in accordance with APM HYD-08 and additional fiber rolls were observed placed around the filter bags for additional erosion control. Crews were observed covering soil stockpiles to prevent erosion in accordance with MM HYD-1 and MM BIO-7 (see Photo 4 – Attachment A).

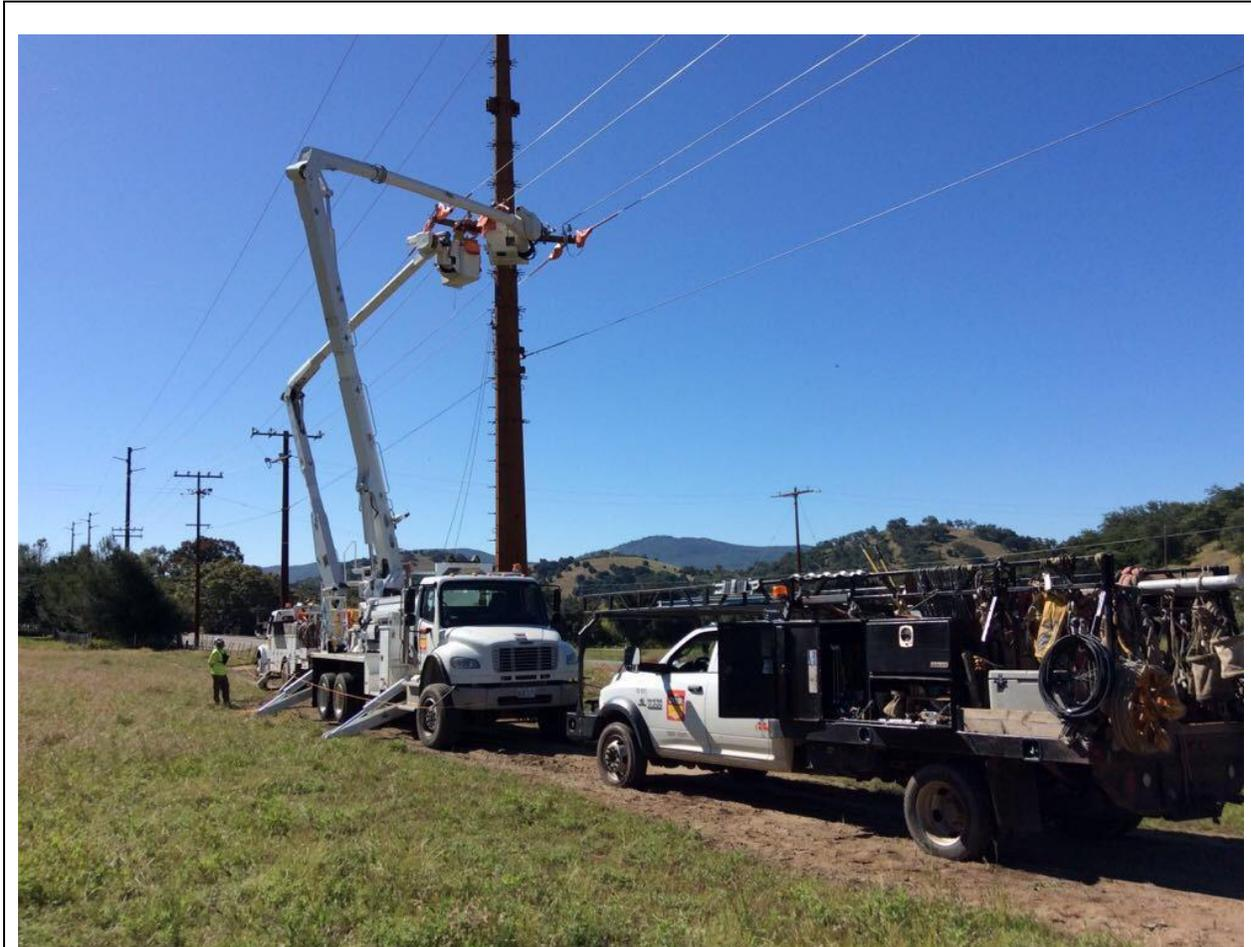
Photo 5: A construction crew was observed removing temporary disconnects at Pole Z128035 on TL 682. Construction work occurred within the work limits and approved access road in accordance with MM BIO-1.

During this reporting period along TL 629A, CPUC ECMs observed construction crews readying work spaces for drilling. This included trimming trees for line and pole clearance, clearing ground vegetation, potholing, setting up drill platforms, spreading wire for drill space, and installing Storm Water Pollution Prevention Plan (SWPPP) Best Management Practices (BMPs) at various pole locations (see Photos 1 through 4 – Attachment A). Additionally, crews were observed conducting trenching for the installation of ground rods and micropile foundation drilling at pole sites. Along TL 6958, construction crews were observed performing overhead work at various pole sites, which included spotting poles, conducting cutover prep work, and repairing an insulator. Along TL 682, ECMs observed crews removing temporary disconnects at several poles, conducting punch-list work, and fixing insulators (see Photo 5 – Attachment A).

Approved workspaces were observed delineated with staking and flagging, and work crews were observed adhering to work space limits and staying on approved access roads in accordance with MM BIO-1 (see Photo 5 – Attachment A). Biological monitors were observed monitoring work sites when initial ground-disturbing or vegetation-removal activities were taking place in accordance with MM BIO-3 and MM BIO-22. During construction and overhead activities along TL 629A, previously-installed arroyo toad (*Anaxyrus californicus*) exclusionary fencing (APM BIO-03) was observed intact (see Photo 1 – Attachment A) and Environmentally Sensitive Area (ESA) signage and flagging per MM BIO-14 and MM BIO-16 were observed in place and ESAs were observed being avoided. To prevent wildlife entrapment, trenches and excavations were observed securely covered or backfilled in accordance with MM BIO-23 along TL 6958 and TL 629A (see Photo 4 – Attachment A). A crew was observed containing food-related trash in secured trash bags and cans in work spaces along TL 629A while performing micropile drilling in accordance with MM BIO-26. Approved avian biologists were observed conducting pre-construction sweeps and monitoring active nests prior to vegetation removal and tree trimming activities along TL 629A and prior to overhead work along TL 6958 in accordance with the Avian Protection Plan/Nesting Bird Management Plan (APP/NBMP) and MM BIO-28 (see Photo 6 – Attachment A).

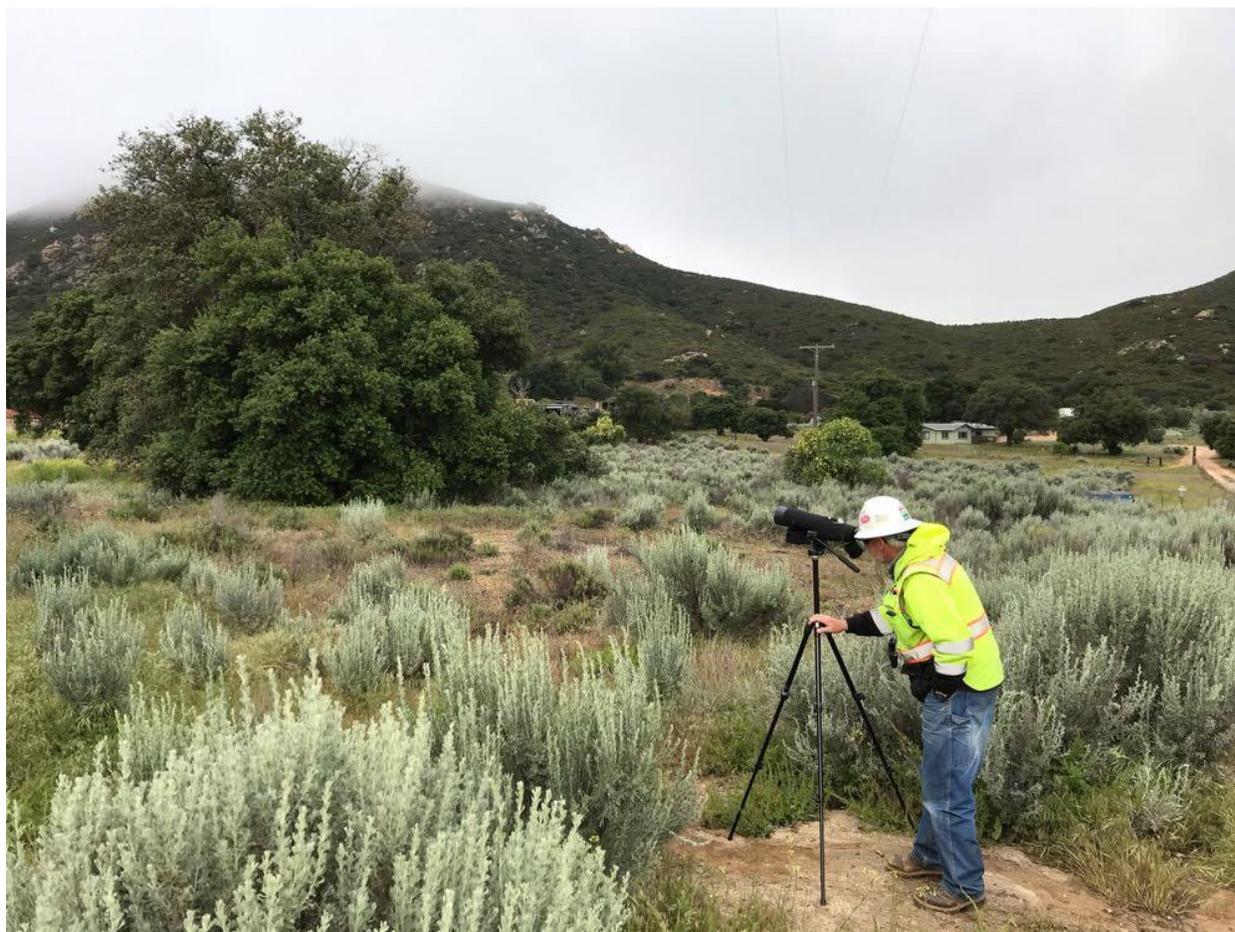
Photo 6: An approved avian biologist was observed monitoring a red-tailed hawk (*Buteo jamaicensis*) nest during overhead work being performed near Pole Z40987 (TL 6958) in accordance with the APP/NBMP and MM BIO-28.
