California Public Utilities Commission <i>Mitigation Monitoring, Compliance, and Reporting</i> <i>Program</i>
	Cleveland National Forest Power Line Replacement Projects Compliance Status Report: 071 June 16, 2019

This compliance status report covers construction activities from June 3, 2019 through June 16, 2019.

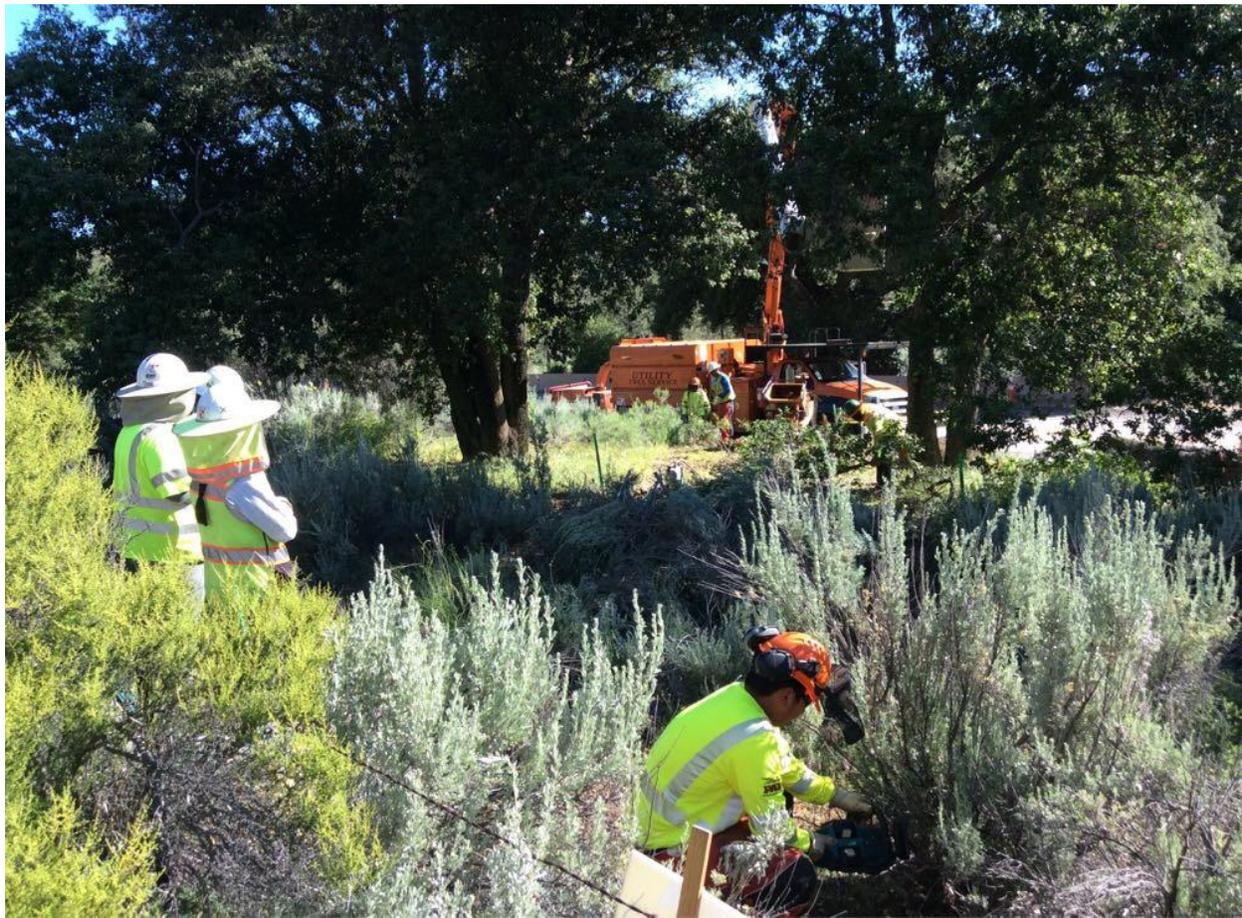
Photo 1: A biological, archaeological, and Native American monitor were observed monitoring vegetation removal and chipping on the temporary access road to Pole Z40494 (TL 629A) in accordance with MM BIO-3, the HPMP, MM CUL-1, and APM CUL-04.

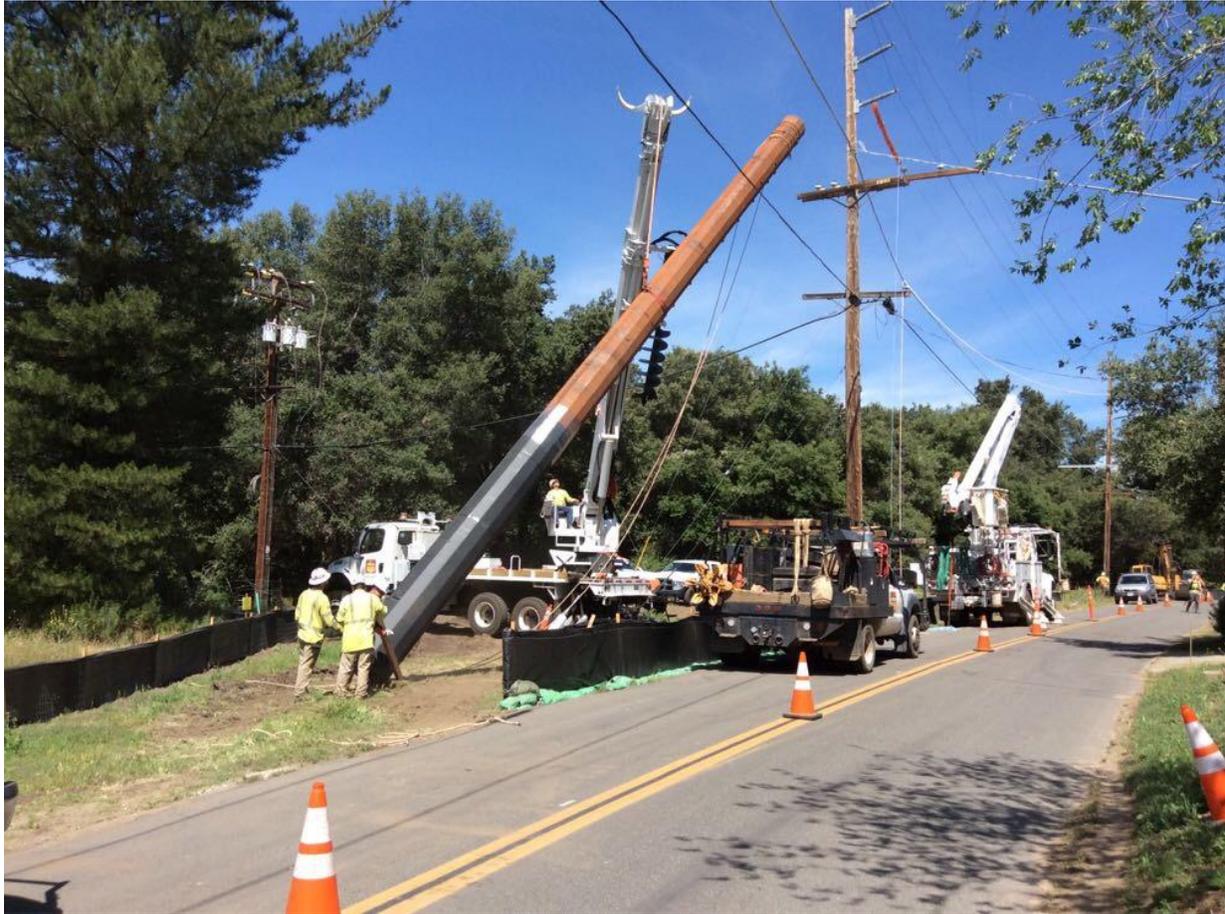
Photo 2: A construction crew was observed setting the pole base at Pole Z172804 (TL 629A). Cones, signage, and traffic flaggers were used to maintain a safe travel corridor for motorists in accordance with the Traffic Control Plan and APM TRANS-02. Arroyo toad exclusion fencing was observed in good condition with gravel bags in accordance with arroyo toad avoidance and minimization measures (APM BIO-03).

Traffic control measures were observed being implemented along TL 629A and C 440 during this reporting period. While setting pole bases on segment TL 629A, crews were observed while utilizing cones, signage, and traffic flaggers to maintain a safe travel corridor for motorists in accordance with APM TRANS-02 (see Photo 2 – Attachment A). Additionally, traffic control signage along Corral Canyon Truck Trail on C 440 was observed in accordance with the Traffic Control Plan (TCP) (APM TRANS-05) (see Photo 5 – Attachment A).

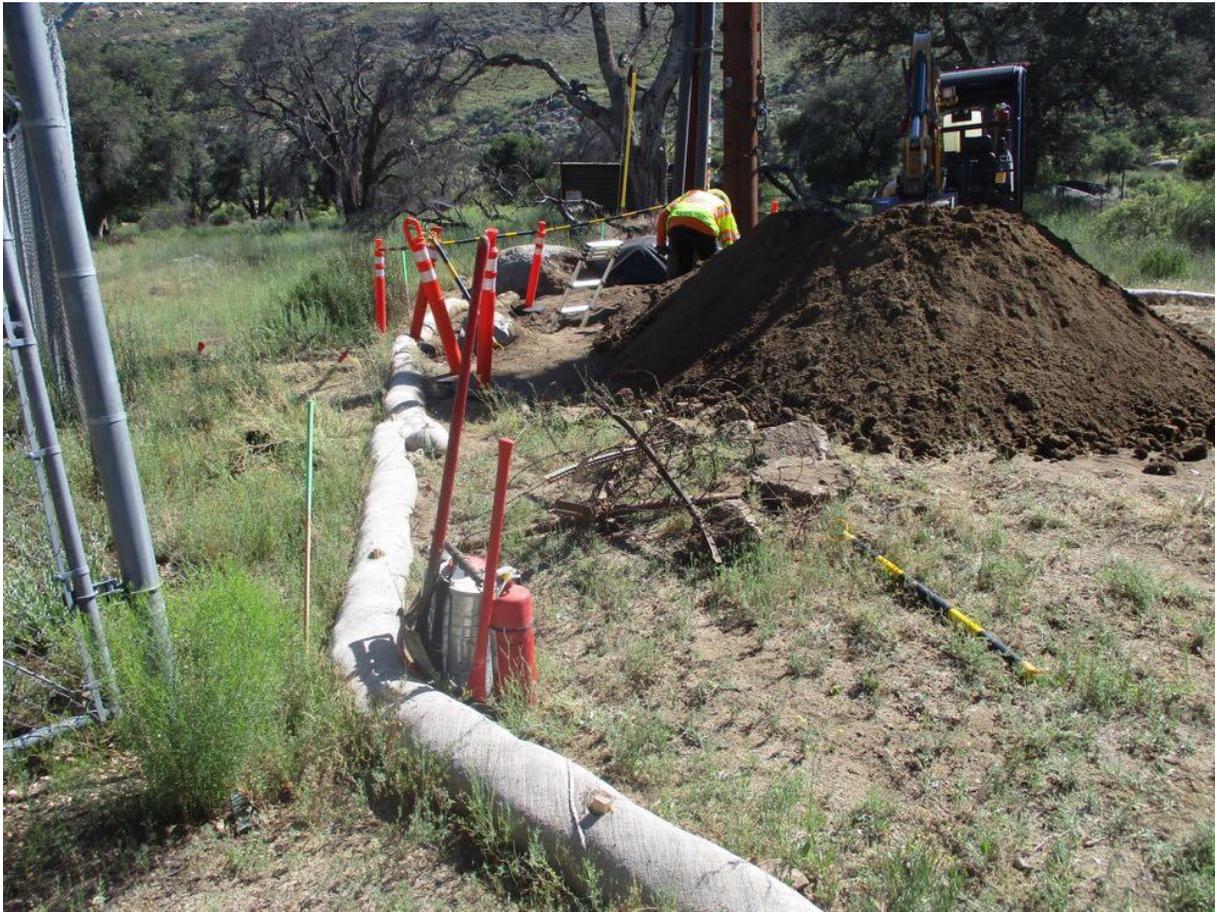
Photo 3: During excavation work to install intercepts at P161903 (C 449), perimeter fiber rolls were observed functional in accordance with the ECP and SWPPP. A complete set of fire tools was staged on site (5-gallon backpack pump, round point shovel, Pulaski, and 2A10BC fire extinguisher) in accordance with the CFPPP (MM FF-1).

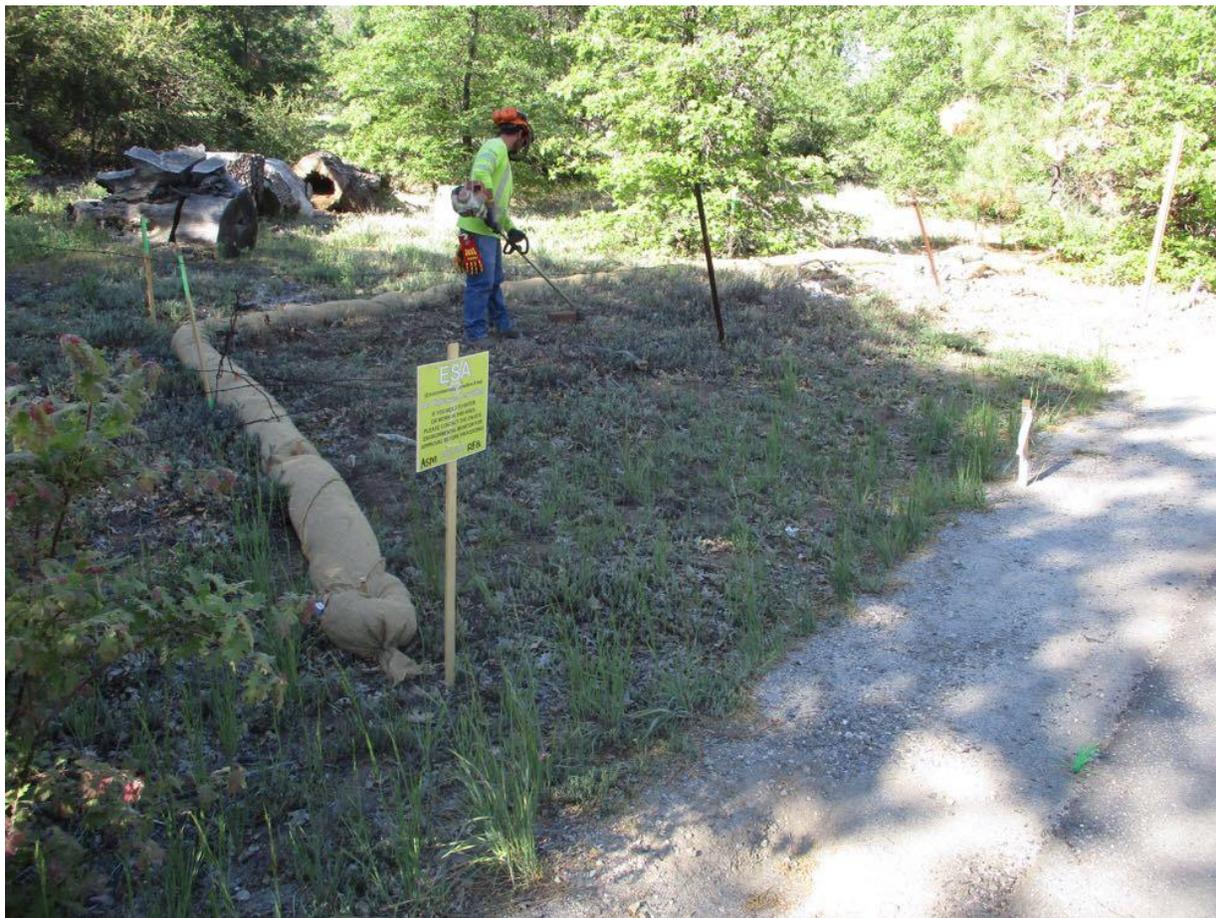
Photo 4: While a construction crew was performing vegetation clearing at a vault along C 440, ESA signs were posted to notify crews that cultural resource monitoring was required at this location per Appendix A of the HPMP. Staking and flagging clearly delineated approved workspace in accordance with MM BIO-1.

During this reporting period along TL 629A, CPUC ECMs observed construction crews readying work spaces by trimming trees, clearing ground vegetation, and installing Storm Water Pollution Prevention Plan (SWPPP) Best Management Practices (BMPs) at pole sites, stringing sites, and staging yards. Crews were observed conducting micropile foundation drilling, setting pole bases, installing ground rods and anchors, and spreading wire (see Photos 1 and 2 – Attachment A). Along C 449, ECMs observed construction crews re-paving along Buckman Springs Road where previous vault work was conducted, excavating for an intercept, and tightening and securing pole anchors at various pole sites (see Photo 3 – Attachment A). Additionally, ECMs observed construction crews conducting overhead work, which included sagging, dead ending, and clipping 12 kV wire. Along C 440 Phase I, construction crews were observed surveying and marking workspaces, installing sediment and erosion BMP, and clearing vegetation in preparation for upcoming vault installation activities (see Photo 4 – Attachment A).

CPUC ECMs observed cultural resource monitors, including archaeological and Native American Monitors, monitoring construction activities occurring within or adjacent to identified archaeological or cultural resource site boundaries in accordance with the Historic Properties Management Plan (HPMP), MM CUL-1, MM CUL-3, and APM CUL-04 (see Photo 4 – Attachment A).

a 5 gallon backpack pump, round point shovel, Pulaski, and 2A10BC fire extinguisher) and these tools were observed within 50 feet of work activities (see Photo 4 – Attachment A). Designated fire patrols with 100-150 gallons of water were observed mobilized along TL 629A, C 449, C 440 while construction crews performed overhead work, tree trimming, vegetation removal, and wire stringing activities in accordance with the fire prevention matrix in the CFPPP.

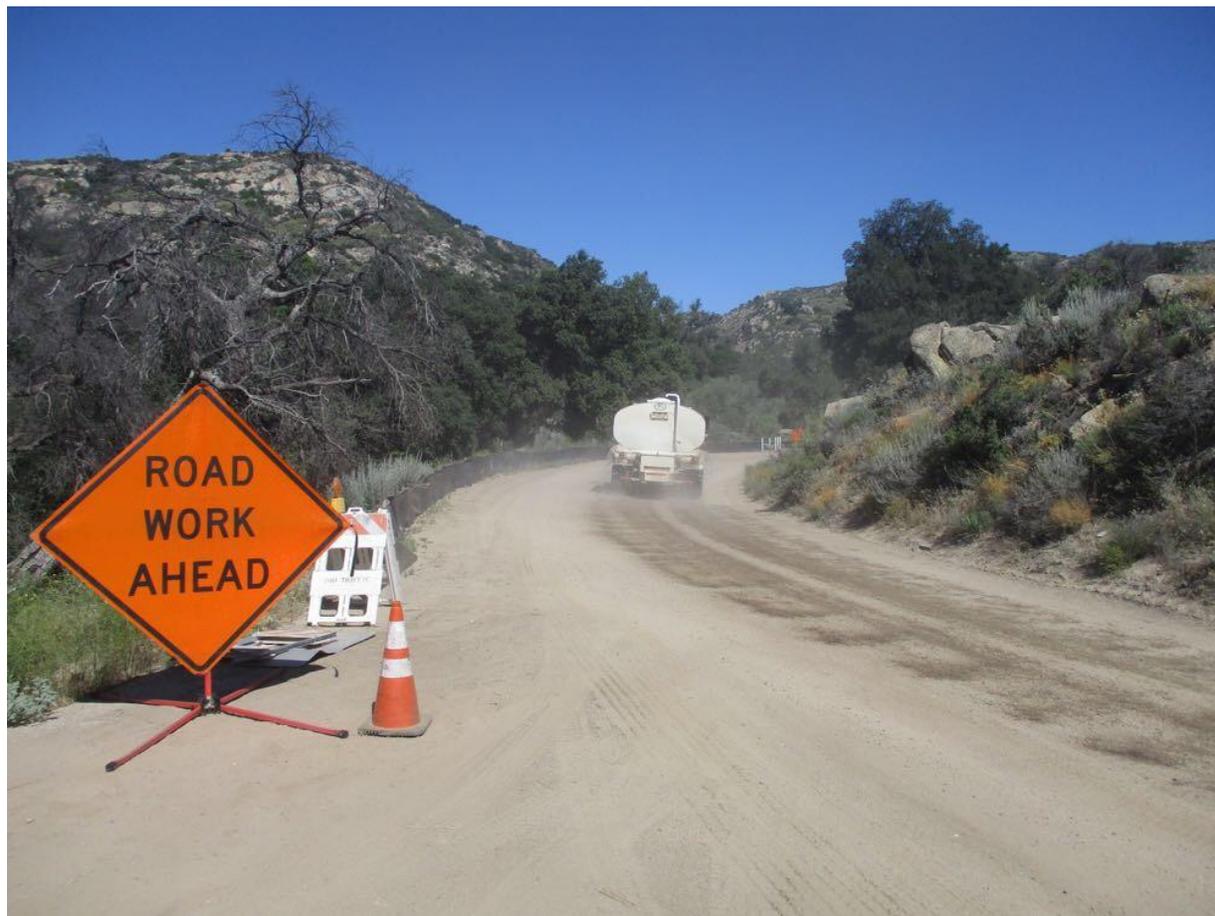
Photo 5: A water truck was observed being used to control fugitive dust emissions along Corral Canyon Truck Trail in accordance with APM AIR-02 and APM AIR-05. Traffic control signage was also observed along the road in accordance with the Traffic Control Plan.

To prevent fugitive dust emissions during project activities, construction crews were observed watering down access routes and active construction areas in accordance with APM AIR-02 (see Photo 5 – Attachment A) and street sweeping to remove mud and debris from Sunrise Highway (C 440). Project personnel were observed maintaining posted speeds of 15 miles per hour on unpaved roads in accordance with APM AIR-03 and MM BIO-24.

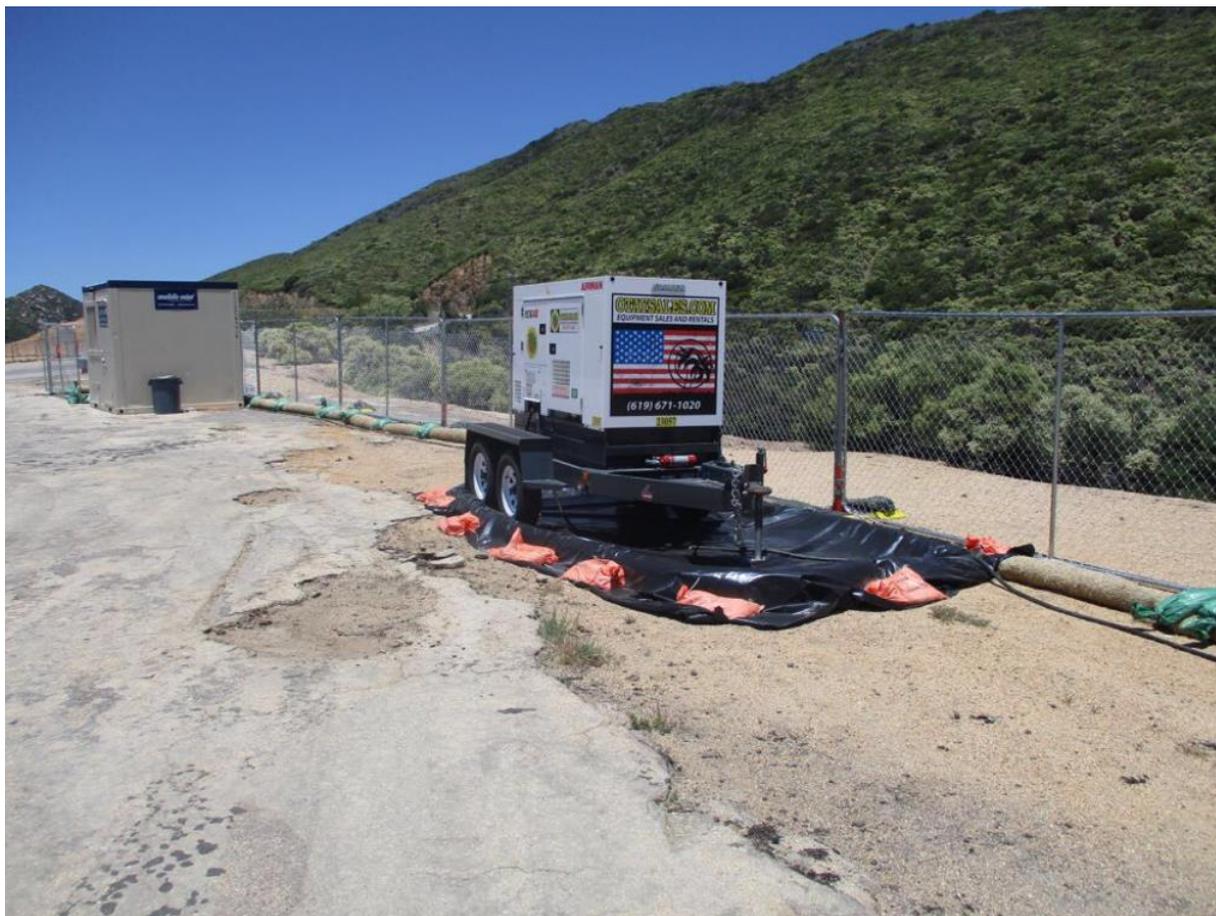
Photo 6: Visqueen was observed staged beneath a stationary generator at a C 440 staging yard for drip and spill protection in accordance with the SRNP and MM PHS-2.

To prevent leaks and spills from being discharged into the soil, construction crews were observed implementing spill prevention BMPs in accordance with the Spill Response and Notification Plan (SRNP) and MM PHS-2. Visqueen and drip pans were observed to be utilized under stationary generators and heavy equipment to prevent leaks and spills of hazardous liquids (see Photo 6 – Attachment A).
