<p><b>California Public Utilities Commission</b>  <b><i>Mitigation Monitoring, Compliance, and Reporting</i></b>  <b><i>Program</i></b></p>
	<p><b>Cleveland National Forest Power Line Replacement</b>  <b>Projects</b></p>
	<p><b>Compliance Status Report: 073</b>   <b>July 14, 2019</b></p>

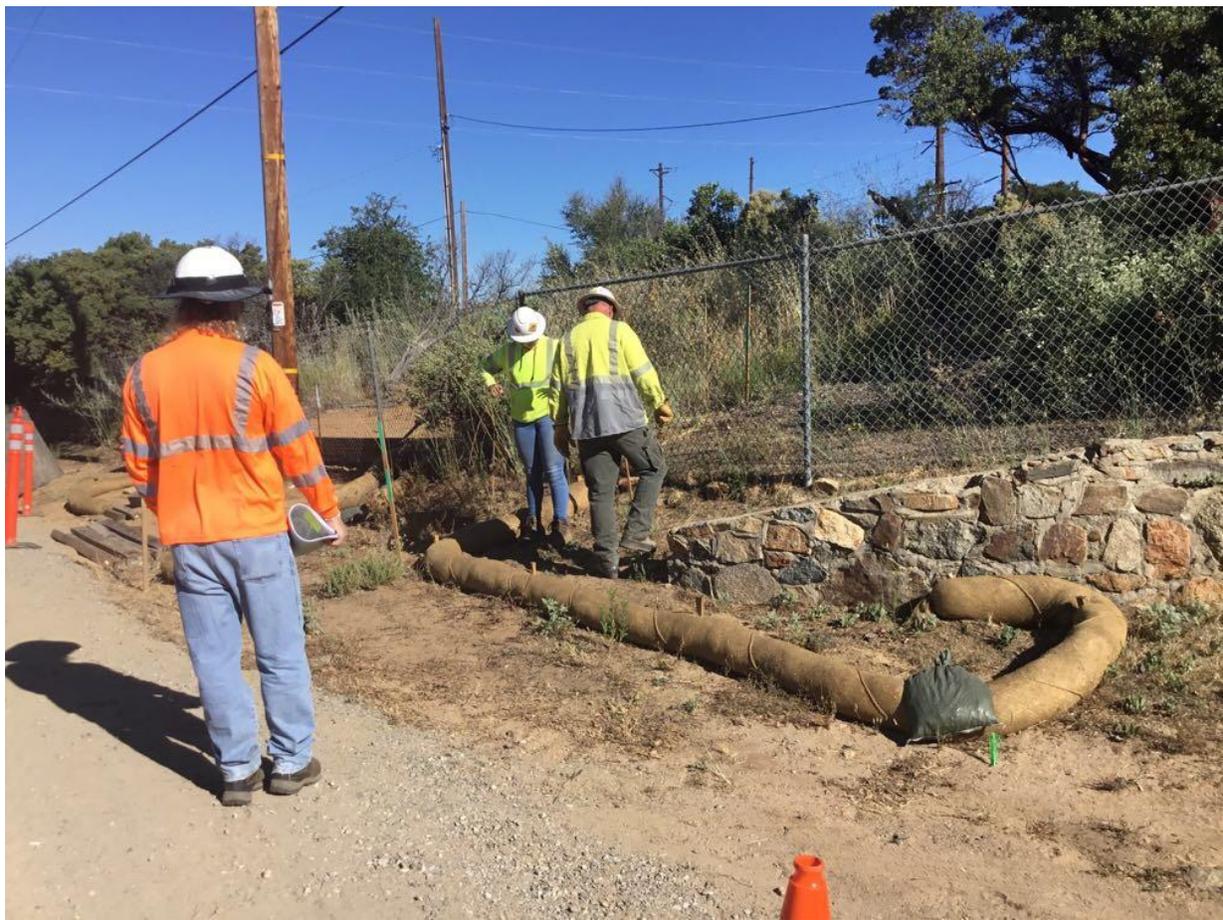
**Photo 1:** A biological monitor was observed clarifying the work limits to construction crew members at an anchor installation site associated with Pole P163905 (TL 629A) in accordance with MM BIO-22. Additionally, the workspace was observed to be clearly delineated with staking in accordance with MM BIO-1.

During this reporting period along TL 629A, CPUC ECMs observed construction crews installing Storm Water Pollution Prevention Plan (SWPPP) Best Management Practices (BMPs), conducting micropile foundation drilling, installing anchors, and cleaning-out pole hole locations (see Photos 1 through 2 – Attachment A). Near the Descanso substation (TL 629A), construction crews were observed installing poles, wire stringing, and setting up to remove circuits. At the Merrigan Staging Yard (TL 629A), crews were observed conducting vegetation removal. Along C 440, ECMs observed construction crews surveying work areas, marking underground alignments, removing vegetation, and installing BMPs. When fire risk conditions allowed such activity in accordance with the Construction Fire Protection/Prevention Plan (CFPPP) (MM FF-1), construction crews were observed excavating and grinding vault sites, placing shoring, and preparing a vault setting (see Photo 3 – Attachment A). Along C 449, construction crews were observed conducting 12 kV termination work, which included splicing underground distribution lines at a vault (see Photo 4 – Attachment A). Along TL 6957, ECMs observed construction crews closing out workspaces and installing or maintaining various erosion controls, including maintaining water bars and energy dissipaters (see Photo 5 – Attachment A), installing jute netting, and application of hydraulic mulch at various post-construction sites (see Photo 6 – Attachment A).

Approved workspaces were observed delineated with staking and flagging, and work crews were observed adhering to work space limits and staying on approved access roads in accordance with MM BIO-1 (see Photo 1 – Attachment A). Workers were observed having completed the Worker Environmental Awareness Program (WEAP), as shown by project hard hat stickers in accordance with MM BIO-2, and biological monitors were observed conducting full-time monitoring of initial ground-disturbing activities such as vegetation removal along TL 629A and C 440 in accordance with MM BIO-3, as well as general biological monitoring (MM BIO-22) (see Photo 1 – Attachment A). ECMs observed the application of hydromulch at completed work sites along TL 6957 (see Photo 6 – Attachment A) in accordance with the Habitat Restoration Plan (HRP) (MM BIO-4). Environmentally Sensitive Area (ESA) signs were observed along access roads on TL 6957 marking the presence of Quino checkerspot butterfly (QCB) host plants to be avoided by construction crews in accordance with MM BIO-16. Following vault excavations along C 440, excavations were securely covered or backfilled and prevented wildlife entrapment in accordance with MM BIO-23. On July 10<sup>th</sup>, an ECM observed loose trash located adjacent to bins at the Merrigan Staging Yard and notified the on-site biological monitor. The biological monitor informed project personnel and later that day the trash was observed removed in accordance with MM BIO-26. ECMs observed pre-construction sweeps and monitoring in accordance with the Avian Protection Plan/Nesting

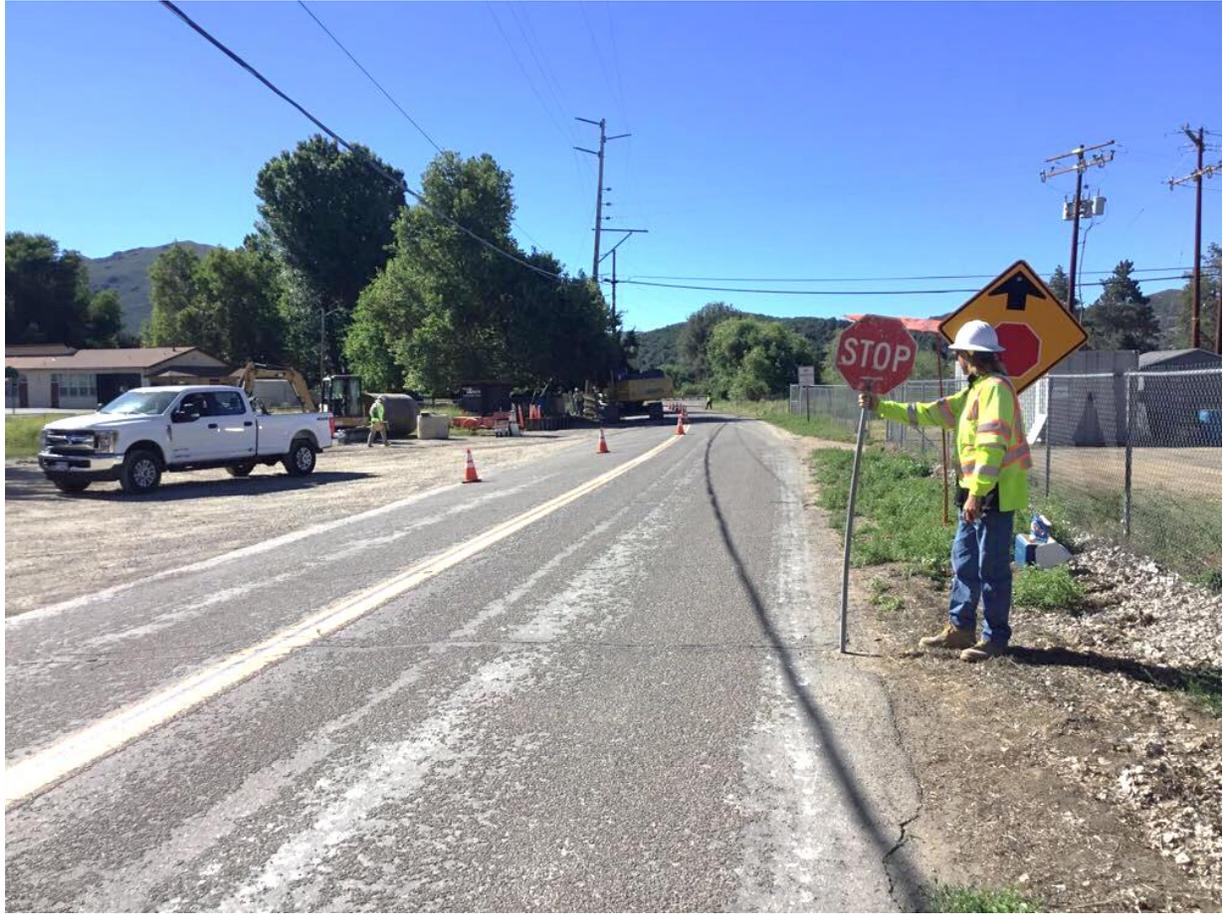
**Photo 2:** During micropile drilling operations along River Drive at Pole Z373253 (TL 629A). A traffic flagger was observed conducting a lane closure and directed one-way traffic in accordance with the TCP (APM TRANS-05) and APM TRANS-02.

Traffic control measures were observed being implemented in accordance with APM TRANS-02 during this reporting period. Traffic flaggers were observed directing one-way traffic around a work zone on TL 629A while construction crews mobilized micropile drilling equipment (see Photo 2 – Attachment A). ECMs observed the use of cones and traffic flagging on Buckman Springs Road (C 449) and Sunrise Highway (C 440) to facilitate overhead work and vault excavation, respectively. These activities were performed in accordance with the Traffic Control Plan (TCP) (APM TRANS-05).

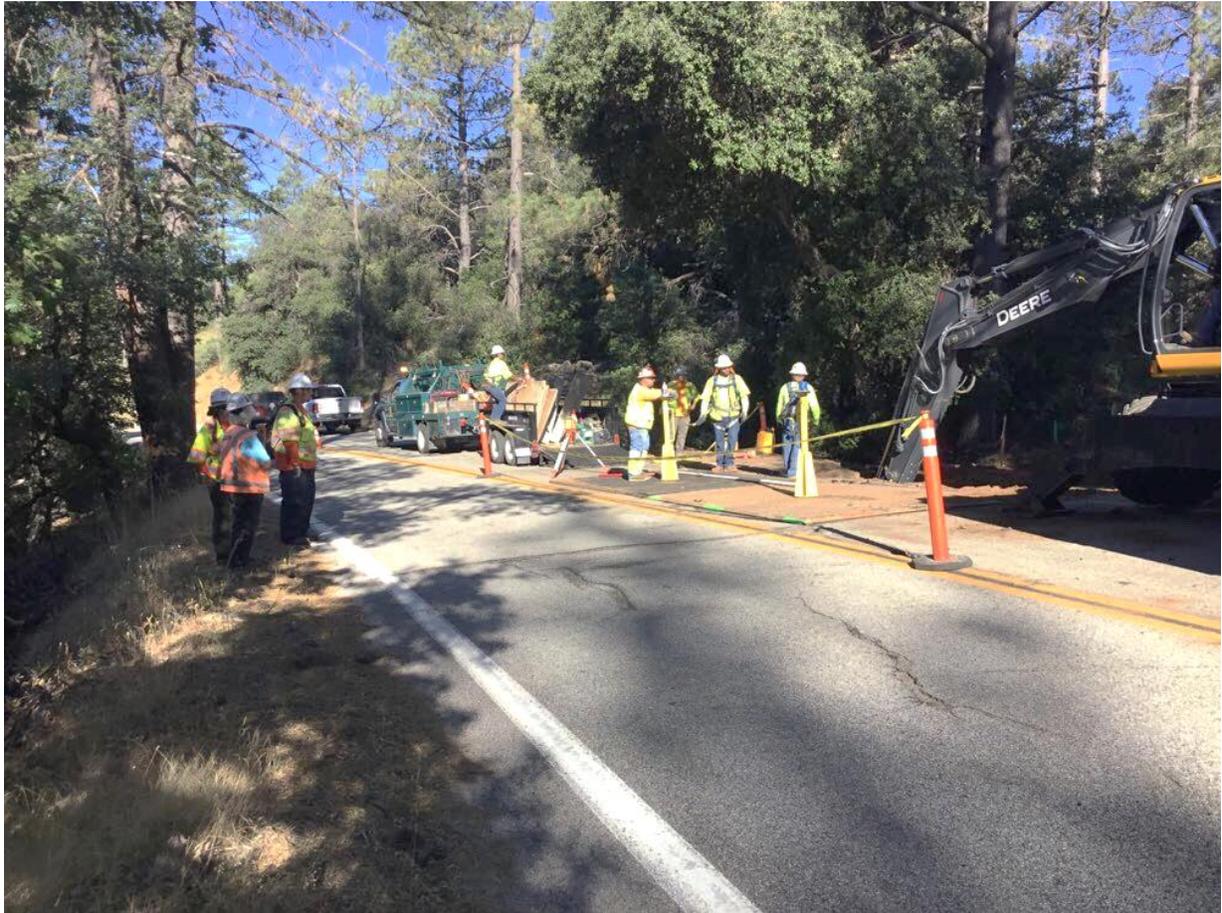
**Photo 3:** A biological, archaeological, and Native American monitor were present for the excavation of a vault site along Sunrise Highway (C 440) in accordance with MM BIO-22, MM CUL-1, APM CUL-04, and the HPMP.

CPUC ECMs observed cultural resource monitors, including archaeological and Native American monitors, monitoring construction activities that occurred within or adjacent to identified archaeological or cultural resource site boundaries in accordance with the Historic Properties Management Plan (HPMP), MM CUL-1, MM CUL-3, and APM CUL-04, including vault installations along C 440 (see Photo 3 – Attachment A).

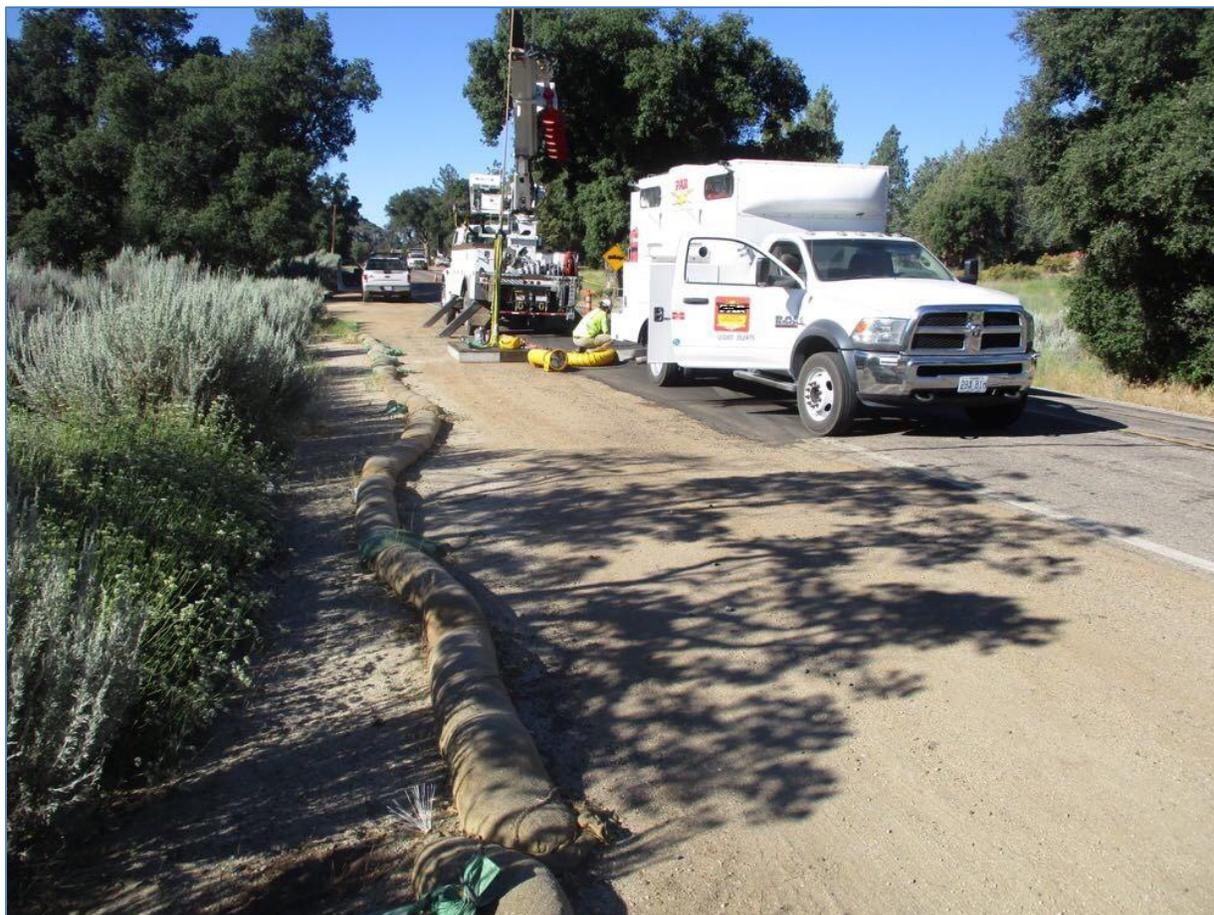
**Photo 4:** A construction crew was observed splicing 12 kV lines at a vault along C 449. Fiber rolls were observed along the work space in good condition in accordance with the ECP and SWPPP (MM HYD-1, MM BIO-7).

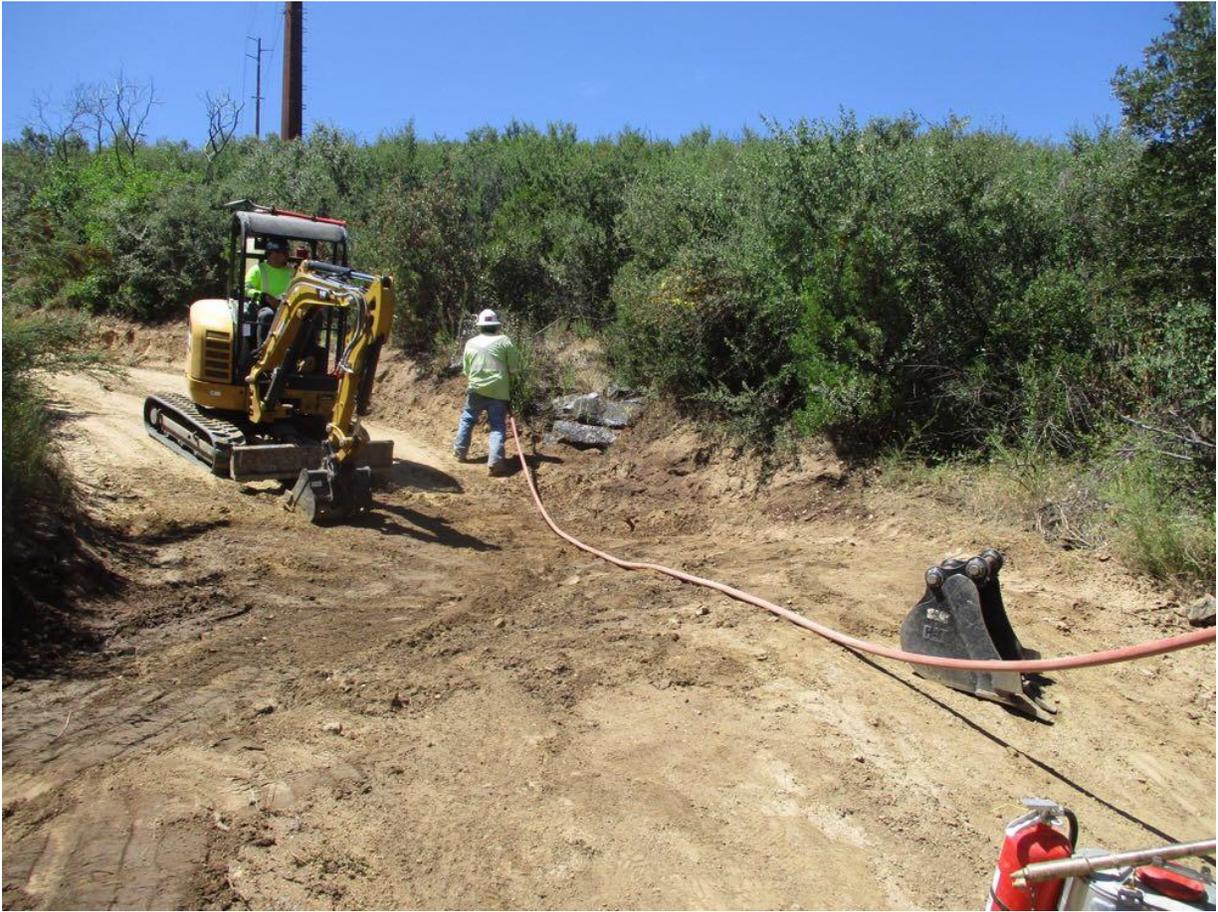
**Photo 5:** Crews were observed conducting erosion control work along the access road between Pole Z571454 (TL 6957) and Barrett Lake Road, such as maintaining a water bar and energy dissipater in accordance with MM HYD-4. The crew was observed watering the work area to prevent ignitions with a 150-gallon tank, pump, and hose. These activities were performed in accordance with the CFPPP fire prevention matrix for grading work on CNF land with a PAL of D. Additionally, a complete set of fire tools was staged on site (5-gallon backpack pump, round point shovel, Pulaski, and 2A10BC fire extinguisher) within 50 feet in accordance with the CFPPP (MM FF-1).

In accordance with the CFPPP (MM FF-1), all project- related vehicles and equipment were observed carrying the required set of fire tools (including a 5 gallon backpack pump, round point shovel, Pulaski, and 2A10BC fire extinguisher) and these tools were observed within 50 feet of work activities. ECMs observed activities occurring along project segments as allowed by CFPPP and fire prevention practices implemented during construction as required by the CFPPP (see Photo 5 – Attachment A).

To prevent impacts to hydrology and water quality, site-specific sediment and erosion control BMPs were observed being implemented and maintained along project alignments in accordance with the project Erosion Control Plan (ECP) and SWPPP (MM HYD-01, MM BIO-7) and APM HYD-09. Work areas along Buckman Springs Road (C 449) were observed to have secured erosion and sediment controls (such as natural fiber covering and fiber rolls per the SWPPP) in order to minimize sediment transport and slow the flow of potential runoff in accordance with the ECP and SWPPP (see Photo 4 – Attachment A). Additionally, ECMs observed crews conducting erosion control maintenance along an access road near Barrett Lake Road (TL 6957) in accordance to MM HYD-4 (see Photo 5 – Attachment A).

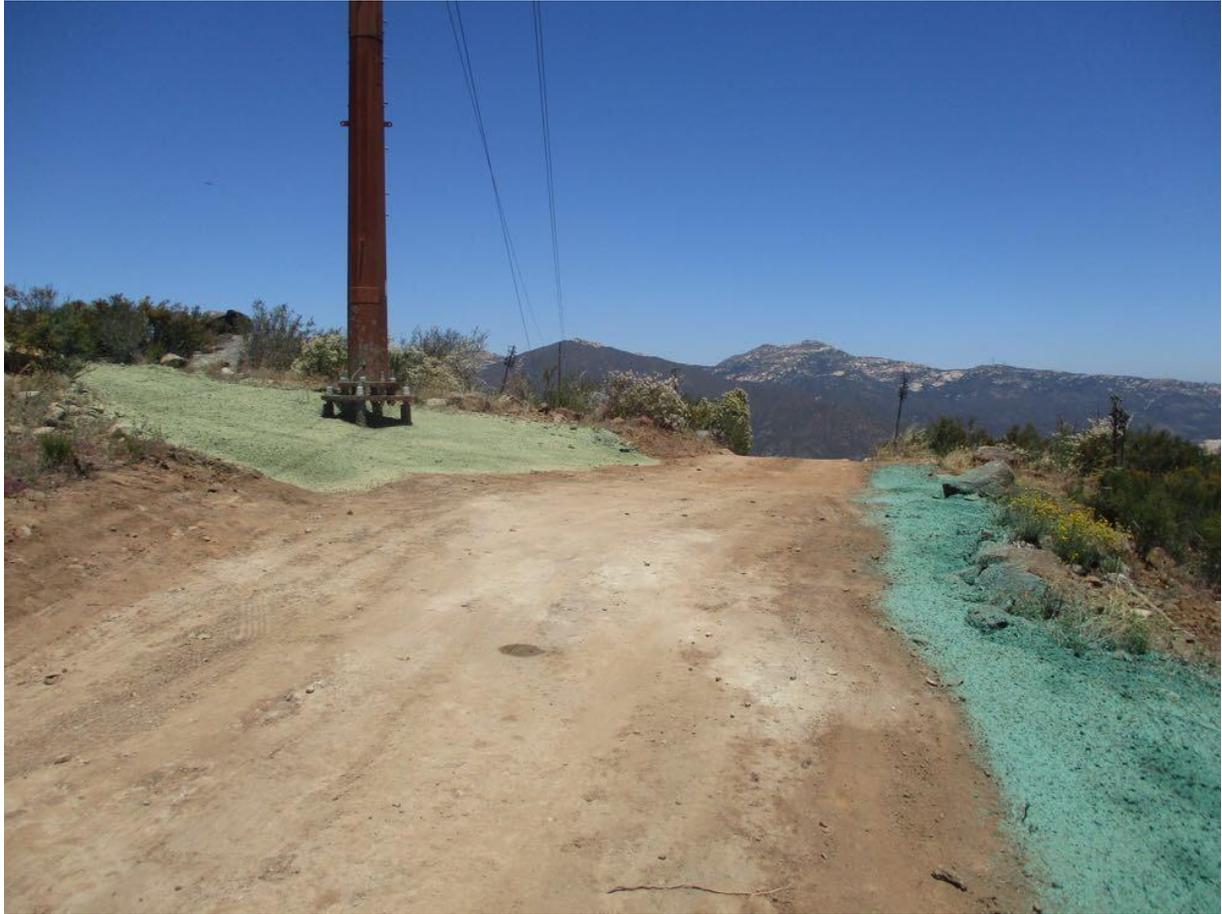
**Photo 6:** Hydraulic mulch was observed applied at completed Pole Z571463 (TL 6957) and along the access road for post-construction erosion control in accordance with the ECP, SWPPP, and HRP (MM HYD-1, MM BIO-9, MM BIO-4).
