<p>California Public Utilities Commission <i>Mitigation Monitoring, Compliance, and Reporting</i> <i>Program</i></p>
	<p>Cleveland National Forest Power Line Replacement Projects</p> <p>Compliance Status Report: 074</p> <p>July 28, 2019</p>

This compliance status report covers construction activities from July 15, 2019 through July 28, 2019.

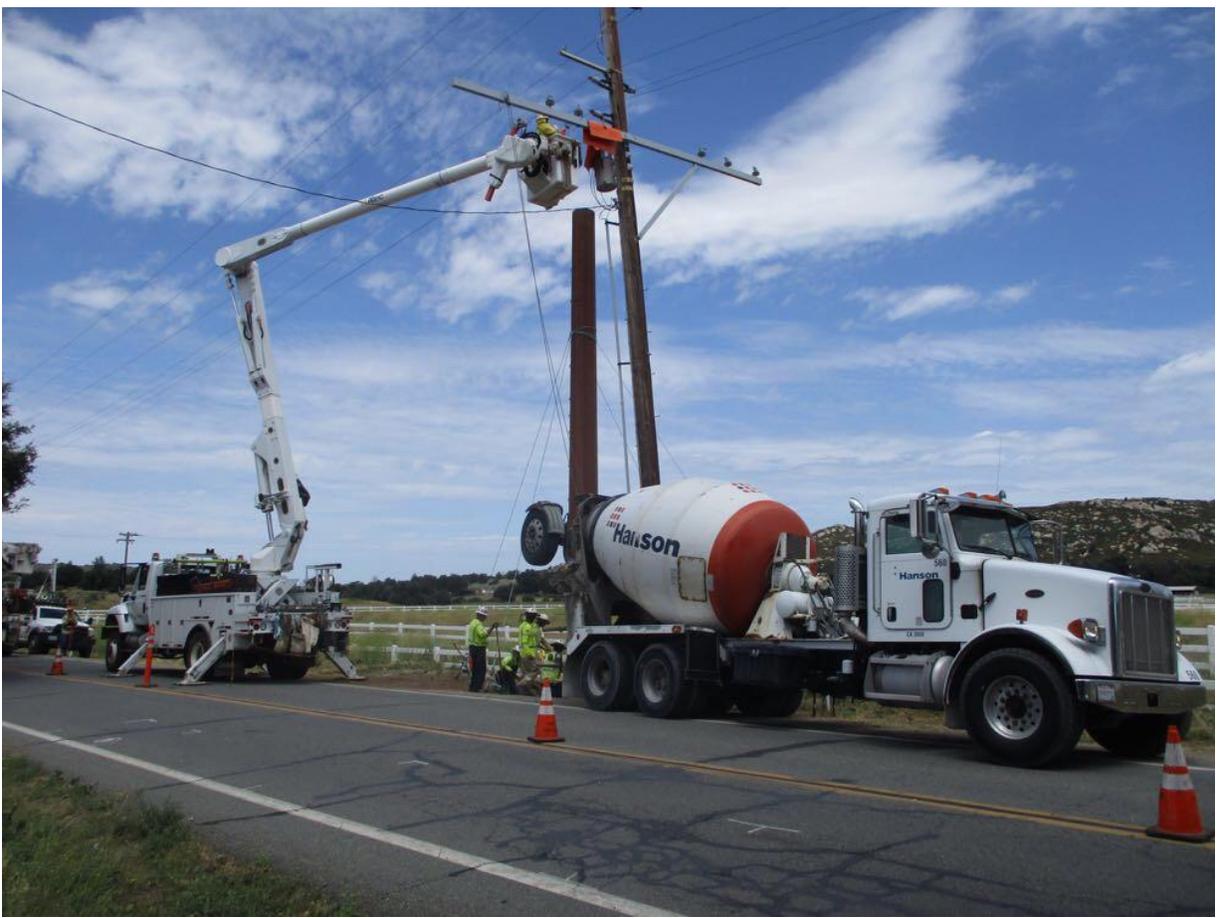
Photo 1: A construction crew was observed removing 12 kV wire protectors used during pole setting, and backfilling around the pole base with concrete on TL 629A. A crew member was conducting traffic control along Viejas Boulevard during the activities in accordance with the TCP (APM TRANS-05).

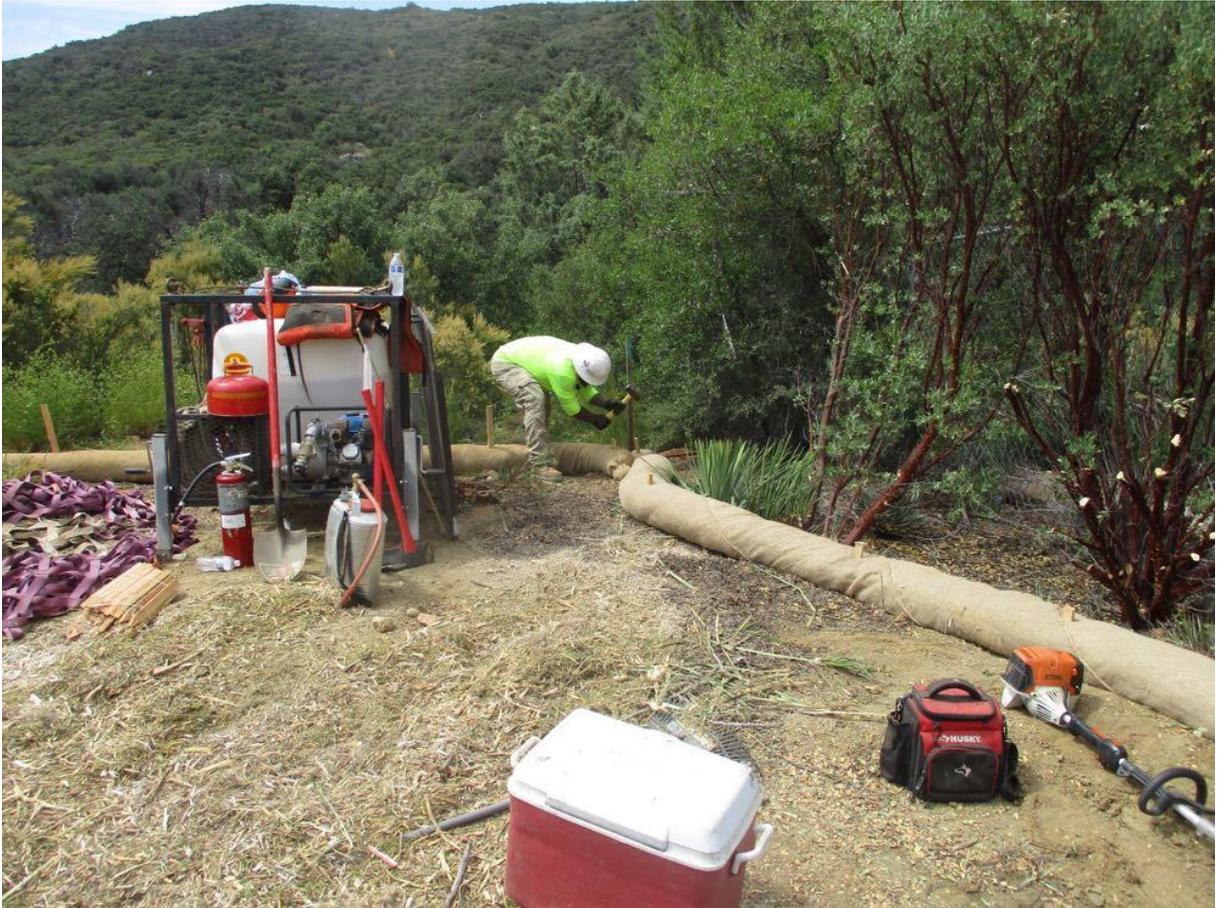
Photo 2: A construction worker observed installing perimeter fiber rolls at Pole Z173110 (TL 629A) for erosion control in accordance with the ECP and SWPPP (MM HYD-01, MM BIO-7).

To prevent impacts to hydrology and water quality, site-specific sediment and erosion control BMPs were observed being implemented and maintained along project alignments in accordance with the project Erosion Control Plan (ECP) and SWPPP (MM HYD-01, MM BIO-7) and APM HYD-09. Work areas along TL 629A were observed to have secured erosion and sediment controls (such as natural fiber covering and fiber rolls per the SWPPP) in order to minimize sediment transport and slow the flow of potential runoff in accordance with the ECP and SWPPP (see Photo 2 – Attachment A).

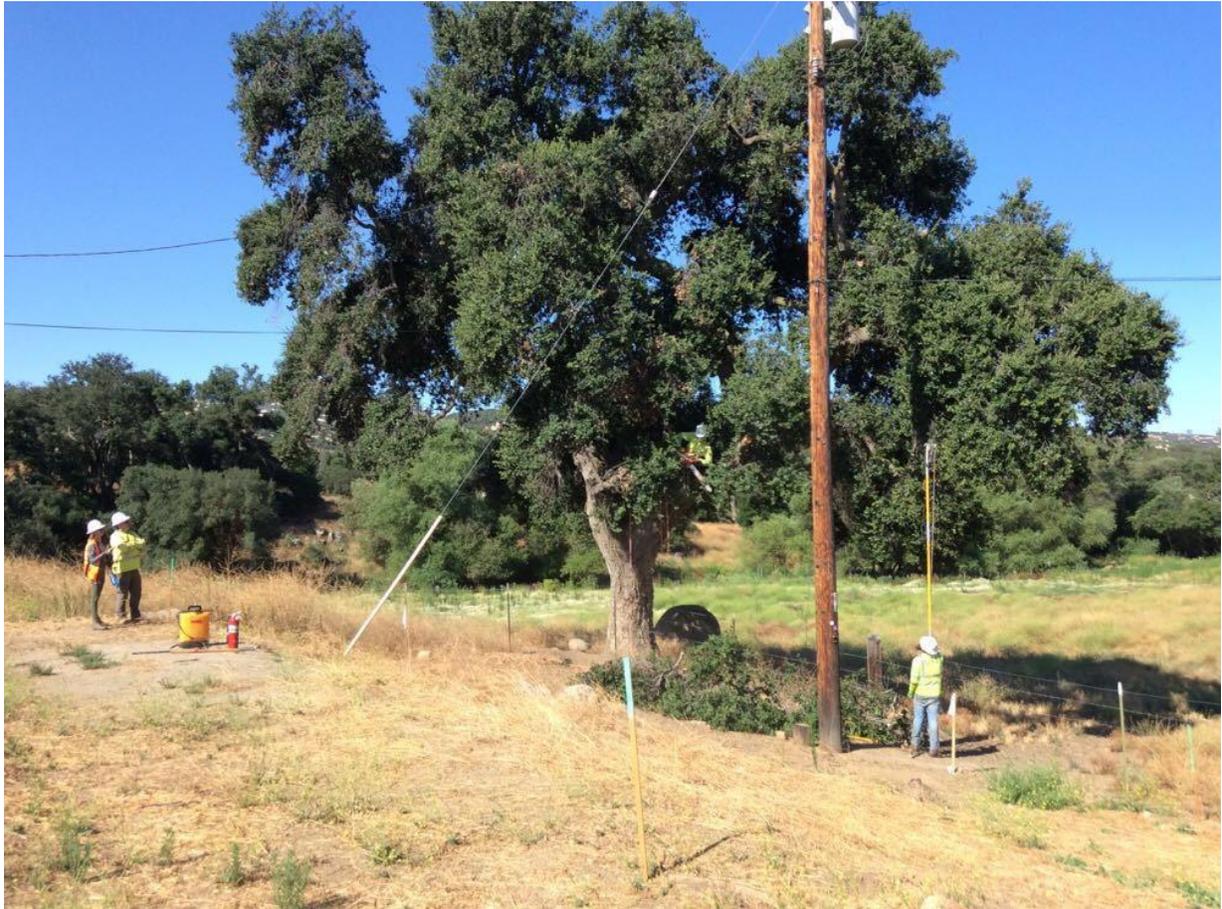
Photo 3: A crew member at Pole P275795 (TL 625C) was observed holding a tree pruner at a work limits stake to increase the visibility of the stake to the crew member in the tree, ensuring that tree trimming remained within approved work limits in accordance with MM BIO-1. Biological monitors were present to oversee the vegetation removal activity in accordance with MM BIO-3.

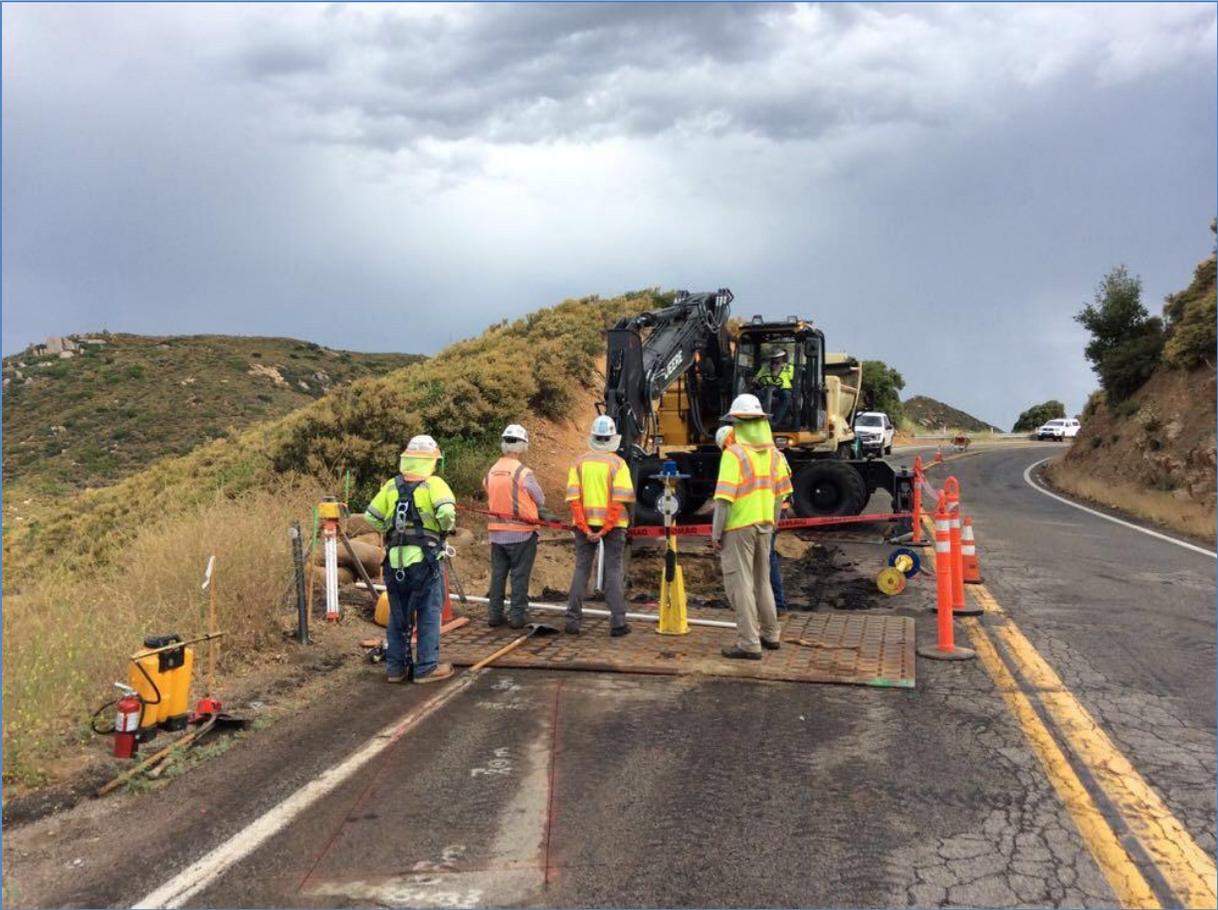
Photo 4: A biological, archaeological, and cultural monitor were present during vault excavation (C 440) in accordance with MM BIO-22, MM CUL-1, and APM CUL-04. A complete set of fire tools were staged on site (5-gallon backpack pump, round point shovel, Pulaski, and 2A10BC fire extinguisher) in accordance with the CFPPP (MM FF-1).

During this reporting period along TL 629A, CPUC ECMs observed construction crews conducting vegetation removal, drilling anchor holes, potholing, and backfilling pole bases with concrete. Near the Descanso substation (TL 629A), construction crews were observed performing overhead work, which included installing and removing wire protectors, stringing wire, and installing pole arms (see Photo 1 – Attachment A). Construction crews were observed conducting helicopter external load operations at Creekside Staging and Fly Yard to support brushing and BMP installation. Additionally, ECMs observed crews drilling pole foundation holes, installing grounds at several pole locations, conducting micropile foundation drilling, and installing Storm Water Pollution Prevention Plan (SWPPP) Best Management Practices (BMPs) (see Photo 2 – Attachment A). Along TL 625C, ECMs observed construction crews installing BMPs and removing vegetation by tree trimming (see Photo 3 – Attachment A). Additionally, crews were observed setting up drilling equipment at various pole locations. Along C 440, CPUC ECMs observed construction crews saw cutting to prepare for locating underground utilities (potholing), tree trimming at Wooded Hill Road, and conducting vault work, which included pouring concrete, bringing excavations to depth, setting vaults, and placing rock in vault excavations (see Photo 4 – Attachment A).

MM CUL-1, MM CUL-3, and APM CUL-04, including vault installations along C 440 (see Photo 4 – Attachment A). On July 25th, SDG&E implemented three stop-work orders on pole locations in order to conduct further investigations in accordance with the HPMP. Crews were observed flagging the area to preclude all work.

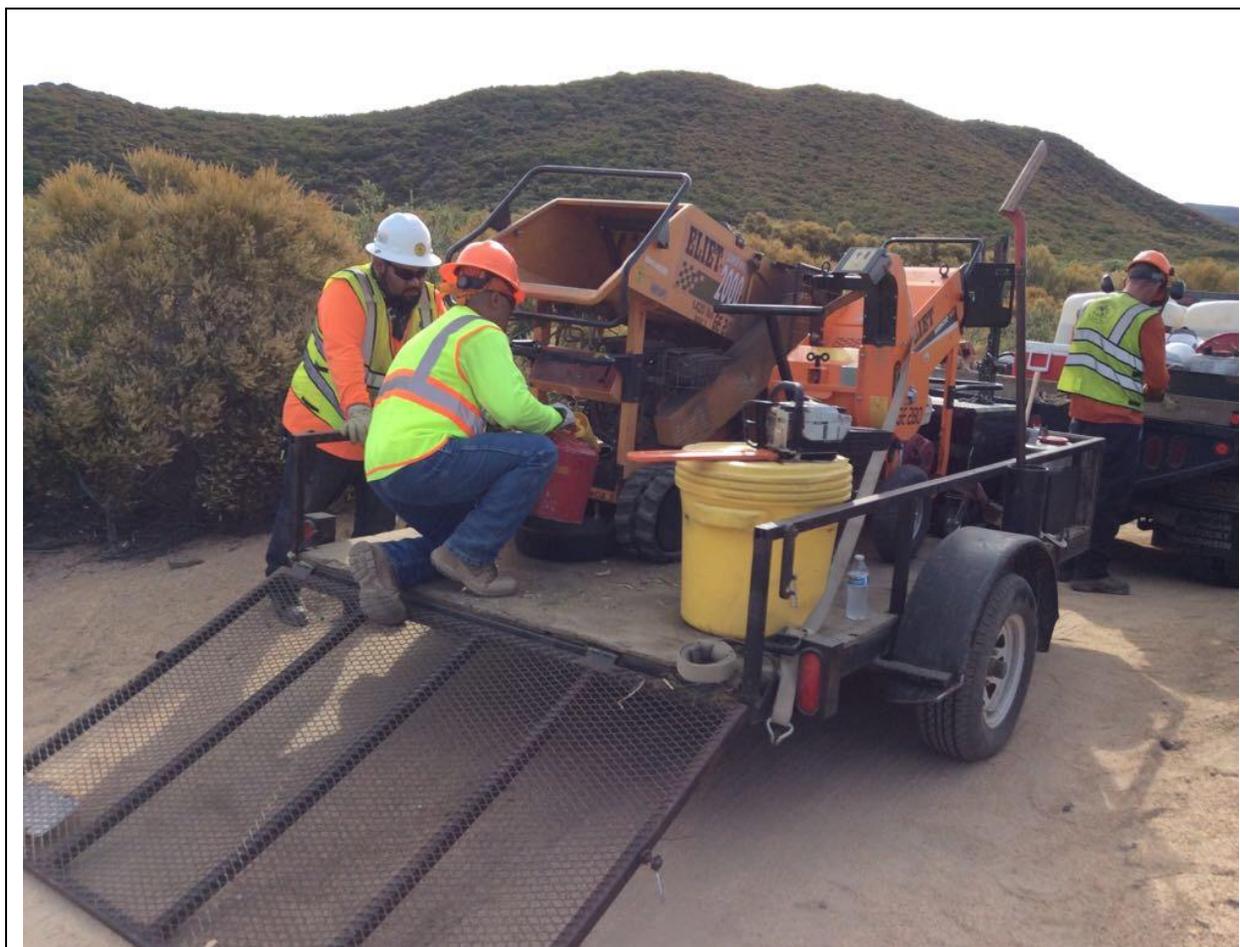
Photo 5: During vegetation removal activities along TL 629A, a drip pan was observed in use during chain saw fueling to prevent the release of hazardous materials onto the ground in accordance with MM PHS-2. The fueling took place first thing in the morning while the chain saw was still cool in accordance with the CFPPP (MM FF-1).

To prevent leaks and spills from being discharged into the soil, construction crews were observed implementing spill prevention BMPs in accordance with the Spill Response and Notification Plan (SRNP) and MM PHS-2 (see Photo 5 – Attachment A). During this reporting period, secondary containment was observed on a number of occasions by ECMs beneath fuel canisters on TL 629A during vegetation removal activities.

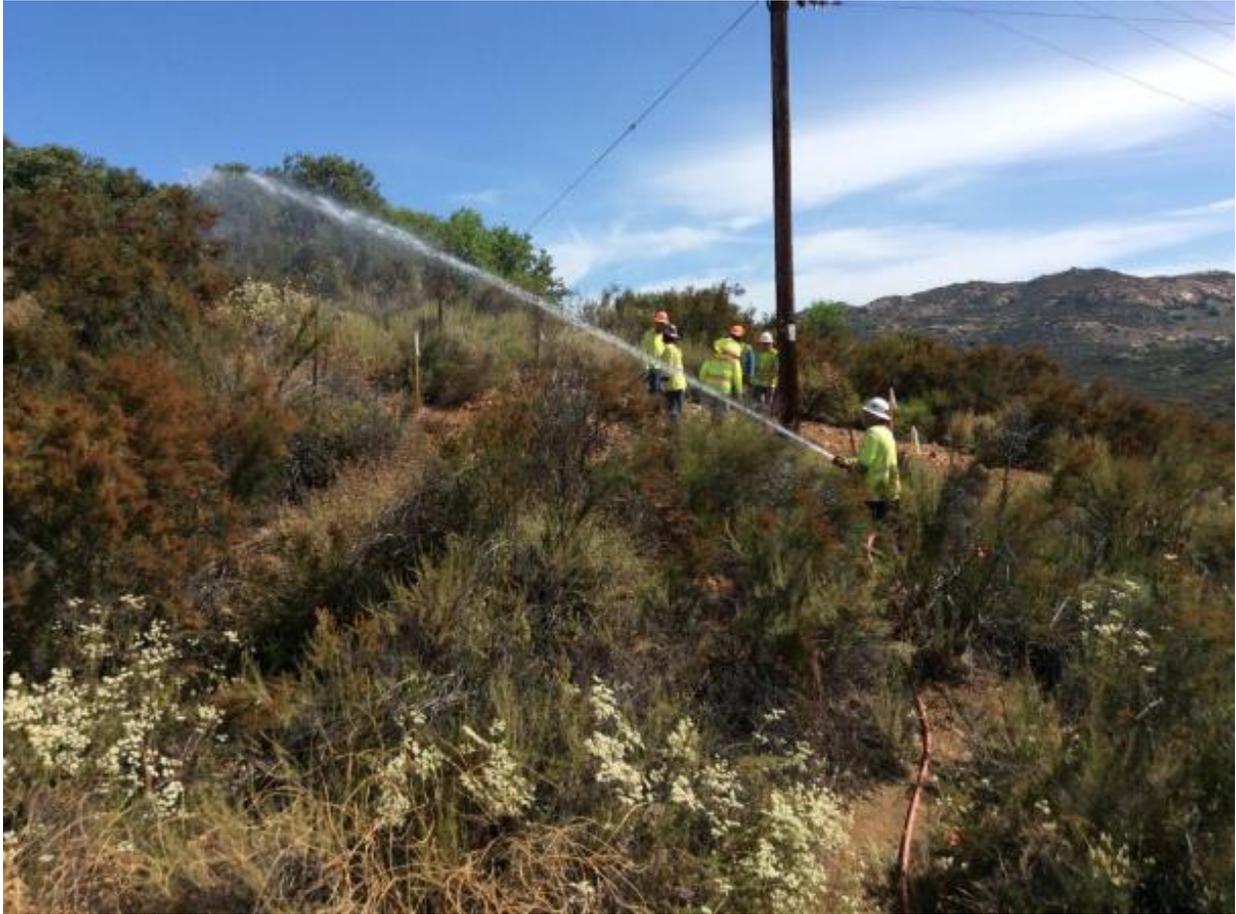
Photo 6: In preparation for vegetation at Pole Z272905 (TL 625C) to be chipped upon removal, the area was wet down prior to the activity in accordance with the CFPPP for the day's fire conditions (Elevated FPI off CNF land). A Fire Patrol was also present with at least 100 gallons of water and a complete set of fire tools on site.

In accordance with the CFPPP (MM FF-1), all project- related vehicles and equipment were observed carrying the required set of fire tools (including a 5 gallon backpack pump, round point shovel, Pulaski, and 2A10BC fire extinguisher) and these tools were observed within 50 feet of work activities. ECMs observed activities occurring along project segments as allowed by CFPPP and fire prevention practices implemented during construction as required by the CFPPP (see Photos 2, 4 and 6 – Attachment A).
