California Public Utilities Commission <i>Mitigation Monitoring, Compliance, and Reporting</i> <i>Program</i>
	Cleveland National Forest Power Line Replacement Projects Compliance Status Report: 075 August 11, 2019

This compliance status report covers construction activities from July 29, 2019 through August 11, 2019.

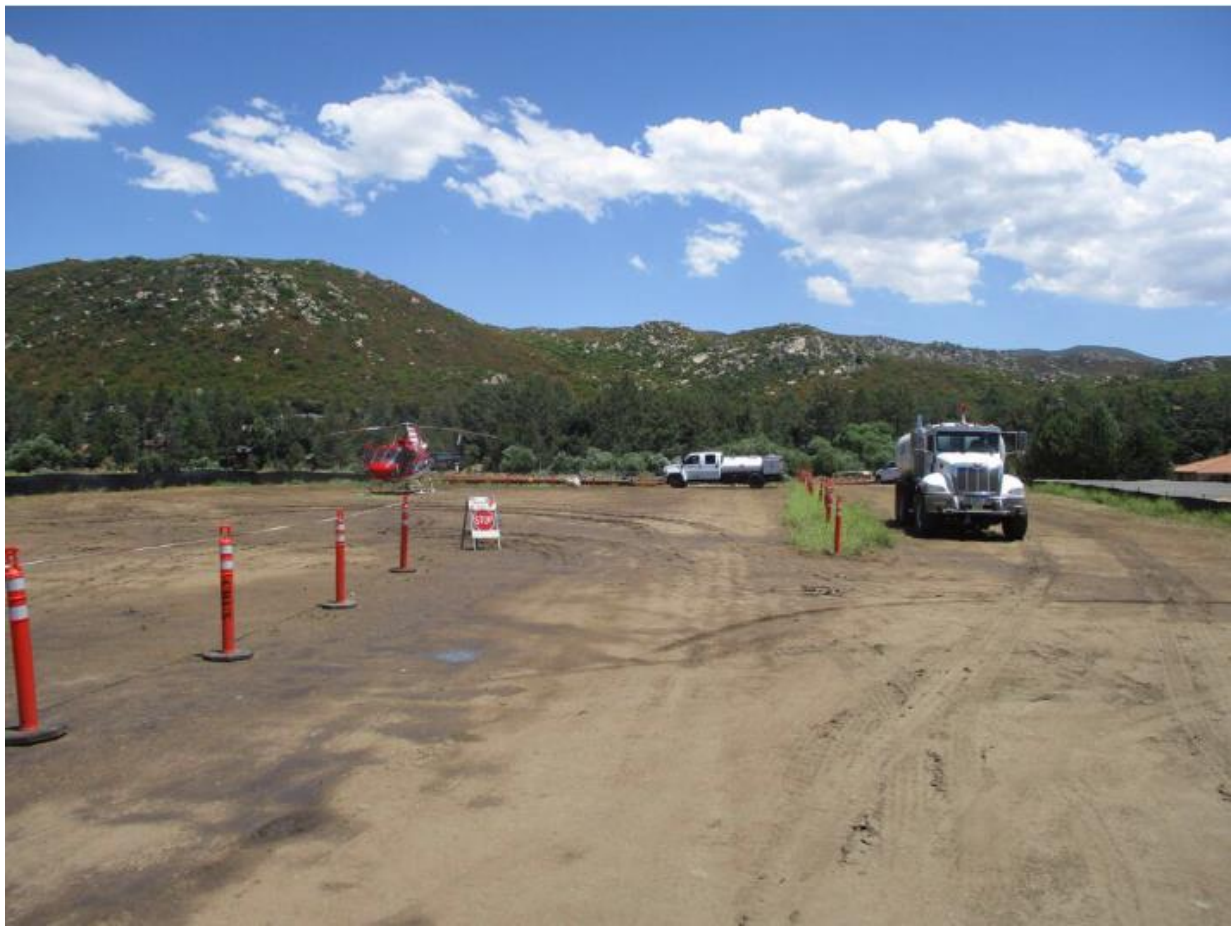
Photo 1: Helicopter activities supporting Geo Pacific brushing work at Z173122 (TL 629A) was observed being conducted out of Creekside Staging and Fly Yard. A water truck watered the designated and delineated helicopter landing area to prevent dust emissions in accordance with the Aviation Safety Plan (MM PHS-5) and APM AIR-02.

To prevent fugitive dust emissions during project activities, construction crews were observed applying water to prevent or mitigate fugitive dust at staging areas prior to helicopter use (see Photo 1 – Attachment A), unpaved access roads, and active construction areas in accordance with APM AIR-02. Trucks that exported dirt spoil off were observed utilizing a load cover to prevent dust in accordance with APM AIR-02 (see Photo 2 – Attachment A). Construction personnel were observed maintaining posted speeds of 15 miles per hour on unpaved roads in accordance with APM AIR-03 and MM BIO-24.

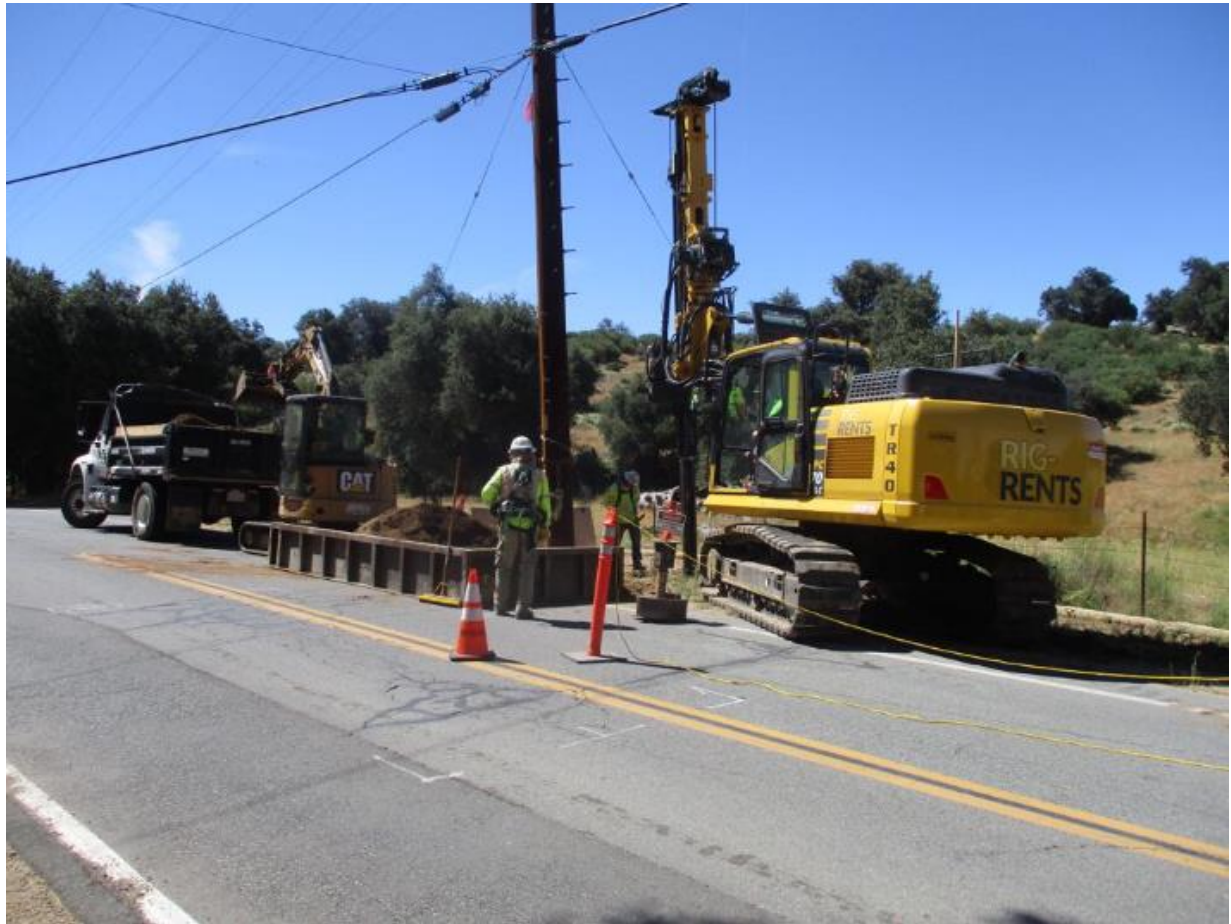
Photo 2: A crew was observed drilling a pole foundation hole at Z163042 (TL 629A), and exporting dirt spoil off-site. The haul truck exporting dirt spoil utilized a load cover to prevent dust in accordance with APM AIR-02.

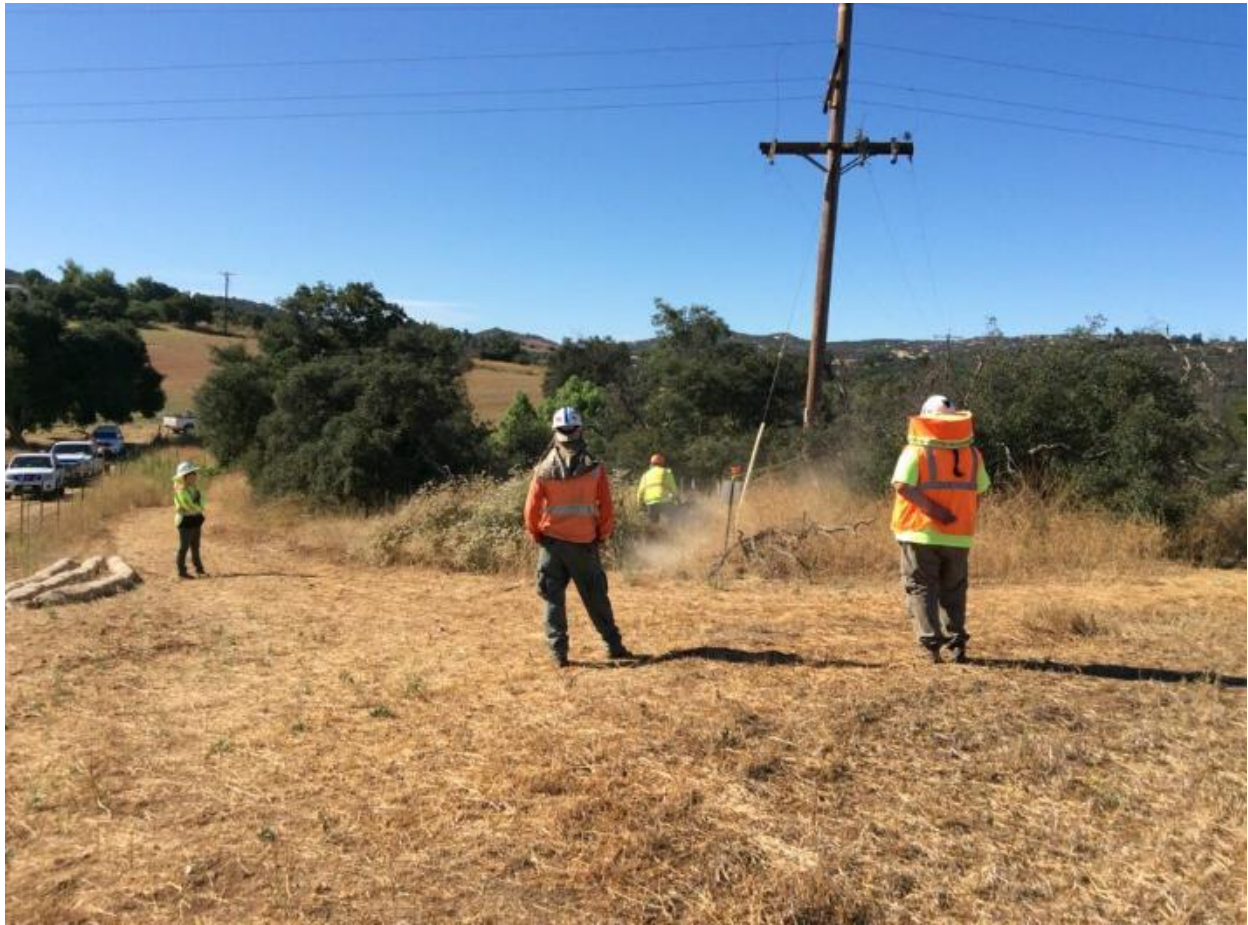
Photo 3: Biological, Archaeological, and Cultural Monitors were observed monitoring initial ground-disturbing activities (vegetation removal) along TL 625C in accordance with MM BIO-3, APM CUL-04, and MM CUL-1.

MM CUL-1, MM CUL-3, and APM CUL-04 (see Photos 3 and 4 – Attachment A). ESAs flagging sensitive work areas were observed in place in accordance with the HPMP.

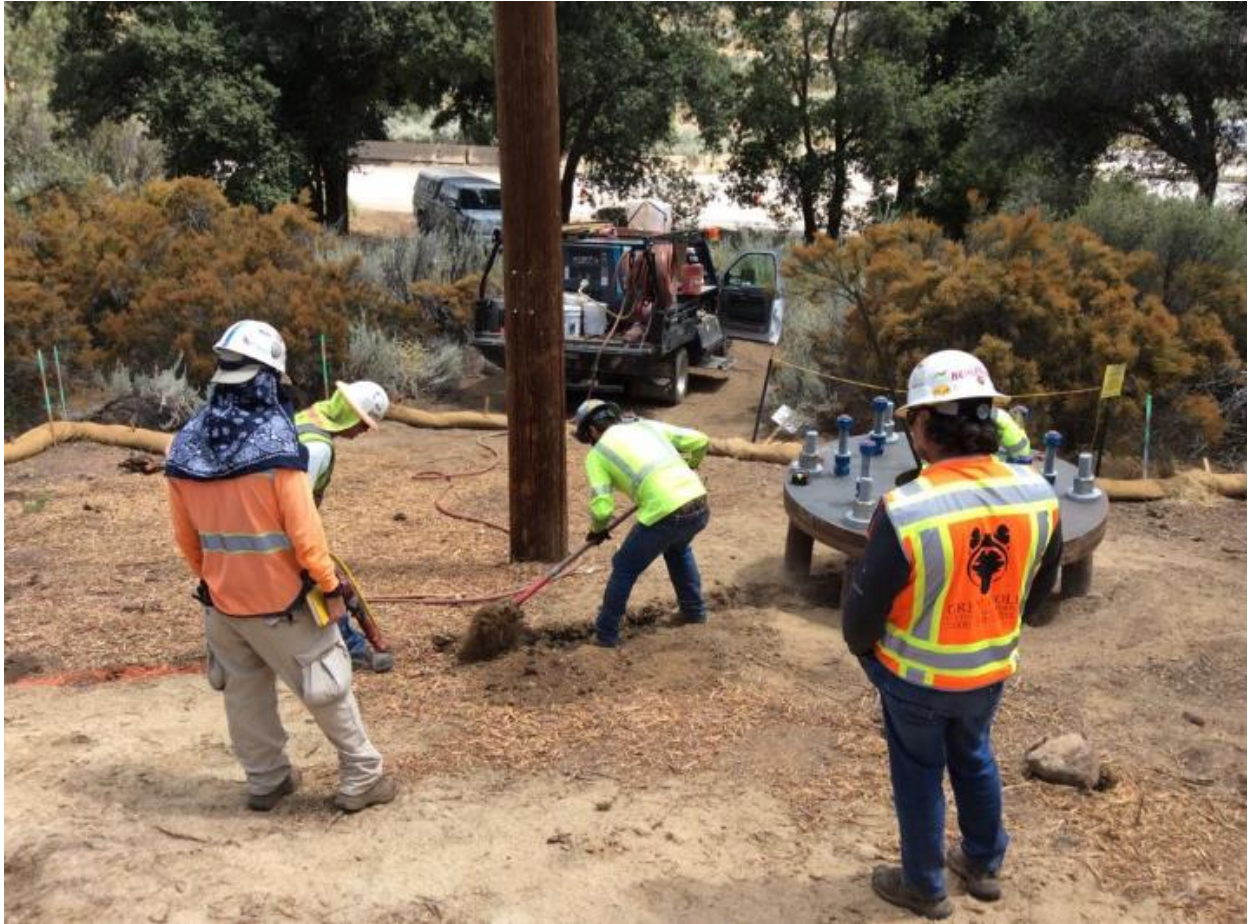
Photo 4: Archaeological and Cultural Monitors were observed monitoring ground rod trenching along TL 629A in accordance with the HPMP, APM CUL-04, and MM CUL-1. Cultural ESA fencing was observed to be in tact in accordance with APM CUL-03. SWPPP BMPs were in place in accordance with MM HYD-1 and MM BIO-7.

To prevent impacts to hydrology and water quality, site-specific sediment and erosion control BMPs were observed being implemented and maintained along project alignments in accordance with the project Erosion Control Plan (ECP) and SWPPP (MM HYD-01, MM BIO-7) and APM HYD-09 (see Photo 4 and Photo 6—Attachment A). Gravel bag dams were observed in good condition and work areas were observed to have secured erosion and sediment controls (such as natural fiber covering and fiber rolls per the SWPPP) in order to minimize sediment transport and slow the flow of potential runoff in accordance with the ECP and SWPPP. Crews were observed sweeping dirt track-out on paved roadways at the end of work days.

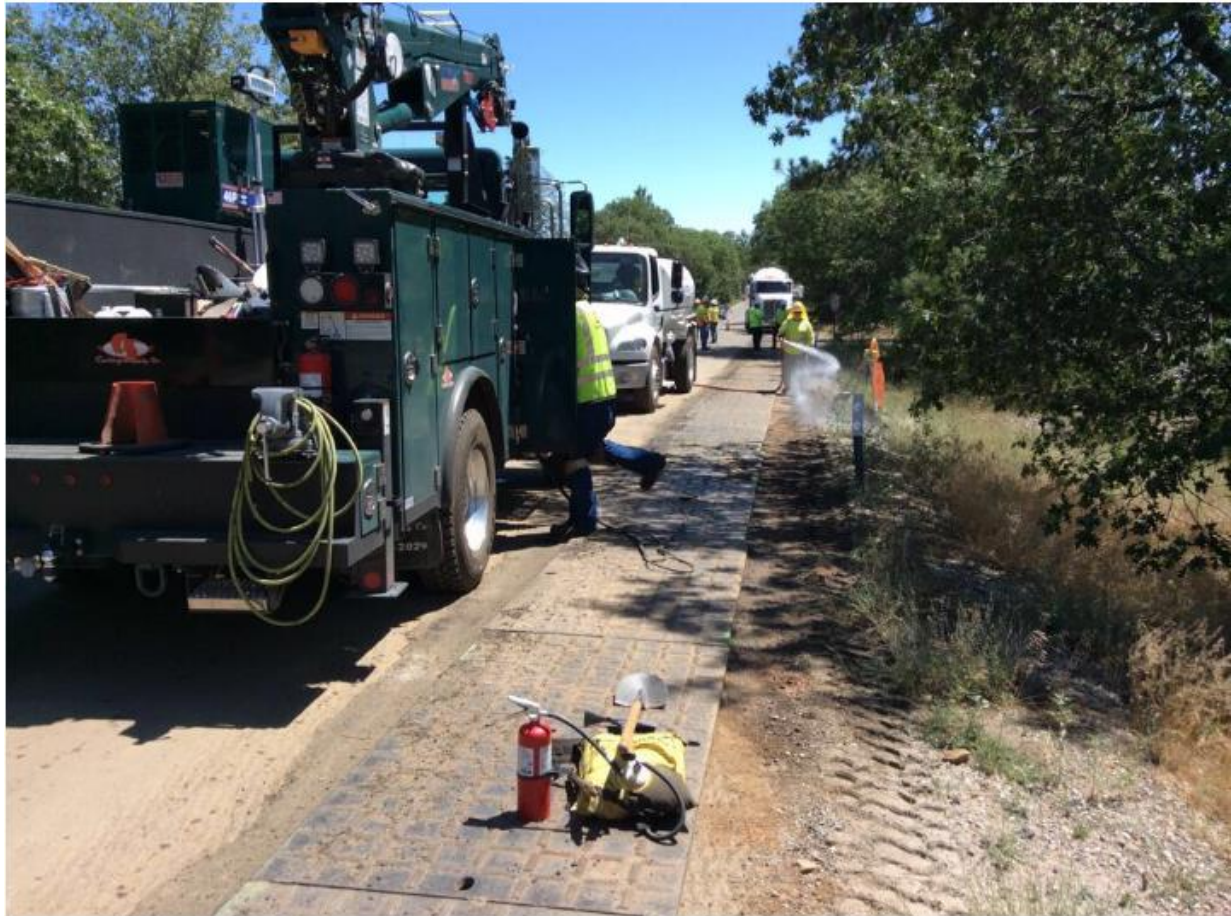
Photo 5: A dedicated fire patrol was observed wetting down the area near 439+50 (C 440) prior to hot work (welding), and a complete set of fire tools was observed within 50 feet of the activity in accordance with the CFPPP for the day's fire conditions (PAL C on CNF land).

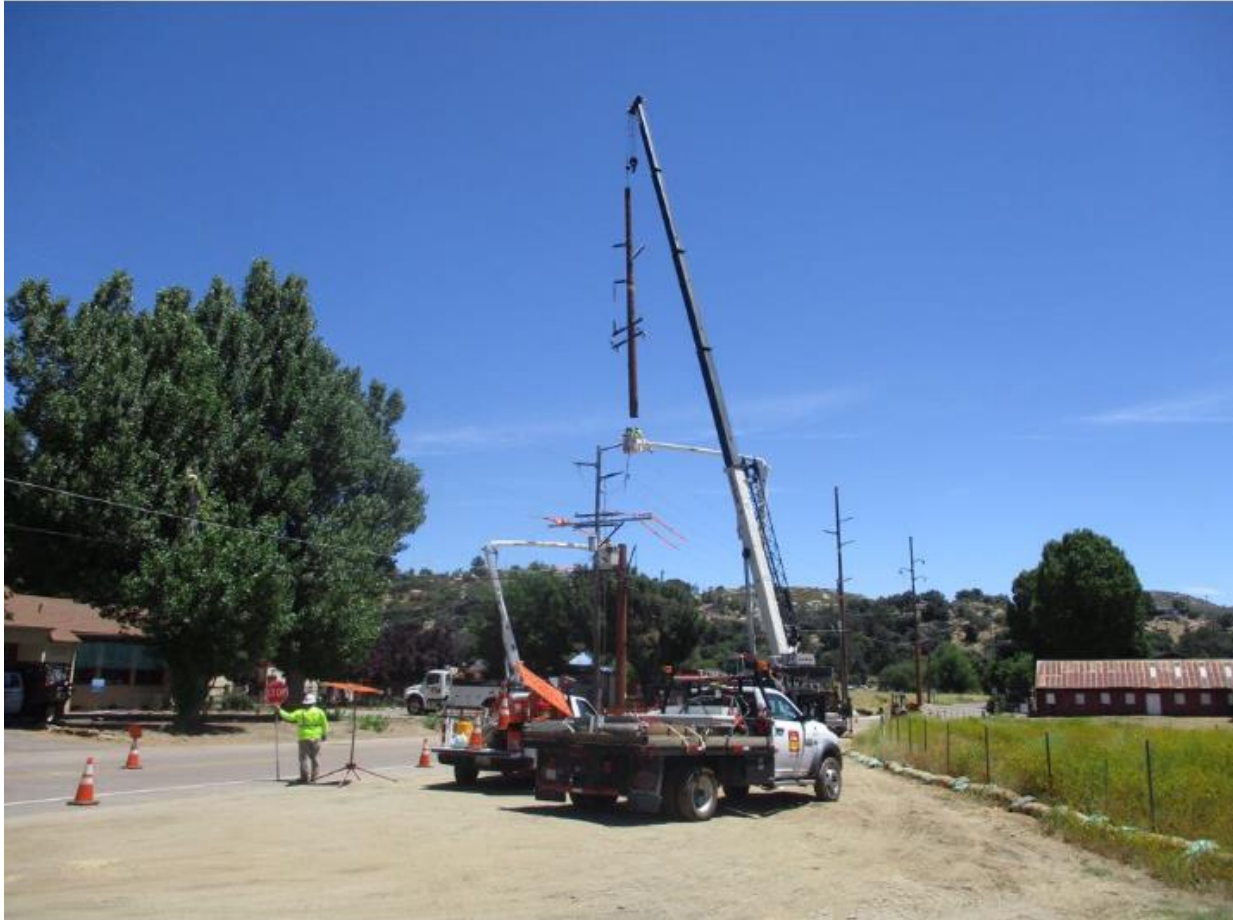
Photo 6: A crew was observed directing traffic along Viejas Boulevard while setting a pole top at Z373147 (TL 629A) in accordance with the TCP (APM TRANS-05).
