<b>California Public Utilities Commission</b> <b><i>Mitigation Monitoring, Compliance, and Reporting</i></b> <b><i>Program</i></b>
	<b>Cleveland National Forest Power Line Replacement</b> <b>Projects</b>  <b>Compliance Status Report: 077</b>  <b>September 8, 2019</b>

This compliance status report covers construction activities from August 26 through September 8, 2019.

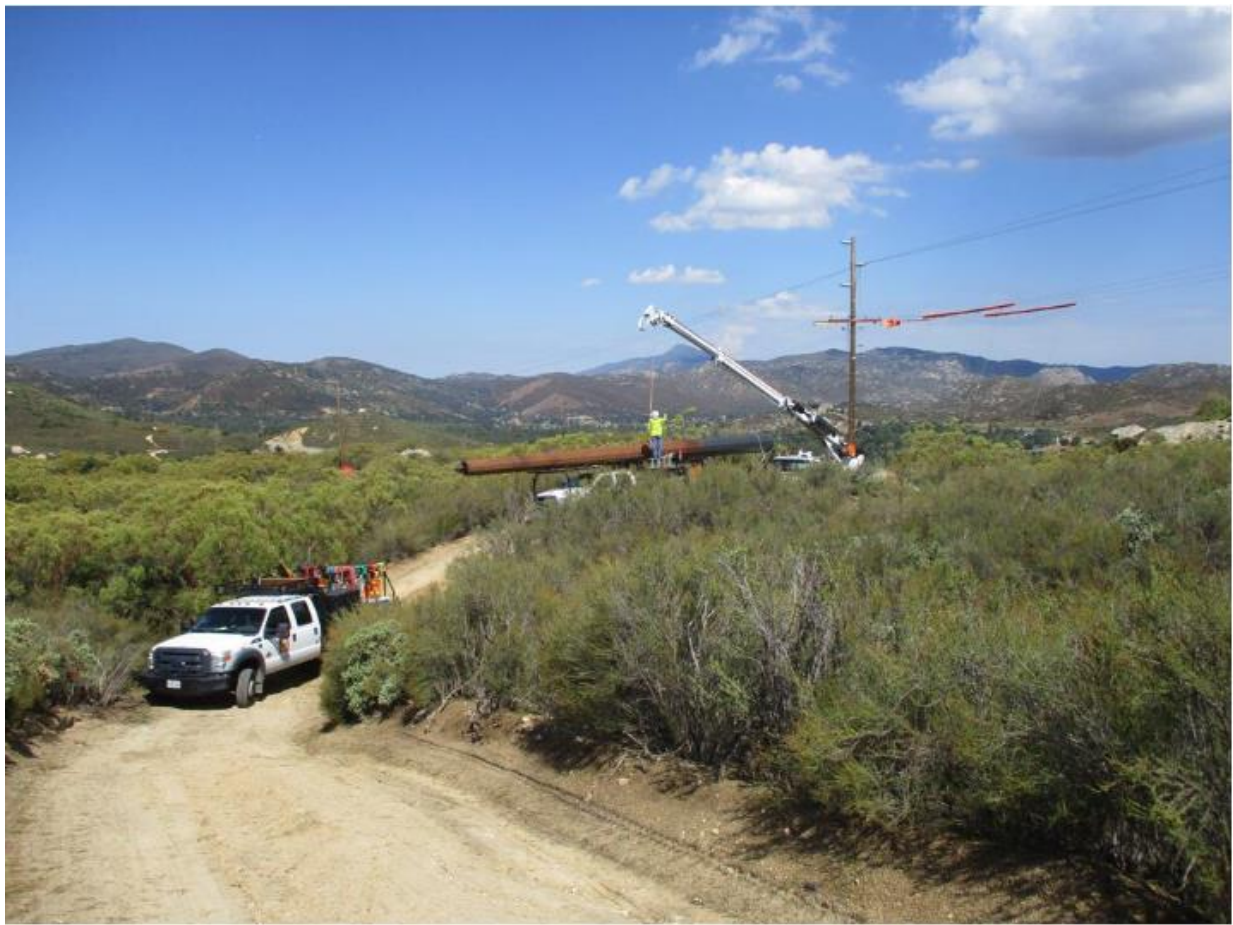
**Photo 1:** While installing a new pole at Z276646 (TL 629A), equipment was staged within the limits of the approved access road in accordance with MM BIO-1.

Approved workspaces were observed delineated with staking and flagging, and work crews were observed adhering to work space limits and staying on approved access roads in accordance with MM BIO-1 (See Photo 1 – Attachment A).. Workers were observed having completed the Worker Environmental Awareness Program (WEAP), as shown by project hard hat stickers in accordance with MM BIO-2. Biological monitors were observed conducting full-time monitoring of initial ground-disturbing activities such as vegetation removal in accordance with MM BIO-3. In accordance with MM BIO-14 and MM BIO-16, Environmentally Sensitive Area (ESA) signs and flagging were observed around areas with special-status species and observed being avoided. Excavation areas were observed by ECMs to be covered to prevent wildlife entrapment in accordance with MM BIO-23. Crews were observed containing trash at work areas in accordance with MM BIO-26. ECMs observed pre-construction sweeps and monitoring in accordance with the Avian Protection Plan/Nesting Bird Management Plan (APP/NBMP) and MM BIO-28 and nesting bird buffers were observed being posted and avoided by crews.

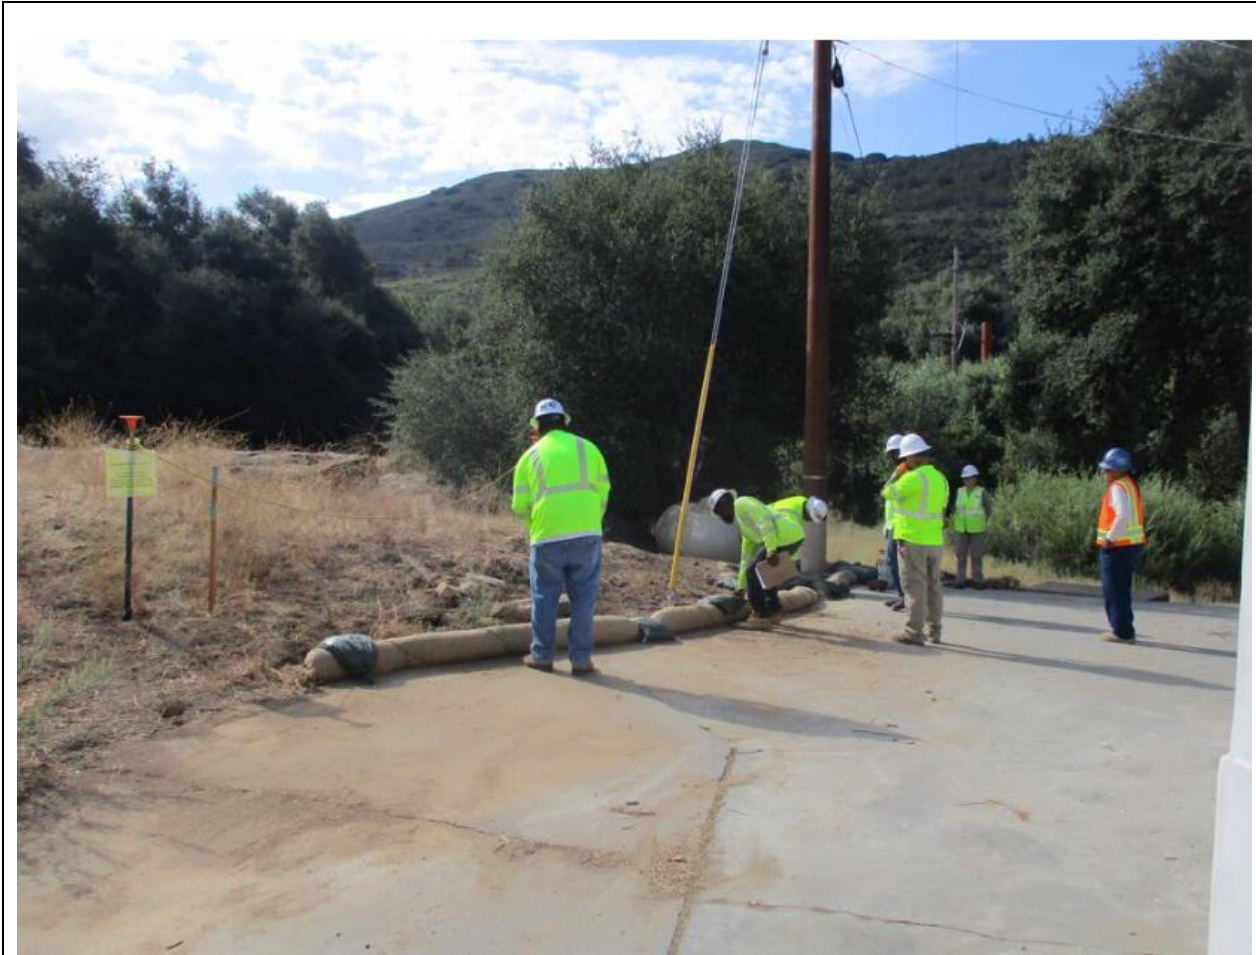
**Photo 2:** During fiber roll installation at TL 629A, two cultural monitors were present, a cultural resources ESA was delineated along the eastern perimeter of the work space, and gravel bags were used to weigh down the fiber rolls instead them being dug into the ground in accordance with the HPMP (MM CUL-1), APM CUL-03, and APM CUL-04.

CPUC ECMs observed cultural resource monitors, including archaeological and Native American monitors, monitoring construction activities that occurred within or adjacent to identified archaeological or cultural resource site boundaries in accordance with the Historic Properties Management Plan (HPMP), MM CUL-1, MM CUL-3, and APM CUL-04 (See Photo 2 – Attachment A).. ESAs flagging sensitive work areas were observed in place in accordance with the HPMP.

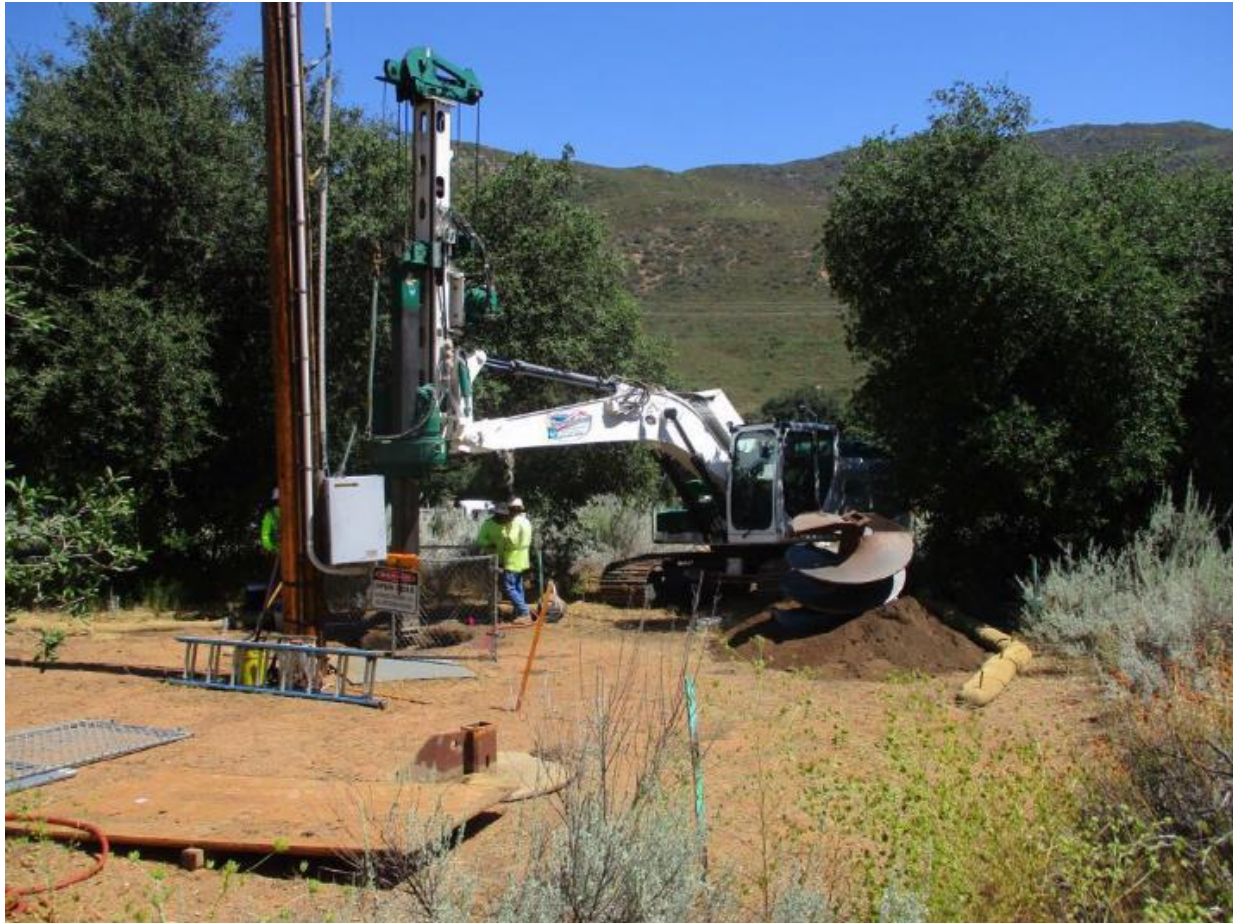
**Photo 3:** A crew was observed drilling a pole hole at Z163184 (TL 629A). To comply with the CFPPP fire prevention matrix (on CNF land, PAL-C), a complete set of fire tools were staged on-site during drilling, and the crew were equipped with a water truck that would follow behind during the movement of the steel-tracked drill.

In accordance with the CFPPP (MM FF-1), all project- related vehicles and equipment were observed carrying the required set of fire tools (including a 5-gallon backpack pump, round point shovel, Pulaski, and 2A10BC fire extinguisher) and were observed within 50 feet of work activities. Fire boxes were observed at staging yards and to ensure 5-gallon backpack pumps were full at all times, fire patrols were observed setting up a “fire tool filling station” after the morning tailboards at the staging yards before project personnel entered the right of ways. ECMs observed activities occurring along project segments as allowed by CFPPP and fire prevention practices implemented during construction as required by the CFPPP (See Photo 3 – Attachment A).

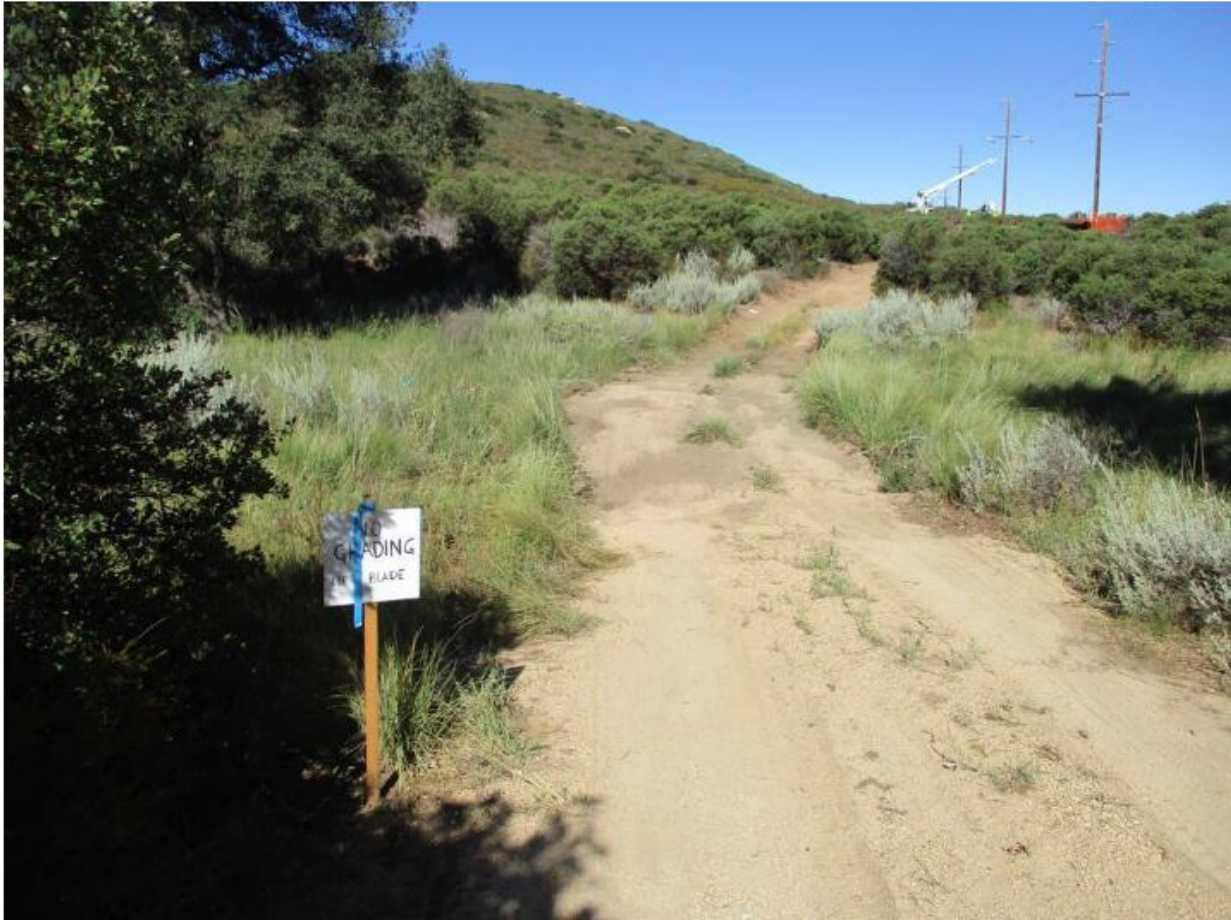
**Photo 4:** During pole setting at Z276641 (TL 629A), a hydrological resource was observed flagged along the approved road to the site, and a sign stating 'no grading, lift blade' was posted to minimize impacts to the stream in accordance with APM HYD-06.

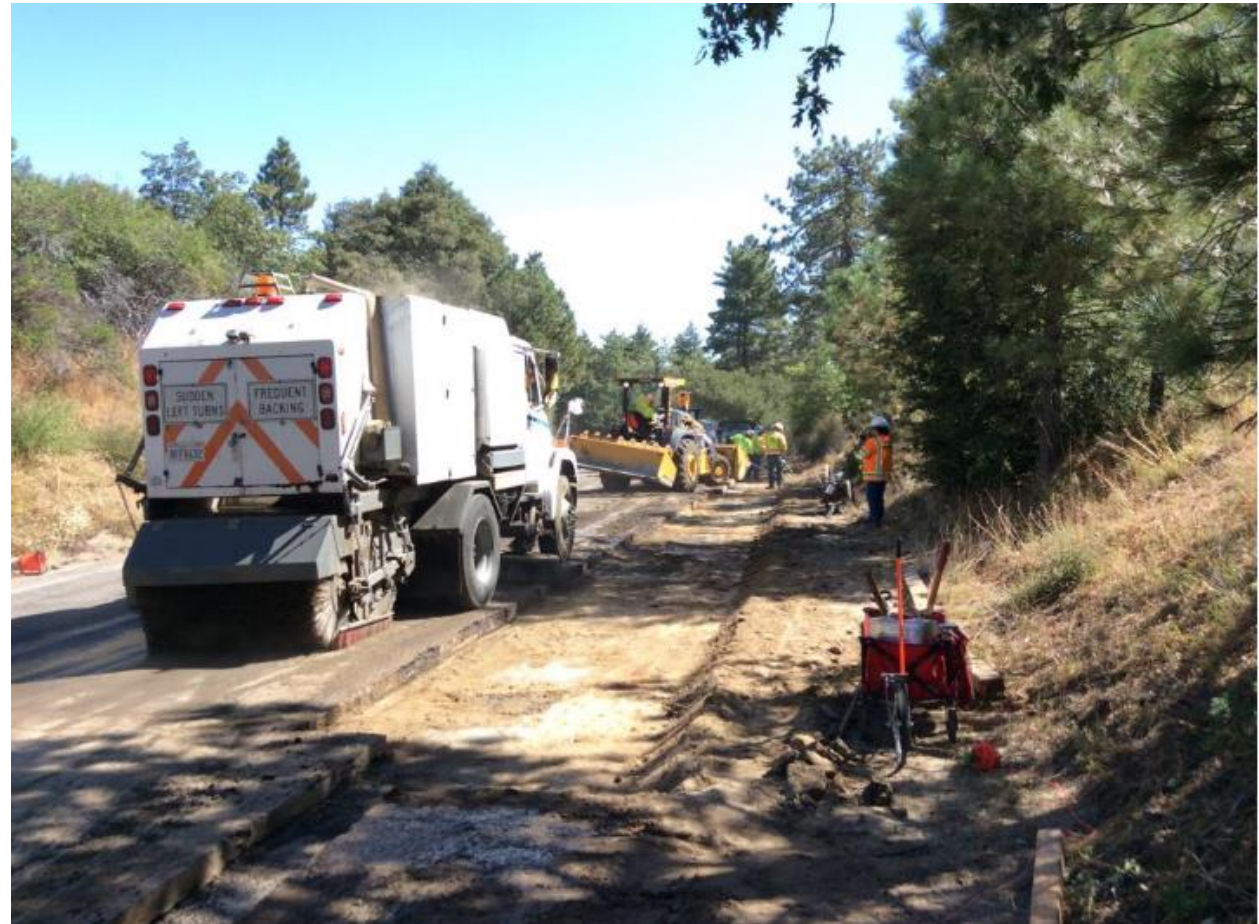
**Photo 5:** A street sweeping machine was observed cleaning up debris associated with asphalt removal near 406+50 (C 440) in accordance with the SWPPP.

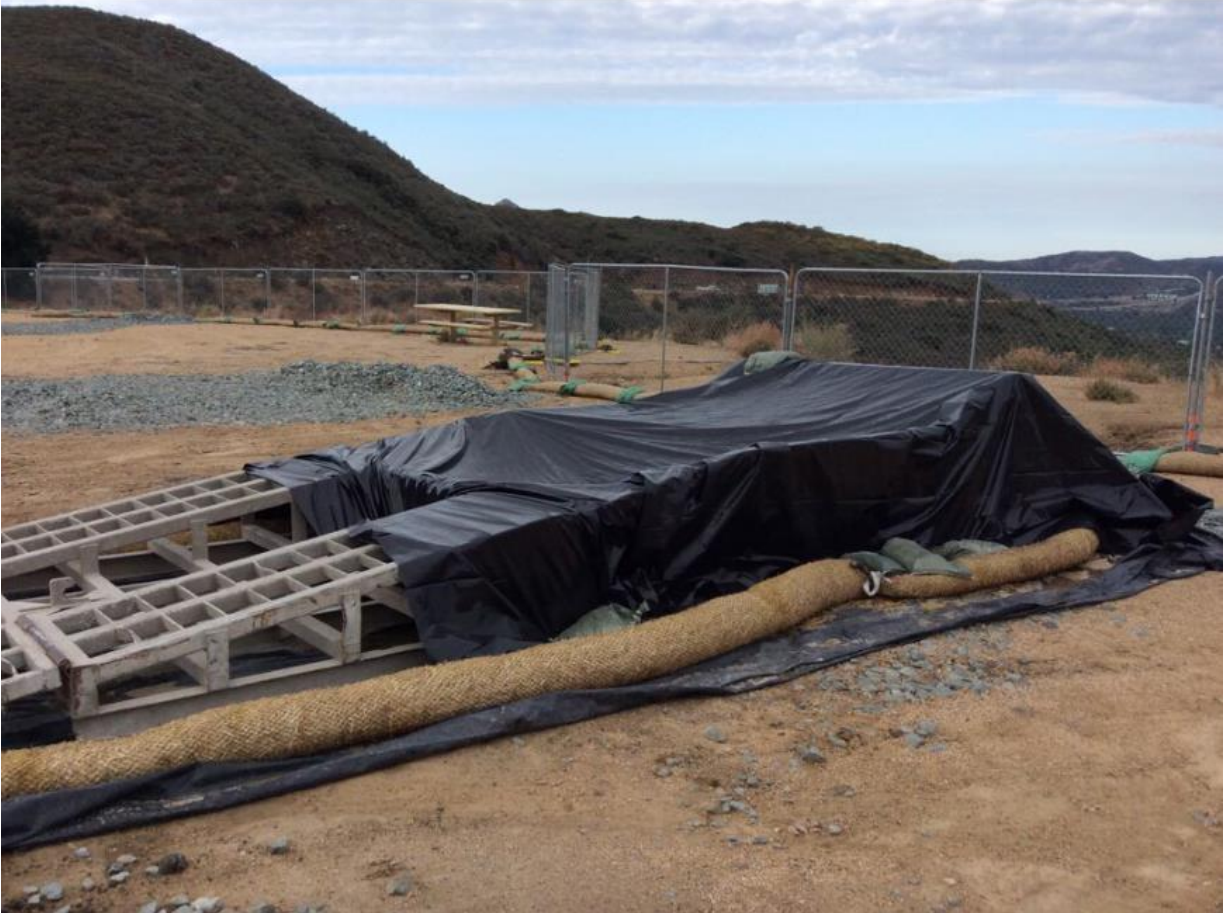
**Photo 6:** The concrete washout bin at Staging Area 2A (C 440) was observed to be covered in preparation for forecasted rain in accordance with the SWPPP.

To prevent impacts to hydrology and water quality, site-specific sediment and erosion control BMPs were observed being implemented and maintained along project alignments in accordance with the project Erosion Control Plan (ECP) and SWPPP (MM HYD-01, MM BIO-7) and APM HYD-09. Hydrological resources were observed flagged for avoidance during construction in accordance with APM HYD-06 (See Photo 4 – Attachment A). Work areas were observed to have secured erosion and sediment controls (such as natural fiber covering and fiber rolls per the SWPPP) in order to minimize sediment transport and slow the flow of potential runoff in accordance with the ECP and SWPPP (See Photos 2, 3, and 6 – Attachment A). Street sweeper machines were observed being used to clean roads after asphalt work along C 440 and crews were observed sweeping dirt track-out on paved roadways at the end of work days in accordance with the SWPPP (See Photo 5 – Attachment A). Concrete washout bins in staging areas were observed being covered prior to rain events in accordance with the SWPPP (See Photo 6 – Attachment A).
