California Public Utilities Commission <i>Mitigation Monitoring, Compliance, and Reporting</i> <i>Program</i>
	Cleveland National Forest Power Line Replacement Projects Compliance Status Report: 078 September 22, 2019

This compliance status report covers construction activities from September 9, 2019 through September 22, 2019.

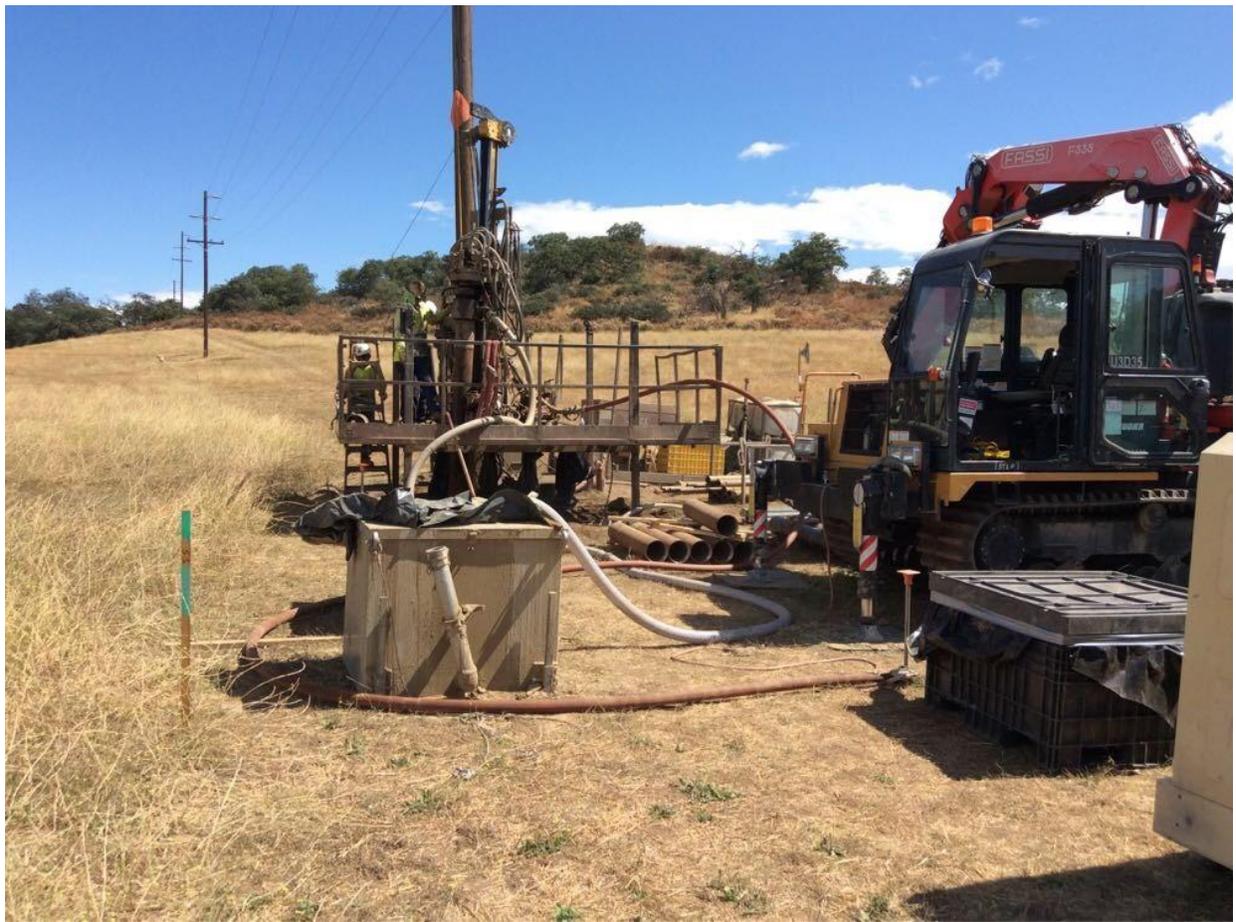
Photo 1: During drilling for a micropile foundation at Pole Z272950 (TL 625C), a crew was observed using a containment box to trap drill cuttings and reduce dust emissions from drilling in accordance with APM AIR-05.

To prevent fugitive dust emissions during project activities, construction crews were observed applying water to prevent or mitigate fugitive dust at staging and fly yards, along unpaved access roads, and in active construction areas in accordance with APM AIR-02. Haul trucks used for dirt export were observed utilizing load covers to prevent dust emissions in accordance with APM AIR-02, and construction personnel were observed maintaining posted speeds of 15 miles per hour on unpaved roads in accordance with APM AIR-03 and MM BIO-24. Construction crews applied water during drilling and used cuttings containment boxes to prevent dust emissions in accordance with APM AIR-05 (See Photo 1 – Attachment A).

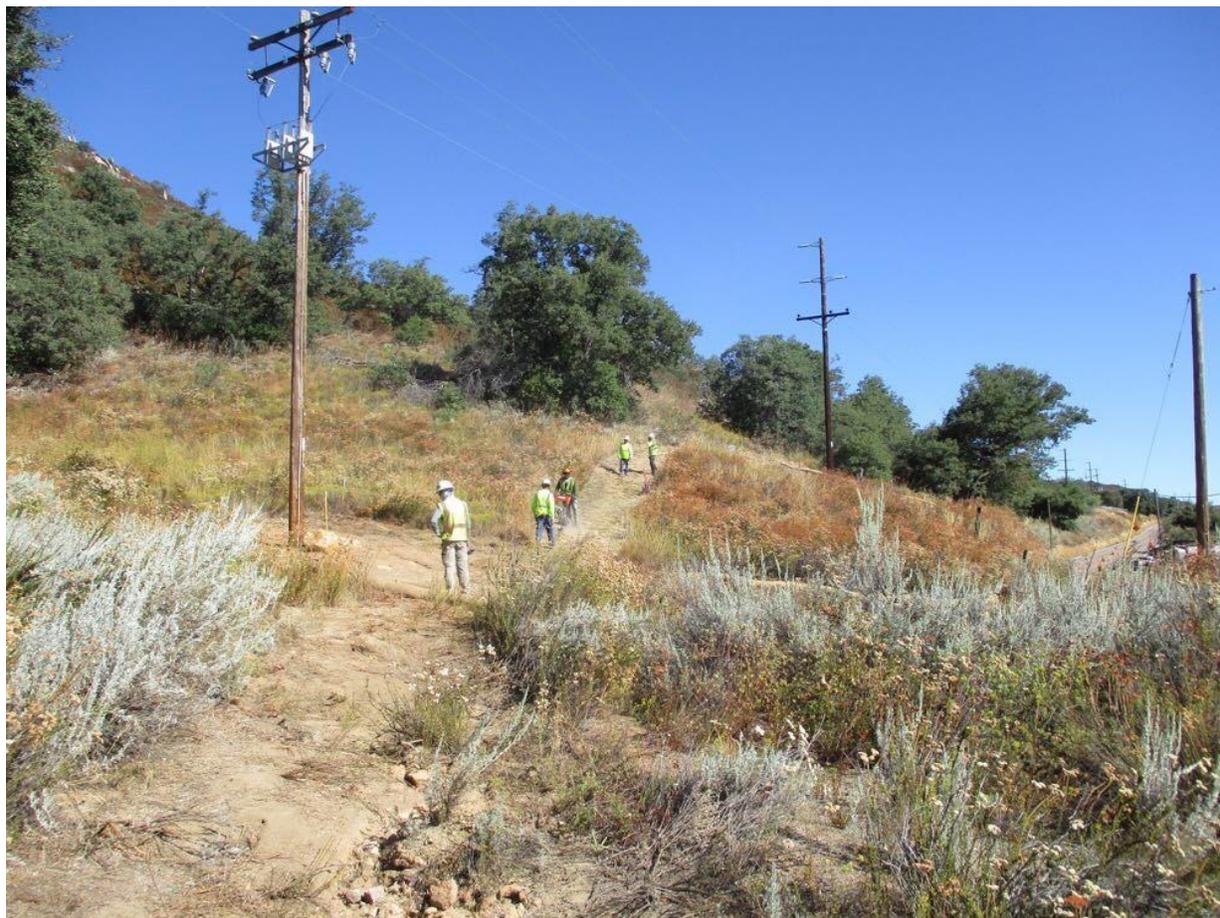
Photo 2: During mowing the construction only access to Pole Z272982 (TL 625C), a crew was observed mowing only within the approved and delineated road in accordance with MM BIO-1, and a biological monitor was observed present on site for vegetation clearing work in accordance with MM BIO-3.

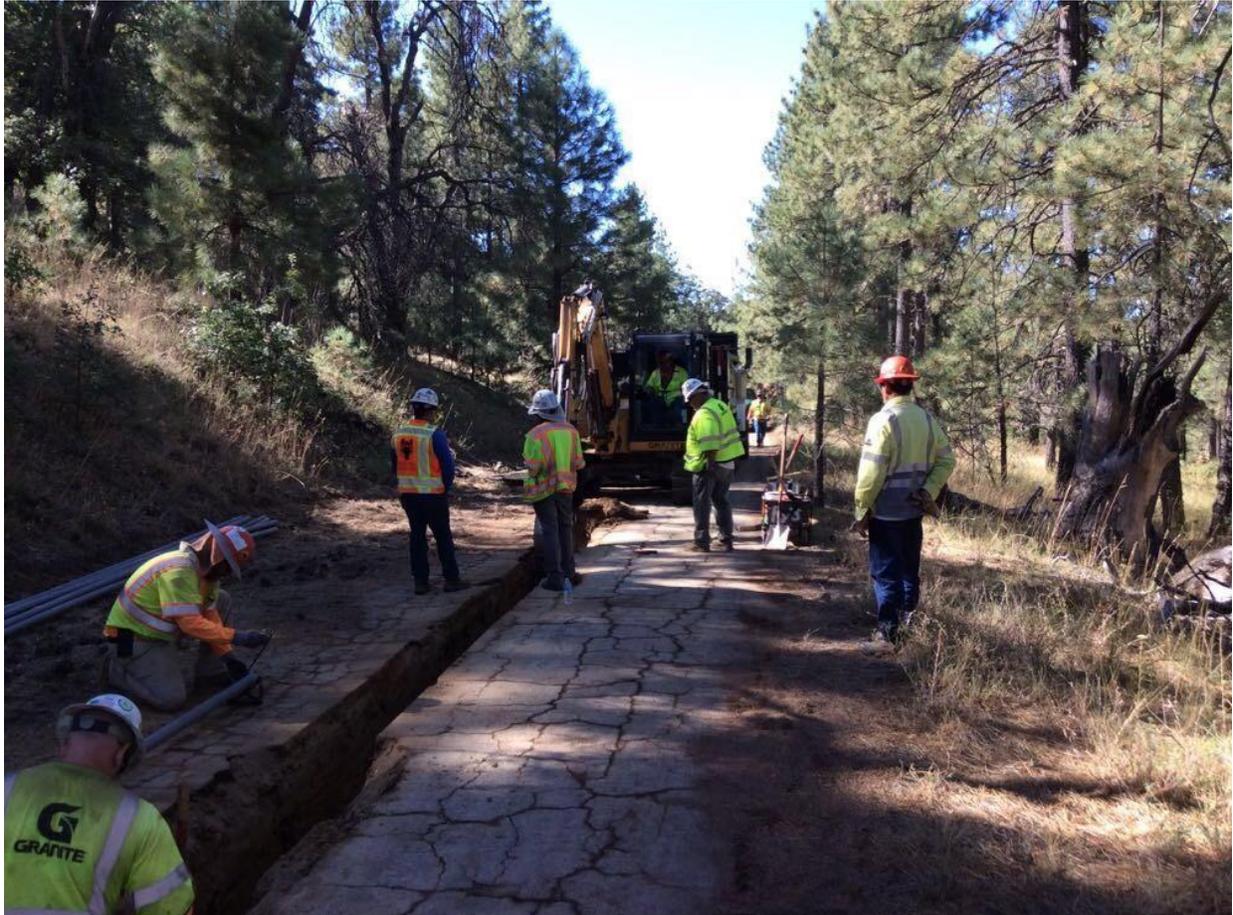
Photo 3: During trenching for the installation of underground utilities along C 440 on Wooded Hill Road, archaeological and cultural monitors were observed inspecting the excavation in accordance with the HPMP (MM CUL-1) and APM CUL-04.

or cultural resource site boundaries in accordance with the Historic Properties Management Plan (HPMP), MM CUL-1, MM CUL-3, and APM CUL-04 (See Photo 3 – Attachment A). Cultural ESAs were signed and roped off to prevent construction access to areas with cultural resources in accordance with the HPMP.

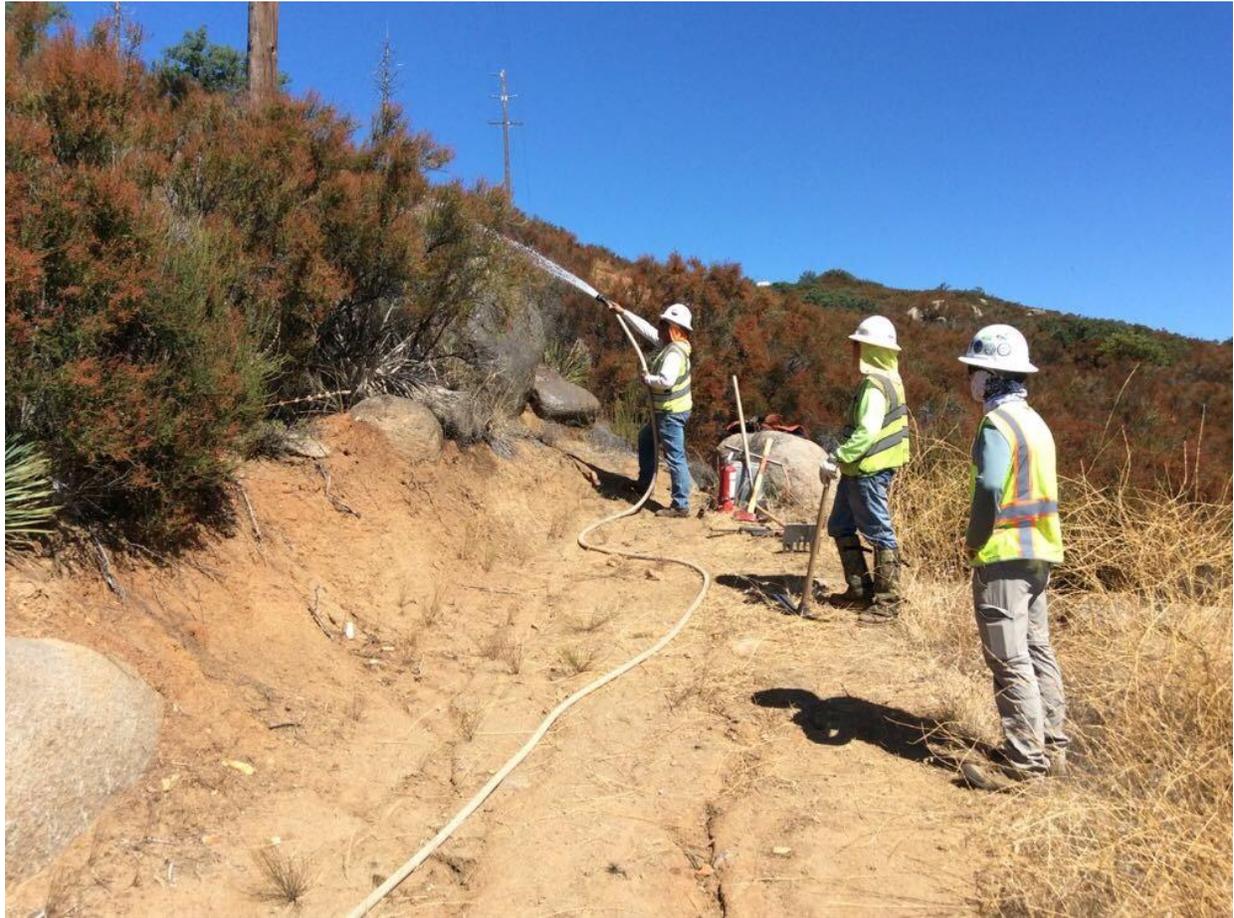
Photo 4: In preparation for vegetation clearing and chipping at Pole Z272992 (TL 625C), the area was wet down in accordance with the CFPPP Fire Matrix (MM FF-1) for chipping work on private land with a FPI of Elevated.

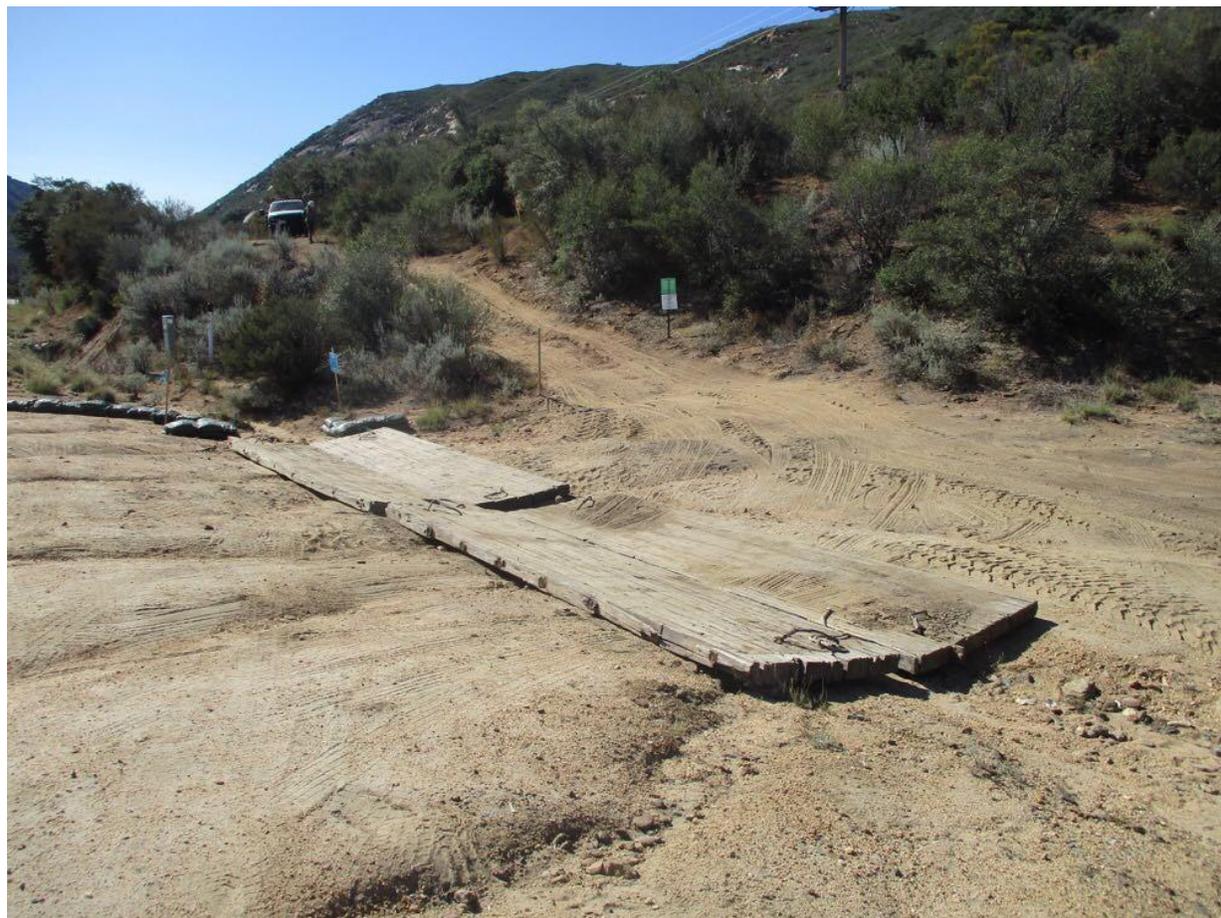
Photo 5: During micropile drilling at Pole Z40255 (TL 629A), a jurisdictional drainage crossing along the site access road was flagged, gravel bags were installed, and timber mats were used to prevent impacts to the stream channel in accordance with APM HYD-06.

To prevent impacts to hydrology and water quality, site-specific sediment and erosion control BMPs were observed being implemented and maintained along project alignments in accordance with the project Erosion Control Plan (ECP), SWPPP (MM HYD-01, MM BIO-7), and APM HYD-09. Sediment and erosion control BMPs were observed being implemented along rights-of-way, and included the use of gravel bag check dams, gravel bag berms, perimeter fiber rolls or straw wattles, silt fence, and track out controls such as rattle plates and rock aprons at staging yards. Dirt stockpiles were managed by being covered with plastic sheets and surrounded with fiber rolls or watered (if in use), and a street sweeper was used for track out cleanup on paved surfaces. Biological monitors and a Qualified SWPPP Practitioner were observed inspecting BMPs along rights-of-way and communicated with SDG&E construction contractors where repairs and maintenance were needed at tailboard meetings and throughout the day. Hydrological resources were flagged for avoidance, and work activities occurred outside of hydrological resources in accordance with APM HYD-06 (See Photo 5 – Attachment A).

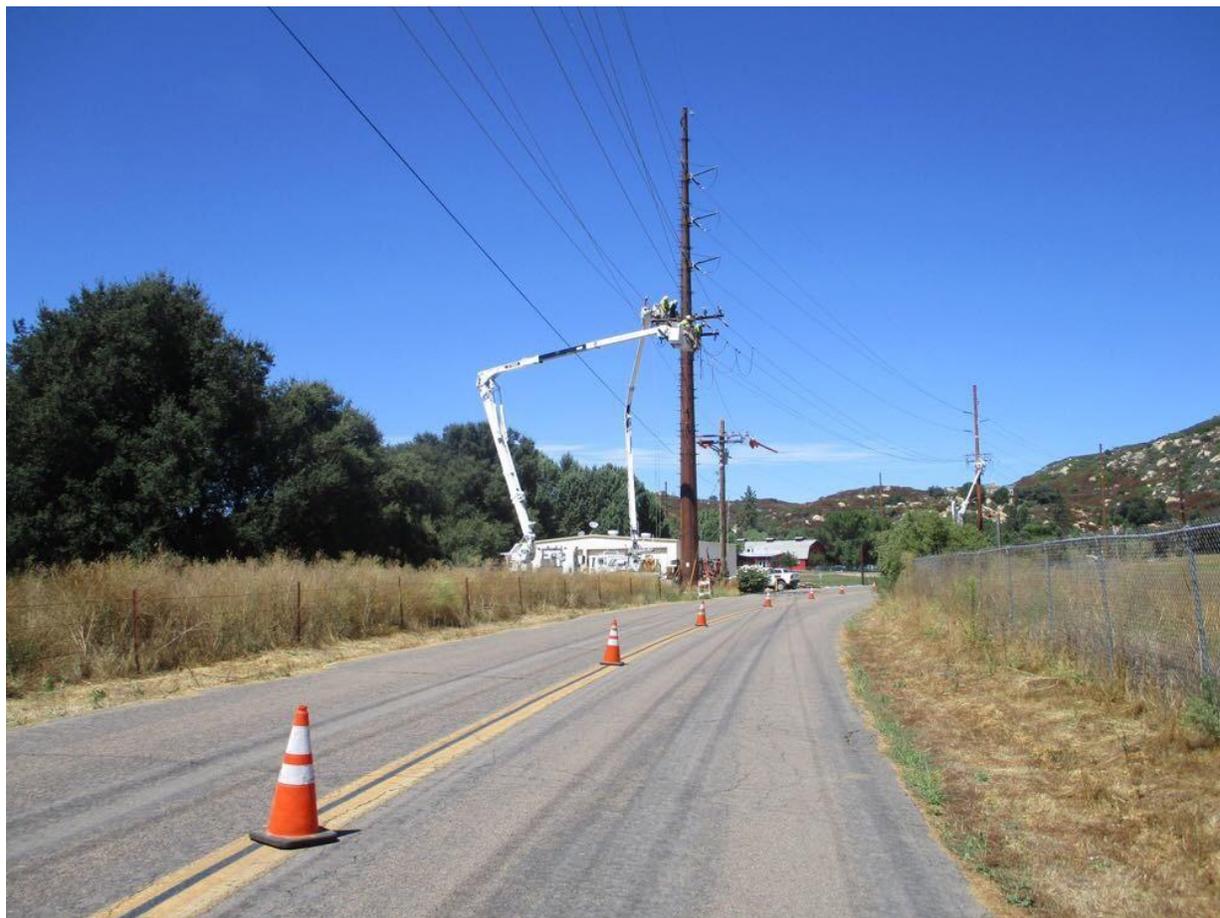
Photo 6: Construction crews observed dead-ending 12 kV lines at Pole Z872453 and Pole Z872452 (TL 629A). A Pro Traffic crew directed one-way traffic around staged equipment on River Drive in accordance with APM TRANS-02.

operations occurring adjacent to Old Highway 80, and directing one-way traffic along Viejas Blvd and River Drive during overhead line work (See Photo 6 – Attachment A). Along TL 625C, lane closures were conducted to allow crews to work safely at work sites along Japatul Valley Road. At C 440, a clearly marked pilot vehicle was used to shuttle traffic through the construction zone along Sunrise Highway where one lane was closed for trenching activities.
