| | <p><b>California Public Utilities Commission</b><br/><b><i>Mitigation Monitoring, Compliance, and Reporting</i></b><br/><b><i>Program</i></b></p> |
| | <p><b>Cleveland National Forest Power Line Replacement</b><br/><b>Projects</b></p> <p><b>Compliance Status Report: 081</b></p> <p><b>November 3, 2019</b></p> |

This compliance status report covers construction activities from October 21, 2019 through November 3, 2019.

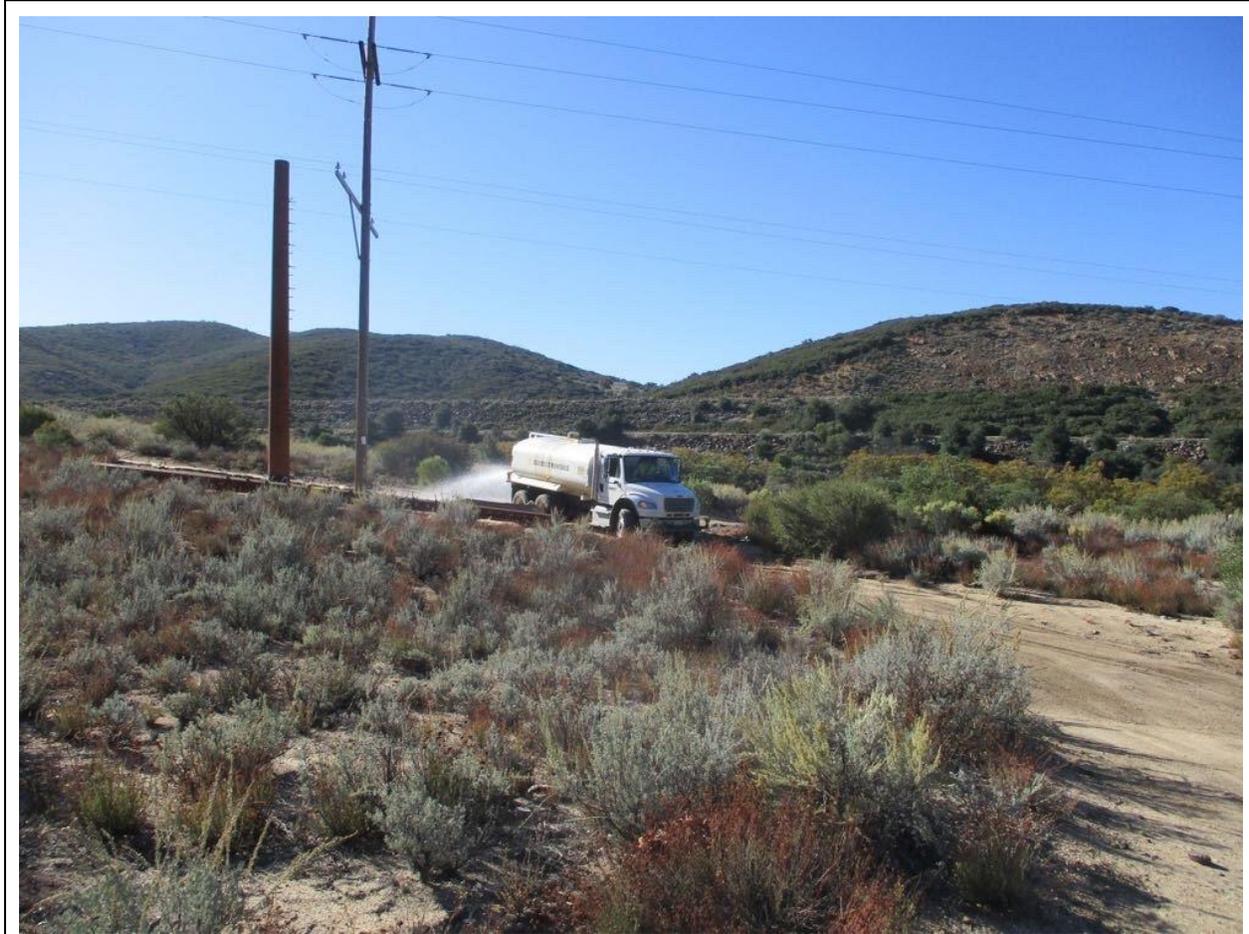
**Photo 1:** Prior to crew ingress into Pole Z276634 (TL 629A), a water truck was observed wetting down the area to prevent dust emissions in accordance with APM AIR-02 and APM AIR-05.

To prevent fugitive dust emissions during project activities, construction crews were observed applying water to prevent fugitive dust at staging and fly yards in preparation for helicopter external load operations, and along unpaved access roads (See Photo 1 – Attachment A) and in work areas in accordance with APM AIR-02. Haul trucks used for dirt export were observed utilizing load covers to prevent dust emissions in accordance with APM AIR-02, and construction personnel were observed maintaining posted speeds of 15 miles per hour on unpaved roads in accordance with APM AIR-03 and MM BIO-24. Construction crews applied water during drilling and used cuttings containment boxes to prevent dust emissions in accordance with APM AIR-05. Additionally, track-out was observed being removed from paved access roads in accordance with APM AIR-05.

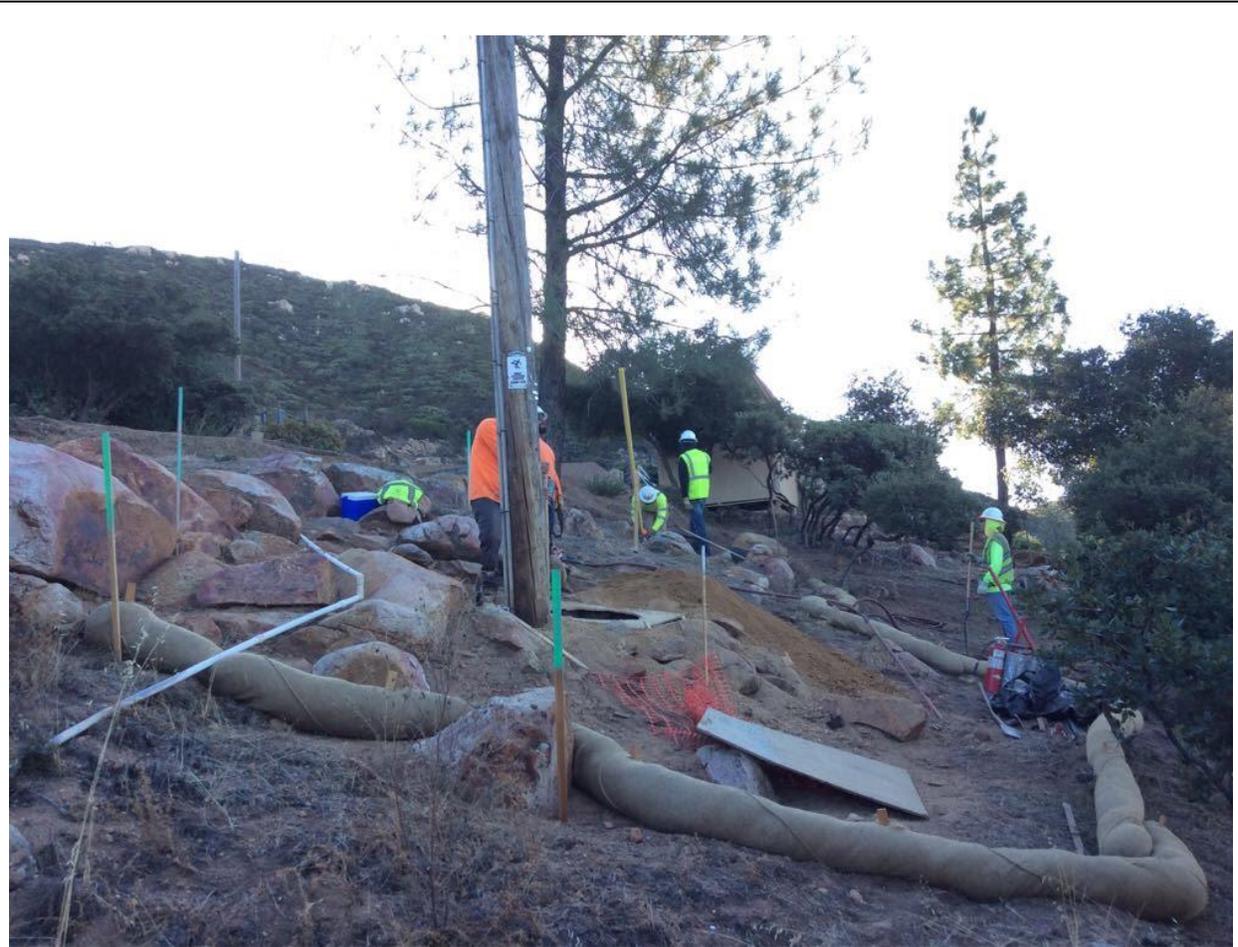
**Photo 2:** During direct bury pole and anchor excavations at Pole P33490 (TL 625C), crews were observed remaining within clearly delineated work limits in accordance with MM BIO-1. SWPPP BMPs were observed in place in accordance with MM HYD-01, MM BIO-7, and APM HYD-09.

Approved workspaces were observed delineated with staking and flagging, and work crews were observed adhering to work space limits and staying on approved access roads in accordance with MM BIO-1 (See Photo 2 – Attachment A). In order to ensure crews were clear on approved access routes, CPUC ECMs observed “no project access” and “approved access” signs at the entrances to access roads. Workers were observed having completed the Worker Environmental Awareness Program (WEAP), as shown by project hard hat stickers in accordance with MM BIO-2. Biological monitors were observed conducting full-time monitoring of initial ground-disturbing activities such as vegetation removal in accordance with MM BIO-3, and monitoring all other construction activities to ensure compliance with mitigation measures, applicant proposed measures, and permit conditions in accordance with MM BIO-22. In accordance with MM BIO-14 and MM BIO-16, Environmentally Sensitive Area (ESA) signs and flagging were observed around areas with special-status plant species, and those areas were observed being avoided by construction personnel. Excavations were observed covered to prevent wildlife entrapment in accordance with MM BIO-23, and the CPUC ECM communicated with the lead biological monitor to ensure no gaps were present. Crews were observed containing trash at work areas in accordance with MM BIO-26.

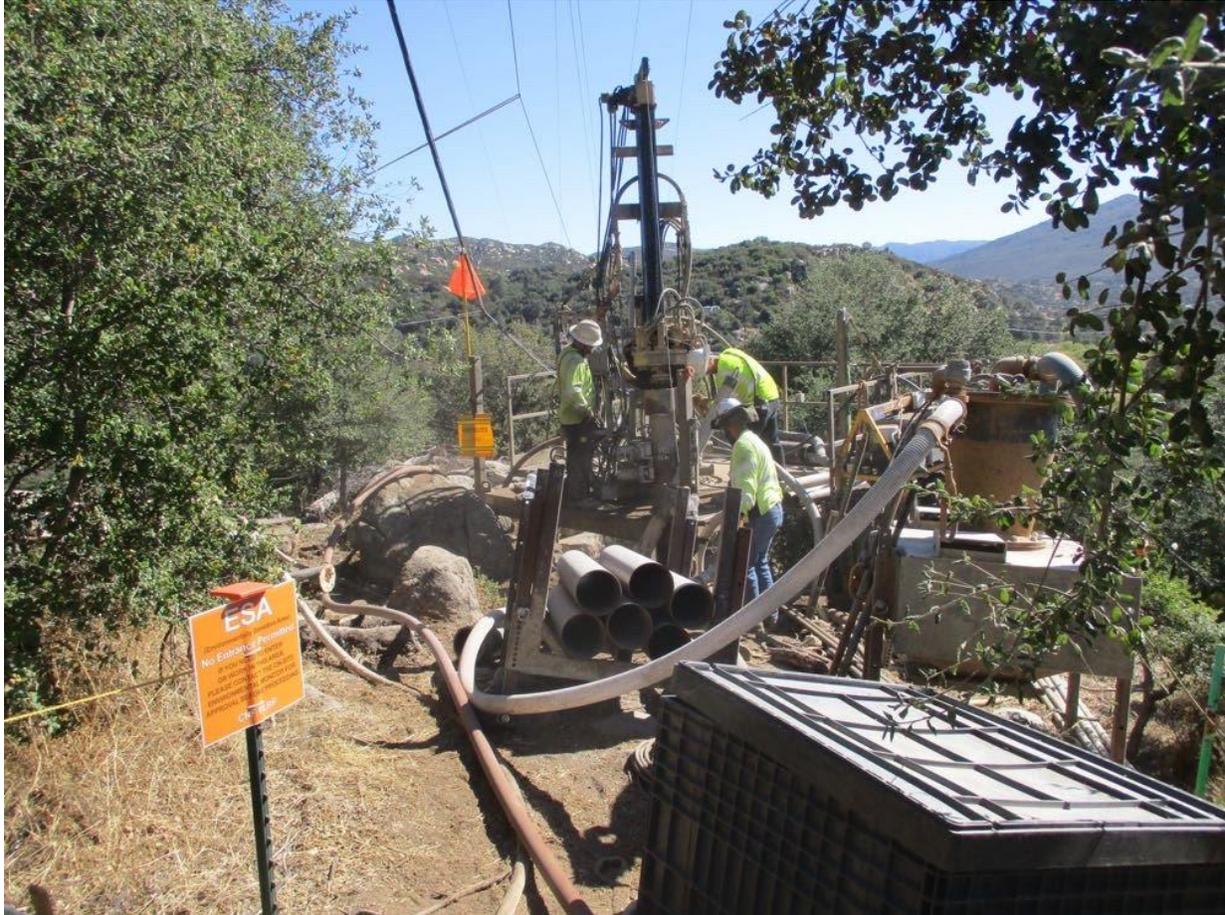
**Photo 3:** Along TL 629A, a micropile drilling crew was observed respecting a clearly delineated cultural ESA in an area with cultural and/or historical resources in accordance with APM CUL-03, the HPMP, and MM CUL-1.

or cultural resource site boundaries in accordance with the Historic Properties Management Plan (HPMP), MM CUL-1, MM CUL-3, and APM CUL-04. In areas with a high probability of cultural resources to occur, archeological and cultural monitors were observed initiating a grounding trench excavation per the HPMP, and screening soils for potential cultural resources. Cultural ESAs were signed and roped off to prevent construction access to areas with cultural and/or historical resources in accordance with the HPMP (See Photo 3 – Attachment A).

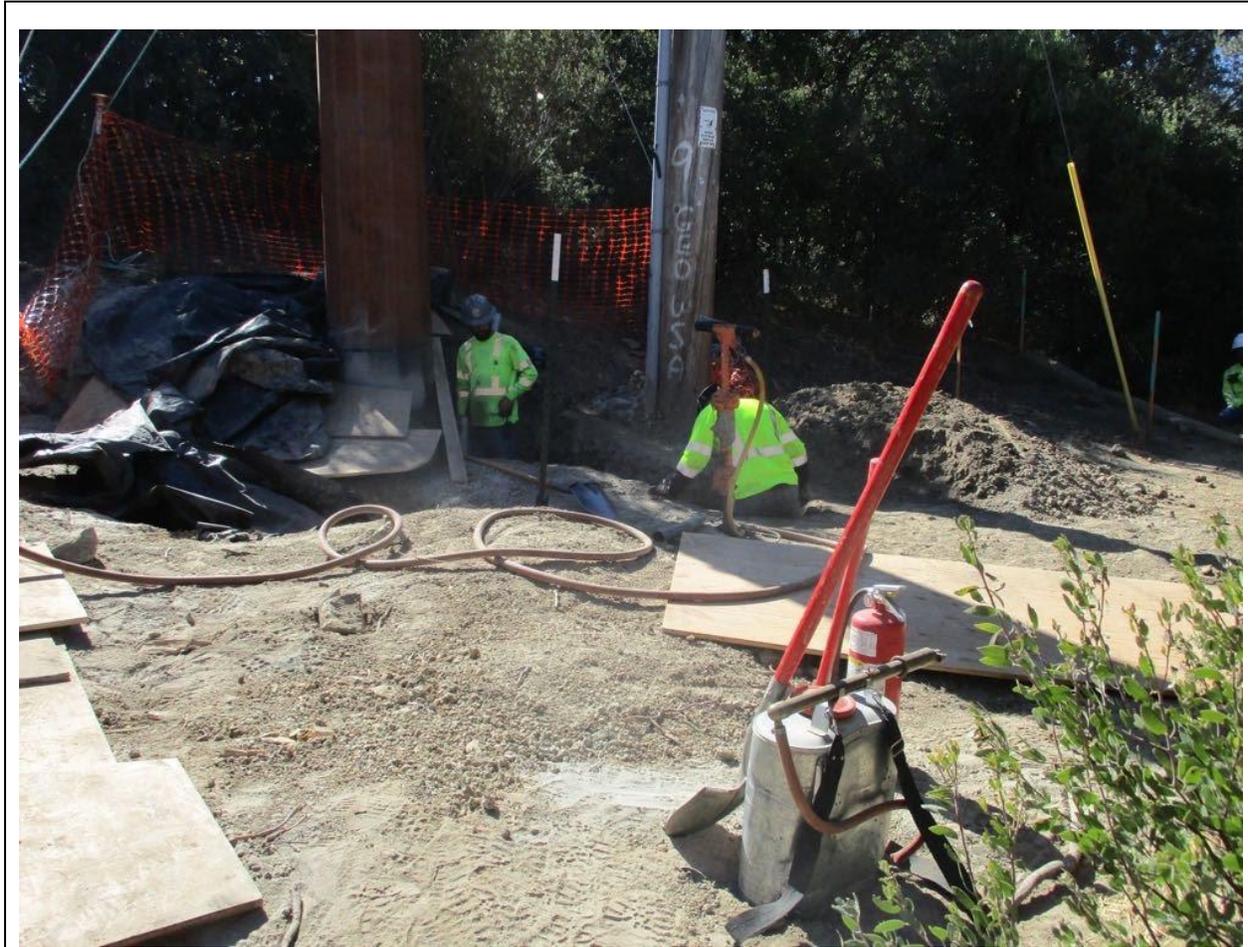
**Photo 4:** During intercept installation at Pole Z172741 (TL 629A), a set of fire tools was observed within 50 feet of the activity in accordance with APM HAZ-04 and the CFPPP (MM FF-1).

In accordance with the Construction Fire Prevention/Protection Plan (CFPPP) (MM FF-1), SDG&E and their construction contractors were observed communicating Fire Potential Index (FPI) and Project Activity Levels (PALs) to work crews at daily tailboard meetings, during which daily fire requirements and restrictions for work on private land and on National Forest System (NFS) land were discussed. All project-related vehicles and equipment were observed carrying the required set of fire tools (each set containing a 5-gallon backpack pump, round point shovel, Pulaski, and 2A10BC fire extinguisher). Construction crews were observed staging a set of fire tools within 50 feet of work activities as required by APM HAZ-04 (See Photo 4 – Attachment A), and within 50 feet of truck-mounted stand-alone combustion engines and compressors in accordance with the CFPPP fire prevention matrices. Fire boxes were observed at staging yards and stocked with the required firefighting tools, including 3 round point shovels, 2 Pulaskis, 2 McLeods, and 1 full 5 gallon backpack pump. Fire patrols were observed monitoring construction activities, checking 5-gallon backpack pumps to ensure they were completely full of water, and inspecting fire extinguishers to ensure they were fully charged and serviced within the year. In accordance with the CFPPP fire prevention matrices, construction crews were observed staffing dedicated fire patrols during hot work and when work occurred with overhead lines. For work on NFS land on days with the PAL designation of EV, dedicated fire patrols were present at each work site in accordance with the CFPPP fire prevention matrix for work on NFS land.

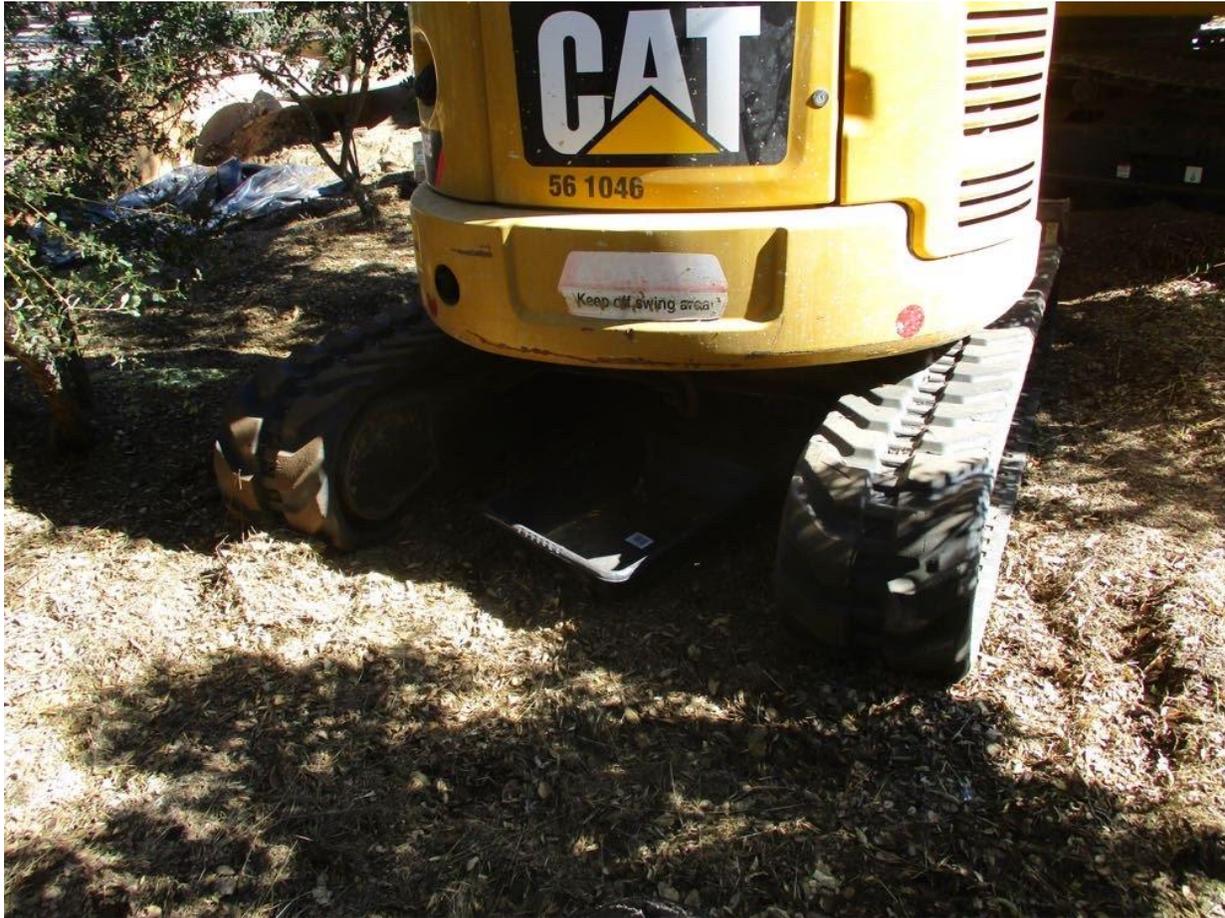
**Photo 5:** During pole hole drilling at Pole Z172739 (TL 629A), the crew was observed using a drip pan beneath staged equipment to prevent leaks or spills from being discharged into the soil in accordance with MM PHS-2.

To prevent leaks and spills from being discharged into the soil in accordance with the Spill Response and Notification Plan (SRNP) and MM PHS-2, construction crews were observed implementing spill prevention BMPs, such as using drip pans under staged equipment (See Photo 5 – Attachment A) and beneath equipment during mechanical work, staging spill kits at work sites, using double-walled fuel tanks or implementing secondary containment beneath staged fuel tanks, and cleaning up spills and disposing of contaminated soils in the designated and properly labeled hazardous waste barrels.

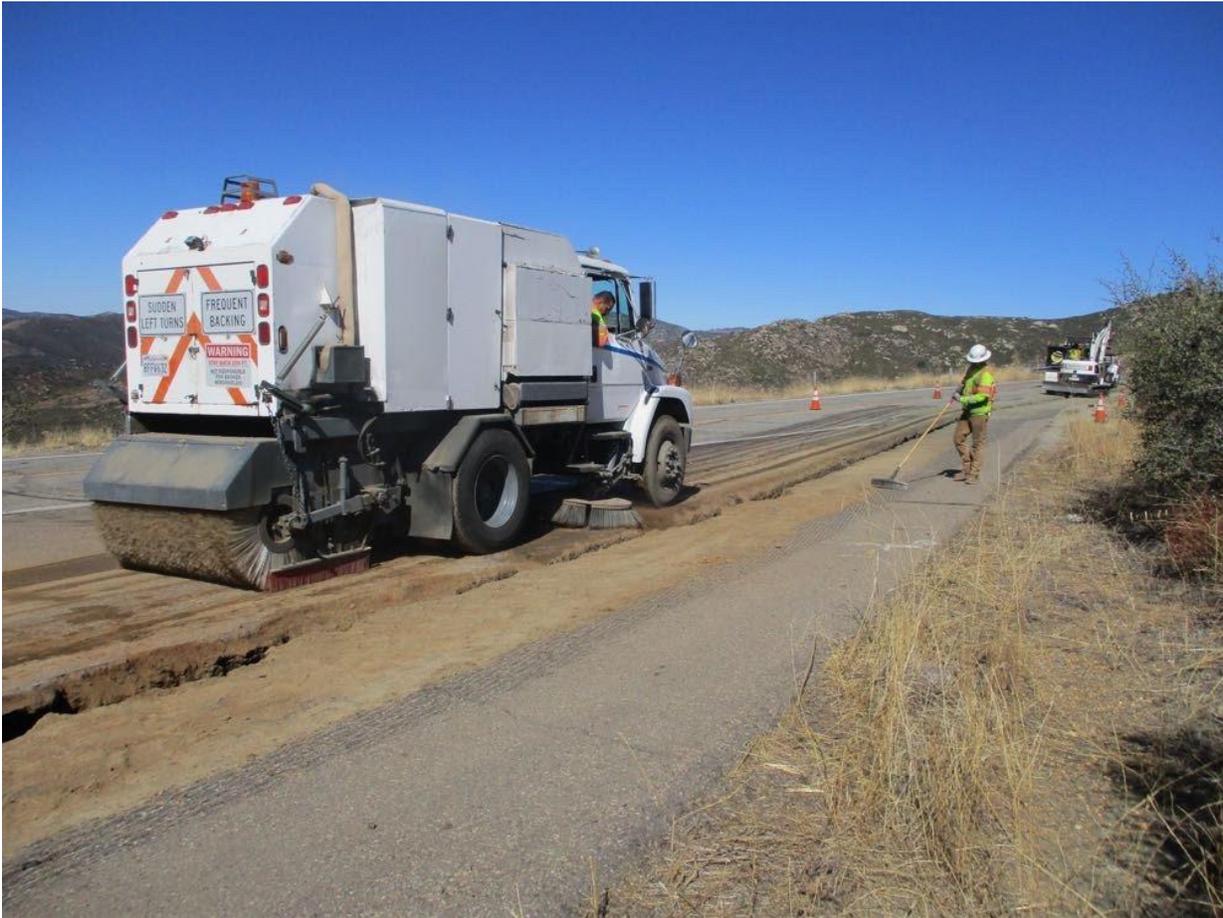
**Photo 6:** After trenching for the underground distribution line at C 440 (Phase 1), a street sweeper was observed being operated along Sunrise Highway to clean the road and prevent off-site erosion in accordance with the ECP (MM HYD-1) and SWPPP (MM BIO-7).
