<b>California Public Utilities Commission</b> <b><i>Mitigation Monitoring, Compliance, and Reporting</i></b> <b>Program</b>
	<b>Cleveland National Forest Power Line Replacement</b> <b>Projects</b>  <b>Compliance Status Report: 082</b>  <b>November 17, 2019</b>

This compliance status report covers construction activities from November 4 through November 17, 2019.

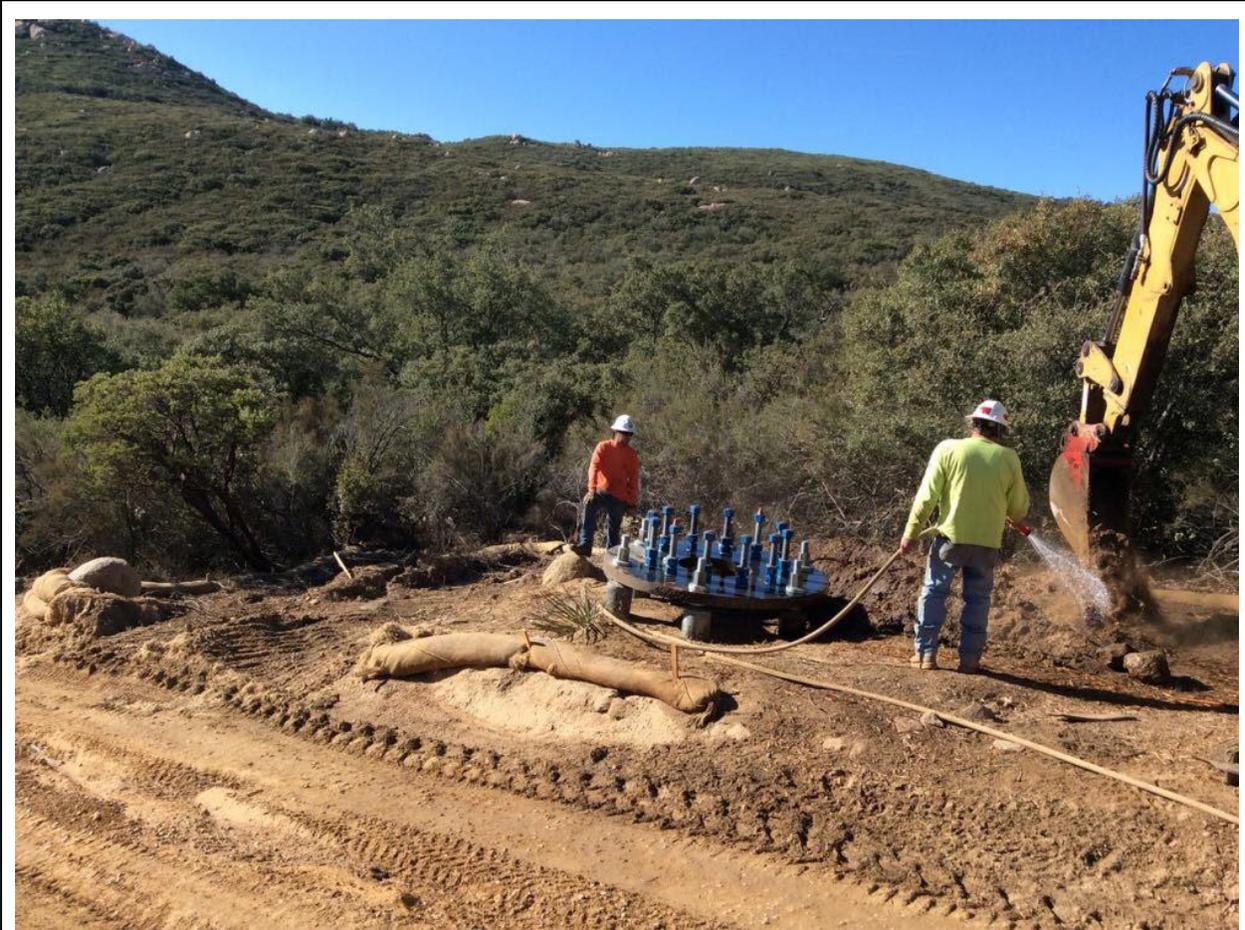
**Photo 1:** A crew at Pole Z293927 (TL 625C) was observed using water to minimize dust emissions during ground rod trenching in accordance with APM AIR-05.

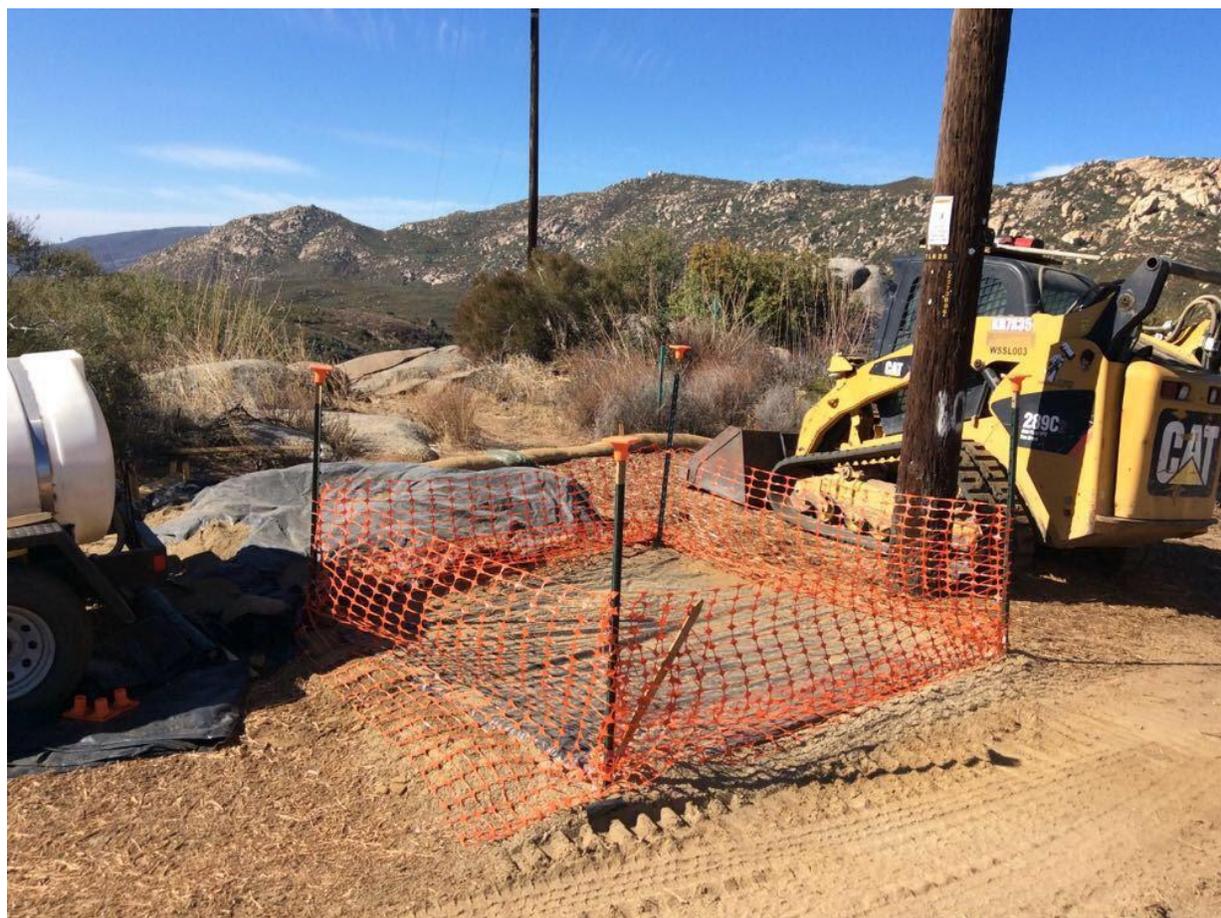
**Photo 2:** The pole hole at Pole Z273006 (TL 625C) was observed to be securely covered to prevent wildlife entrapment in accordance with MM BIO-23.

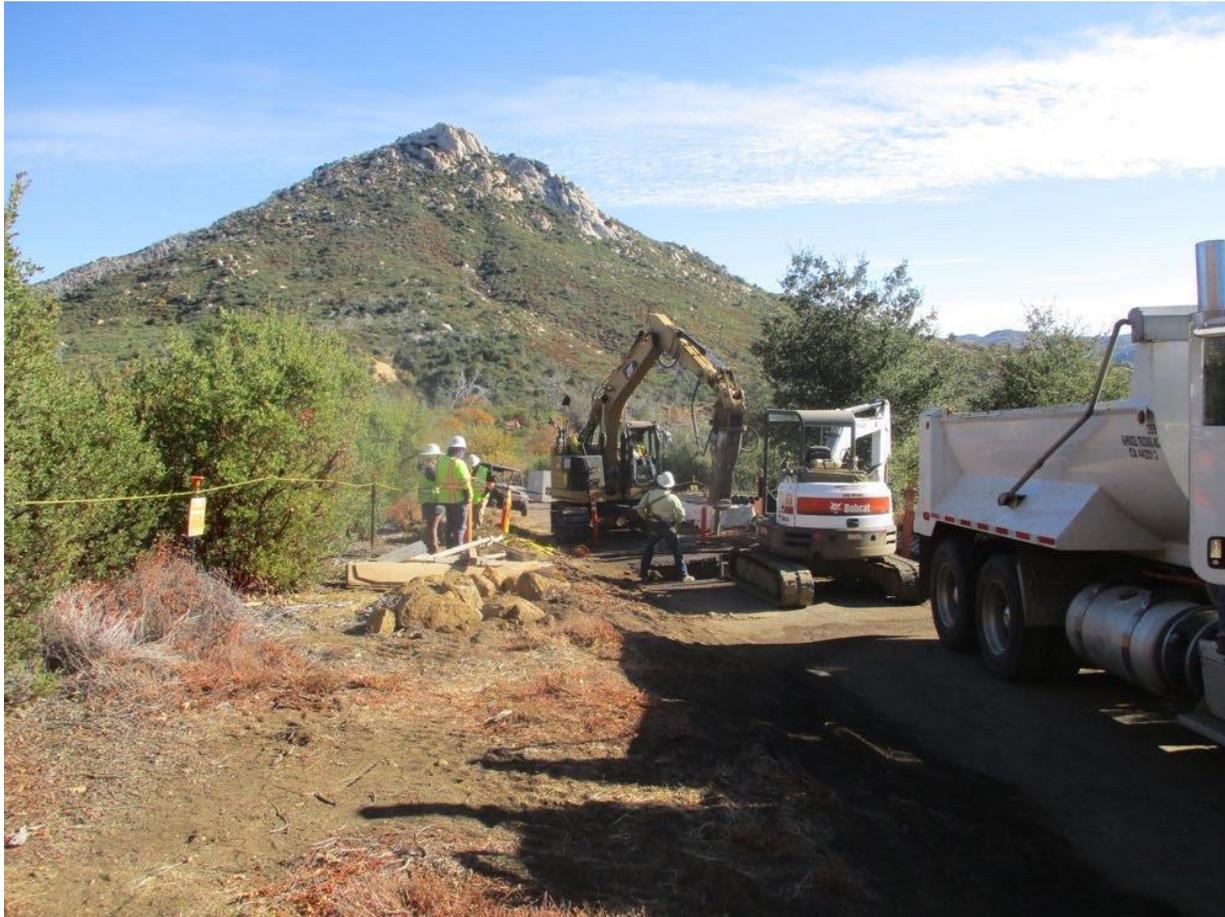
**Photo 3:** Along C 79A, project personnel were observed avoiding a clearly delineated cultural ESA in an area with cultural and/or historical resources in accordance with APM CUL-03, the HPMP, and MM CUL-1. Additionally, Archaeological and Cultural Monitors were present to monitor excavations in accordance with the HPMP, MM CUL-1, MM CUL-3, and APM CUL-04.

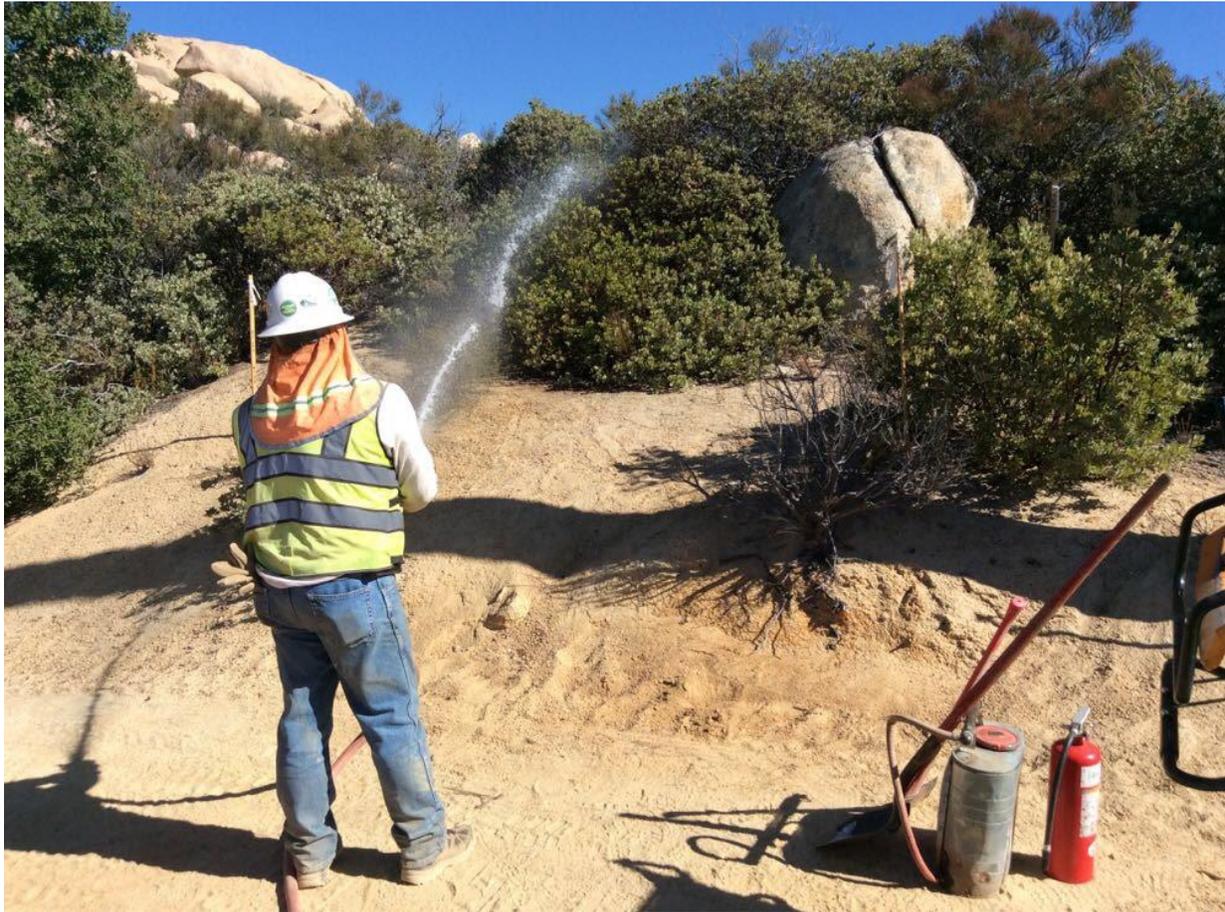
**Photo 4:** A crew member was observed wetting down vegetation prior to removal and chipping at Pole Z273018 (TL 625C) in accordance with the CFPPP Fire Prevention Matrix for the activity on NFS land with a Project Activity Level (PAL) D. In addition, a complete set of fire tools was observed on site.

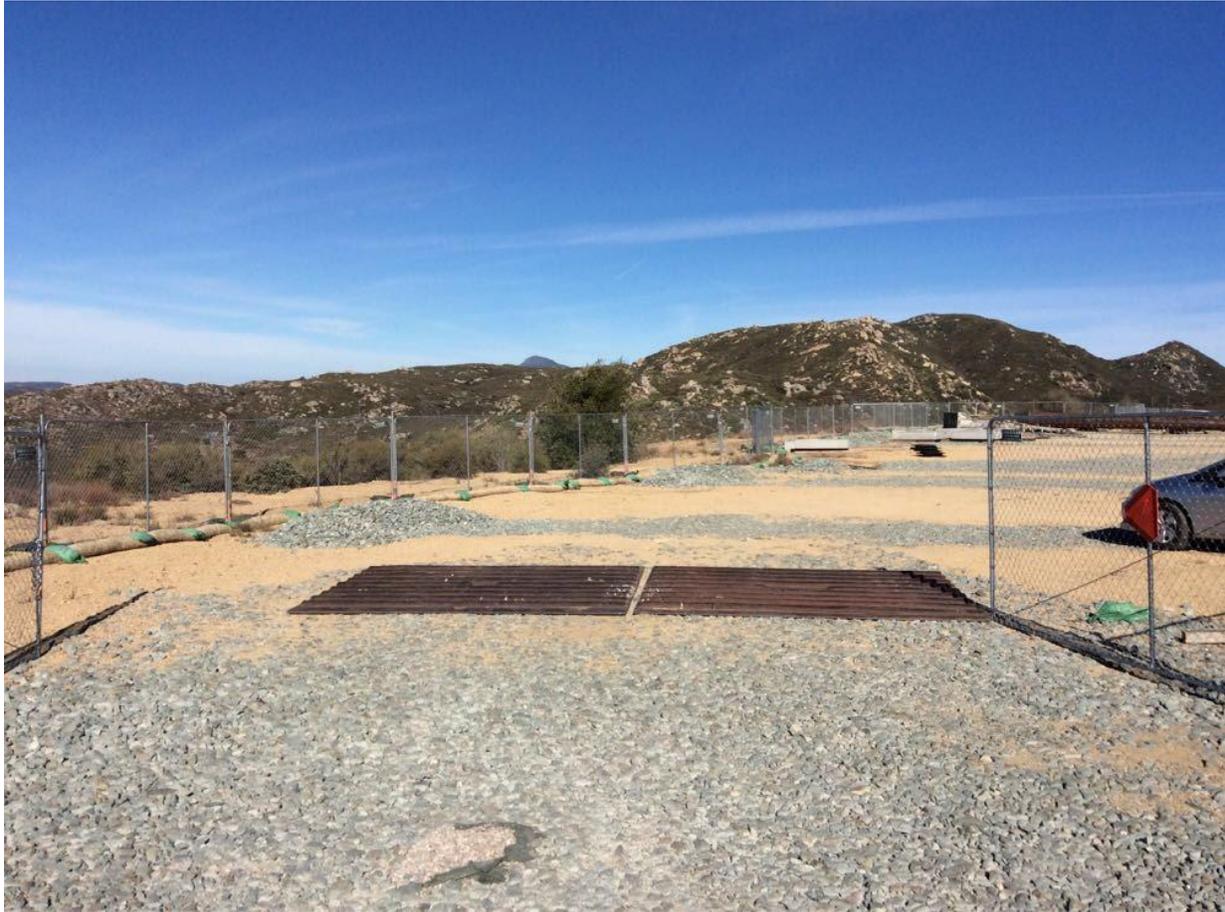
**Photo 5:** The entrance to Staging Yard 2A (C 440) was observed to be stabilized with rattle plates and rock aprons in accordance with project Erosion Control Plan (ECP), SWPPP (MM HYD-01, MM BIO-7), and APM HYD-09.

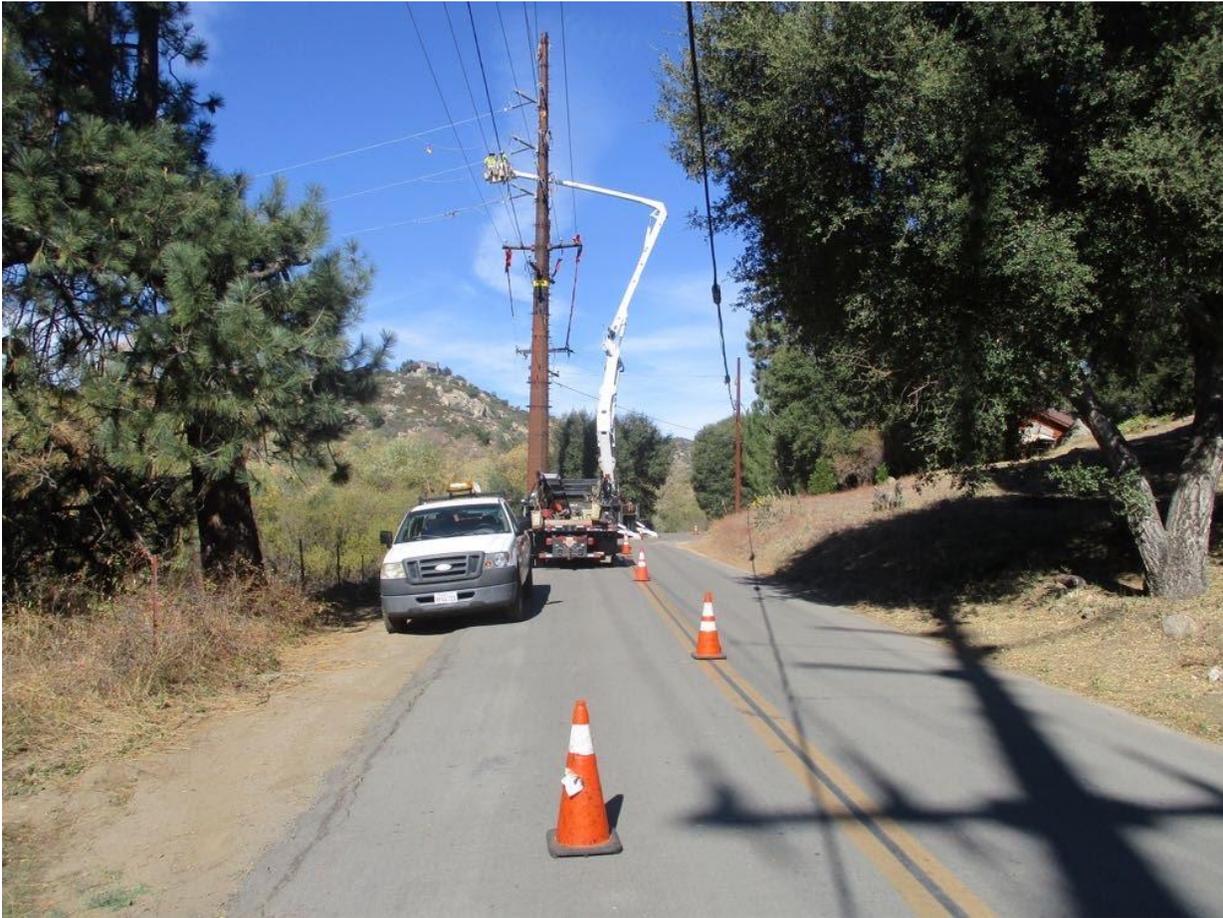
**Photo 6:** During overhead dead-end activities at Pole Z172800 (TL 629A), one-way traffic was directed around the work site with the use of signage, cones, and flaggers in accordance with APM TRANS-02 and APM TRANS-05.
