California Public Utilities Commission <i>Mitigation Monitoring, Compliance, and Reporting</i> <i>Program</i>
	Cleveland National Forest Power Line Replacement Projects Compliance Status Report: 084 December 15, 2019

This compliance status report covers construction activities from December 2 through December 15, 2019.

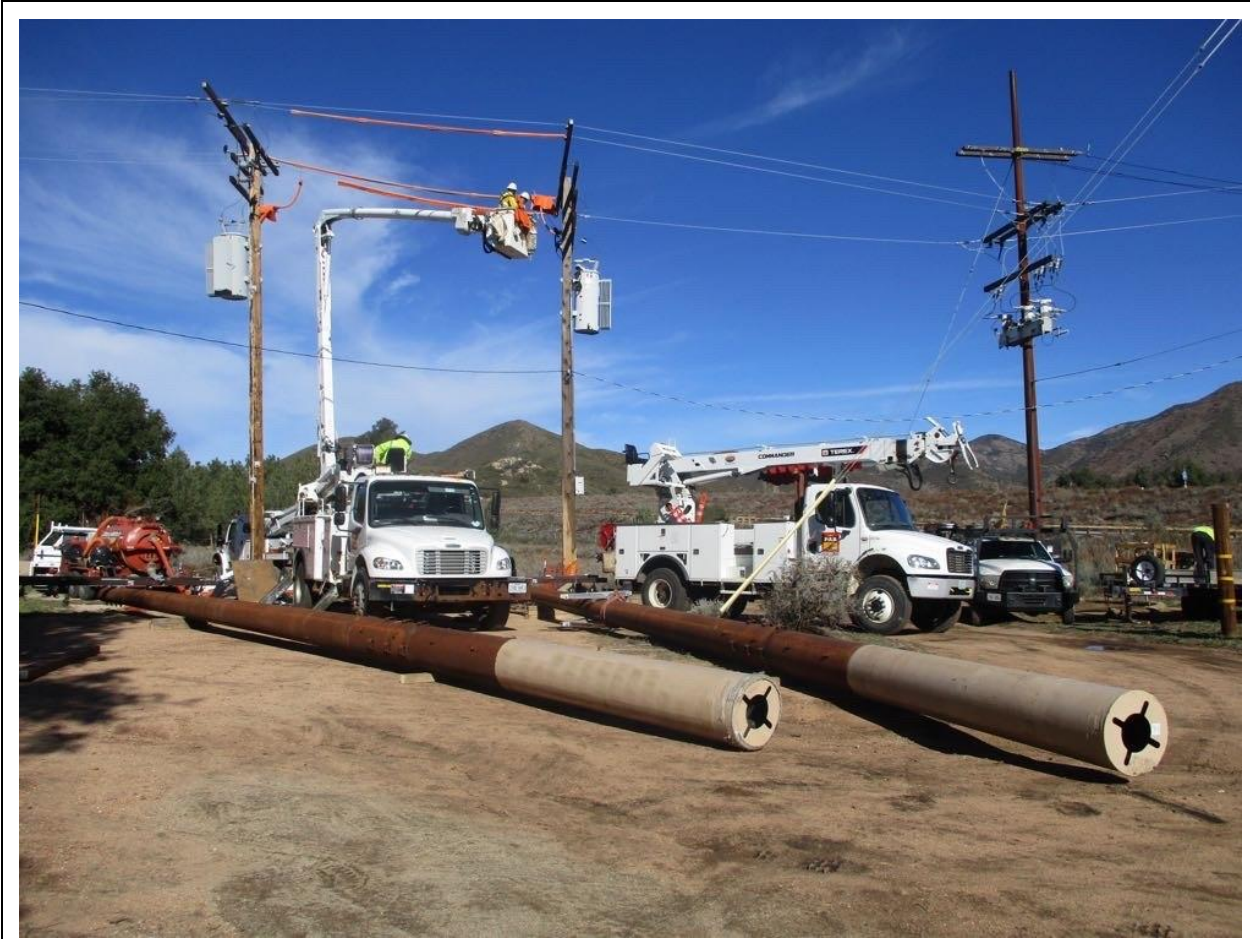
Photo 1: A line crew observed conducting overhead wire work and installing wire protectors in preparation for pole setting at Poles P164041 and P164042 along TL 629A.

During this reporting period along TL 629A, CPUC ECMs observed construction crews drilling and digging pole holes; drilling for and proof testing micropile foundations; conducting overhead work, spreading overhead wire, and framing and setting new poles (see Photo 1 – Attachment A); backfilling and compacting around new poles; conducting line work to service homes; transporting equipment via helicopter external load operations; trimming trees for line clearance and chipping; and trenching for the installation of grounding wire. Along TL 625C, CPUC ECMs observed construction crews mobilizing equipment; drilling for, pressure grouting, proof testing, and capping micropile foundations; drilling and digging pole holes; conducting overhead work, installing grounds; installing cross arms, spreading wire, installing wire protectors, framing and setting new poles; backfilling around new poles with concrete; conducting earth work; and trenching and installing grounding rods and wire. Along TL6923, CPUC ECMs observed crews mobilizing equipment and materials; conducting maintenance grading of access roads; and clearing vegetation and installing erosion control BMP's for pole work spaces. Along C 440, CPUC ECMs observed construction crews saw-cutting and removing asphalt; trenching; excavating vaults; installing conduit package and slurring it in; paving over trench; de-watering vaults and trench; and street sweeping. Along C 79A, CPUC ECMs observed construction crews trenching; excavating vaults; installing conduit package; transporting dirt and managing dirt stockpiles; conducting erosion control BMP maintenance; and cleaning up sites.

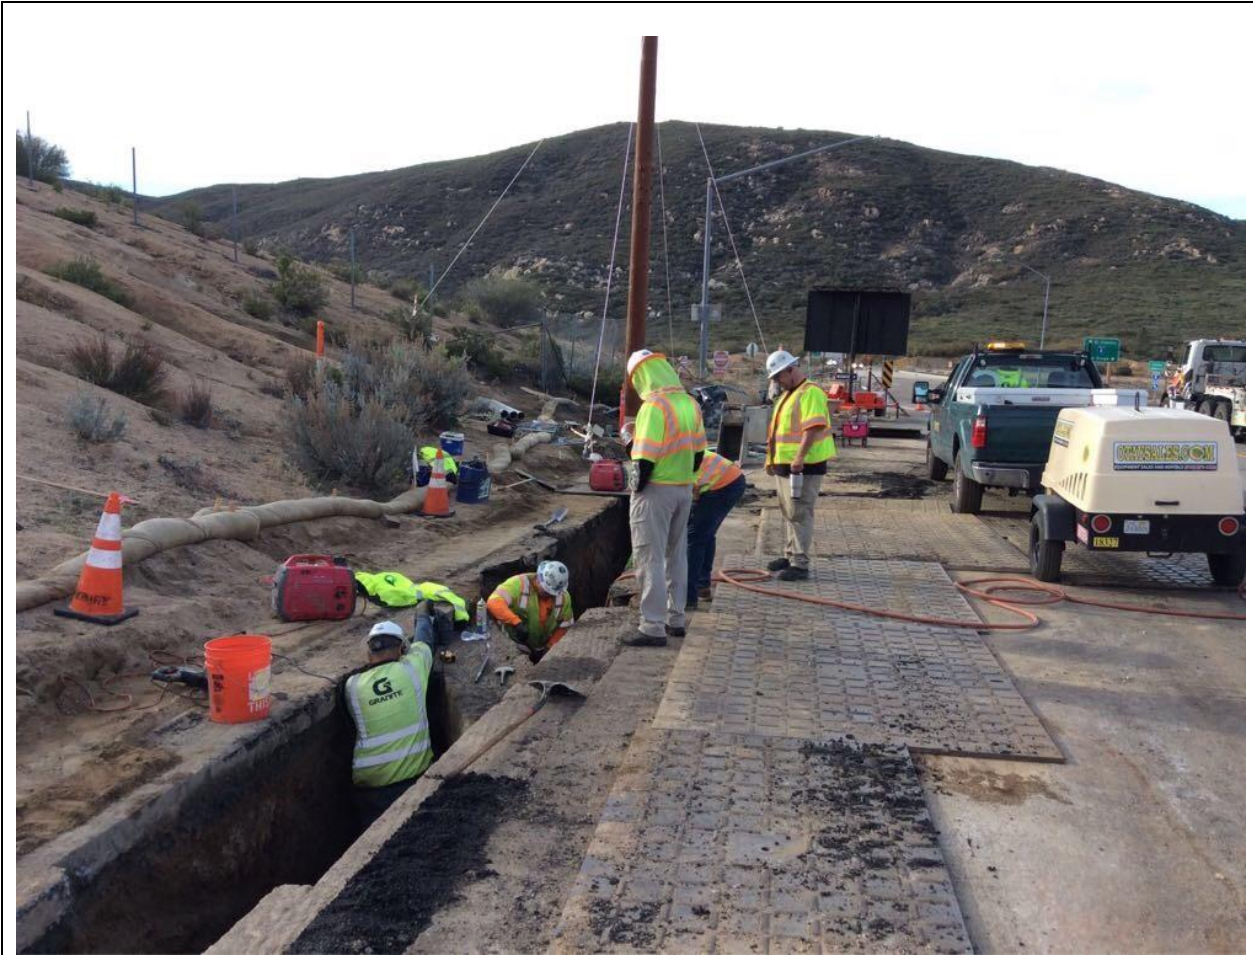
Photo 2: While construction crews installed conduit package near Vault 1 along C 440, a biological monitor was observed inspecting the site to ensure compliance with MMs, APMS, and permit conditions in accordance with MM BIO-22.

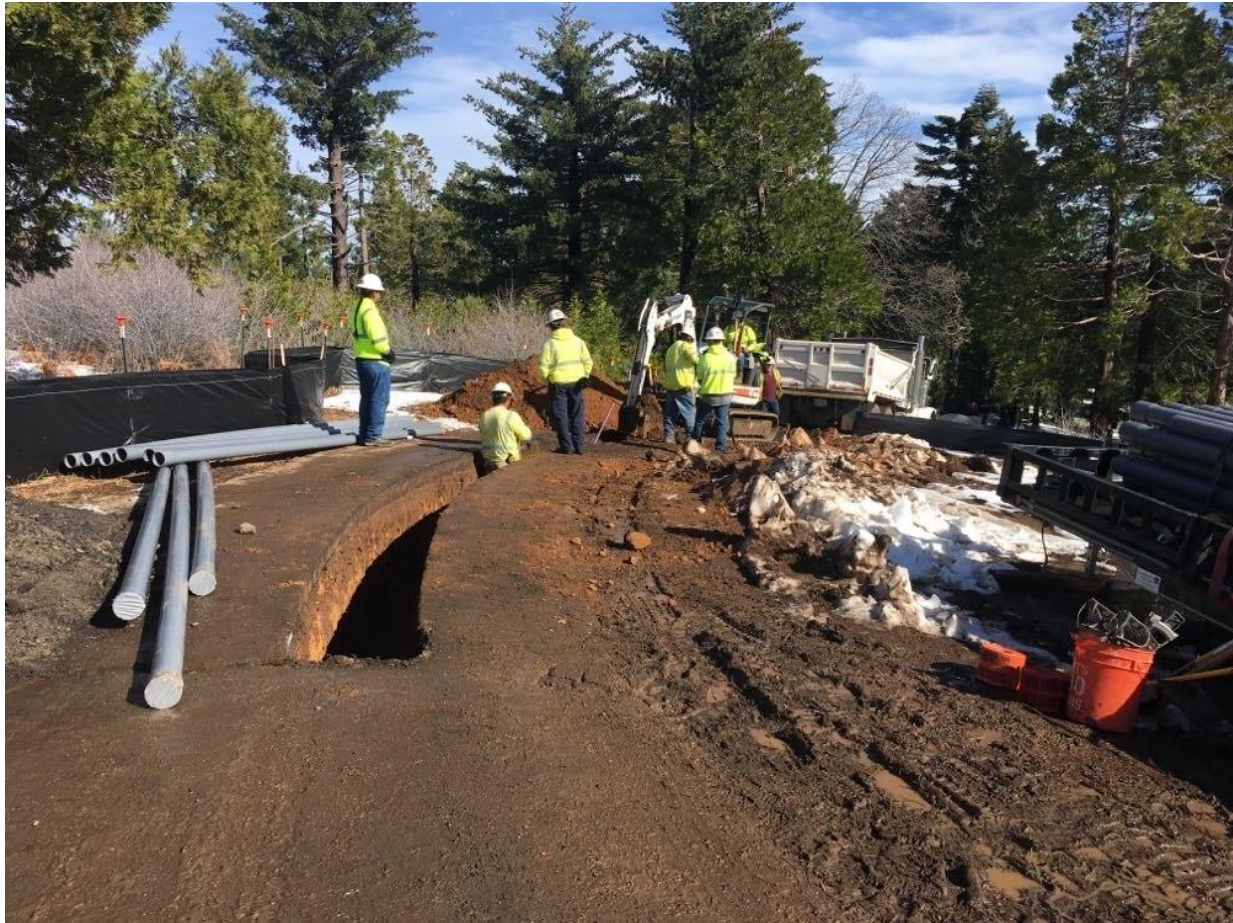
Photo 3: Along C 79A near station 36+00, during trenching, soil export, and conduit installation, cultural monitors were observed inspecting excavated soils and viewing trench sidewalls to prevent unauthorized impacts to potentially buried cultural resources in accordance with the HPMP, MM CUL-1, and APM CUL-04.

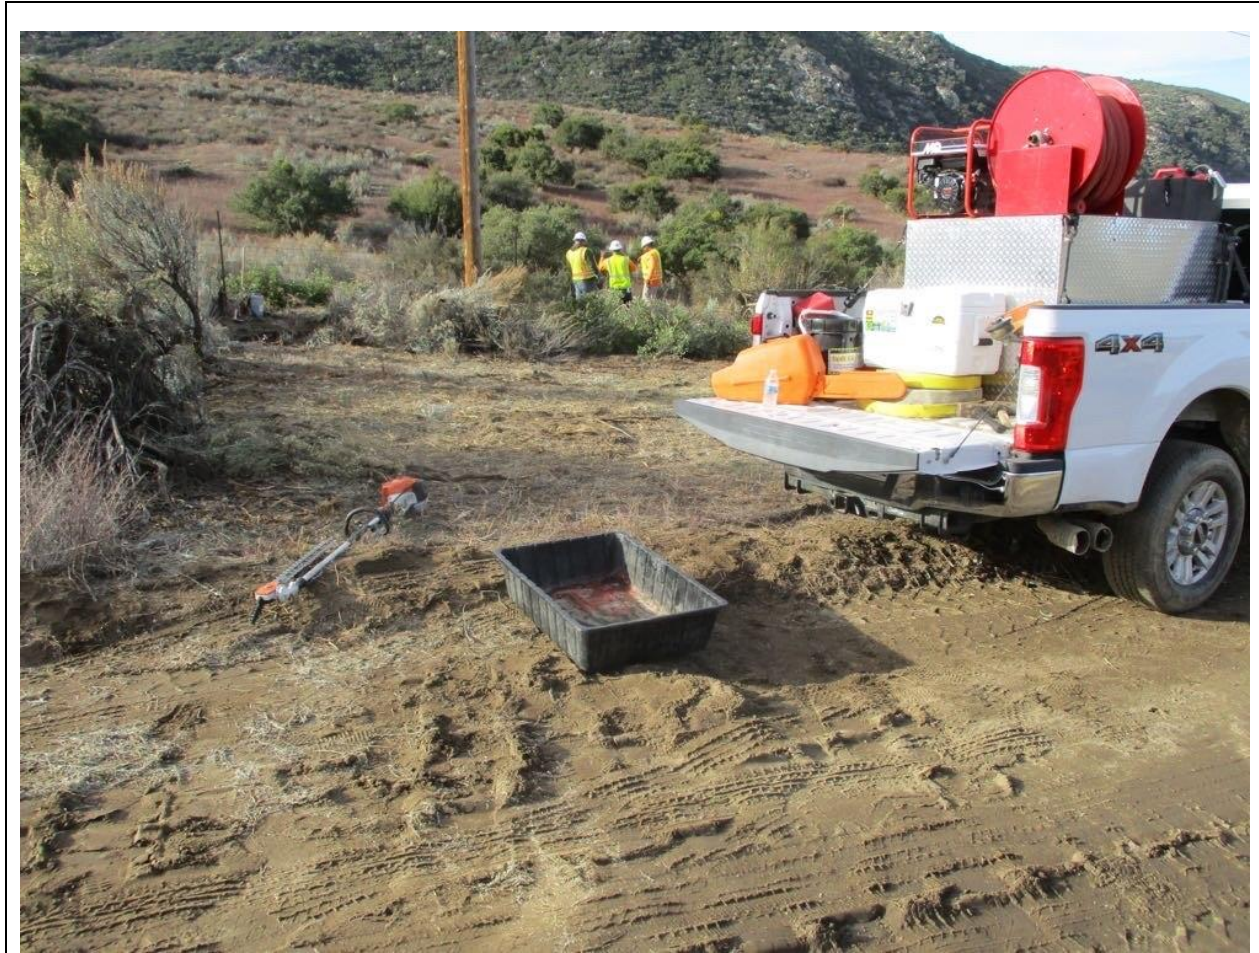
Photo 4: To prevent leaks and spills from being discharged into the soil during vegetation clearing work at Pole Z46583 (TL 6923), the construction crew refueled equipment over a drip pan in accordance with the SNRP and MM PHS-2.

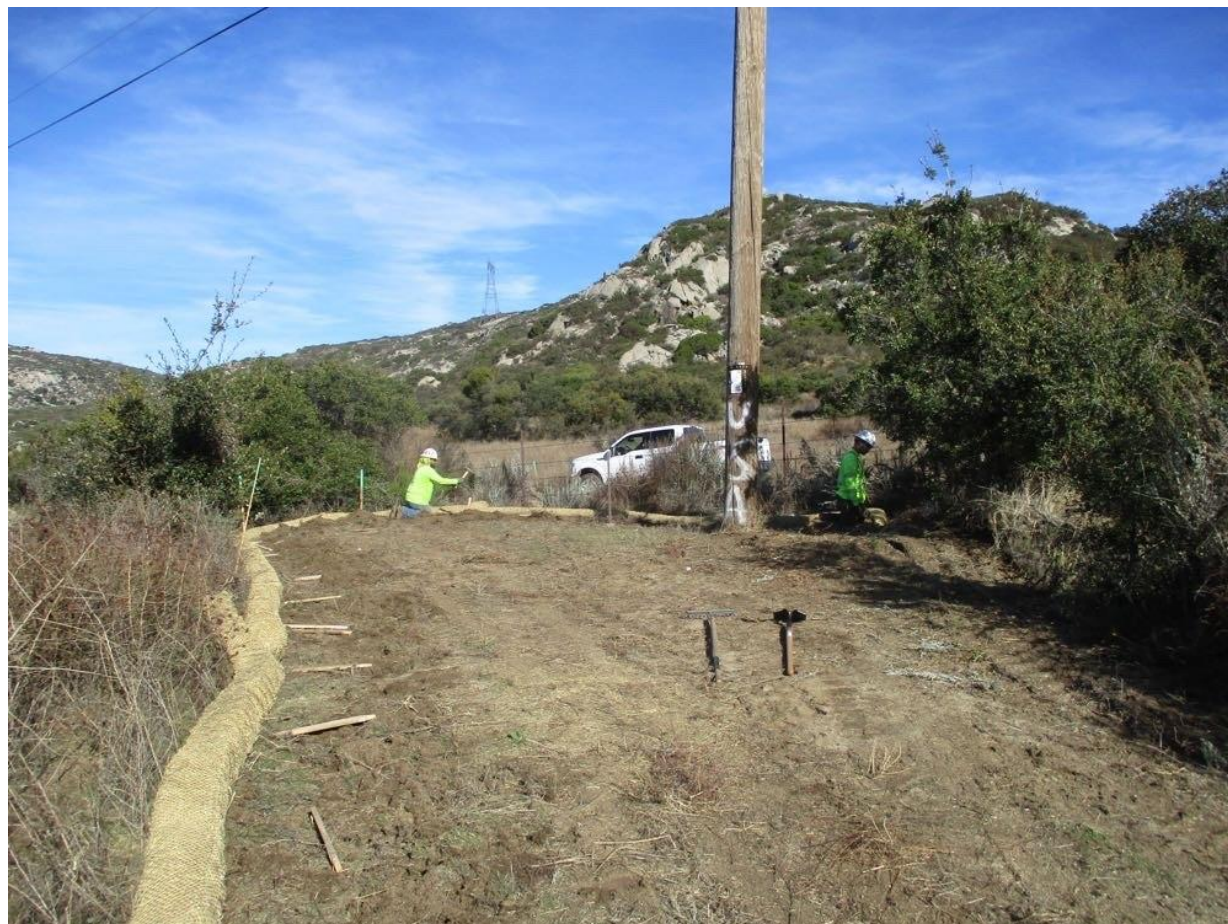
Photo 5: A construction crew observed installing straw wattles for erosion and sediment control around the workspace perimeter at Pole Z46583 (TL 6923) in accordance with the ECP and SWPPP.

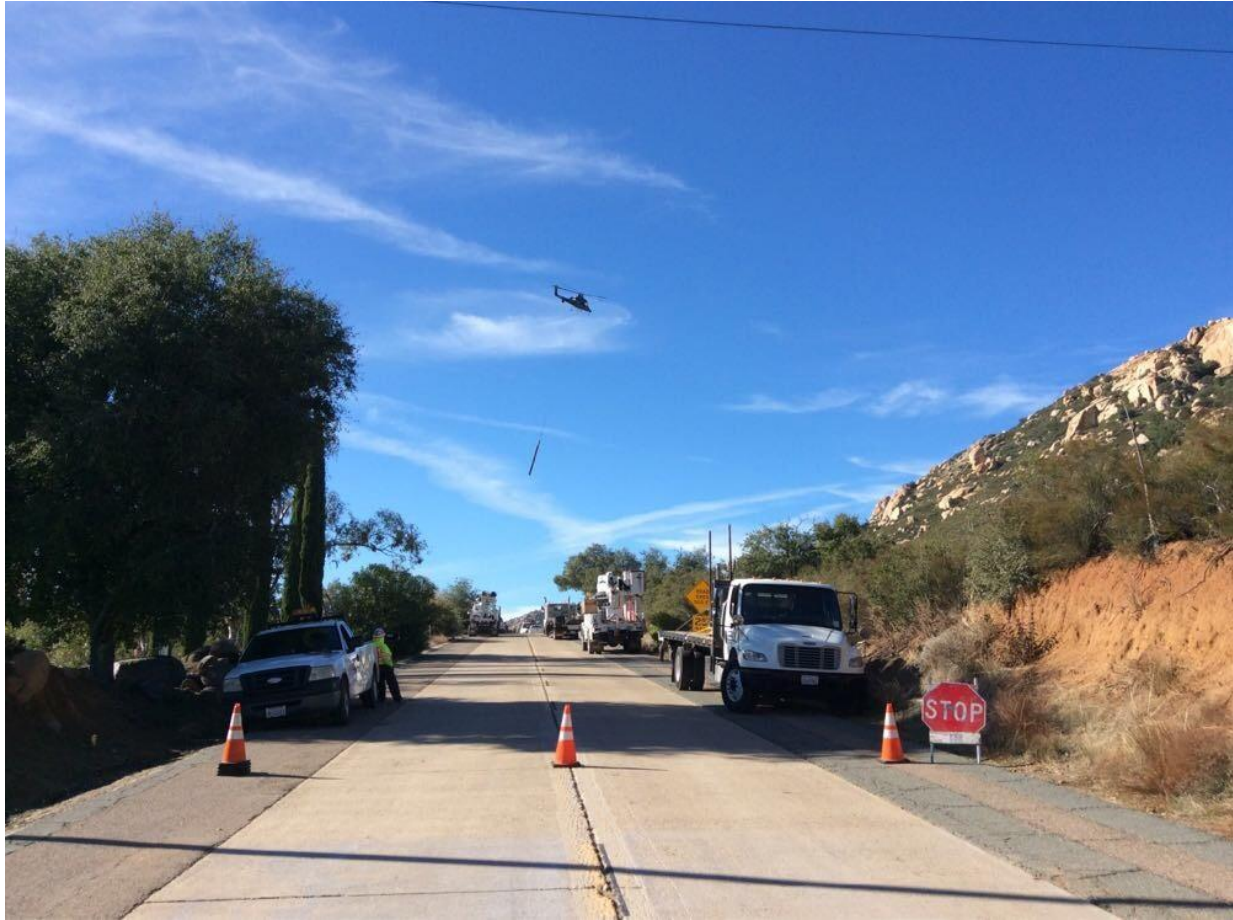
Photo 6: In accordance with the APM TRANS-02 and the Aviation Safety Plan (MM PHS-5), traffic control measures such as cones, signage, and flaggers were observed being used to regulate traffic and prevent the public from accessing Wildwood Glen Fly Yard (TL 625C), where helicopter external load operations supporting pole installation were being conducted.
