<p>California Public Utilities Commission <i>Mitigation Monitoring, Compliance, and Reporting</i> <i>Program</i></p>
	<p>Cleveland National Forest Power Line Replacement Projects</p> <p>Compliance Status Report: 087</p> <p>January 26, 2020</p>

This compliance status report covers construction activities from January 13 through January 26, 2020.

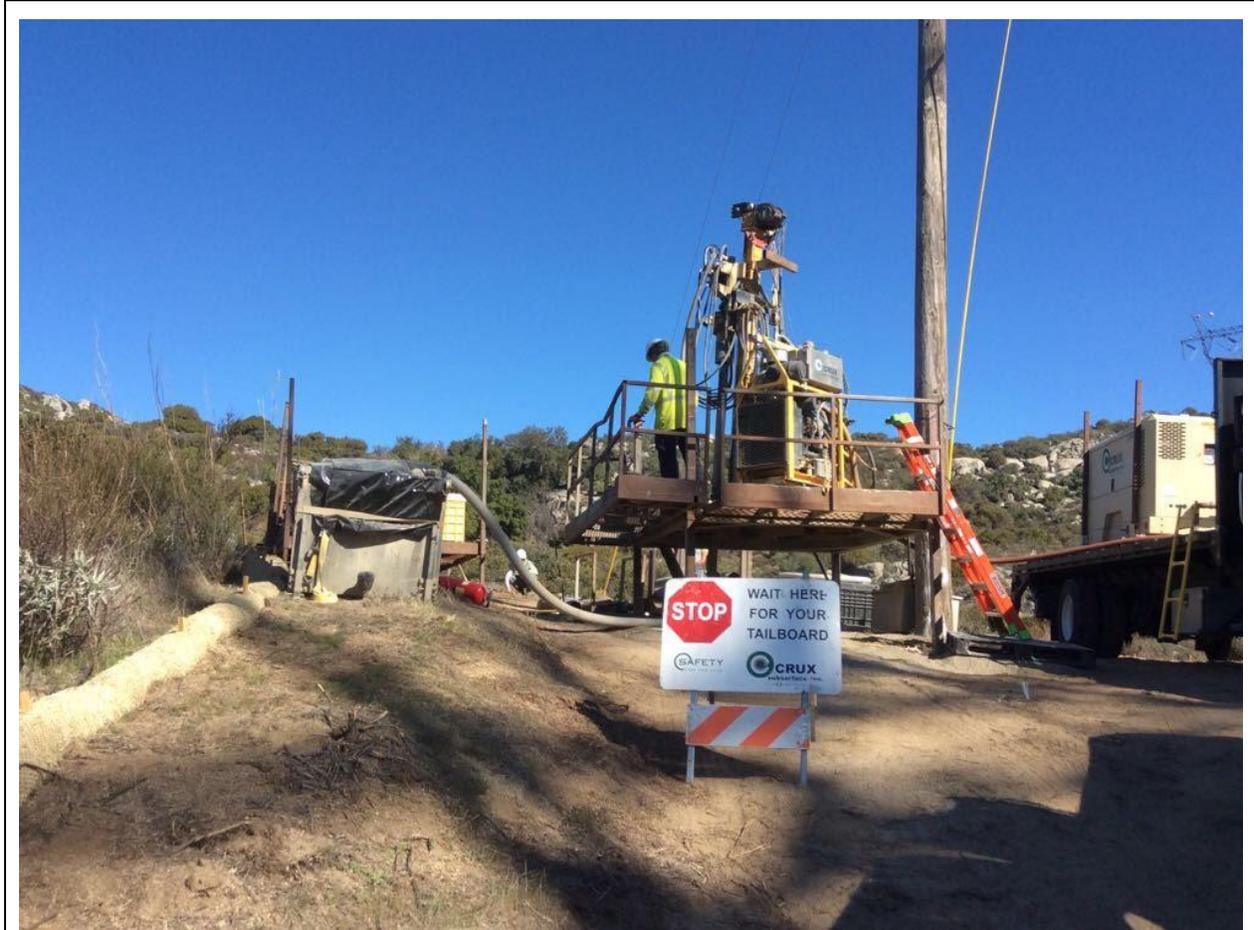
Photo 1: During micropile drilling at Pole Z972890 (TL 6923), a containment box was used to trap drill cuttings and reduce dust emissions in accordance with APM AIR-05.

To prevent fugitive dust emissions during project activities, construction crews were observed applying water at staging and fly yards in preparation for helicopter external load operations, along unpaved access roads, and in work areas in accordance with APM AIR-02. Haul trucks used for dirt export were observed utilizing load covers to prevent dust emissions in accordance with APM AIR-02, and construction personnel were observed maintaining posted speeds of 15 miles per hour on unpaved access roads in accordance with APM AIR-03 and MM BIO-24. Construction crews applied water during perforating and drilling and used cuttings containment boxes to prevent dust emissions in accordance with APM AIR-05 (see Photo 1 – Attachment A).

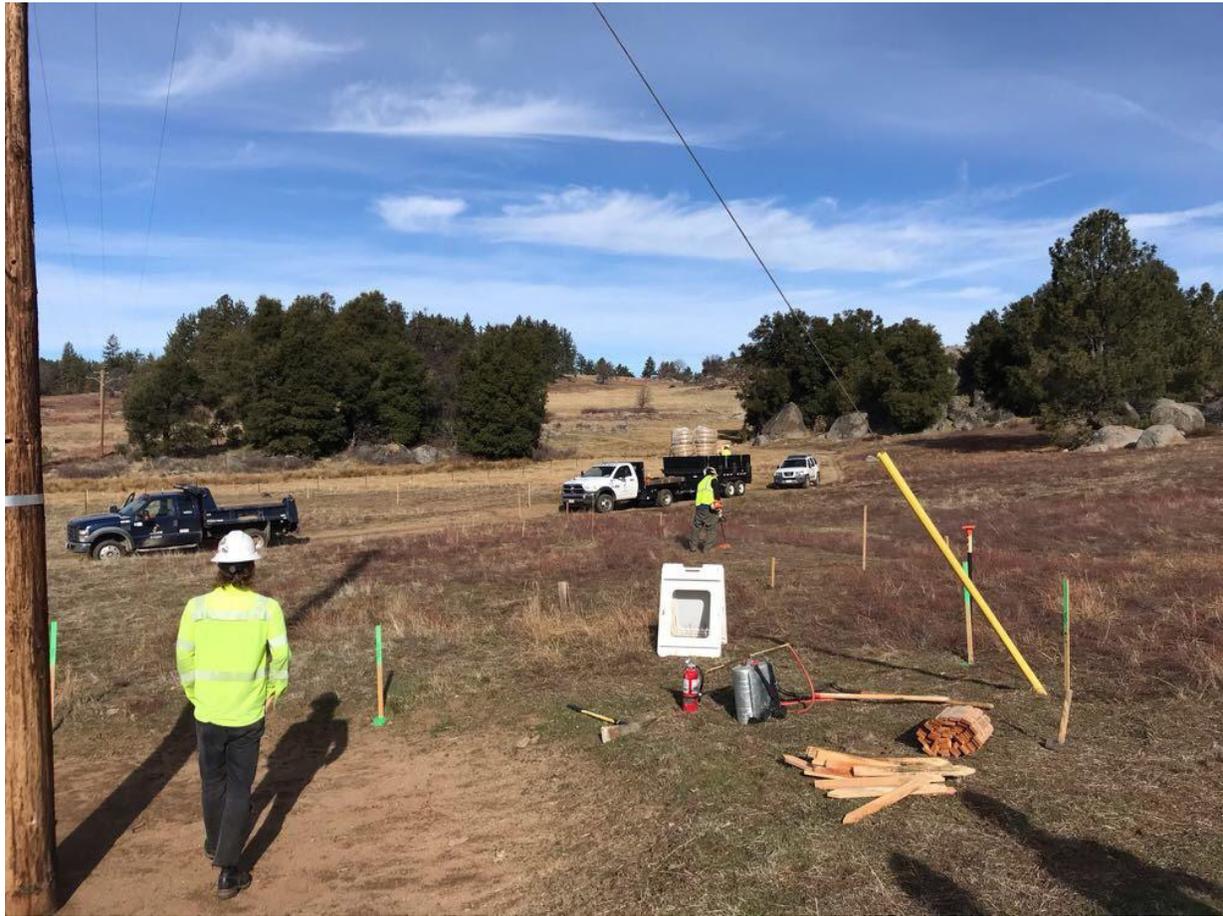
Photo 2: During vegetation removal on the access road to Pole P40065 (C 440), a biological monitor was observed monitoring the activity in accordance with MM BIO-3, and the crew was observed remaining within clearly delineated work limits in accordance with MM BIO-1.

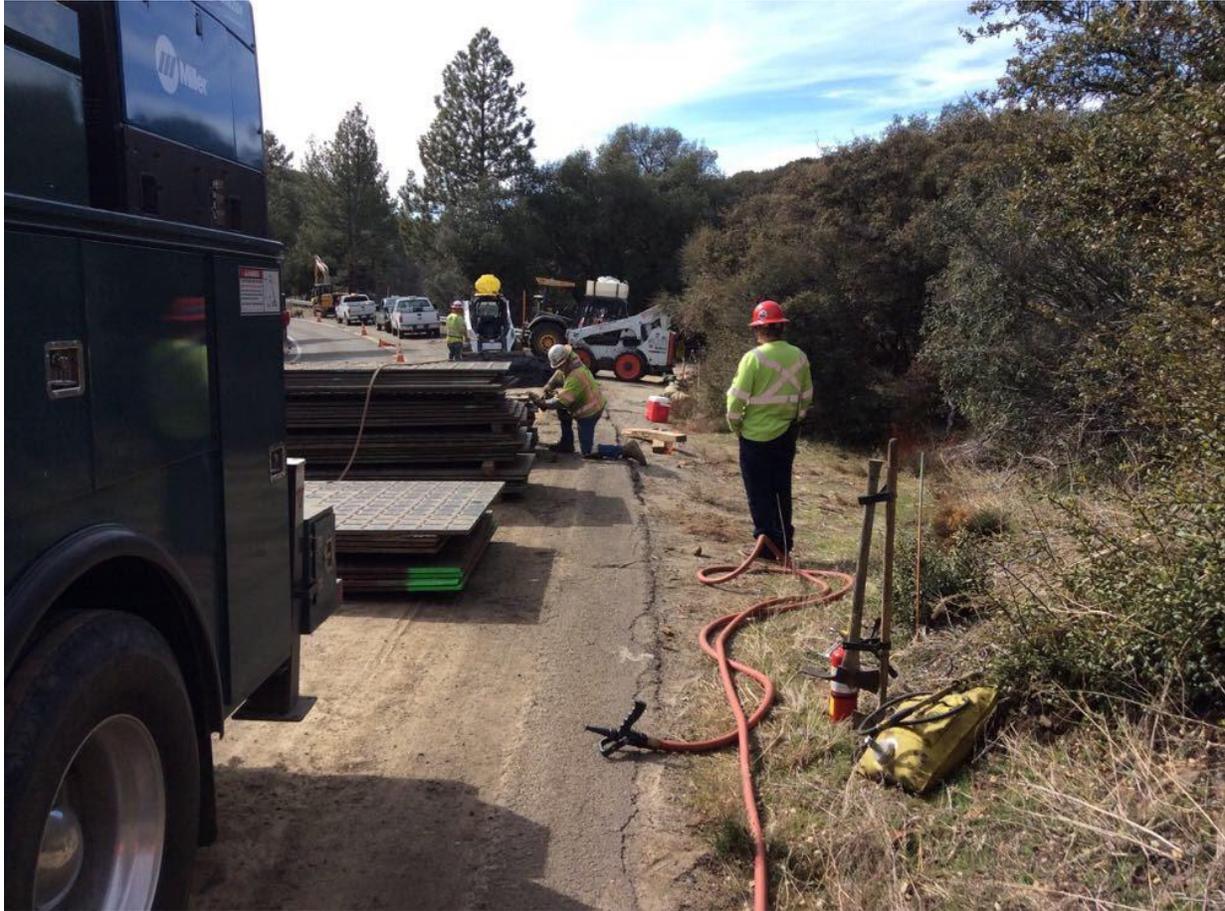
Photo 3: A Dedicated fire patrol, equipped with a full set of fire tools (5-gallon backpack pump, round point shovel, Pulaski, and 2A10BC fire extinguisher), was observed monitoring hot work near station 211+20 (C 440) in accordance with the CFPPP. The fire patrol noted that he had also wet down the surrounding area prior to the activity.

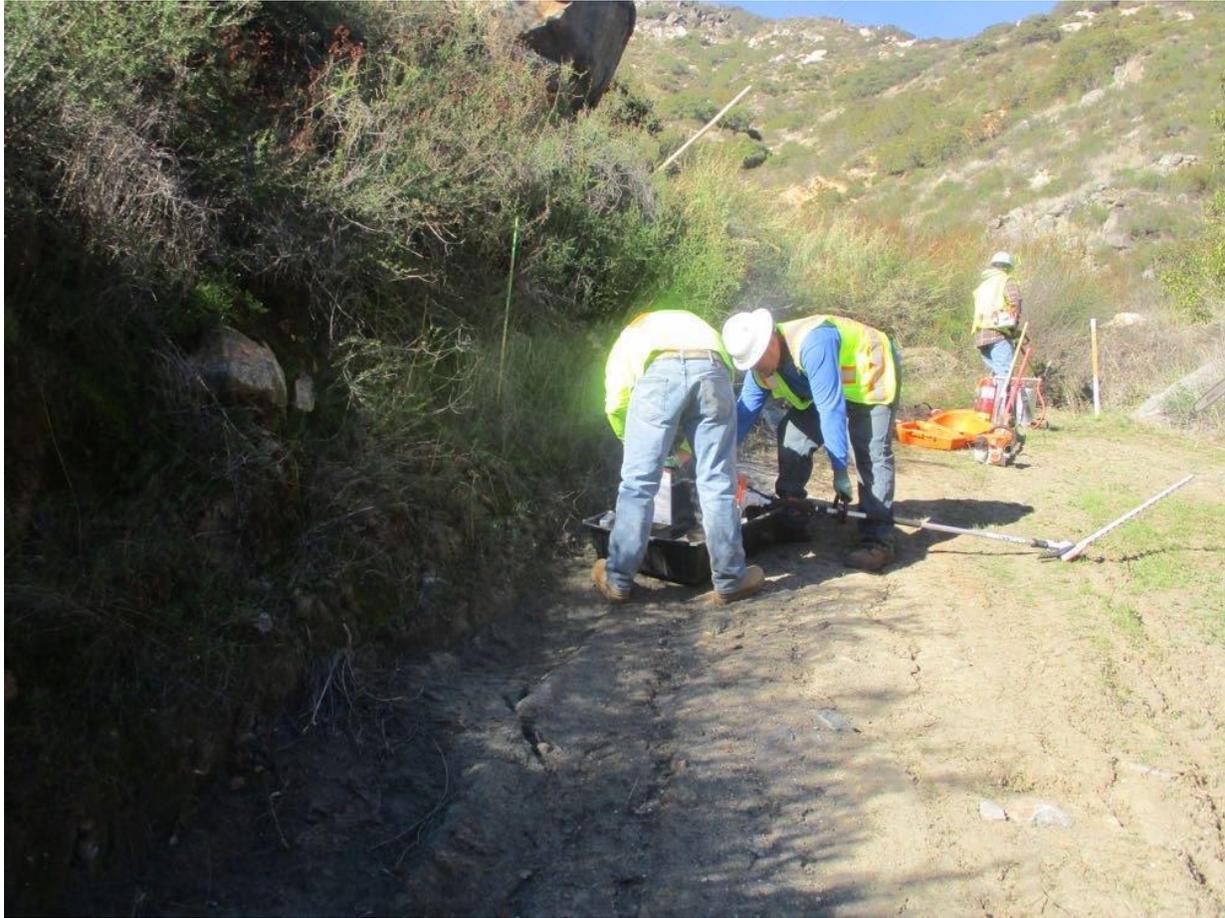
Photo 4: A vegetation removal crew was observed using a drip pan while refueling tools at Pole Z571489 (TL 6923) to prevent leaks or spills from being discharged onto the ground in accordance with MM PHS-2 and the SRNP.

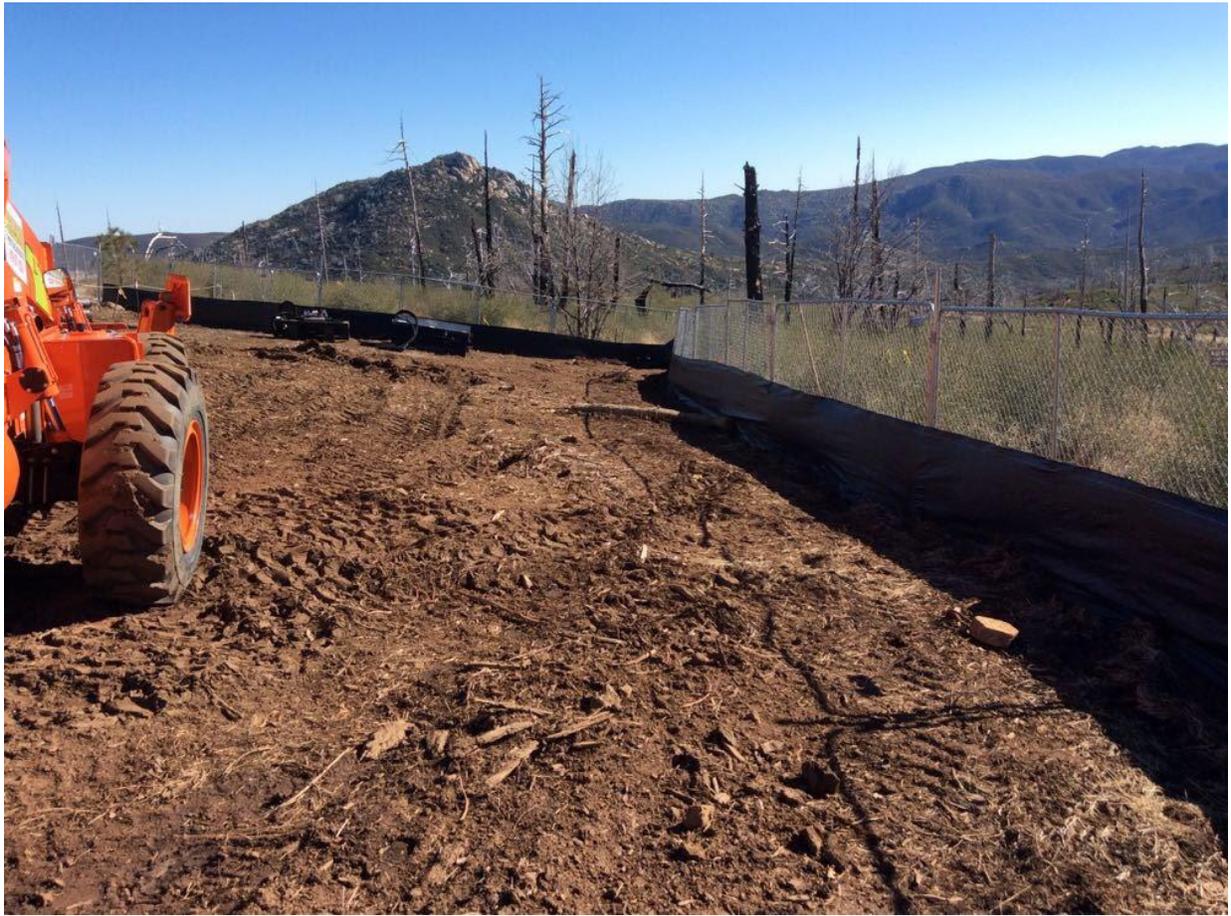
Photo 5: Silt fence at Azalea Staging Yard (C 79A) was observed to be in good condition in accordance with the ECP and SWPPP.

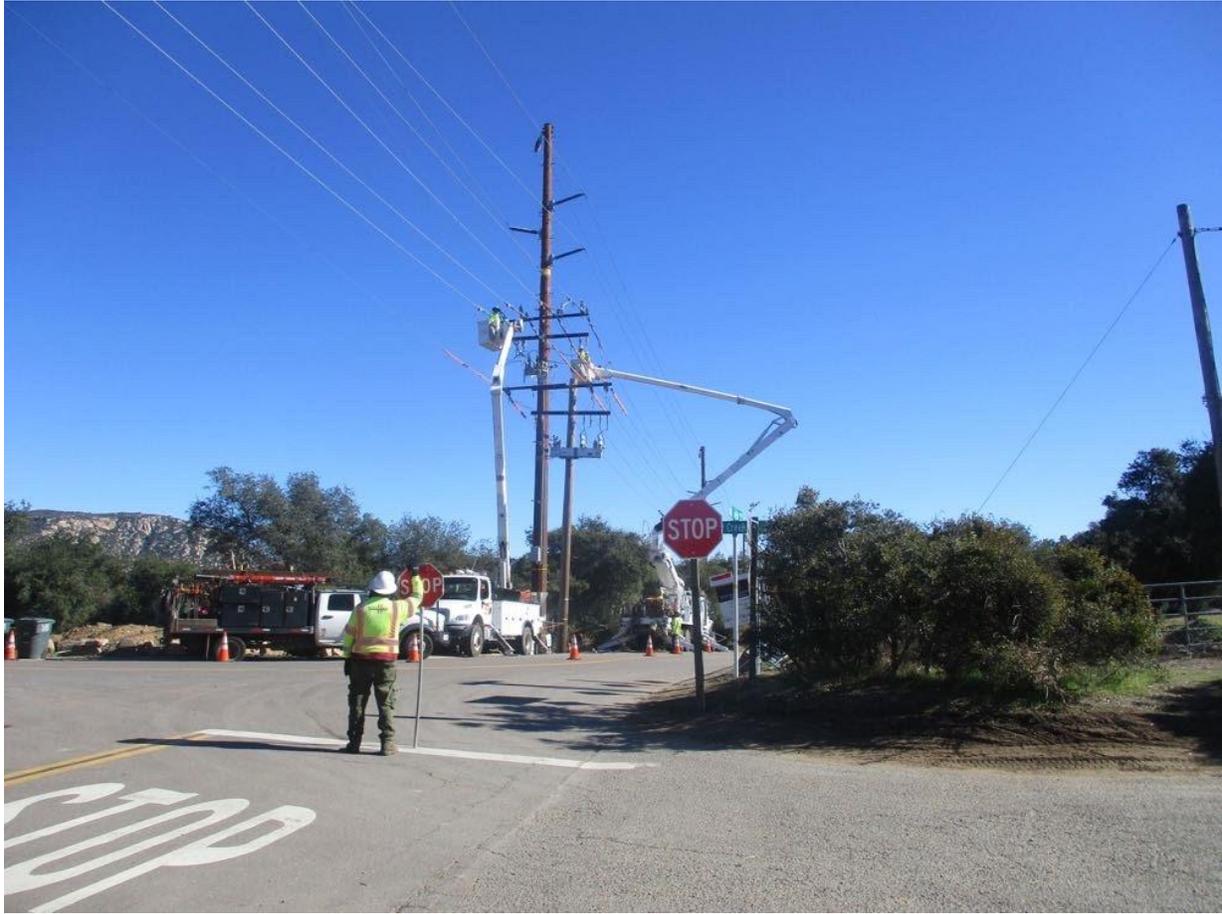
Photo 6: During overhead work associated with 12 kV wire stringing at Pole Z172738 (TL 629 A), a traffic control crew directed one-way traffic around the activity on Oak Grove Drive in accordance with the TCP and APM TRANS-02.

Traffic control measures were observed being implemented in accordance with APM TRANS-01 through APM TRANS-05 during this reporting period. CPUC ECMs observed traffic control crews helping to facilitate construction activities by directing one-way traffic along roads associated with TL 629A (see Photo 6 – Attachment A), TL 625C, and C 440 Phase 1. Motorists were notified of construction activities with signage, and guided around construction activities on or near public roadways with signs, cones, signals, and the use of a pilot car. Traffic was observed being temporarily stopped when helicopter external load operations crossed over public roadways, and construction and traffic control crews adhered to specific traffic control restrictions within a half mile of schools.
