California Public Utilities Commission <i>Mitigation Monitoring, Compliance, and Reporting</i> <i>Program</i>
	Cleveland National Forest Power Line Replacement Projects Compliance Status Report: 089 February 23, 2020

This compliance status report covers construction activities from February 10 through February 23, 2020.

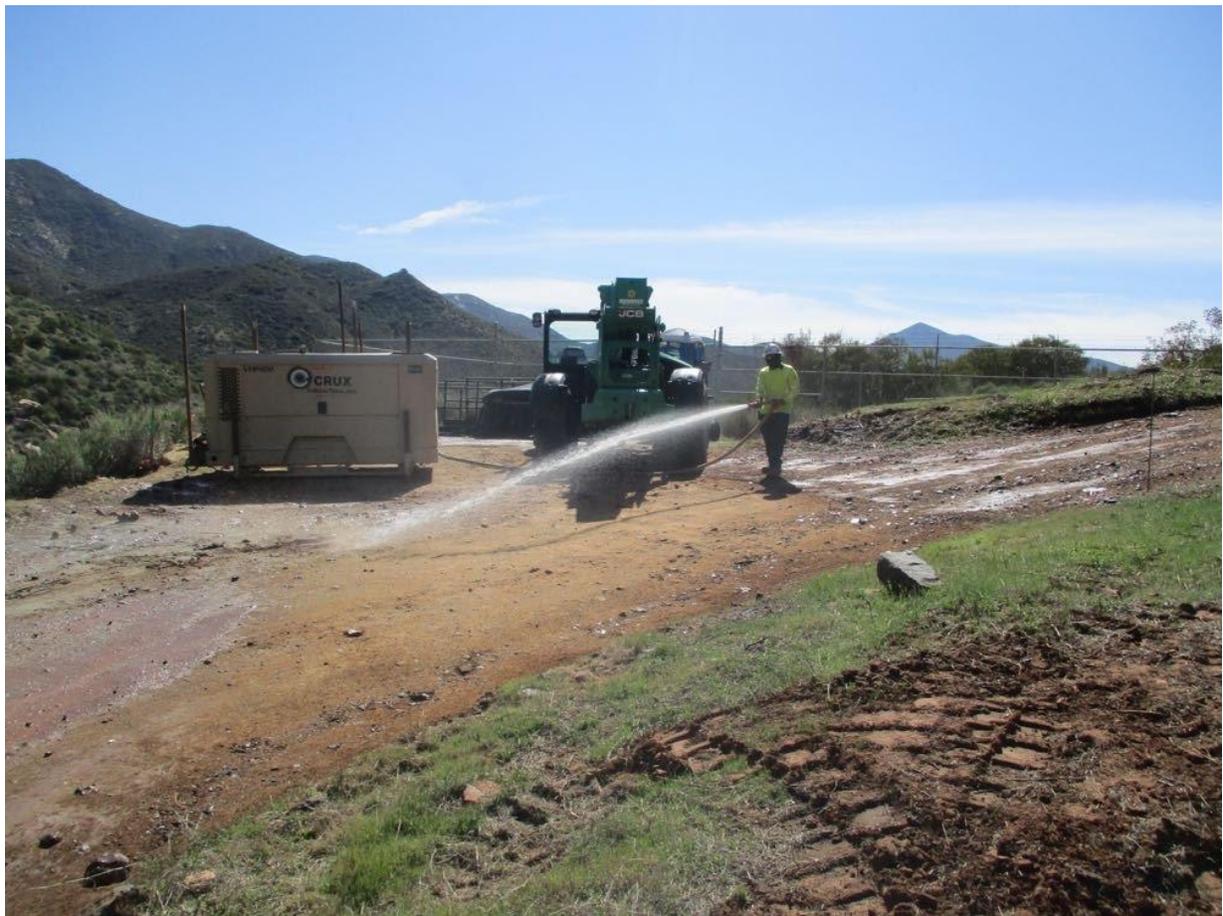
Photo 1: A crew member was observed wetting down the work area at Pole Z972788 (TL 6923) prior to helicopter external load operations to minimize dust emissions in accordance with APM AIR-02 and APM AIR-05.

To prevent fugitive dust emissions during project activities, construction crews were observed applying water to prevent fugitive dust at staging and fly yards in preparation for helicopter external load operations (see Photo 1 – Attachment A), along unpaved access roads, and in work areas in accordance with APM AIR-02. Haul trucks used for dirt export were observed utilizing load covers to prevent dust emissions in accordance with APM AIR-02, and construction personnel were observed maintaining posted speeds of 15 miles per hour on unpaved access roads in accordance with APM AIR-03 and MM BIO-24. Construction crews applied water during perforating and drilling and used cuttings containment boxes to prevent dust emissions in accordance with APM AIR-05.

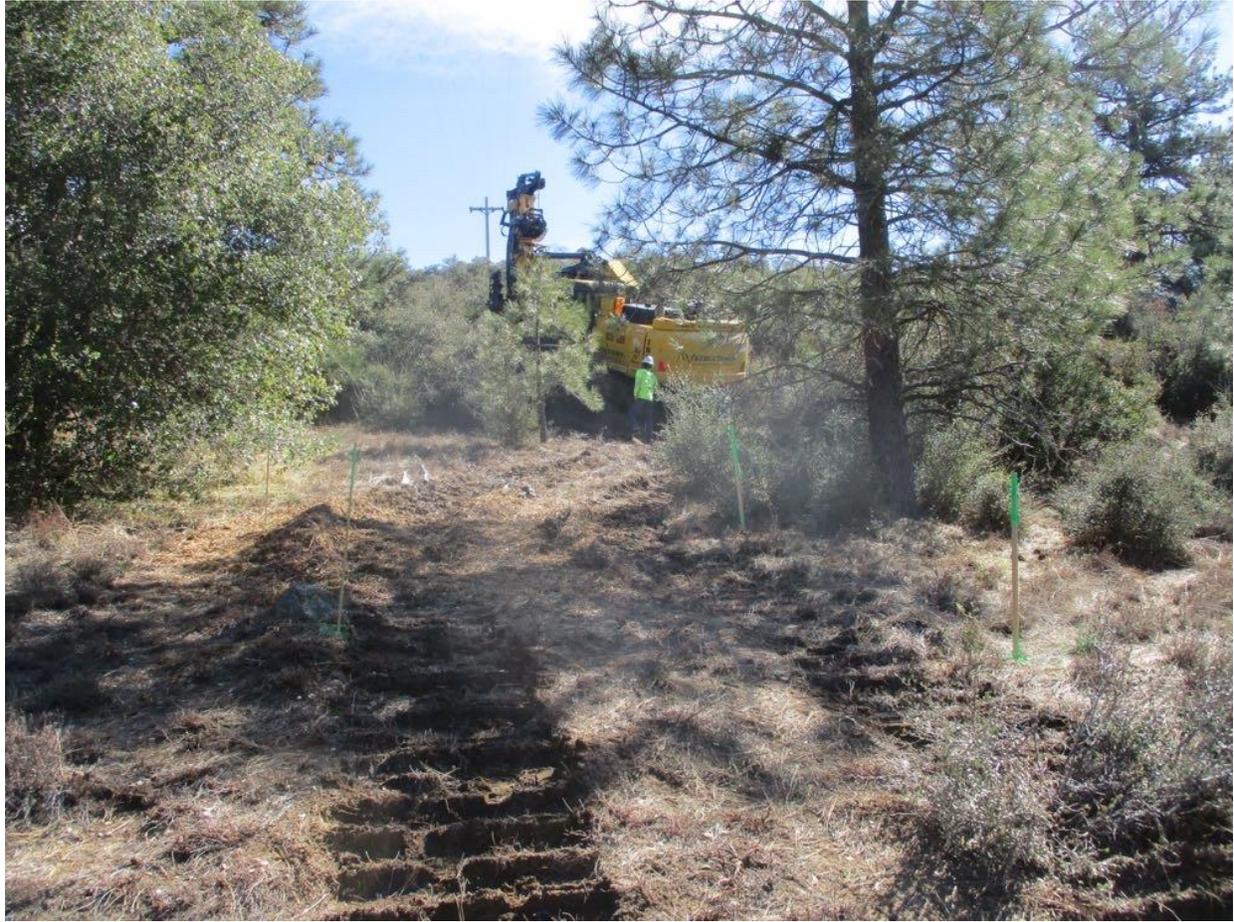
Photo 2: Crews remained within the designated construction only access route limits on the way to pole P258409, in accordance with MM-BIO-1.

Approved workspaces were observed delineated with staking and flagging, and work crews were observed adhering to work space limits and staying on approved access roads in accordance with MM BIO-1 (see Photo 2 – Attachment A). In order to ensure crews were clear on approved access routes, CPUC ECMs observed “no project access” and “approved access” signs at the entrances to access roads. Workers were observed having completed the Worker Environmental Awareness Program (WEAP), as shown by project hard hat stickers in accordance with MM BIO-2. Biological monitors were observed conducting full-time monitoring of initial ground-disturbing activities such as vegetation removal in accordance with MM BIO-3, and monitoring all other construction activities to ensure compliance with mitigation measures, applicant proposed measures, and permit conditions in accordance with MM BIO-22. Excavations were observed covered to prevent wildlife entrapment in accordance with MM BIO-23, and crews were observed containing trash at work areas in accordance with MM BIO-26. CPUC ECMs also observed salvaged topsoil for use in restoration activities in accordance with the Habitat Restoration Plan and MM-BIO-4 (see Photo 3 – Attachment A). Biological Monitors were present to monitor bird nests during construction activities and ensure helicopter pilots respected helicopter bird nest buffers along TL 625C and TL 6923, in accordance with the Avian Protection Plan/Nesting Bird Management Plan (APP/NBMP) and MM BIO-28.

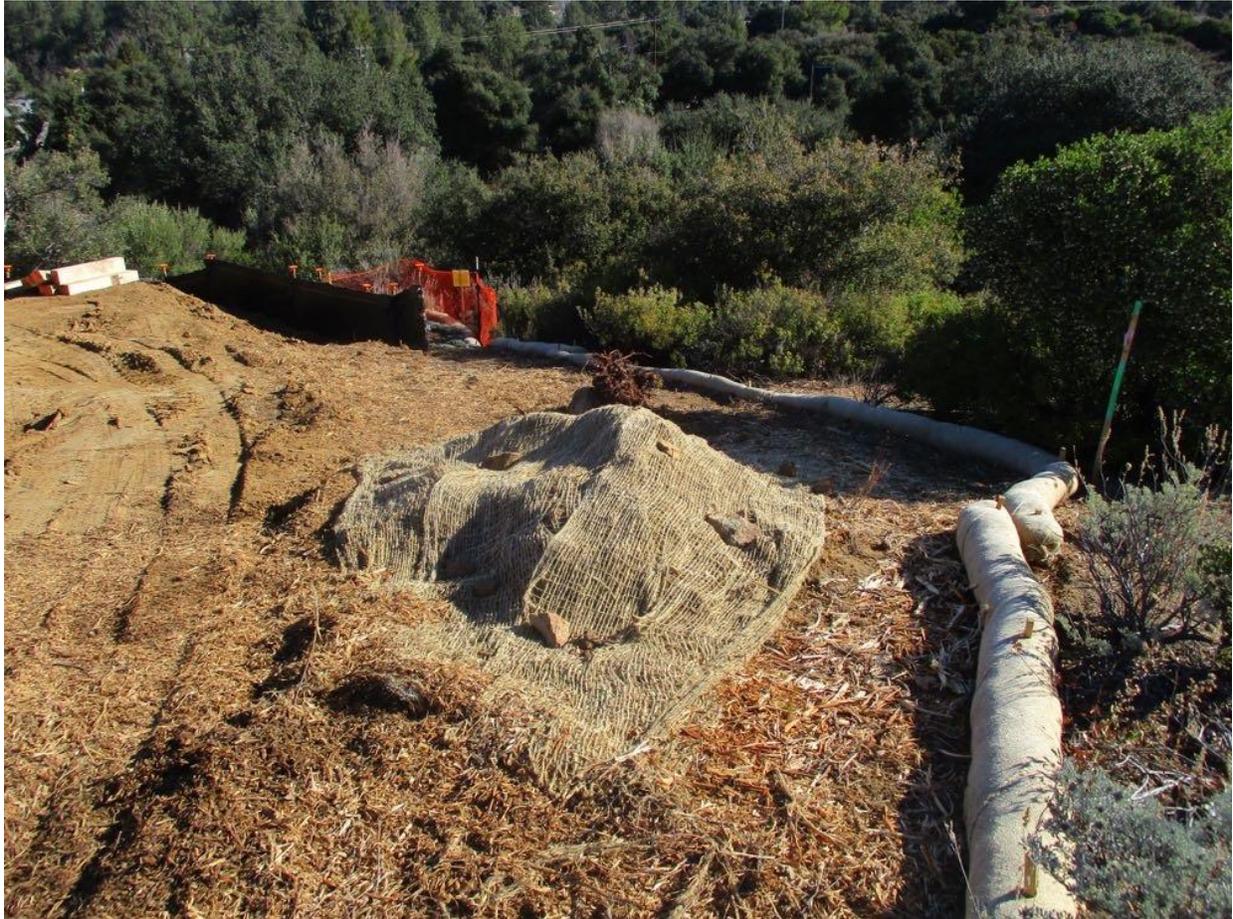
Photo 3: Salvaged topsoil was set aside after crane pad grading at pole Z774861. The topsoil will be used for restoration in accordance with the Habitat Restoration Plan and MM-BIO-4.

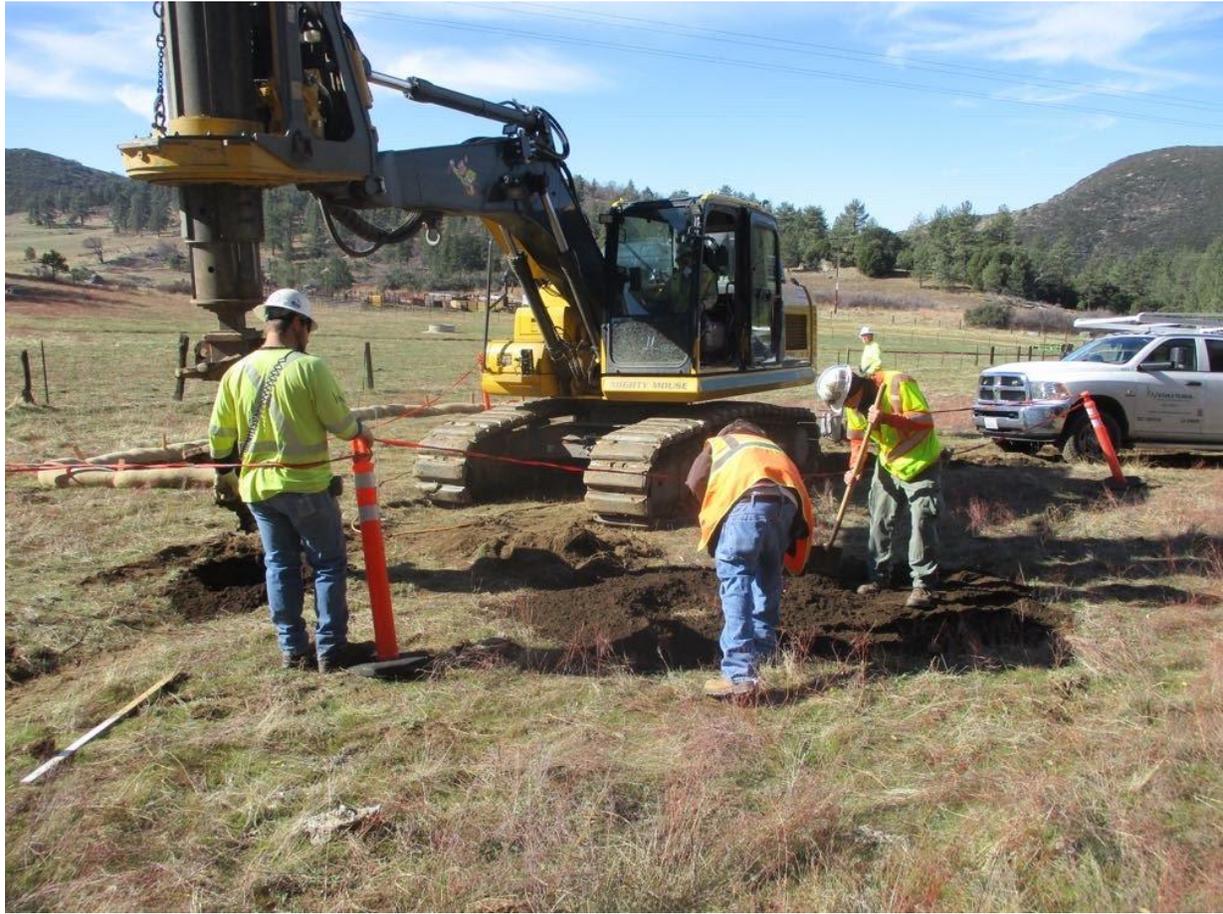
Photo 4: During pole hole drilling at along C 440, Archaeological and Cultural Monitors were observed monitoring the activity in accordance with APM CUL-04 and MM CUL-1 and inspecting excavated spoils for cultural resources in accordance with Appendix A of the HPMP.

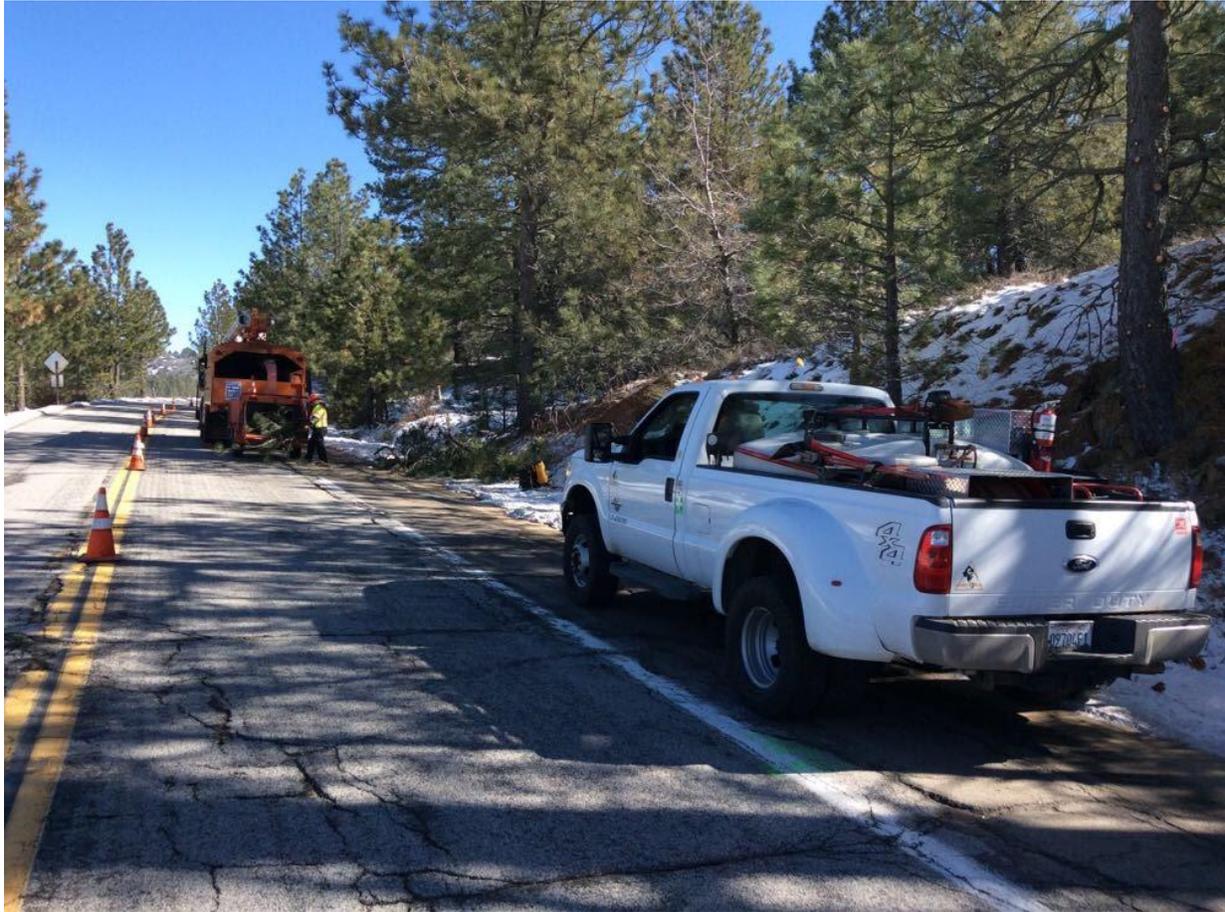
Photo 5: During vegetation chipping on Sunrise Highway (C 440), a full set of fire tools was staged within 50 feet of the activity and a Fire Patrol was equipped with at least 100 gallons of water with pump and hose in accordance with the CFPPP specifications for chipping on CNF land with a PAL C.

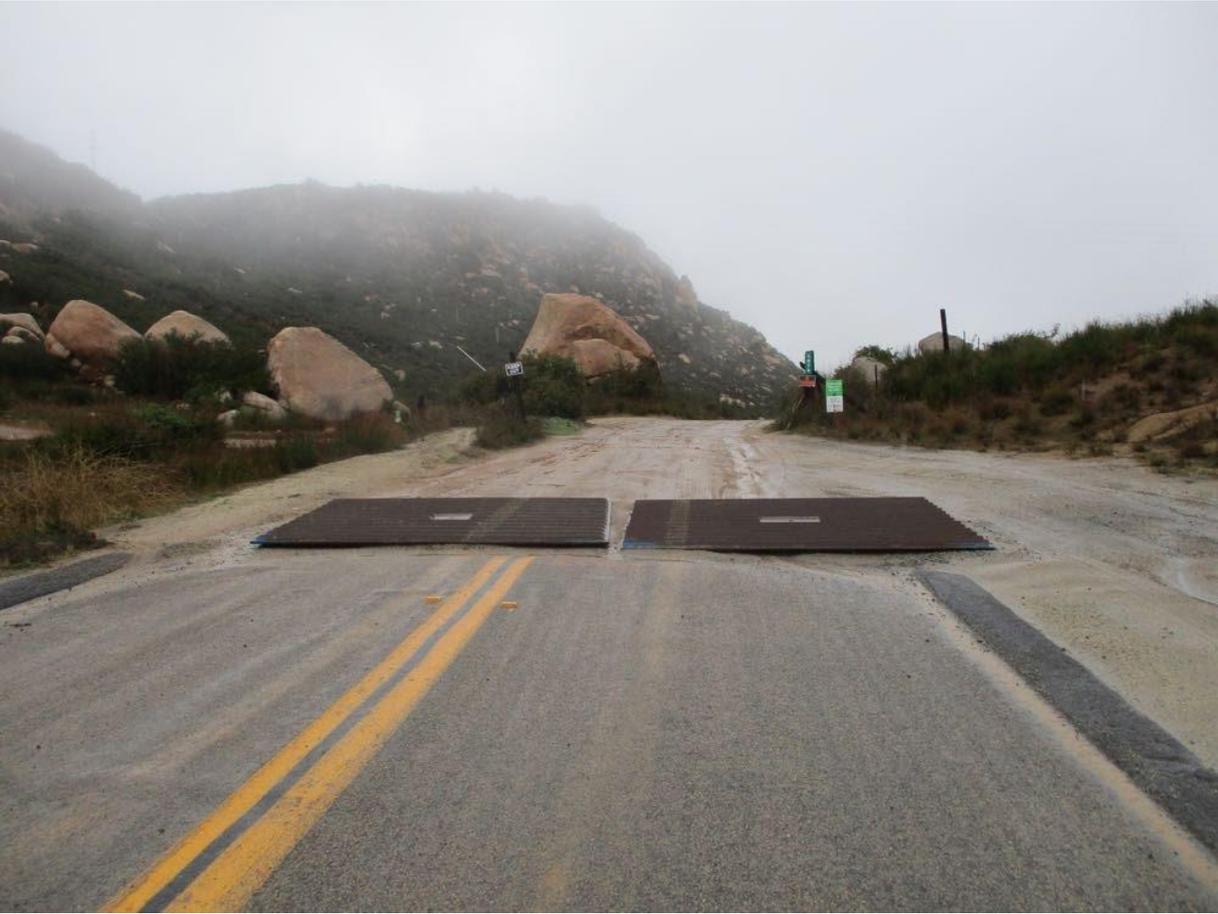
Photo 6: Rattle plates were observed at the point of ingress/egress to the Right of Way off Round Potrero Road (TL 6923) in accordance with the ECP and SWPPP.
