<p>California Public Utilities Commission <i>Mitigation Monitoring, Compliance, and Reporting</i> <i>Program</i></p>
	<p>Cleveland National Forest Power Line Replacement Projects</p> <p>Compliance Status Report: 090</p> <p>March 8, 2020</p>

This compliance status report covers construction activities from February 24 through March 8, 2020.

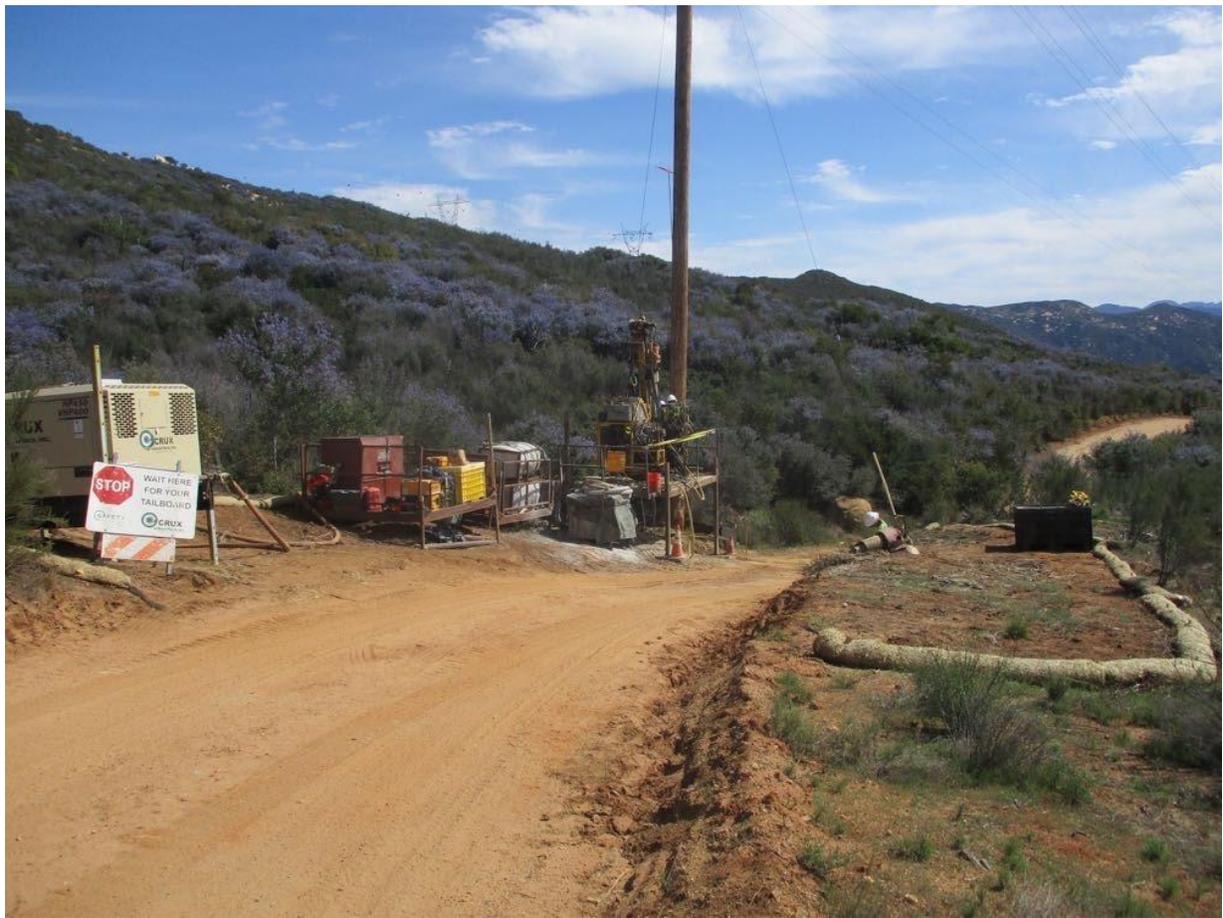
Photo 1: During micropile drilling at Pole Z571478 (TL 6923), perimeter erosion control BMPs were observed to be in good condition in accordance with the ECP and SWPPP.

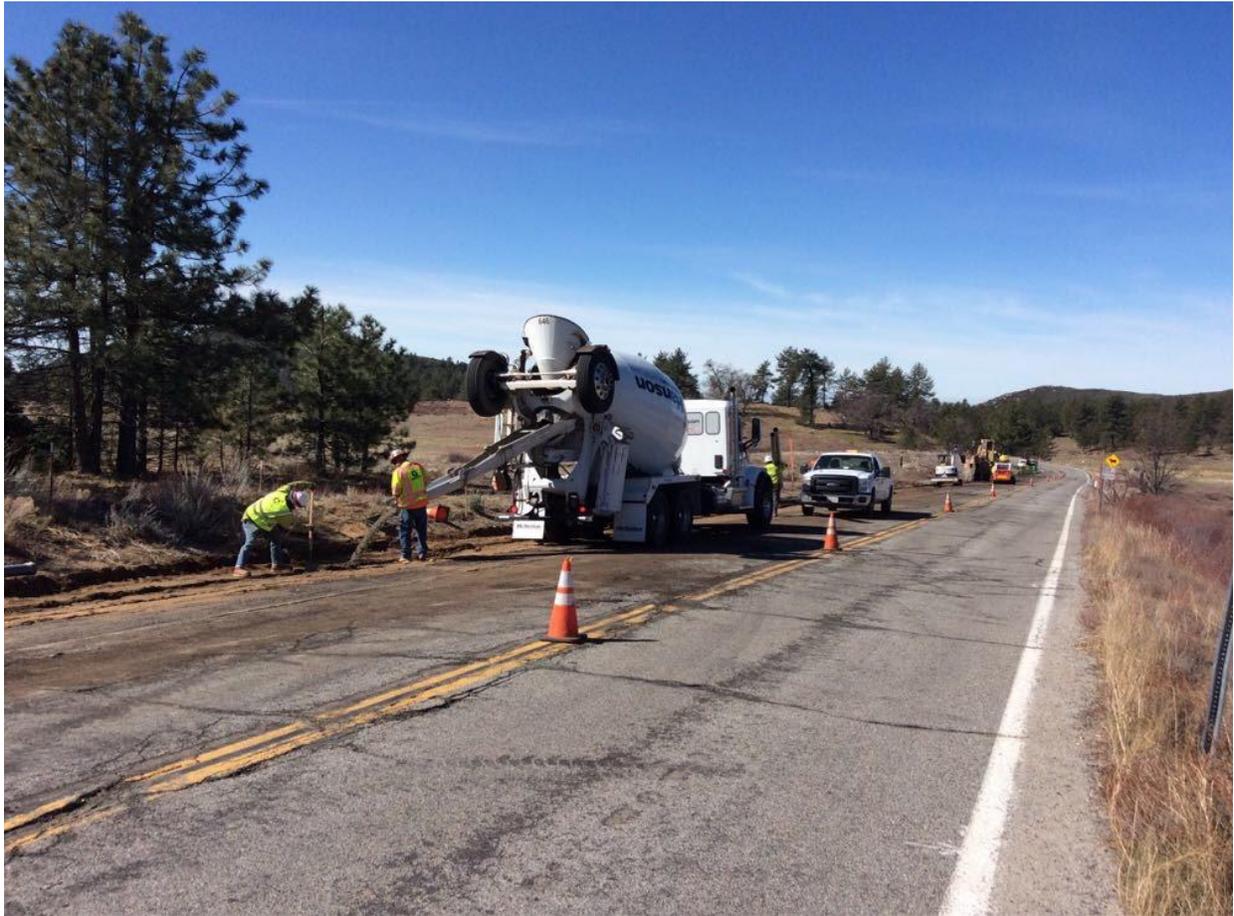
Photo 2: Crews were observed trenching, installing conduit, and slurring in the conduit package along Sunrise Highway (C 440). A pilot vehicle was used to lead one-way traffic through the work area in accordance with the Traffic Control Plan and APM TRANS-02.

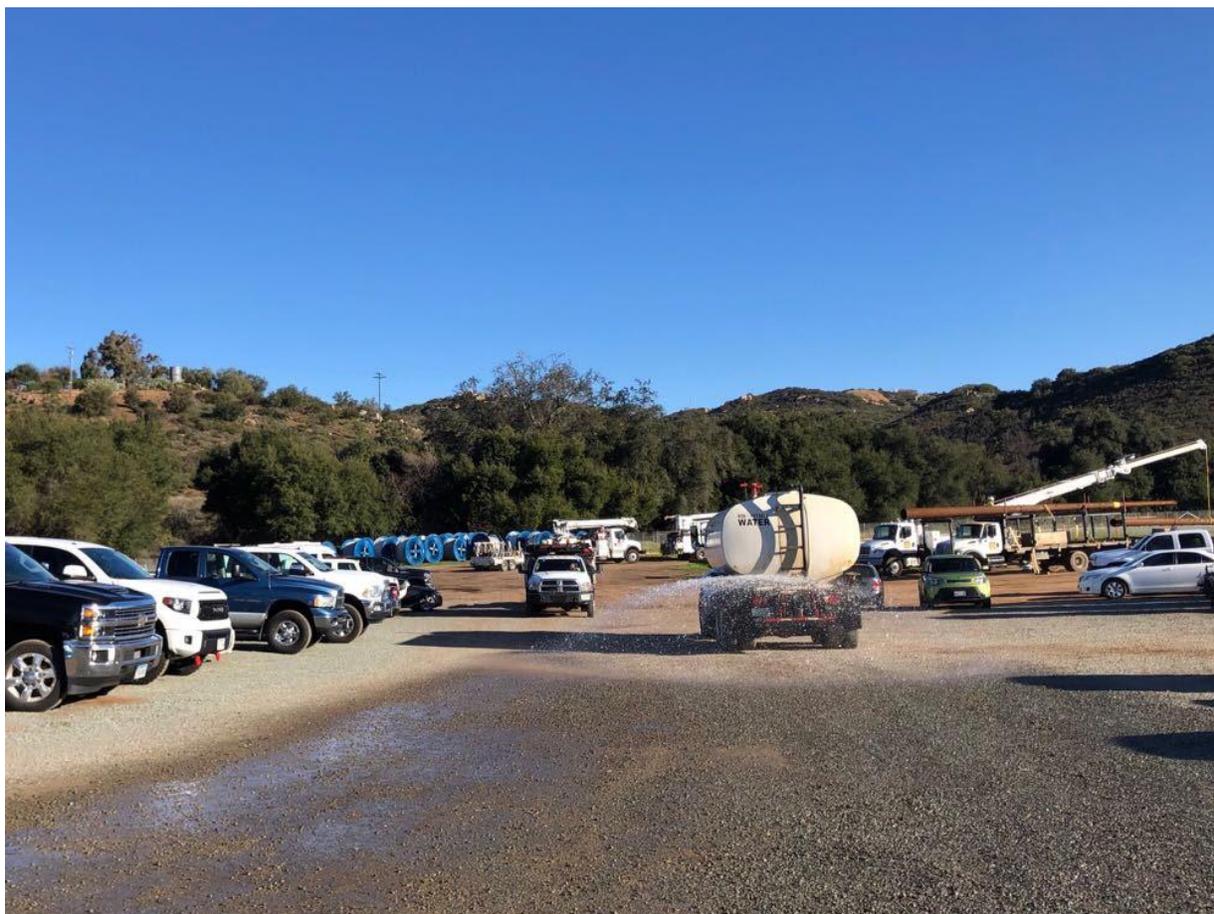
Photo 3: Water was applied to the ground at Bookout Staging Yard (TL 625C) to minimize dust emissions during crew egress from the yard in accordance with APM AIR-02.

To prevent fugitive dust emissions during project activities, construction crews were observed applying water to prevent fugitive dust at staging and fly yards in preparation for helicopter external load operations, along unpaved access roads, and in work areas in accordance with APM AIR-02 (see Photo 3 – Attachment A). Haul trucks used for dirt export were observed utilizing load covers to prevent dust emissions in accordance with APM AIR-02, and construction personnel were observed maintaining posted speeds of 15 miles per hour on unpaved access roads in accordance with APM AIR-03 and MM BIO-24. Construction crews applied water during perforating and drilling and used cuttings containment boxes to prevent dust emissions in accordance with APM AIR-05.

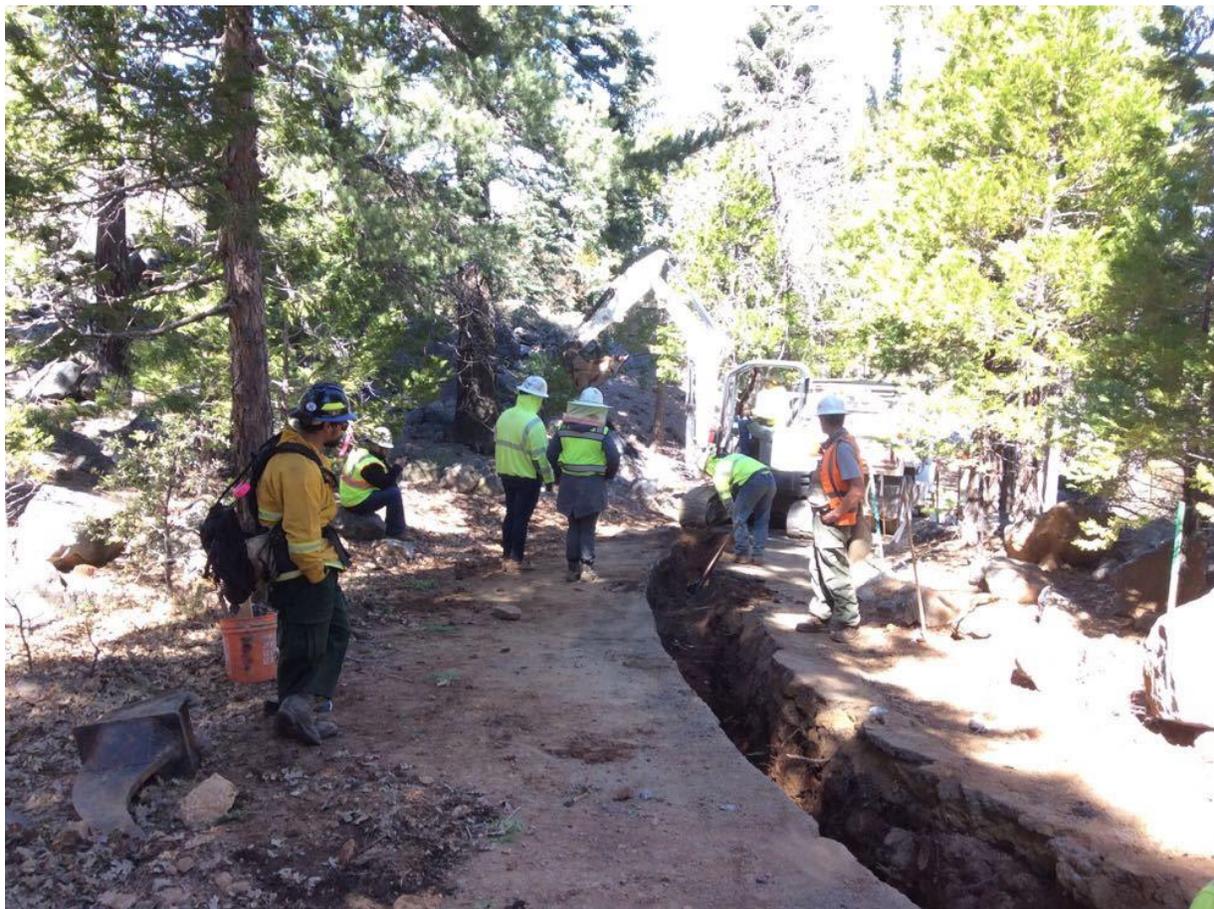
Photo 4: Archaeological and Cultural Monitors were observed present to monitor trenching activities along C 79A in accordance with the HPMP, APM CUL-04, and MM CUL-1. A Biological Monitor and a Fire Patrol were also present in accordance with MM BIO-22 and the CFPPP, respectively.

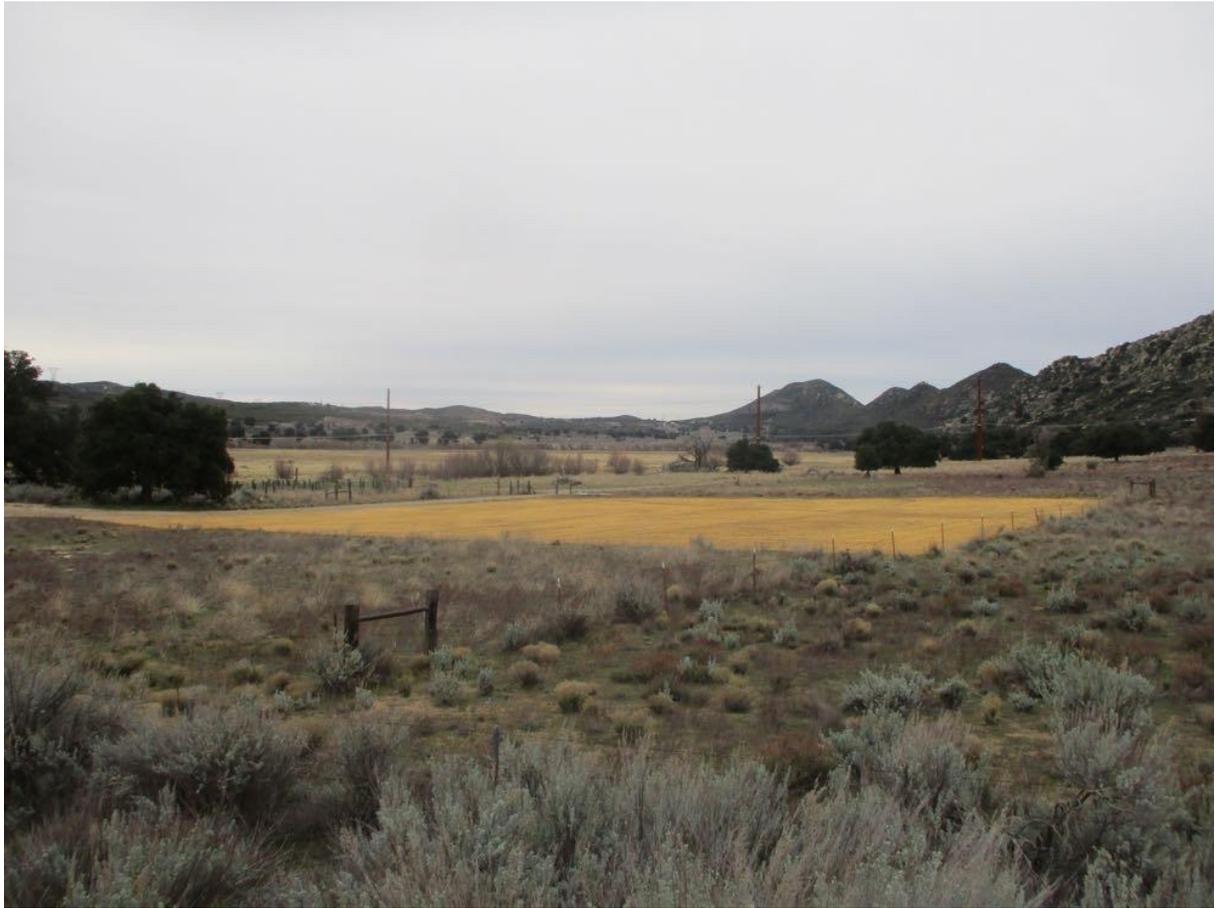
Photo 5: The gravel was removed from Kitchen Creek Staging Yard, the site was de-compacted, and hydromulch was applied in accordance with the Habitat Restoration Plan.

construction activities and ensure a helicopter bird nest buffer was respected along TL 625C, in accordance with the Avian Protection Plan/Nesting Bird Management Plan (APP/NBMP) and MM BIO-28. CPUC ECMs also observed work areas and staging yards where work has been completed and hydroseed has been applied in accordance with the Habitat Restoration Plan (see Photo 5 – Attachment A).

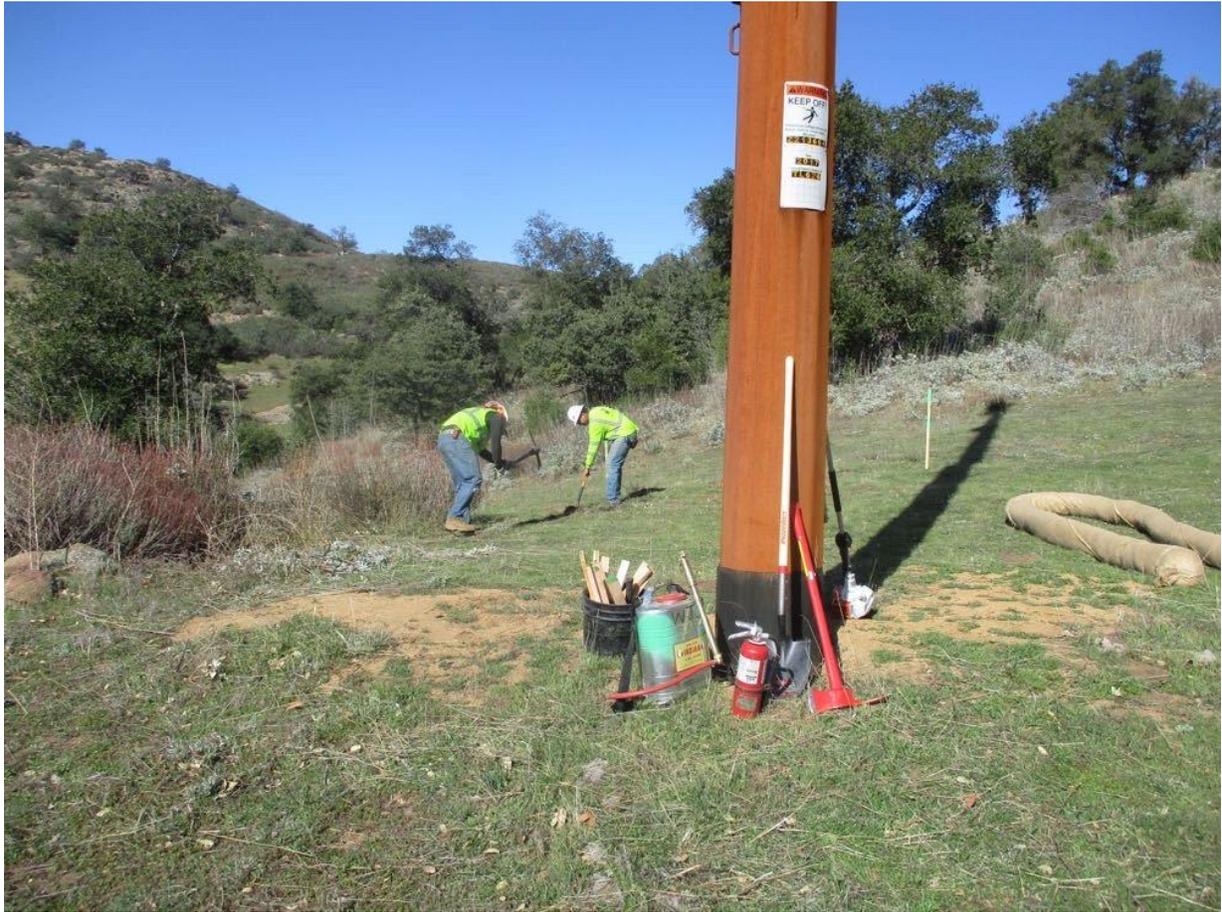
Photo 6: During erosion control BMP installation at Pole P259375 (TL 626 Conversion North), a full set of fire tools (5-gallon backpack pump, Pulaski, round point shovel, and 2A10BC fire extinguisher) was observed within 50 feet of the activity in accordance with APM HAZ-04 and the CFPPP.
