PACIFICORP

**Lassen Substation**  
*Jurisdictional Delineation Report*

## *Jurisdictional Delineation Report*

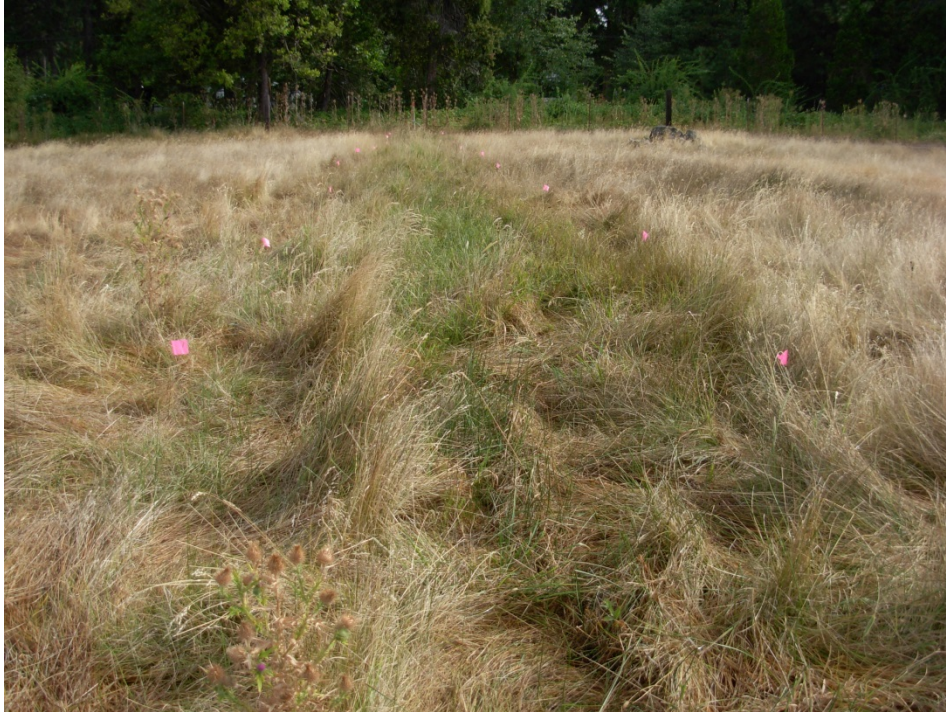
**Photo 1. Wetland W-1-11.** View is northeast toward the agricultural ditch, from approximately 85 feet (26 meters) southeast of pole 23/48 (taken September 16, 2011).

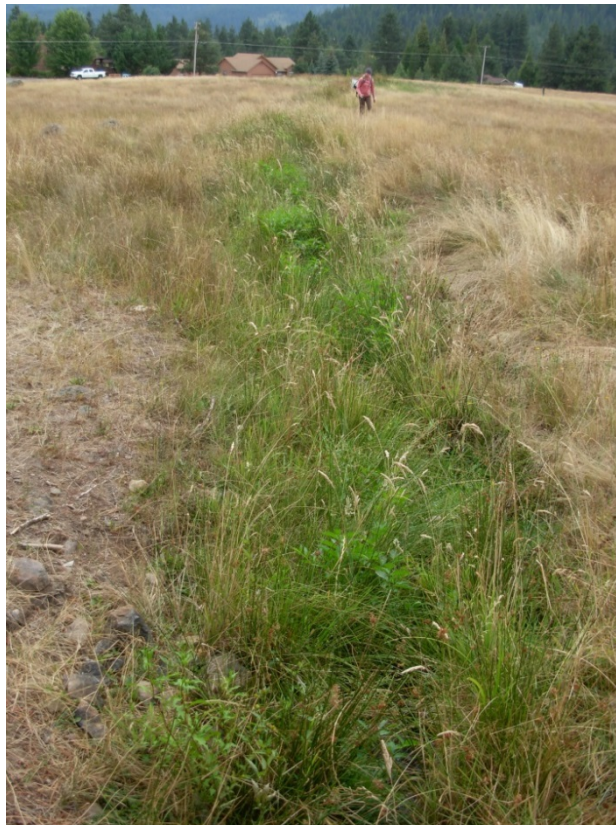
**Photo 2. Wetland W-1-11.** View is southwest from edge of ROW, approximately 25 feet east of pole 24/48 (taken September 16, 2011).

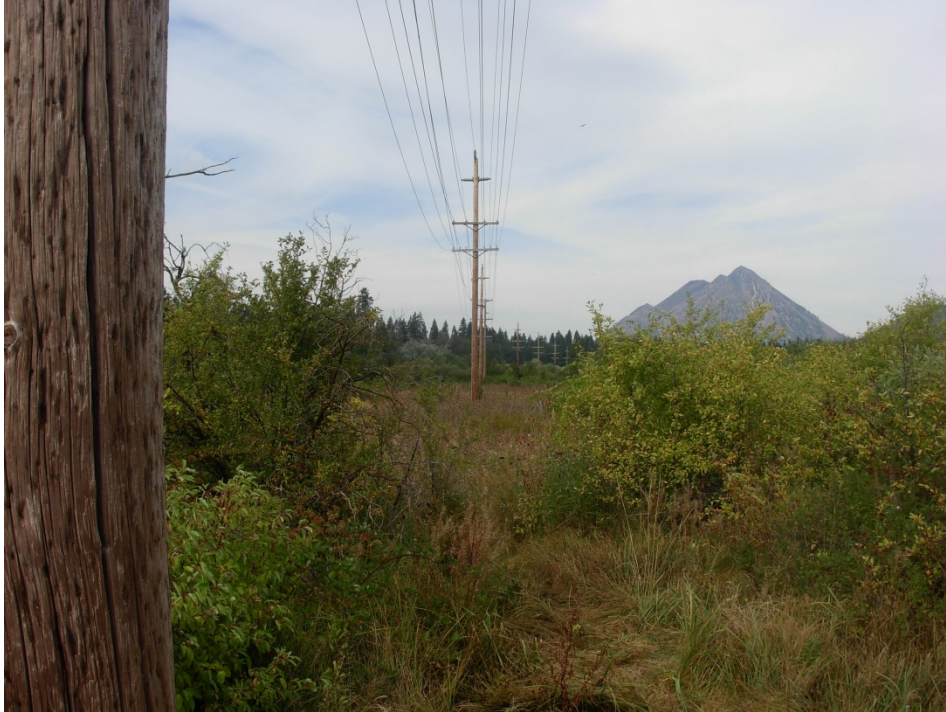
Sample location A was the reference upland site and is located approximately 20 feet northwest of the small drainage ditch that follows the north side of the substation pad, as shown in Figure 5C (also refer to Appendix B Photo 3). No hydric soil indicators were observed (10YR 2/1 100 percent at 0 to 10 inches) and; although an impermeable layer was reached at 10 inches, this layer proved to be concrete, possibly from substation construction, and no other hydric indicators were observed at this site.

**Photo 3. Wetland W-2-11.** View is to the north looking across the man-made mitigation wetland from pole 13/48 (taken September 20, 2011).

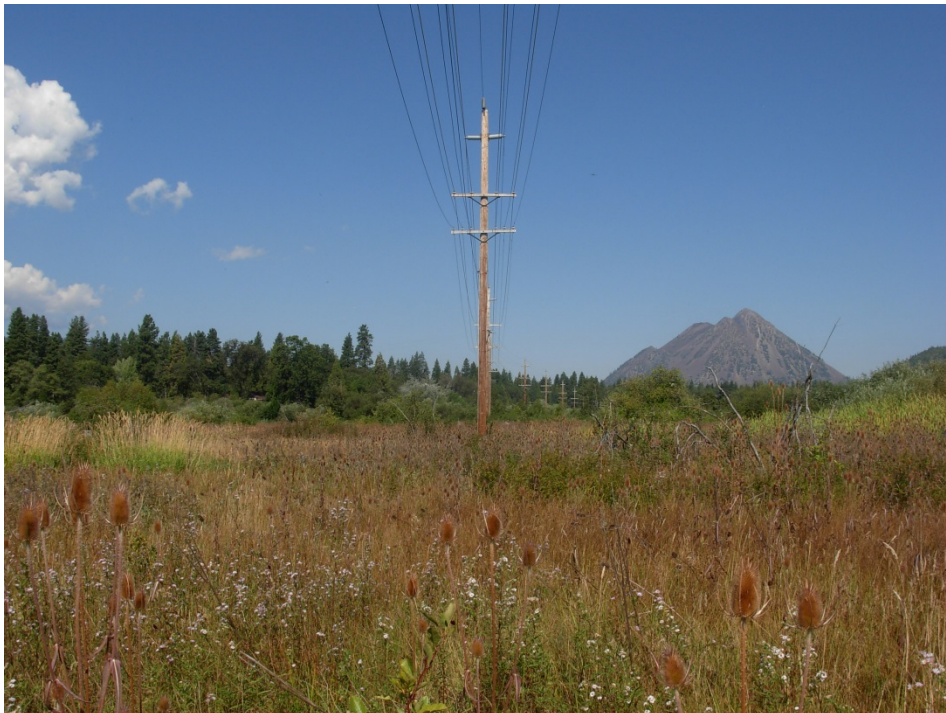
**Photo 4. Wetland W-2-11.** View is to the north from pole 12/48 across the man-made wetland toward Cold Creek (taken September 20, 2011).

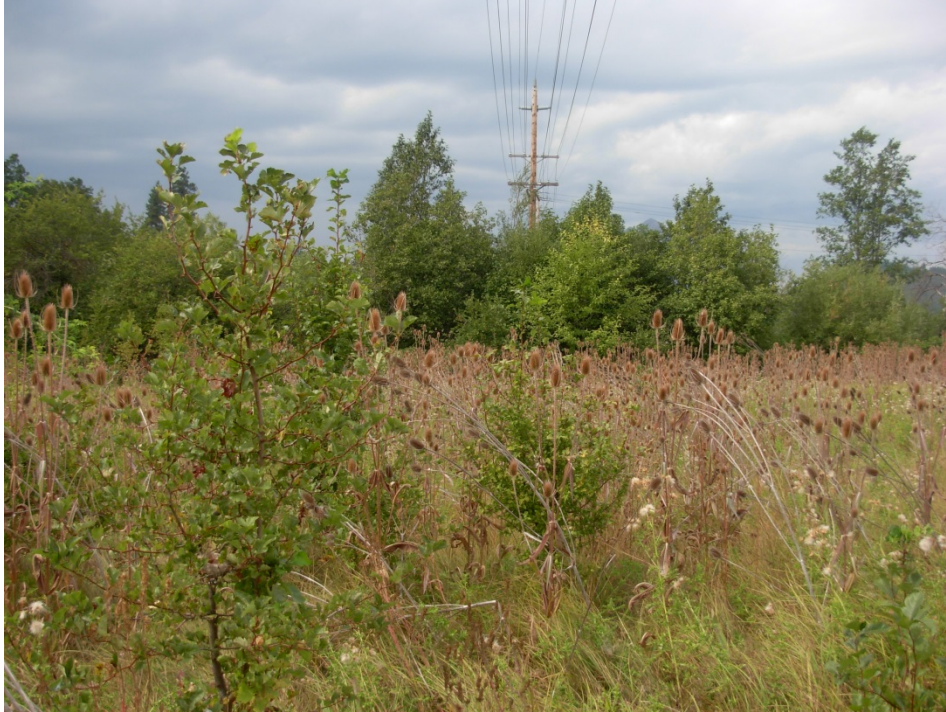
Sampling point D possesses one obvious hydrology indicator: geomorphic position. This location is located approximately 100 feet south of Cold Creek in an area that is nearly level (see Appendix B Photo 5). The hydric soil indicator is redox dark surface (F6) based on observations of a matrix value of 3 or less and a chroma of 2 or less containing 5 percent or more distinct or prominent redox concentrations occurring as pore linings (10YR 2/2, 7 to 20 inches containing 5 percent 5YR 4/4 pore linings). The uppermost layer (0 to 7 inches) was observed to have a matrix of 10YR 2/2 with no redox features.

**Photo 5. Wetland W-2-11.** View is north toward the riparian vegetation along Cold Creek, from approximately 25 feet north of pole 10/48 (taken September 20, 2011).

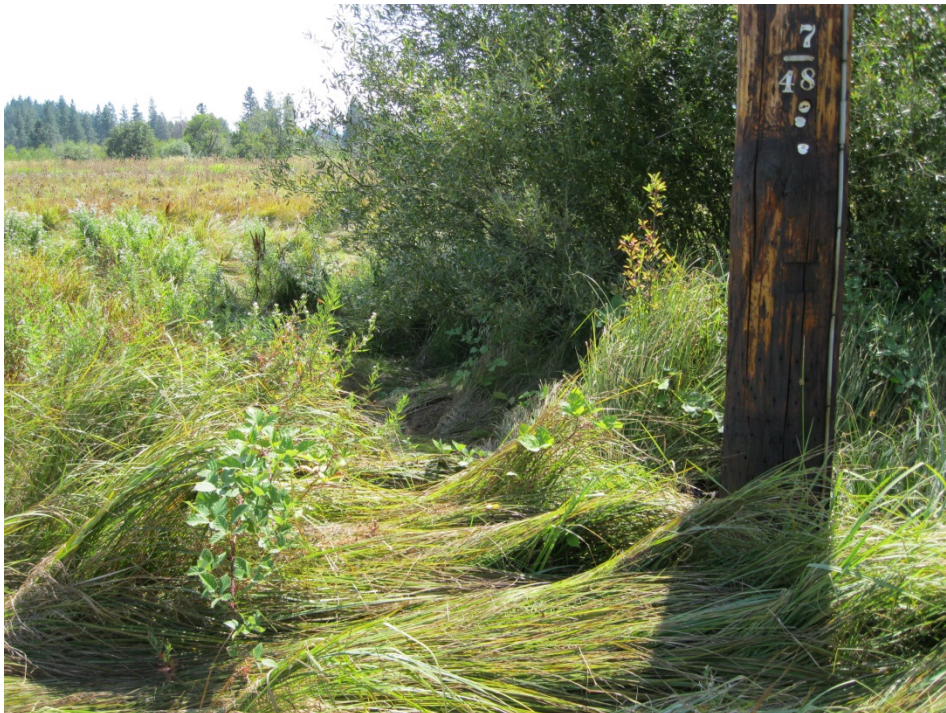
Hydrology of this site between pole 9/48 and Hatchery Lane included surface water (during the dry season of a drought year, and over 3 feet deep in some areas), drainage patterns, and geomorphic position in a shallow concave area near the bottom of a large flat field (between Cold Creek on the south and a wetland swale on the west). No soil pits were dug between pole 9/48 and Hatchery Lane due to the density of the vegetation and the presence of both standing and flowing water throughout the ROW. The vegetation communities in this half of the site are characterized as dry montane meadow between poles 7/48 and 9/48, which were dominated by grasses (e.g., creeping bentgrass, reed canarygrass) and by both rhizomatous and clump-forming rushes (common horsetail rush, common rush, rufous bulrush; see Appendix B Photo 6). North of pole 7/48 and extending to

**Photo 6. Wetland W-2-11.** View is south across the slope wetland toward Cold Creek (taken September 14, 2011).

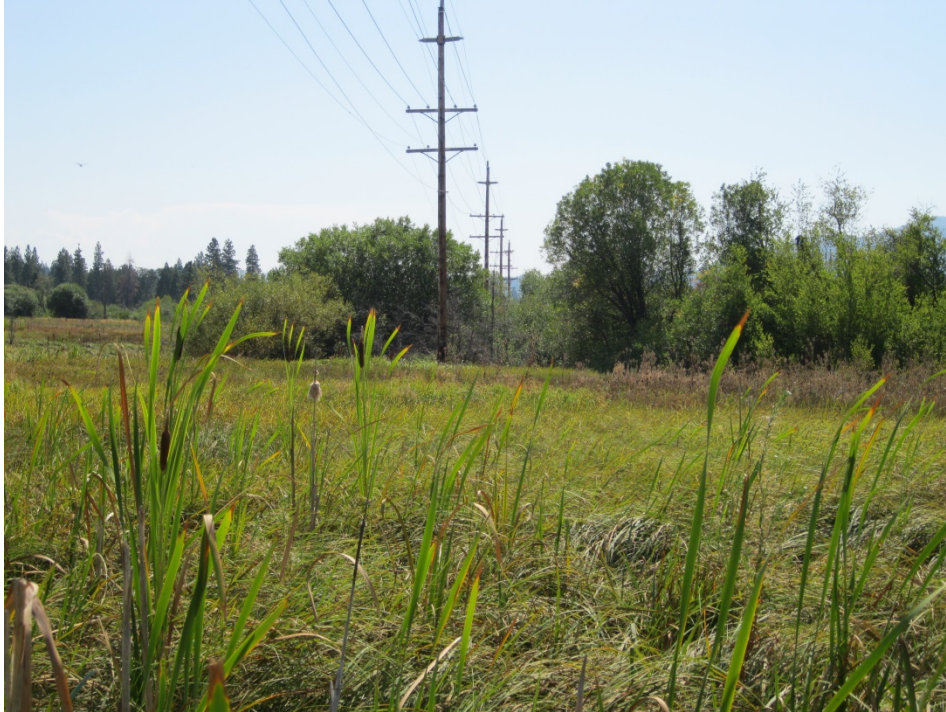
**Photo 7.** Wetland W-2-11. View is south across the slope wetland from pole 5/48 (taken September 14, 2011).

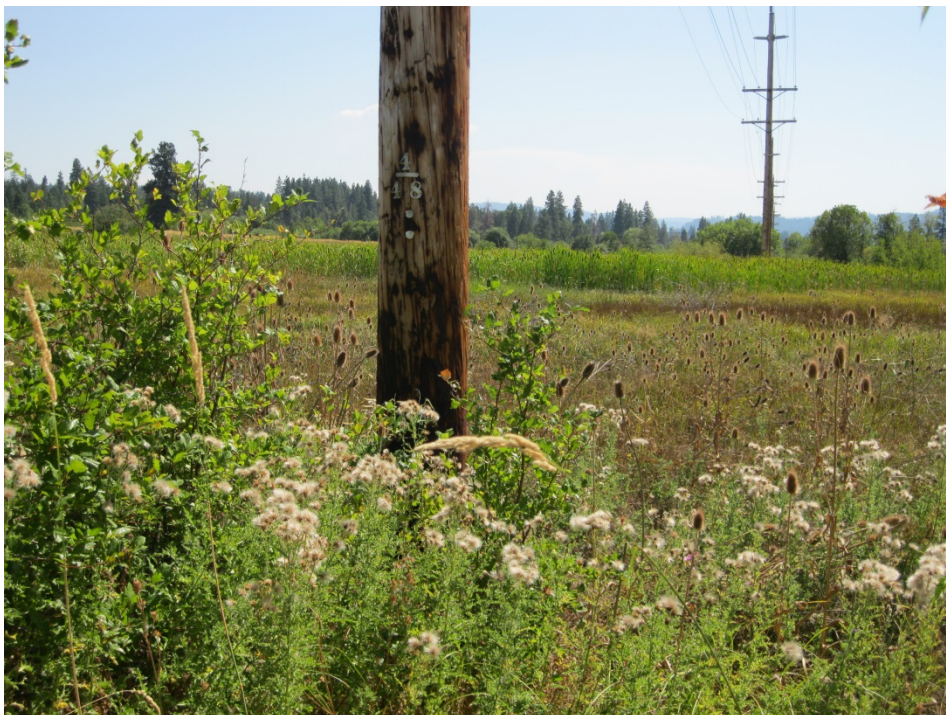
**Photo 8.** Wetland W-2-11. View is from the berm at Hatchery Lane, looking south across the slope wetland. The observed freshwater marsh is visible around pole 5/48 (taken September 14, 2011).

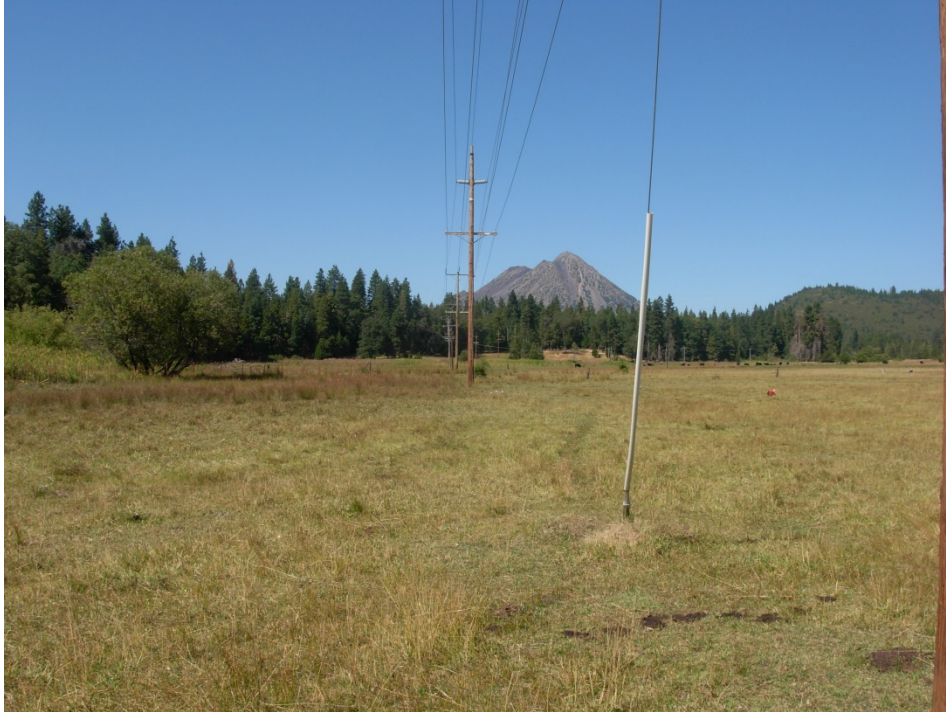
**Photo 9. Wetland W-3-11.** View is from pole 3/48, looking north across the slope wetland. A portion of the reference sample site is visible on the left (taken September 16, 2011).

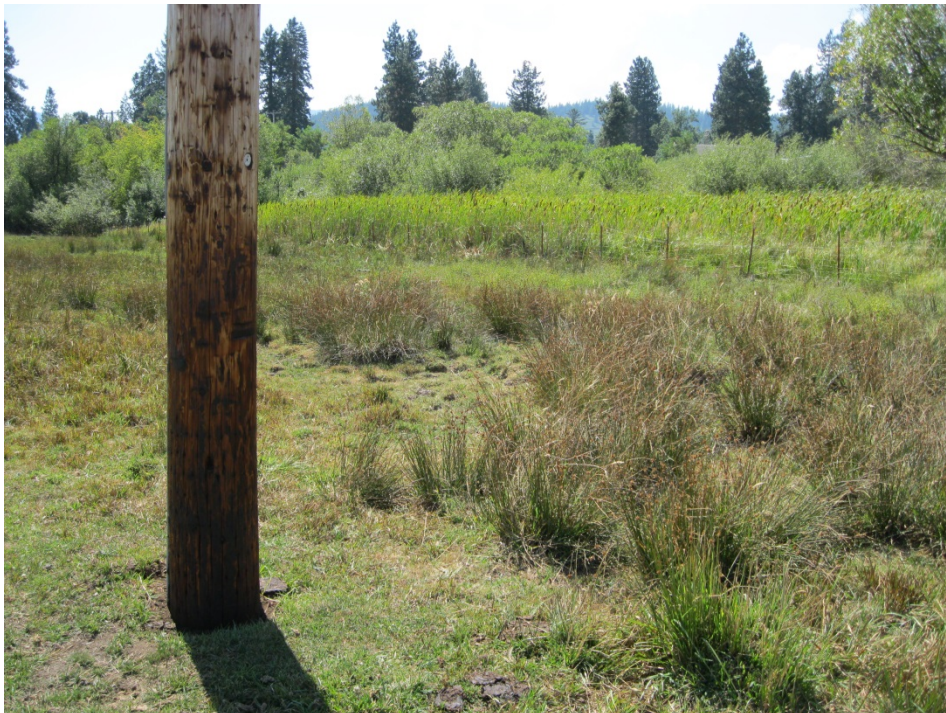
During the field investigation it was observed that W-3-11 slopes south/southeast toward the observed freshwater wetland west of poles 1/48 and 2/48, and a wetland swale (mapped as a PSSC wetland by the NWI; see Appendix B Photo 10). This wetland swale flows from north to south, seeping beneath Hatchery Lane, and discharges into Cold Creek (RWQCB 2006, ENPLAN 2008). This wetland swale provides hydrologic connectivity to waters of the U.S. as an adjacent water as defined in §328.3(a)(6) of the Final Rule and is therefore jurisdictional to the USACE under Section 404 CWA.

**Photo 10. Wetland W-3-11.** View is from pole 2/48 west toward the wetland swale that connects W-3-11 with W-2-11 and Cold Creek (taken September 14, 2011).

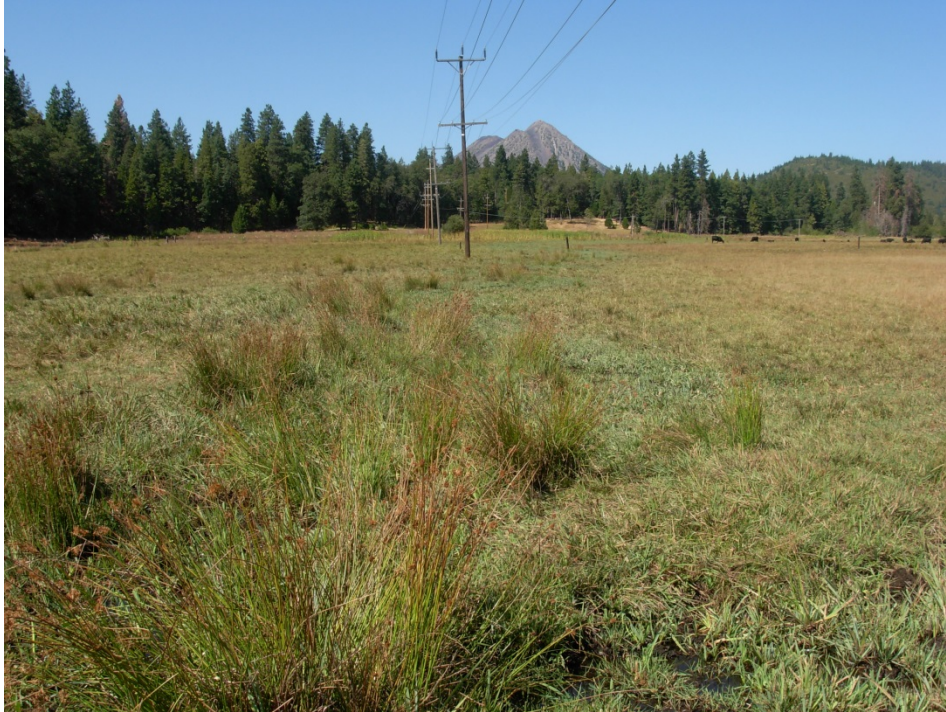
Photo 11. Wetland W-3-11. View is north across the slope wetland from pole 1/48 (taken September 16, 2011).

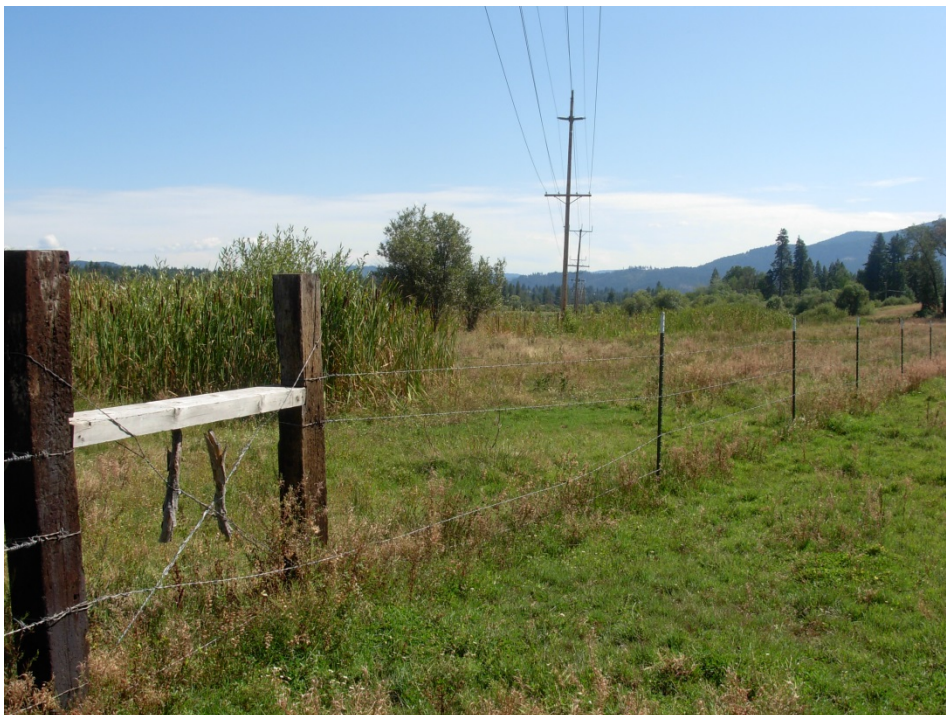
During the field investigation, a second freshwater marsh surrounded by exclusion fencing was observed within the ROW between poles 21/47 and 23/47 (see Appendix B Photo 12). The marsh is a natural wetland that has been remediated as mitigation for Section 401 CWA violations (ENPLAN 2008), and therefore no wetland sampling was conducted within the exclusion fencing. Drainage patterns were observed crossing through the ROW between 23/47 and 1/48, and surface water was observed within the ROW between 21/47 through 24/47.

Photo 12. Wetland W-3-11. View is south from pole 21/48 across the exclusion fencing that protects the freshwater mitigation marsh (taken September 16, 2011).

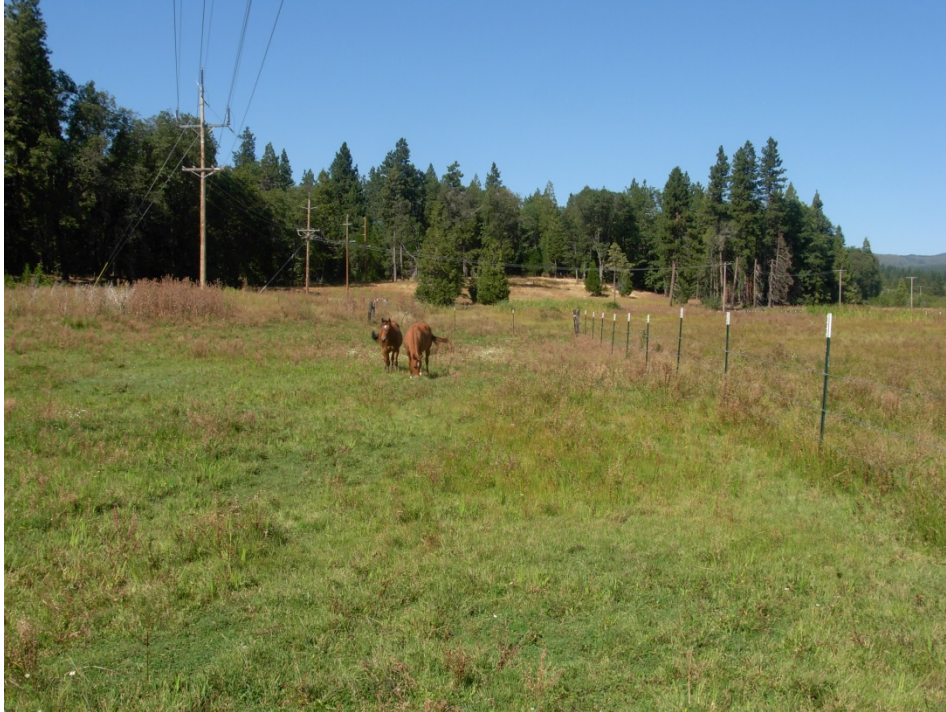
**Photo 13. Wetland W-3-11.** View is north from pole 21/48 across the northern edge of the slope wetland (taken September 16, 2011).

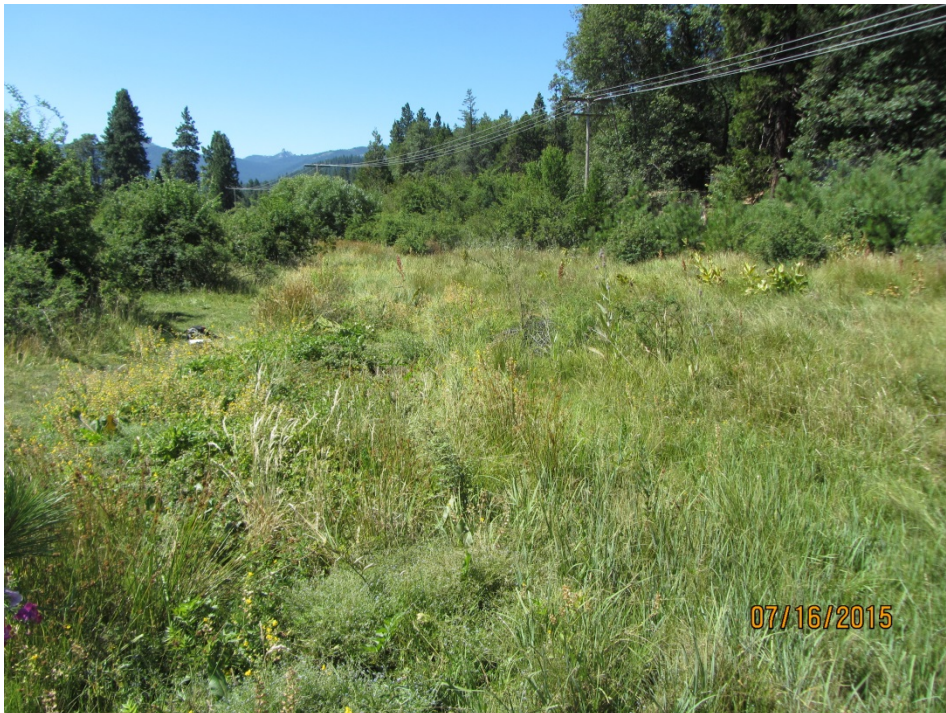
Wetland W-1-15 is a slope wetland that forms the northern continuation of W-3-11, but was investigated on a later date (see Figure 5G and Appendix B Photo 14). The NWI has mapped the eastern half of this wetland as PEMC. However, the wetland was observed to extend beyond the NWI boundary west of the distribution ROW (see Appendix B Photo 15). The hydrology source for this section of the larger wetland is a culvert located on the western side of a dirt access road leading from the end of Smith Road. The other end of this culvert was not located during the field investigations, but since water was observed flowing from the pipe in the dry season during an extreme drought, this culvert may be spring-fed, as are the culverts in W-2-11.

**Photo 14. Wetland W-1-15.** View is south along the distribution line from the culvert that contributes water to this slope wetland.

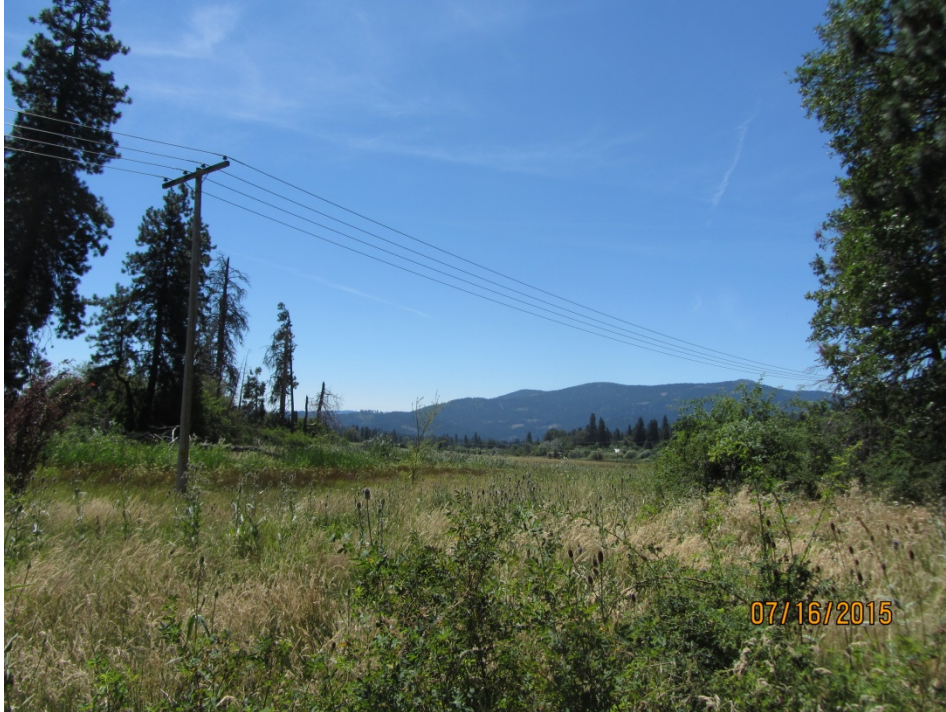
**Photo 15. Wetland W-1-15.** View is south across the slope wetland from the wetland/upland boundary. The transmission line and wetland W-3-11 are visible in the distance.
