SDG&E February 21, 2012 Response
A. 11-10-015 Mira Sorrento Project PTC
Energy Division Data Request 01 Dated February 3, 2012
SDGE-ED-001: Q 1

Reference: Results of the 2012 Transects for San Diego Gas & Electric's Mira Sorrento Substation Project (RECON Number 4938)

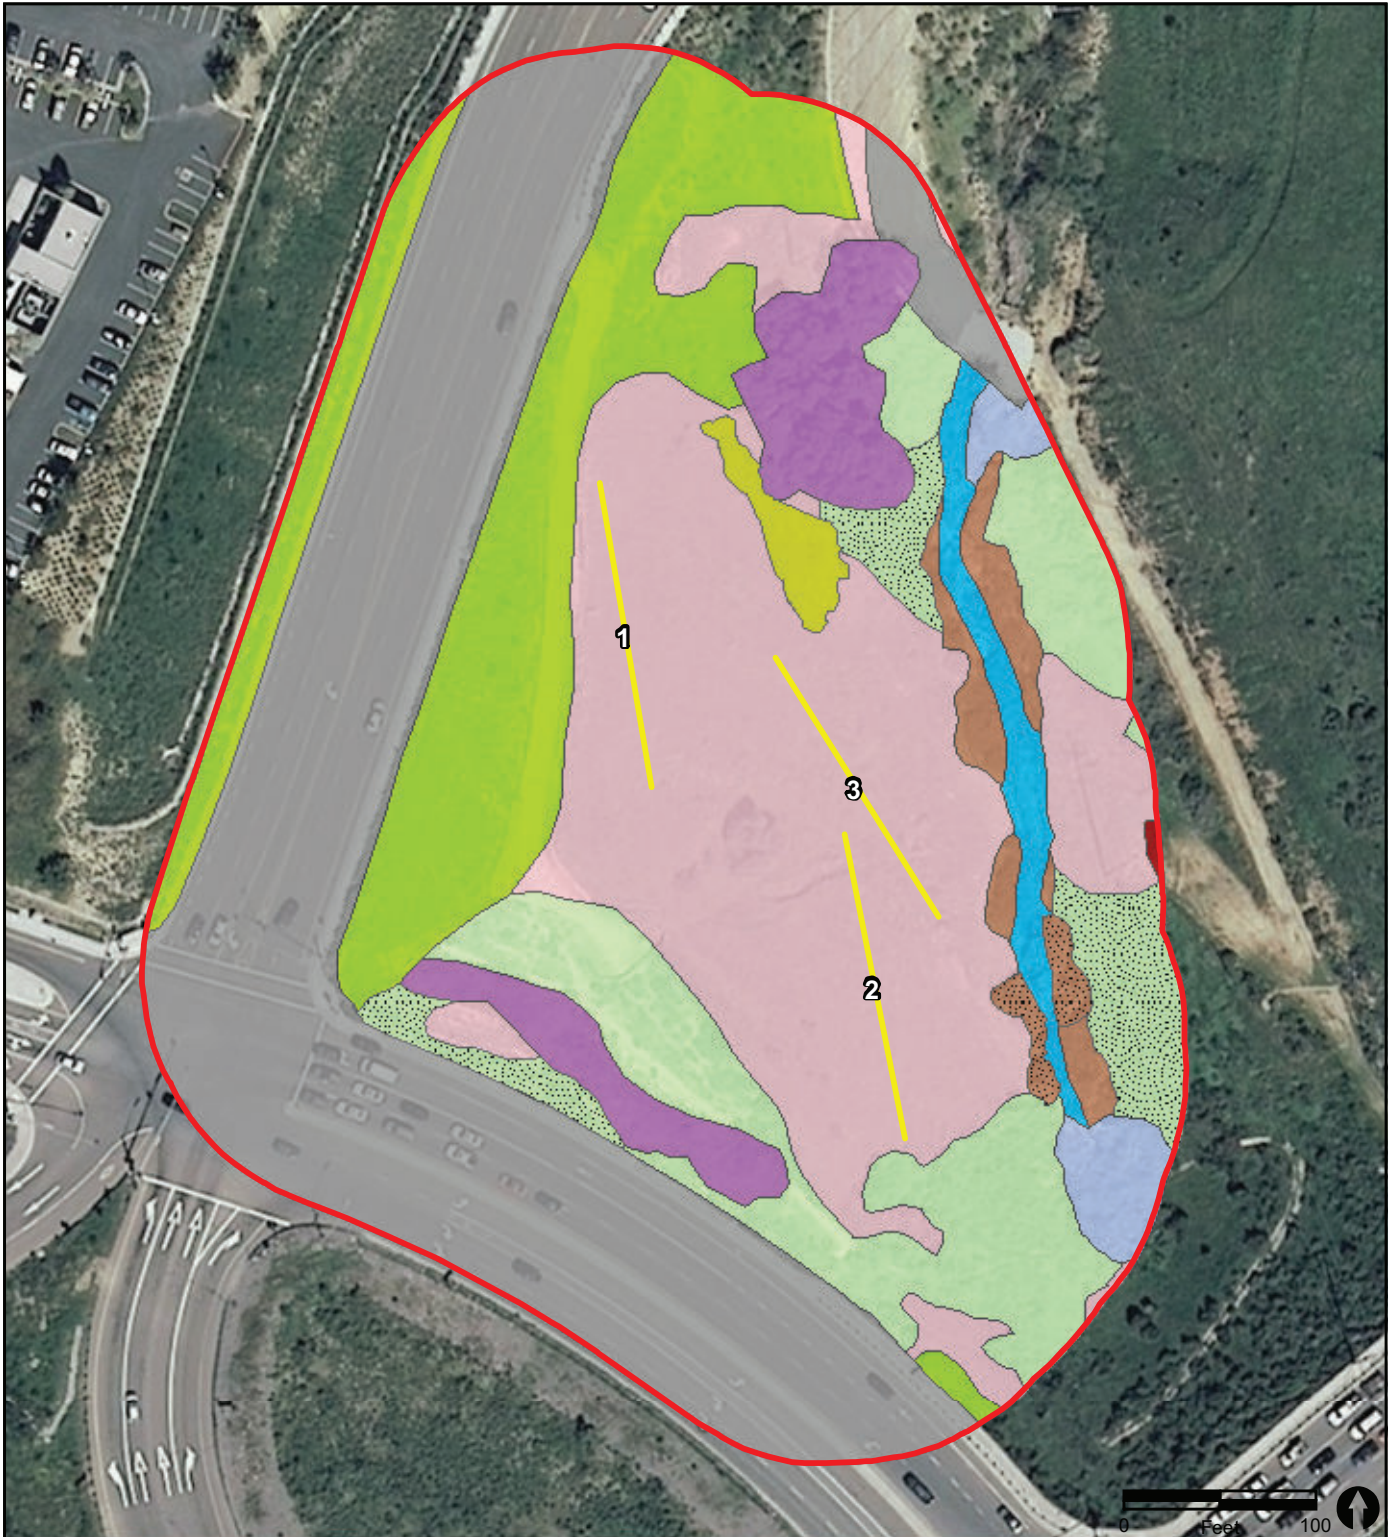
FIGURE 1

Existing Biological Resources and Transect Locations within the Mira Sorrento Substation Project Survey Area

On February 16, 2012, RECON biologists Brenna Ogg and Kayo Valenti surveyed the disturbed habitat as mapped in the 2010 biological technical report (RECON 2010). The largest stand of disturbed habitat was sampled using the point-intercept transect monitoring method to estimate percent cover of grasses and non-native forb species. This method uses a 50-meter-long transect centered in a 50-meter by 5-meter plot. Vegetation was sampled by the point method at every 0.5-meter interval along three 50-meter transect lines to determine species and cover. The percent cover was determined by dividing the number of intercepts of grasses or non-native forbs by the total number of sample points. All plant species observed within the 50-meter by 5-meter plot were also recorded. Transect locations are provided on Figure 1.

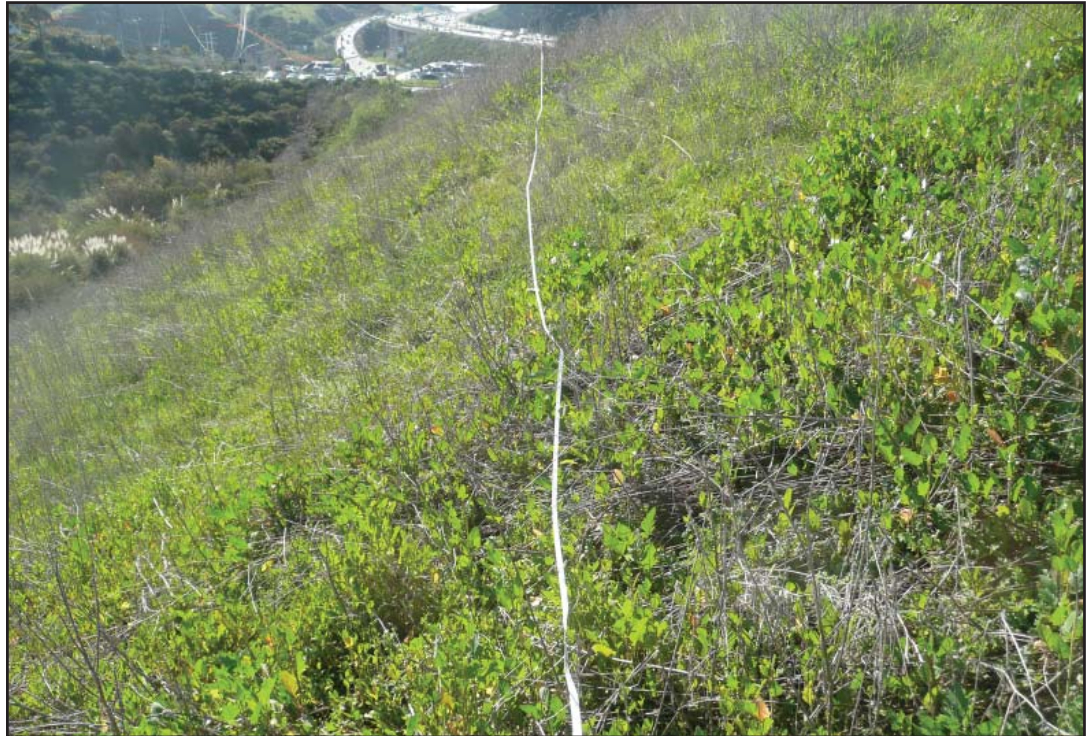
PHOTOGRAPH 1
Facing South from the Start of Transect 1, February 16, 2012

Overall non-native grass cover within the largest stand of disturbed habitat ranged between 6 and 40 percent, with an average of 21 percent. Overall non-native forb cover within the disturbed habitat ranged between 88 and 91 percent, with an average of 89 percent. The common non-native grass species encountered during point-intercept sampling were rattail fescue (*Vulpia myuros*) and red brome (*Bromus madritensis* ssp. *rubens*). Dominant non-native forb species included Italian thistle (*Carduus pycnocephalus*) and black mustard (*Brassica nigra*). Other species encountered in low numbers during point-intercept sampling included bristly ox-tongue (*Helminthotheca echioides*) and red-stemmed filaree (*Erodium cicutarium*). Additional plant species observed in low density within the 50-meter by 5-meter plots included fennel (*Foeniculum vulgare*), California geranium (*Geranium californicum*), wild oat (*Avena* sp.), poison hemlock (*Conium maculatum*), and coyote brush (*Baccharis pilularis*). Photographs 1 through 3 show south-facing views of each transect.

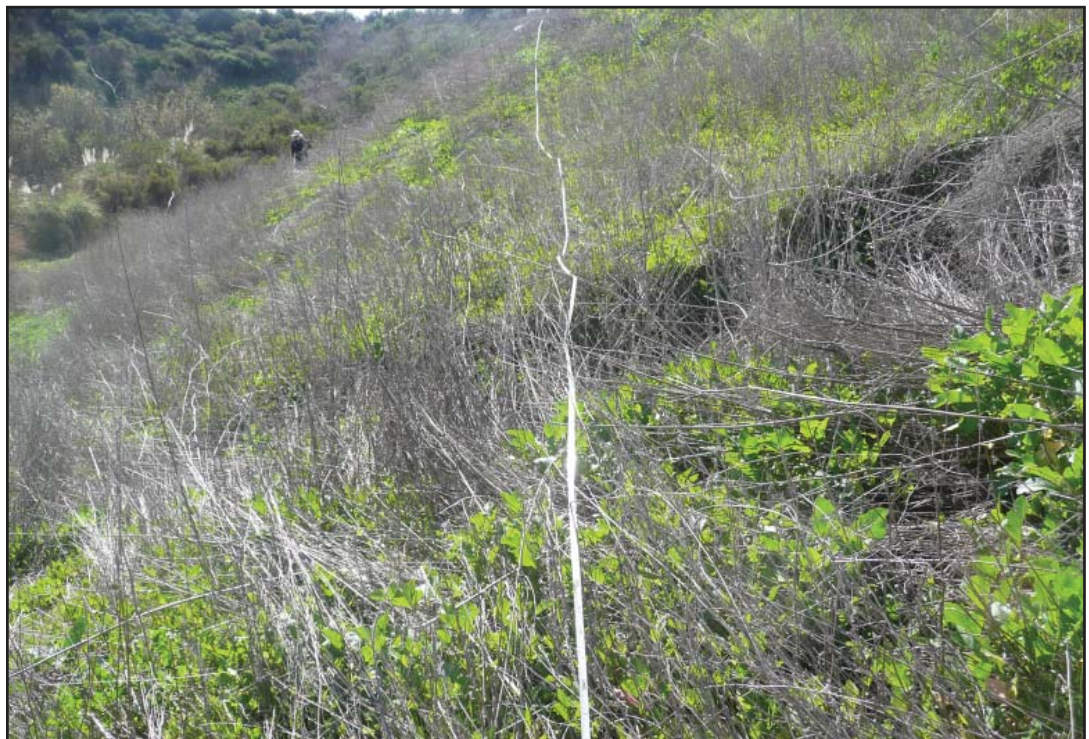
PHOTOGRAPH 2
Facing South from the Start of Transect 2, February 16, 2012

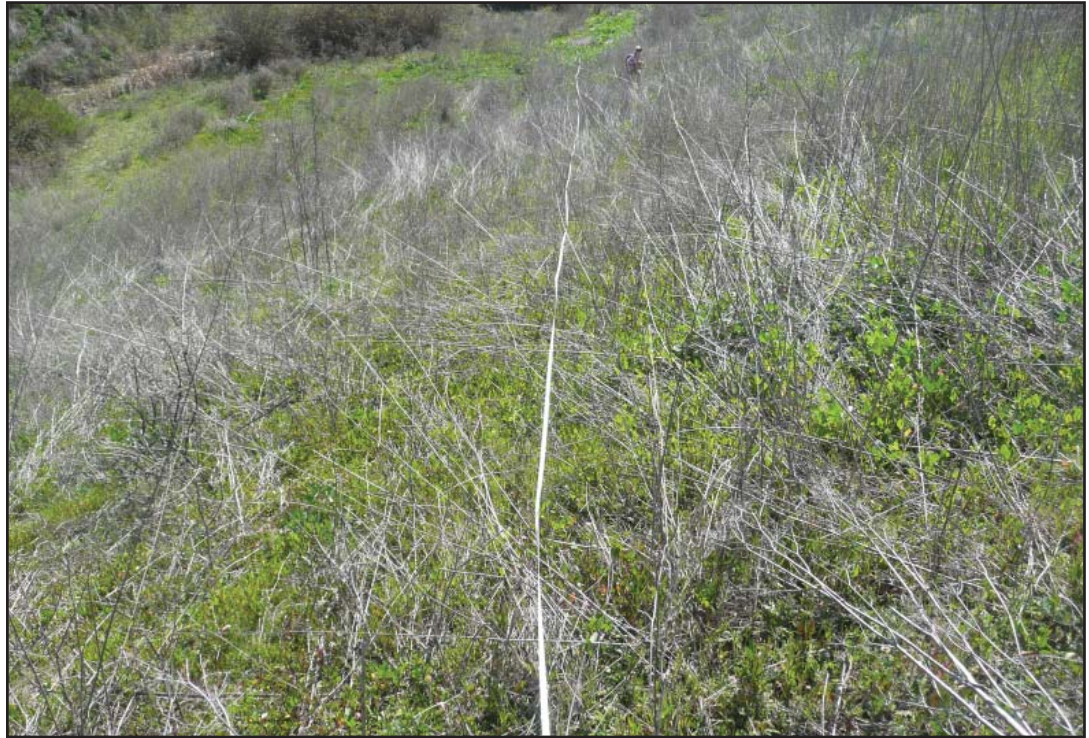
PHOTOGRAPH 3
Facing South from the Start of Transect 3, February 16, 2012

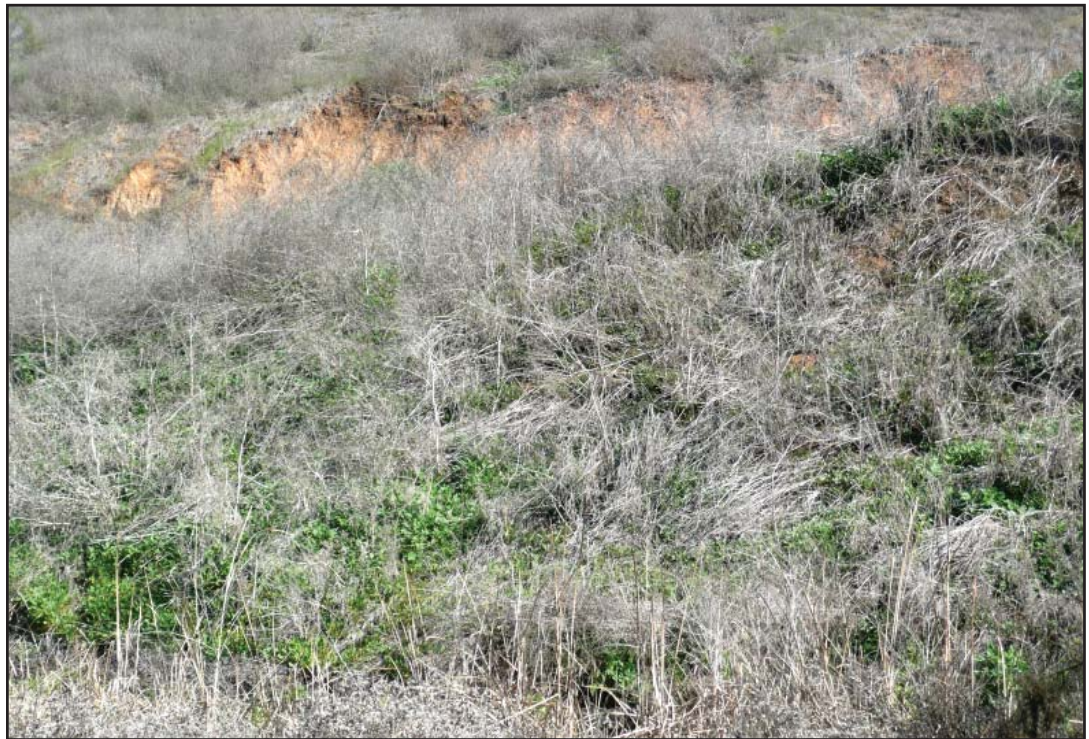
PHOTOGRAPH 4
Disturbed Habitat within Eastern Portion of the
Survey Area, Facing East, February 16, 2012

While no transects were placed within the smaller polygons identified as disturbed habitat, visual estimates of vegetative cover confirmed that these areas were similar in composition to the larger polygon surveyed. Photograph 4 provides an east-facing view of the easternmost disturbed habitat polygon. This area was typical of the remaining disturbed habitat polygons, within which non-native forb species dominated, and few to no non-native grasses were observed.
