Memorandum

From: Tamara Spear
San Diego Gas & Electric Company
Subject: TL 637 Wood to Steel Project Reconnaissance-Level Jurisdictional Waters
Assessment Summary
Date: May 21, 2013

Project Description:

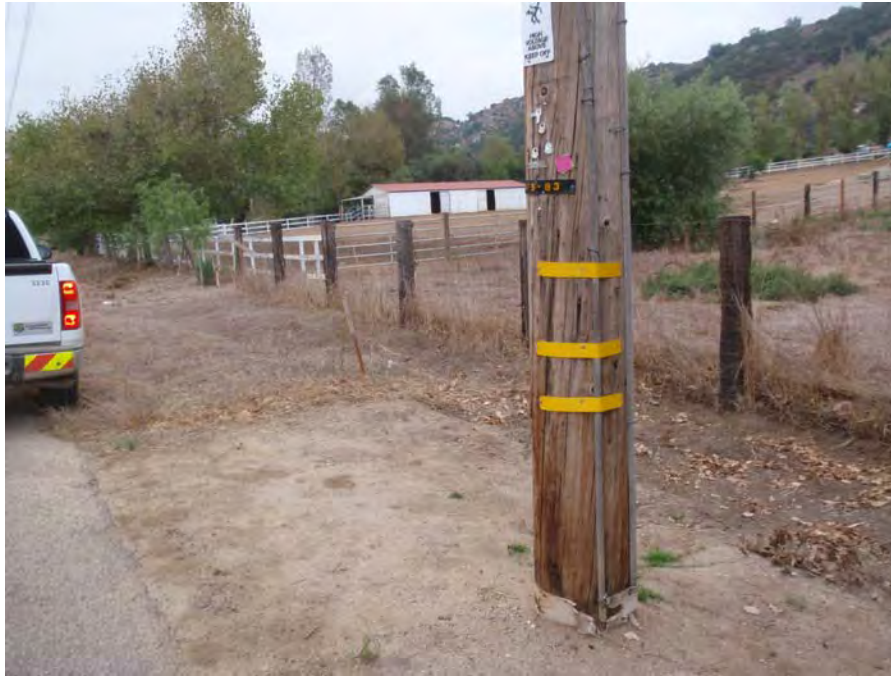
Pole D167. Photo taken looking east along Creelman Rd. The stake is located to the east of the pole (background). Stake is located on bank of erosional/drainage feature and will require BMPs to avoid impacts. Location #15

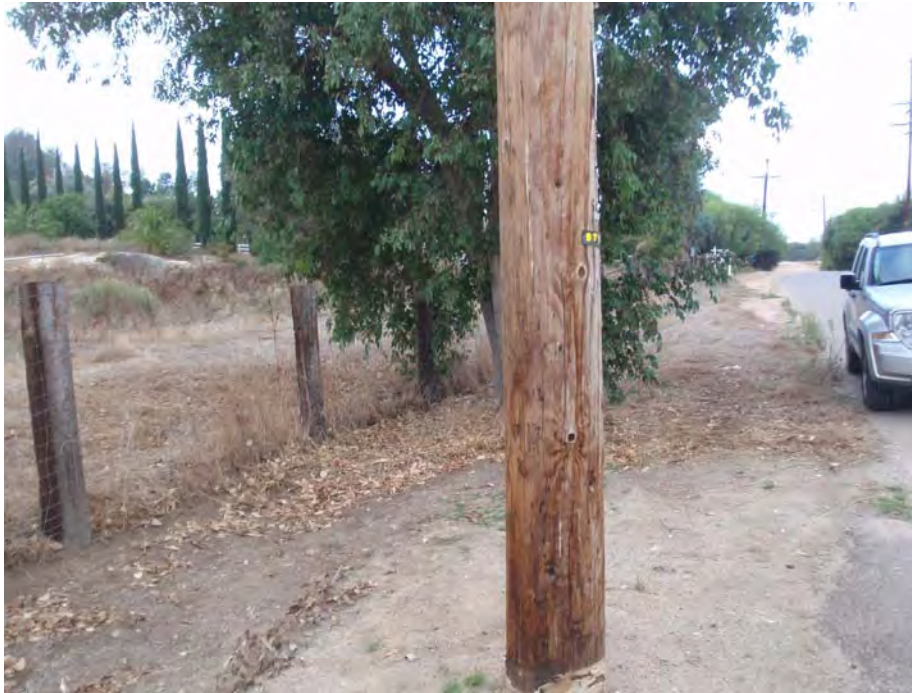
Pole D167, direct bury. Photo taken looking west along Creelman Rd. Existing pole can be removed without impacts to the erosional/drainage feature on the right hand side of the photo. Location #15

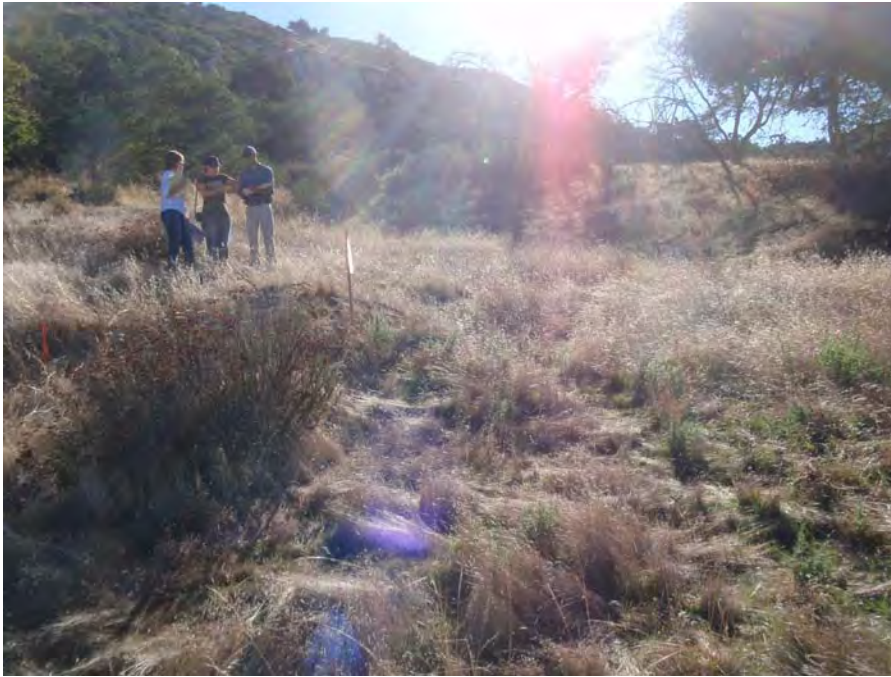
Pole P152. The stake is located on the bank of a swale feature. Propose to move stake location 8ft 4inches to the N (340 degrees from stake, or left of the stake) to avoid impacts to feature on the center/right. Location #10

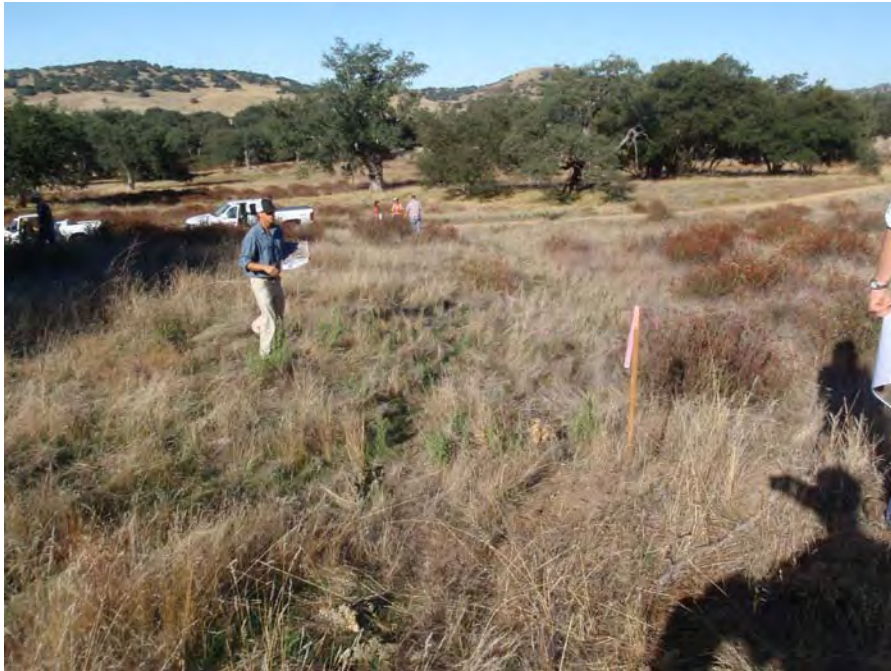
Pole P152. Photo taken looking west along the overland travel from access road over feature to staked location. Surveyor is standing in the swale feature. Oak tree trimming may be required for pole removal. (Location #10)

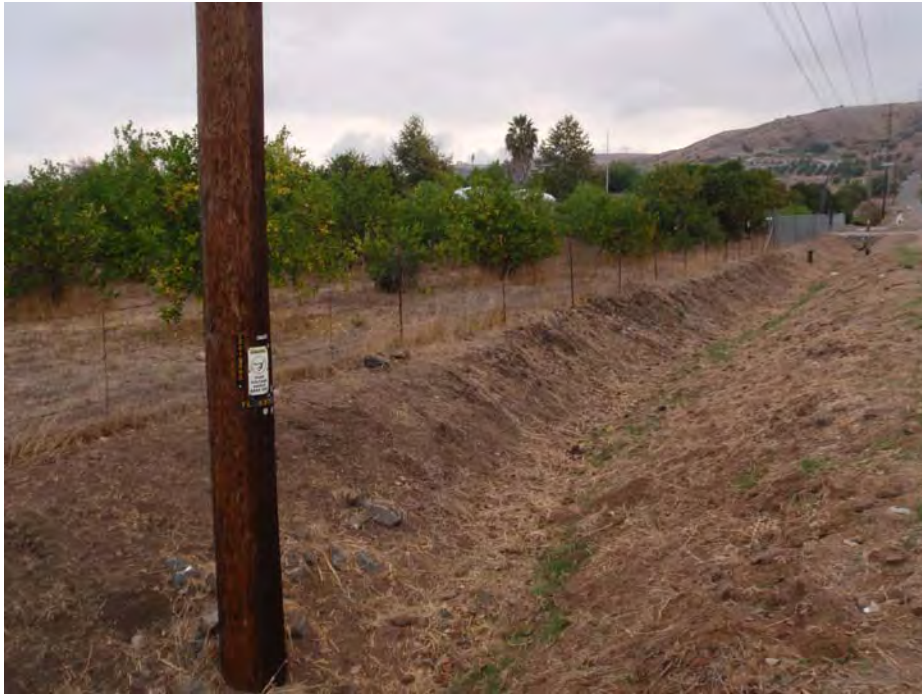
Pole R11. Photo taken looking east along Creelman Rd. The poles along the north side of Creelman will be relocated to south side (P168). Pole located within a drainage feature. Location #16

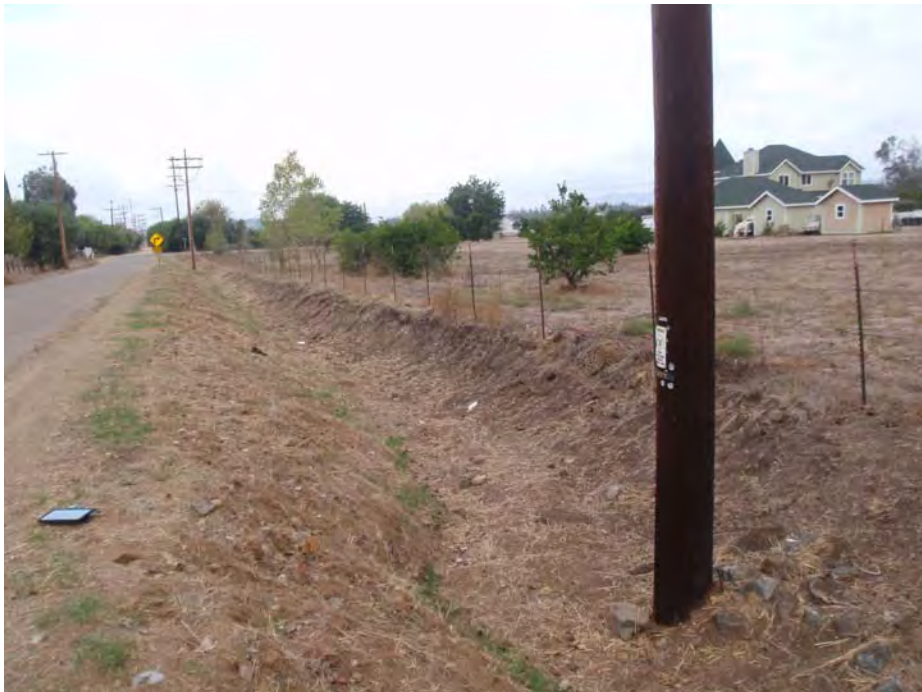
Pole R11, pole removal. Photo taken looking west along Creelman Rd. Pole is located within a drainage feature. Options for removal are cut at base and leave, or access pole from road and pull out with boom truck and wench to minimize impacts. Location #16

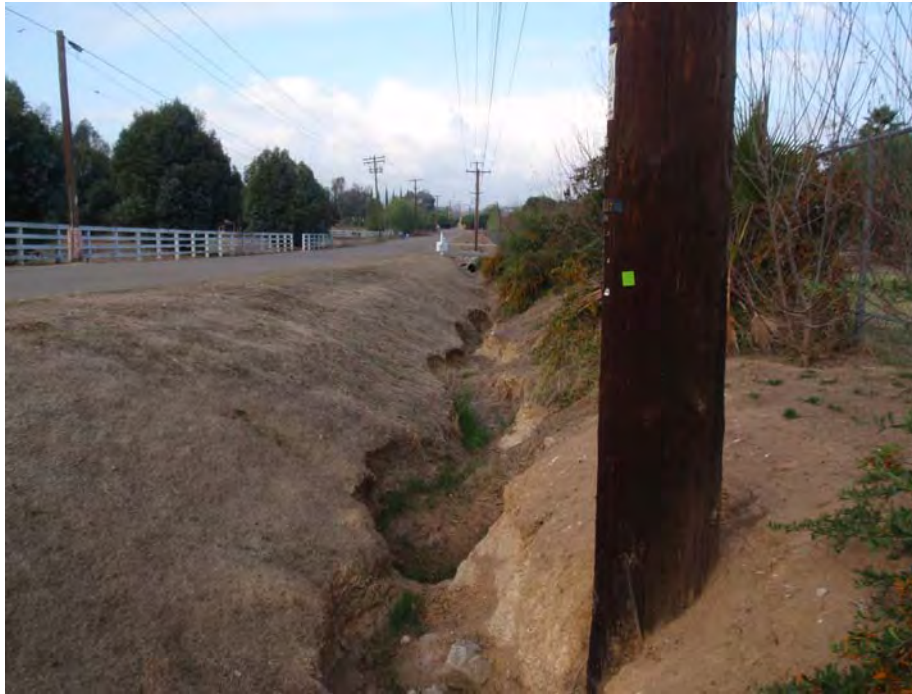
Pole R13. Photo taken looking west along Creelman Rd. Existing pole located a drainage feature. Removal: access pole from road and pull out with boom truck and wench to minimize impacts. May require back hoe to dig out from exposed bedrock. Location #17

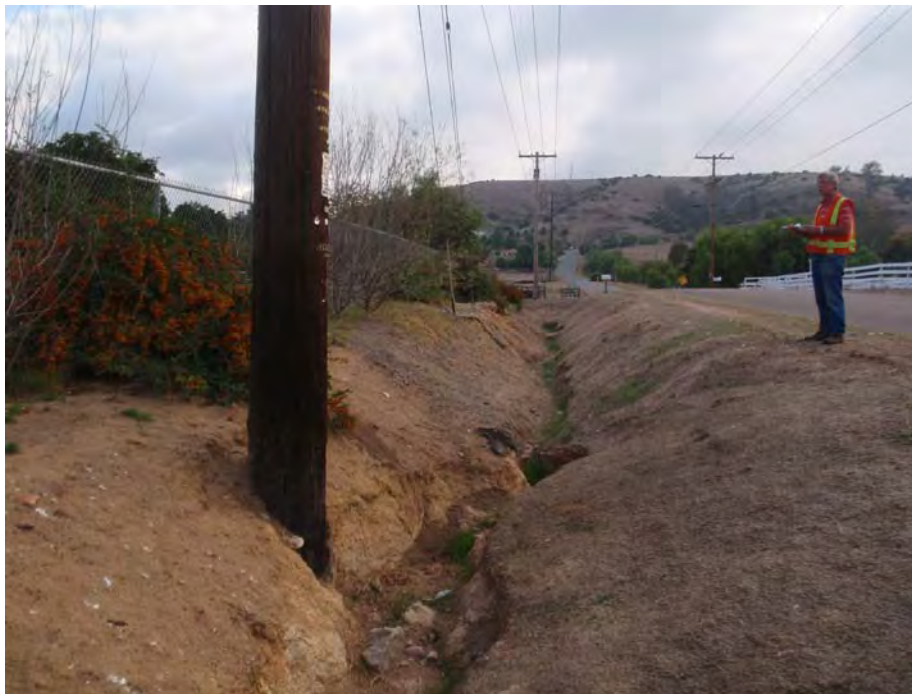
Pole R13, pole removal. Photo taken looking east along the north side of Creelman Rd. Temporary disturbance of up to 10 feet will occur during removal. Location #17

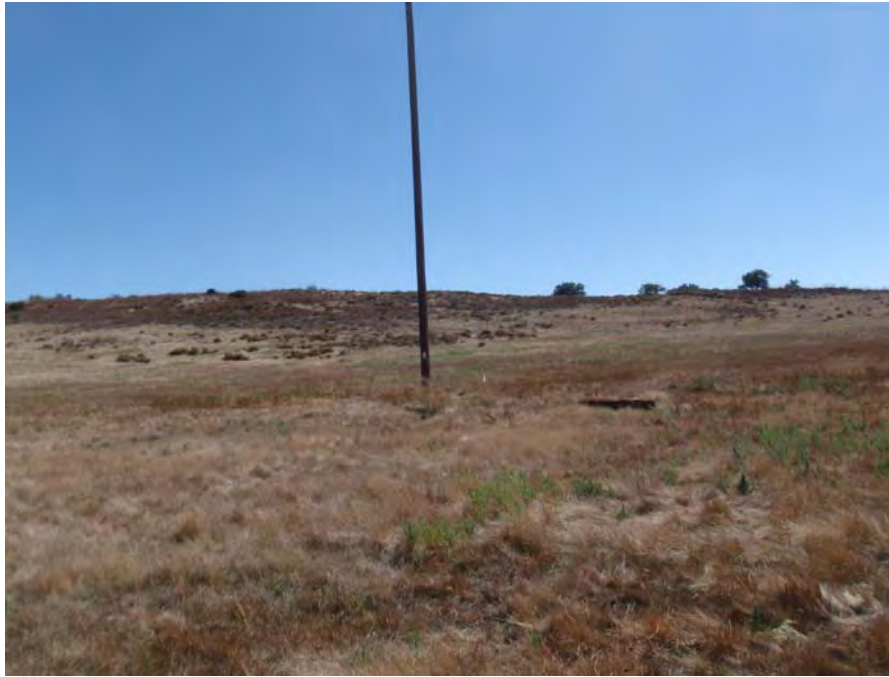
Pole P103, pole removal and relocation. Photo taken looking southeast from staked location towards pole located in wetland meadow area, to be removed. Location #4

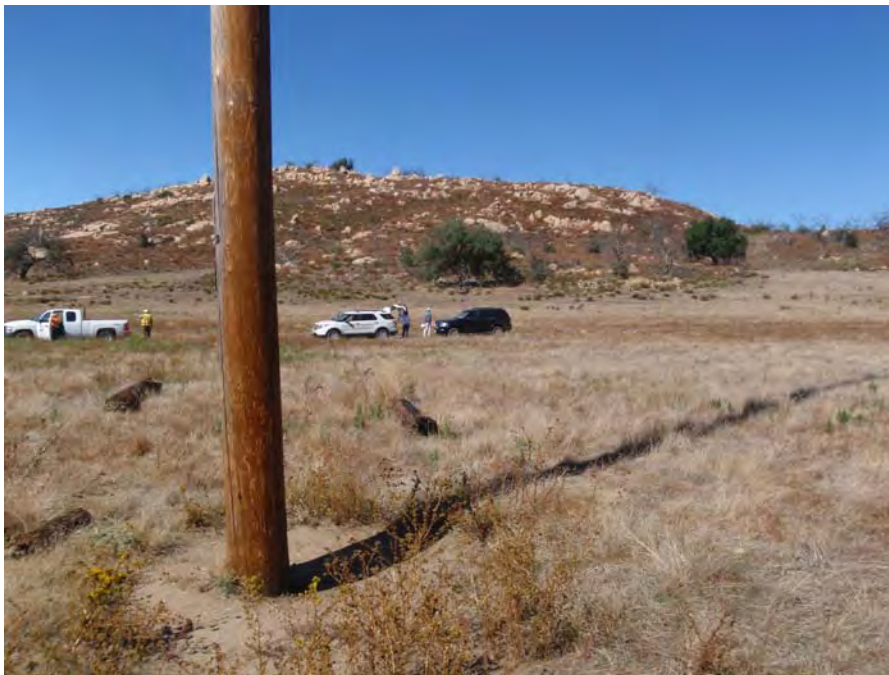
Pole P103. Photo taken looking northwest towards access road. The pole will be relocated between two access roads within 15 feet of staked location, within a more disturbed wetland area. Removal of pole will temporarily disturb the wetland area. Relocation will minimize disturbance during maintenance activities of pole, since pole will be directly adjacent to two access roads. Loc.#4

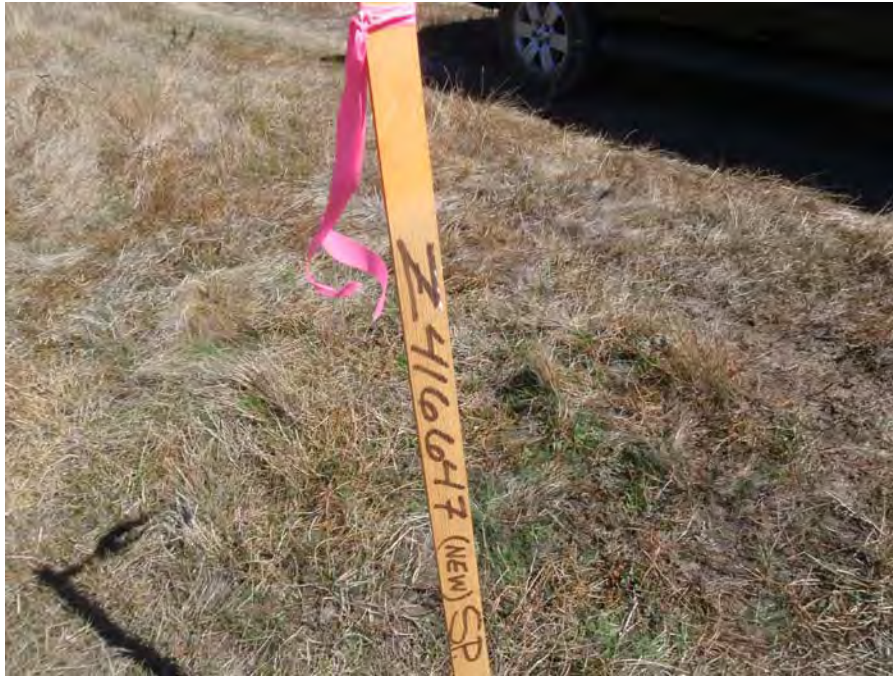
Pole P103, pole removal and relocation area. Relocation will minimize disturbance during maintenance activities. Location #4

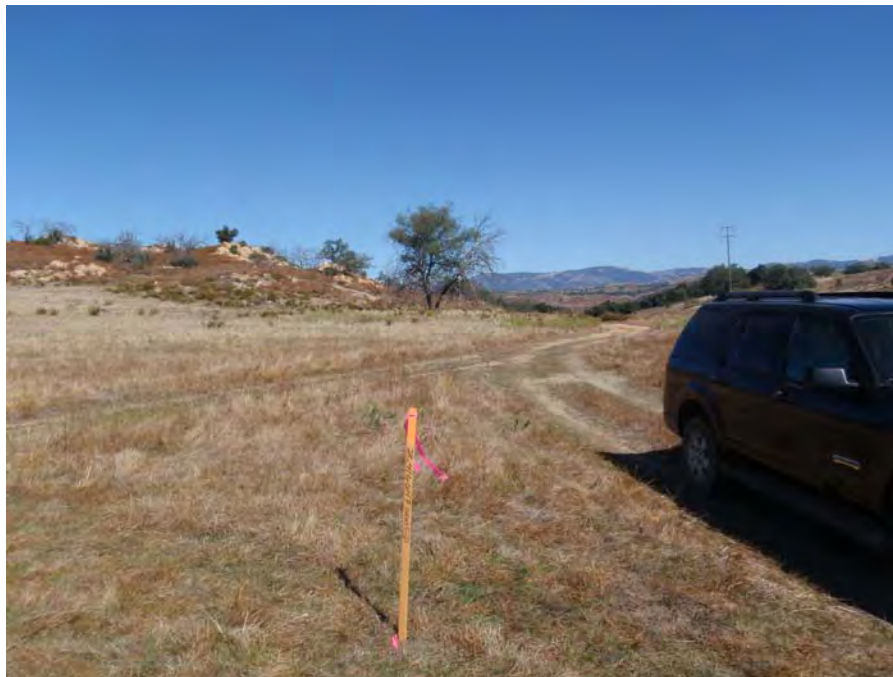
Pole P103. Photo taken looking northeast along the intersection of two access roads. Relocation area will minimize disturbance during maintenance activities of pole, since pole will be directly adjacent to two access roads. Location #4

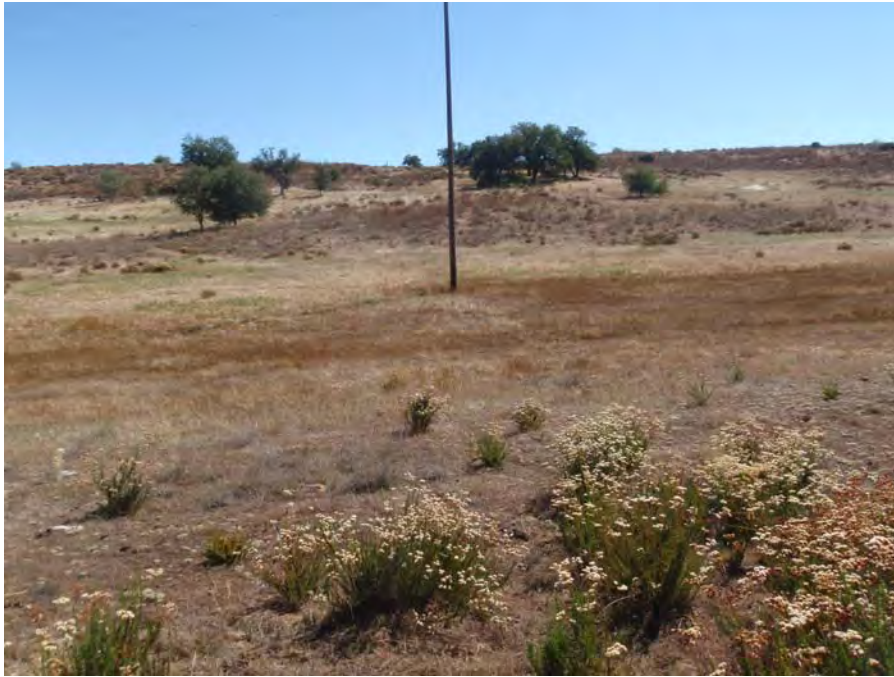
Pole P104, pole removal and relocation. Photo taken looking southeast from staked location towards pole located in wetland meadow area, to be removed. Relocation will minimize disturbance during maintenance activities. Location #5

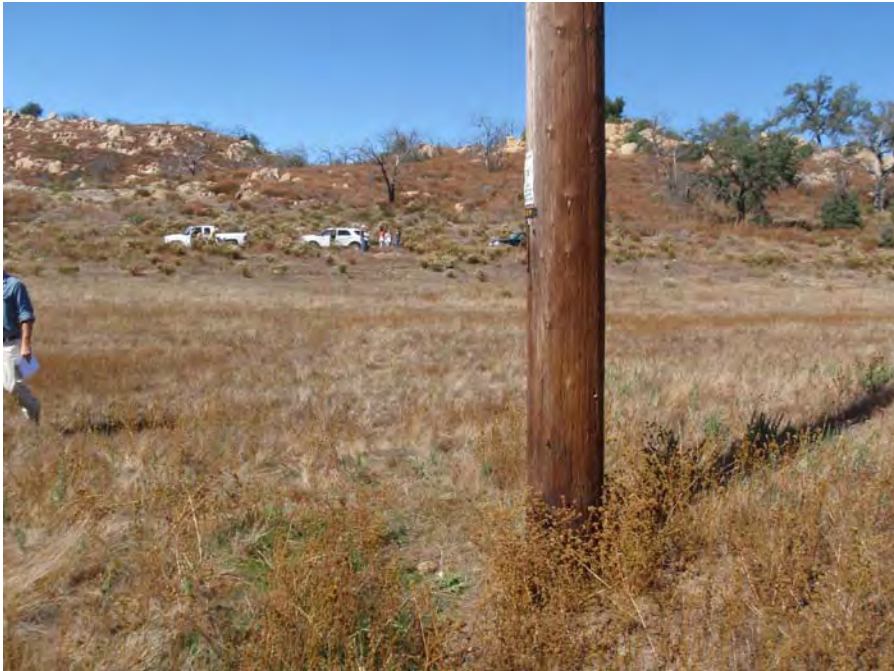
Pole P104. Photo taken looking northwest towards access road. The pole will be relocated to this side of the access road, outside of the wetland area. Removal of pole will temporarily disturb the wetland area, but will minimize disturbance during maintenance activities of pole (access to pole).

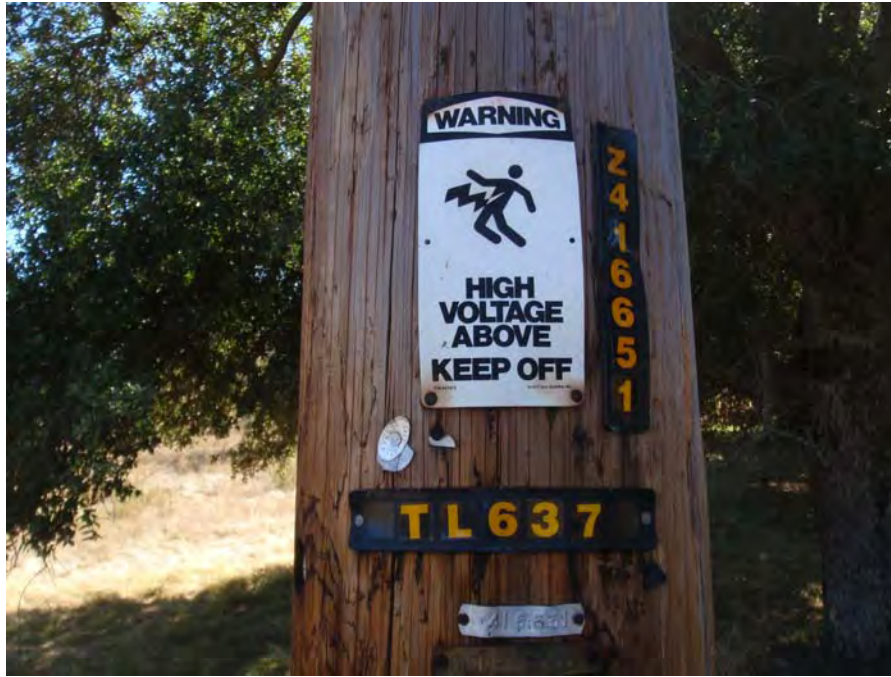
Pole R107, removal. Pole located in wetland area, will be removed. Englemann oak tree trimming will be required. Possible removal of oak trees since span will be increased. Location #8

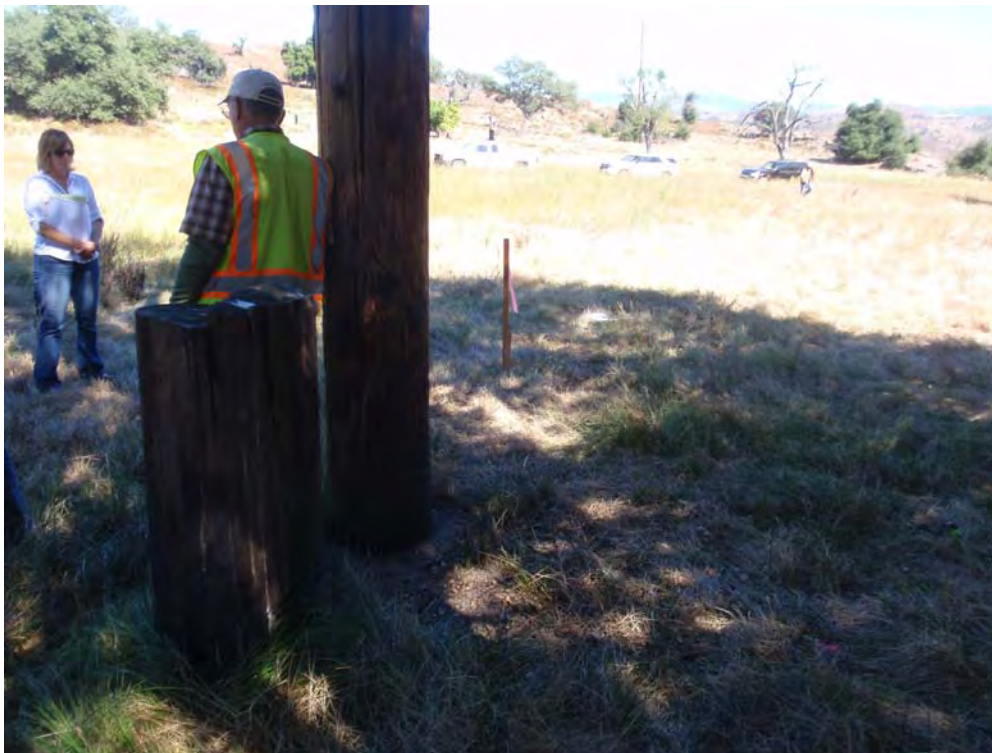
Pole R107. Photo taken looking northwest towards access road. This pole and existing pole butt will be removed and will not be relocated. Location #8

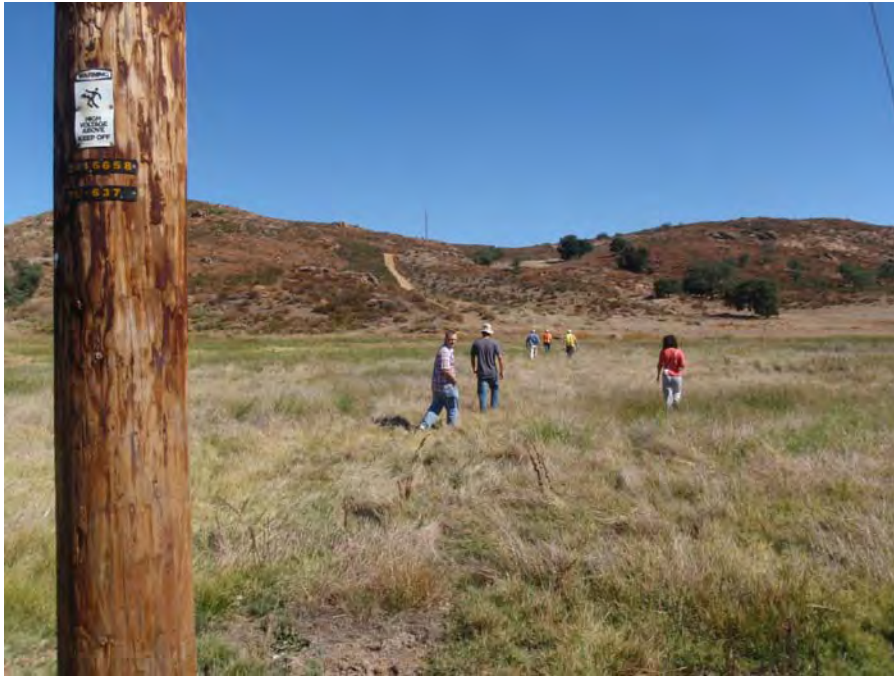
Pole P114, removal (and relocation). Photo taken looking west towards access road. Existing pole located within wetland meadow area, new location along access road outside wetland boundary. Access to pole by overland travel or helicopter. Location #9

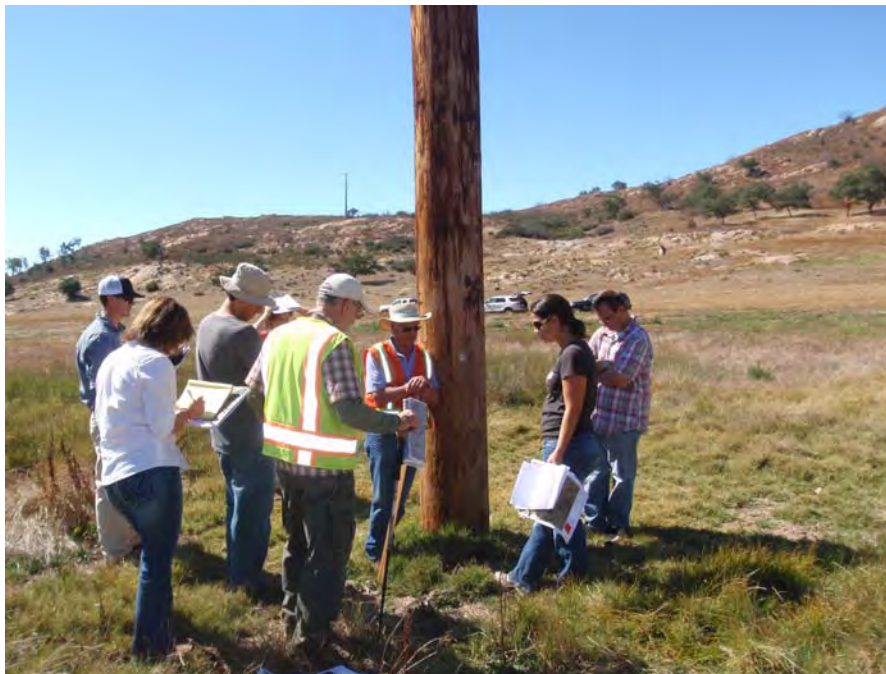
Pole P114. Photo taken looking southwest towards access road. If conditions are dry during construction, the meadow in photo will require mowing for overland travel. An existing pole butt which may require removal is located on this side of the pole, a few feet from pole P114.

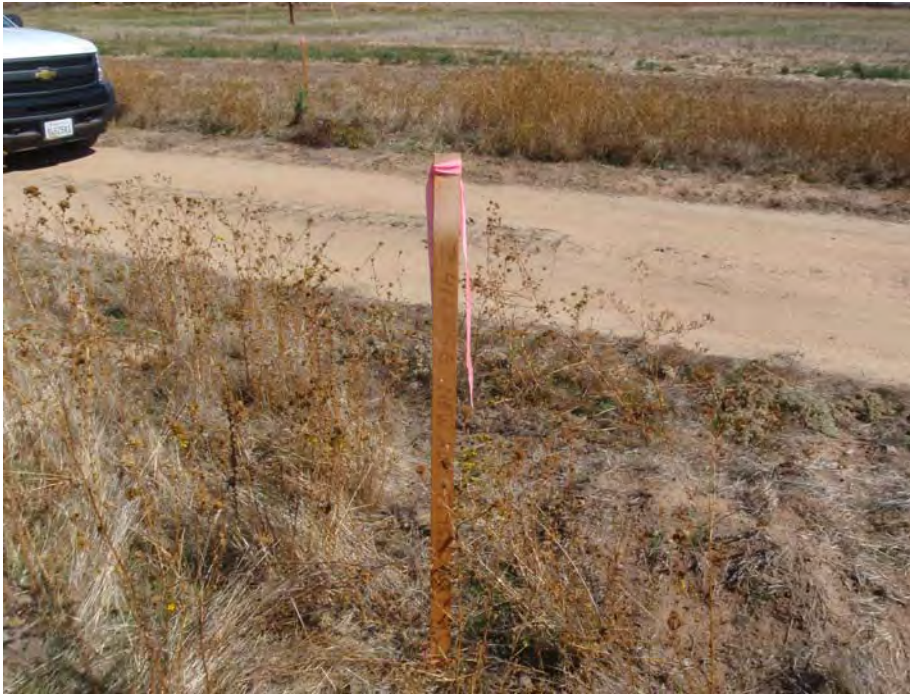
Pole P114, relocation area. Photo taken looking northeast towards access road and old pole location. New pole located outside wetland meadow area. Location #9

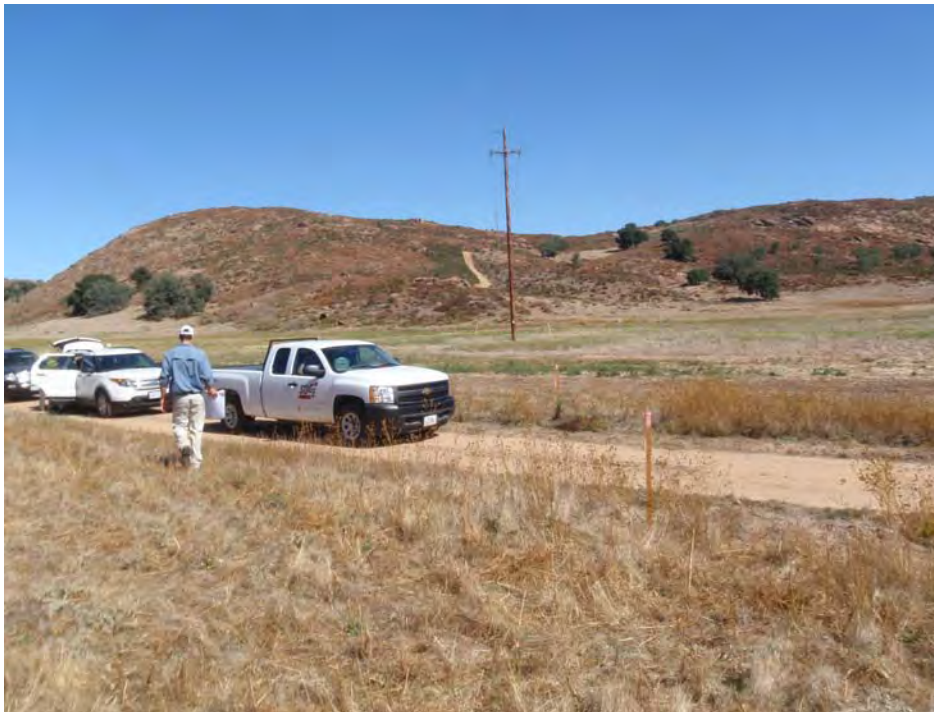
Pole P114. Photo taken looking northeast at new pole location in foreground and old pole location in background. Location #9

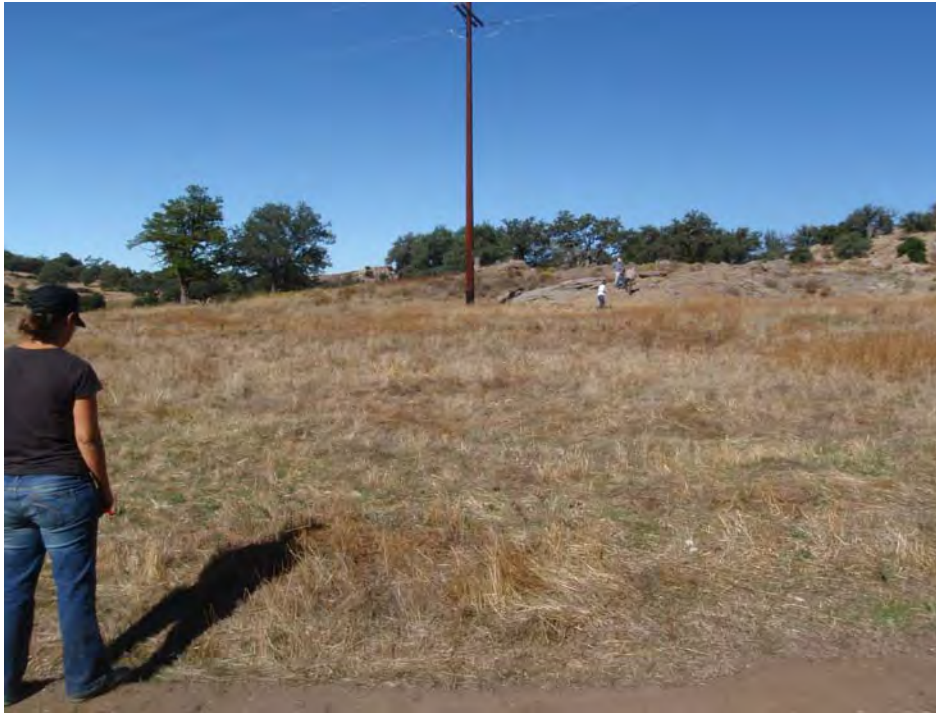
Pole P129, micropile. Pole not located within a drainage/wetland feature; however, a wetland meadow exists between access road and pole. Overland travel during dry conditions to avoid ruts in meadow is proposed. If wet, helicopter will be used for removal and installation processes. Loc #11

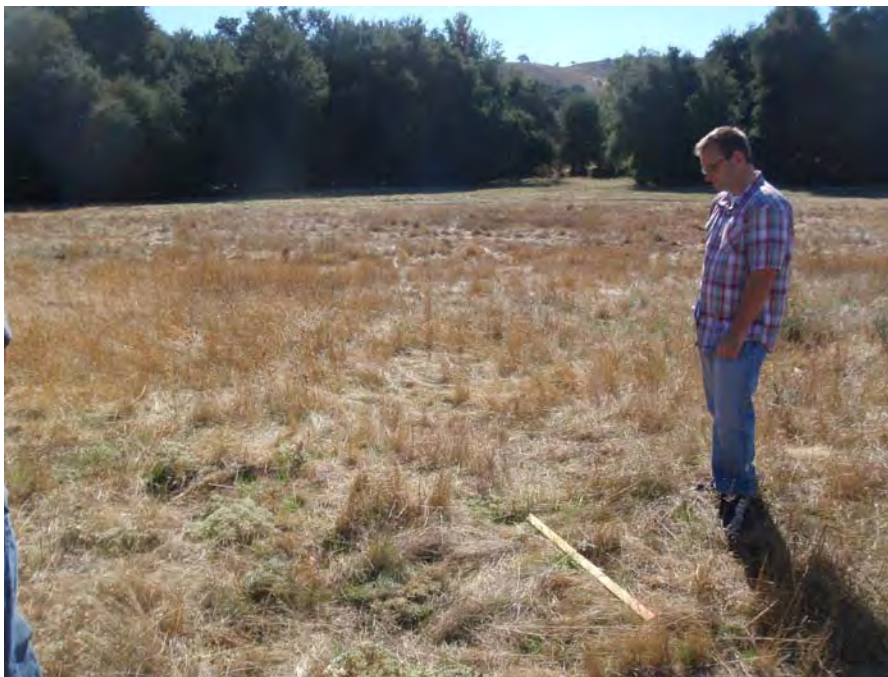
Pole P129. Photo taken from staked location towards the access road. If conditions are dry during construction, the meadow in photo will require mowing for overland travel. Location #11

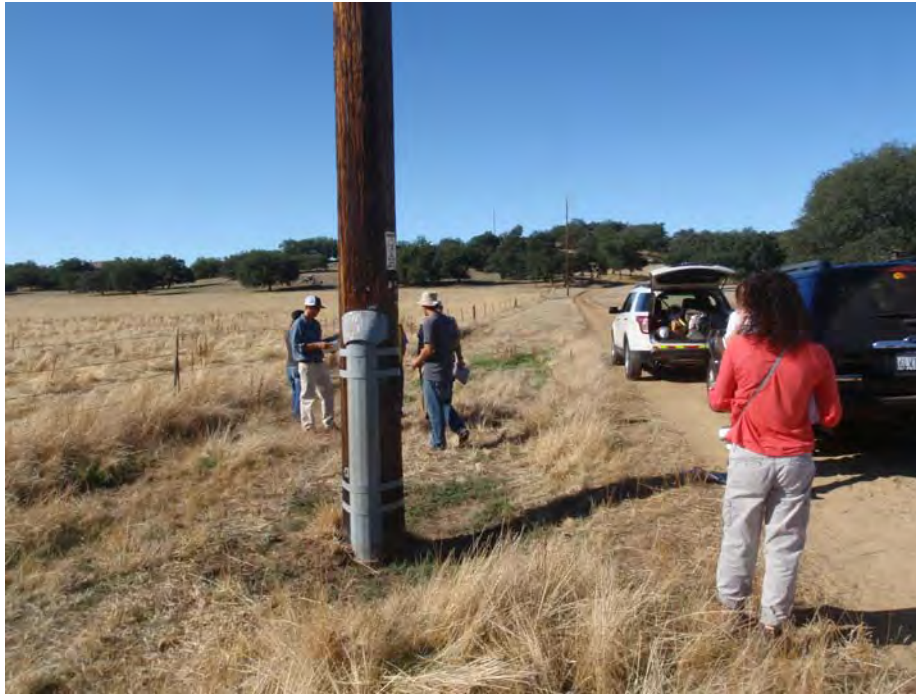
Pole P148, micropile. Photo taken looking southwest along the wetland meadow area to the left of the access road. Pole removal and relocation will occur in the disturbed wetland area. Pole P147 in background. Location #1

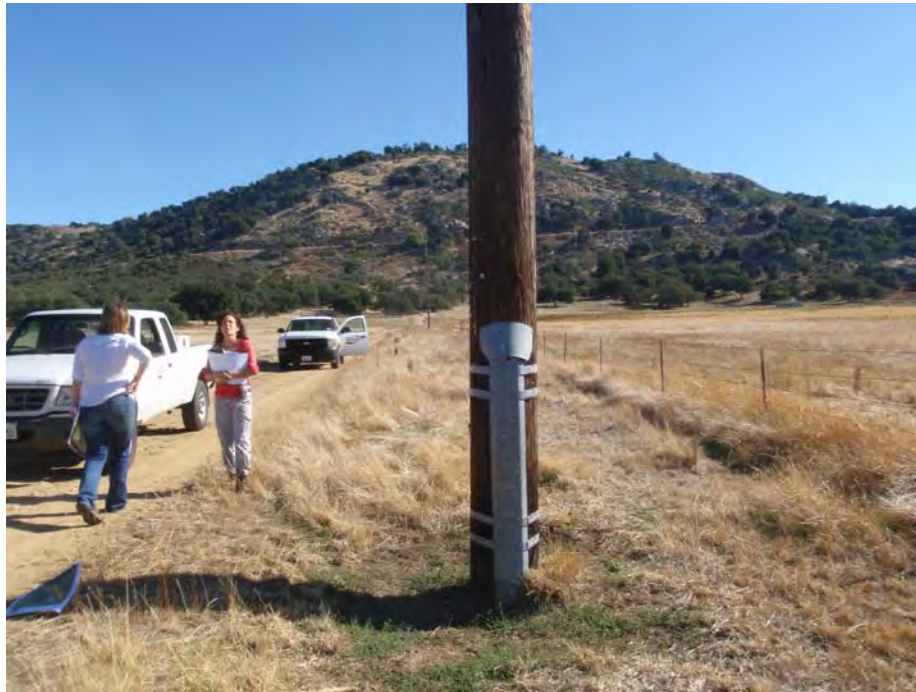
Pole P148. Photo taken looking northeast along the disturbed wetland meadow area. Temporary disturbance area is approximately 55ft by 20ft, from the access road to the fence. Location #1

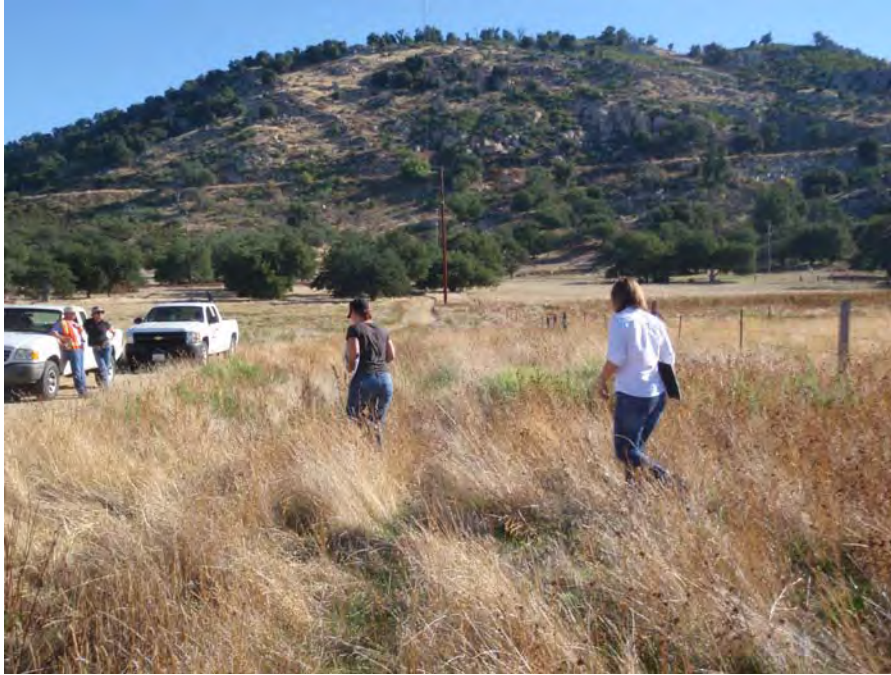
Pole P149, direct bury. Photo taken looking northeast along the wetland meadow area. Pole removal and relocation will occur in the disturbed wetland area. Pole P150 in background. Loc#2

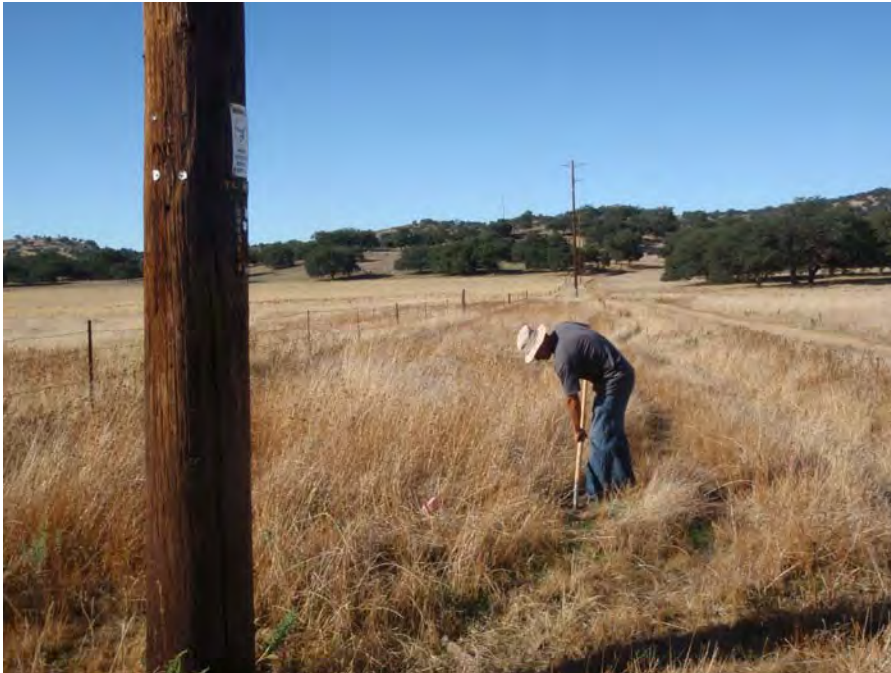
Pole P149. Photo taken looking southwest along the disturbed wetland meadow area. Soils identified in the area contained redox features indicative of anaerobic conditions. Pole P148 in background. Location #2

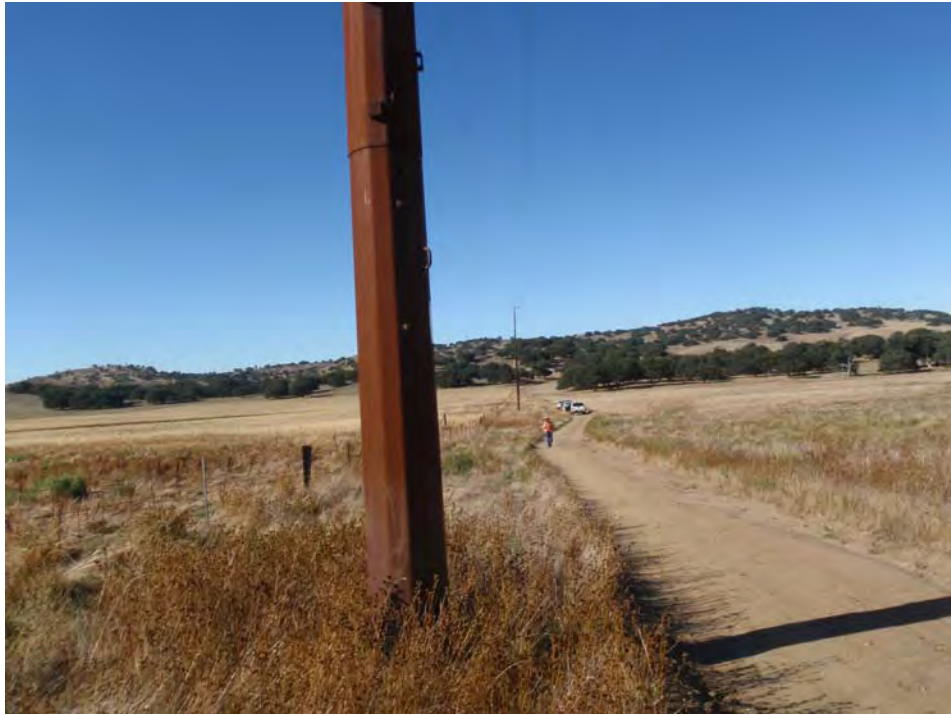
Pole P150, direct bury. Photo taken looking southwest along the wetland meadow area. Pole removal and relocation will occur in the disturbed wetland area. Pole P149 in background. Loc#3

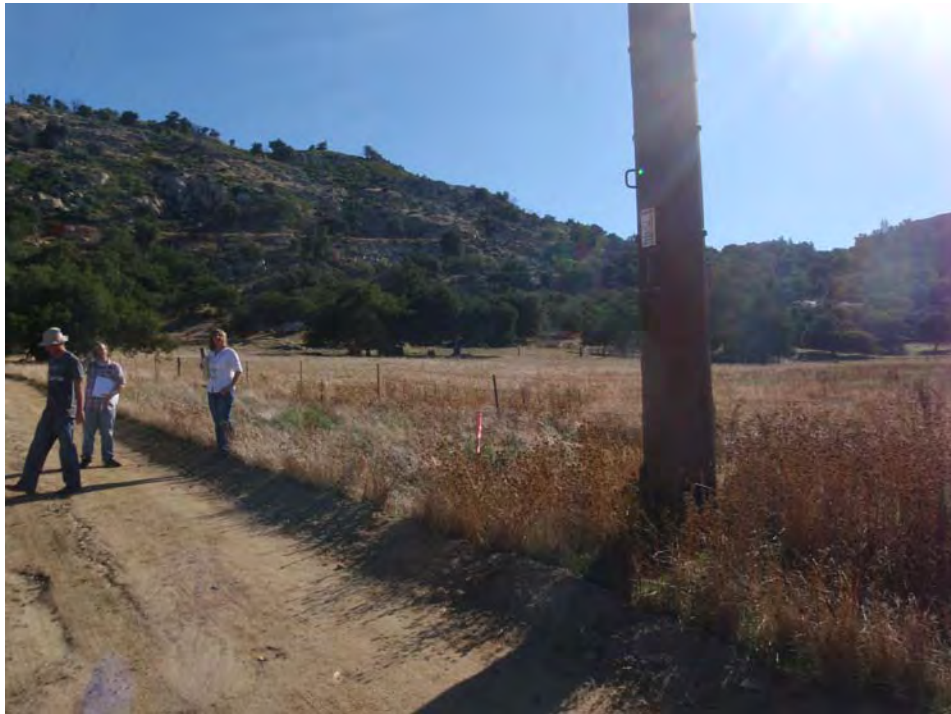
Pole P150. Photo taken looking east along the disturbed wetland meadow area. Temporary disturbance area is approximately 10 square feet for installation, and 10 feet for removal. Loc #3

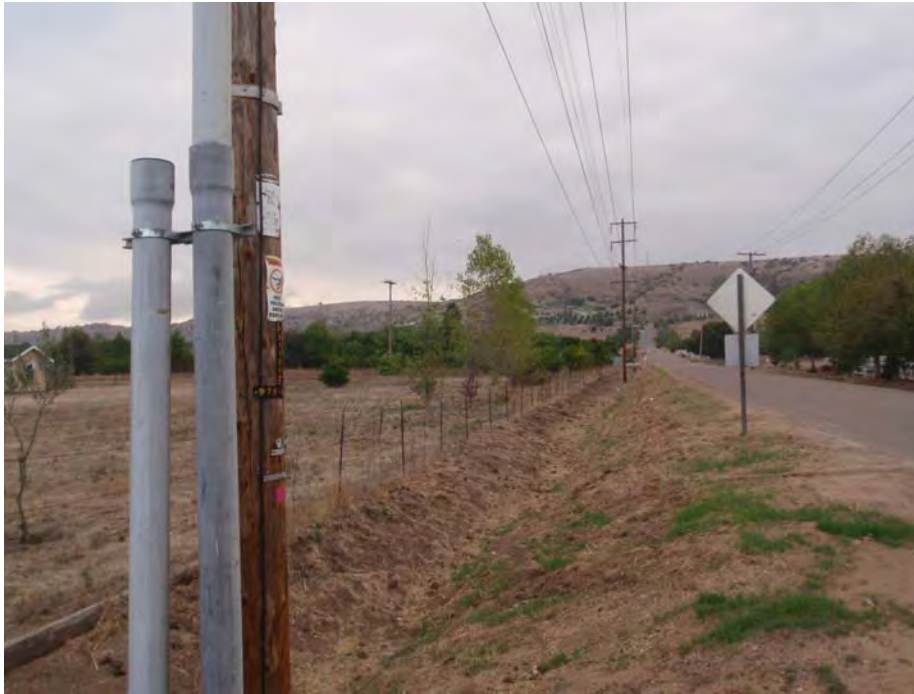
Pole R10. Photo taken looking east along Creelman Rd. The poles along the north side of Creelman will be relocated to south side (D167). Pole located within a drainage feature. Loc #12

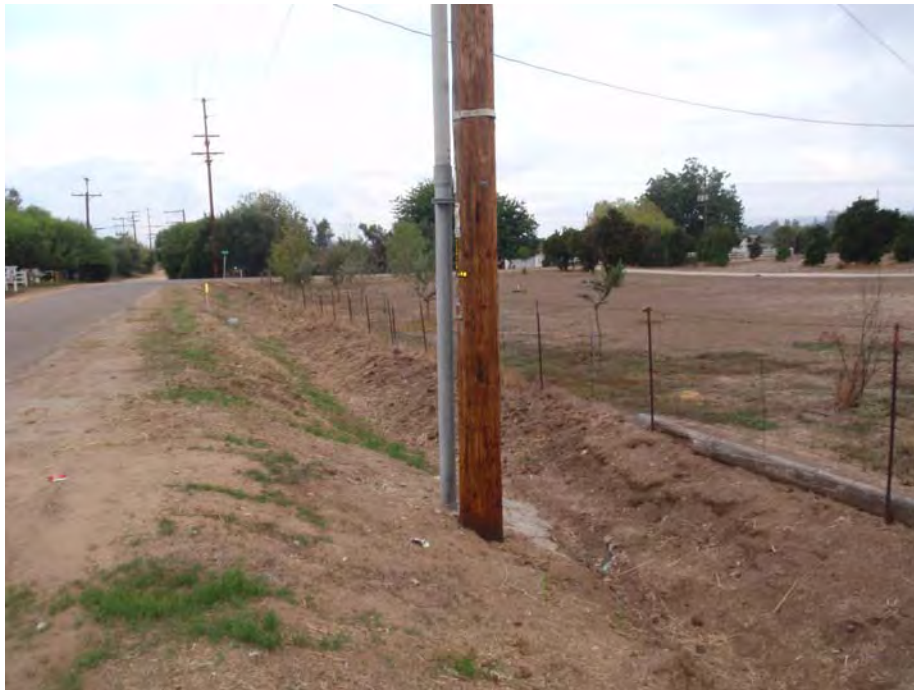
Pole R10, pole removal. Photo taken looking west along Creelman Rd. Pole is located within a drainage feature. Options for removal are cut at base and leave, or access pole from road and pull out with boom truck and wench to minimize impacts. Location #12

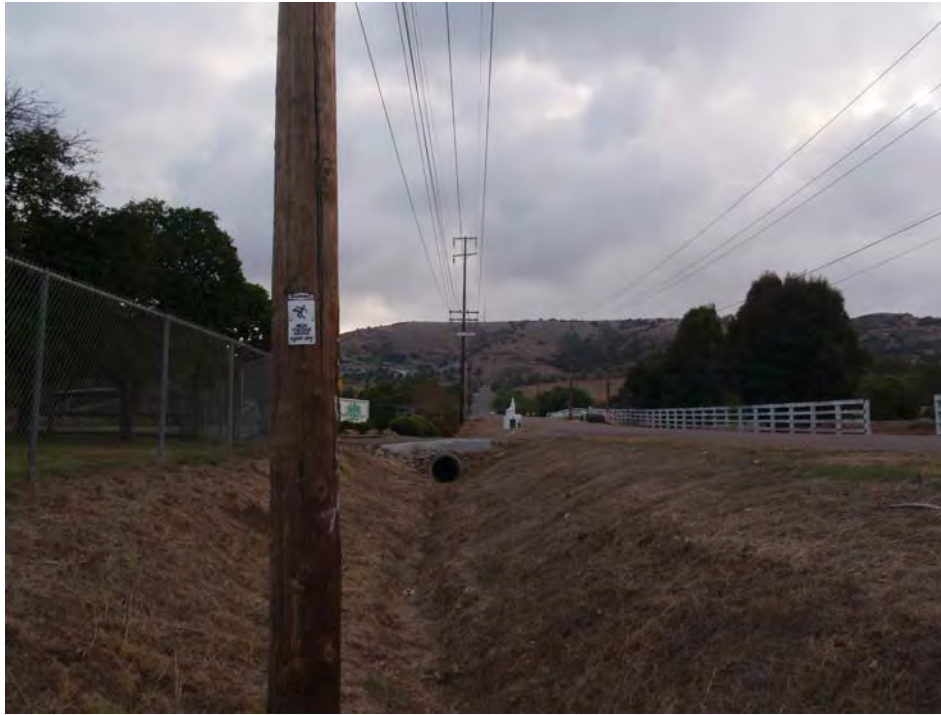
Pole R169. Photo taken looking east along Creelman Rd. Existing pole located a drainage feature. Removal: access pole from road and pull out with boom truck and wench to minimize impacts. Loc#13

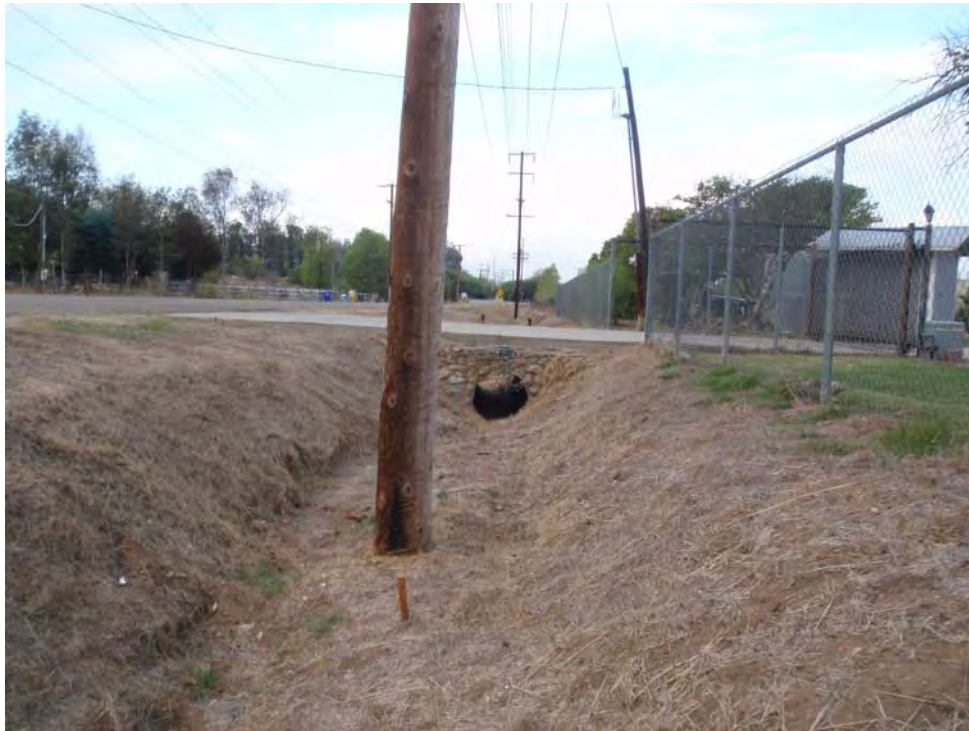
Pole R169, pole removal. Temporary disturbance of up to 10 feet will occur during removal. Loc 13

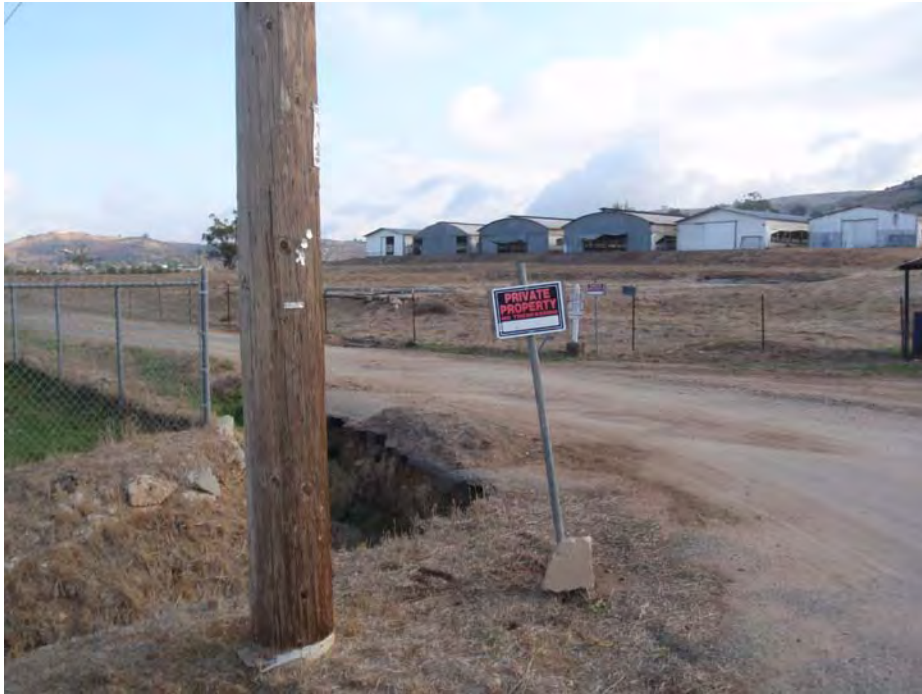
Pole R171. Photo taken looking east along the north side of Creelman Rd. Existing pole located at the top of a drainage feature. Removal: access pole from road and pull out with boom truck and wench to minimize impacts. Will require BMPs to avoid impacts to drainage. Location #14
