Memorandum

From: Tamara Spear
San Diego Gas & Electric Company
Subject: TL 637 Wood to Steel Project Reconnaissance-Level Jurisdictional Waters
Assessment Summary
Date: May 21, 2013

Project Description:

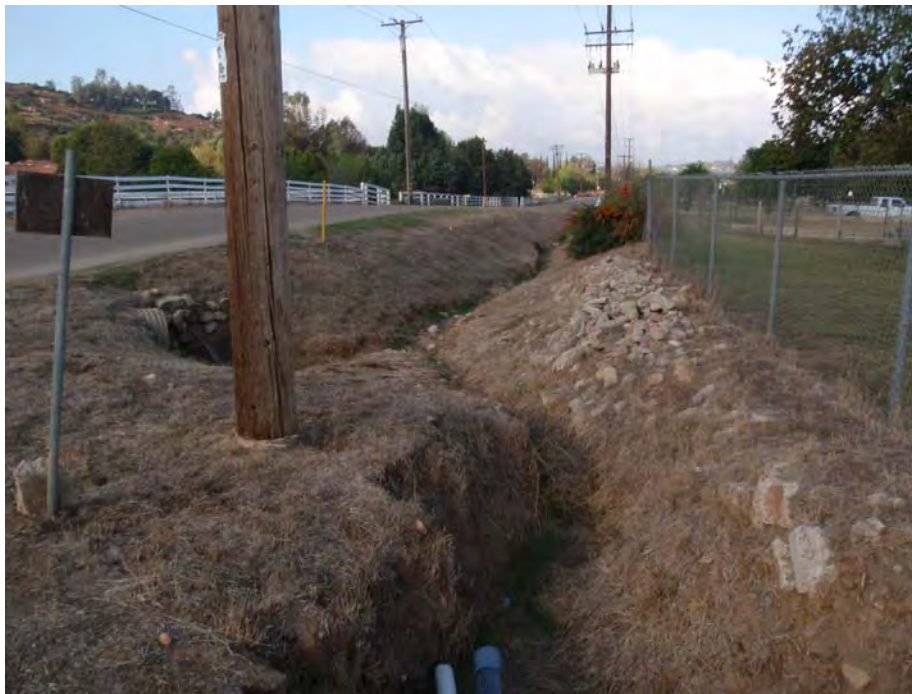
Pole R171, removal. Photo taken looking west along the north side of Creelman Rd. Drainages can be avoided with BMP implementation. Location #14

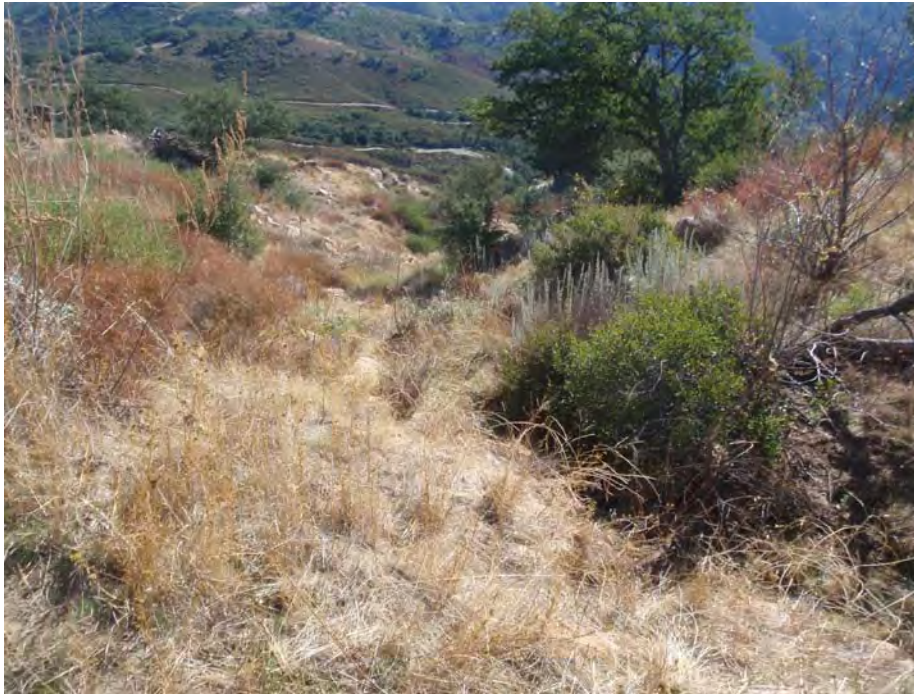
Photo taken along access road crossing drainage feature between poles P141 and P140, looking south (downstream). OWHM 2ft, Bank to bank 12ft measured south of pole. Location #19

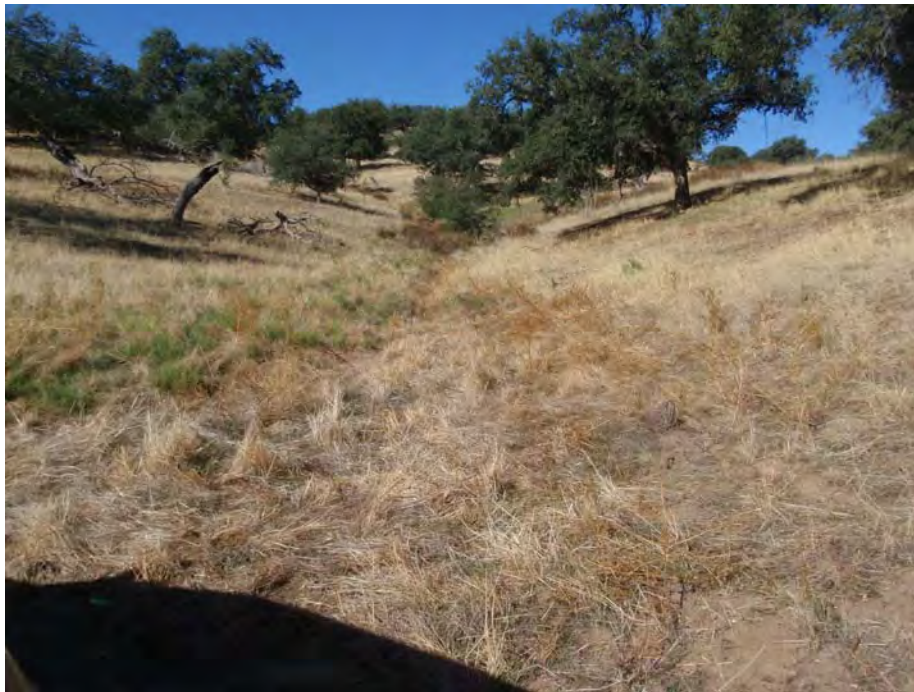
Photo taken from access road looking north at swale feature. No culvert was present. To avoid impacts, placement of gravel less than 6 inches on access road is proposed. Second option is to use plates to travel over feature.

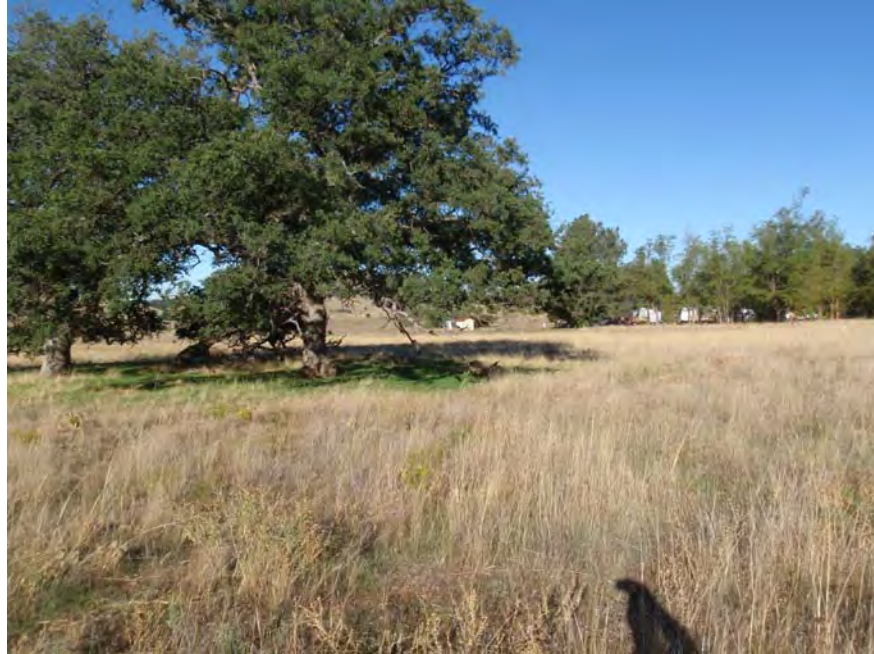
Santa Ysabel Staging Yard, located approximately 1100 feet southwest of substation. The staging area is approximately 6 acres and will avoid the oak tree depicted in this picture. The surrounding habitat is disturbed non-native grassland with a few scattered native upland species including California buckwheat, tarplant and vinegar weed.

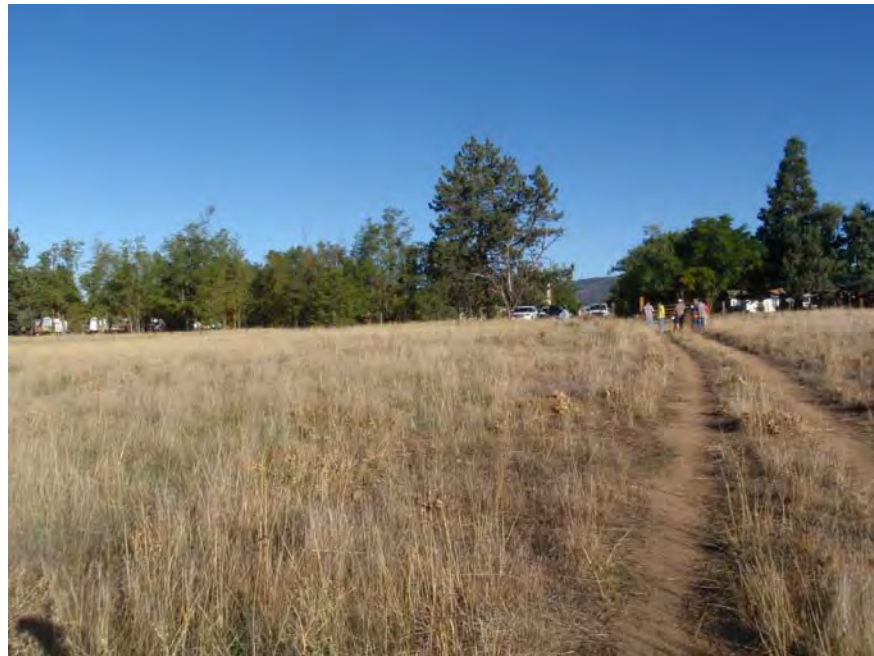
Photo taken looking north along the eastern boundary of the Santa Ysabel staging area. No drainage features were observed during the survey. Small mammal burrows were observed.
