<p>California Public Utilities Commission <i>Mitigation Monitoring, Compliance, and Reporting Program</i></p>
	<p>East County (ECO) Substation Project</p> <p>Compliance Status Report: 025</p> <p>March 16, 2014</p>

SUMMARY

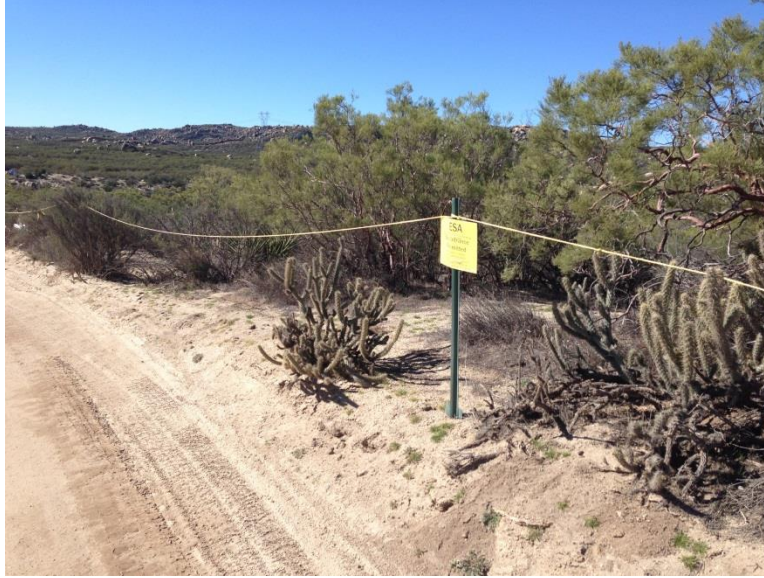
Photo 1: In accordance with MM-CUL-1A, ESA markers were observed being maintained along the right-of-way to protect ESAs from inadvertent trespass.

In accordance with MM-CUL-1A, ESA markers were observed being maintained along the right-of-way in areas of active construction to protect Environmentally Sensitive Areas (ESA) from inadvertent trespass (see Photo 1 – Attachment A). Archeological monitors and Native American observers were onsite monitoring construction activities in proximity to ESA's and in areas of initial ground disturbance.

Intersections between underground activities and publicly accessed paved roads were equipped with rumble plates to minimize the potential for trac-out along paved surfaces in accordance with MM-HYD-1 and MM-BIO-4a (see Attachment A - Photo 1). Trac-out observed along paved surfaces was observed being cleaned on a regular basis in accordance with the Dust Control Plan and MM-BIO-4a.

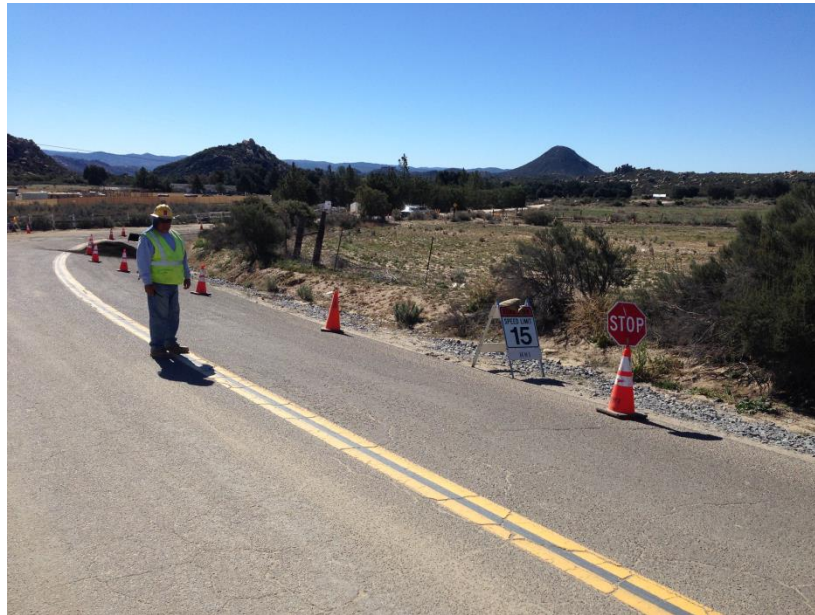
Photo 2: In accordance with MM-TRA-1, flaggers and signage are being utilized along Jewel Valley Road to ensure the safe passage of motorists during construction activities.

Traffic control measures were observed being implemented along Jewel Valley Road and Old Highway 80 in areas of active construction. Traffic control measures included signage notifying motorists of construction activities and flaggers directing one-way traffic per MM-TRA-1 (see Attachment A – Photo 2).

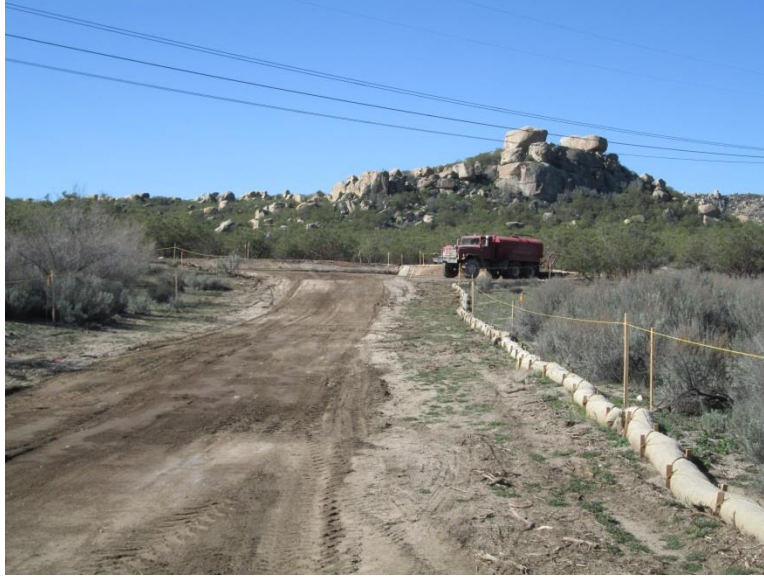
Photo 3: In accordance with MM-HYD-1 and the East County Substation Stormwater Pollution Prevention Plan (SWPPP), straw-wattles have been placed along the work limits to minimize the potential for erosion to be discharged offsite.

Erosion control devices including silt fence were installed along the work limits to minimize the potential for discharges to occur beyond the project work limits in accordance with the SWPPP and MM-HYD-1 (see Attachment A - Photo 3).

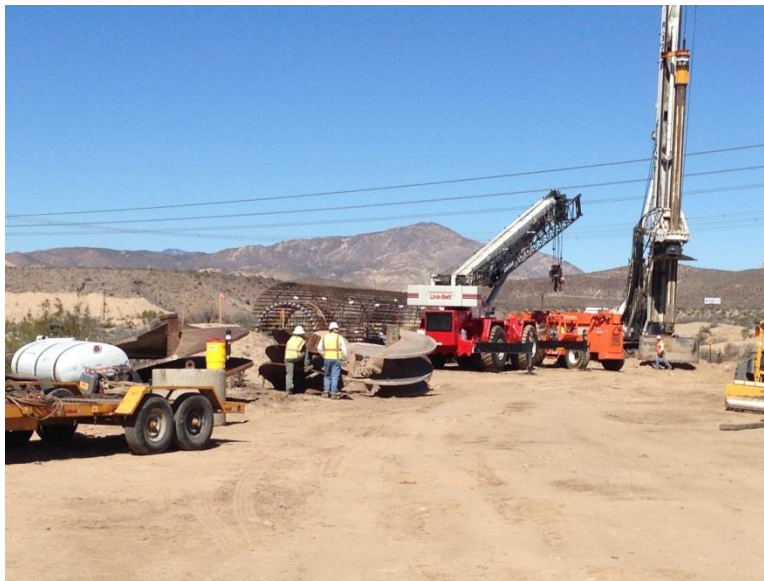
Photo 4: Construction crews were observed completing drilling activities within the approved work limits at steel-pole 90 in accordance with MM-BIO-1a.

In accordance with MM-BIO-1a, the work limits have been clearly defined prior to ground disturbing activities (see Attachment A – Photo 4). Pre-construction nesting bird surveys were conducted by a CPUC approved biologist in accordance with MM-BIO7-j.

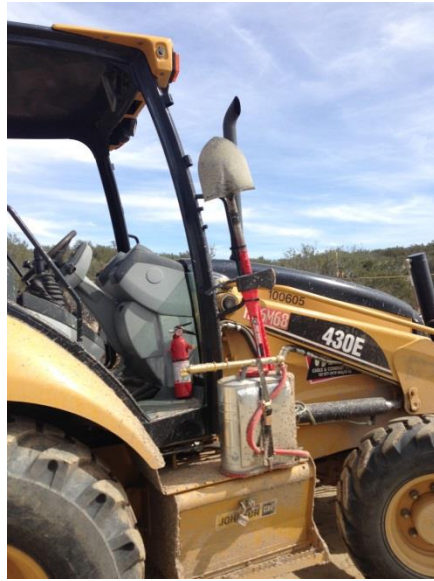
Photo 5: In accordance with MM-FF-1 and the Construction Fire Prevention/Protection Plan, fire equipment was observed to be present on construction equipment.

Per the Construction Fire Prevention/Protection Plan, SDG&E was observed inspecting equipment along the ROW to ensure fire suppression equipment was present (see Attachment A – Photo 5).

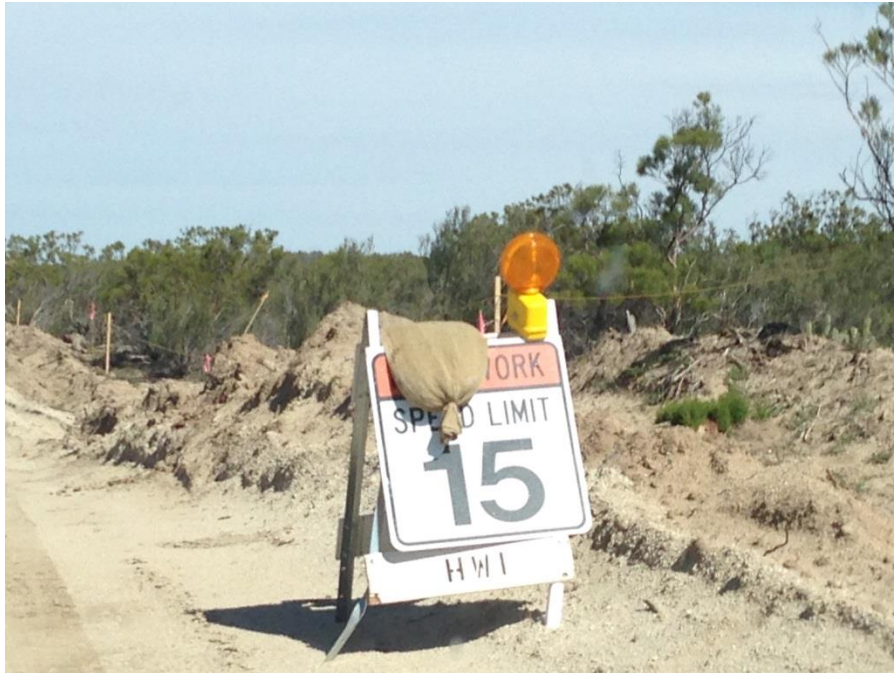
Photo 6: In accordance with MM-BIO-7b, speed limit signage has been placed along access roads to enforce speed limits in and around all construction areas.

As required by MM-BIO-4a and MM-AQ-1, water trucks were observed suppressing fugitive dust emissions in areas of active construction and along unpaved access roads. Signage has been placed along access roads to enforce speed limits in and around all construction areas (see Attachment A – Photo 6).
