Subject: Energia Sierra Juarez (ESJ) Well Access Road - Project Number 09-0107420

AECOM has prepared this biological letter report in accordance with County of San Diego Guidelines (2010) for the analysis of a proposed access road for San Diego Gas and Electric (SDG&E) to access an existing water well owned and operated by the Jacumba Community Services District.

ESJ Well Driveway Project Number 09-0107420

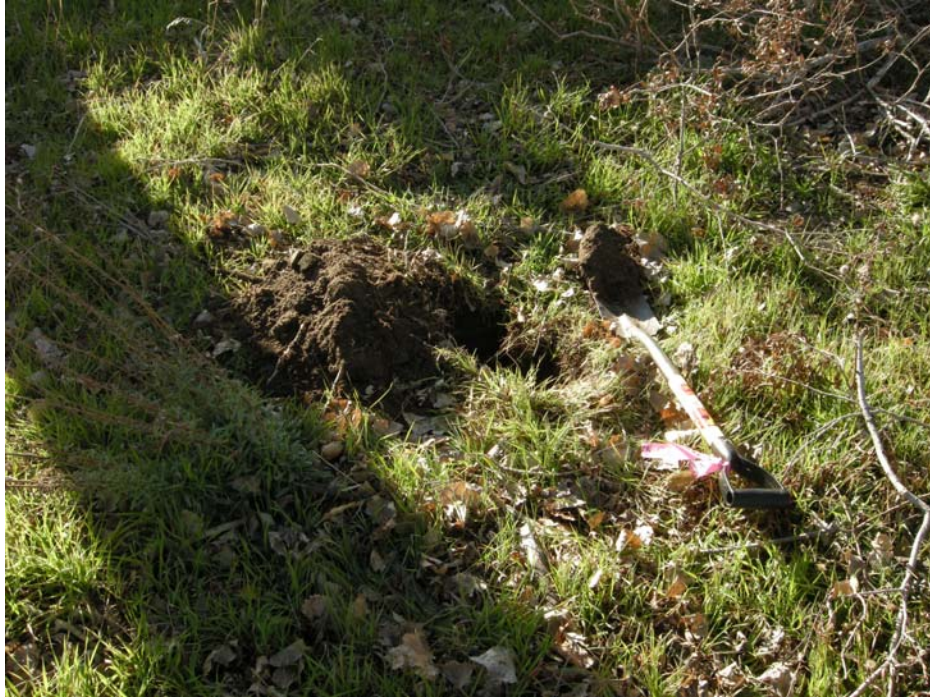
Depth (inches)	Matrix		Redox Features				Texture ³	Remarks
	Color (moist)	%	Color (moist)	%	Type ¹	Loc ²		
0-18	10YR 2/2						Coarse	Sandy mixture

Sample pit one.

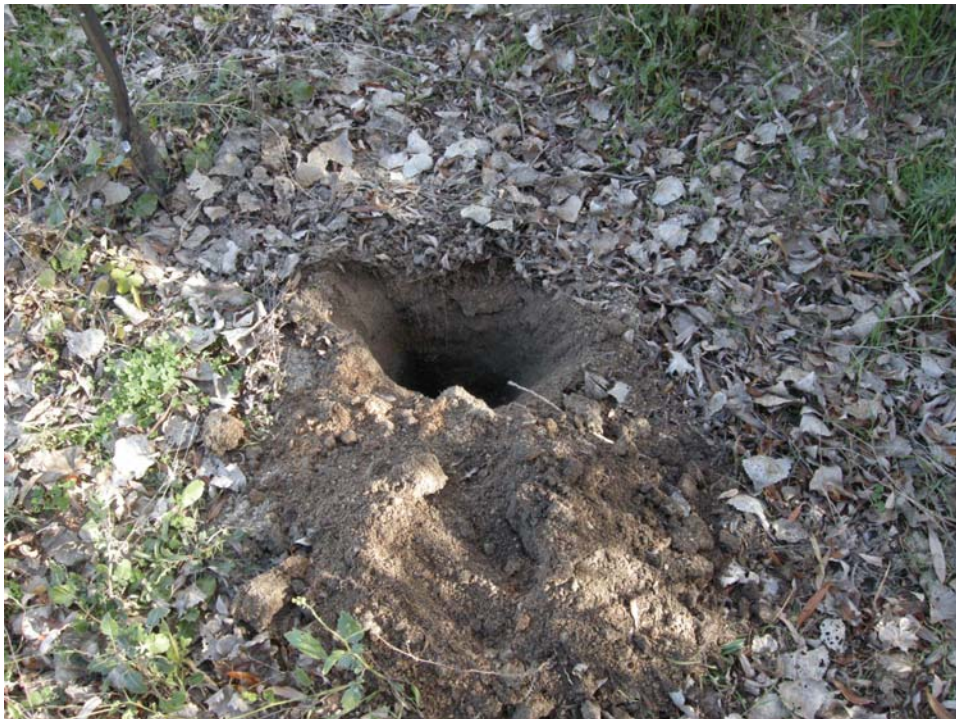
Depth (inches)	Matrix		Redox Features				Texture ³	Remarks
	Color (moist)	%	Color (moist)	%	Type ¹	Loc ²		
0-8	10YR 2/2						Coarse	Large pieces
8-10	7.5 4/6						Coarse	DG like feel
10-20	10YR 2/2						Coarse	Sand like feel

Sample pit two.

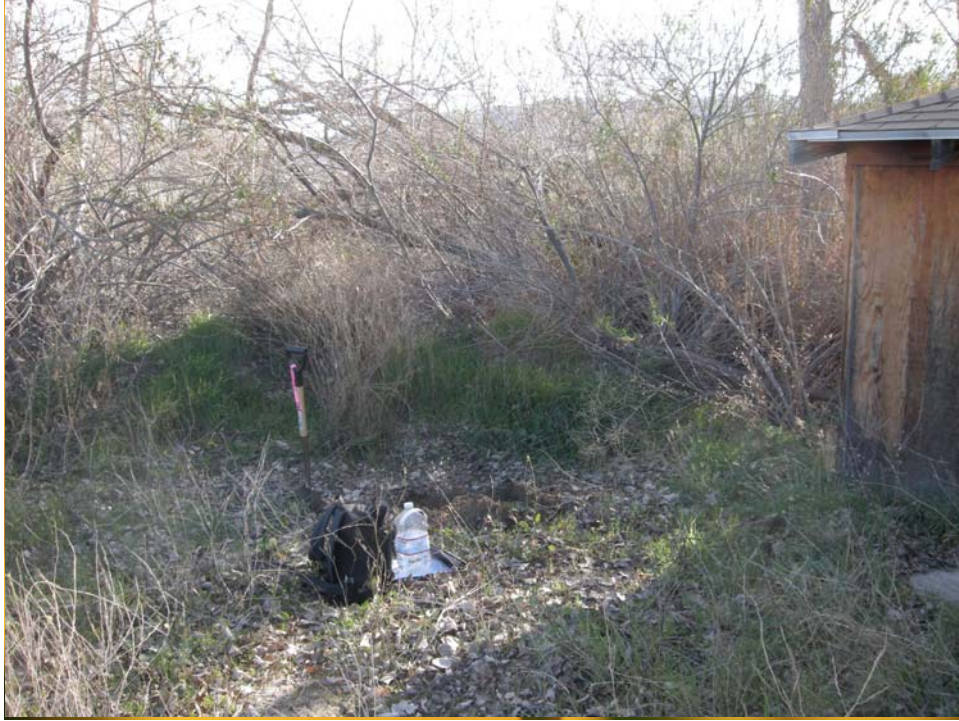
Sample pit two and surrounding habitat.

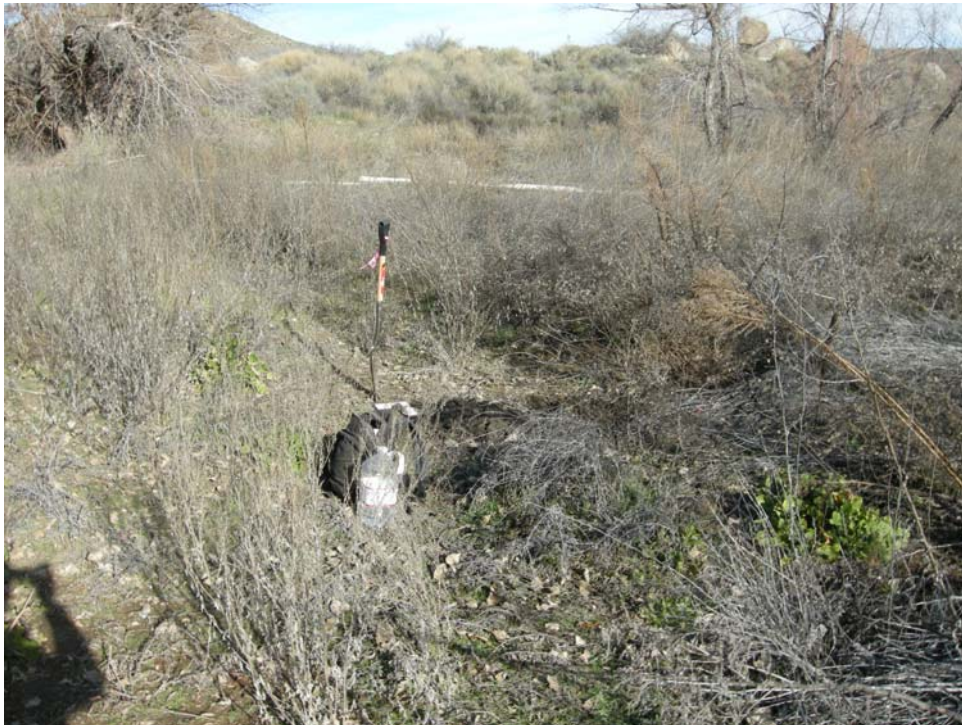
Depth (inches)	Matrix		Redox Features				Texture ³	Remarks
	Color (moist)	%	Color (moist)	%	Type ¹	Loc ²		
0-20	10YR 2/1						Coarse	Sandy feel

Sample pit three.

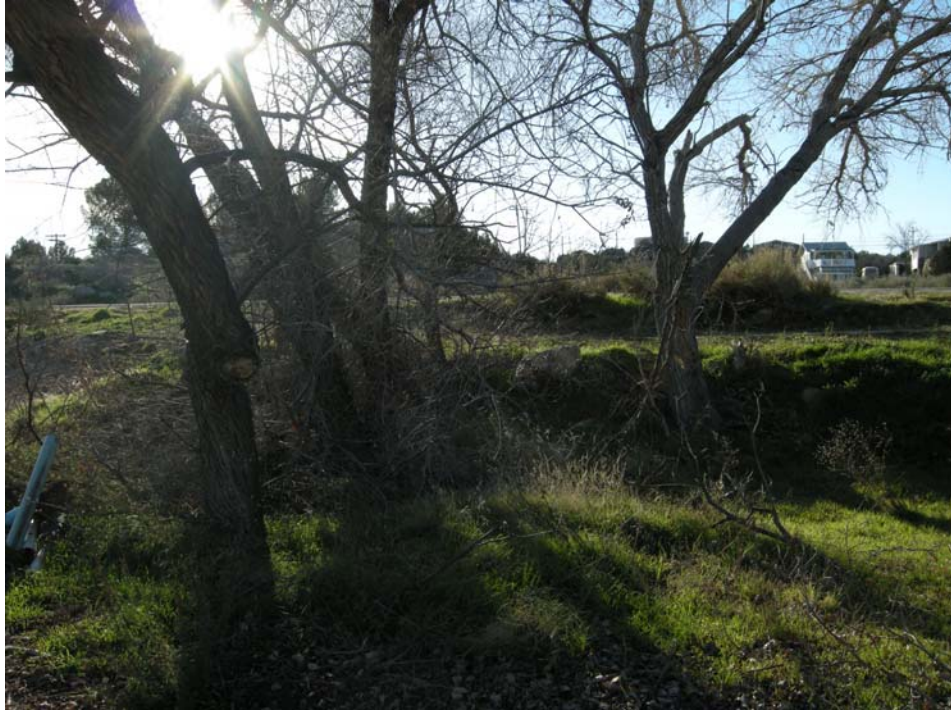
Habitat around pit one.

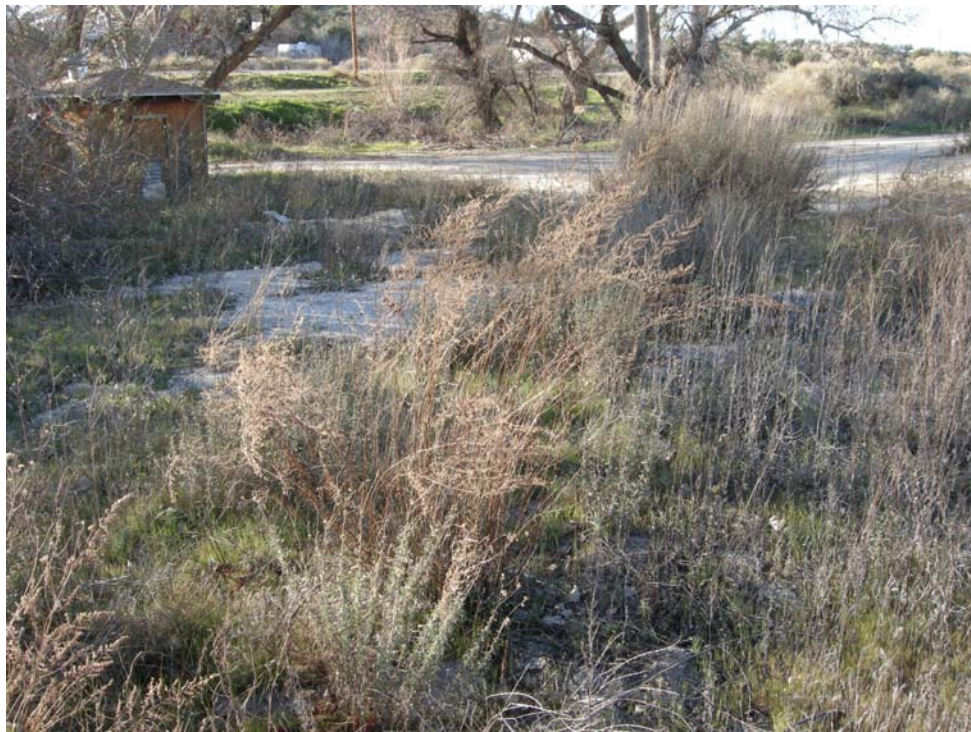
Adjacent Habitats.
