<p>California Public Utilities Commission <i>Mitigation Monitoring, Compliance, and Reporting Program</i></p>
	<p>CalPeco 625 and 650 Electrical Line Upgrade Project</p> <p>Compliance Status Report: 001</p> <p>August 25, 2015</p>

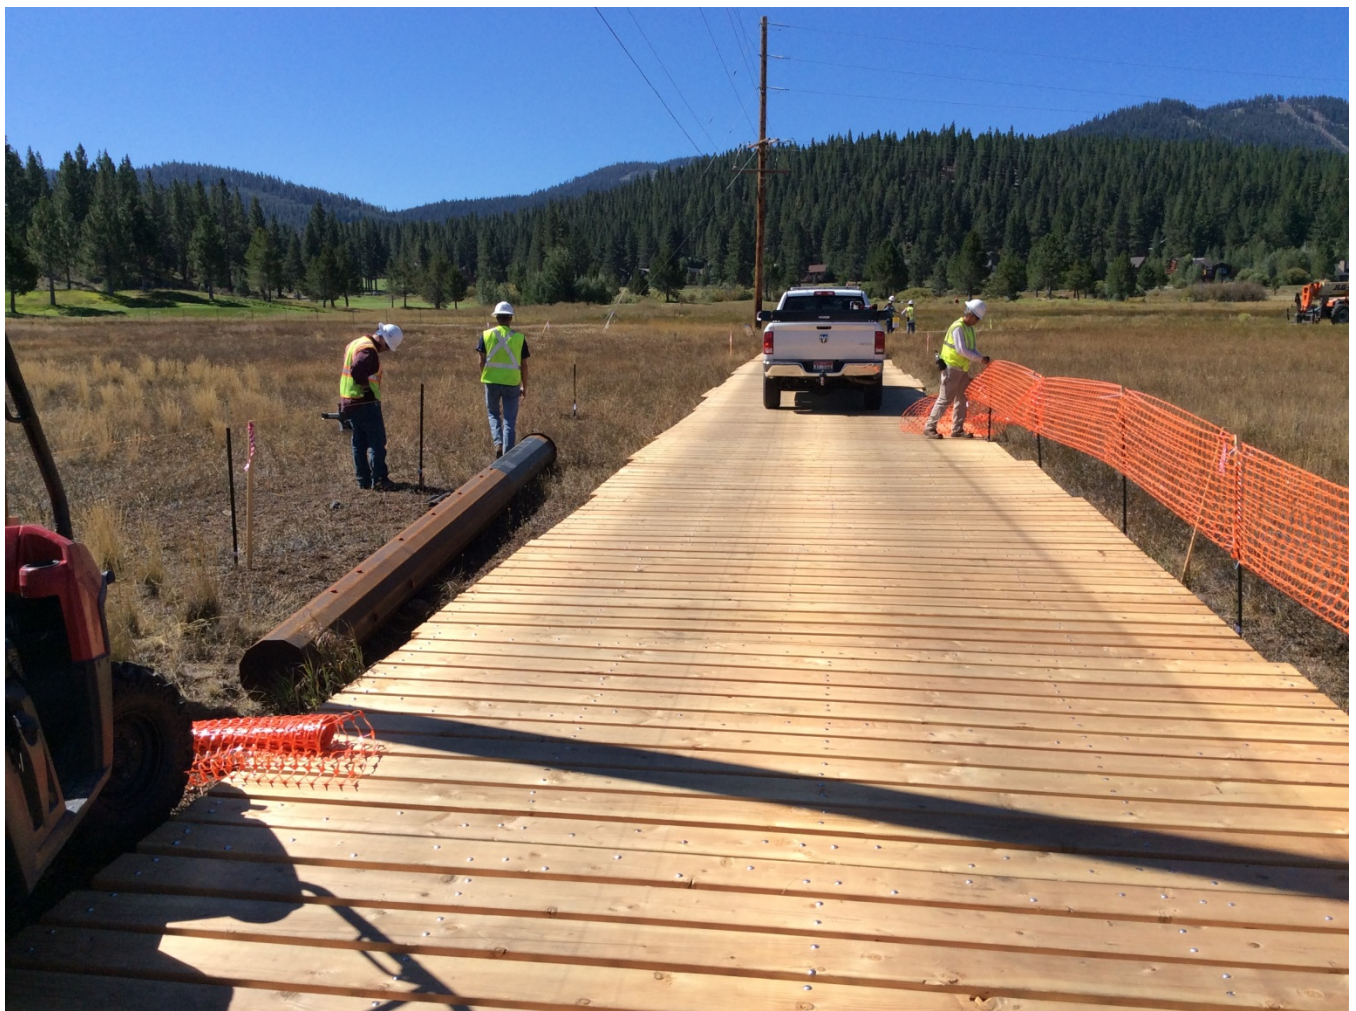
Photo 1: Crews installing work area fencing in Martis Valley to delineate approved work areas, consistent with APM-BIO-26 and the project's Flagging, Fencing, and Signage Plan. Work in this area is restricted to a 20-foot-wide portion of the ROW and timber matting has been installed to minimize impacts from vehicle and equipment travel. Also note that clearance is being provided at fence bottoms to allow for wildlife movement through the ROW.

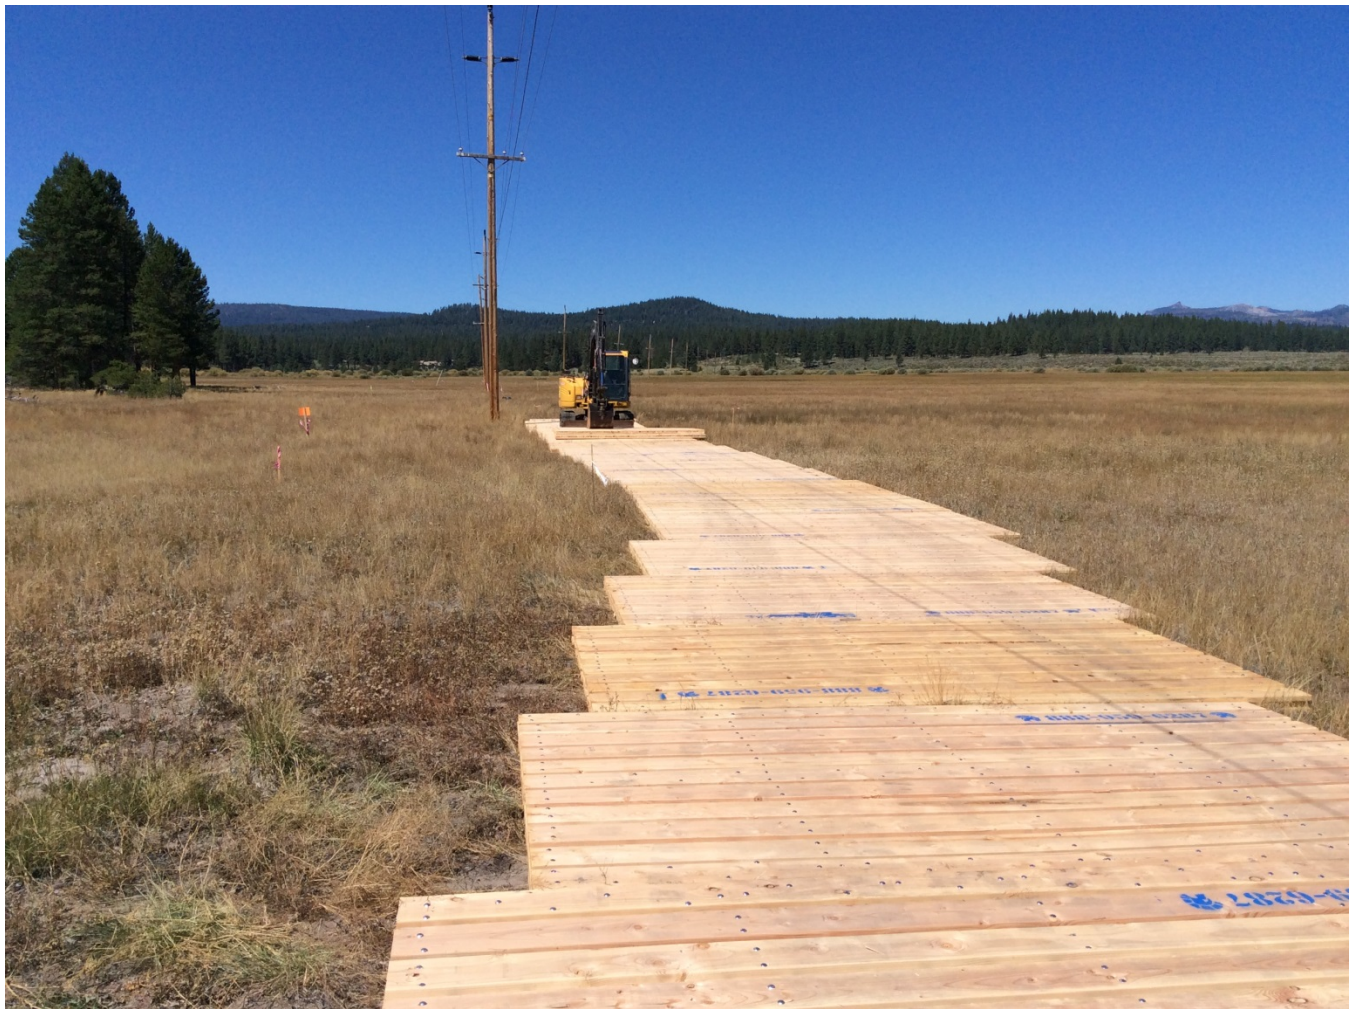
Photo 2: Timber matting being installed within the 20-foot-wide portion of the ROW to minimize impacts from vehicle and equipment travel

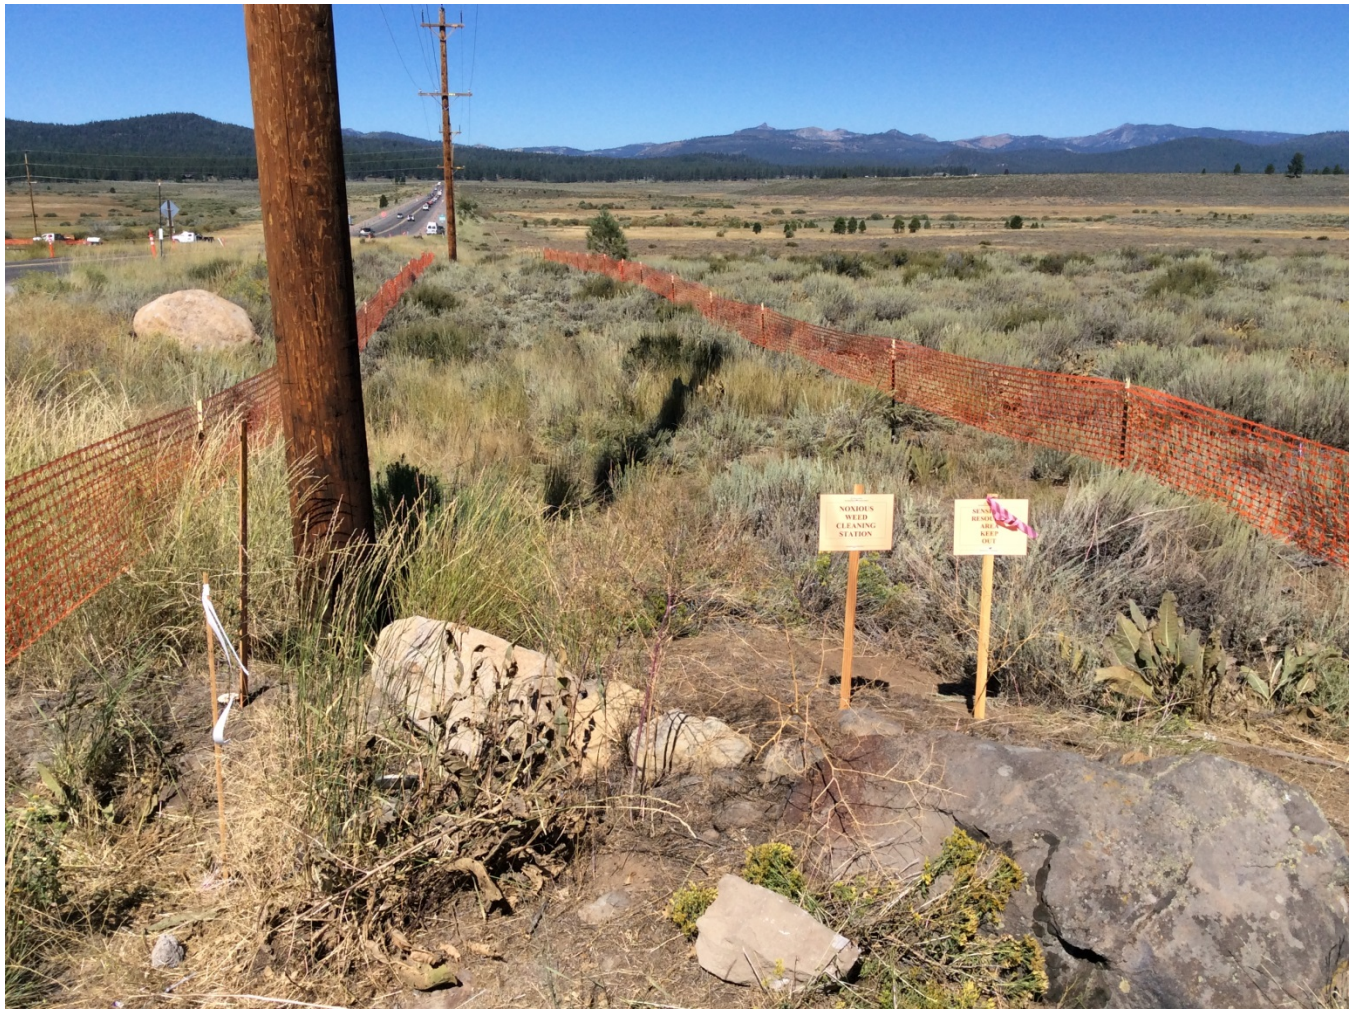
Photo 3: Fencing installed to delineate approved work areas and sign indicating sensitive resource exclusion area, consistent with APM-BIO-26 and the project's Flagging, Fencing, and Signage Plan. Second sign identifies noxious weed cleaning station, consistent with APM-BIO-5.

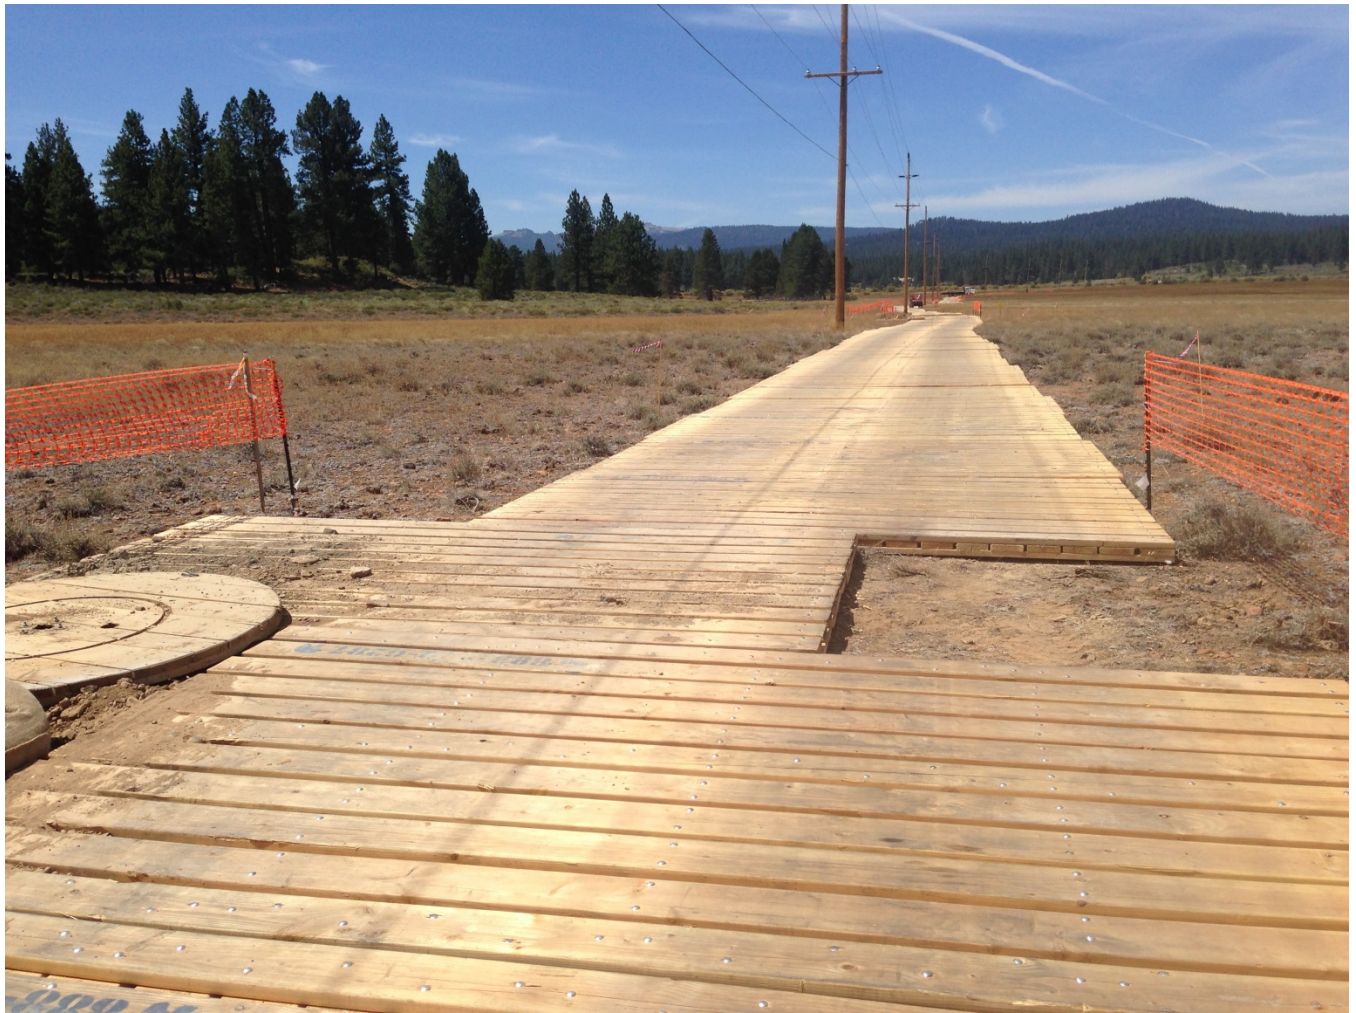
excavated pole holes in Martis Valley had been covered by dragging timber matting over the hole. This resulted in overland travel in areas where the matting had been displaced along the construction ROW, inconsistent with the work covered under NTP-2 and the project's 401 Water Quality Certification. Dudek notified Liberty Utilities of these non-compliant conditions on August 20, 2015. Liberty Utilities notified the CPUC on August 20, 2015 that, to address these issues, all topsoil piles will be covered and plywood or other adequate material will be used to cover open excavations so that shifting of the matting would not be necessary. Confirmation that these corrective actions have been implemented will be verified in the field on subsequent monitoring visits.

Photo 4: Timber matting in Martis Valley shifted onto open excavations, resulting in overland travel in upland areas. Liberty Utilities stated they will use other materials to cover excavations, which will be confirmed in subsequent compliance inspections.

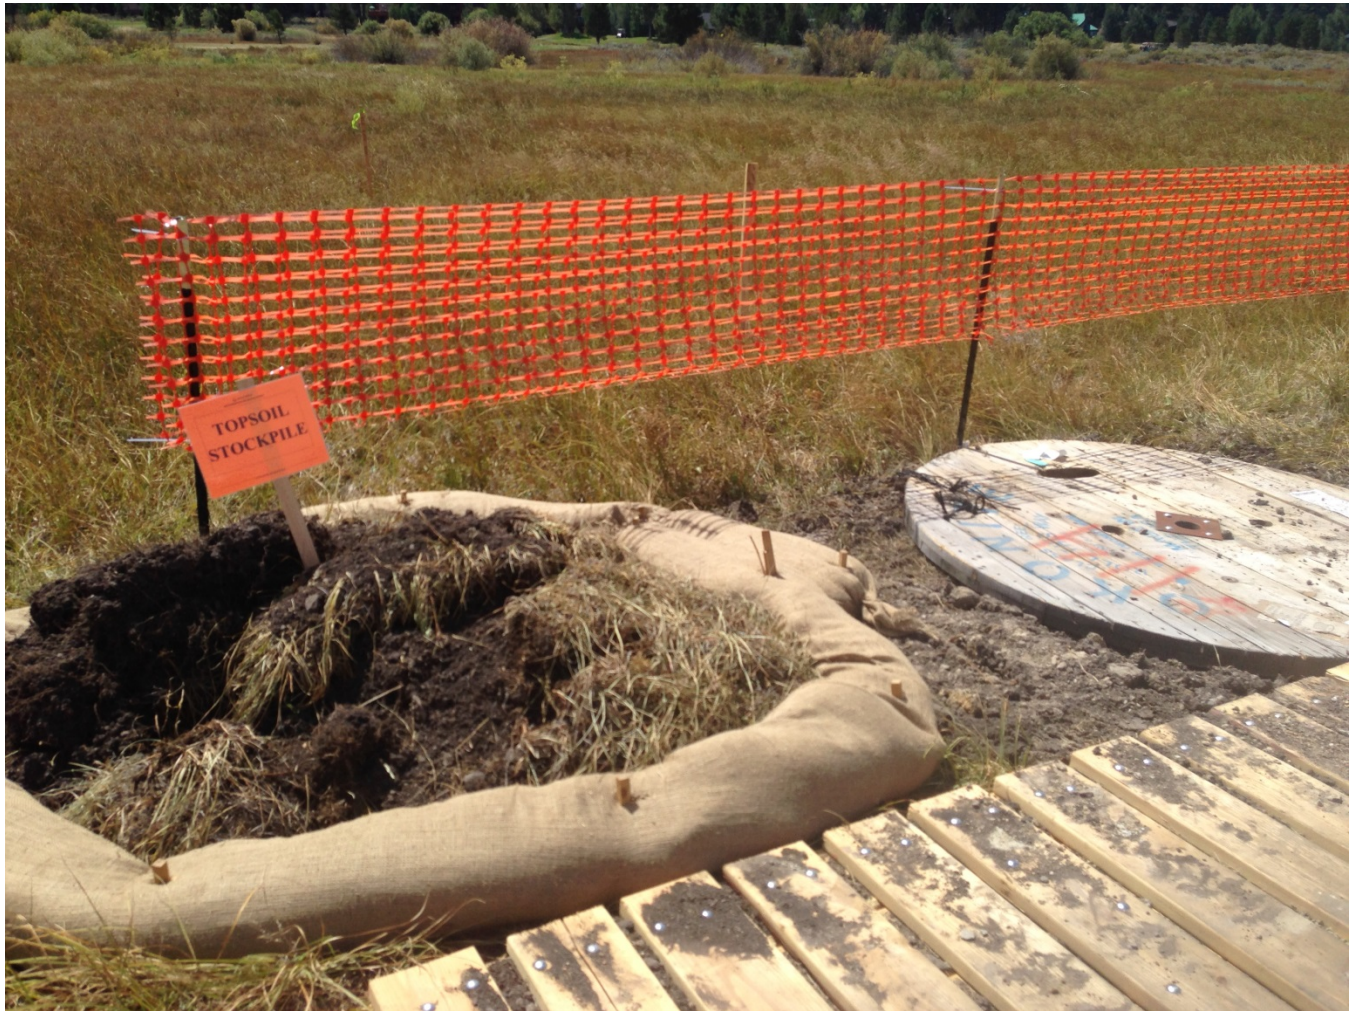
During a compliance monitoring visit on August 19, 2015, Dudek monitors observed topsoil from excavated pole holes had been separated and piled, with wattles installed; however, the piles were not covered, as required under APM-BIO-23. Dudek monitors also observed that, in some locations,

Photo 5: Topsoil salvaged and segregated in accordance with APM-BIO-23; however, the pile is not covered, as required under APM-BIO-23. Liberty Utilities stated they will cover topsoil piles, which will be confirmed in subsequent compliance inspections.

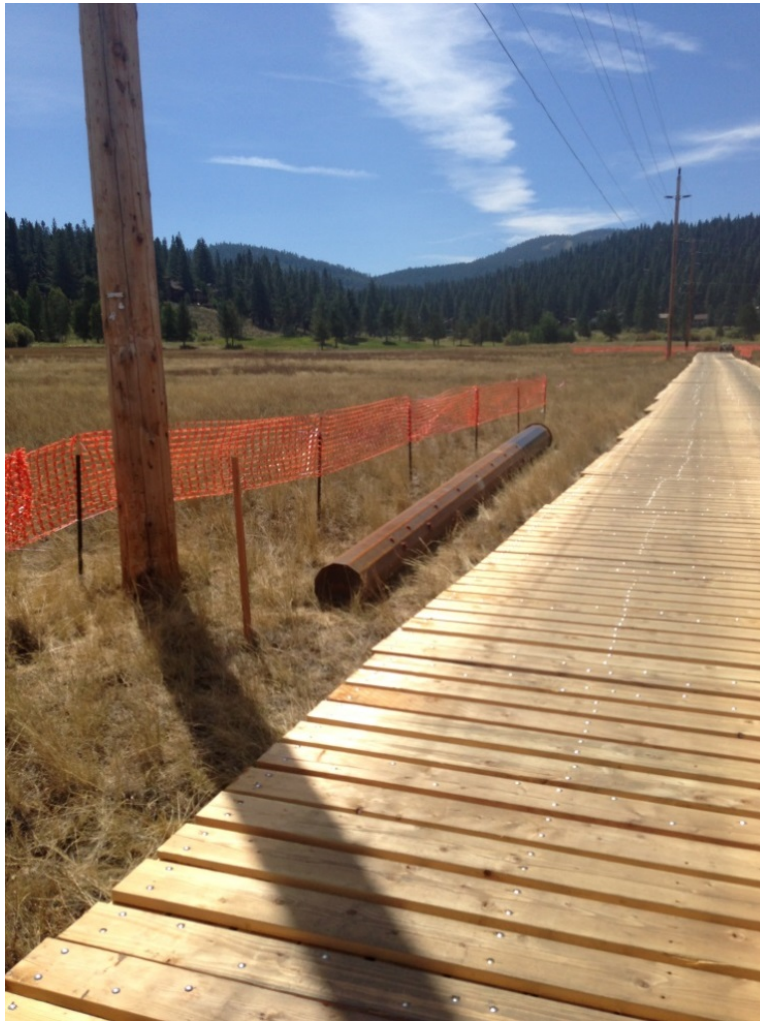
Photo 6: Material being staged inside fenced work area with project access via timber matting through Martis Valley.
