Santa Barbara County Reliability Project Construction Non-Compliance Report

Incident Date:	9/19/2018	Report No.:	NCR-04
Date Submitted:	9/27/2018	Location:	Segment 3B near Abandonment Construct M5-ST5
Level:	Level 2	Relevant Plan/ Measure:	MM BIO-1
Current Land Use:	Disturbed existing access road undisturbed land	Sensitive Resources:	Plummer's baccharis (<i>Baccharis plummerae</i>)

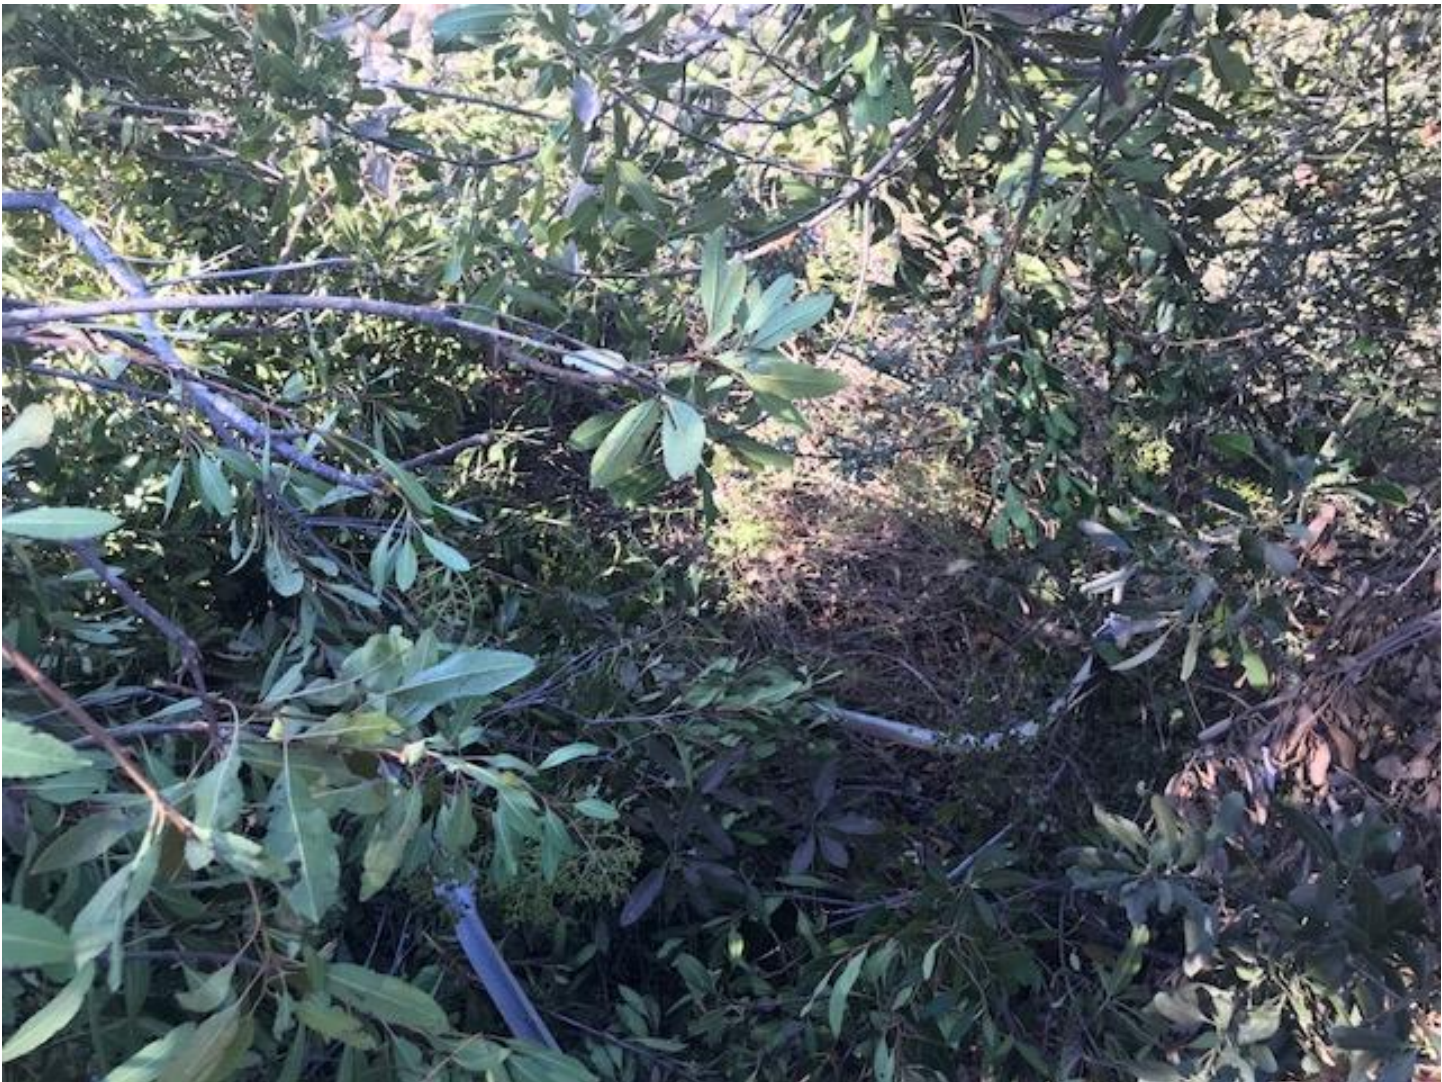
The biologists observed a H&M Civil crew conducting tower wreck-out work outside of the disturbance limits and prior to the biological monitor conducting a sweep. The incident was observed on Segment 3B at Construct M5-ST5 on 9/19/2018 at 1530 and was not in any listed species habitat. The area affected was surveyed and was partially outside approved disturbance limits within a Plummer's baccharis ESA (FRED Species Event 1053). Three Plummer's baccharis plants were damaged. The plants were slightly crushed but are expected to survive. ESA flagging was present and installed correctly. See attached photos. The incident conflicts with MM-BIO 1: Clearly mark project boundaries and sensitive areas.

Photo 1: Plummer's baccharus plants damaged.

Biological resources were damaged, which violated project mitigation requirements. The CPUC agrees with SCE's response to the incident thus far, but would like to see additional measures taken. Specifically, SCE must ensure that all future work related to this project (e.g., tower wreck-out or application of Natina) are done under the supervision of a biological monitor.

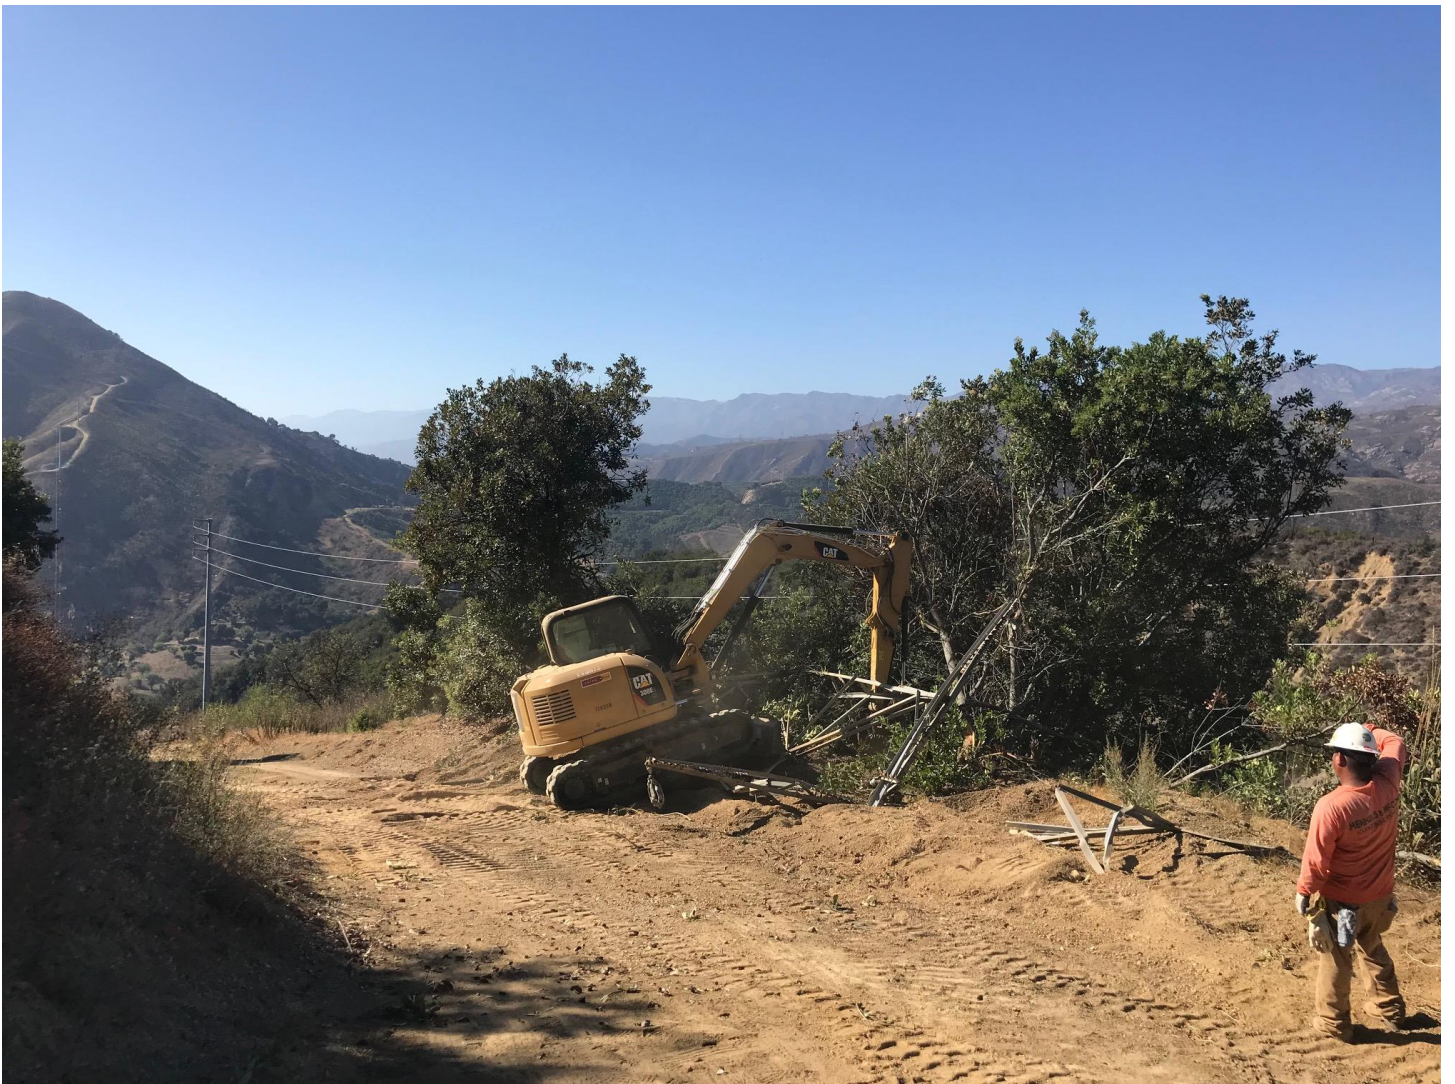
On September 19, 2018, Southern California Edison (SCE) notified the California Public Utilities Commission (CPUC) that a Henkels and McCoy (H&M) civil crew was conducting tower wreck-out work outside of the disturbance limits and prior to the biological monitor conducting a sweep. The incident occurred on Segment 3B at Construct M5-ST-5. The area affected was surveyed and partially outside approved disturbance limits within a Plummer's baccharis Environmentally Sensitive Area (ESA). Three Plummer's baccharis plants were damaged by being slightly crushed. The damaged plants are expected to survive. ESA signs marking project boundaries and sensitive areas were present and installed correctly.

Photo 2: Mini-excavator outside of approved disturbance limits.

H&M management met with the crew involved to determine the root cause of the incident. It was determined that the H&M civil crew believed that the work was similar to the 11 structure removals (CPUC exempt action) and did not require monitoring. H&M management corrected that assumption and let the crew know that the remaining abandoned facility work is all related to the SBCRP project, and therefore subject to the project mitigation measures. H&M incorporated a management step for approving any "project" vs "non-project" work. This process change was implemented and will prevent future incidents with a similar root cause.
