Appendix K-2: Air Quality Local Significant Thresholds

Estimated Emissions within South Coast Air Basin, Substation Construction

- Replacement of the aging and obsolete 138/12kV substation that currently exists on the Capistrano Substation site;
- Addition of a new 230kV gas insulated substation; and
- Rebuilding and expanding the existing 12kV distribution substation and the 138kV transmission substation, utilizing gas insulated technology (138kV only).

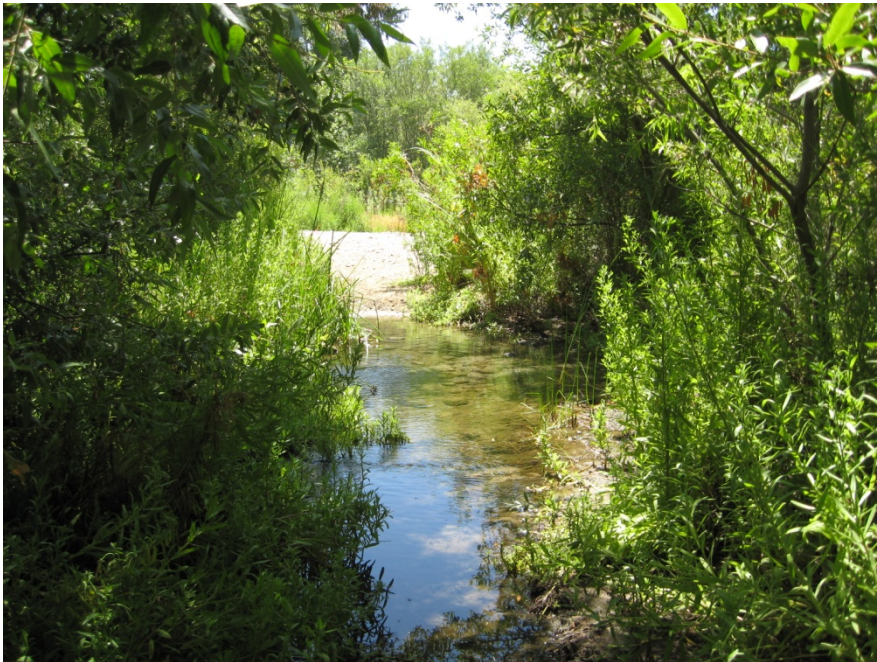
Photograph 4: View of southern willow scrub (SWS) within San Juan Creek. SWS is found in areas adjacent water sources and includes a high percentage of native hydrophilic vegetation.

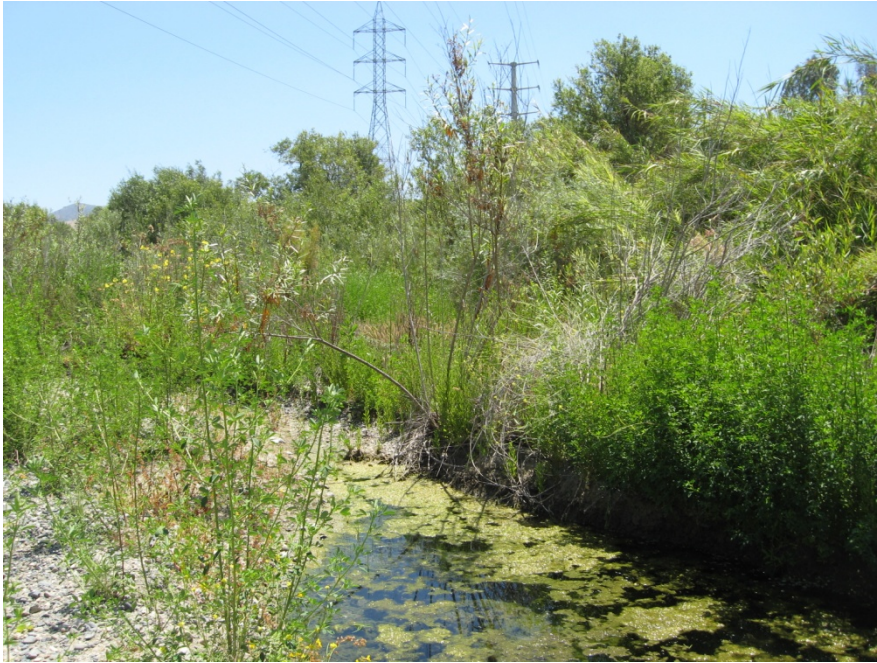
Photograph 5: View of disturbed SWS within San Juan Creek. Disturbed SWS has relatively open canopy due to disturbance that often leads to invasion of non-native species.

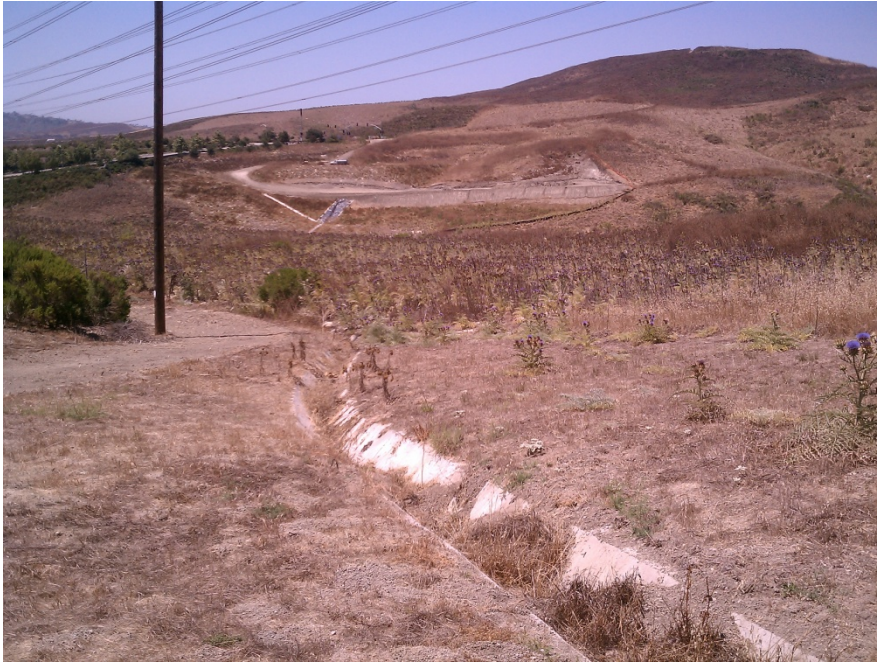
Photograph 7: View of ruderal habitat within the survey corridor. Ruderal habitat is generally associated with significant human disturbance and is often found near disturbed and developed areas.

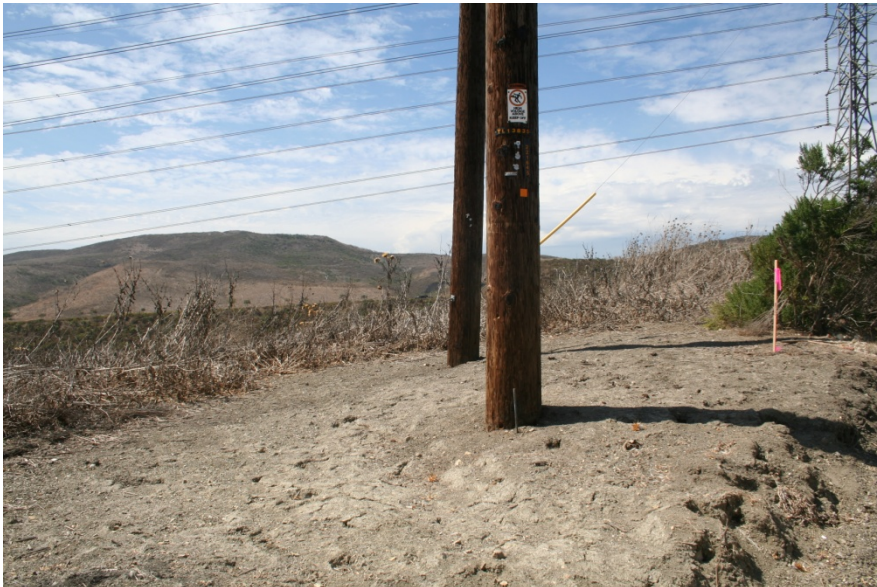
Photograph 8: View of disturbed habitat adjacent to an existing transmission pole. Disturbed areas are relatively free of vegetation due to ongoing maintenance or recent human activity.

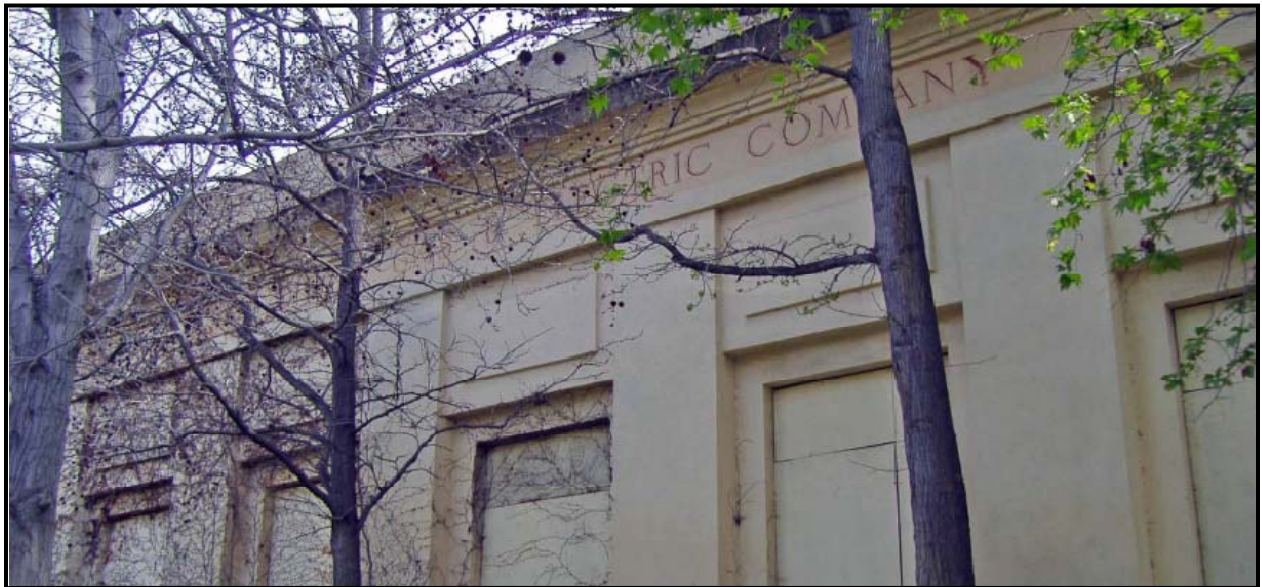
Figure 5. West Elevation of the San Diego Gas & Electric Building on Camino Capistrano Illustrating the Company's Name.

Although the substation has been generally referred to as the San Diego Gas & Electric facility, all architectural drawings and diagrams are identified as being Southern California Edison facility. The name “San Diego Gas & Electric Company” was not officially accepted until ca. 1940, suggesting the building was originally labeled as “Southern California Edison” (as illustrated in the architectural drawings) and renamed later (Figure 5).

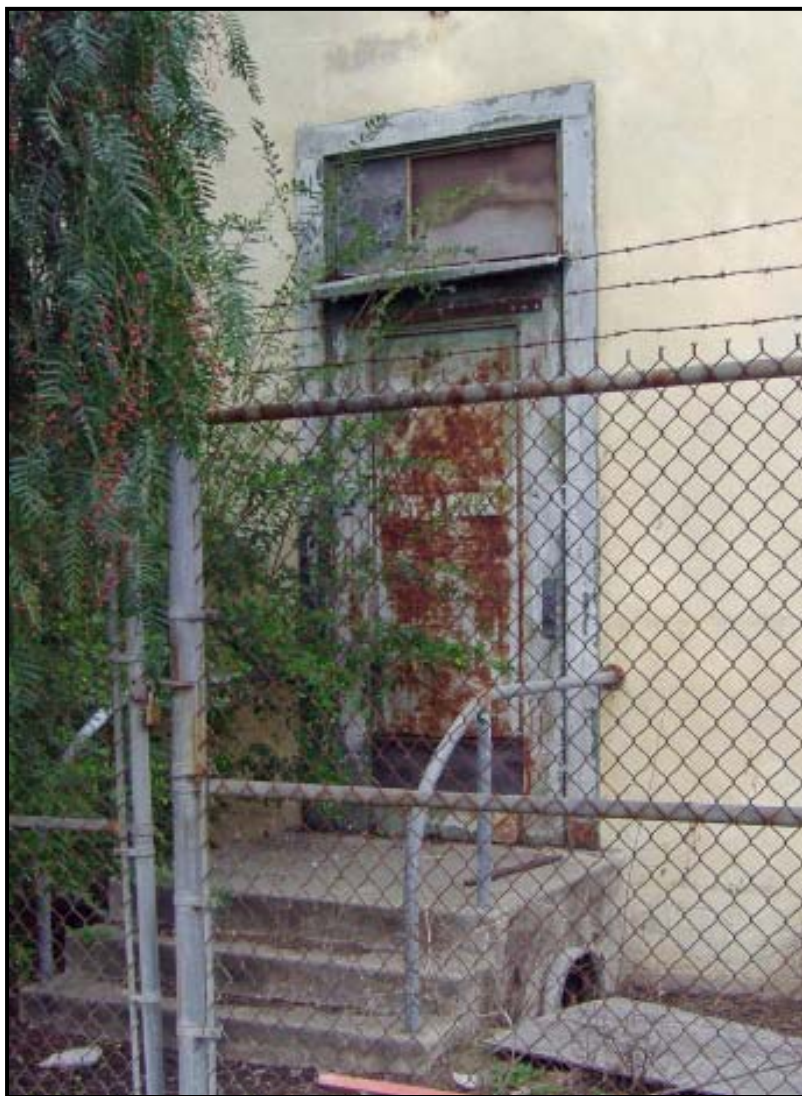
Figure 12. Doorway on Eastern Elevation of Building.

To the far-eastern elevation, there is a short wall of 32 feet and 8 inches in width and 26 feet and 10 inches in height. The single doorway is a single wide, solid panel door with 3 over 3 fenestration that complements the other entries (Figure 11; next page). As designed, this doorway was centrally located on the elevation and rested on the finished floor level. The recent field survey identified this door, as defined, but also noted the presence of a small stoop outside the doorway (Figure 12). Further, the windows above

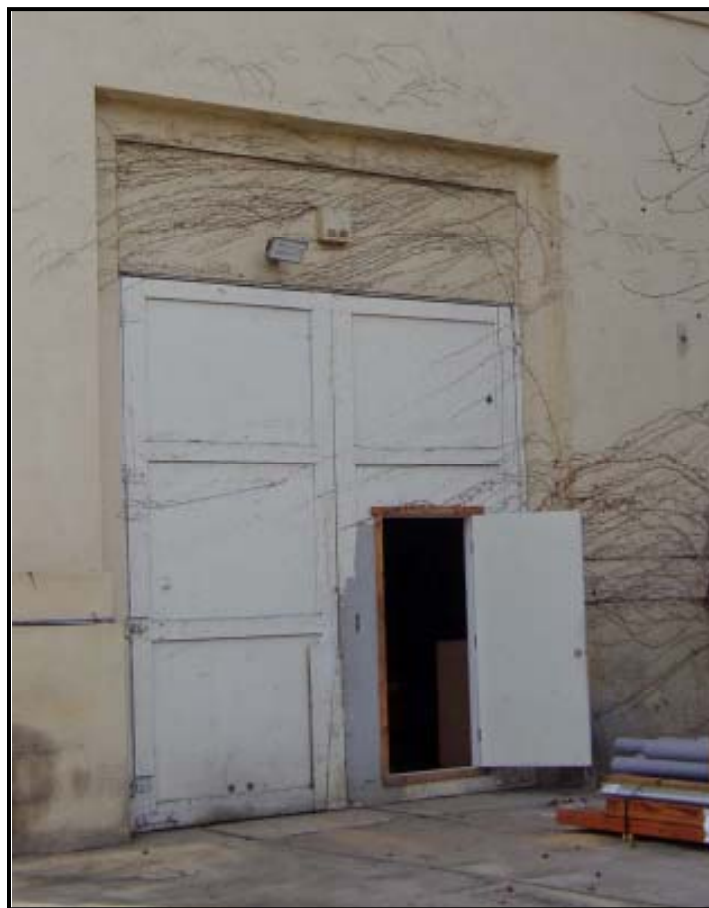
Figure 16. Overview of North Elevation, Main Entry, March, 2008.

Illustrated in Figure 16, the current condition of the main entry is considerably different than originally planned. The original doors are gone, apparently, are the windows

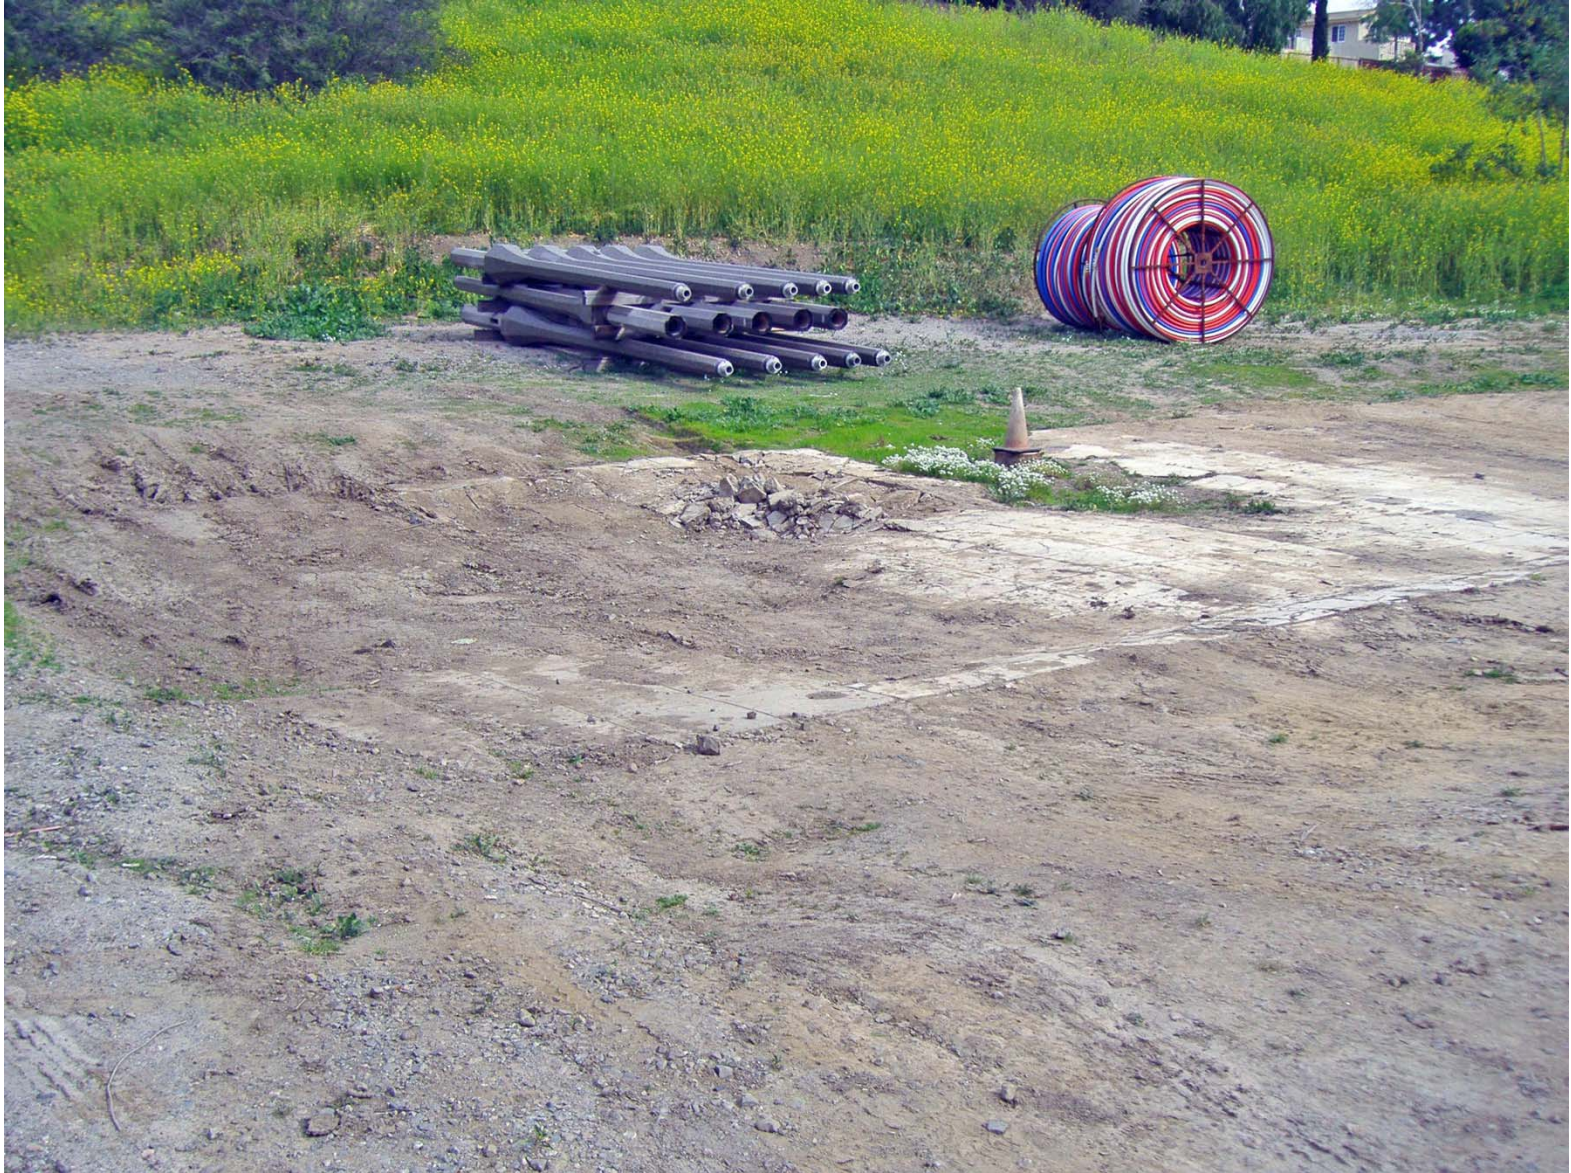
Broken Concrete Pad Identified as a Garage Area (facing Northeast).
