SAN DIEGO GAS & ELECTRIC SAN MARCOS TO ESCONDIDO TIE LINE (TL) 6975 69KV PROJECT

October 2022 Quarterly Report

November 21, 2022

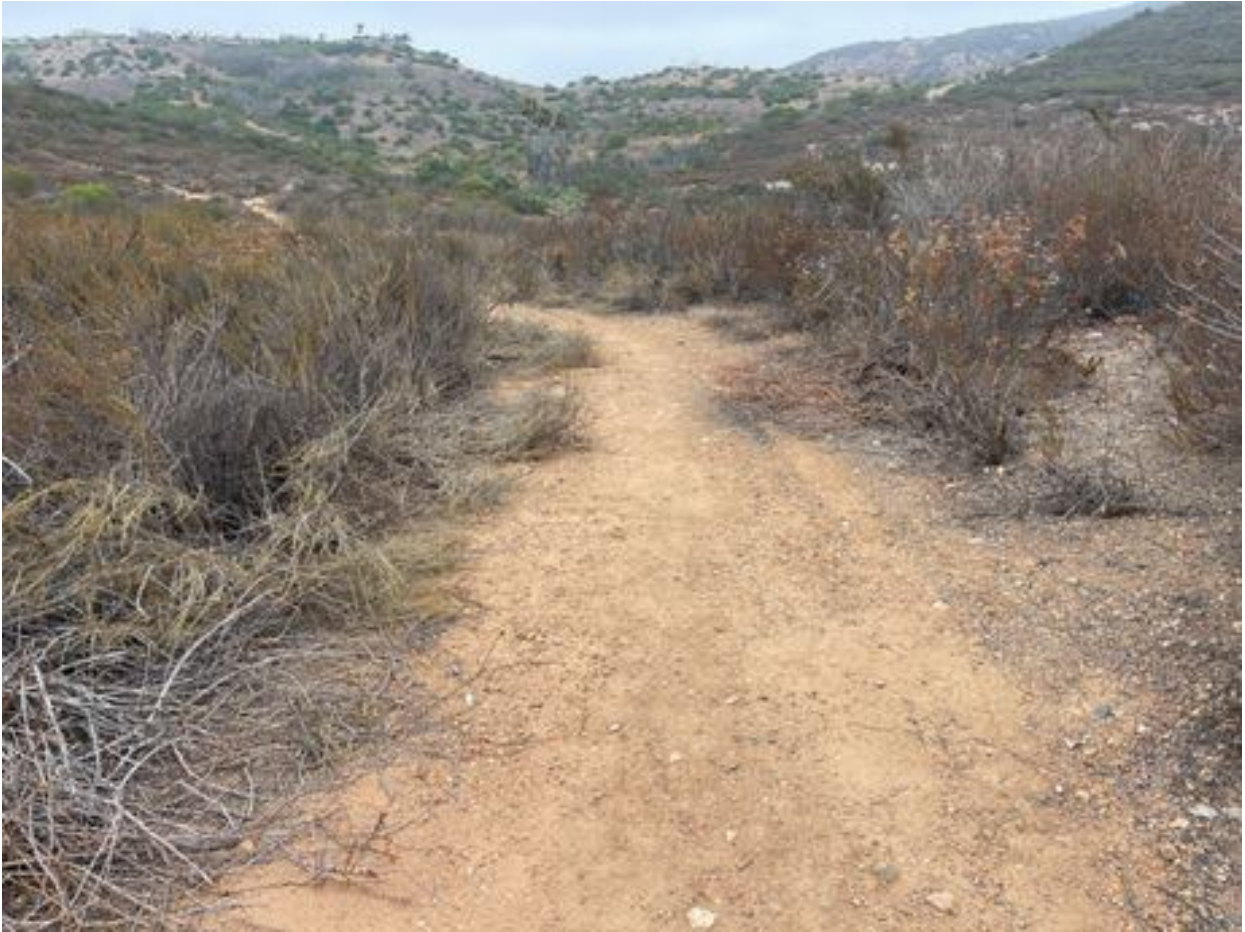
Site Photo 2

Location 64 - north facing view of veg crushed by cement truck that attempted to drive down unauthorized road. CSS plants on either edge of road were crushed for approximately 200 meters. Driver then backed out the way he came.

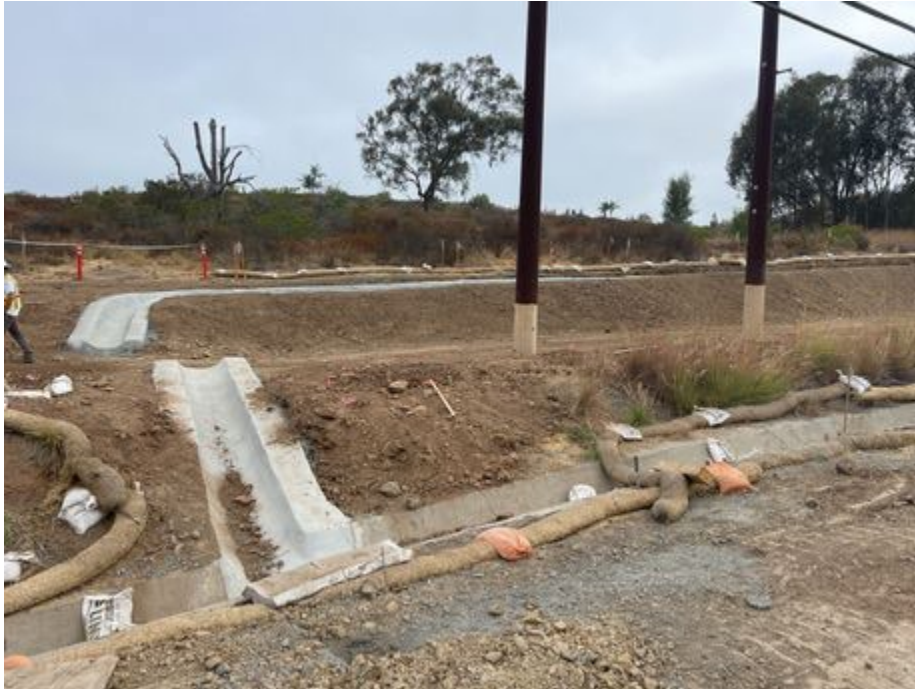
Site Photo 7

Location 74. Brow ditch complete

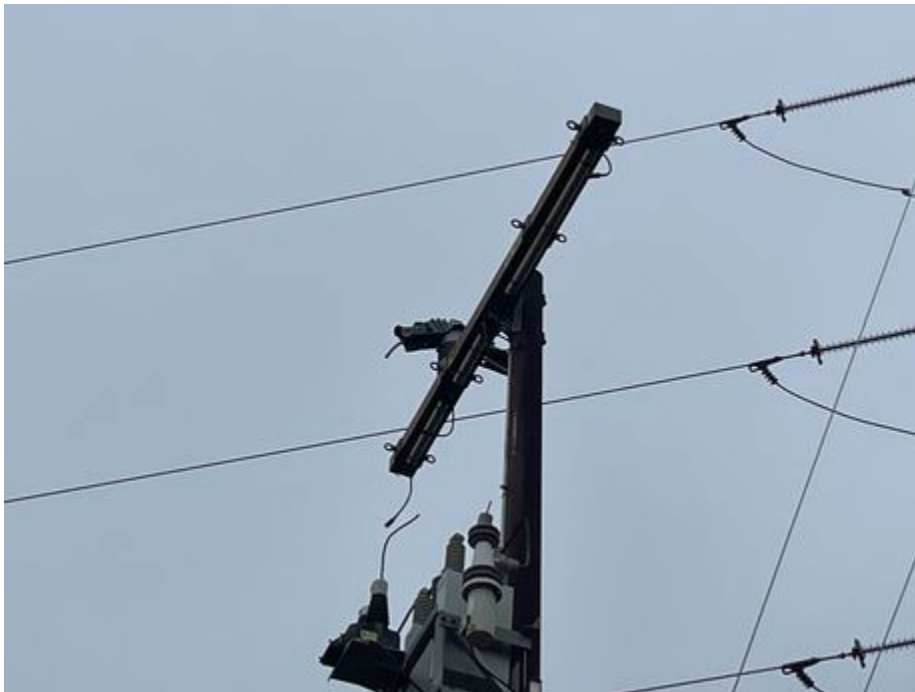
Site Photo 8

Location 74. Nest in cross arm of pole to be removed.

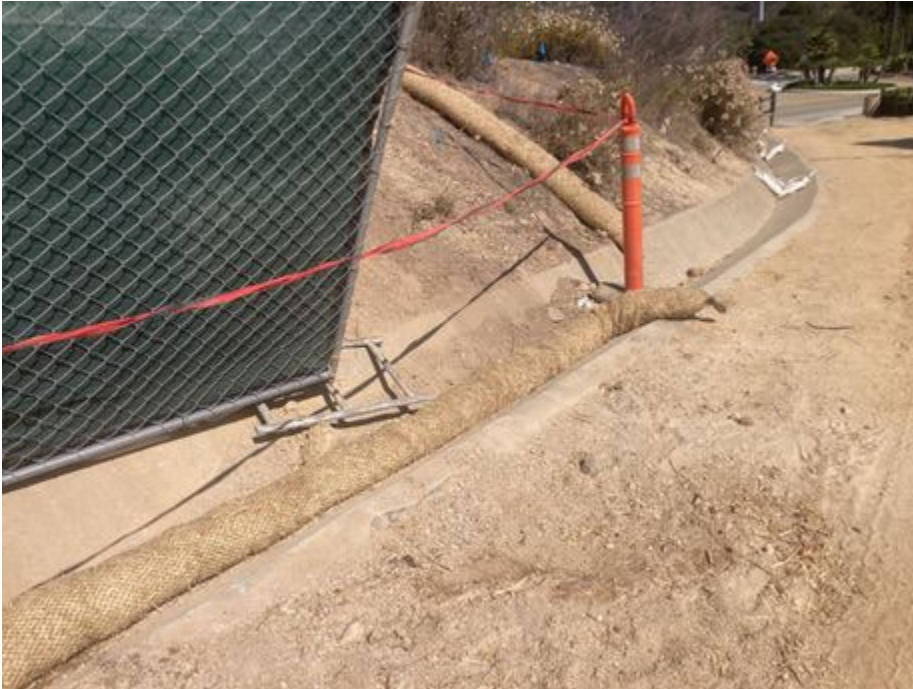
Site Photo 9

Location 56. Project related soils have fallen into the v-ditch. BMPs in place, however, some gravel bags have broken open. Recommend cleaning the v-ditches and work area after crew has mobilized to the next location. No significant rainfall in the weather forecast. Looking northwest.

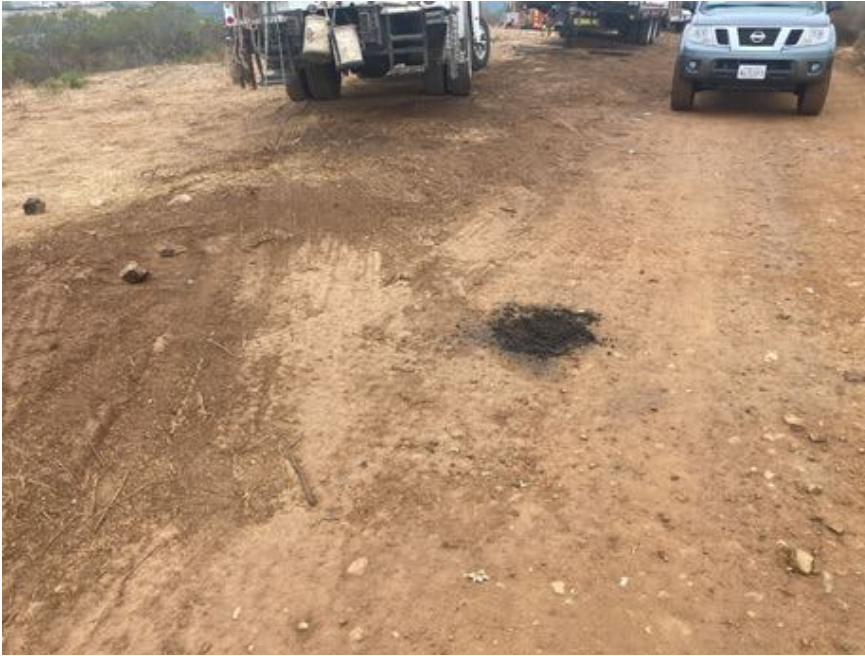
Site Photo 4

Snub site. Several residual fire spots have been found on the access road and ROW where small fires were set by the public. Personnel have been instructed to thoroughly water the area and immediately inform the environmental inspector of each location. Looking east.

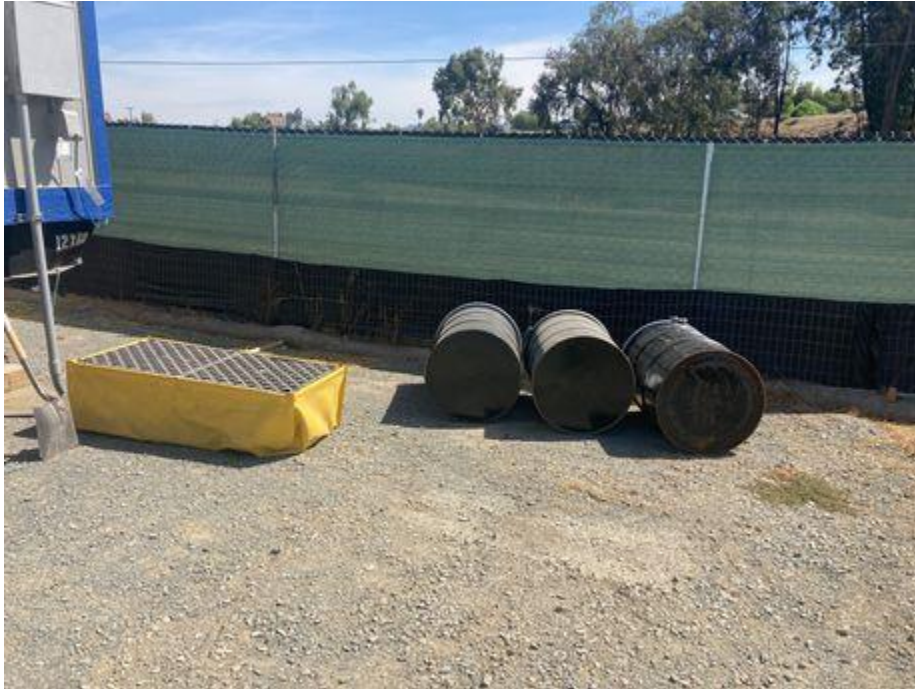
Site Photo 8

Rock Springs Yard. Three empty 55-gallon barrels were laying on the ground next to the project trailer. No labels were on the containers indicating present/previous contents. No secondary containment or suitable hazardous waste storage containment was observed in the area for these drums. Looking northeast.

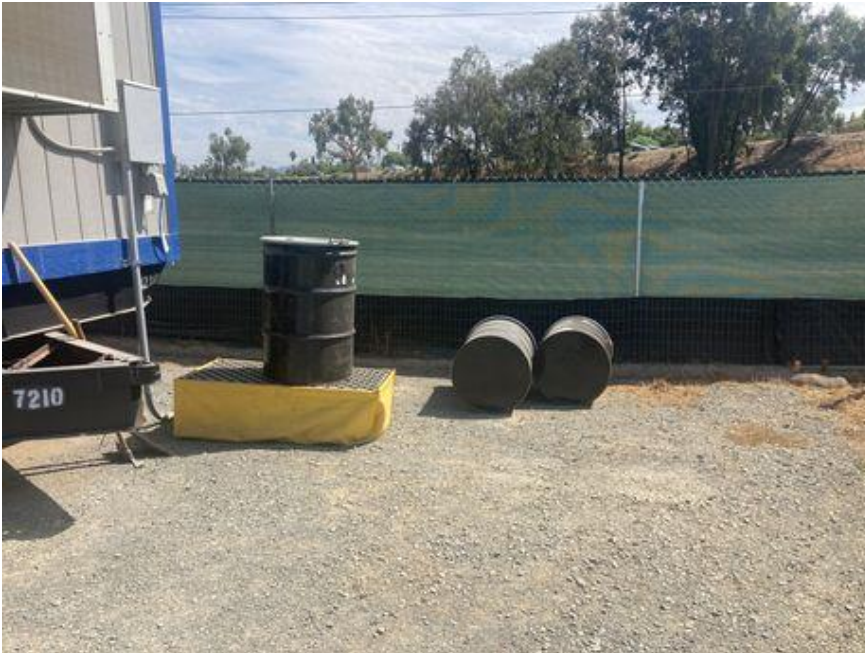
Site Photo 10

Rock Springs Staging Yard. One 55-gallon drum on top of secondary containment platform. Label states flammable hazardous materials. The drums on the ground were empty. Looking northeast.

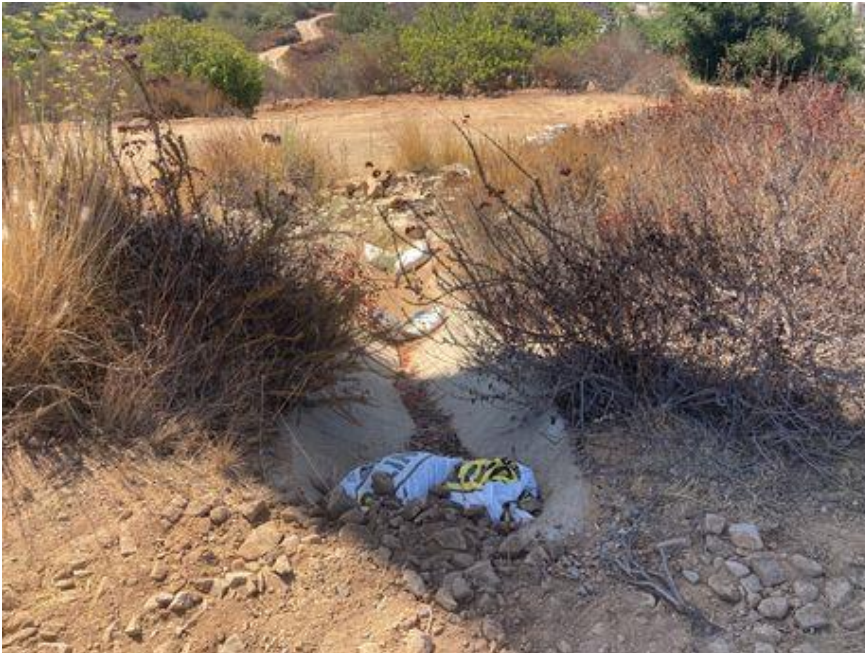
Site Photo 8

Location 64. Stockpile has been removed and gravel bags have kept material from falling into the brow ditch. Recommended cleaning up the ditch as a part of site clean-up occurring today. Looking south.

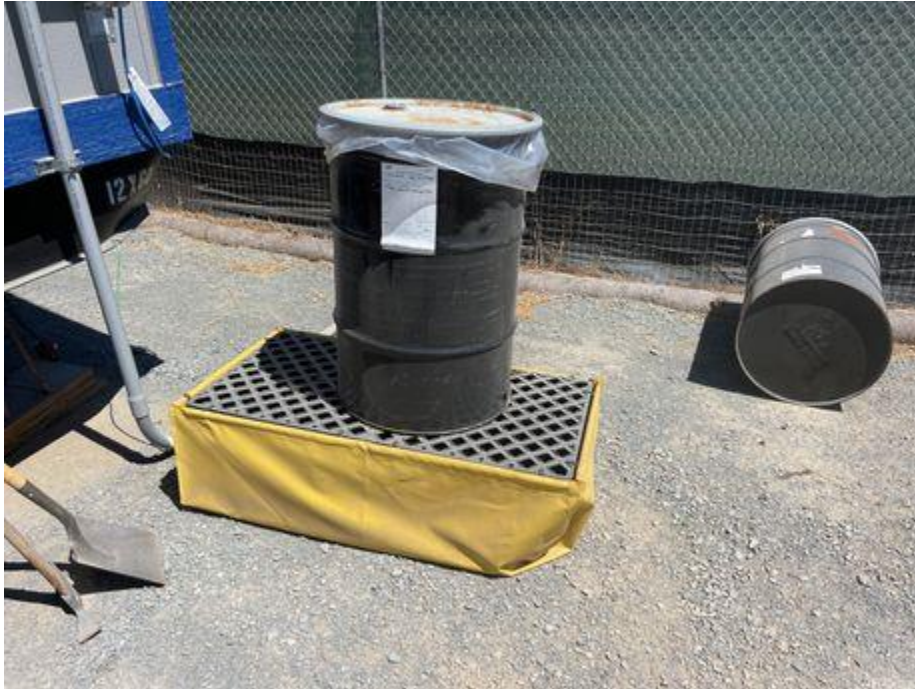
Site Photo 9

Oily rocks in hazardous materials containment in Rock Springs yard

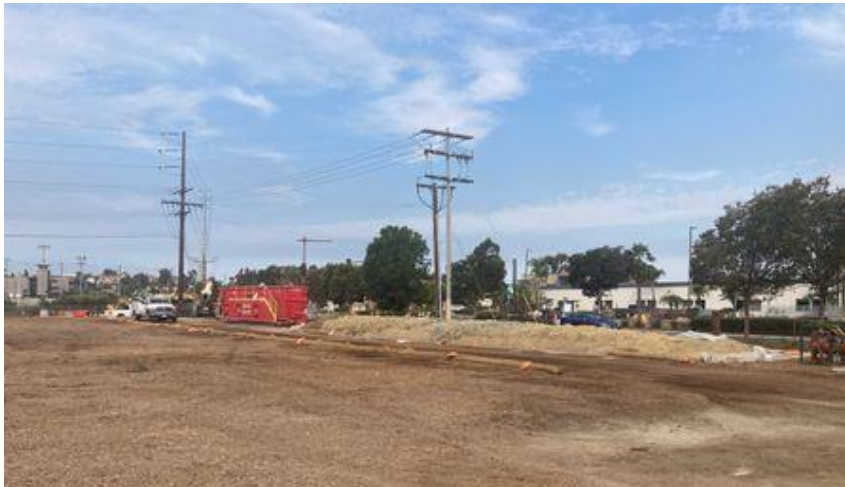
Site Photo 2

Location 8. Spoil piles from foundation drilling will be covered up and straw waddles will completely encircle the area before the upcoming rain event. Looking northwest.

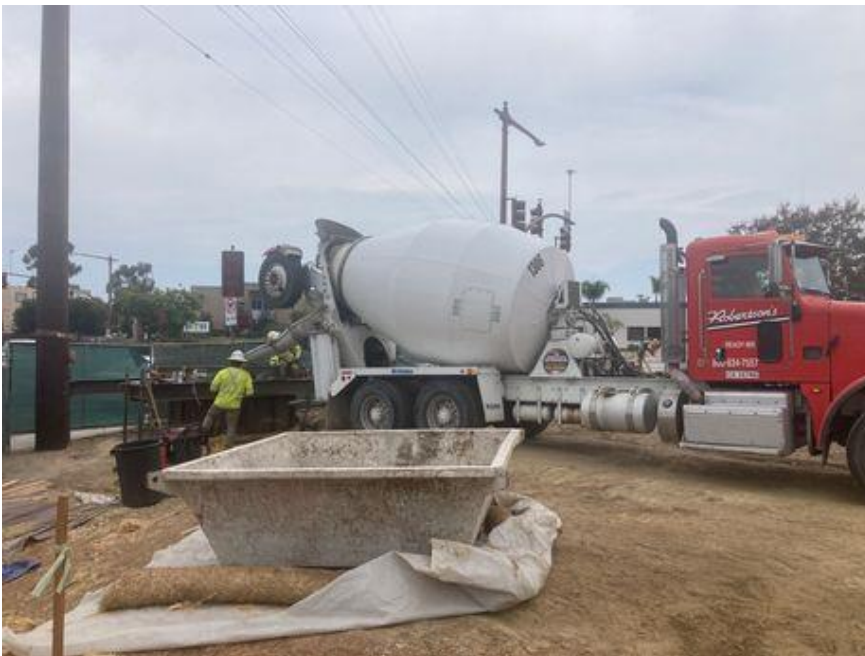
Site Photo 8

Location 8. Concrete pour for 30 foot foundation. Looking northwest.

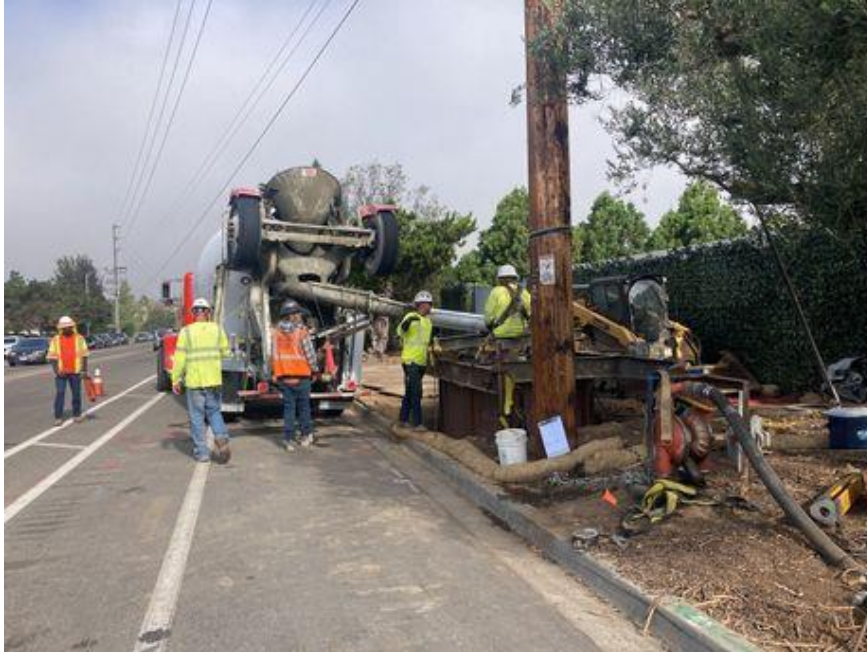
Site Photo 4

Location 3. Concrete pour for 32-foot-deep pole foundation. Looking northwest.

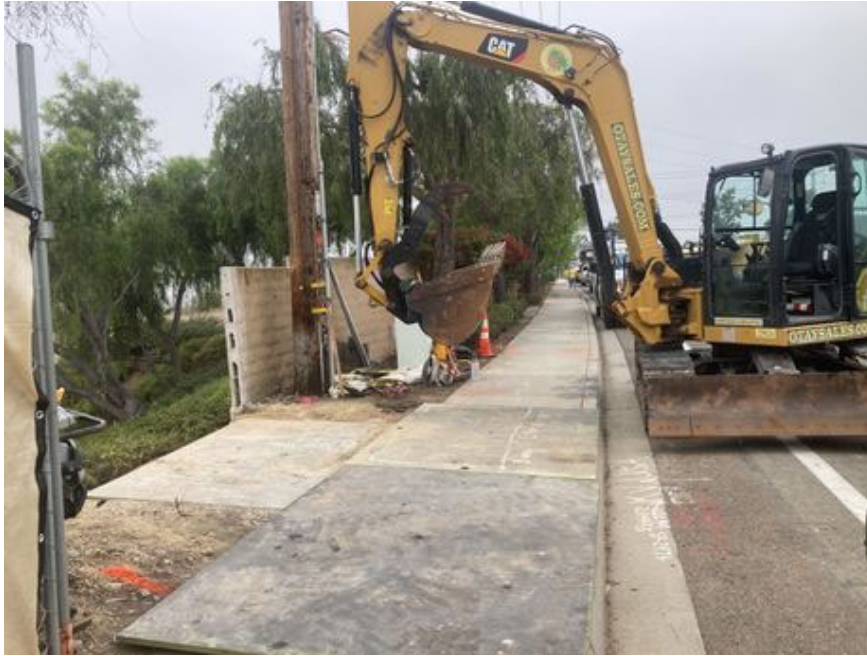
Site Photo 5

Location 49. Screen wall removal. Work was stopped due to concerns expressed by a representative from the neighboring HOA regarding placement of the new wall and encroachment into HOA property. Crew stopped wall work and will relocate the existing irrigation line away from the drill location. Looking southeast.
