In the Matter of the Application of SOUTHERN) Application No. _____
CALIFORNIA EDISON COMPANY (U 338-E) for a)
Permit to Construct Electrical Facilities)
With Voltages Between 50 kV and 200 kV:)
Moorpark-Newbury 66 kV Subtransmission Line Project)

Dated: October 28, 2013

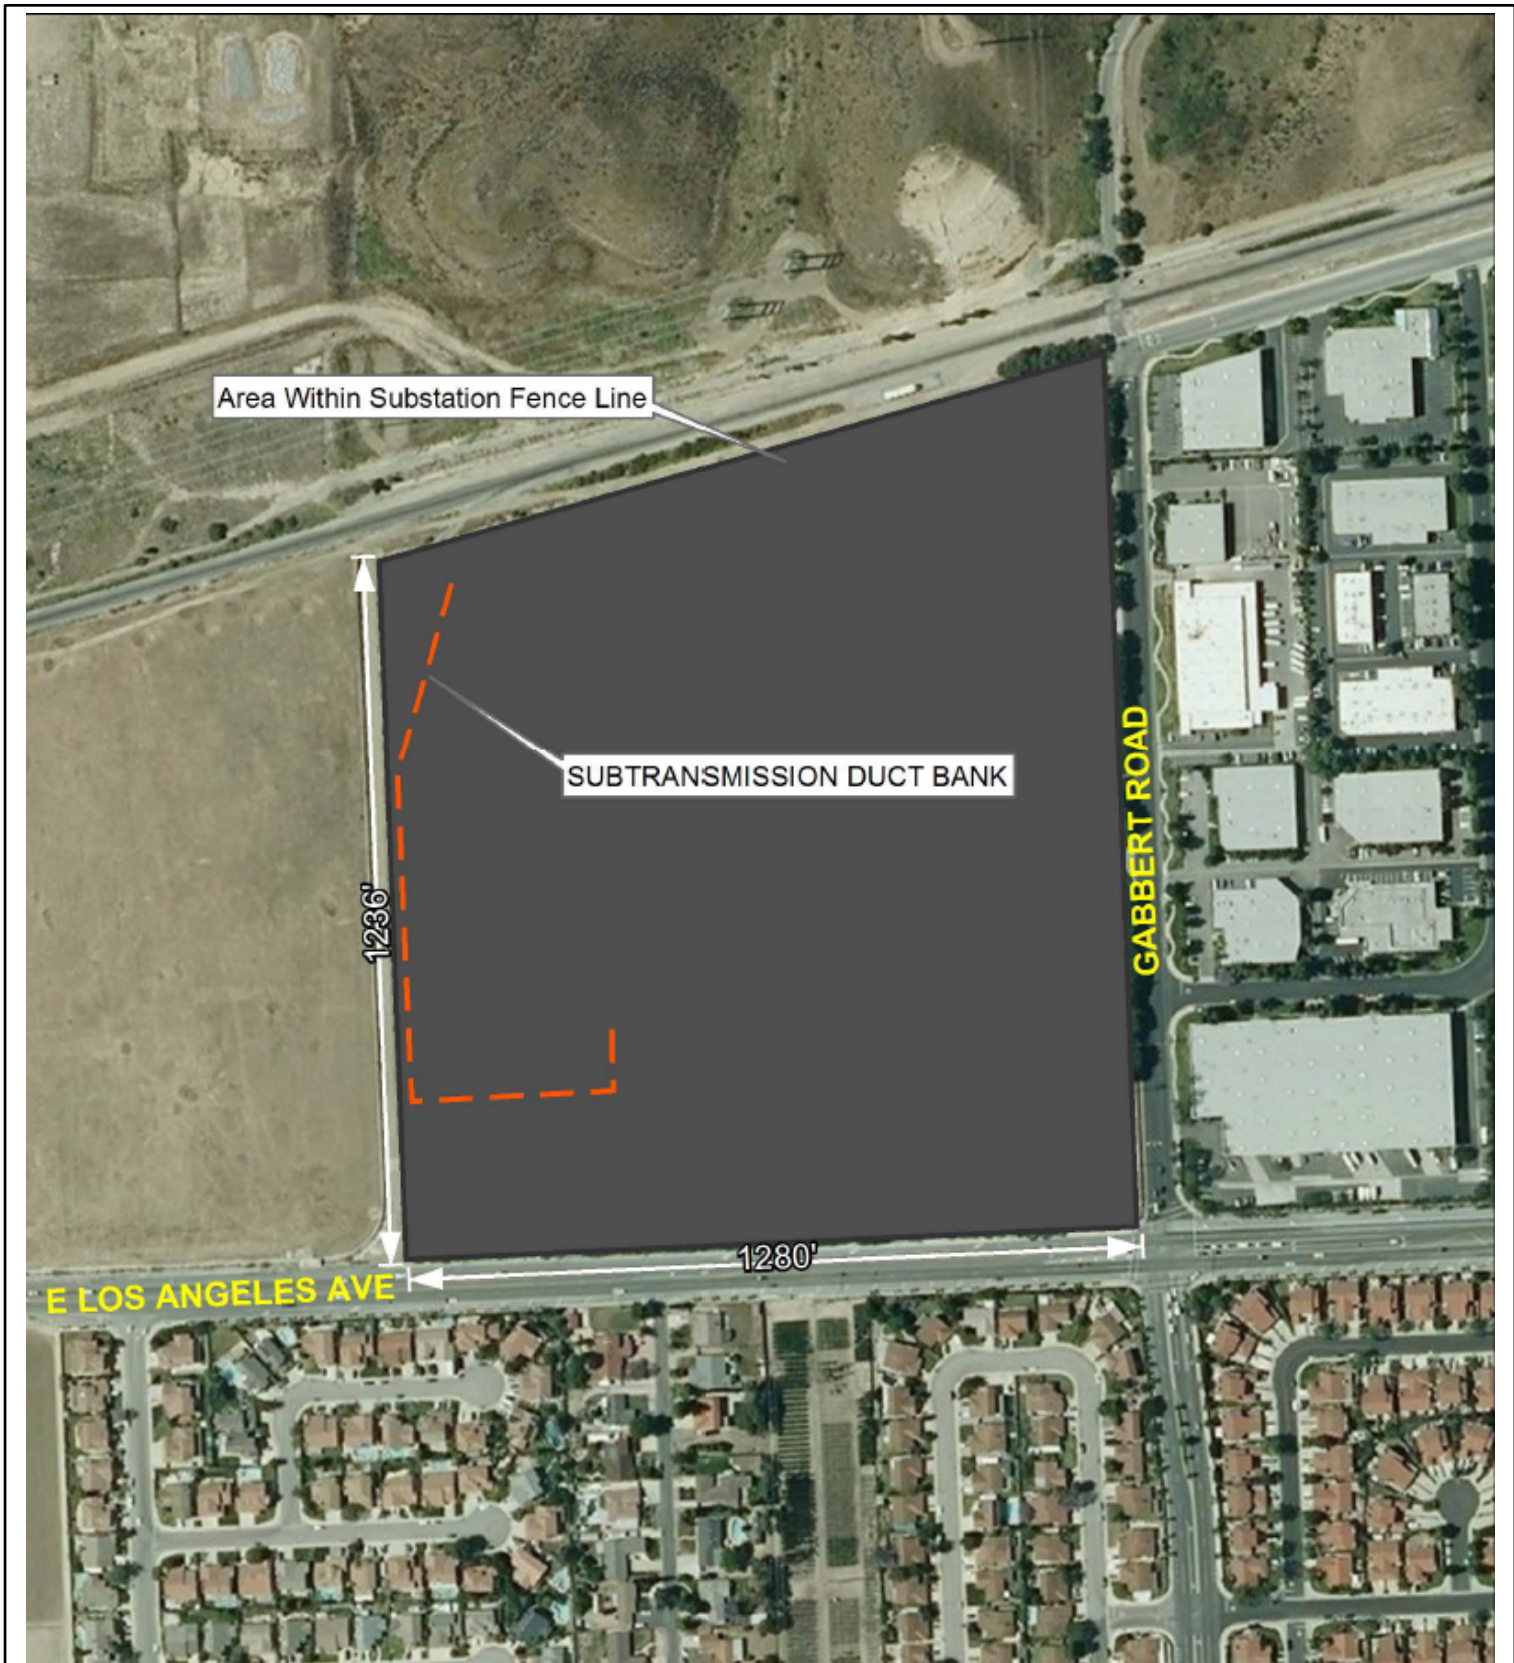
EXISTING MOORPARK SUBSTATION AREA

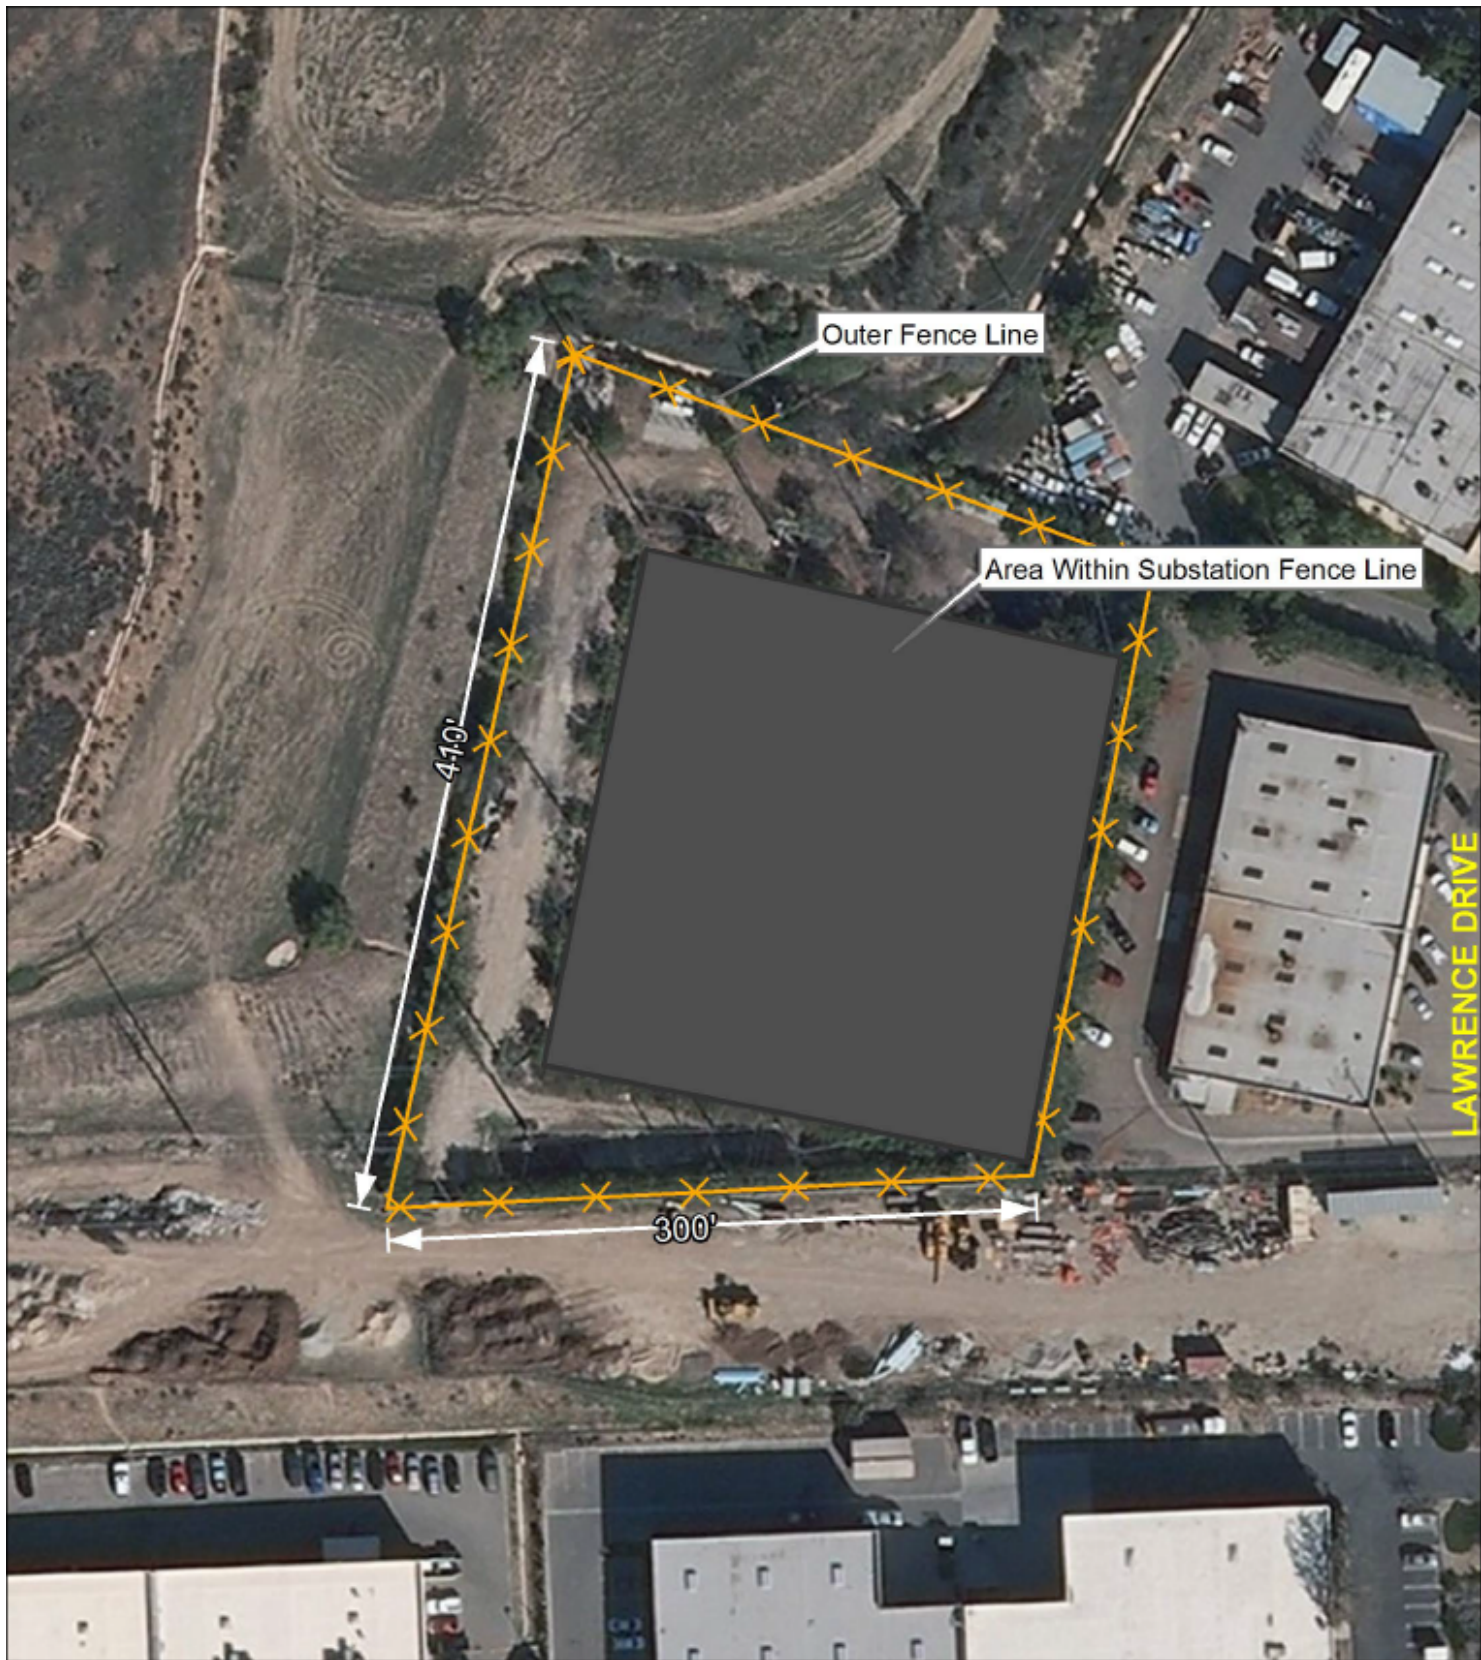
EXISTING NEWBURY SUBSTATION AREA

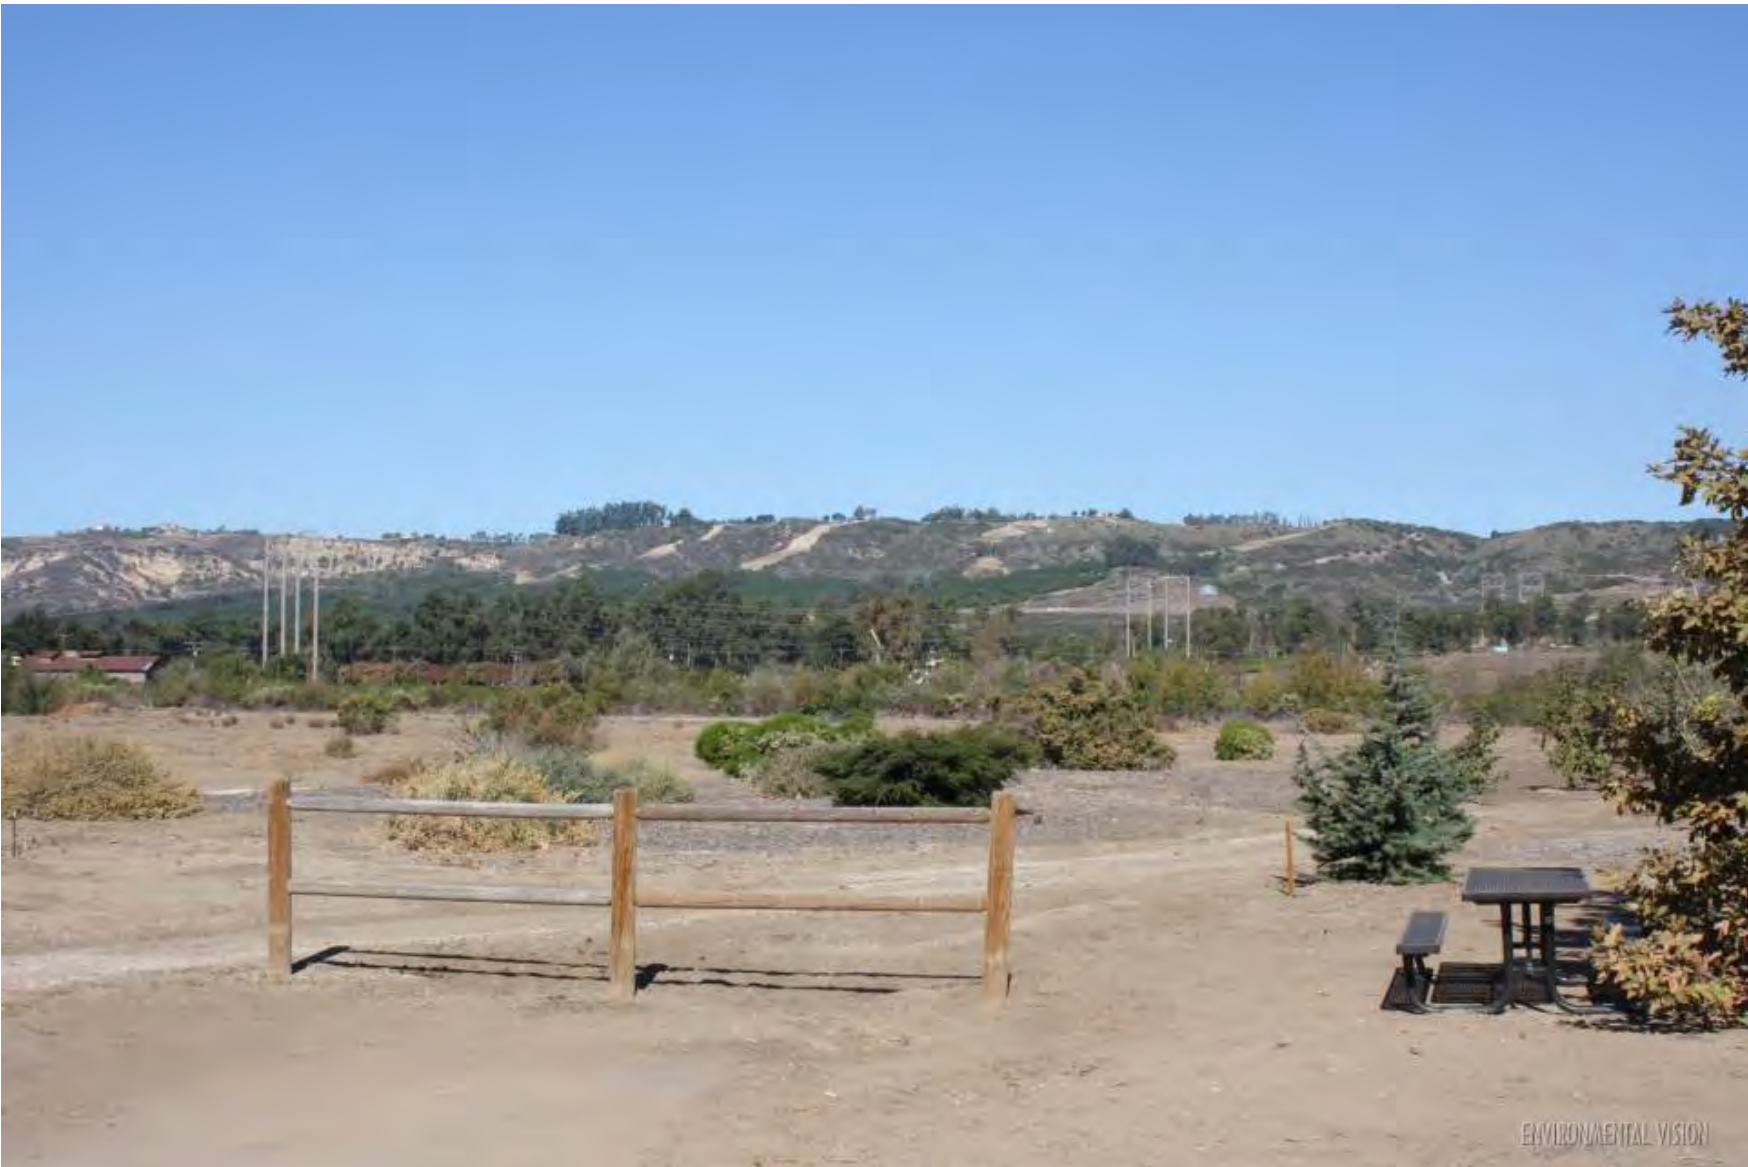
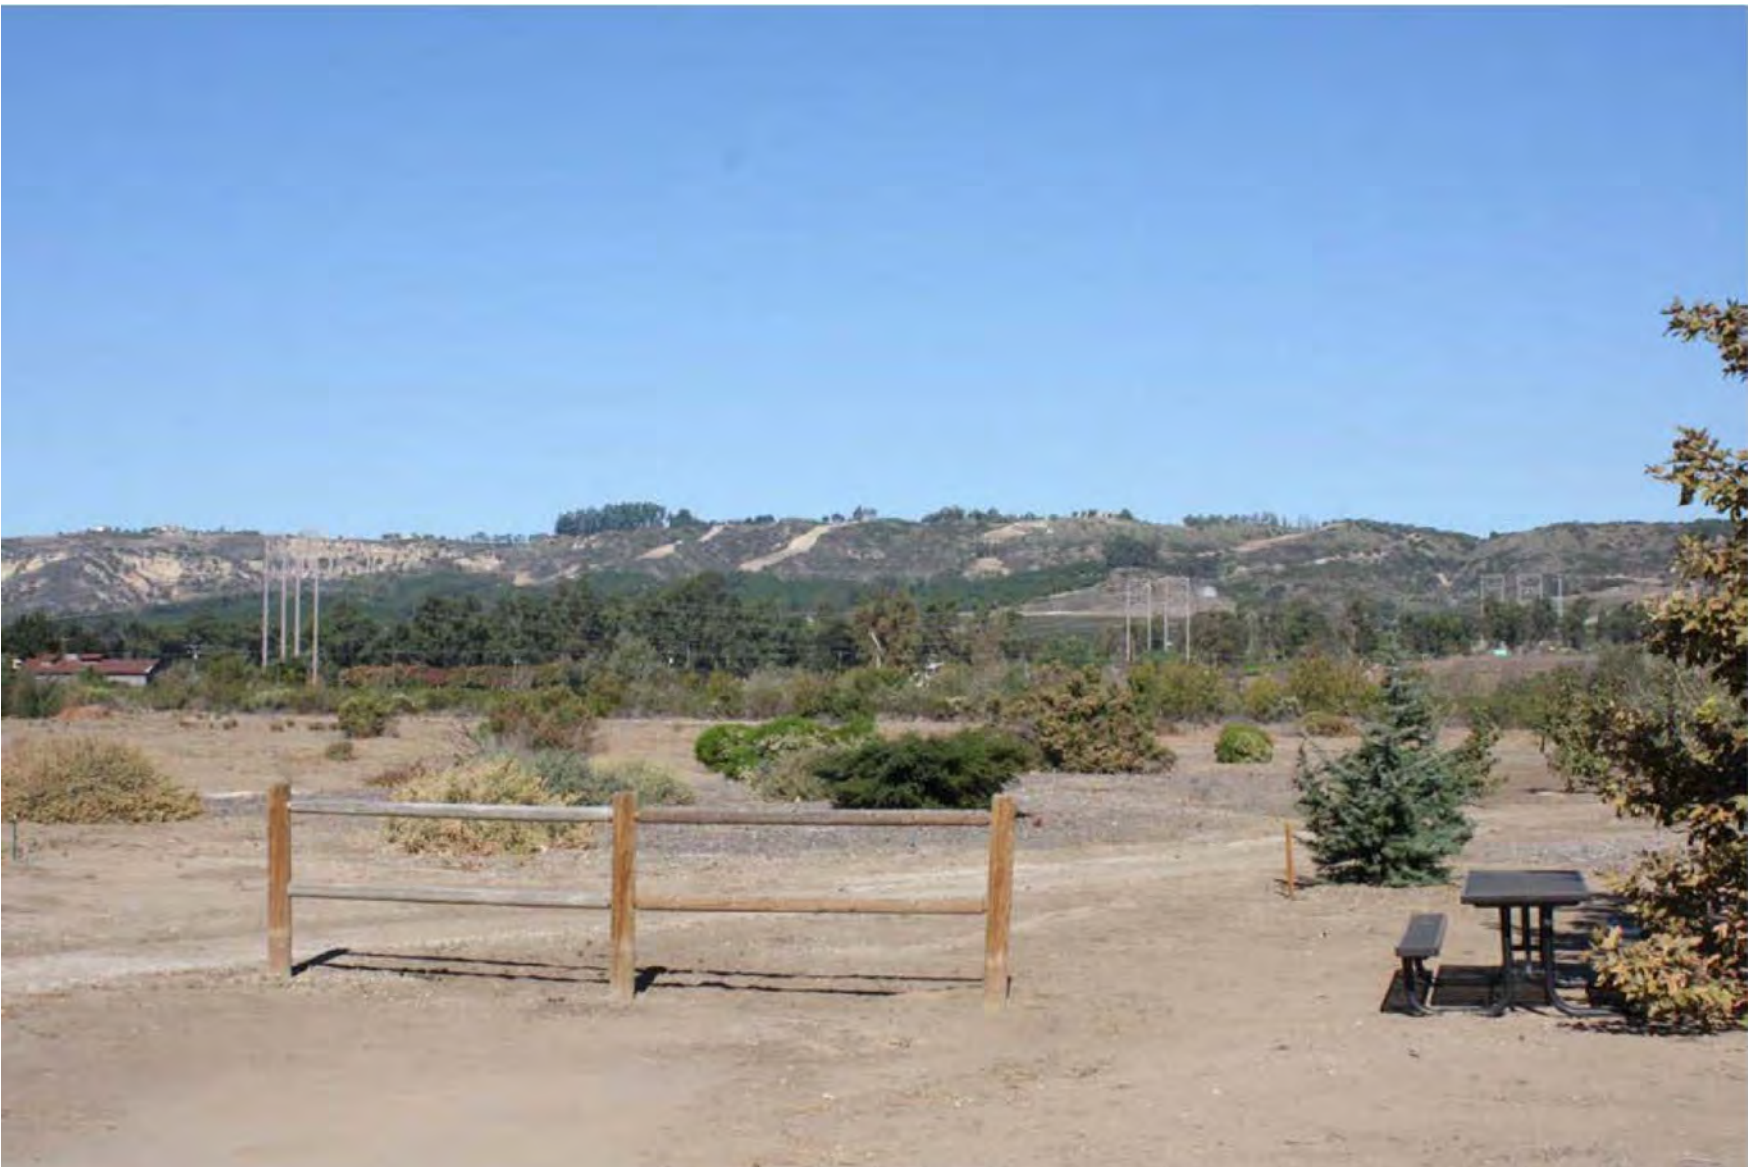
Figure
4.1-4b

Visual Simulation of Conditions Prior to Past Construction Activities

Photograph of Conditions at the Conclusion of Past Construction Activities

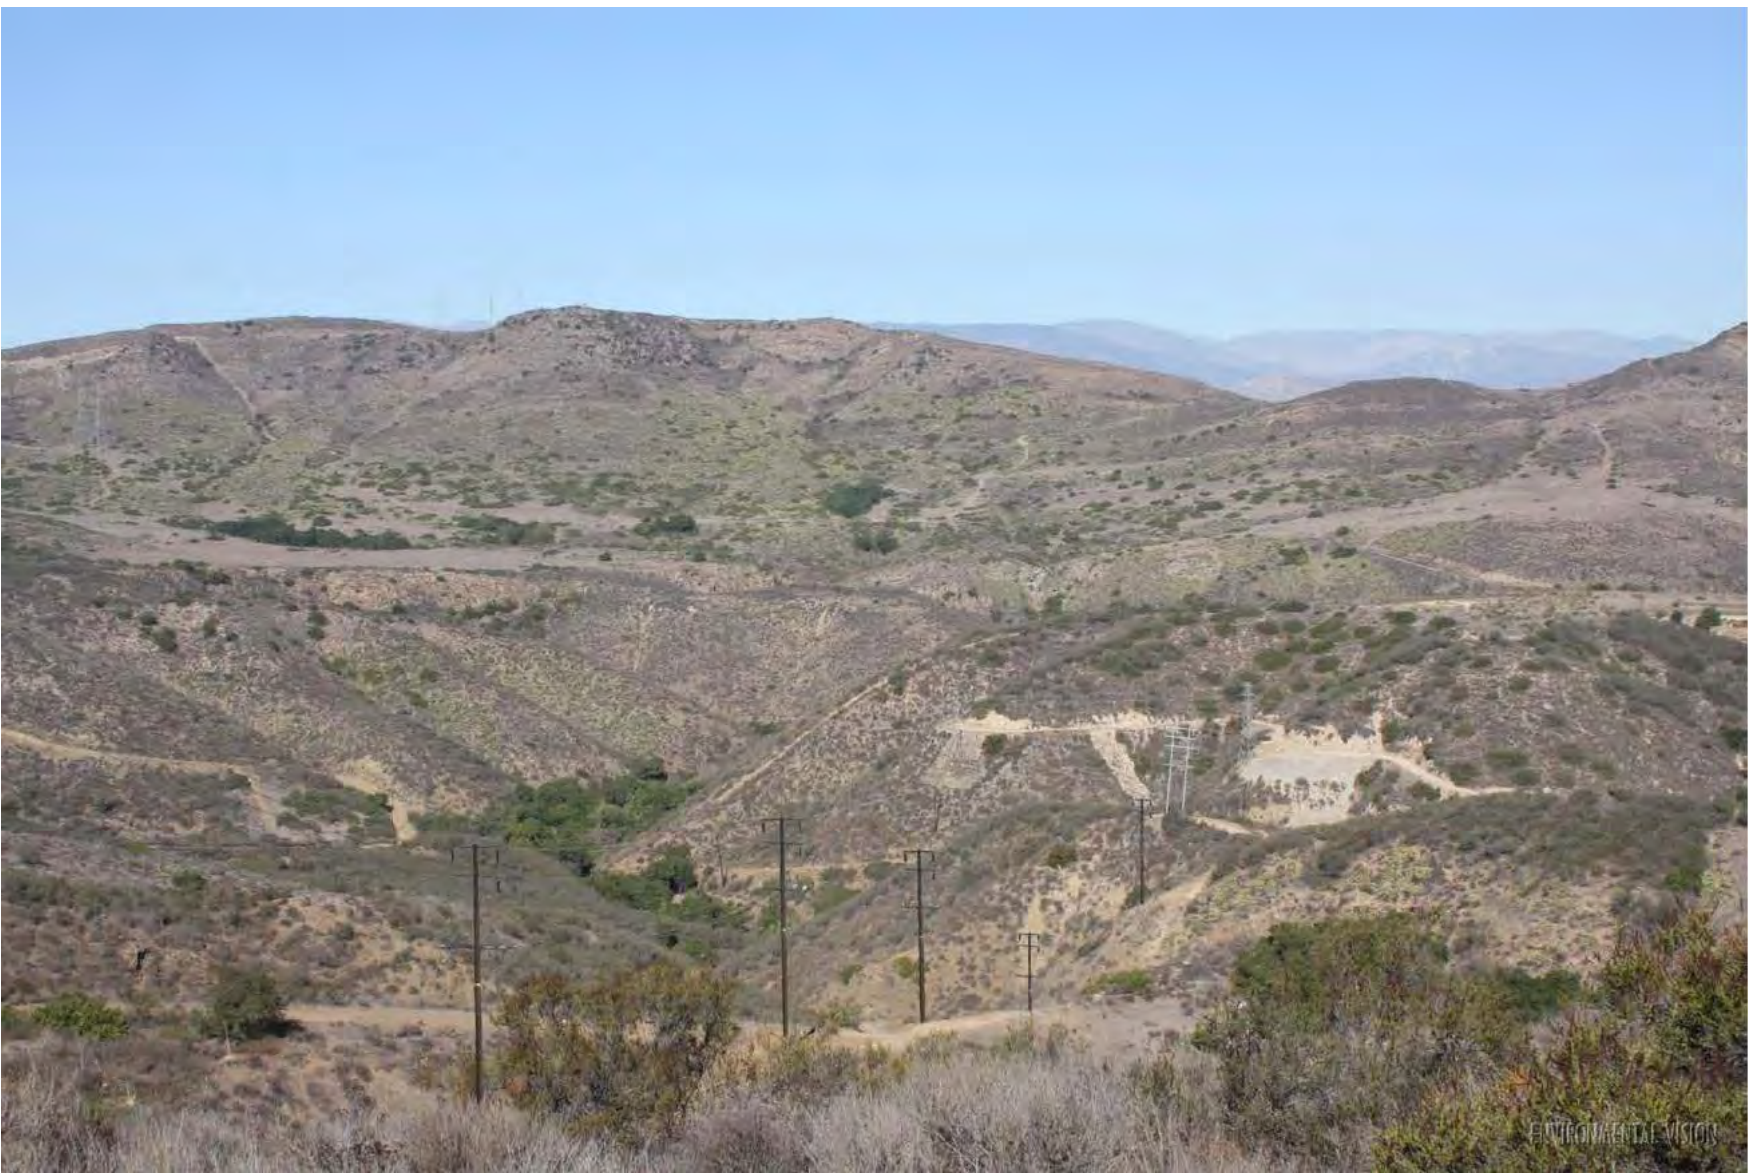
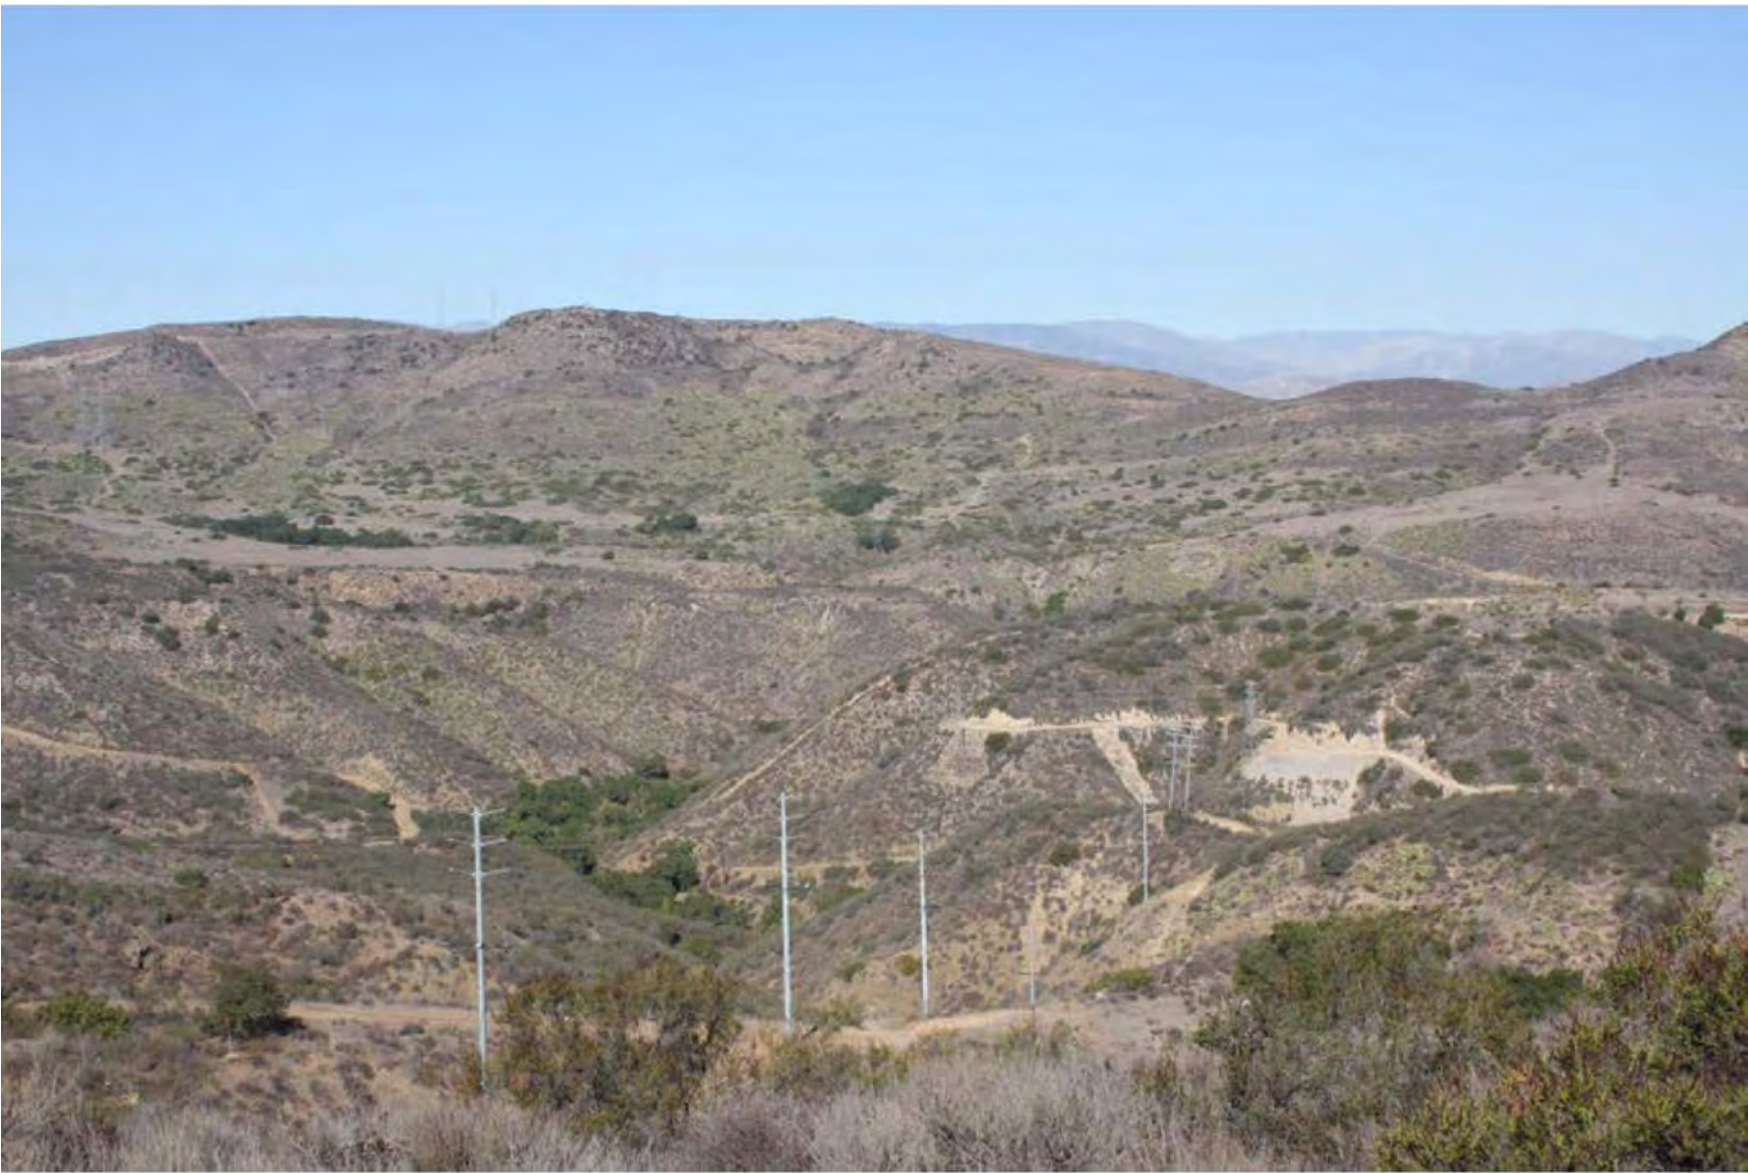
Visual Simulation of Conditions Prior to Past Construction Activities

Photograph of Conditions at the Conclusion of Past Construction Activities

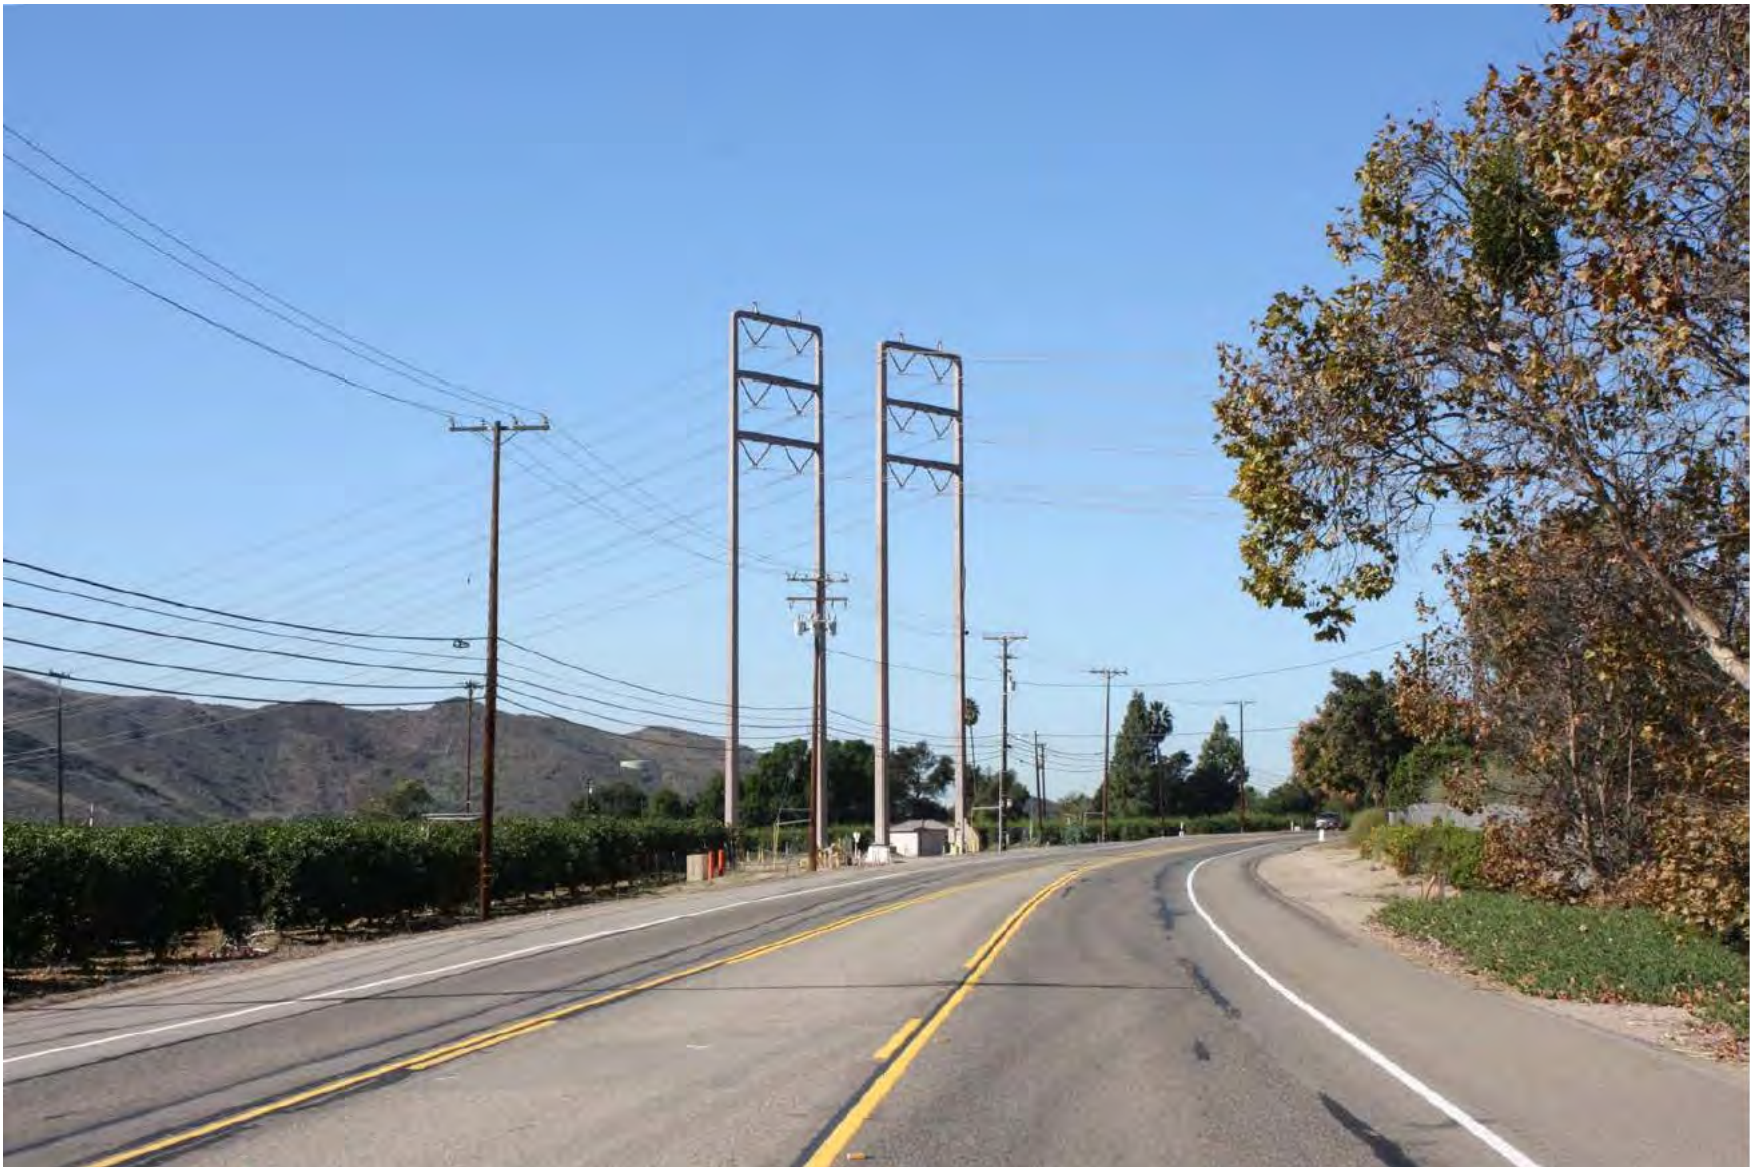
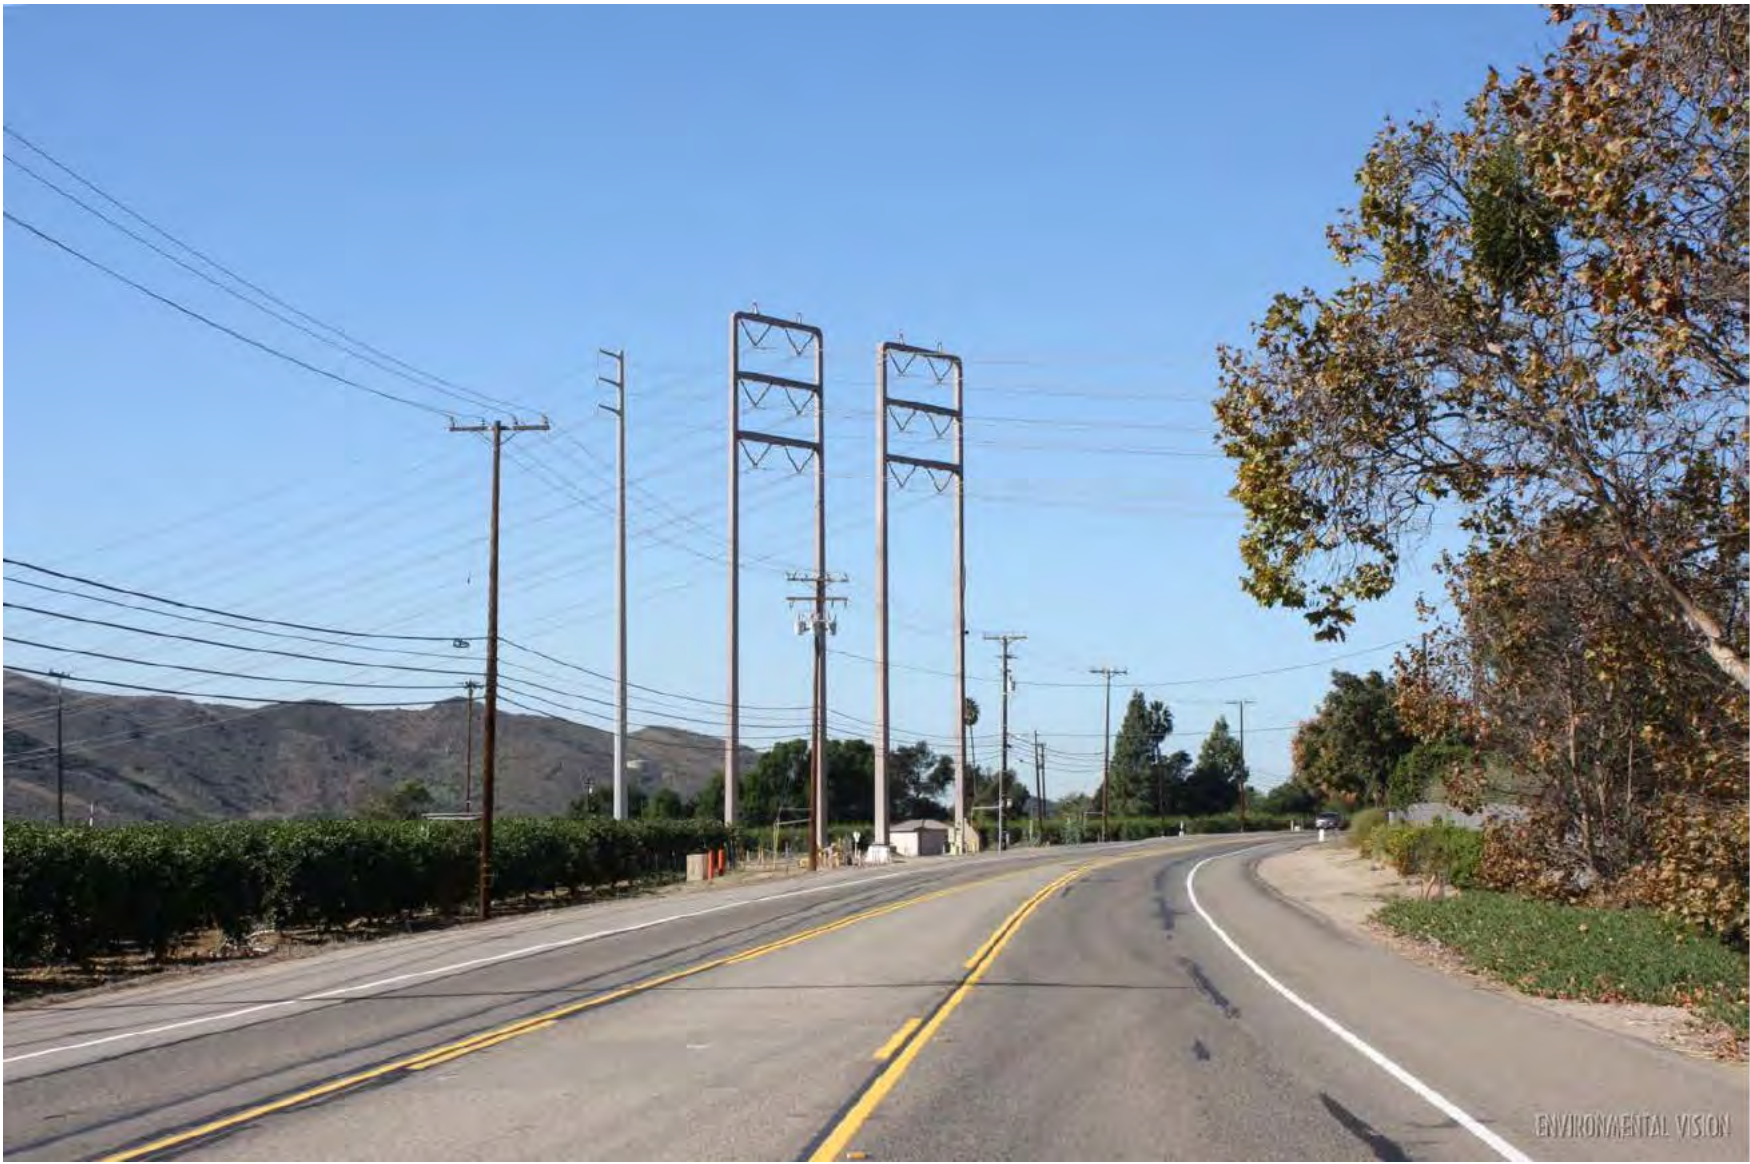
Figure
4.1-5b

Photograph of Conditions Prior to Past Construction Activities

Visual Simulation of Conditions at the Conclusion of Future Construction Activities

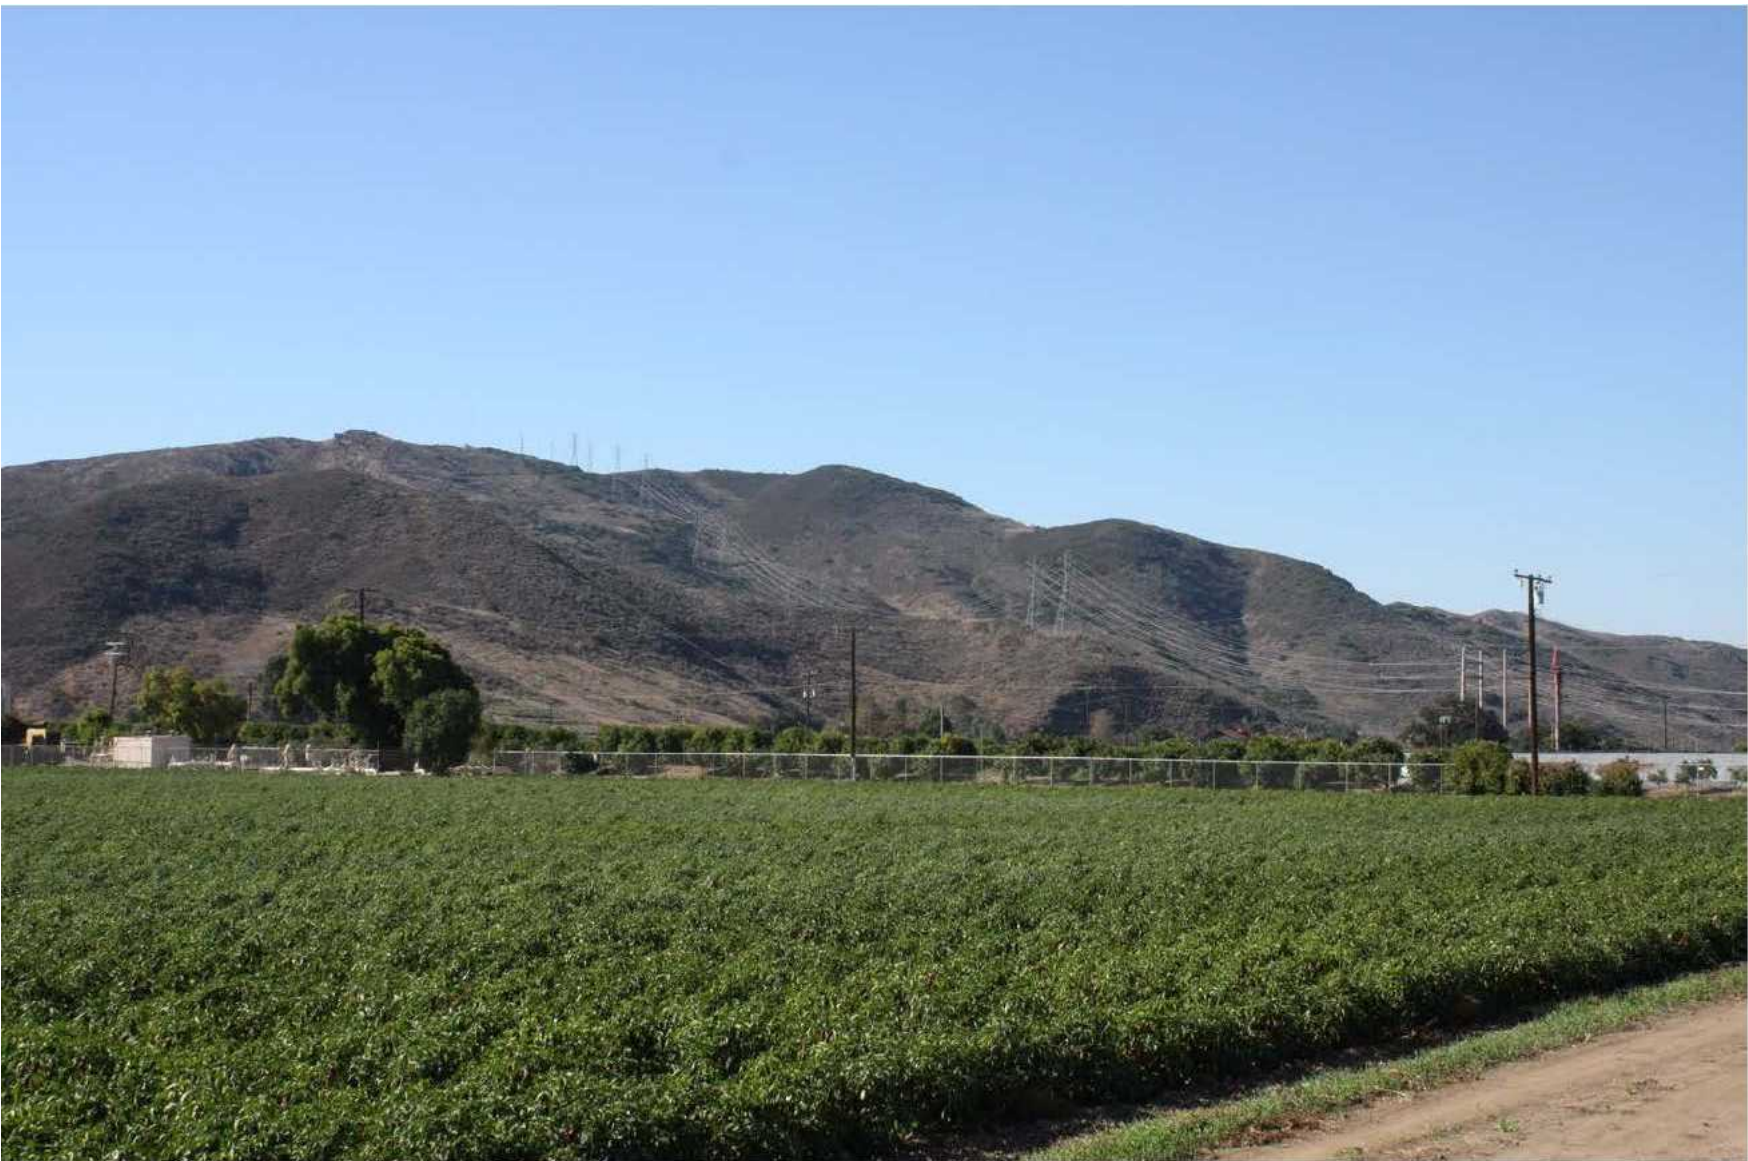
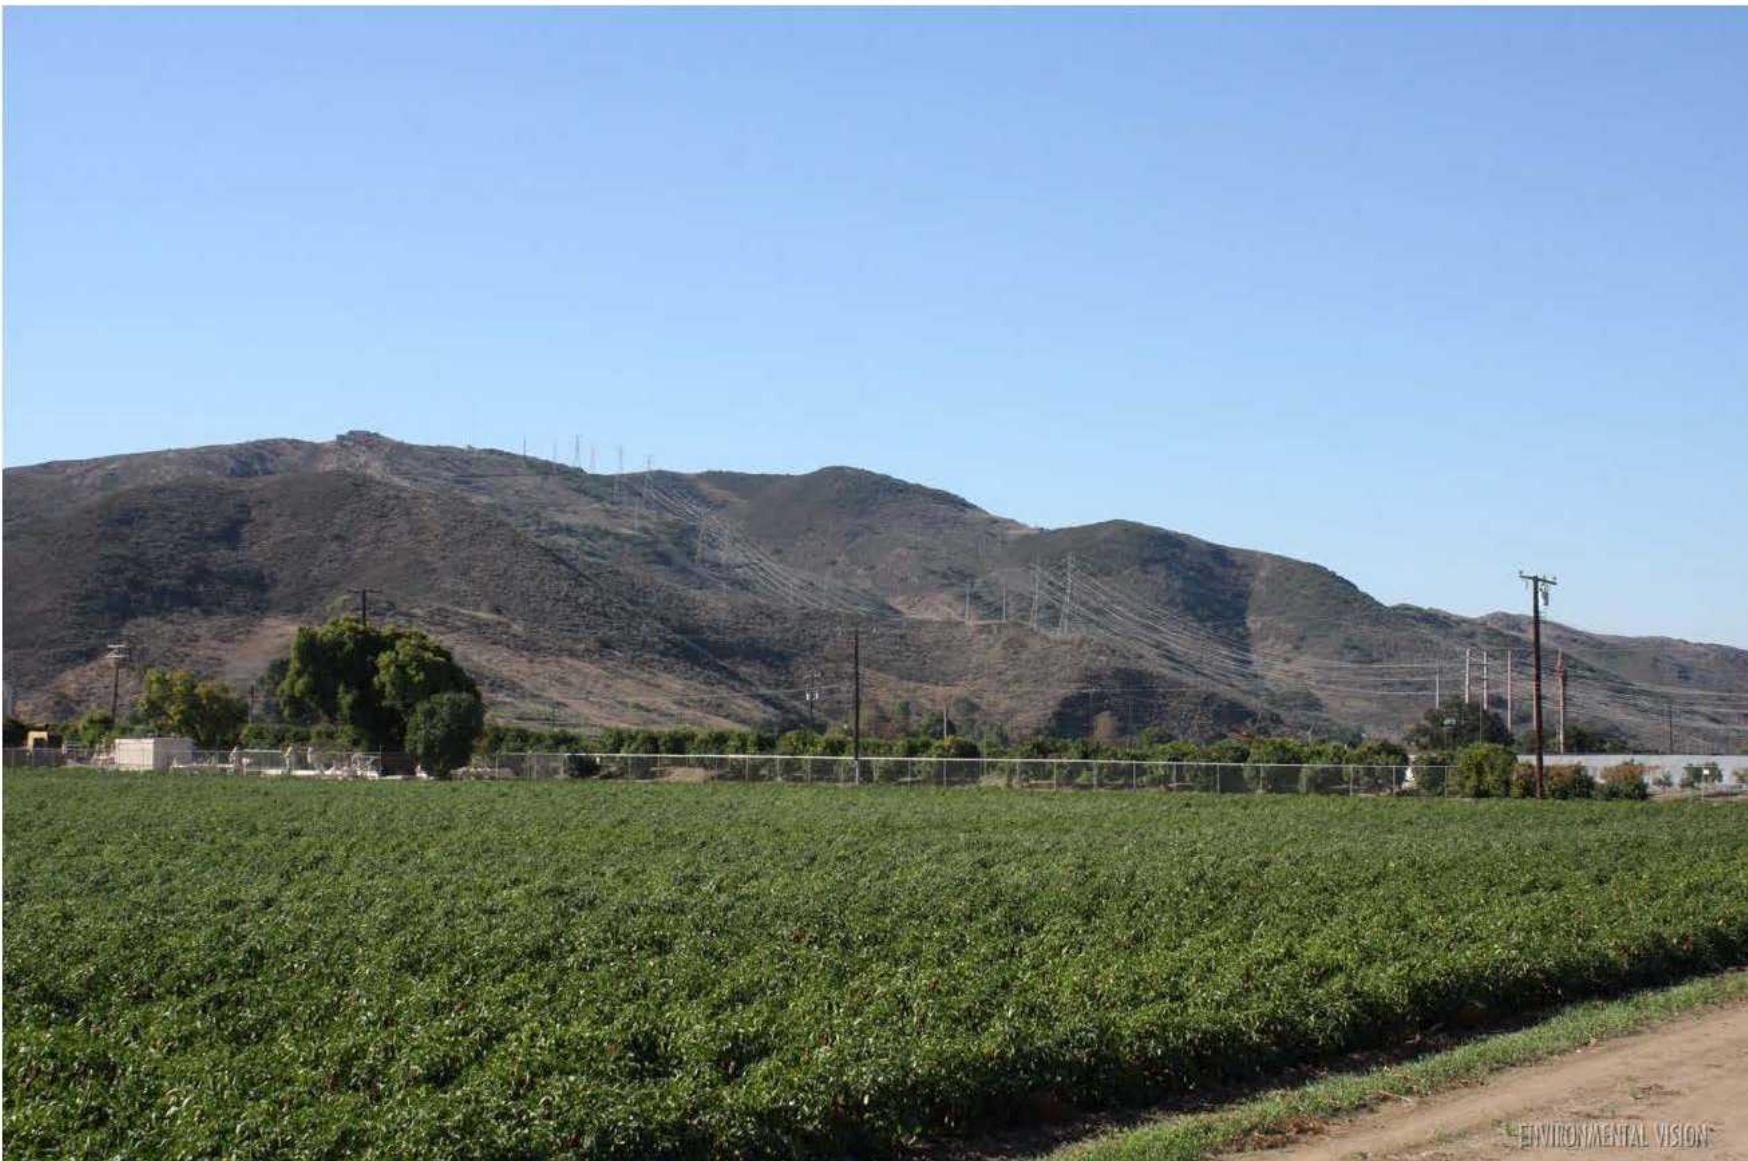
Figure
4.1-5c

Photograph of Conditions Prior to Past Construction Activities

Visual Simulation of Conditions at the Conclusion of Future Construction Activities
