In the Matter of the Application of SOUTHERN) Application No. _____
CALIFORNIA EDISON COMPANY (U 338-E) for a)
Permit to Construct Electrical Facilities)
With Voltages Between 50 kV and 200 kV:)
Moorpark-Newbury 66 kV Subtransmission Line Project)

Dated: October 28, 2013

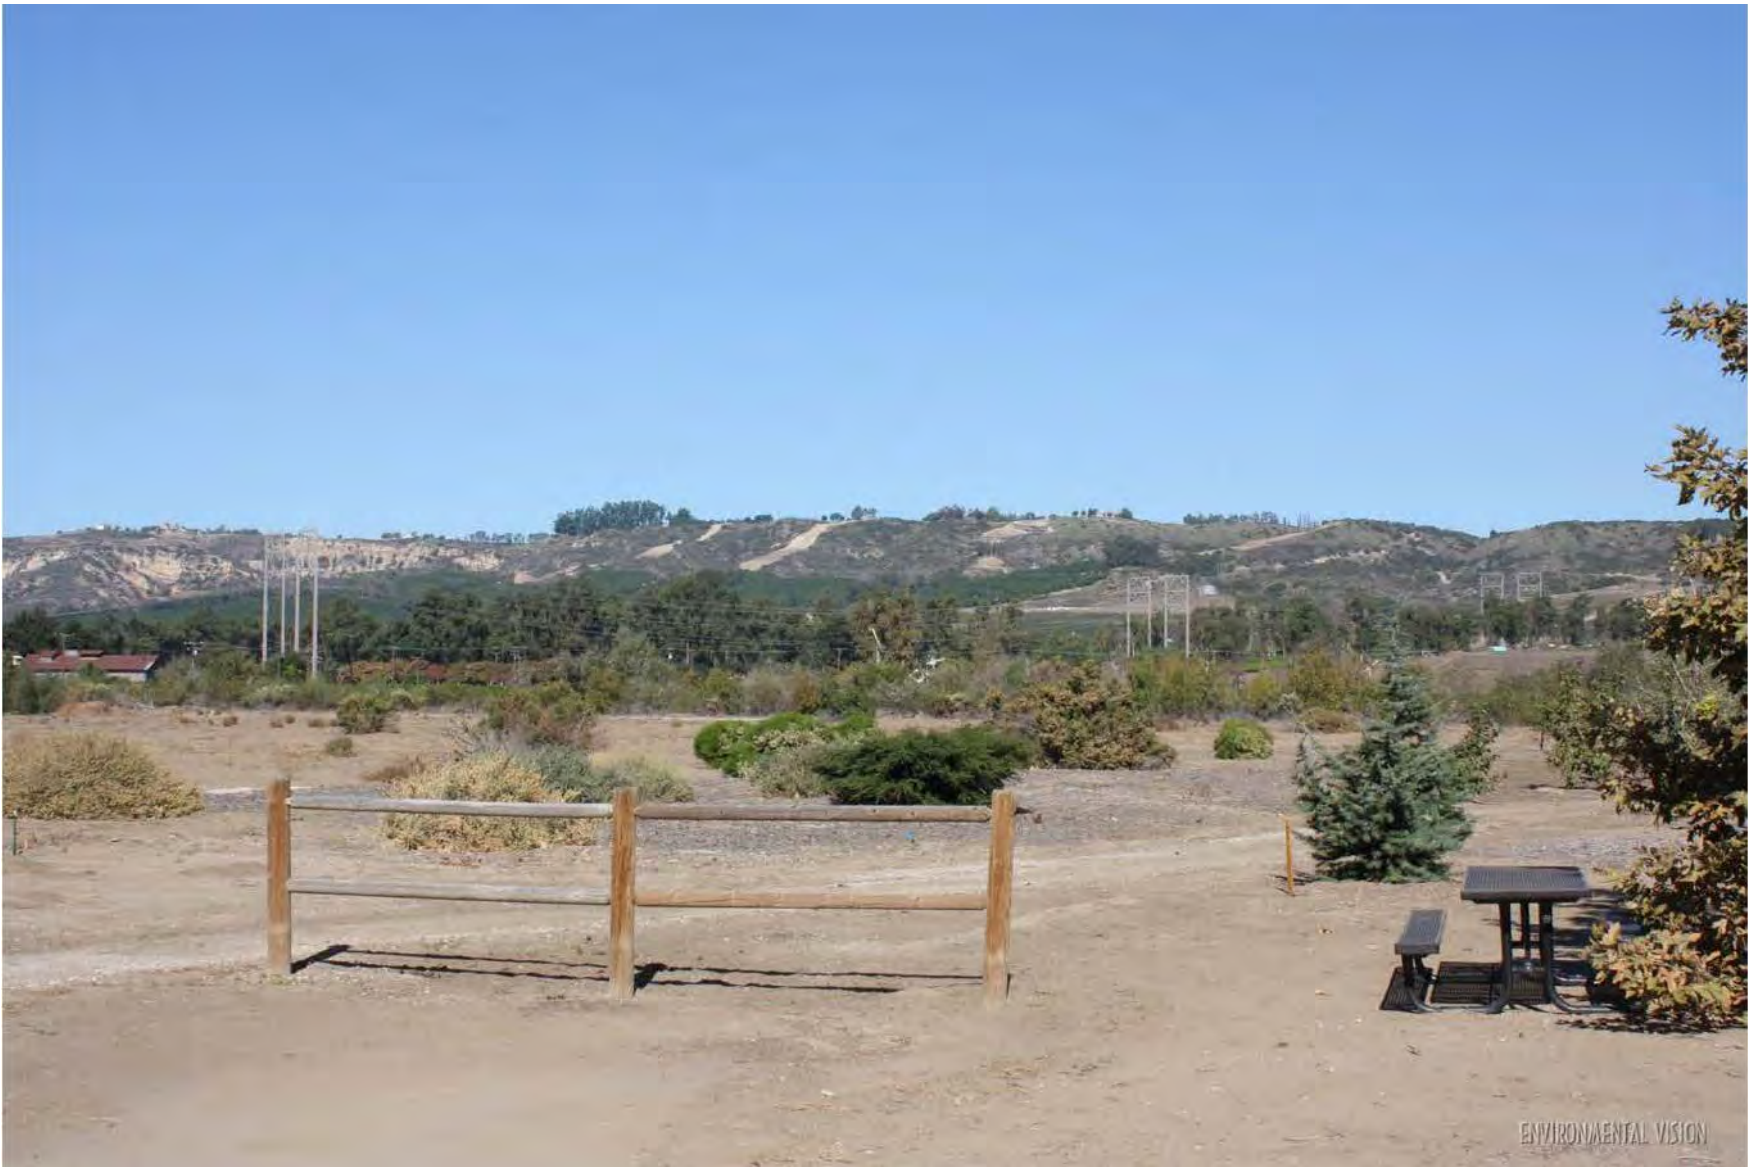
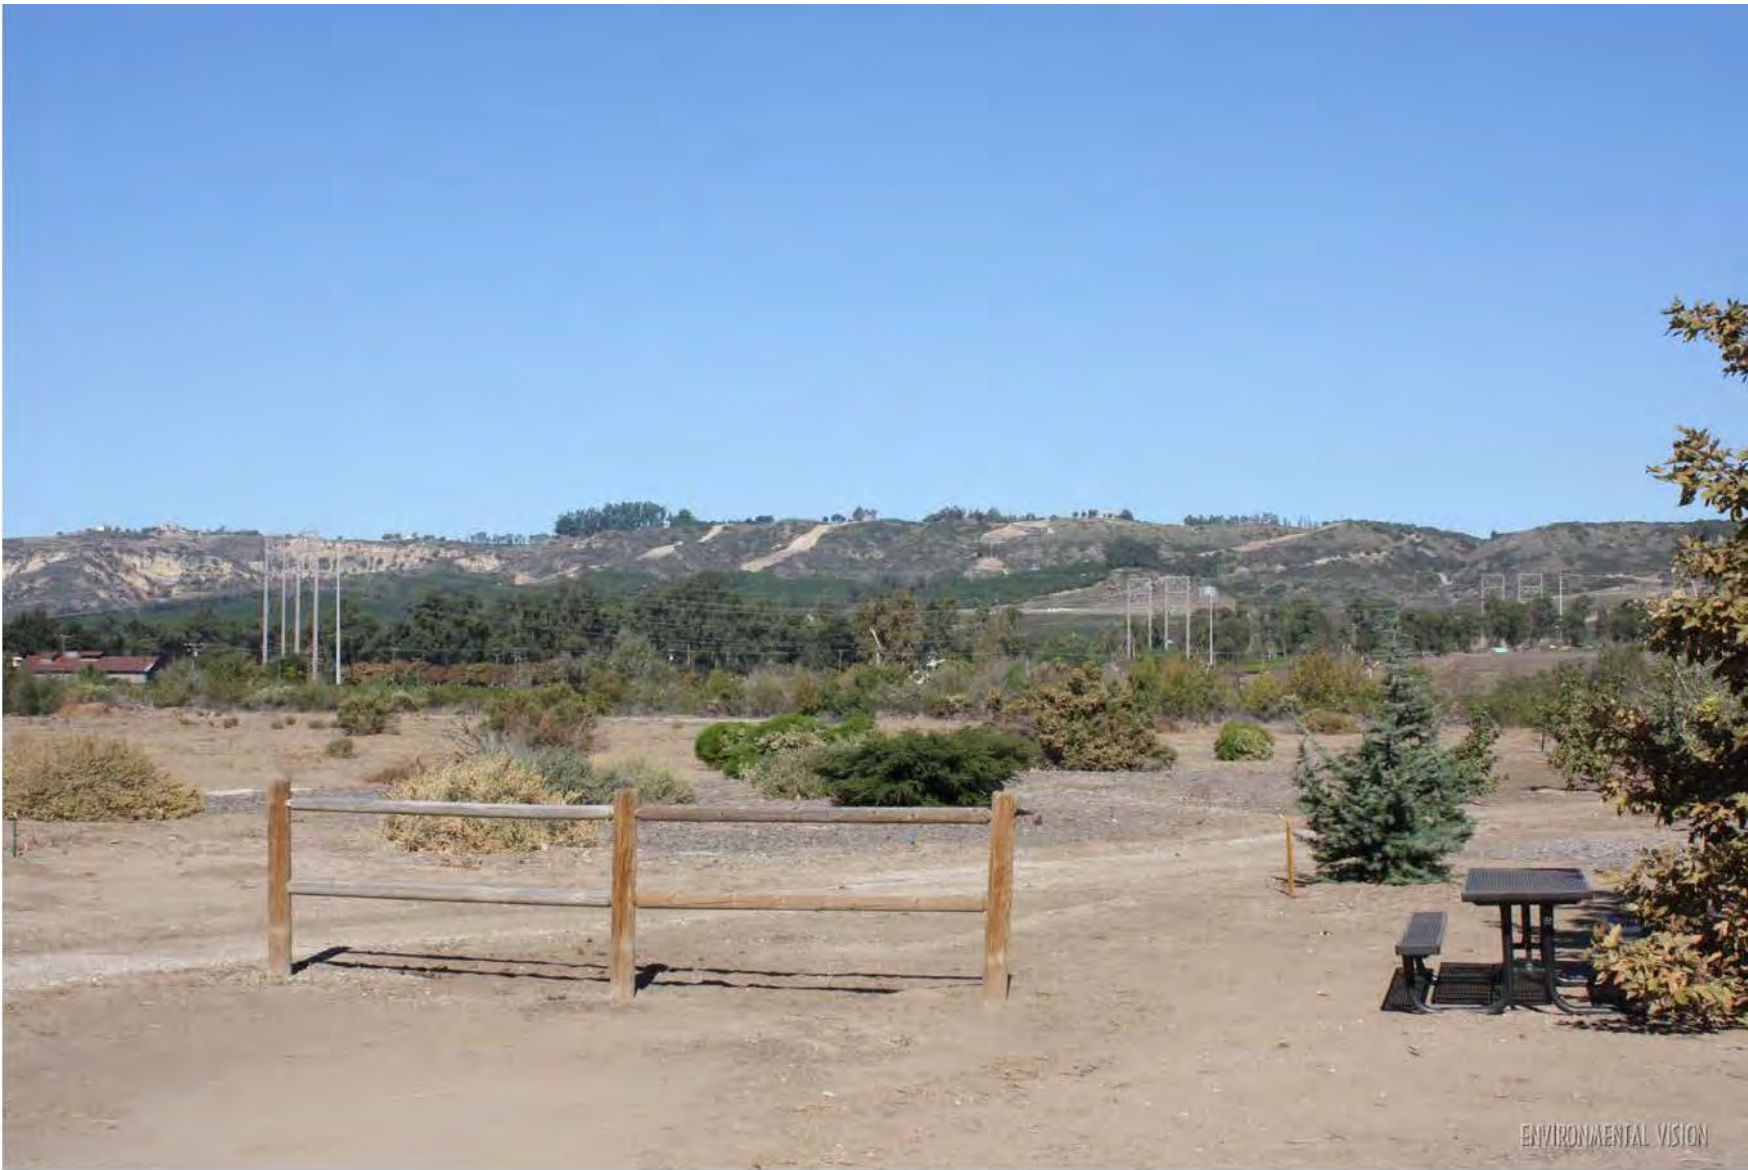
Visual Simulation of Conditions Prior to Past Construction Activities

Visual Simulation of Conditions at the Conclusion of Future Construction Activities

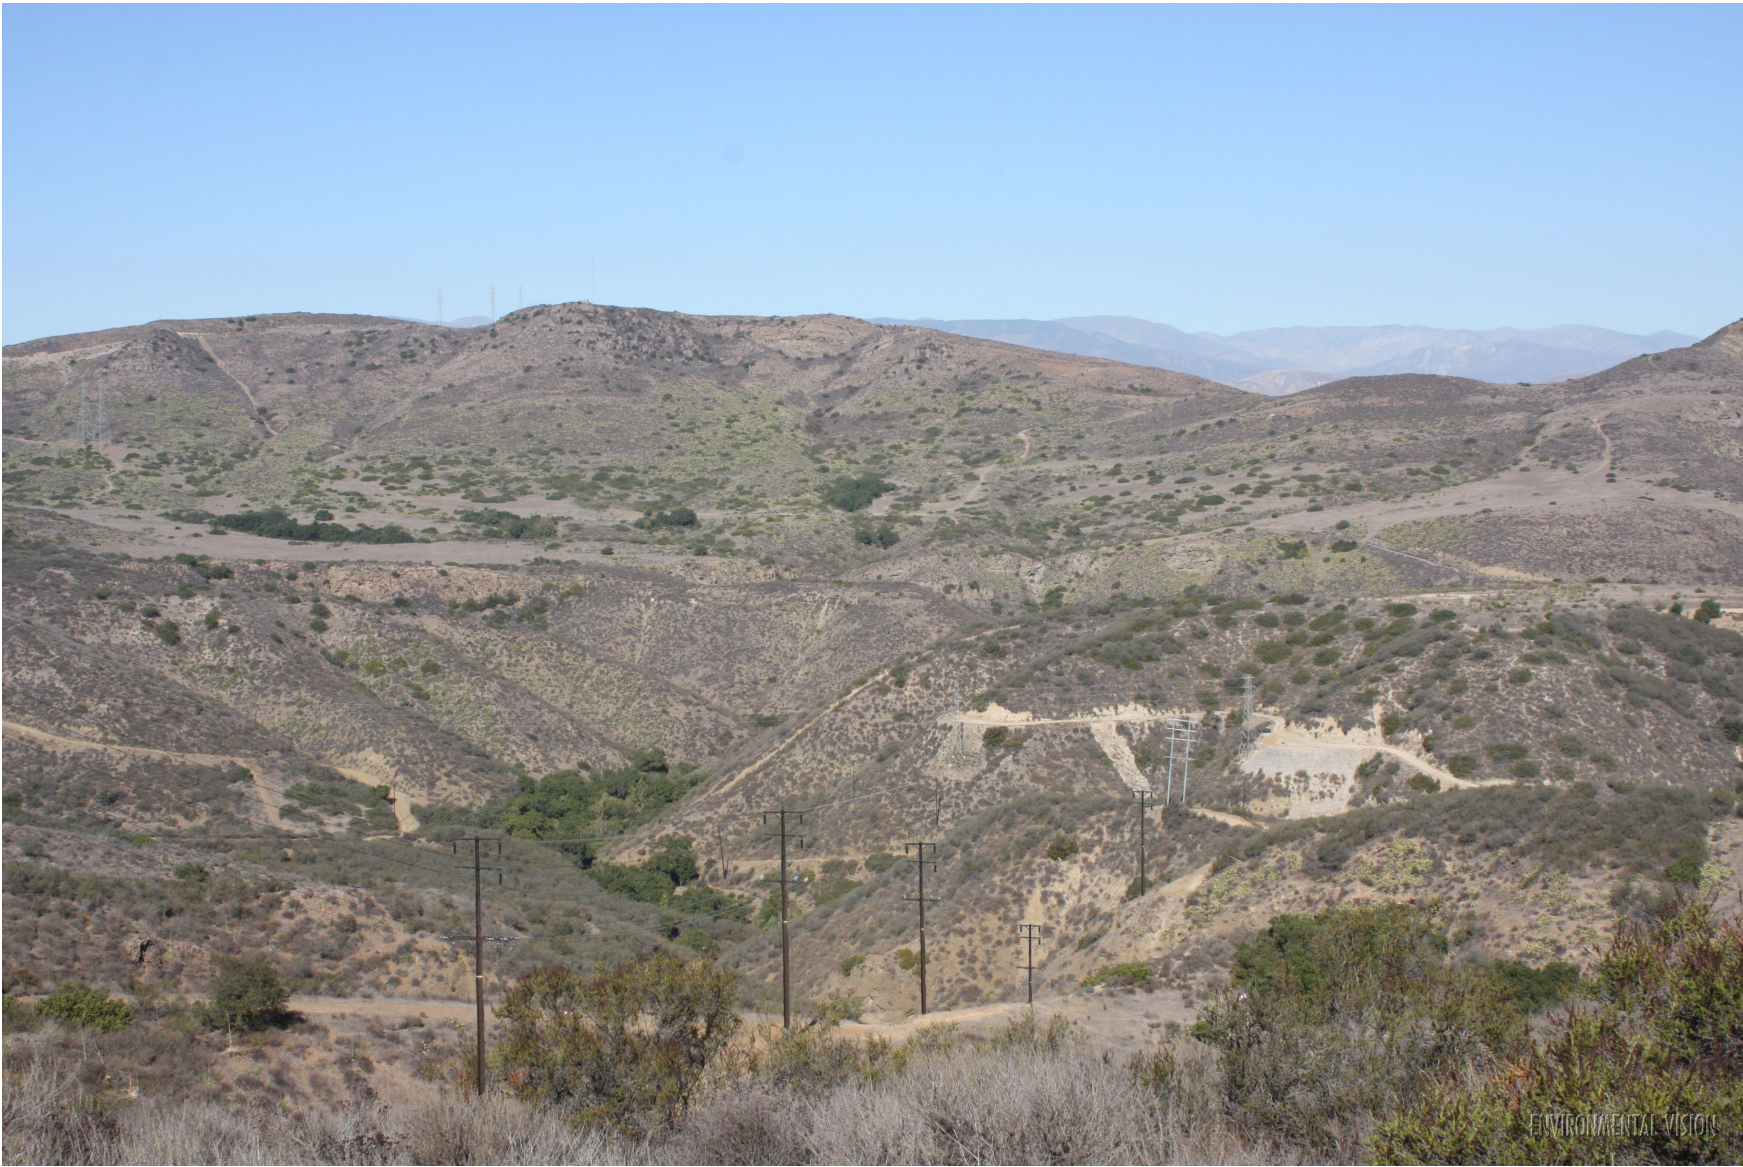
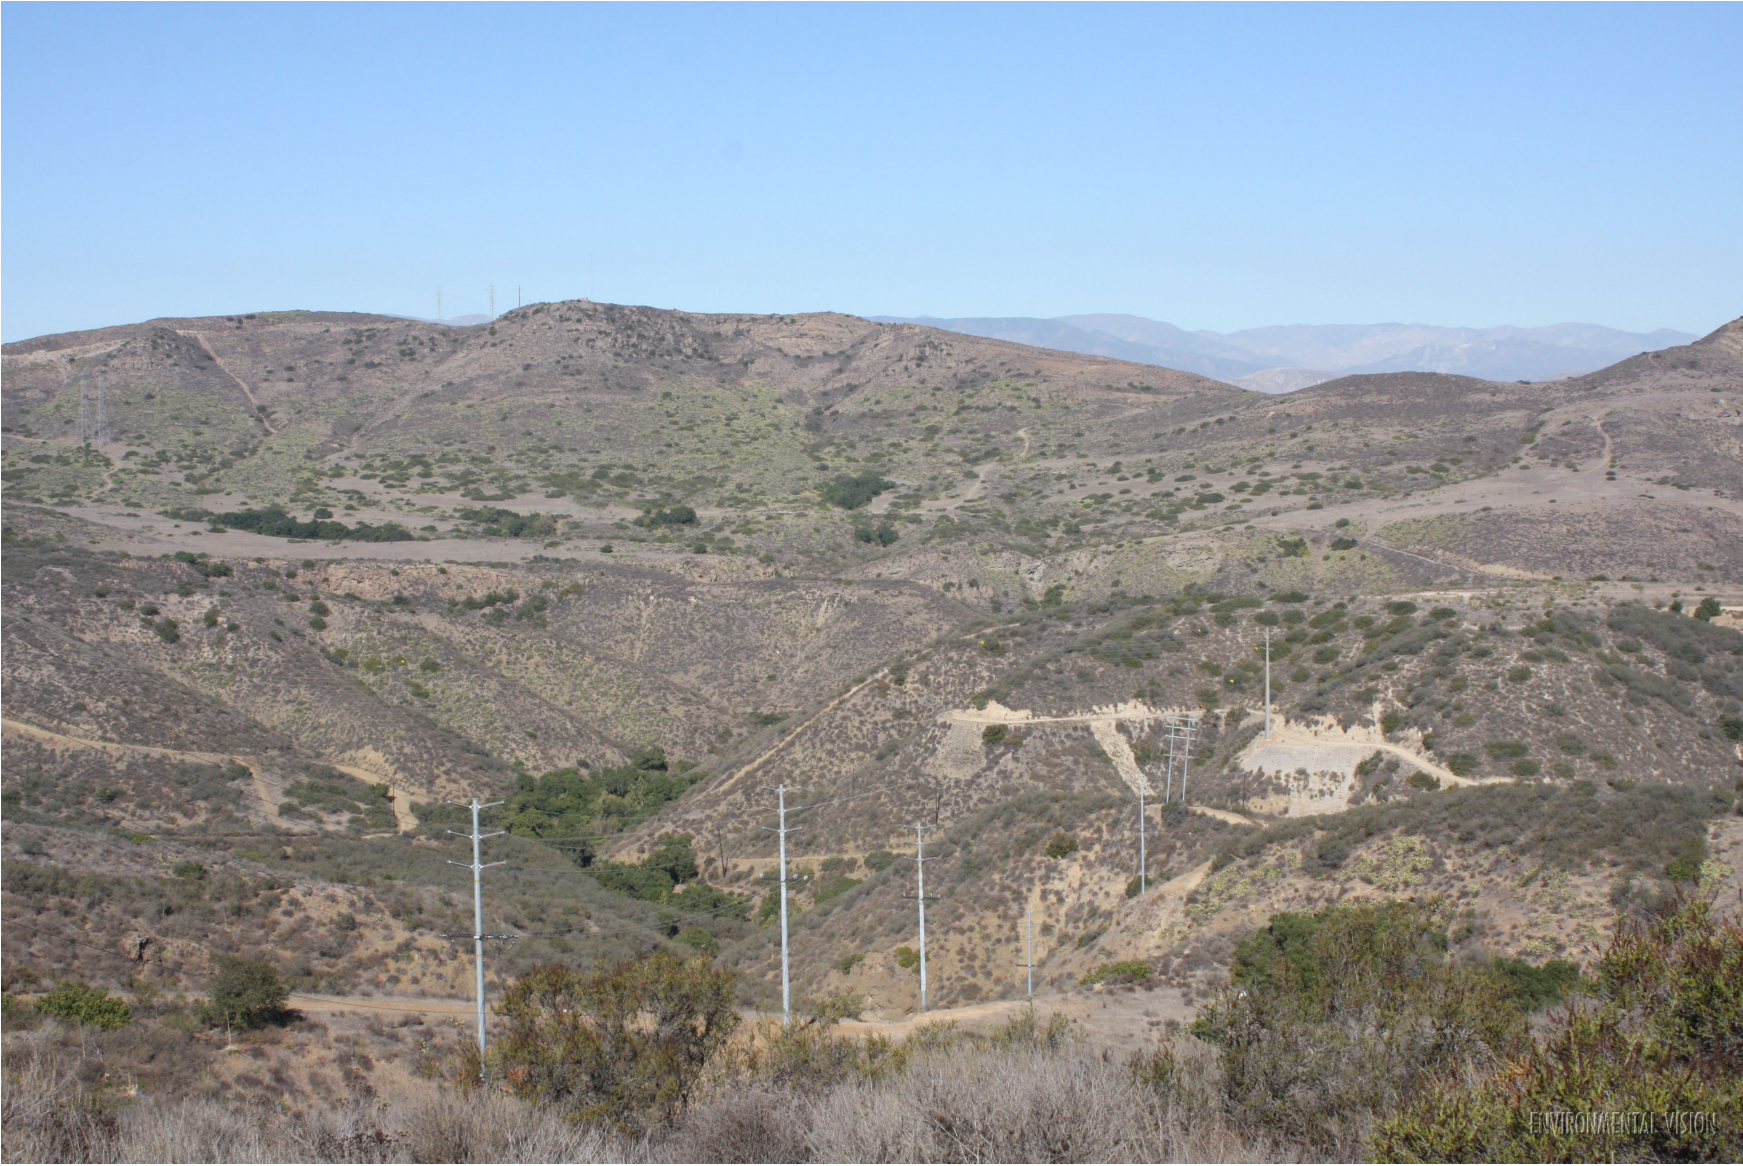
Figure
4.1-5e

Visual Simulation of Conditions Prior to Past Construction Activities

Visual Simulation of Conditions at the Conclusion of Future Construction Activities

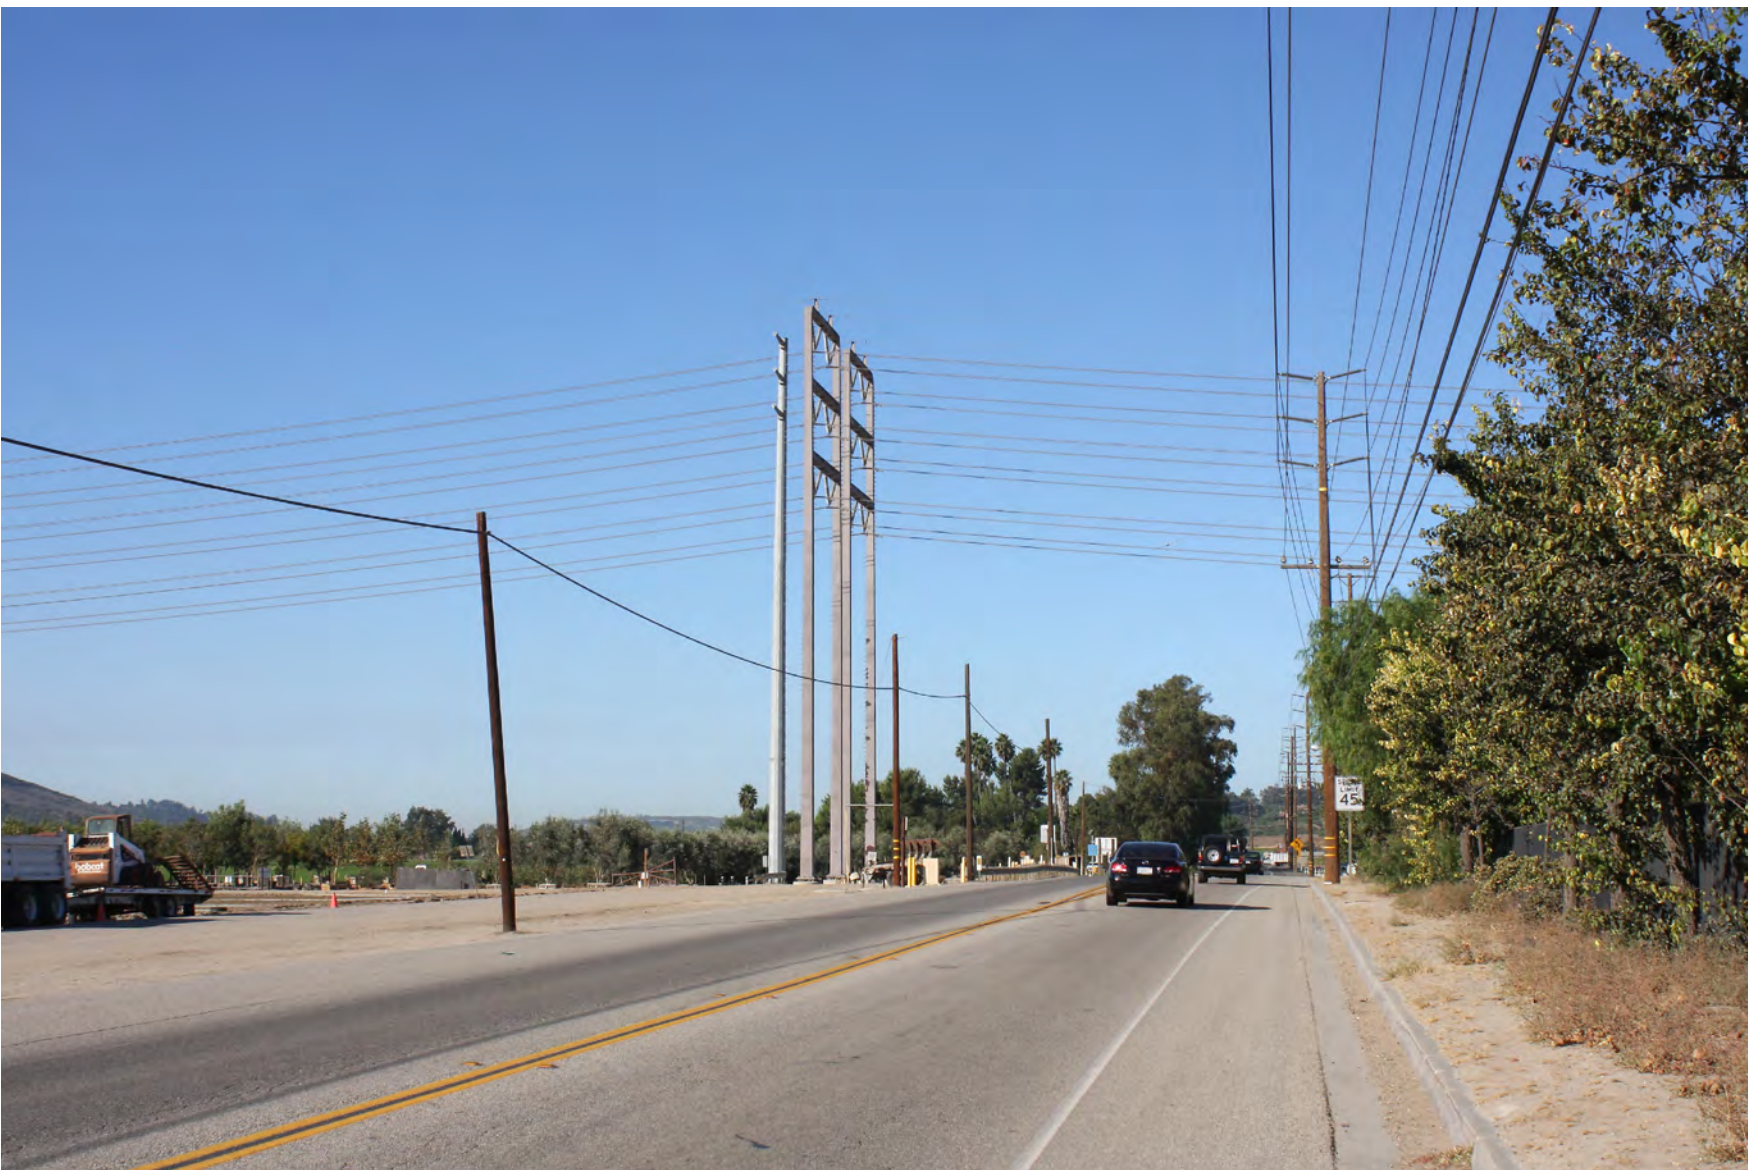
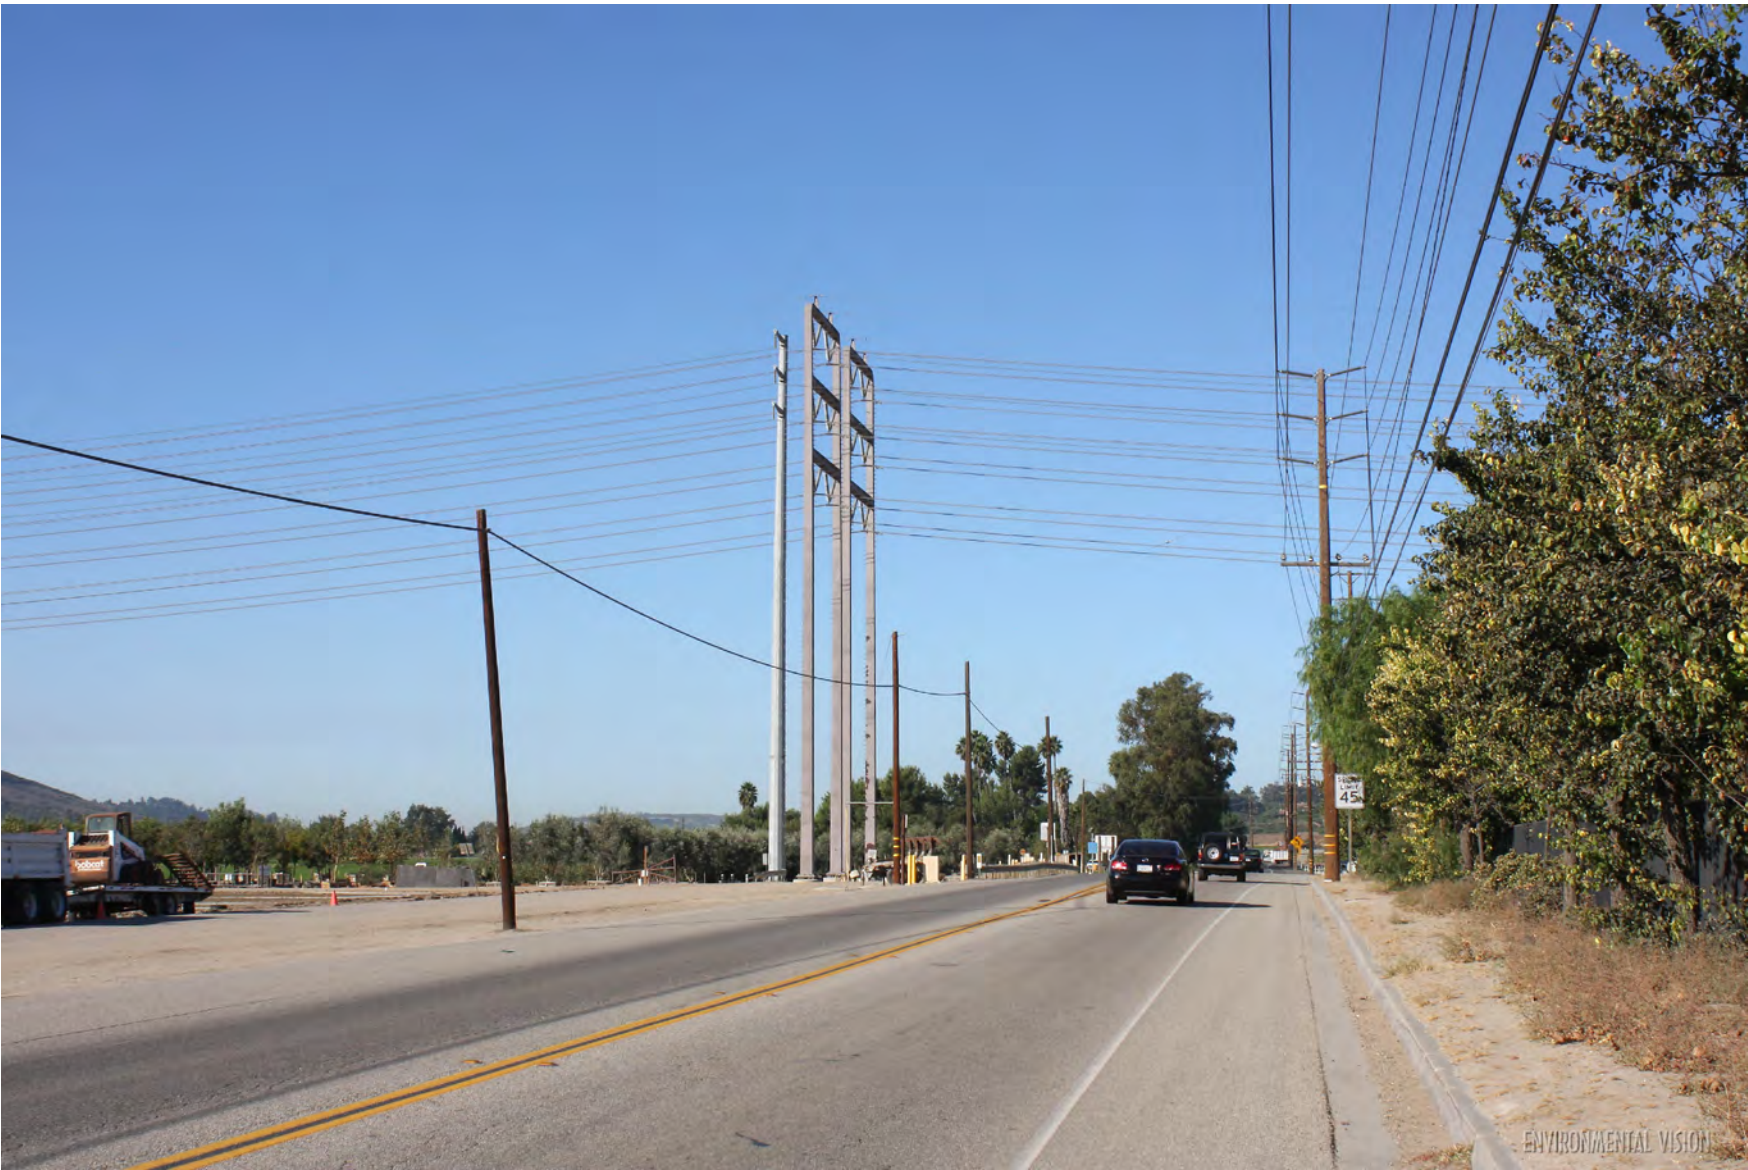
Visual Simulation of Conditions at the Conclusion of Past Construction Activities

Visual Simulation of Conditions at the Conclusion of Future Construction Activities

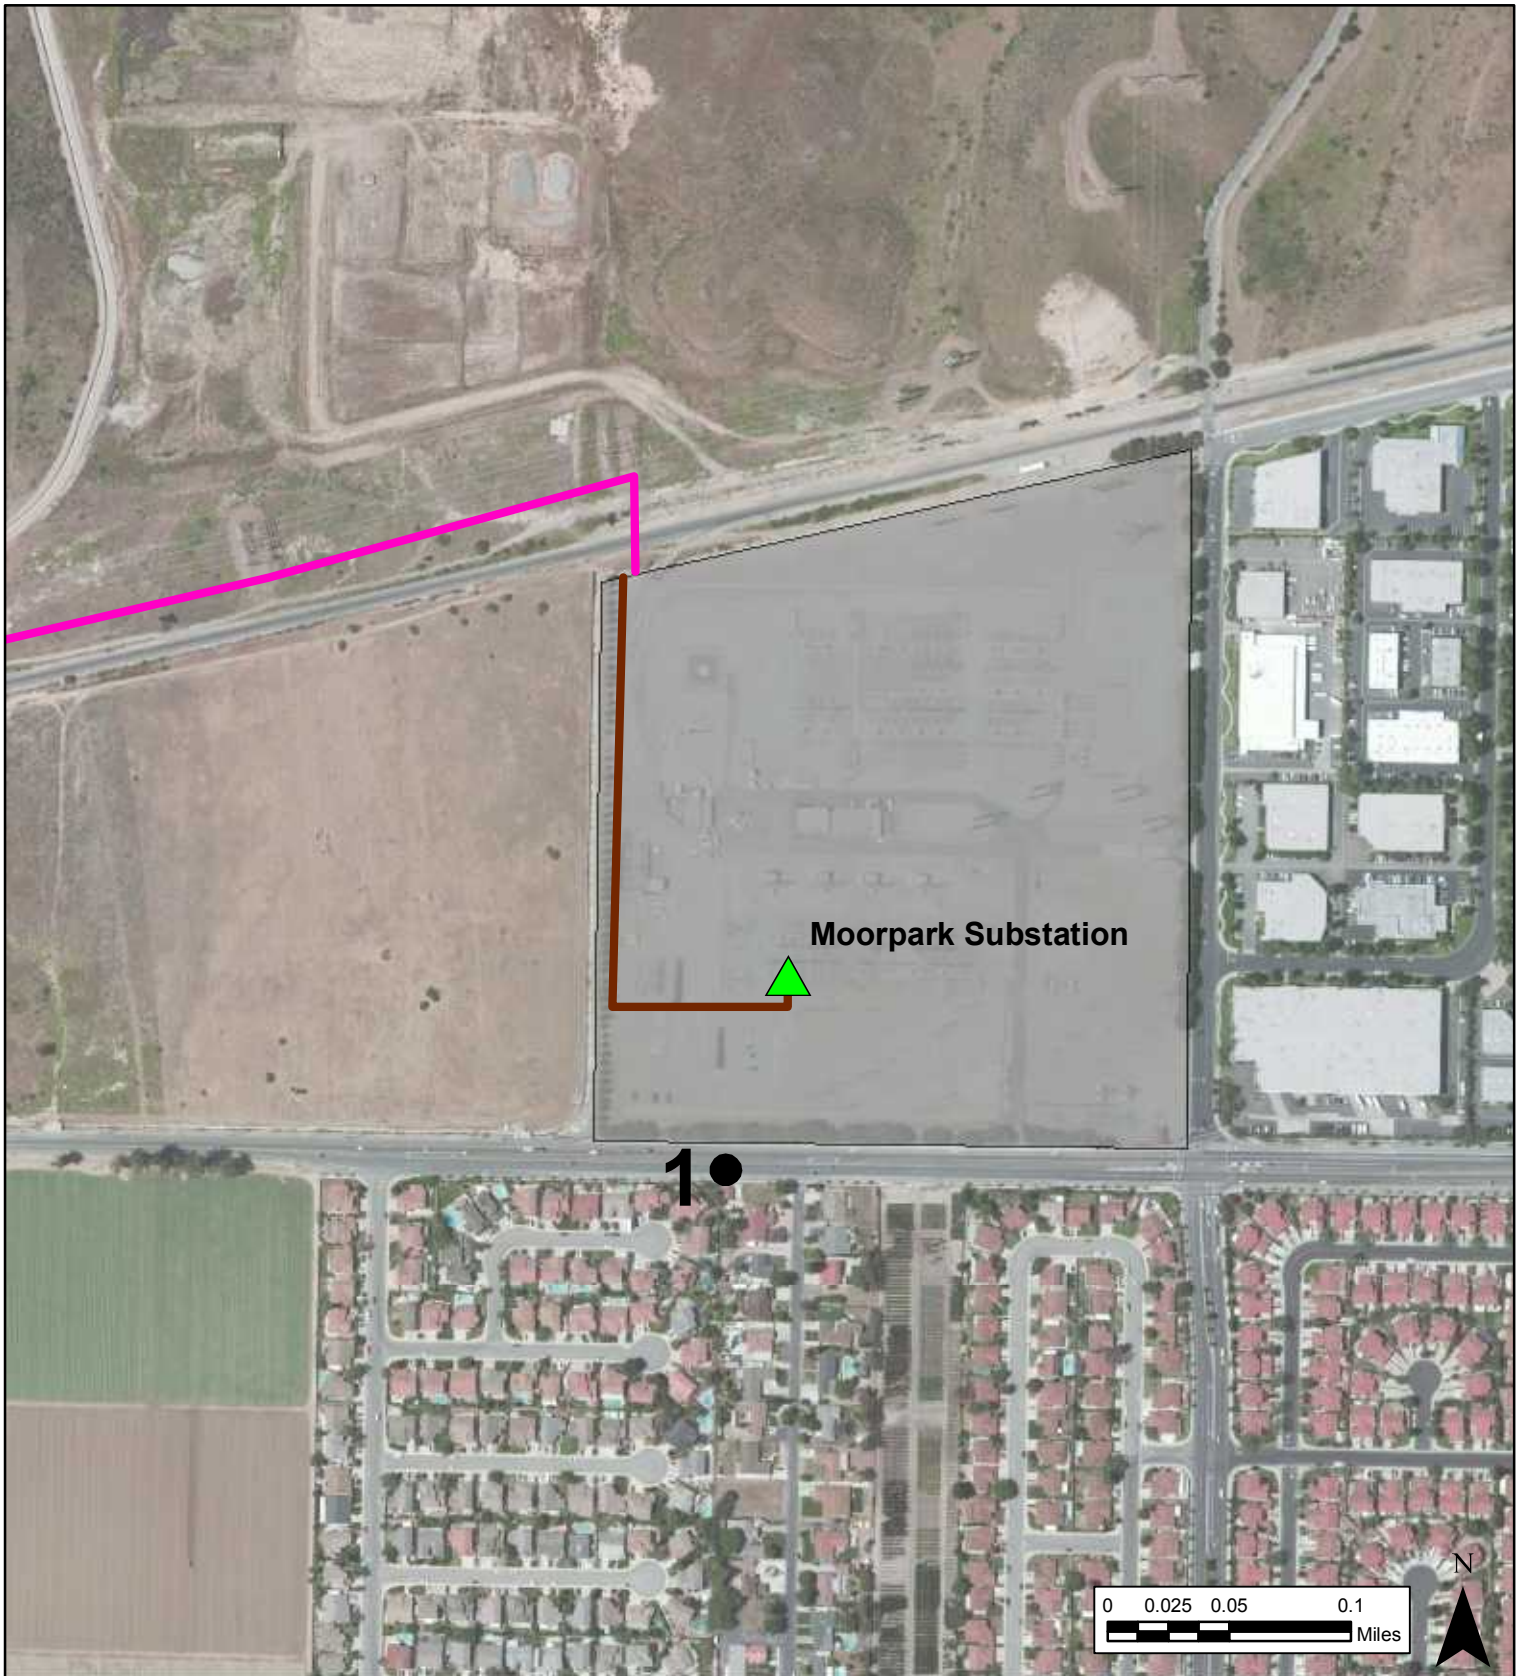
<div> <div> <div>●</div> <div>Noise Monitoring Location</div> </div> <div> <div>▲</div> <div>Substation</div> </div> </div> <div> <div>Project Sections</div> <div> <div>—</div> <div>Project Section 1</div> </div> <div> <div>—</div> <div>Project Section 2</div> </div> </div>	<div> <div> <div>SOUTHERN CALIFORNIA EDISON</div> <div>MOORPARK-NEWBURY 66 kV SUBTRANSMISSION LINE PROJECT</div> <div>VENTURA COUNTY, CALIFORNIA</div> <div>PROPONENT'S ENVIRONMENTAL ASSESSMENT</div> </div> <div> <div>NOISE MONITORING LOCATION -</div> <div>PROJECT SECTION 1</div> </div> <div> <div> <div> <div> <div> <div></div> <div></div> </div> <div> <div>SOUTHERN CALIFORNIA</div> <div>EDISON®</div> </div> <div> <div>An EDISON INTERNATIONAL® Company</div> </div> </div> <div> <div> <div></div> <div>ARCADIS</div> </div> <div> <div>Infrastructure · Water · Environment · Buildings</div> </div> </div> </div> <div> <div>Figure</div> <div>4.12-1b</div> </div> </div> </div></div>

To document the existing ambient noise levels in the Project Area, a series of one-hour equivalent sound level measurements (L_{eq} , A-weighted) were taken at a total of eight locations in the Project Area (Figures 4.12-1a through 1e). The results of this monitoring are shown in Table 4.12-2 below.

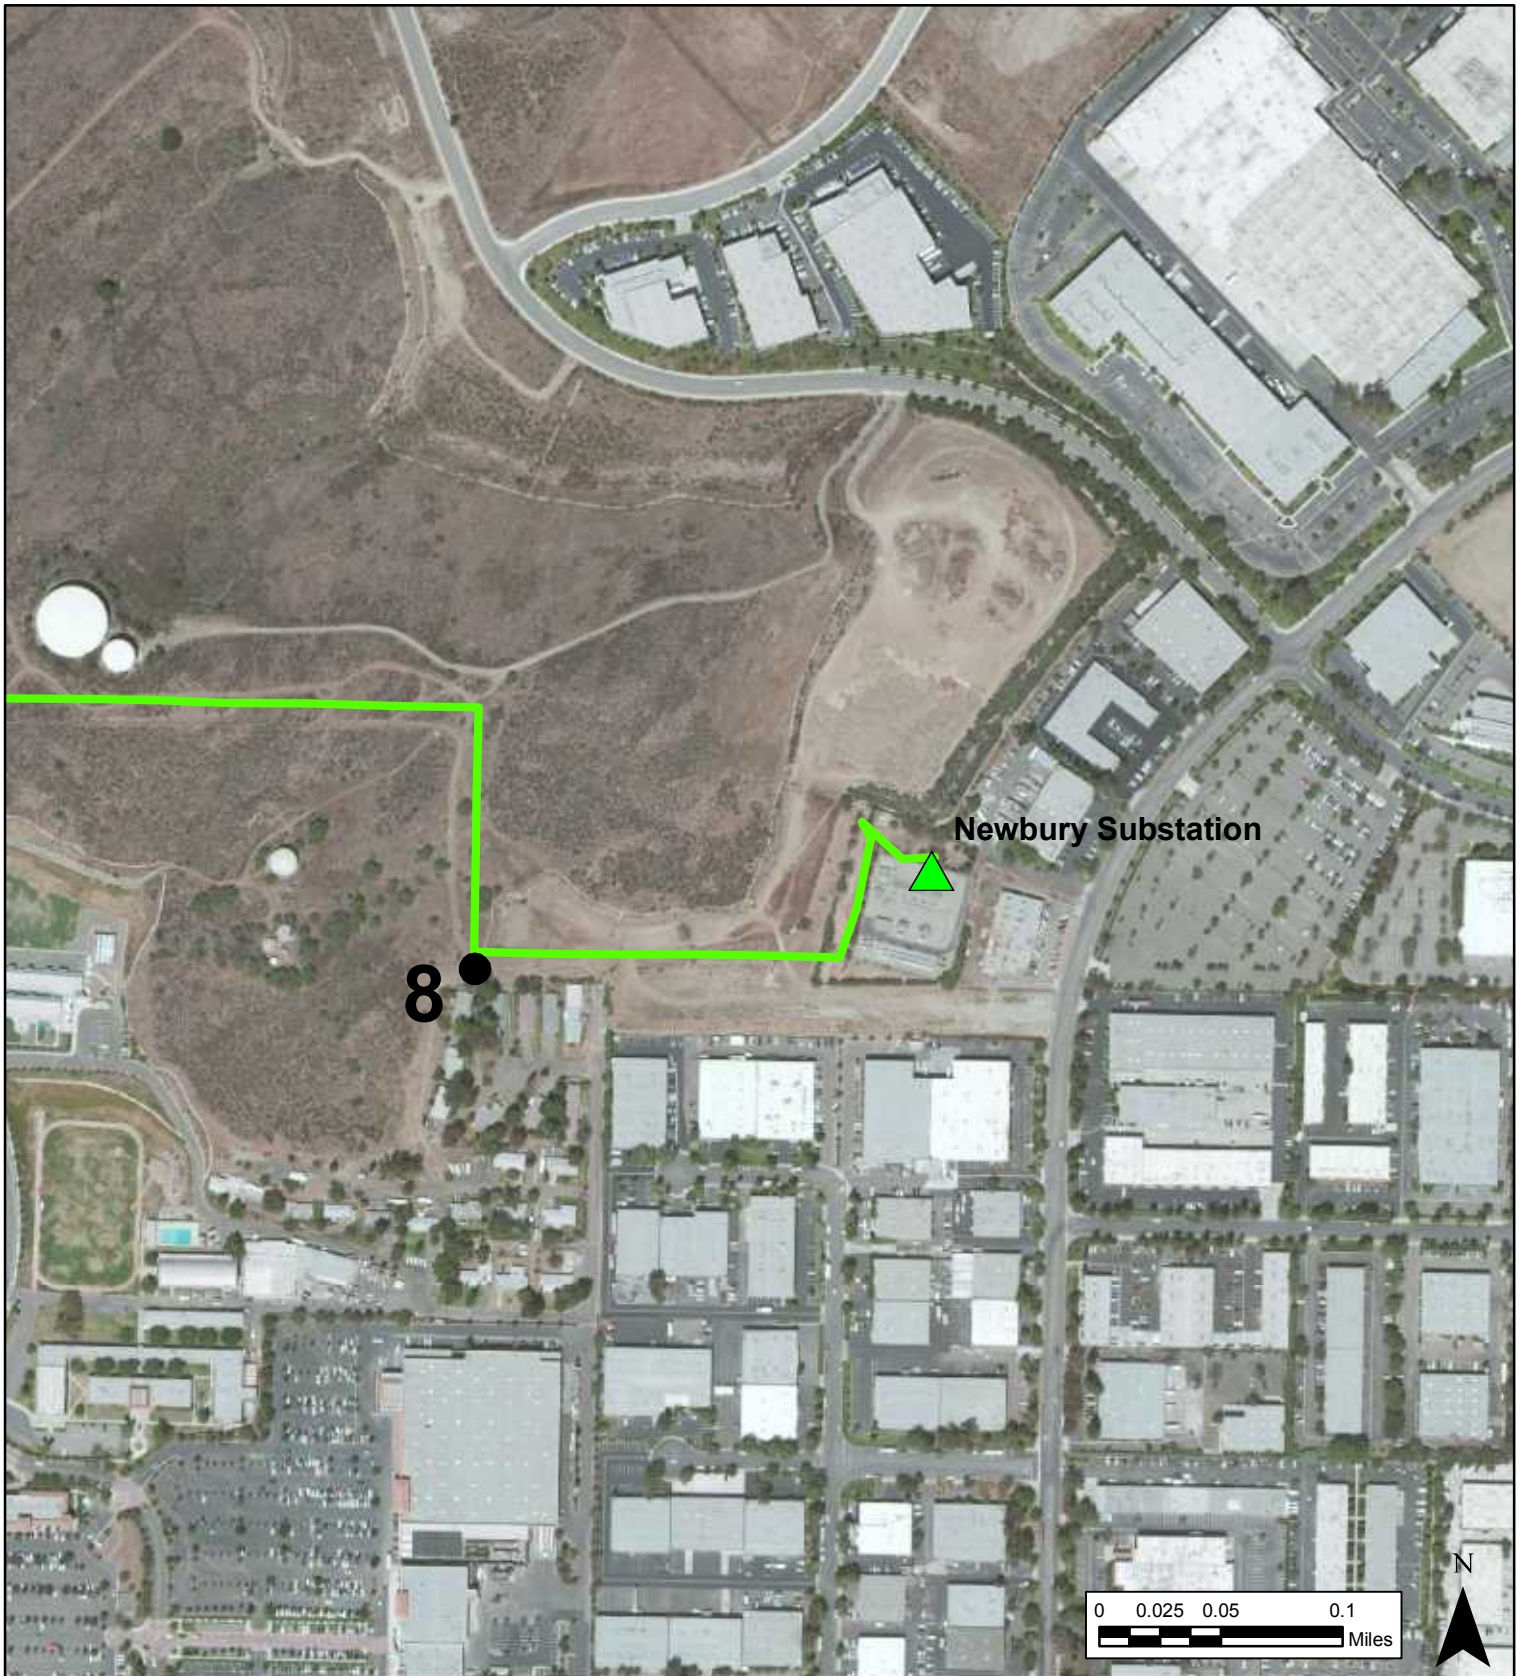
Figure
4.12-1e

- Noise Monitoring Location
- ▲ Substation
- Project Sections**
- Project Section 4

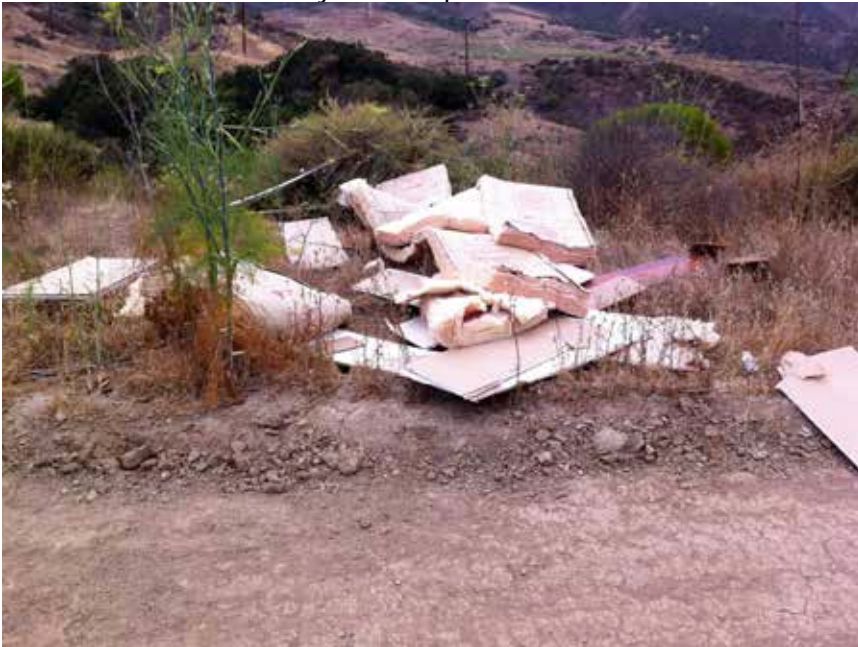
- 4) New dumping has occurred off Conejo Center Drive, including a pile of fiberglass insulation and drywall scraps.

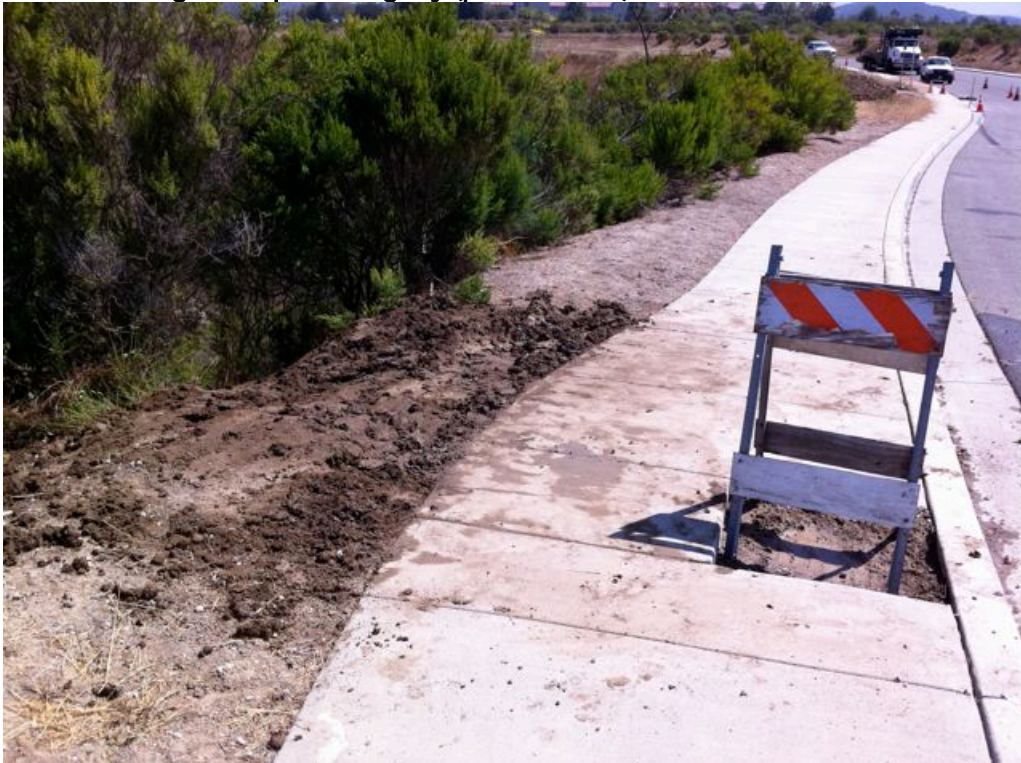
- 1) The gully undercutting the sidewalk on Conejo Center Drive grew larger in the storms around 3/20 and presents a potential trip hazard for the public. **Resolved by city workers filling the top of the gully (photo below).**

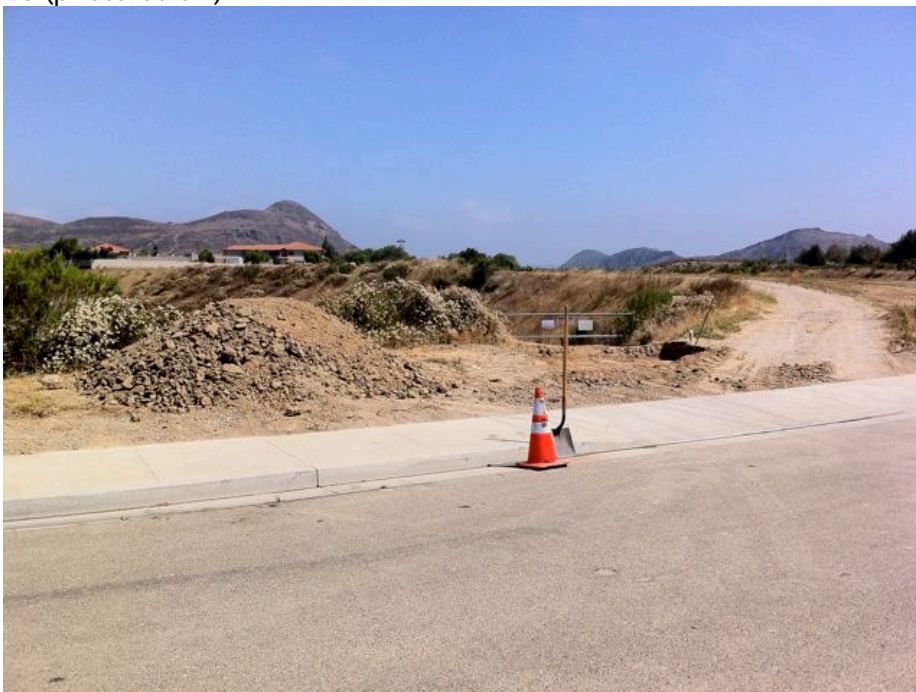
- 1) Tarps covering stockpiles on existing stockpiles at each construction entrance were being replaced.
- 2) A new construction entrance was being constructed for the road leading to towers 24-40 (photo below).

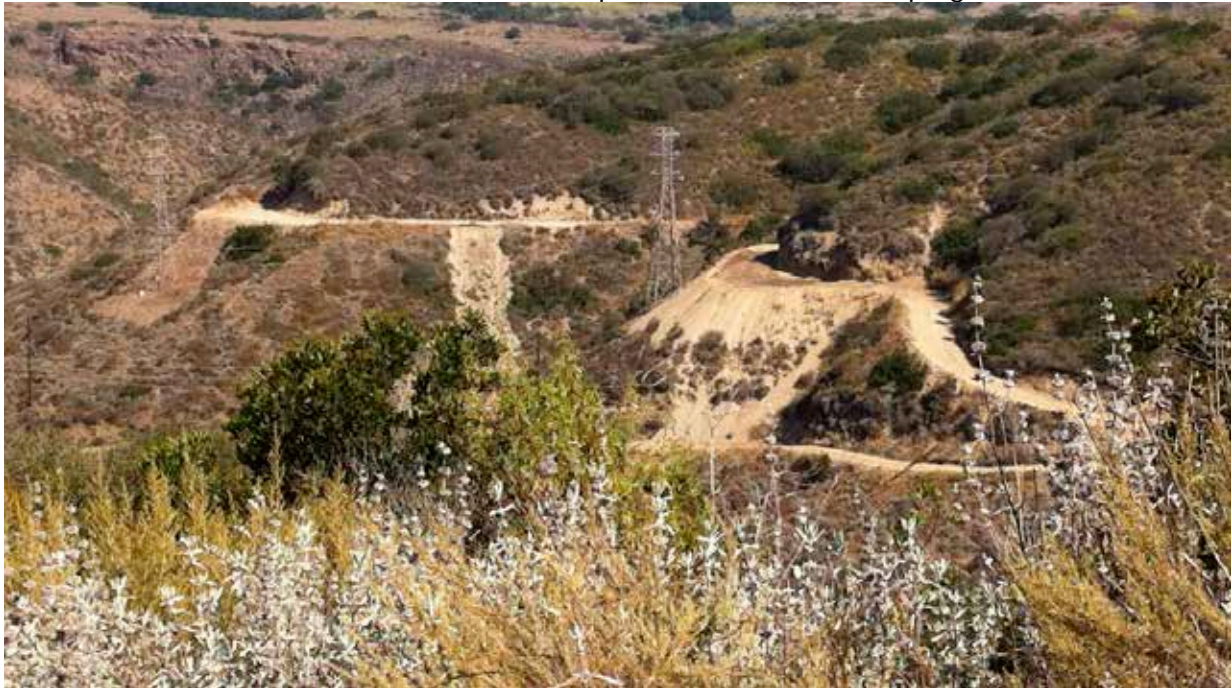
- 1) The newly graded road for poles 24-40 will need extensive drainage work to prevent erosion and sediment-laden storm water runoff.
- 2) There has been extensive grading to create a construction pad for pole 40. Resulting loose fill material stretches ~50 feet down and ~150 feet across the steep slope below. Careful stabilization will be needed to prevent erosion or slumping.

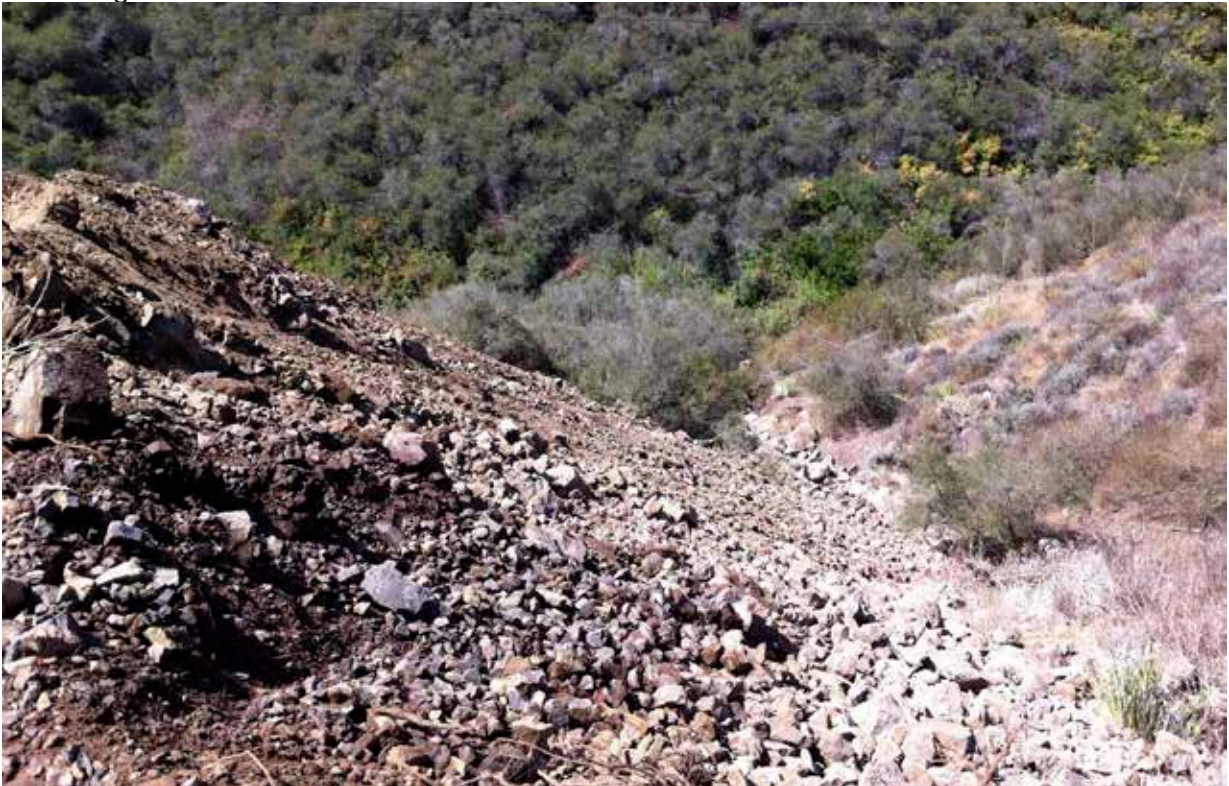
- 3) Extensive grading was underway to create a construction pad for pole 38. Resulting loose fill material stretches ~75 feet down and ~150 feet across the steep slope below. Careful stabilization will be needed to prevent erosion or slumping into the tributary of Calleguas Creek below.

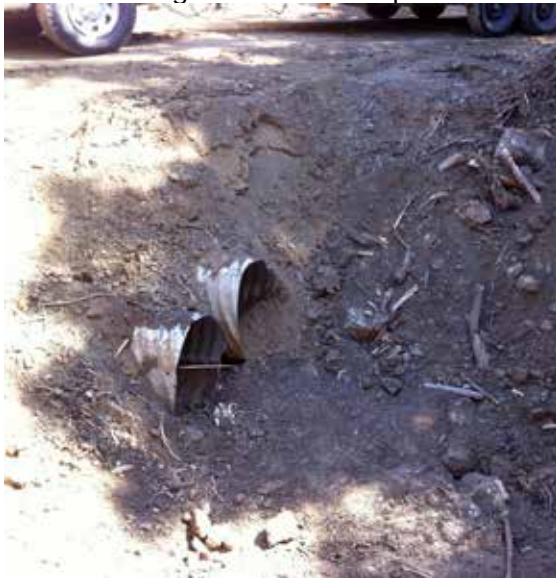
- 1) The stream crossing east of pole 40 has been graded too widely for the existing culverts. Options include (a) lengthening the culverts, (b) stabilizing the road edges to prevent slumping in front of the culverts, (c) pulling back the road edges away from the ends of the culverts resulting in a narrower road. Separately, the culverts may be undersized for the drainage as the crossing had washed out previously. Recommended action includes increasing the diameter of the culverts, adding a third culvert, and/or adding a trash rack to protect the inlets.

Inlets partially blocked.

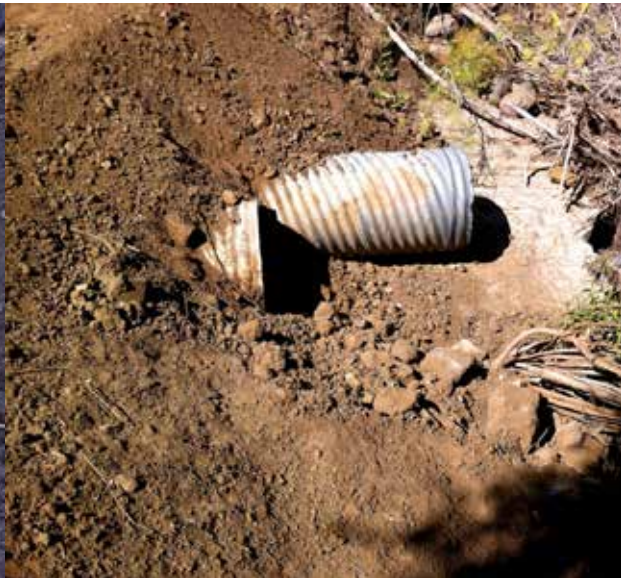
Sediment falling in front of outlet.
