In the Matter of the Application of SOUTHERN) Application No. _____
CALIFORNIA EDISON COMPANY (U 338-E) for a)
Permit to Construct Electrical Facilities)
With Voltages Between 50 kV and 200 kV:)
Moorpark-Newbury 66 kV Subtransmission Line Project)

Dated: October 28, 2013

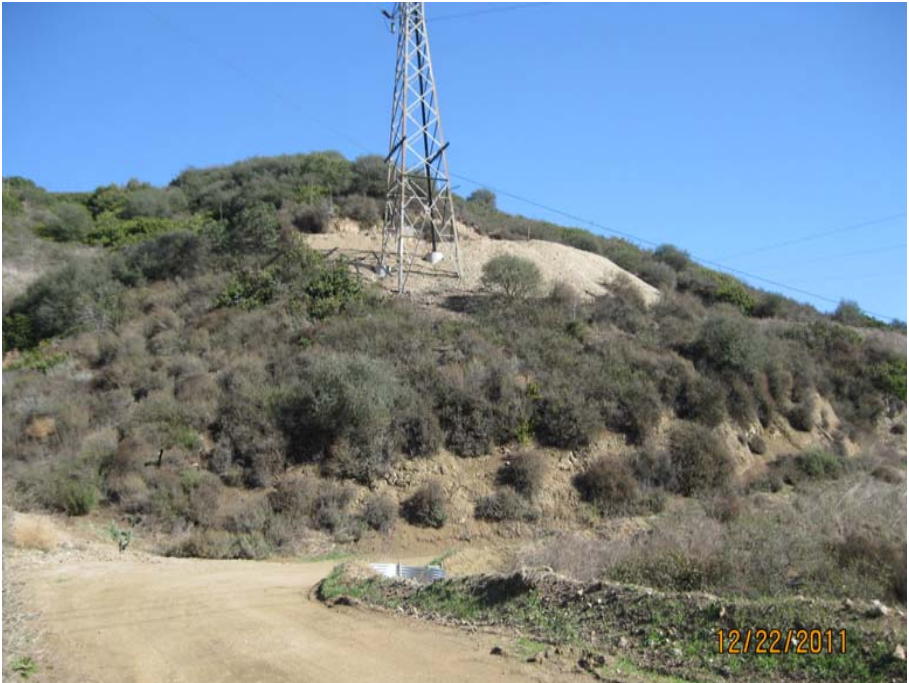
Photo 9: View looking northeast of top section of erosion at Site C.

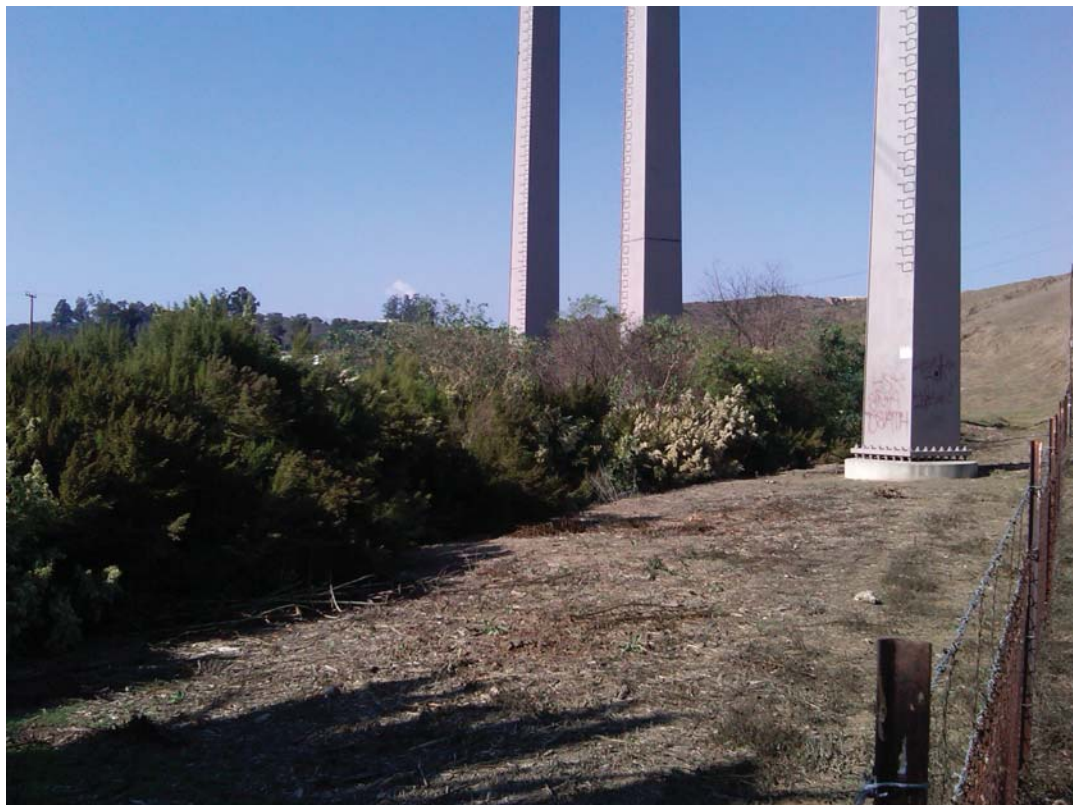
Photographic Documentation – Tower Location No. 6

October 26, 2011. Riparian Vegetation Conditions at Tower Location 6.

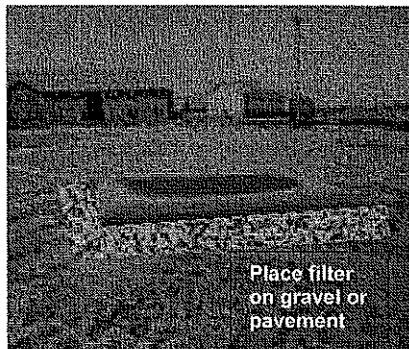
Gravity Bag Filter

- A gravity bag filter, also referred to as a dewatering bag, is a square or rectangular bag made of non-woven geotextile fabric that collects gravel, sand, silt, and fines.

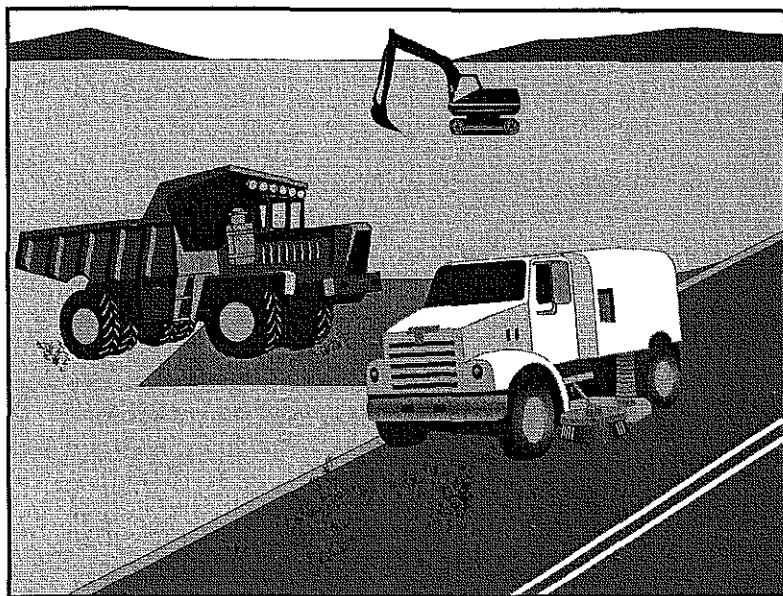
Street sweeping and vacuuming includes use of self-propelled and walk-behind equipment to remove sediment from streets and roadways, and to clean paved surfaces in preparation for final paving. Sweeping and vacuuming prevents sediment from the project site from entering storm drains or receiving waters.
