memorandum

subject MPWSP – Ryan Ranch – Bishop Interconnection Project Weekly Report (02/17/2020 – 02/21/2020)

RE: **MPWSP Construction Biological Monitoring Report**

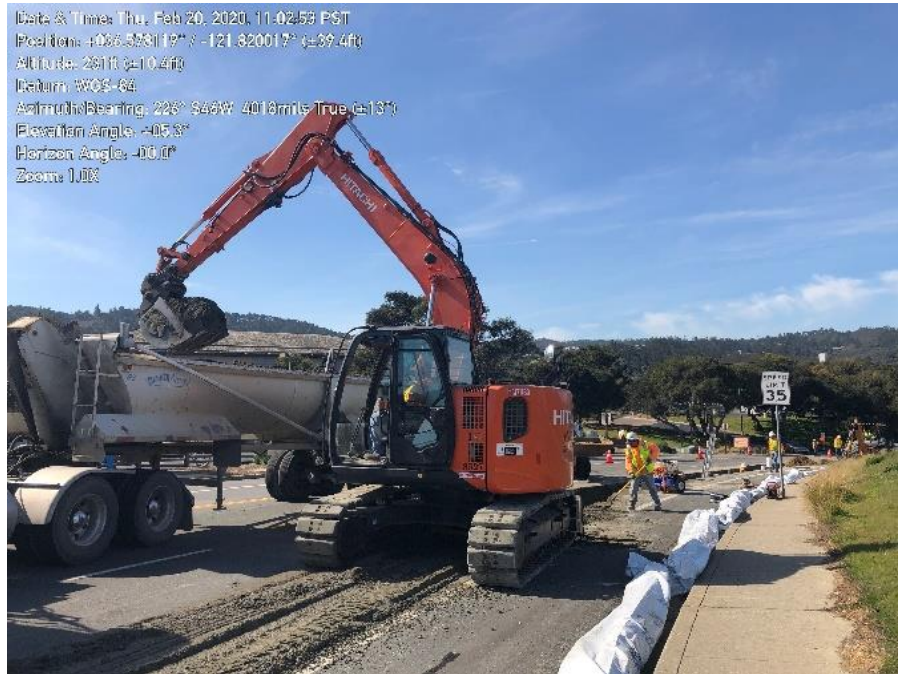
Construction activities occurred on Ragsdale Drive during the week of 02/17/2020 – 02/21/2020. Construction activities consisted of excavation and installation of 8-inch pipe. Pipeline installation activities were conducted by Monterey Peninsula Engineering (MPE). Additional information about construction activities is included in the weekly CalAm report included in **Appendix A** and CPUC inspection logs included in **Appendix B**.

Photo 1. MPE excavation of pipeline trench on Ragsdale Drive.

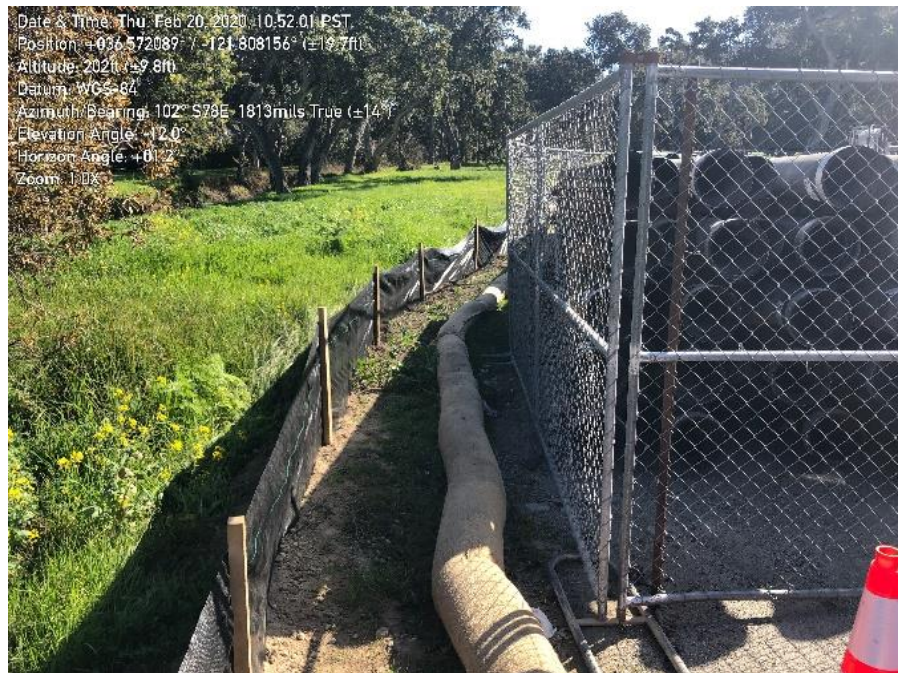
- An unnamed creek is located approximately 50-feet north of the staging area. Due to the potential for California red-legged frog to occur in the unnamed creek, ESA recommended installing silt fence around the perimeter of the staging area (not including the road) to prevent any animals from entering the staging area. Silt fence was installed on 2/19/2020 around the staging area.

Photo 2. Silt fence installed around staging area off of York Road

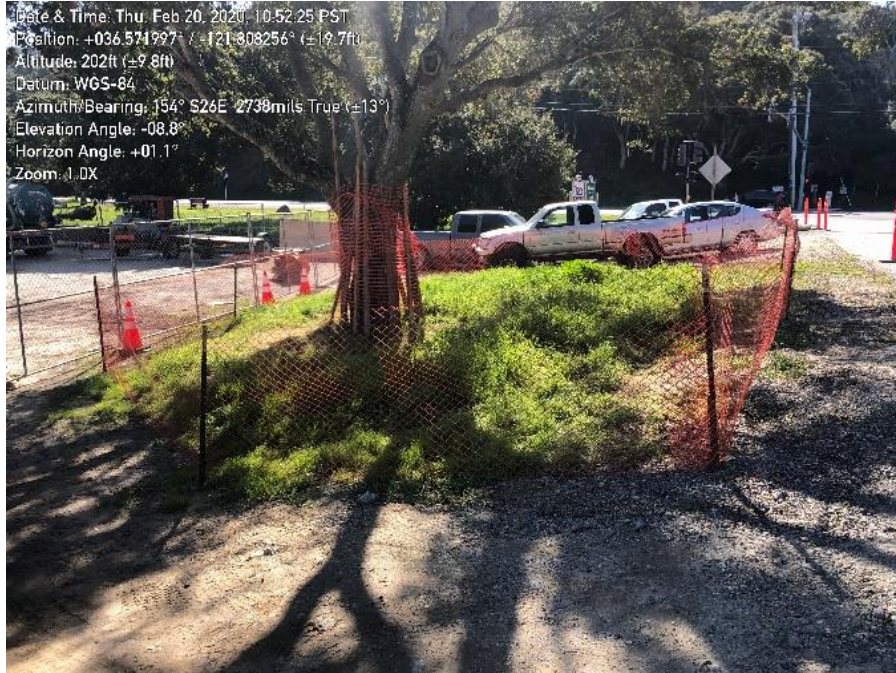
- Cyclone fencing and wildlife-friendly straw wattle were placed around the graveled area prior to the start of pipeline installation activities. On 2/12/2020, the ESA monitor noted that cars were being parked around a mature coast live oak tree growing along the street and outside of the cyclone fencing and discussed adding fencing as tree protection to prevent and impacts from vehicles and/or equipment. Tree protection was installed in the form of orange construction fencing around the drip line of the coast live oak tree.

Photo 3. Tree protection installed around coast live oak tree in front of York Road staging area

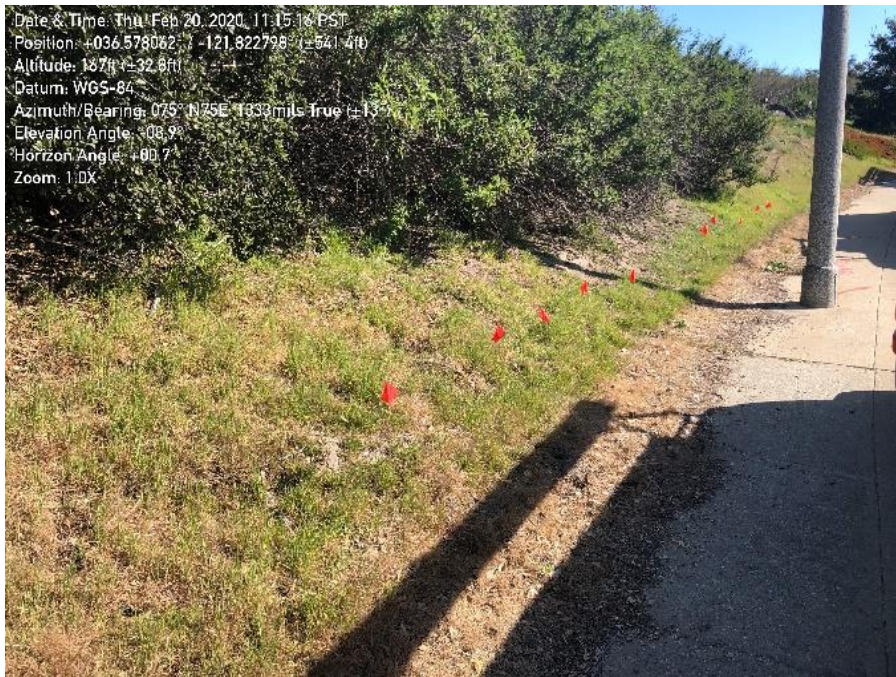
On 2/12/2020, CalAm monitors discussed necessary protection measures for woodrat middens which have been found along Ragsdale Avenue with ESA. Some of the middens are within 50 feet of the construction area, but are located on a vegetated hillside not easily accessible by vehicles. The MMCRP notes the following:

CalAm monitors installed flagging along Ragsdale Avenue where middens have been observed to demarcate the area and prevent any construction related impacts to middens.

Photo 4. Flags along Ragsdale Drive demarcating areas with woodrat middens

Mitigation Measure 4.6-1k.3. If nests are observed outside of the construction area, the qualified biologist shall demarcate a minimum 50-foot buffer area with orange construction fencing and require that all construction activities and disturbance remain outside of the fencing.

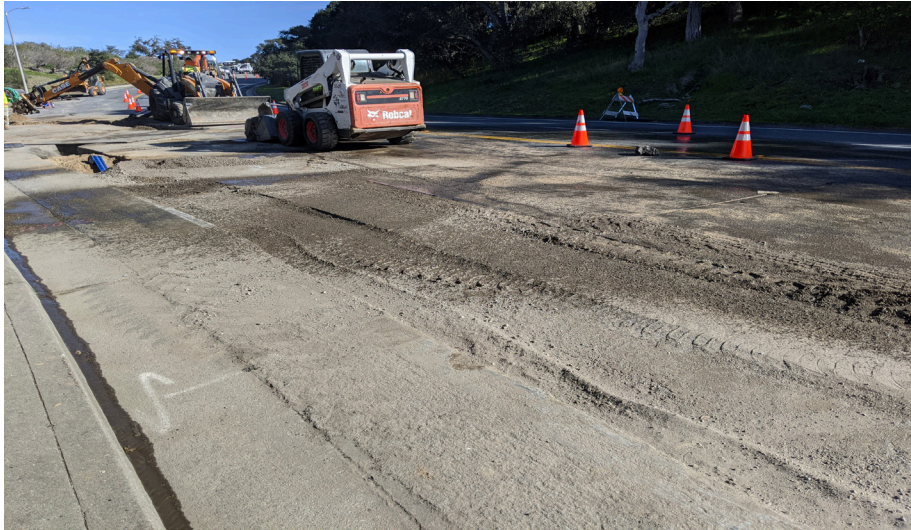
Photo 1. Dust abatement within minimal water usage. (2-18-2020).

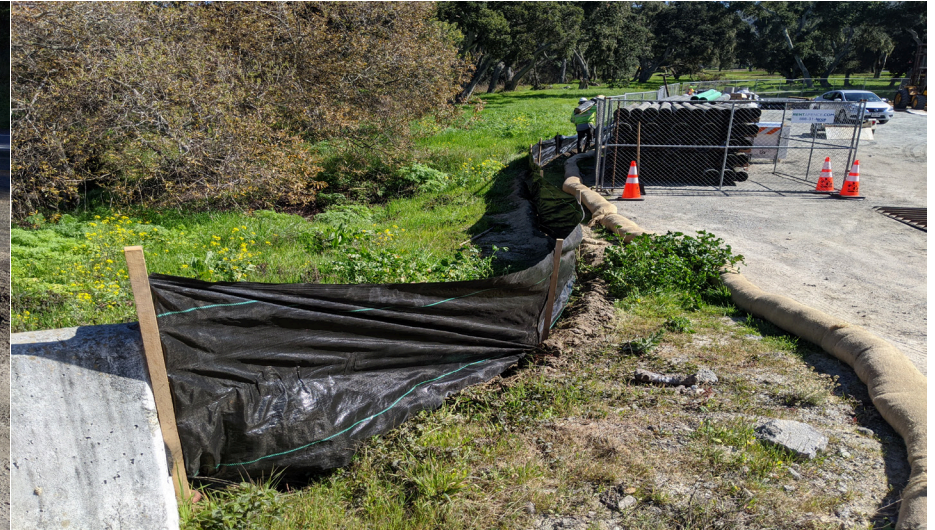
Photo 2. Installation of silt fencing around staging area. (2-19-2020).

- Directed installation of silt and ESA fencing at staging area.
 - Photographed and recorded all monitoring activities.
- 2/20/2020
 - Conducted wildlife clearance survey on all vehicles and equipment at staging area and on alignment.

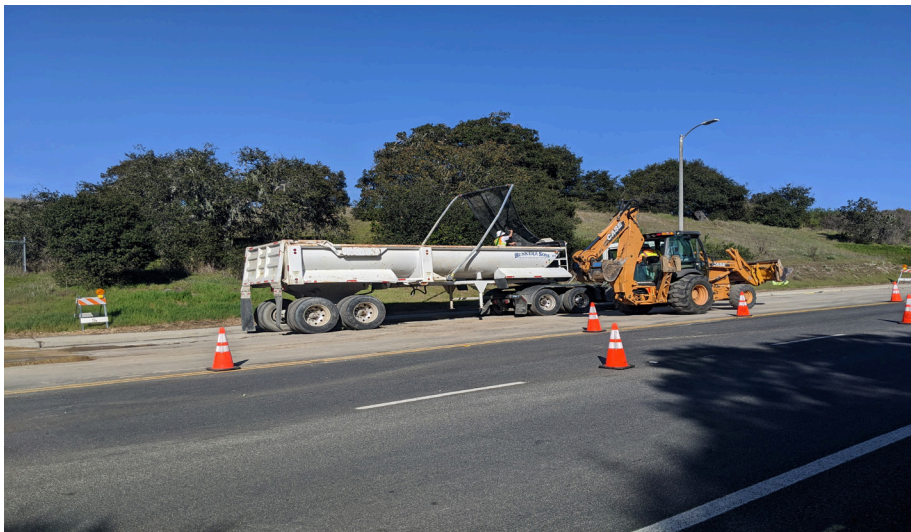
Photo 3. Dust control coverage over soil transportation vehicles. (2-19-2020).

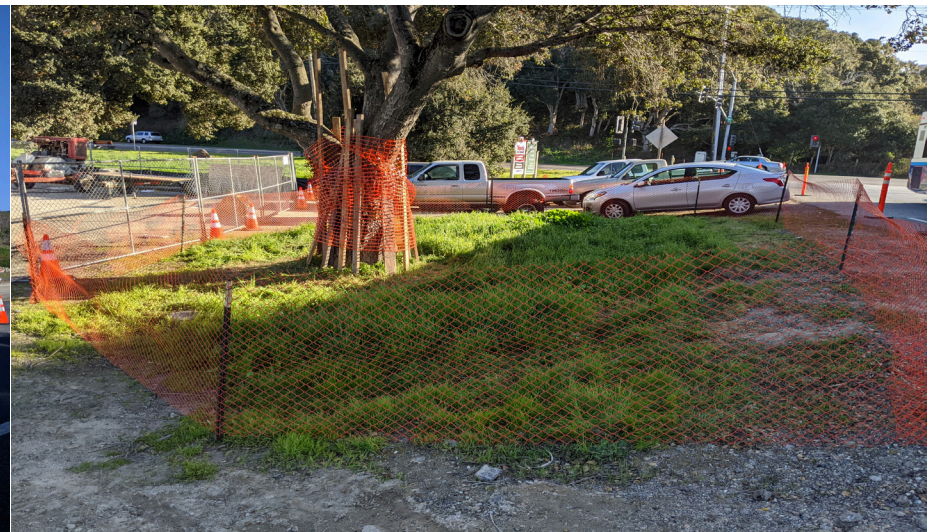
Photo 4. Completed ESA fencing protection around tree outside of staging area. (2-19-2020).

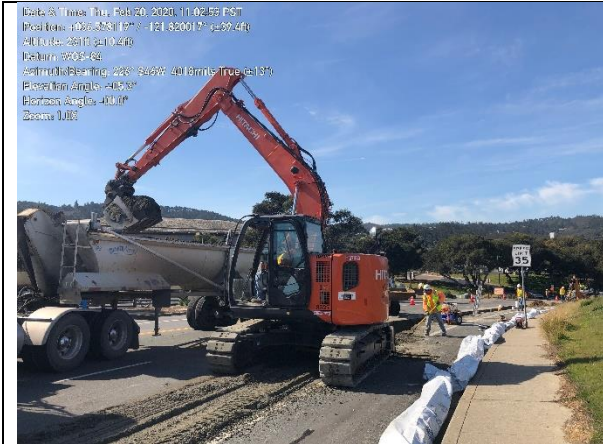
Photo 1. MPE excavation of pipeline trench

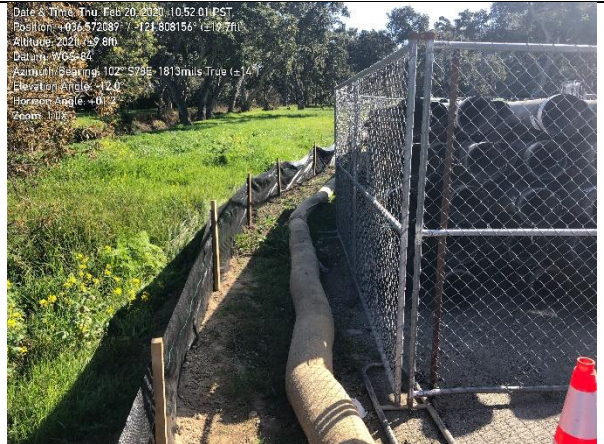
- Cyclone fencing and wildlife-friendly straw wattle have been placed around the graveled area. On 2/19/2020, silt fence surrounding the parking area was installed to prevent any wildlife potentially residing in the nearby unnamed creek from entering the staging area. The unnamed creek is located approximately 50-feet north of the staging area.
- Tree protection has been installed in the form of orange construction fencing around the drip line of a mature coast live oak tree, located between the staging area and York Road.
- CalAm monitors noted that they had requested MPE to provide trash receptacles and instruct all workers on site to dispose of any trash.

Photo 2. Silt fence surrounding staging area

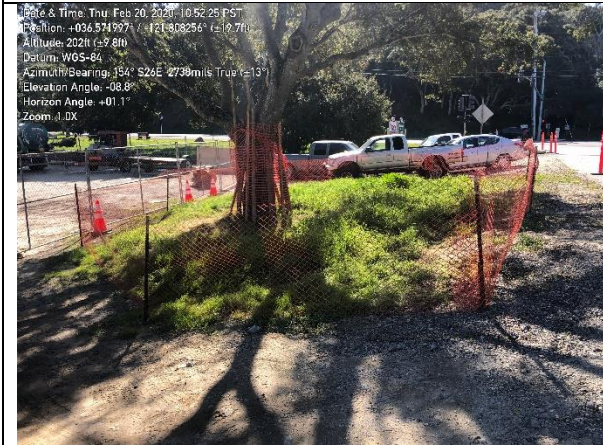
Photo 3. Tree protection installed around drip line of oak tree

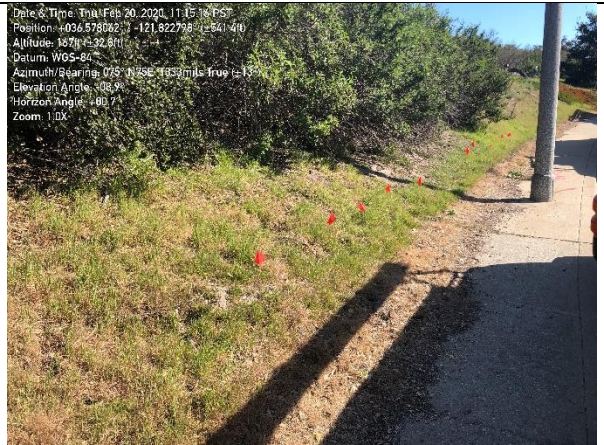
- Special status species plants (i.e., *Horkelia cuneata ssp.*) have been flagged along the entire construction area.
- On 2/12/2020, CalAm monitors noted that woodrat middens had been found along Ragsdale Avenue. Flagging was installed along Ragsdale Avenue where middens have been observed to demarcate the area and prevent any construction related impacts to middens.

Photo 4. Flags along Ragsdale Drive demarcating areas with woodrat middens
