memorandum

subject MPWSP – Carmel Valley Pump Station Project Weekly Report (12/14/2020 – 12/18/2020)

CalAm Weekly Report

CPUC Inspection Logs

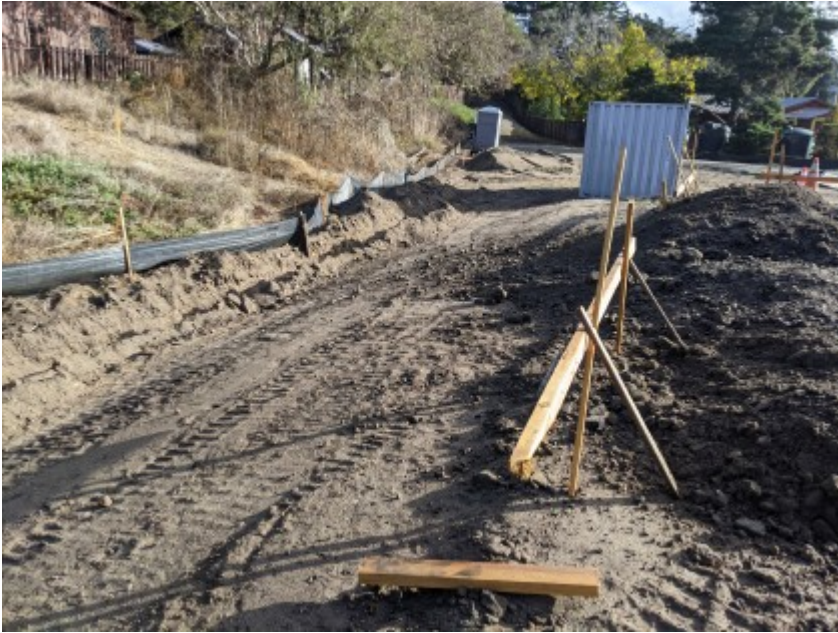
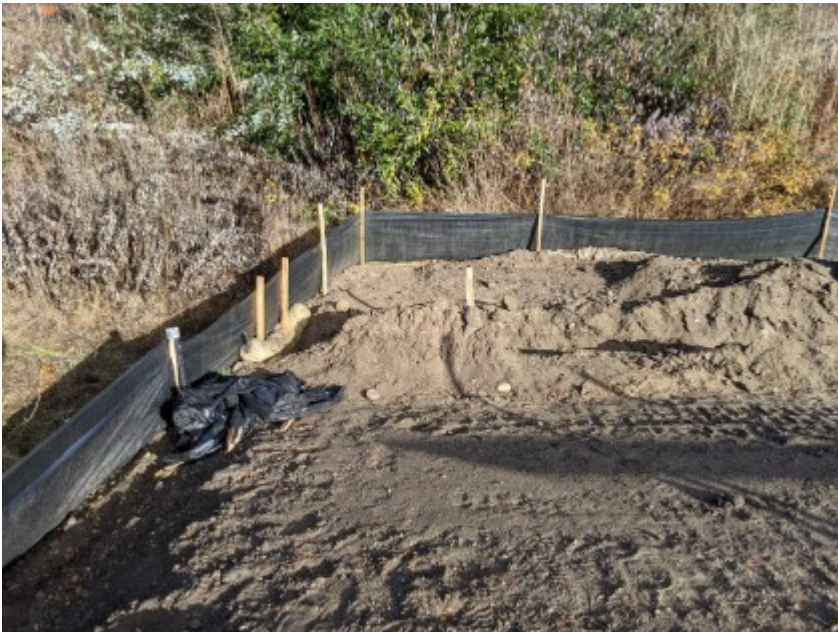
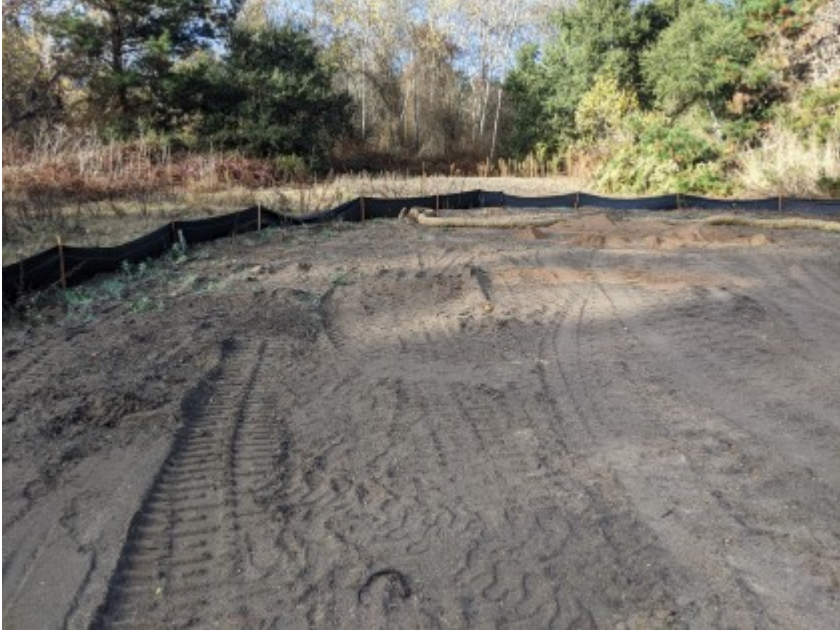
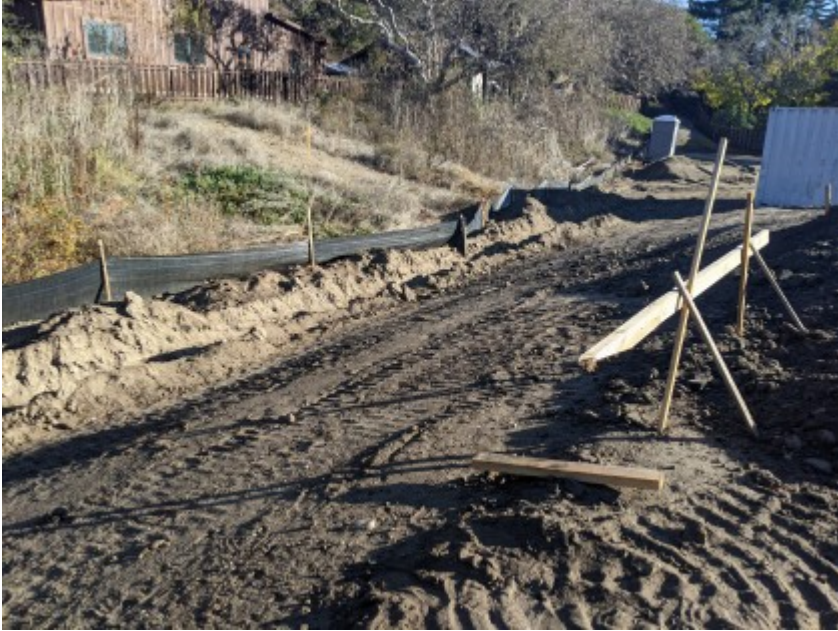
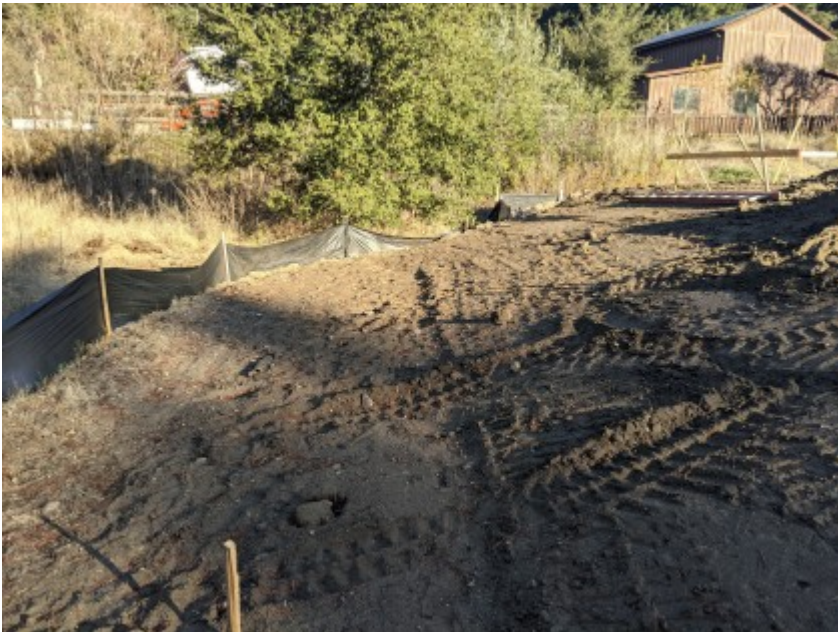
12/14/2020 - Intact exclusionary fencing surrounding work area.

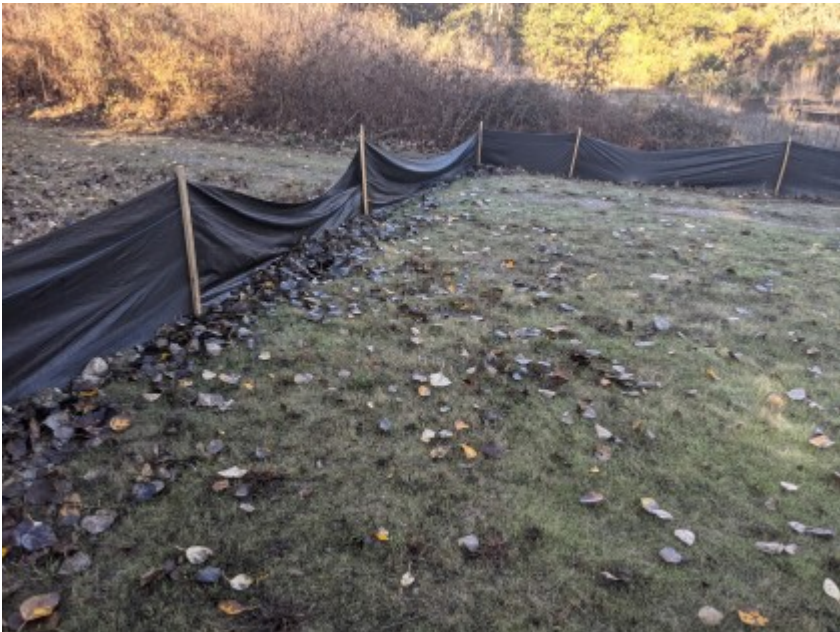
- DD&A compliance monitor inspected the status of exclusionary fencing and proper trash disposal in accordance with Mitigation Measure 4.6-1c.
- DD&A performed ongoing monitoring according to Mitigation Measure 4.6-1a.
- Met with ESA and walked site.
- Identified section of exclusionary fencing in need of repair on southern end of work area.
- Photographed and recorded all monitoring activities.

12/15/2020 - Exclusionary fencing on southern end of work area beginning to sag, in need of repairs

- A small section of silt fence along the south side of the site was slumped and identified as needing repair.

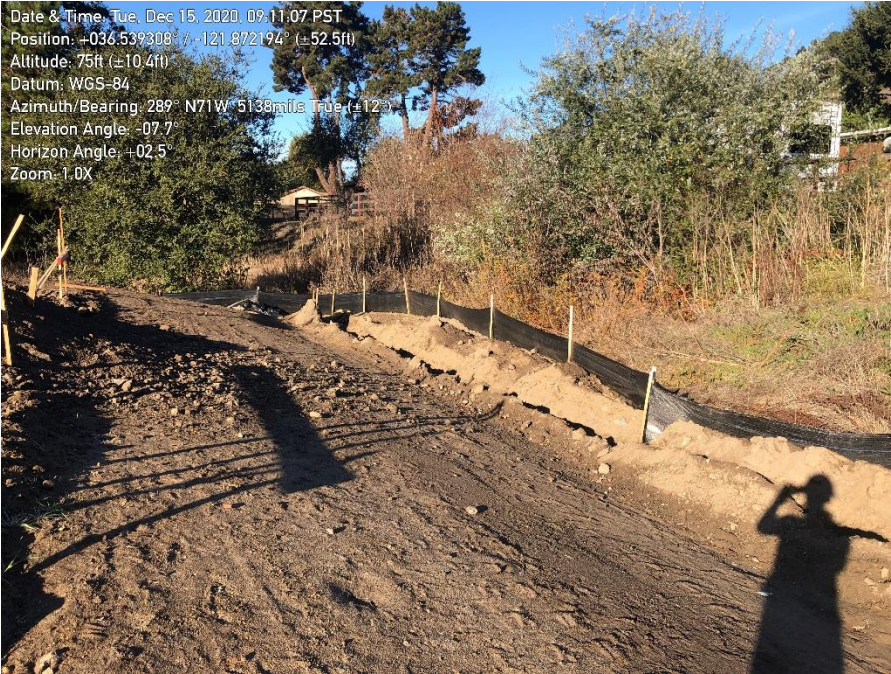
Photo 1. Silt fence near pad.

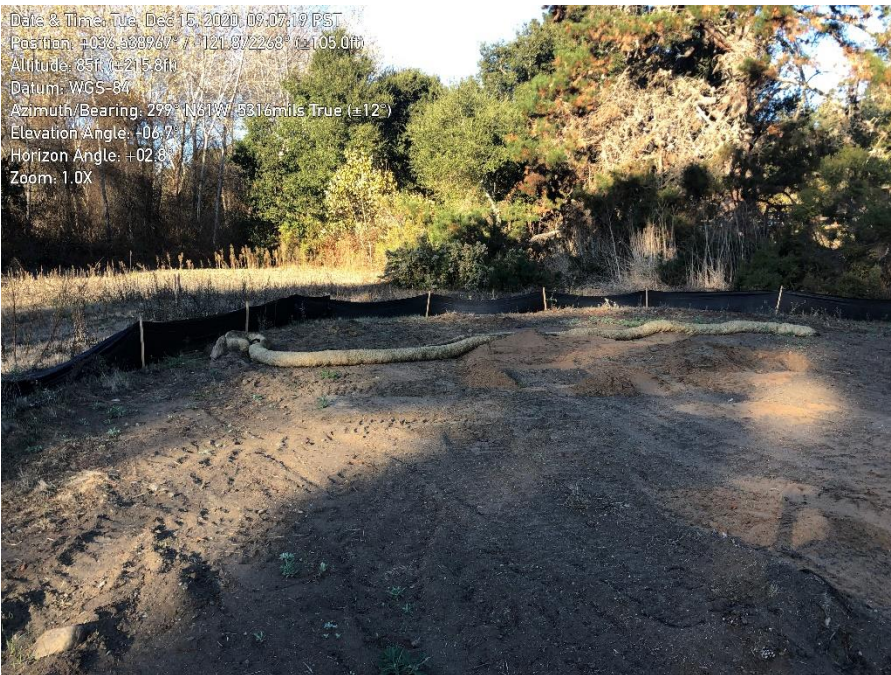
- CalAm monitor onsite to conduct weekly site inspection.
- Silt exclusion fence in acceptable condition to prevent special-status amphibians from entering the site (Mitigation Measure 4.6-1o). Minor slumping near south side of site will need to be repaired.
- Pipes in work area were capped as required by Mitigation Measure 4.6-1o.

Photo 2. Silt fence at south end of side.

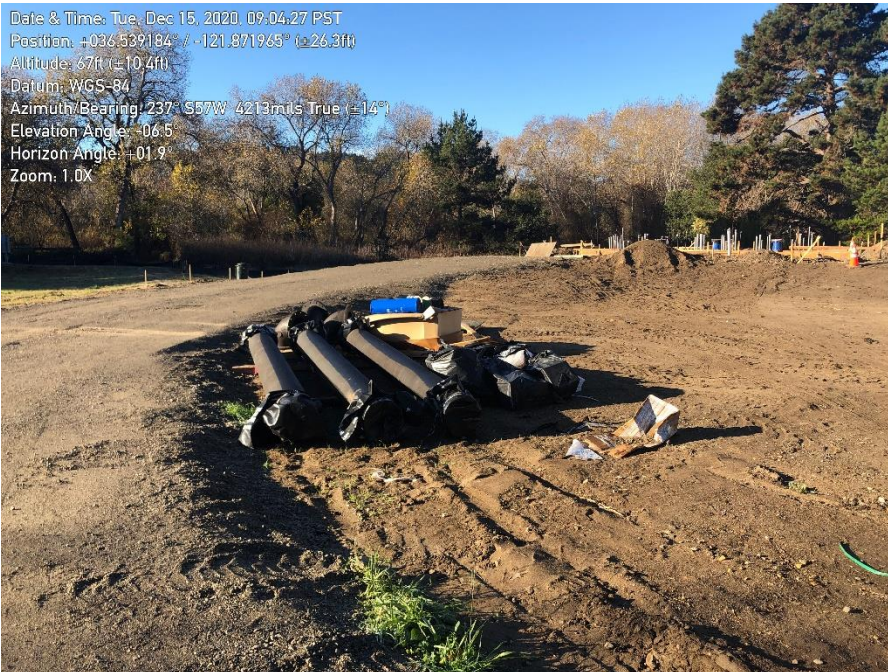
Photo 4. Pipes stored on site capped.

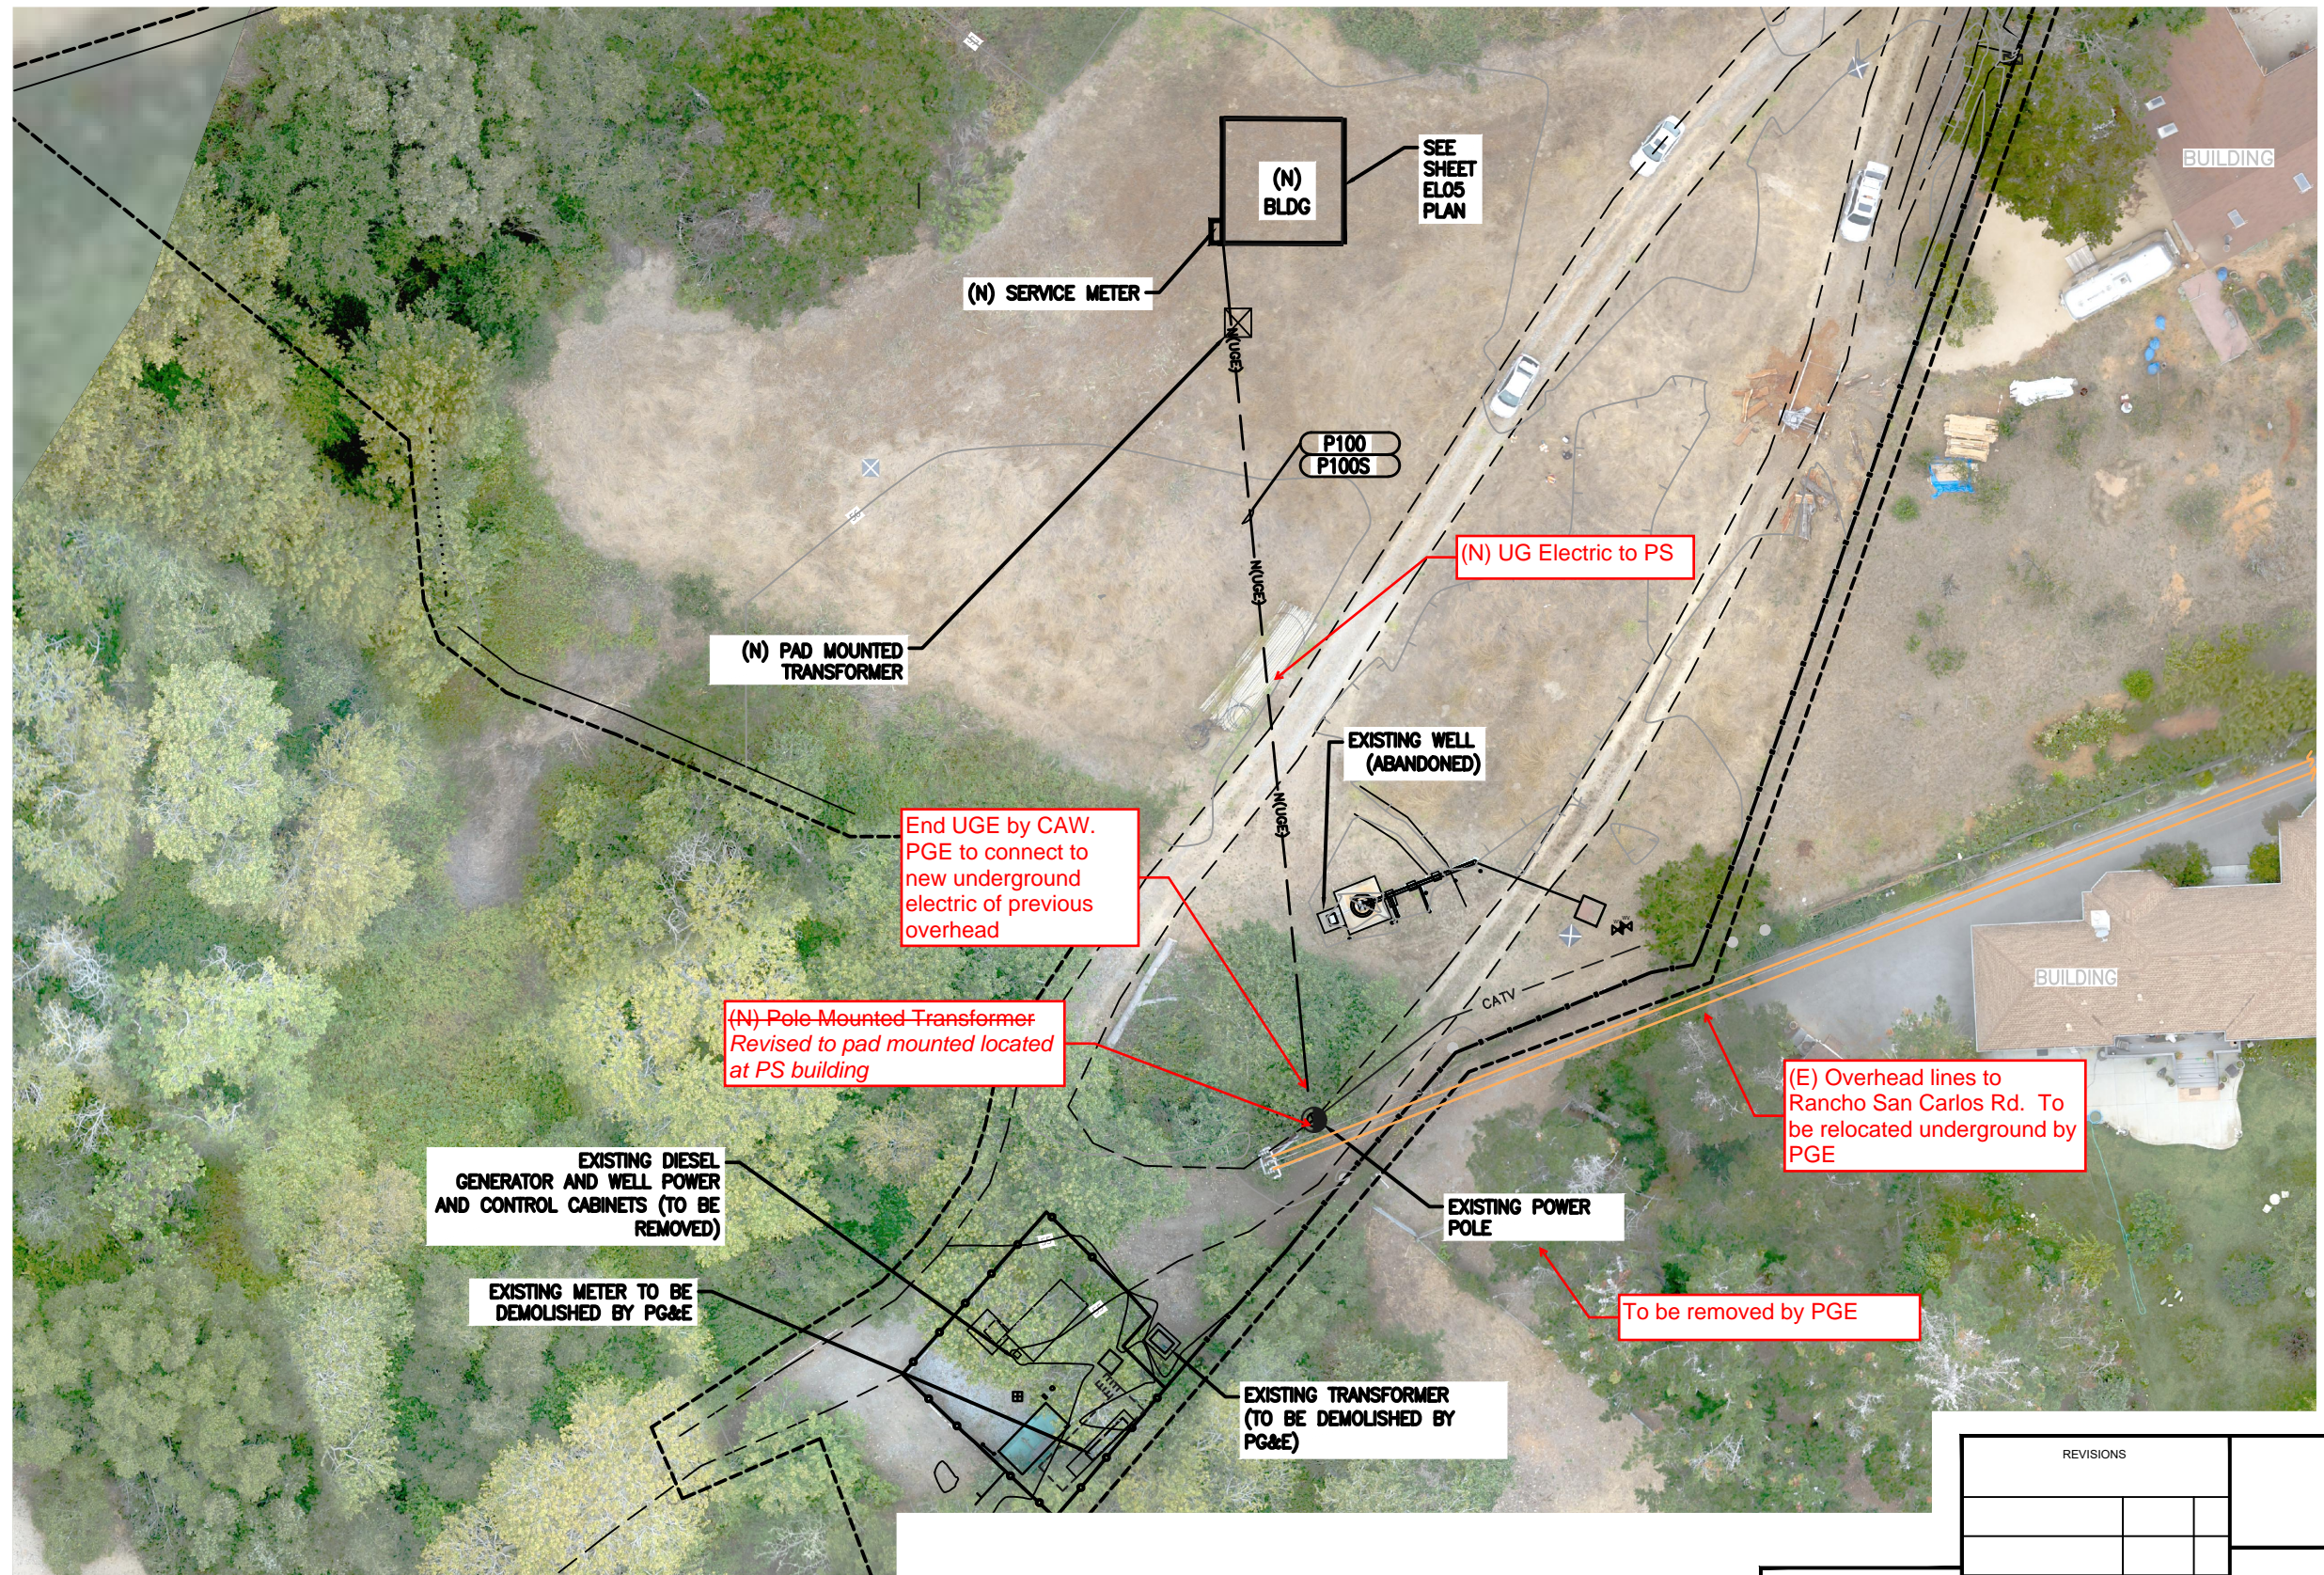
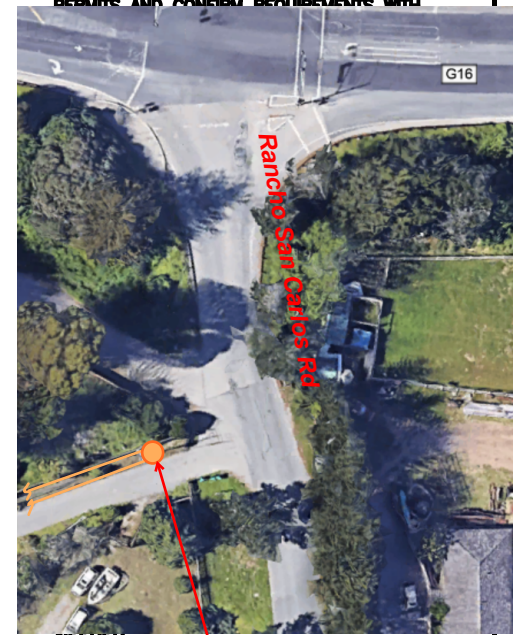
EL03

(E) Power Pole To be removed by PGE

(E) Overhead lines to Rancho San Carlos Rd. To be relocated underground by PGE

(N) Pole Mounted Transformer Revised to pad mounted located at PS building

End UGE by CAW. PGE to connect to new underground electric of previous overhead

(N) UG Electric to PS

(N) PAD MOUNTED TRANSFORMER

CalAm submitted Minor Project Refinement Request (MPR) No. 2 to the CPUC on December 14, 2020. The original project design included installation of underground power lines to connect the Pump Station to an existing Pacific Gas and Electric (PG&E) power pole on the project site. Independent of the project, PG&E plans to underground its existing overhead power lines from the power pole to Rancho San Carlos Road and remove the existing power pole. This independent PG&E project requires that CalAm construct a new 76" x 70" pad-mounted transformer within a small section of the approved gravel yard near the Pump Station that would replace the existing pole-mounted transformer (see attached figures).
