# memorandum

subject MPWSP – Carmel Valley Pump Station Project Weekly Report (11/22/2021 – 11/26/2021)

### CalAm Weekly Report

### **CPUC Inspection Logs**

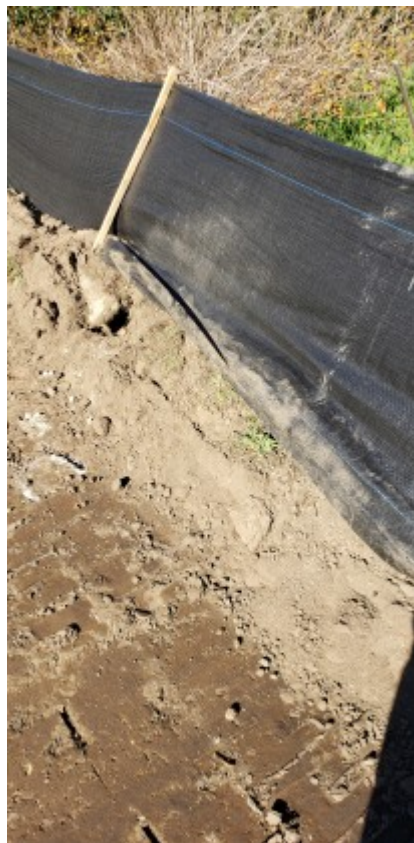
11/24/2021 - Exclusion fence pulled out from ground.

Multiple sections of exclusion fence were damaged and/or not properly keyed-in to the ground. The fencing was not in acceptable condition to prevent special-status amphibians from entering the work area (**Mitigation Measure 4.6-1c** and **Mitigation Measure 4.6-1o**). Water, presumably from the leaking water truck, was observed pooled on site. Per **Mitigation Measure 4.6-1c.15**, water used for dust abatement should be minimized in a way to prevent formation of puddles that could attract wildlife.

- Photographed project site conditions.
- DD&A compliance monitor conducted WEAP training for grading crew.
- DD&A compliance monitor documented sections of the exclusion fencing that had been removed or damaged.
- Biological Lead discussed site conditions with project contractor, requested fence repair, and removal of leaking water truck.

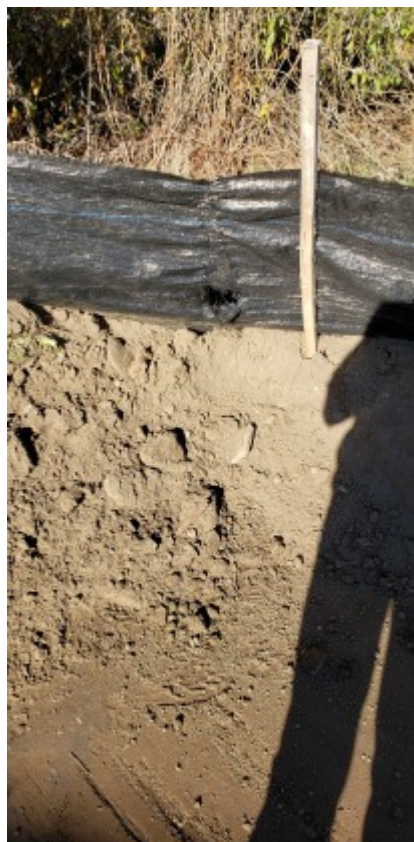
11/24/2021 - Hole in exclusion fence.

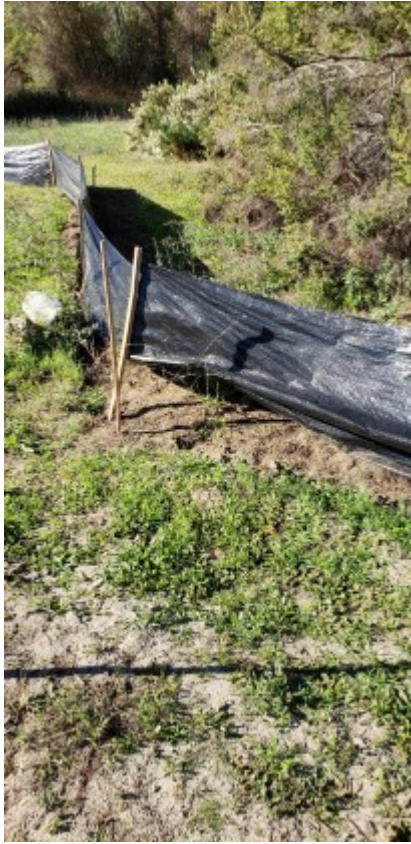
11/24/2021 - Exclusion fence pulled out of ground.

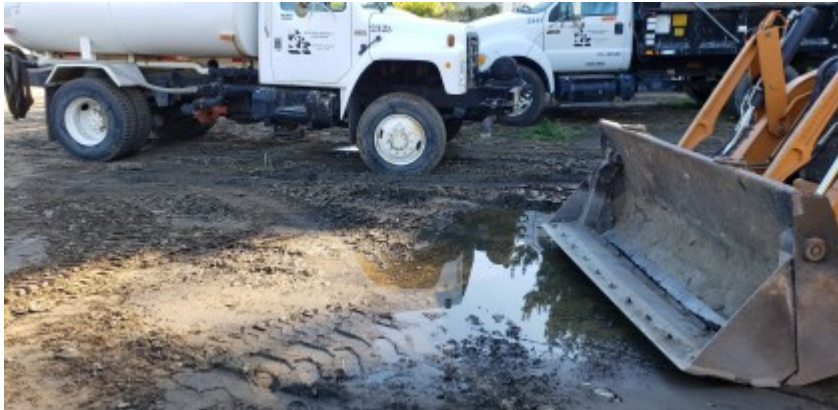
11/24/2021 - Standing water from leaking water truck. MPE to remove truck, repair leak, or discharge water before end of day.

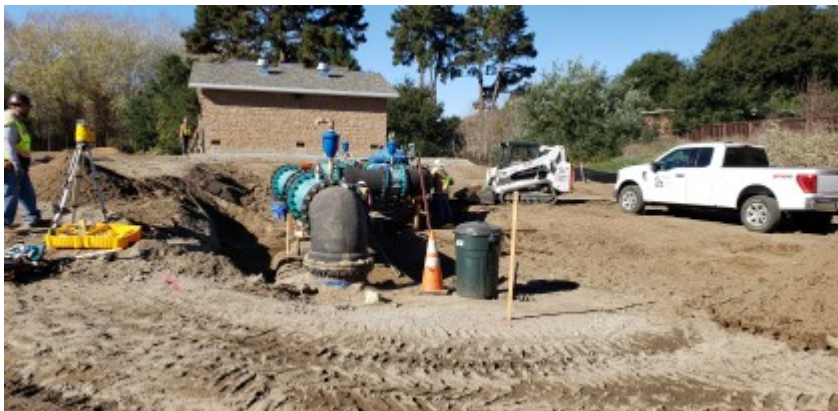
11/24/2021 - Grading activities prior to concrete slab pour.

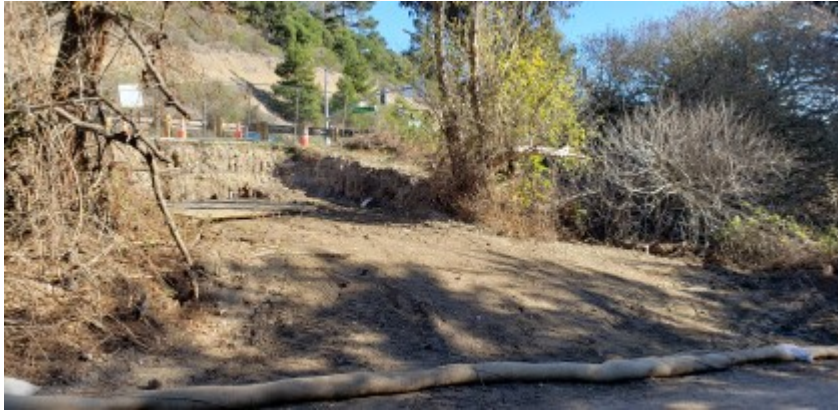
Construction activities observed during the week of 11/22/2021 – 11/26/2021 included grading in preparation for planned concrete pouring. Work was conducted by Monterey Peninsula Engineering (MPE). No additional work was conducted on the tie-in this week as crews finalize methods for dewatering the existing pipeline in Carmel Valley Road.

11/24/2021 - Carmel Valley Road tie in location.

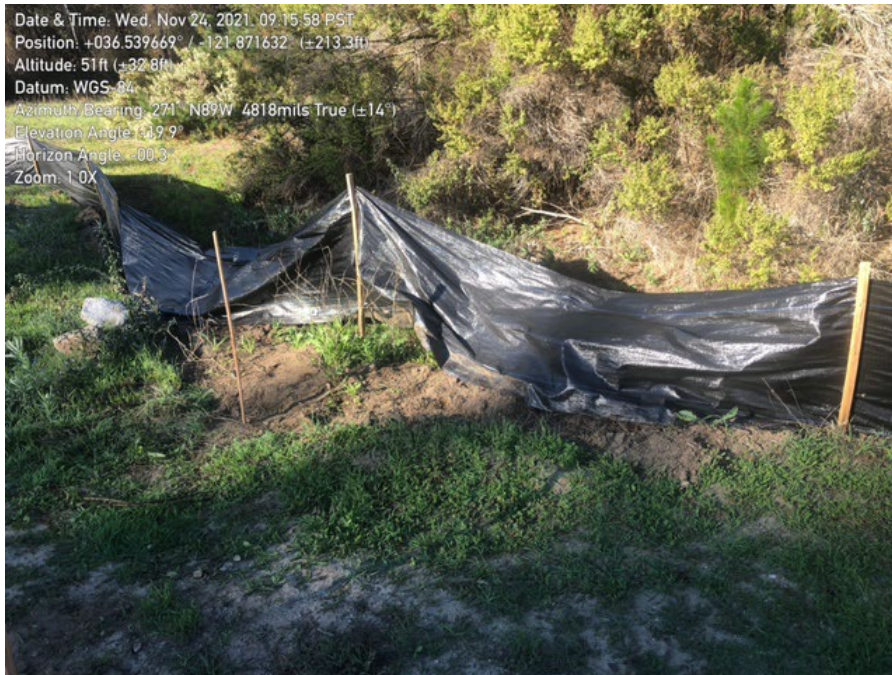
- Silt fence is down/not keyed-in in multiple locations.
- A large puddle of water was observed on site. The water truck nearby was leaking water. Per MM 4.6-1c.15, water used for dust abatement should be minimized in a way to prevent formation of puddles that could attract wildlife.
- MPE conducted worker environmental awareness training for new MPE crew members.
- Spoils stock pile is covered with Visqueen and protected with amphibian-friendly straw wattle.
- Amphibian-friendly BMPs remain installed along access road at pipeline connection point.
- No hazardous materials storage issues observed.

Photo 1. Silt fence not keyed-in.

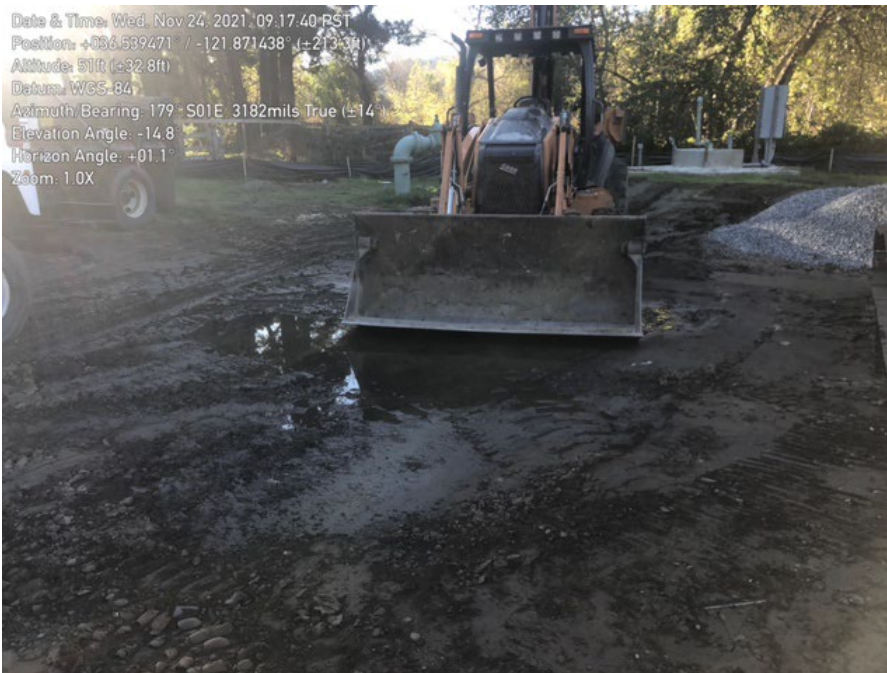
Photo 2. A large puddle has formed on site.

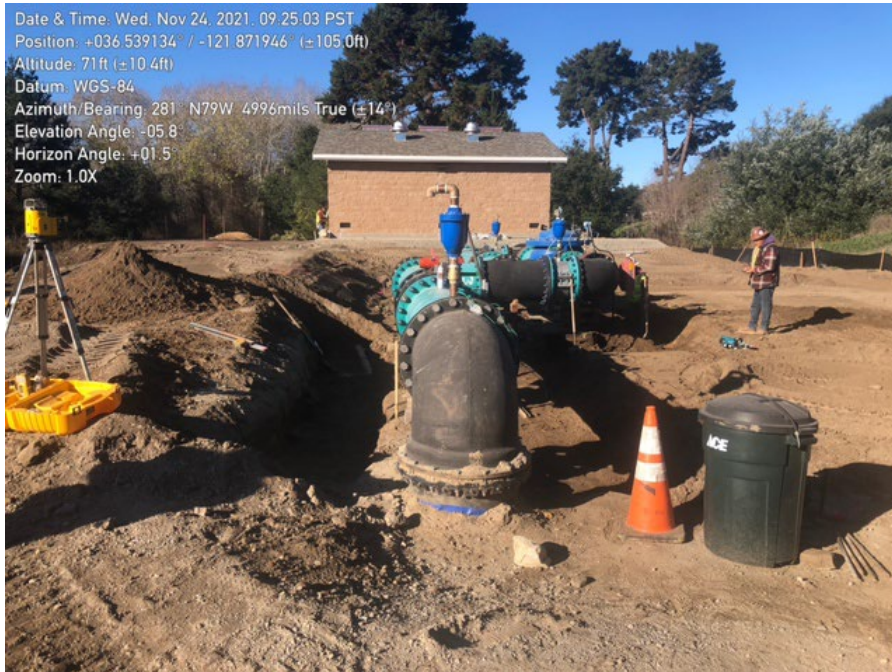
- Monterey Peninsula Engineering (MPE) preparing area around above ground piping for concrete pad installation.
- Denise Duffy & Associates (DD&A) compliance monitor on site.

Photo 3. Prep for concrete pour.
