**PRELIMINARY DELINEATION OF WATERS OF THE UNITED STATES
INCLUDING WETLANDS, FOR THE**

**ESTRELLA SUBSTATION AND PASO ROBLES AREA
REINFORCEMENT PROJECT**

September 2017

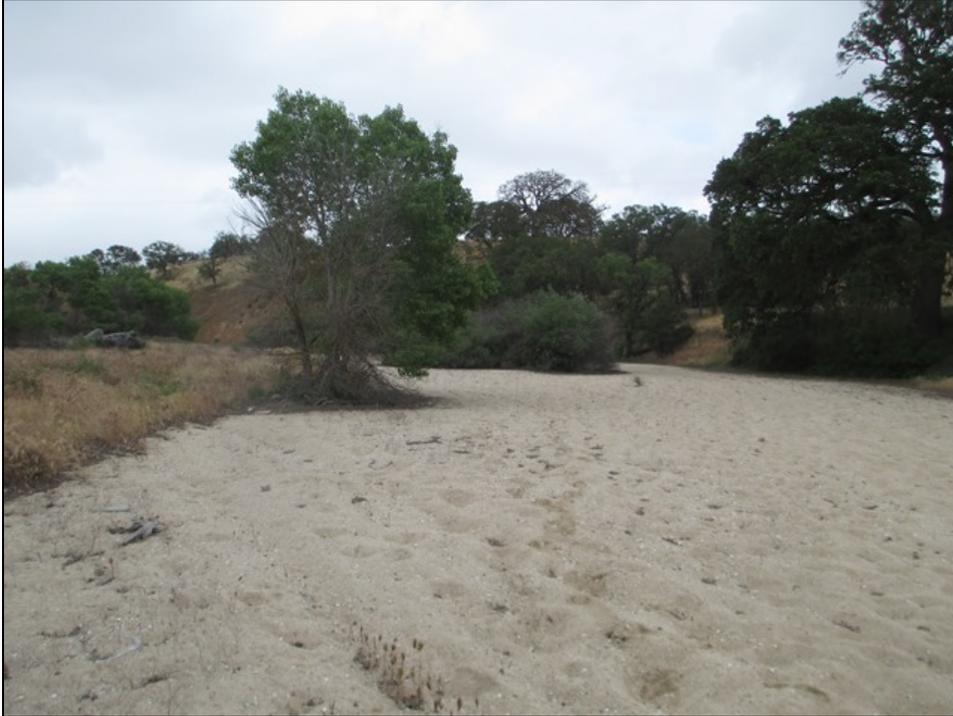
**PHOTO 1.
RUB-1: Huerhuero
Creek**

View facing
northwest along
Huerhuero Creek
showing clearly
visible OHWMs and
the adjacent
floodplain.

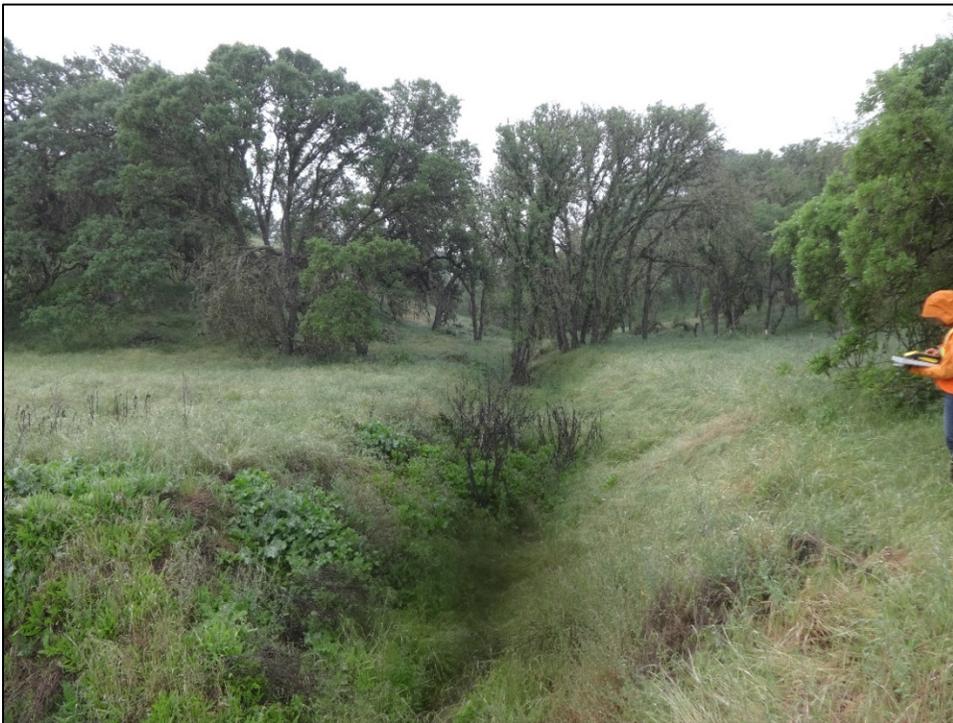
**PHOTO 2.
RUB-2: Unnamed
Tributary to
Huerhuero Creek**

View facing south
showing the
ephemeral drainage
feature along the
south side of Union
Road.

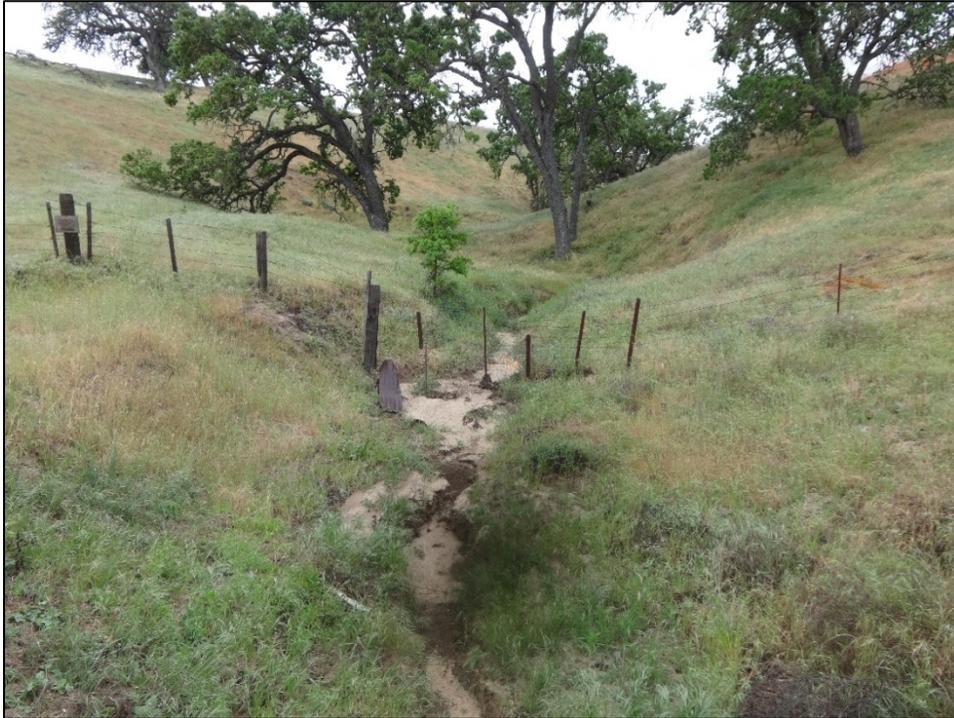
PHOTO 3.
RUB-3: Unnamed
Tributary to
Huerhuero Creek

View facing south showing the ephemeral drainage feature along the south side of Union Road.

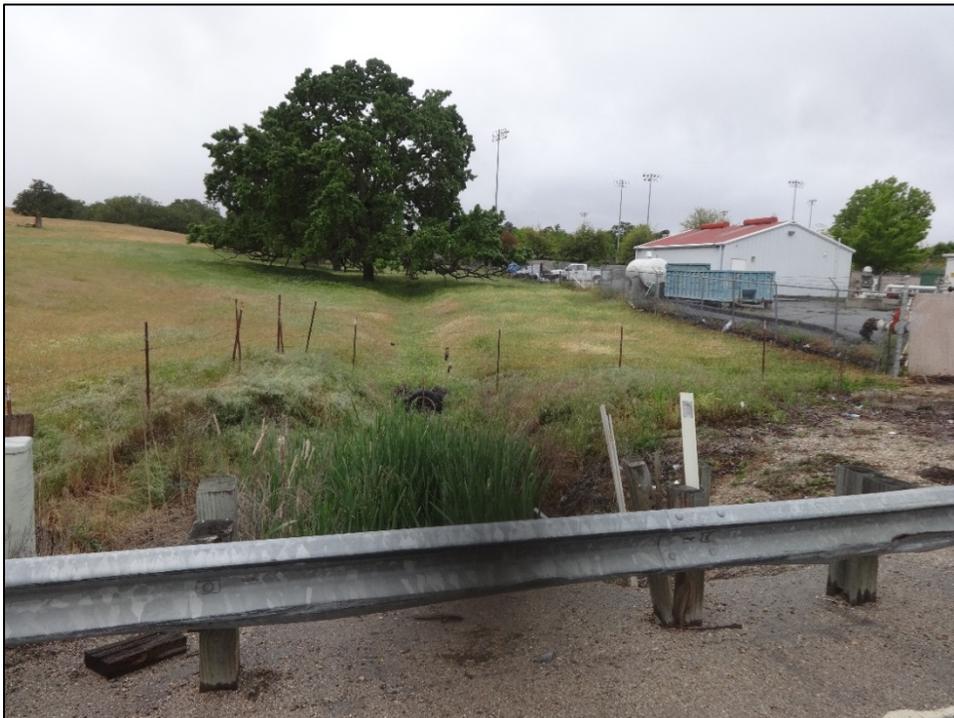
PHOTO 4.
RUB-4: Unnamed
Tributary to
Huerhuero Creek

Upstream of Union Road, the drainage channel and surrounding habitat consists of annual grasses and forbs, most notably ripgut brome and foxtail barley (*Hordeum jubatum*). Immediately upstream of the Union Road culvert crossing, a dense stand of emergent cattail was observed growing in a pool of standing freshwater. Just beyond the cattail, on the downstream (north) side of Union Road, a dense narrow strand of coyote brush lines the drainage feature. Although the NWI maps this portion of the channel as freshwater emergent wetland, the channel lacked a dominance of hydrophytic vegetation and therefore soil pits were not examined.

View facing south showing the ephemeral drainage feature along the south side of Union Road.

Note the stand of emergent cattail near the culvert inlet.

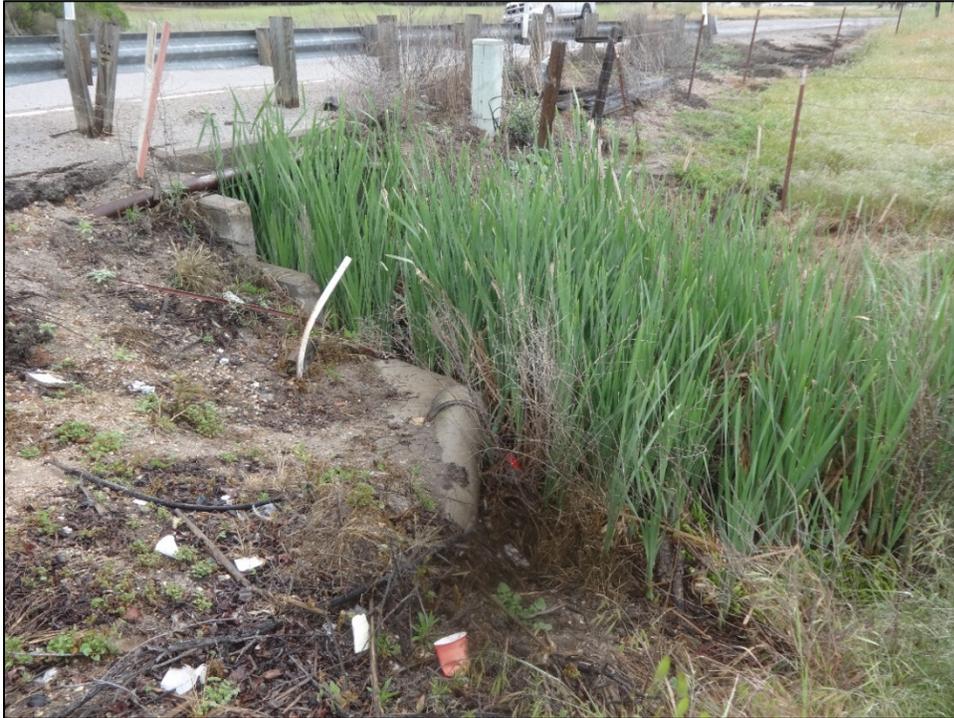
PHOTO 5.
RUB-4: Unnamed
Tributary to
Huerhuero Creek

View facing
northeast showing
ponded water and
cattails growing near
the culvert inlet at
RUB-4.

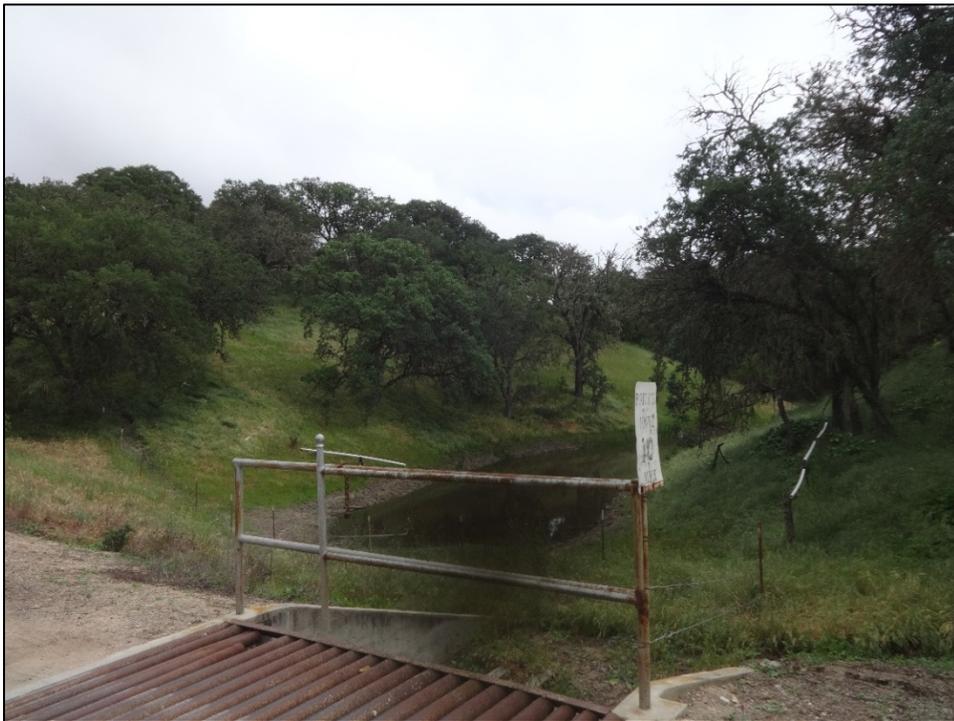
PHOTO 6.
RUB-5: Unnamed
Tributary to
Huerhuero Creek

RUB-5 flows through blue oak woodlands containing a relatively dense canopy of blue oak and valley oak trees with an understory of nonnative annual grasses. The majority of the bed and banks of the drainage channels were vegetated with annual grasses, with the exception of the low-lying area between the confluence and the dam/roadway, which was ponded with water. No emergent vegetation was observed in the ponded area.

View facing south
showing ponded
water in the drainage
feature along
RUB-5.

Note the manmade
dam and spillway in
bottom of photo.

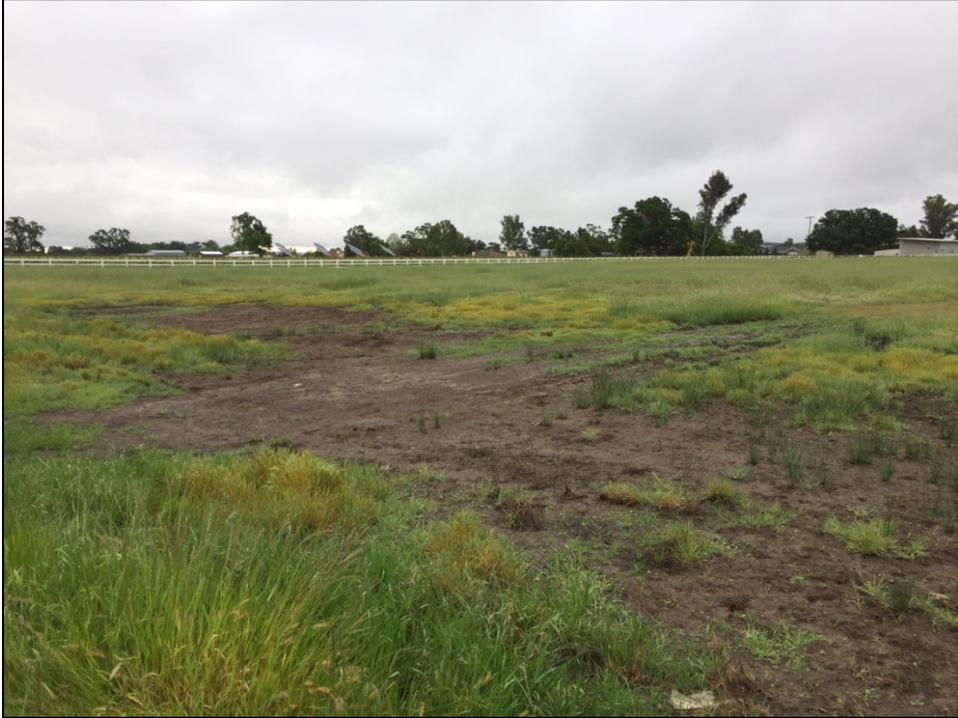
PHOTO 7.
PEW-1: Seasonal Wetland

A large, low-lying depression was observed in an open field approximately 115 feet east of Buena Vista Drive. Two sample points were investigated: Sample Point 4 was located within the seasonal wetland and Sample Point 5 was located upslope in what the delineators presumed to be uplands (refer to Appendix A, Sheet 5; Appendix D, Photos 7 and 8).

The seasonal wetland, which is visible on aerial imagery, is located in an open field dominated by annual grasses and forbs. Vegetation in Sample Point 4 consisted of common spikerush (*Eleocharis macrostachya*; obligate wetland [OBL]), saltgrass (*Distichlis spicata*; facultative [FAC]), coyote thistle (*Eryngium vaseyi*; facultative wetland [FACW]), erect dwarf cudweed (*Hesperexax sparsiflora*; facultative upland [FACU]), and an unknown *Downingia* species (OBL). The dominance of common spikerush and saltgrass was sufficient to pass the hydrophytic vegetation dominance test. The investigation revealed silty loam and clay soil that was moist throughout the pit. The soil on the surface down to 3 inches was silty loam (10YR 3/2) with reddish-brown concentrations (5YR 4/6) in the matrix, and clay soil (7.5YR 5/1) occurred from 3 down to 16 inches with the same concentrations (5YR 4/6) in the matrix. The redox concentrations and matrix value and chroma met the criteria for Depleted Matrix (F3). Large surface soil cracks were observed throughout the seasonal wetland, meeting the criteria for wetland hydrology indicator B6. The field investigation was conducted immediately following a rain event; however, no ponding was observed in the low-lying area. Sample Point 4 contains a presence of hydrophytic vegetation, hydric soils, and wetland hydrology.

View facing west showing the seasonal wetland that contained evidence of hydrophytic vegetation, hydric soils, and wetland hydrology.

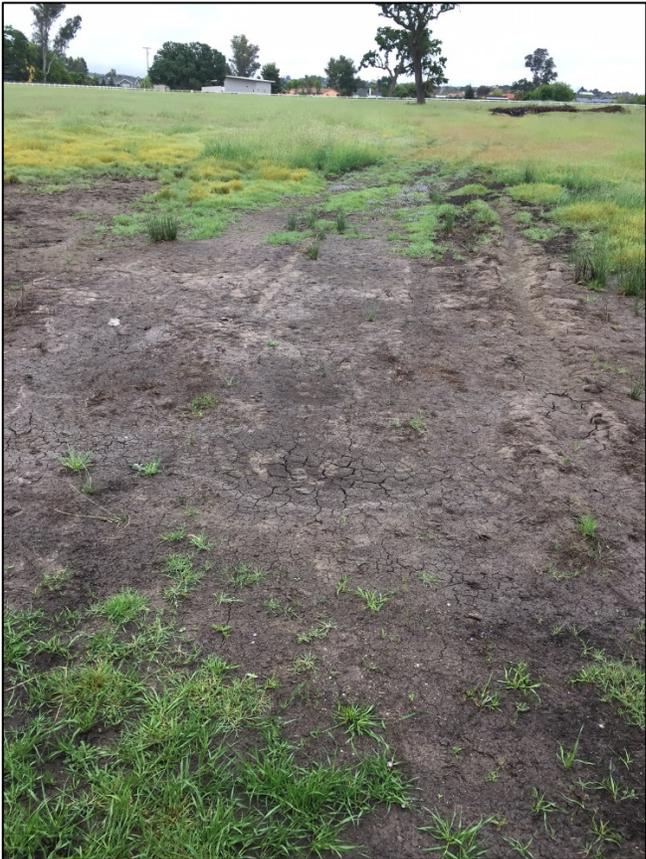
PHOTO 8.
PEW-1: Seasonal Wetland

View facing south showing the cracked soils in the seasonal wetland.

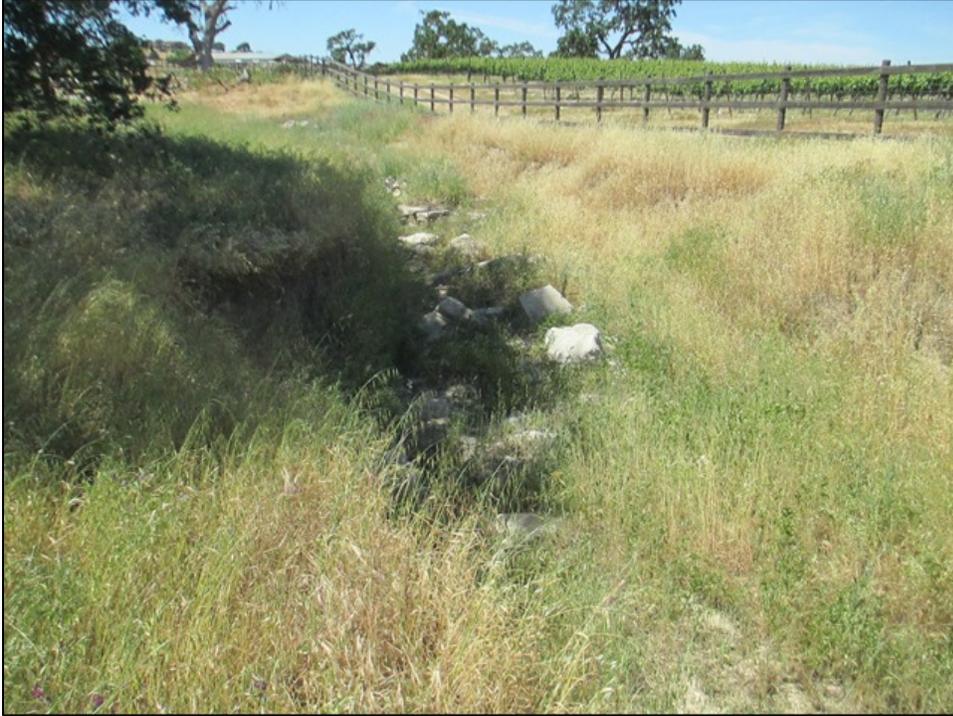
PHOTO 9.
RUB-6: Unnamed
Tributary to
Huerhuero Creek

Consistent with what was observed during the field investigation, the Web Soil Survey shows Arbuckle-San Ysidro complex, 2 to 9 percent slopes (Soil Map Symbol 106) in the delineation area. This soil type is listed as a hydric soil on the NRCS Hydric Soils List (NRCS 2003). Large blocks of concrete debris were scattered along the bed and banks, likely as an erosion control mechanism. Further downstream beyond the concrete rubble, scouring is more evident along the bed of the channel.

View facing north
showing concrete
debris scattered
through the
ephemeral drainage
feature.

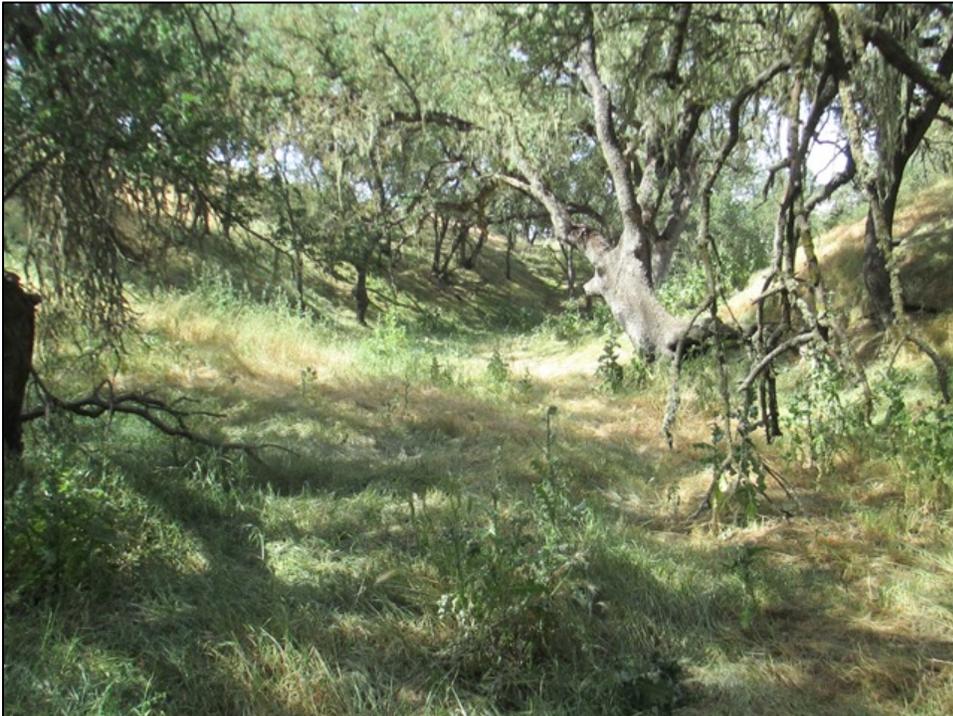
PHOTO 10.
RUB-7: Unnamed
Tributary to Salinas
River

View facing
northwest showing
ephemeral drainage
feature.

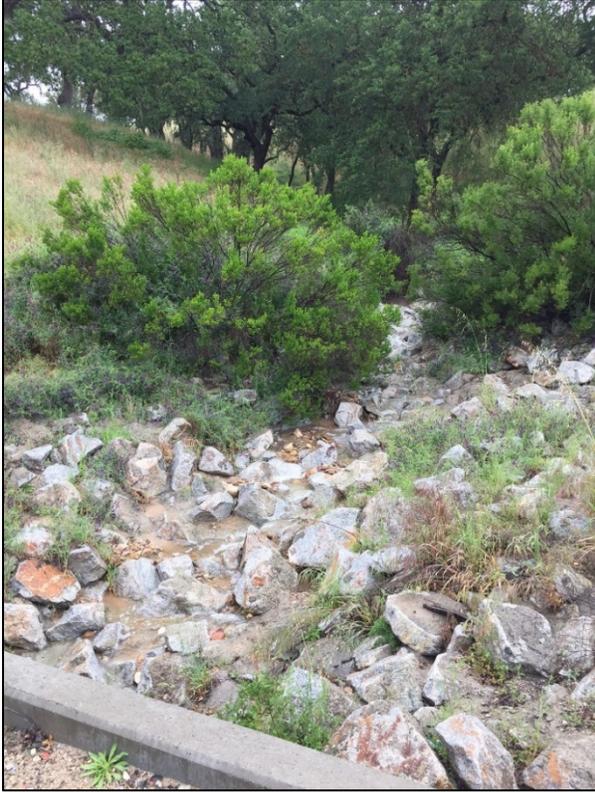
PHOTO 11.
RUB-8: Unnamed
Tributary to Salinas
River

Rock slope protection lines the bed and banks of the channel for approximately 50 feet at the River Road culvert inlet. The remainder of the channel generally consists of sandy loam soils. Consistent with what was observed during the field investigation, the Web Soil Survey shows Arbuckle-Positas complex, 30 to 50 percent slopes (Soil Map Symbol 104) occurring along the

View facing northeast showing ephemeral drainage feature with rock slope protection around the culvert inlet.

Note storm water flowing through the channel.

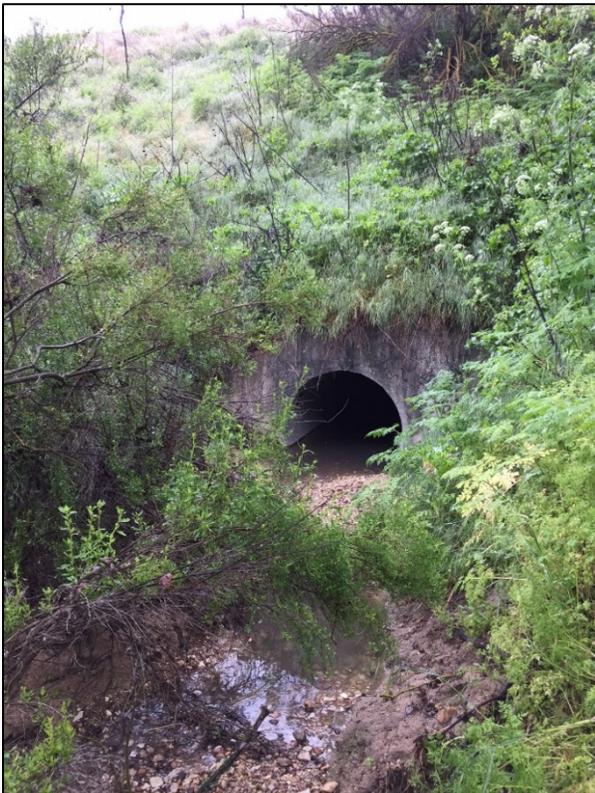
PHOTO 12.
RUB-9: Unnamed
Tributary to Salinas
River

View facing east showing where the culvert crossing beneath CA-46 drains out into a short (approximately 40-foot-long) ephemeral drainage channel before flowing back into another culvert that connects to the Salinas River riparian corridor.

Note flowing water in the channel.

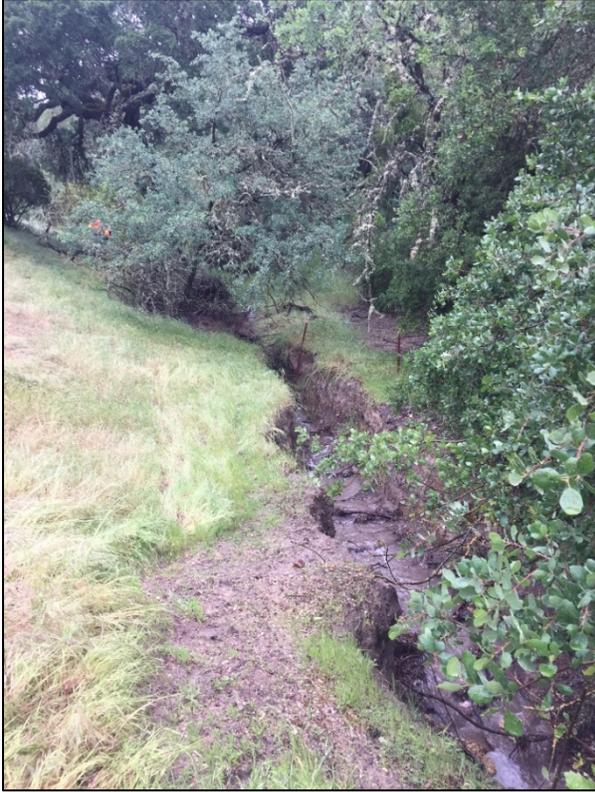
PHOTO 13.
RUB-10: Unnamed
Tributary to Salinas
River

RUB-10 flows through blue oak woodlands with a dense overhead canopy and an understory of annual grasses and forbs. A large patch of skunkbush (*Rhus aromatic*; FACU) was observed along the northern perimeter of the channel. No hydrophytic vegetation was observed. The banks of the drainage channel were devoid of vegetation.

Consistent with what was observed during the field investigation, the Web Soil Survey shows Nacimiento-Los Osos complex, 30 to 50 percent slopes (Soil Map Symbol 180) along the drainage channel. The banks were steep, with evidence of scouring and erosion along the length of the channel. Although a soil pit was not dug at this location, eroded banks exposed silty shaley soils.

View facing east
showing the
ephemeral drainage
channel.

Note scouring along
the banks and water
flowing through the
channel.

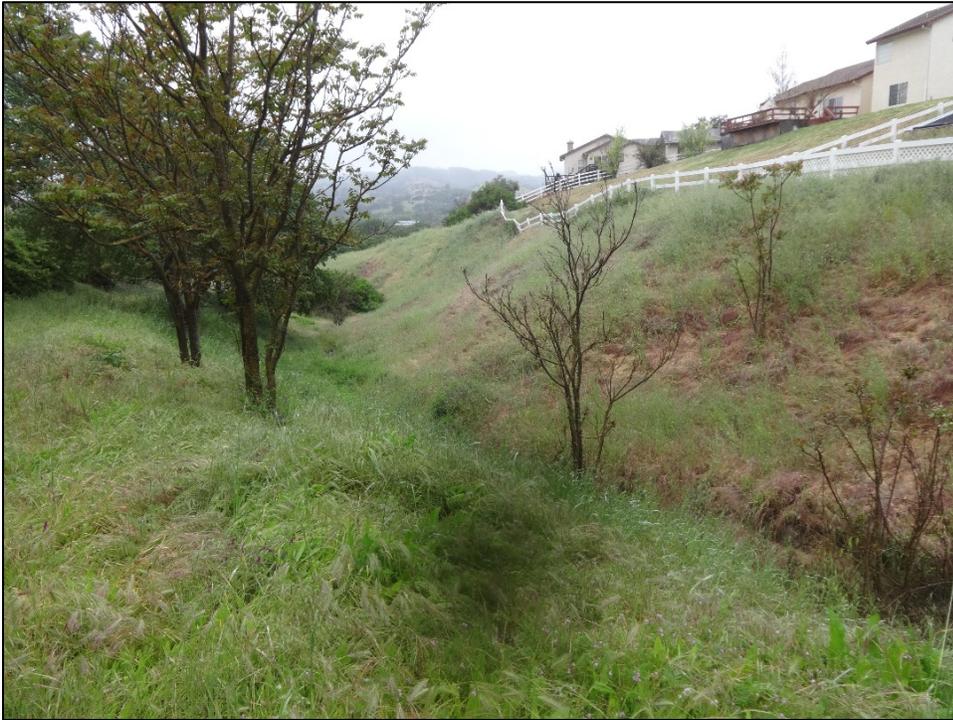
PHOTO 14.
RUB-11: Unnamed
Tributary to Salinas
River

View facing west
showing the
ephemeral drainage
channel.

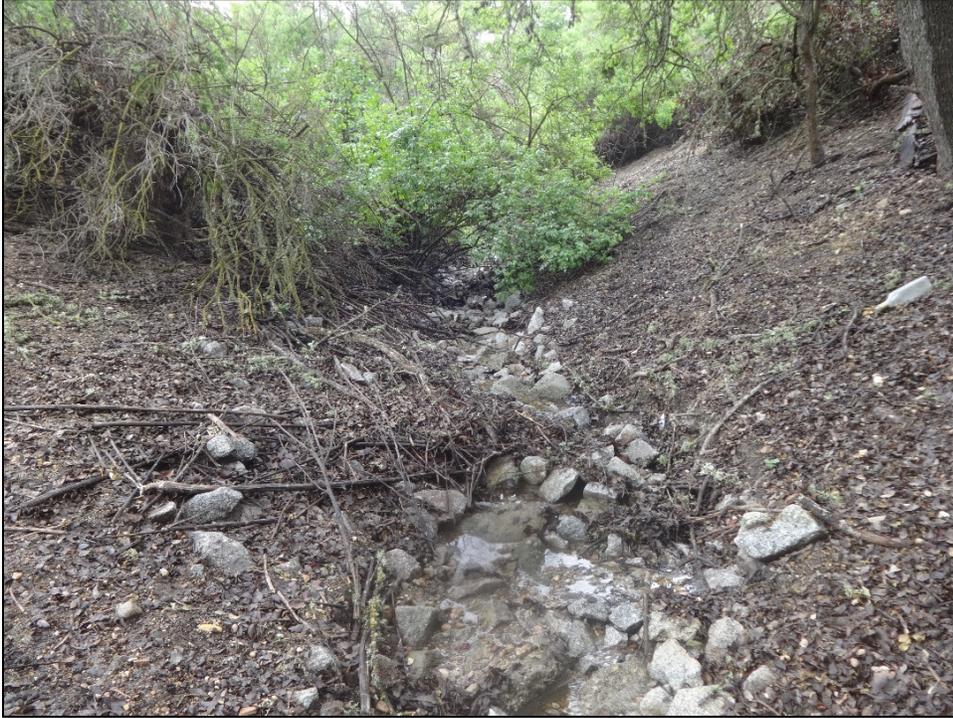
PHOTO 15.
RUB-12: Unnamed
Tributary to Salinas
River

View facing east
showing the
ephemeral drainage
channel.

Note water flowing
through the rock-
lined channel.

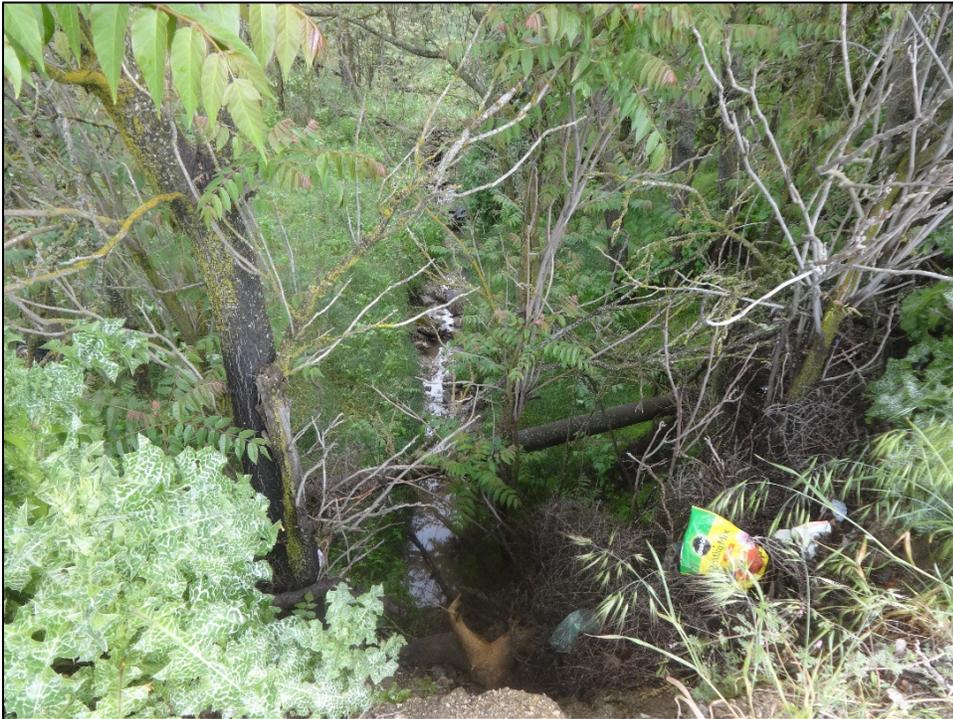
PHOTO 16.
RUB-14: Unnamed
Tributary to Salinas
River

View facing east
looking down from
above the culvert
inlet, showing the
storm water flowing
through the
ephemeral drainage
channel.
